## **RCRA Inspection Report**

Wilbert Plastic Services  
2930 Greenville Highway  
Easley, Pickens County, South Carolina 29640

EPA ID No. SCD982126146

June 16, 2021

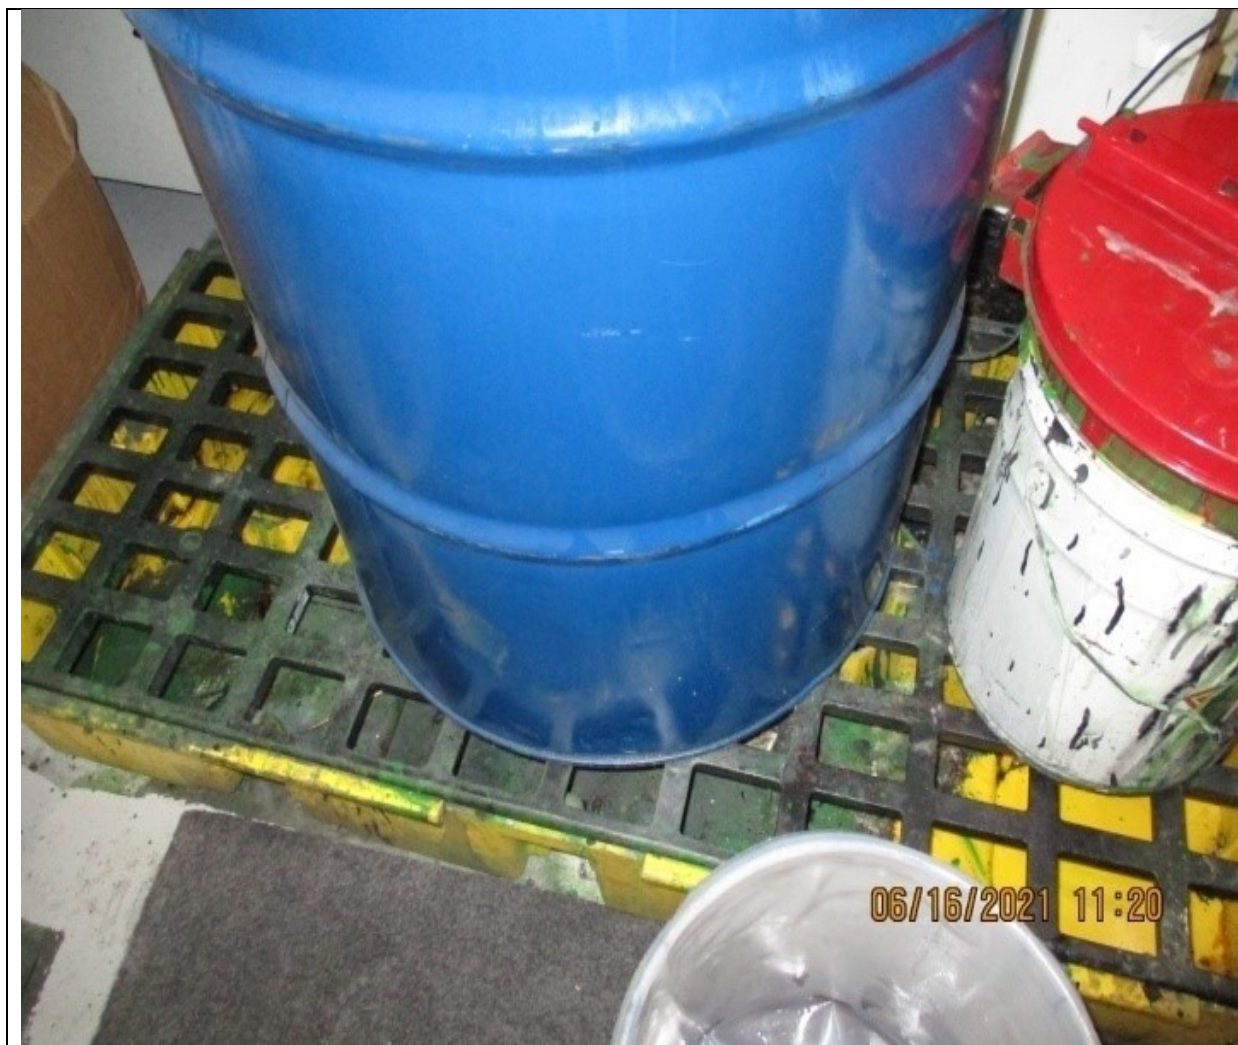
Wilbert manages a hazardous waste SAA across from the Robotic Paint Storage Shed. The inspectors observed one 55-gallon container accumulating hazardous waste in this SAA. The inspectors observed the container was on a spill pallet, closed, labeled with the words hazardous waste (flammable liquids NOS (Toluene, Xylene) Paint & Solvent D001/D035/F003/F005 with profile number 660352) and labeled with a flammable hazard indicator. The inspectors also observed one 5-gallon container used for storing the funnel for the 55-gallon container. The inspectors observed visible paint waste was accumulating in the bottom of the container and a paint spill in the spill pallet at the time of this inspection (SCDHEC Photographs 14, 16, 17 and 18). Although the 5-gallon container was labeled with a flammable hazard indicator, it was not closed or labeled with the words “Hazardous Waste.”

Wilbert. Robotic Paint SAA. The inspectors observed a release/spill of hazardous waste. Photograph 16 taken by SCDHEC at 11:20 a.m. The SCDHEC Photographs in this report document the Photograph number used in the State of South Carolina report.

**Pursuant to 25 S.C. Code Ann. Regs. 61-79.262.90, which is a condition of the LQG Permit Exemption, A generator must clean up any hazardous waste discharge that occurs during generation or processing or storage and take such other action as may be required or approved by Federal, State, or local officials so that the hazardous waste discharge no longer presents a hazard to human health or the environment. See also 262.34(a)(4) and 265 Subpart D.**

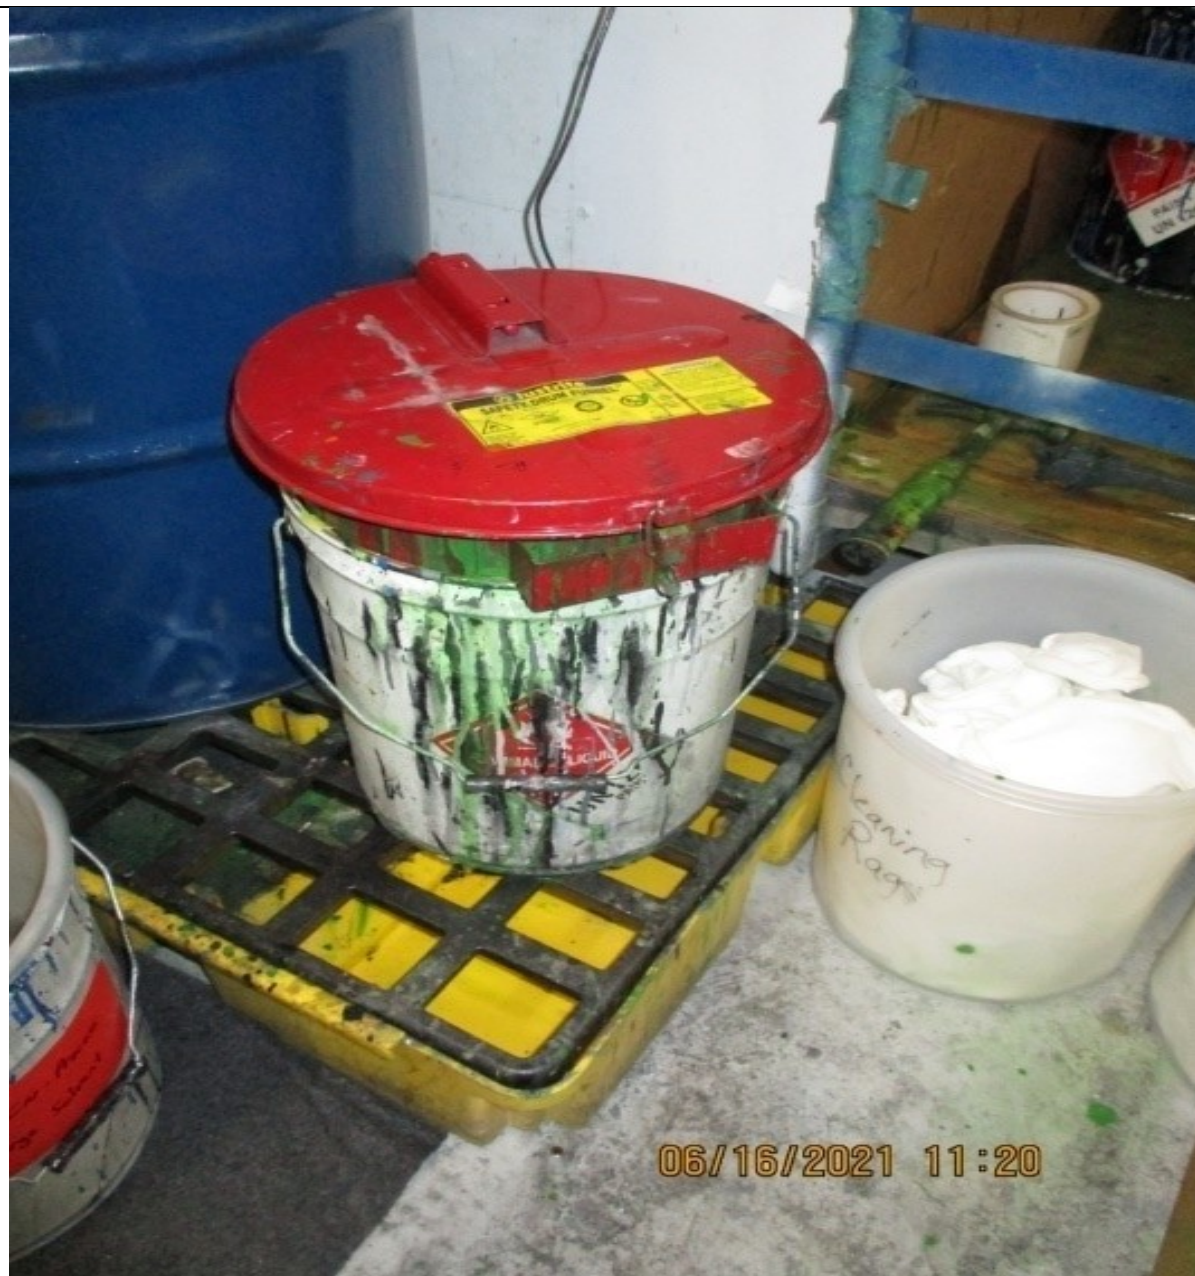
Wilbert. Robotic Paint SAA. The inspectors observed a 5-gallon container with a funnel accumulating hazardous waste. Photograph 17 taken by SCDHEC at 11:20 a.m. The SCDHEC Photographs in this report document the Photograph number used in the State of South Carolina report.

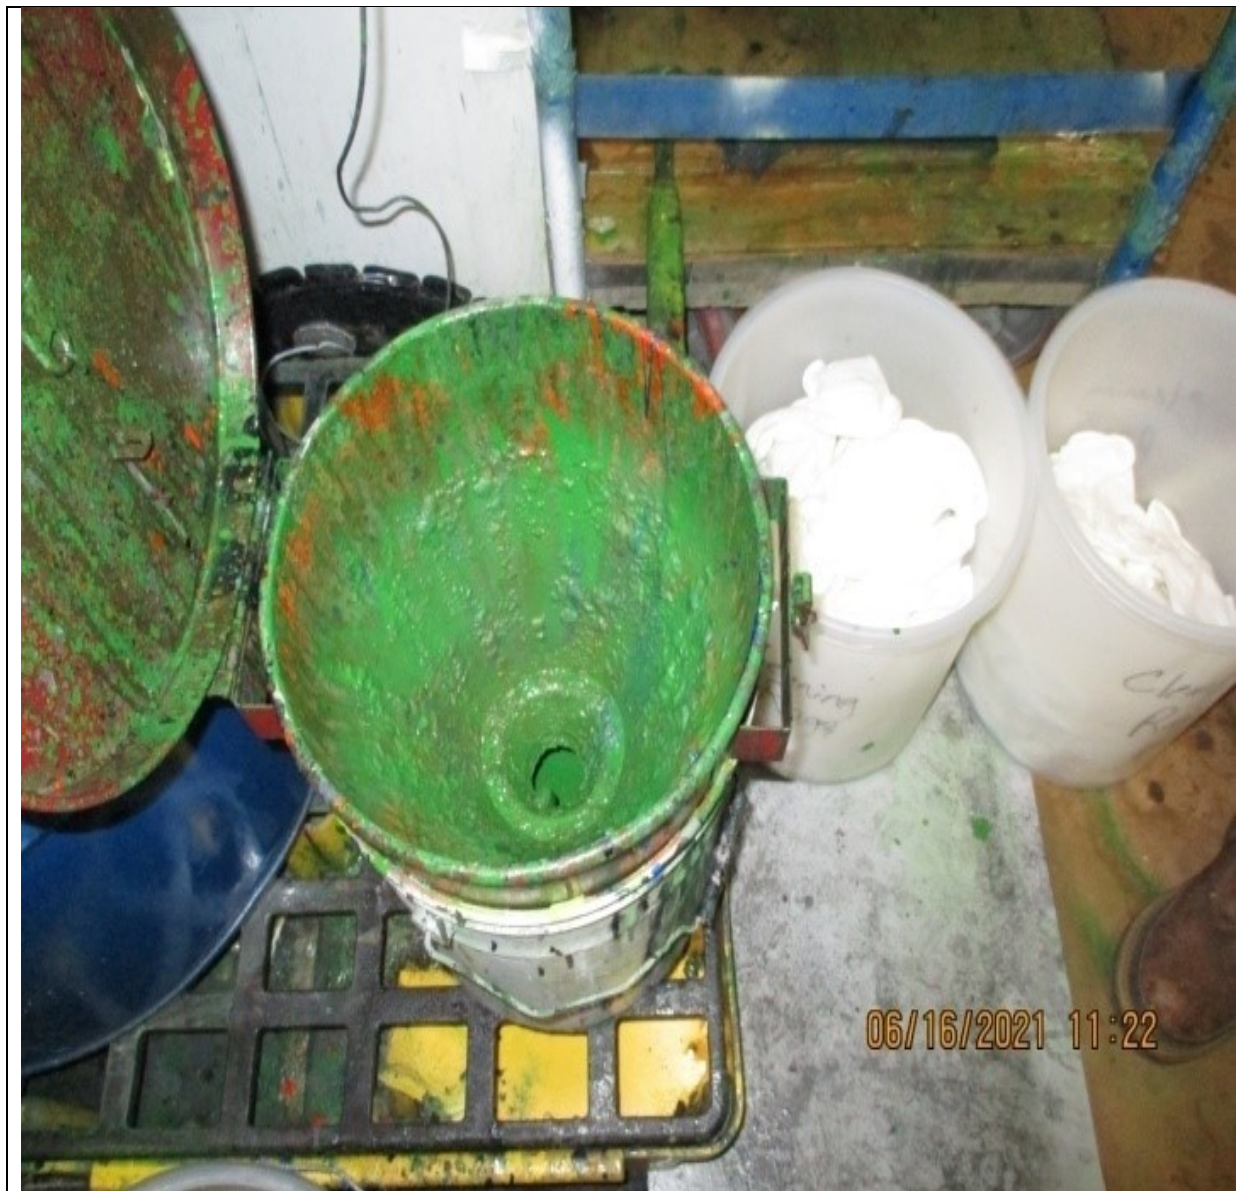
Wilbert. Robotic Paint SAA. The inspectors observed a 5-gallon container with a funnel accumulating hazardous waste. Photograph 18 taken by SCDHEC at 11:22 a.m. The SCDHEC Photographs in this report document the Photograph number used in the State of South Carolina report.

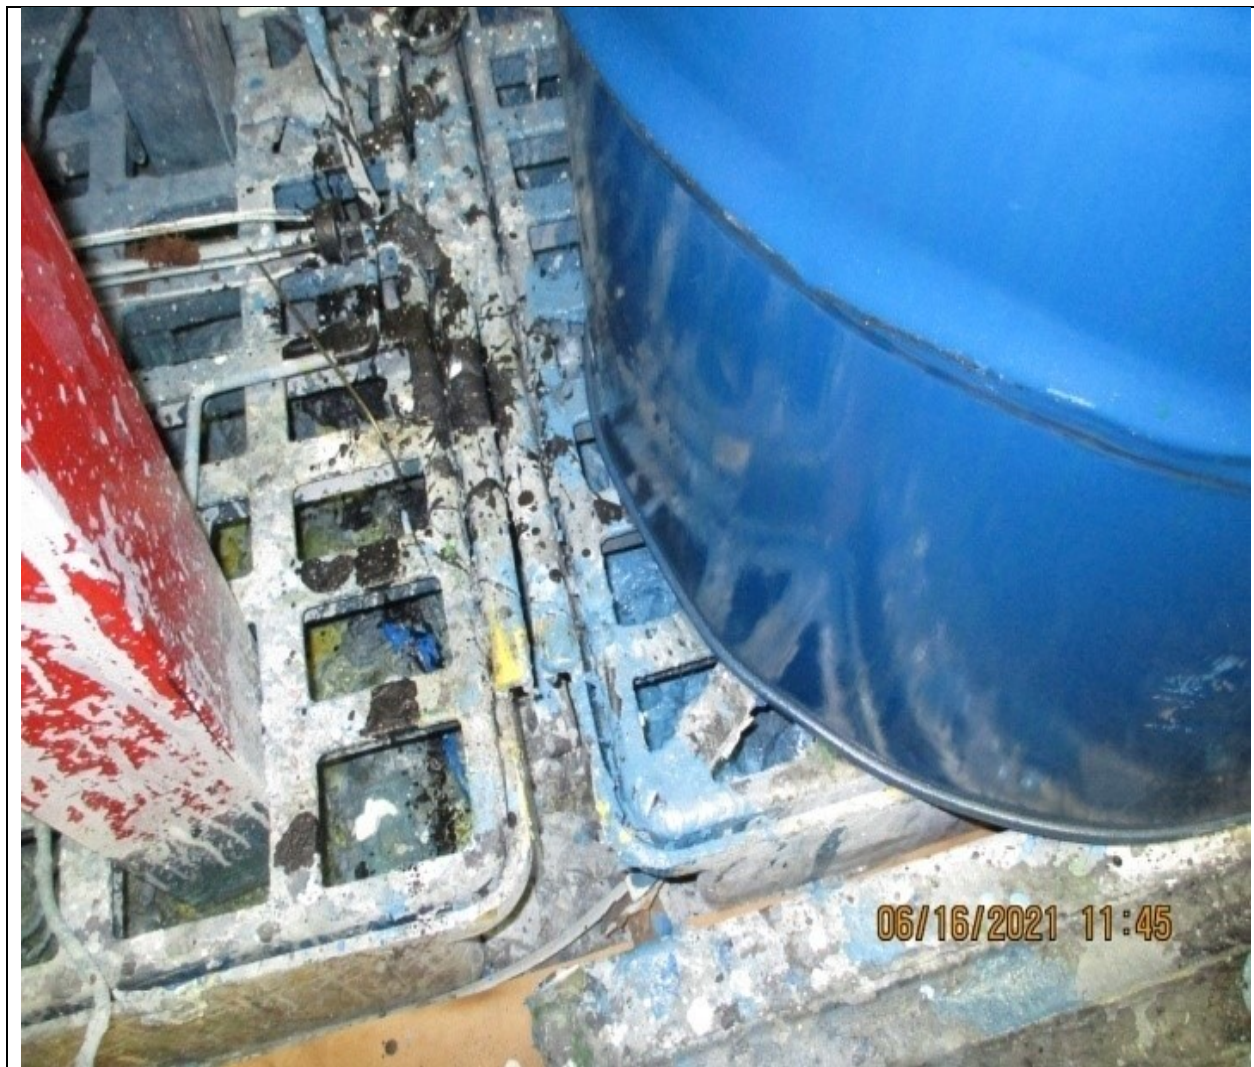
Paint and solvent products are mixed in 55-gallon containers for use in the paint booths. Wilbert manages a hazardous waste SAA in the Paint Mix Room for accumulating hazardous waste (xylene and toluene D001, D035, F003, F005). The inspectors observed one 55-gallon drum on a spill pallet in this SAA. The inspectors observed the container was closed, in good condition, labeled with the words hazardous waste and marked with a flammable hazard indicator. The spill pallet had a visible spill(s) of paint at the time of the inspection (SCDHEC Photograph 28).

Wilbert. Paint Mix Room SAA. The inspectors observed a release/spill of hazardous waste. Photograph 28 taken by SCDHEC at 11:45 a.m. The SCDHEC Photographs in this report document the Photograph number used in the State of South Carolina report.

**Pursuant to 25 S.C. Code Ann. Regs. 61-79.262.90, which is a condition of the LQG Permit Exemption, A generator must clean up any hazardous waste discharge that occurs during generation or processing or storage and take such other action as may be required or approved by Federal, State, or local officials so that the hazardous waste discharge no longer presents a hazard to human health or the environment. See also 262.34(a)(4) and 265 Subpart D.**

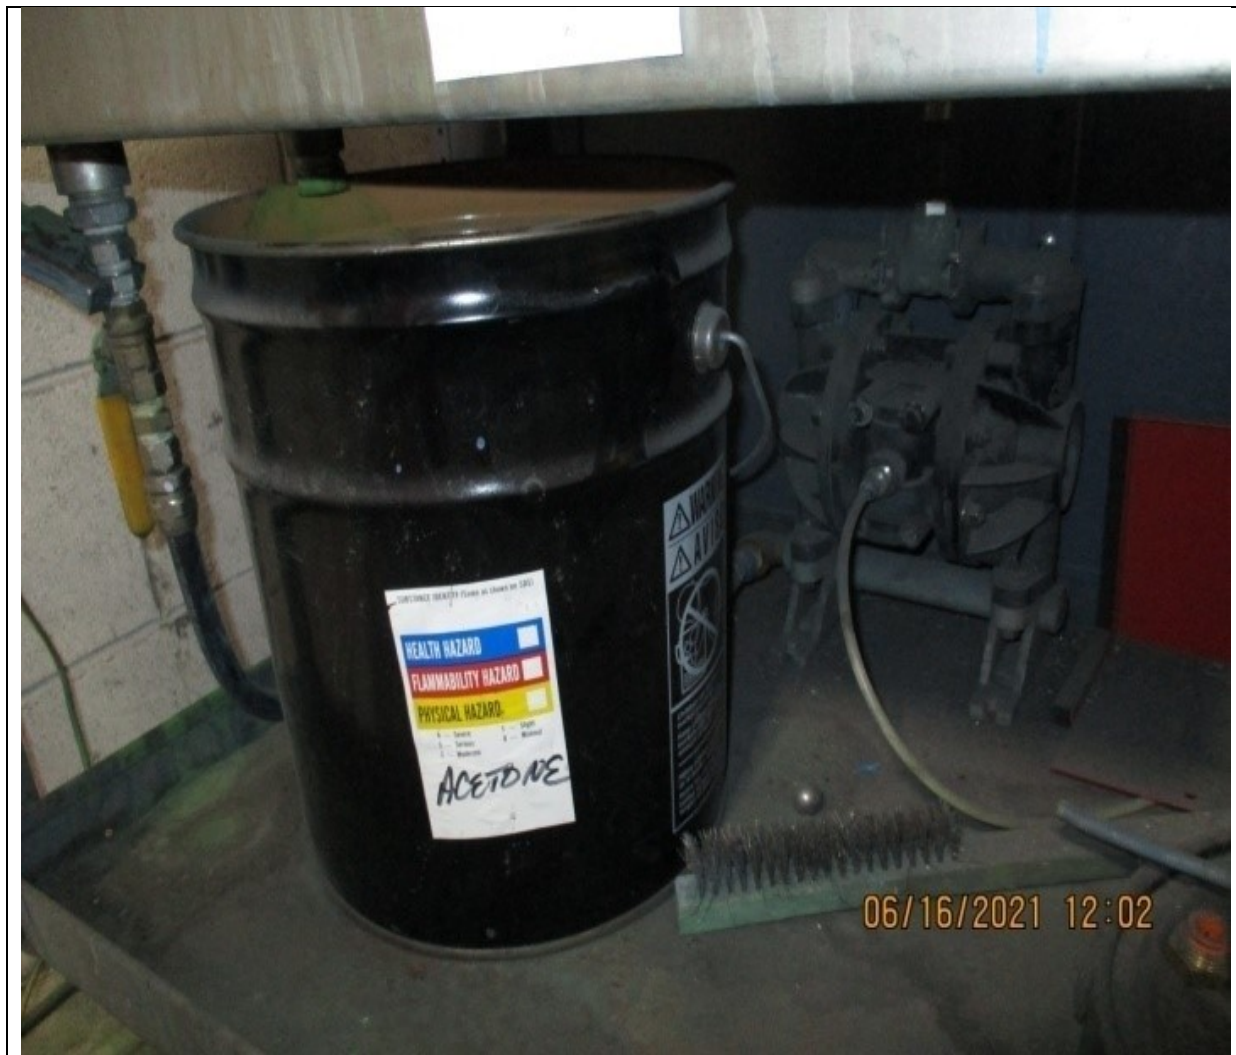
Wilbert. Paint Maintenance Shop. The inspectors observed a part washer with a 5-gallon container accumulating waste acetone. Photograph 33 taken by SCDHEC at 12:02 p.m. The SCDHEC Photographs in this report document the Photograph number used in the State of South Carolina report.

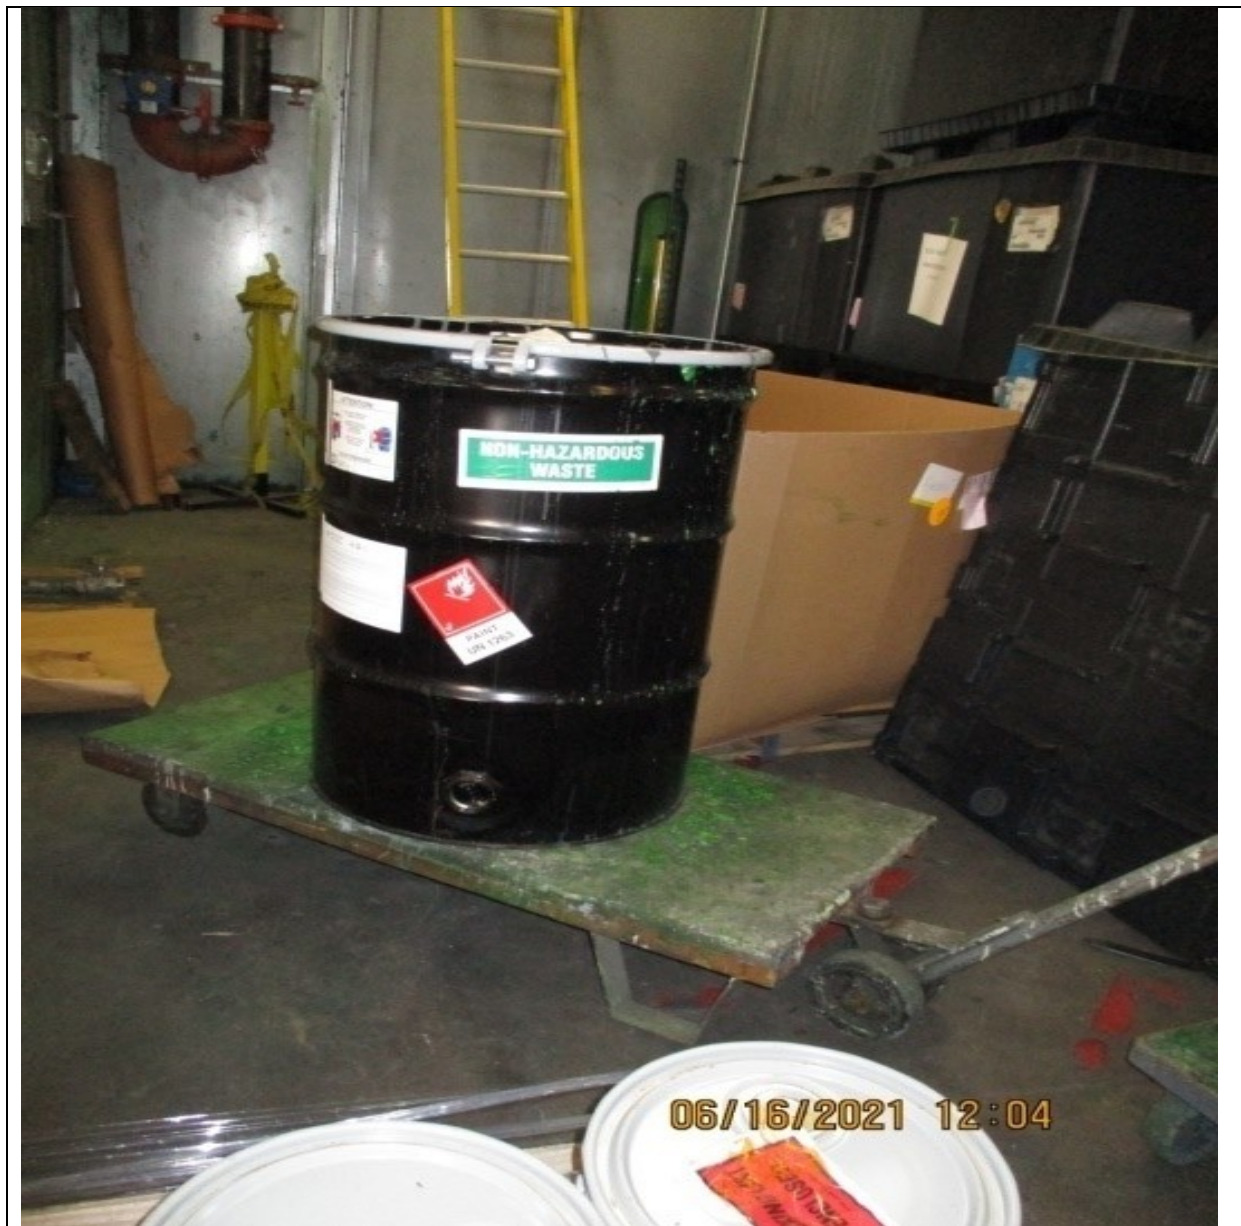
The Primer Booth is equipped with a waterfall curtain to capture the paint emissions. The water is recirculated in a trough located behind the paint booth. Wastewater generated from the operation is shipped approximately one time per year. Paint solids are separated from the water by the addition of Poly D-Tac SF, resulting in the paint solids floating on the water surface. Mr. Putman indicated the pH range of the system is 9-11 and explained the paint solids are periodically removed from the trough and accumulated in a 55-gallon container. The inspectors observed a 55-gallon container on a cart in this area accumulating paint solids. The inspectors observed the container was closed, labeled with the words non-hazardous waste, and labeled with a flammable hazard indicator (SCDHEC Photograph 35). Documentation that an accurate waste determination was performed on the wastewater and paint solids was not observed in the record review.

Wilbert. Paint Booth Wash Water Area. The inspectors observed paint solids accumulating in a 55-gallon container generated from the wash water booth. Photograph 35 taken by SCDHEC at 12:04 p.m. The SCDHEC Photographs in this report document the Photograph number used in the State of South Carolina report.

**Pursuant to 25 S.C. Code Ann. Regs. 61-79.262.11 [40 C.F.R. § 262.11], a person who generates a solid waste, as defined in 25 S.C. Code Ann. Regs. 61-79.261.2 [40 C.F.R. § 261.2], must use the steps articulated in 25 S.C. Code Ann. Regs. 61-79.262.11 [40 C.F.R. § 262.11] to make an accurate determination as to whether that waste is a hazardous waste in order to ensure wastes are properly managed according to applicable RCRA regulations.**
