## **RCRA Compliance Evaluation Inspection Report**

**Carfair Composites USA, Inc. (Carfair)**  
EPA ID Number: ALR000059410  
NAICS Code: 336211

Physical Address: 1861 Electronics Drive  
Anniston, Alabama 36207  
Calhoun County

March 16, 2022, 9:00 a.m.

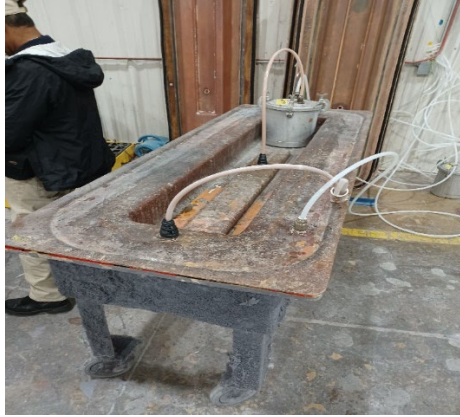
The first process that occurs on the production floor is called Resin Transform Mold (RTM). The RTM process comprises of two molds (Open Mold and Closed Mold). In this process, the fiberglass sheet is cut into "A Mold" (Top), the bottom portion as "B Mold". Each of these portions then receive a resin/epoxy gelcoat on their exterior surface. Once the gelcoat sets, the A Mold and B Mold are put together to form a hollow shell of a specific bus part. A resin gun is used to pump resin into the closed mold at one of the several resin pumping stations. A vacuum pump is attached to the resin pumping station to pull any air pockets out and to completely fill all spaces of the mold (Photo-1). A methyl ethyl ketone peroxide (MEKP) catalyst is used to speed up the process of the resin forming a complete solid component. Any excess resin is captured in a disposable bucket shaped liner within the resin pumping machine. Once cured, the solid parts are removed from the molds using a mold release chemical and the bucket liner of now solid resin is disposed of as solid waste.

Photo-1 Resin Pumping Station

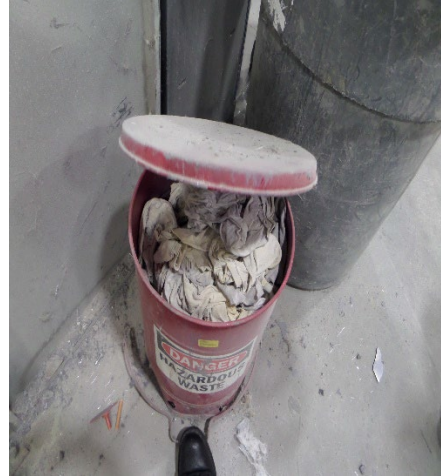
The inspectors observed several five-gallon satellite accumulation area (SAA) containers in the production area containing solvent-contaminated Wipes/Rags (F003) (Photo-4). The five-

gallon containers were observed to be closed and labeled as “Hazardous Waste”. According to Mr. Ledbetter, rags with acetone are used to spot clean and to remove excess mold in the mold release process. The rags stored in the SAA container did not appear to contain any free liquids. ***The inspectors recommended Mr. Ledbetter to consider managing the solvent-contaminated wipes sent for disposal pursuant to 40 CFR 261.4(b)(18) provided the conditions of the exclusions are met which includes storage requirements, labeling, accumulation time limits and recordkeeping.***

Photo-4 Solvent Wipes

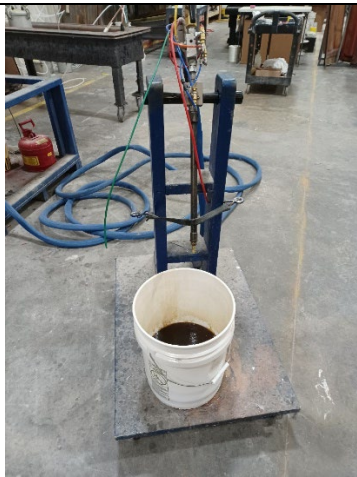
The "open mold" process is similar except that the mold that remains open at all times is laminated and filled with resin manually by the employees. Each time a resin gun is used to pump resin into a mold it is flushed with acetone to keep any residue resin from solidifying in the gun. According to Mr. Ledbetter, there are a total of five-gun cleaning stations throughout the various production areas (Photo-2). At these stations, acetone is pumped through the resin gun and the spent solvent is collected in an open five-gallon container. The spent material collected in the containers is in a liquid state but later cures into a solid material due to the resin remaining in the mixture (Photo-3).

Photo-2 Resin Gun Cleaning Station

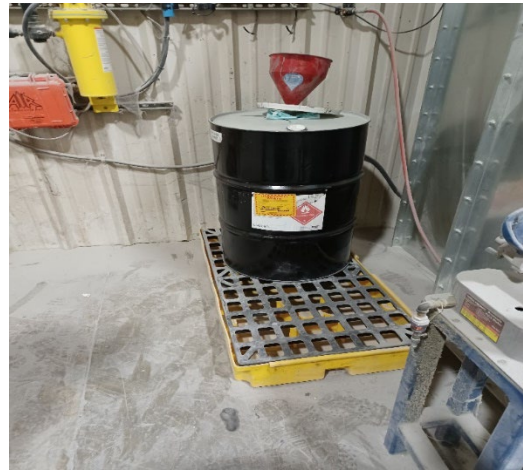
Some parts from the production area are sent for painting at the facility’s Paint Booth. Waste Paint/Thinner mixture are generated in the Paint Booth area from cleaning resin guns and mixing paint. The inspector observed one 55-gallon SAA drum containing waste paint thinner on a containment pallet (Photo-5). The drum was observed to be closed and labeled as “Hazardous Waste”. The drum also had a hazard indication label as “Flammable”. The drum was observed to be intact and nonleaking at the time of inspection.

Photo-5 SAA Drum near the Paint Booth

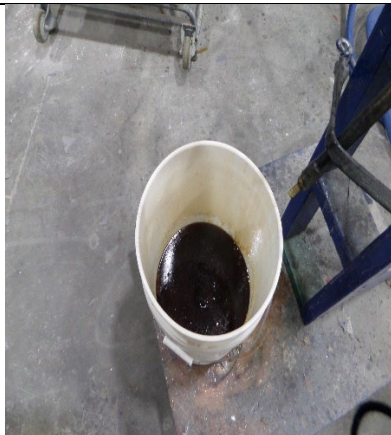
**Pursuant to ADEM Admin. Code r. 335-14-3-.01(2) [40 C.F.R. § 262.11], a person who generates a solid waste, as defined in ADEM Admin. Code r. 335-14-2-.01(2) [40 C.F.R. § 261.2], must make an accurate determination as to whether that waste is a hazardous waste in order to ensure wastes are properly managed according to applicable RCRA regulations articulated in ADEM Admin. Code r. 335-14-3-.01(2) [40 C.F.R. § 262.11].**

Photo-3 Waste Liquid requiring waste determination

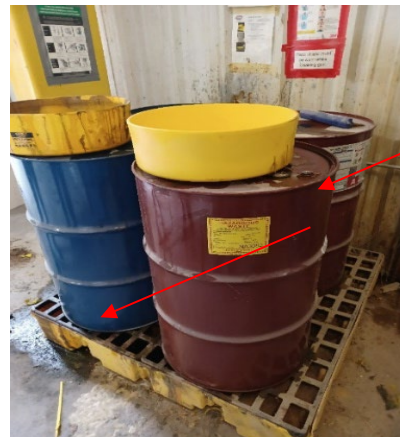
According to Mr. Ledbetter, some parts receive a polyurea coating in the FMJ Area. The material is similar to bedliners in trucks. Step wells and the articulating pieces that allow the bus to bend are coated in the FMJ Area to provide protection from the weather elements and increase traction for those entering and exiting the bus. The polyurea coating is created by the chemical reaction of the mixture comprising of two materials known as “Part A (“isocyanates”) and Part B (“amines”)”. According to Mr. Ledbetter, the excess Part A/Part B generated as part of the coating process are managed as hazardous waste. The inspectors observed two SAA 55-gallon drums with funnel adapters staged on a containment pallet in the FMJ satellite storage area (Photo-6). One SAA drum was used to store waste from excess Part A and the adjacent SAA drum contained waste from excess Part B (D002). The inspectors observed waste liquid residue on the lids of the Part A and Part B SAA drums. The inspectors observed visible stain on the floor near the containment pallet staging the two SAA drums (Photo-6). According to Mr. Ledbetter, Part B is “corrosive” and is shipped offsite as a hazardous waste. The drum storing excess Part B was observed to be closed and labeled. The drum was observed to be full and did not have an accumulation start date on the container.

**Pursuant to ADEM Admin. Code r. 335-14-3-.01(5)(a) [40 C.F.R. § 262.15(a)], a generator may accumulate as much as 55 gallons of non-acute hazardous waste in containers at or near the point of generation where wastes initially accumulate, which is under the control of the operator of the process generating the waste, without a permit or without having interim status, as required by Section 22-30-12(b) of the AHWMMA, Ala. Code § 22-30-12(b) [Section 3005 of RCRA, 42 U.S.C. § 6925], and without complying with ADEM Admin. Code r. 335-14-3-.01(6)(b) [40 C.F.R. § 262.16(b) or §262.17(a)], except as required in ADEM Admin. Code r. 335-14-3-.01(5)(a) [40 C.F.R. § 262.15(a)(7) and (8)], provided that the generator complies with the satellite accumulation area conditions listed in ADEM Admin. Code r. 335-14-3-.01(5)(a) [40 C.F.R. § 262.15(a)] (hereinafter referred to as the “SAA Permit Exemption”).**

**Pursuant to ADEM Admin. Code r. 335-14-3-.03(5)(c)1.(ii) [40 C.F.R. § 262.34(c)(2)], which is a condition of the SAA Permit Exemption, a generator who accumulates either hazardous waste or acutely hazardous waste listed in §261.31 or §261.33(e) in excess of the amount listed in paragraph (c)(1) of this section at or near any point of generation must, with respect to that amount of excess waste, comply within three days with paragraph (a) of this section or other applicable provisions of this chapter. During the three-day period the generator must continue to comply with paragraph (c)(1)(i) and (ii) of this section. The generator must mark the container holding the excess accumulation of hazardous waste with the date the excess amount began accumulating.**

**Pursuant to ADEM Admin. Code r. 335-14-3-.01(6)(b)8.(i) [40 C.F.R. § 262.16(b)(8)(i)], which is a condition of the SQG Permit Exemption, a generator is required to maintain and operate its facility to minimize the possibility of a fire, explosion, or any unplanned sudden or non-sudden release of hazardous waste or hazardous waste constituents to air, soil, or surface water which could threaten human health or the environment.**

Photo-6 Leak in the SAA (FMJ Area)

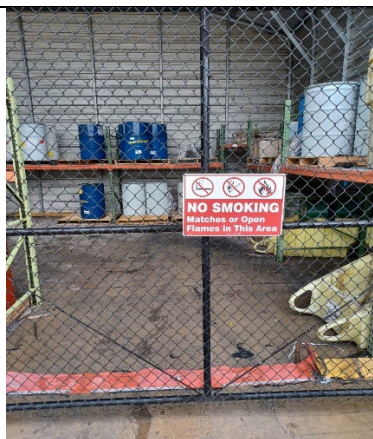
The Central Hazardous Waste Storage Area comprises of a concrete pad enclosed with a corrugated metal roof structure at the rear of the production building (Photo-7). The gate was closed, and the warning signs were posted at the entrance. At the time of the inspection there were three 55-gallon drums of waste solvent/resin and one 55-gallon drum of waste “Part B” from the polyurea coating area. All the four drums were observed to be closed, labeled and on pallets. Two of the hazardous waste drums were staged on a raised metal rack (Photo-8). The inspectors could not access the hazardous waste containers stored on the metal rack to determine the condition of the containers. The inspectors observed that none of the hazardous waste drums had accumulation start dates and EPA Waste Codes. The labels on the containers including hazard indication labels were observed to be weathered and peeling. There were no leaks or spills observed in the storage area. The storage area was observed to be equipped with fire extinguisher and spill kits.

Photo-7 Central Hazardous Waste Storage Area

*The inspectors recommended Mr. Ledbetter to store hazardous waste drums such that the owner or operator can inspect the hazardous waste containers for leaks and deterioration of containers caused by corrosion or other factors.*

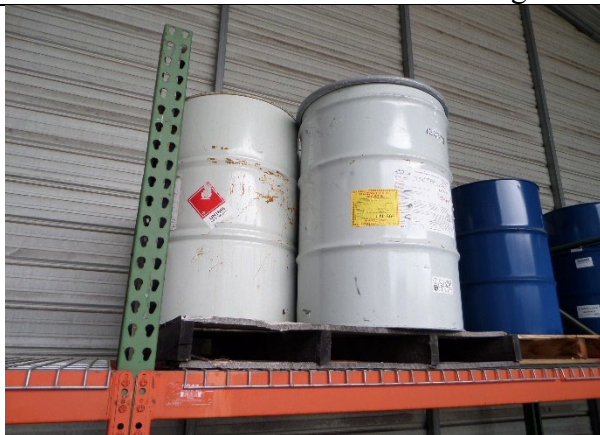
Pursuant to ADEM Admin. Code r. 335-14-3-.03(5)(d) [40 C.F.R. § 262.34(d)], a generator of greater than 100 kilograms but less than 1,000 kilograms of hazardous waste in a calendar month is a Small Quantity Generator (SQG) and may accumulate hazardous waste on-site for 180 days or less without a permit or without having interim status, as required by Section 22-30-12(b) of the AHWMMA, Ala. Code § 22-30-12(b) [Section 3005 of RCRA, 42 U.S.C. § 6925], provided that the generator complies with the conditions listed in ADEM Admin. Code r. 335-14-3-.03(5)(d)2. [40 C.F.R. § 262.34(d)(1)-(5)] (hereinafter referred to as the “SQG Permit Exemption”).

Pursuant to ADEM Admin. Code r. 335-14-3-.01(6)(b)6(i) [40 C.F.R. § 262.16(b)(6)(i)], which is a condition of the SQG Permit Exemption, a generator must mark or label its containers with the date upon which each period of accumulation begins clearly visible for inspection on each container.

Photo-8 Hazardous Waste Drums of Metal  
Racks
