## RCRA COMPLIANCE EVALUATION INSPECTION REPORT

W. M. Barr & Company (W M Barr)  
2609 Fite Road  
Memphis, Tennessee 38017  
EPA ID: TND007017288

October 27, 2022      9:00 a.m.

**COMPLIANCE EVALUATION INSPECTION**

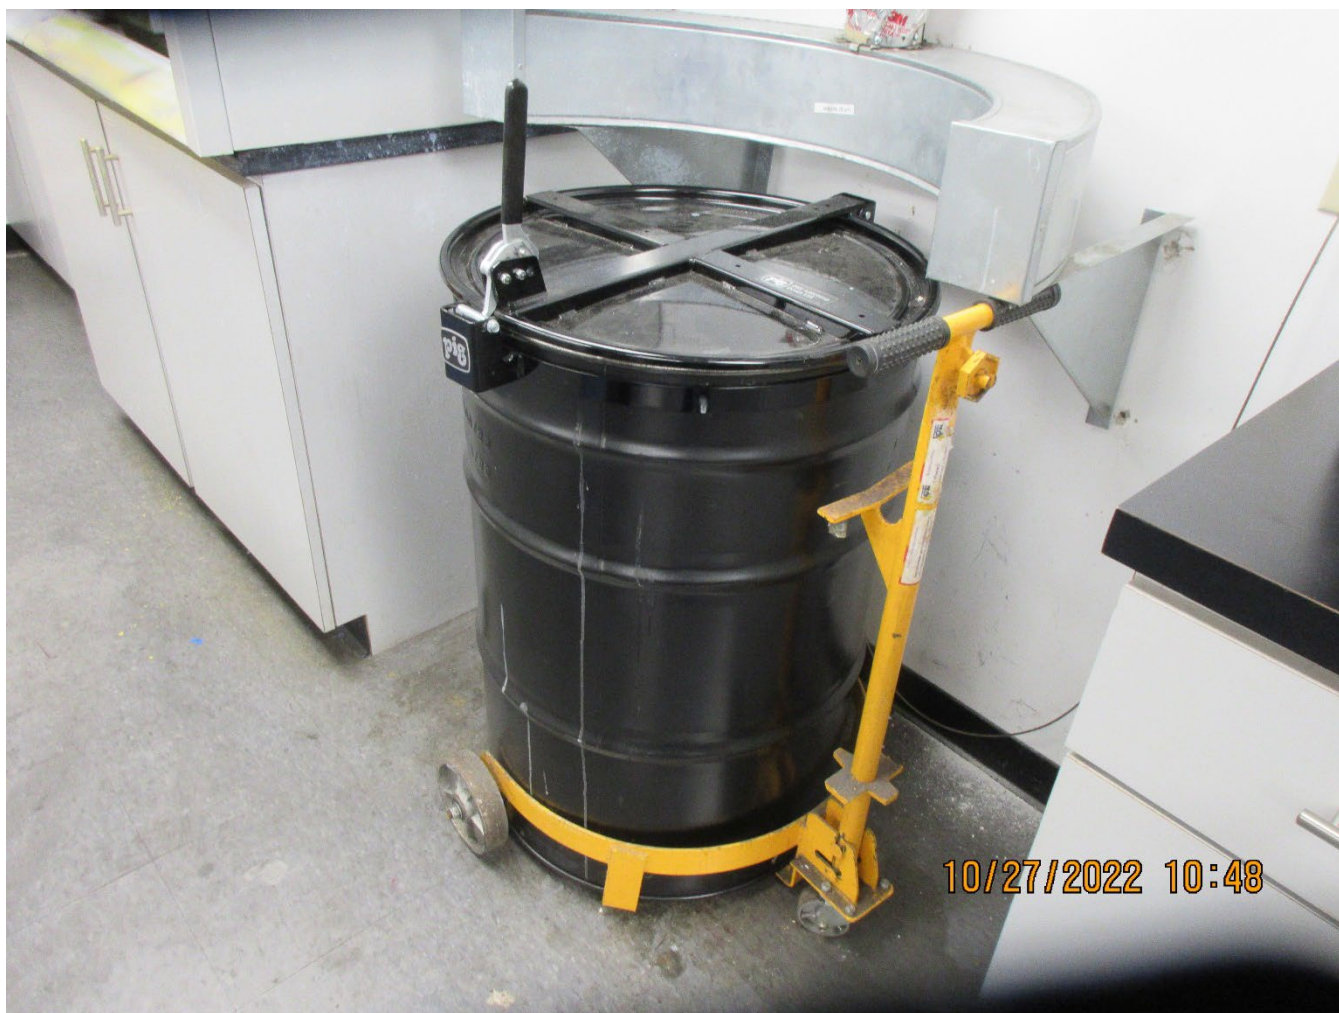
This area is located on the second floor of the building. One 55-gallon container (Photos 1-2) was observed within a SAA of the laboratory for the management of contaminated rags, beakers, lab wastes and spent personal protective equipment. The container was closed but not labeled at the time of the inspection. A label was placed on the container at the time of the inspection.

**Photo 1 – 55-gallon hazardous waste drum in Quality Control Lab without labels**

**Pursuant to Tenn. Comp. R. & Regs. 0400-12-01-.03(4)(e)5(i)(II) [40 C.F.R. § 262.34(c)(1)(ii)], which is a condition of the SAA Permit Exemption, a generator is required to mark satellite accumulation containers either with the words "Hazardous Waste" or with other words that identify the contents of the containers.**

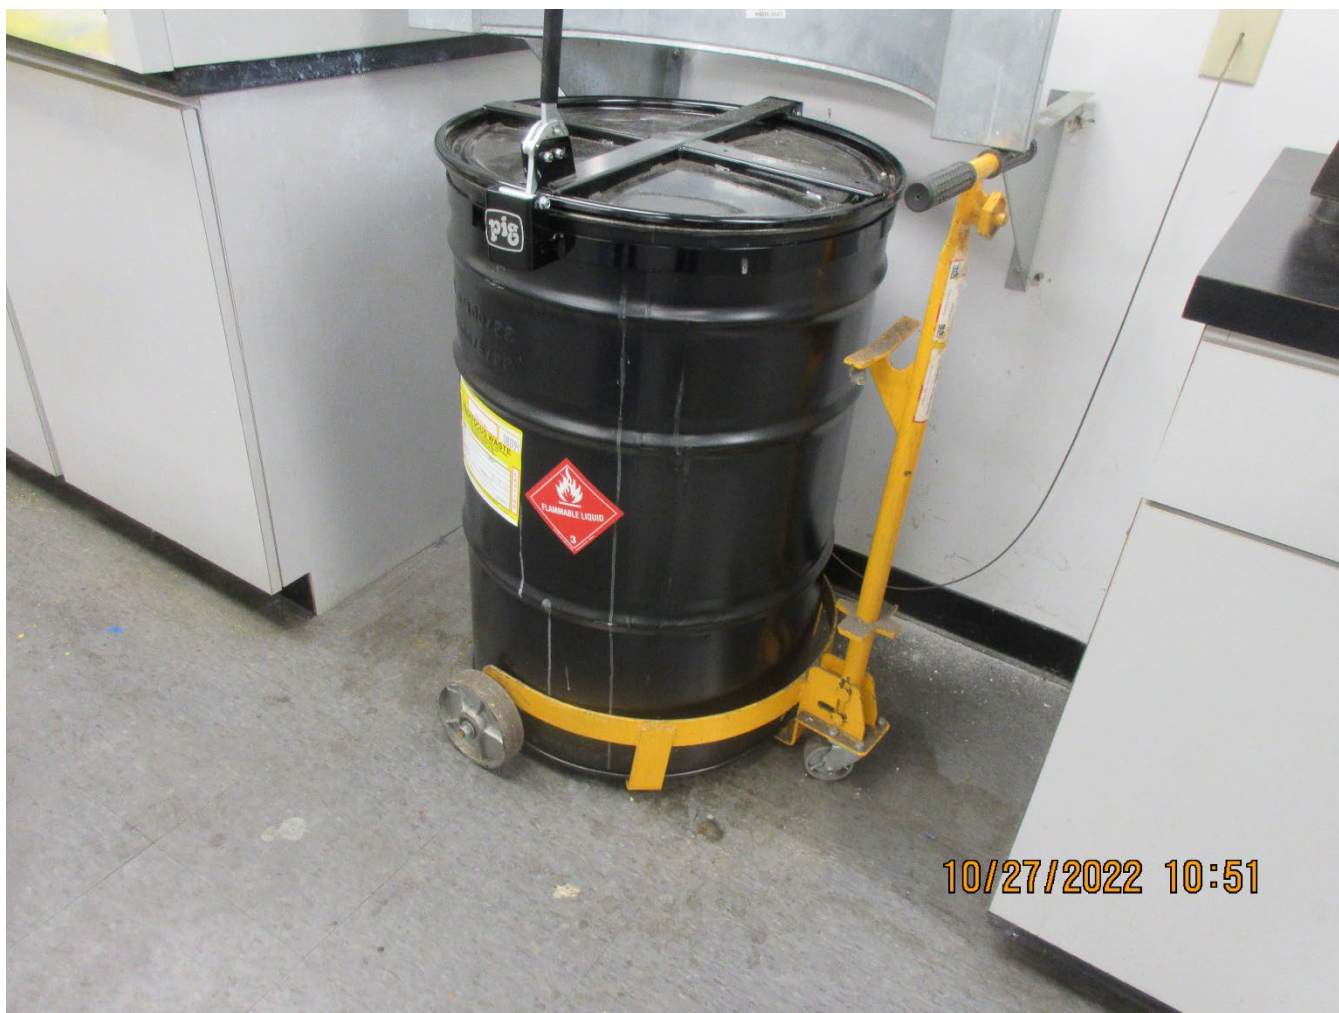
**Photo 2 – 55-gallon hazardous waste drum in Quality Control Lab with labels added**

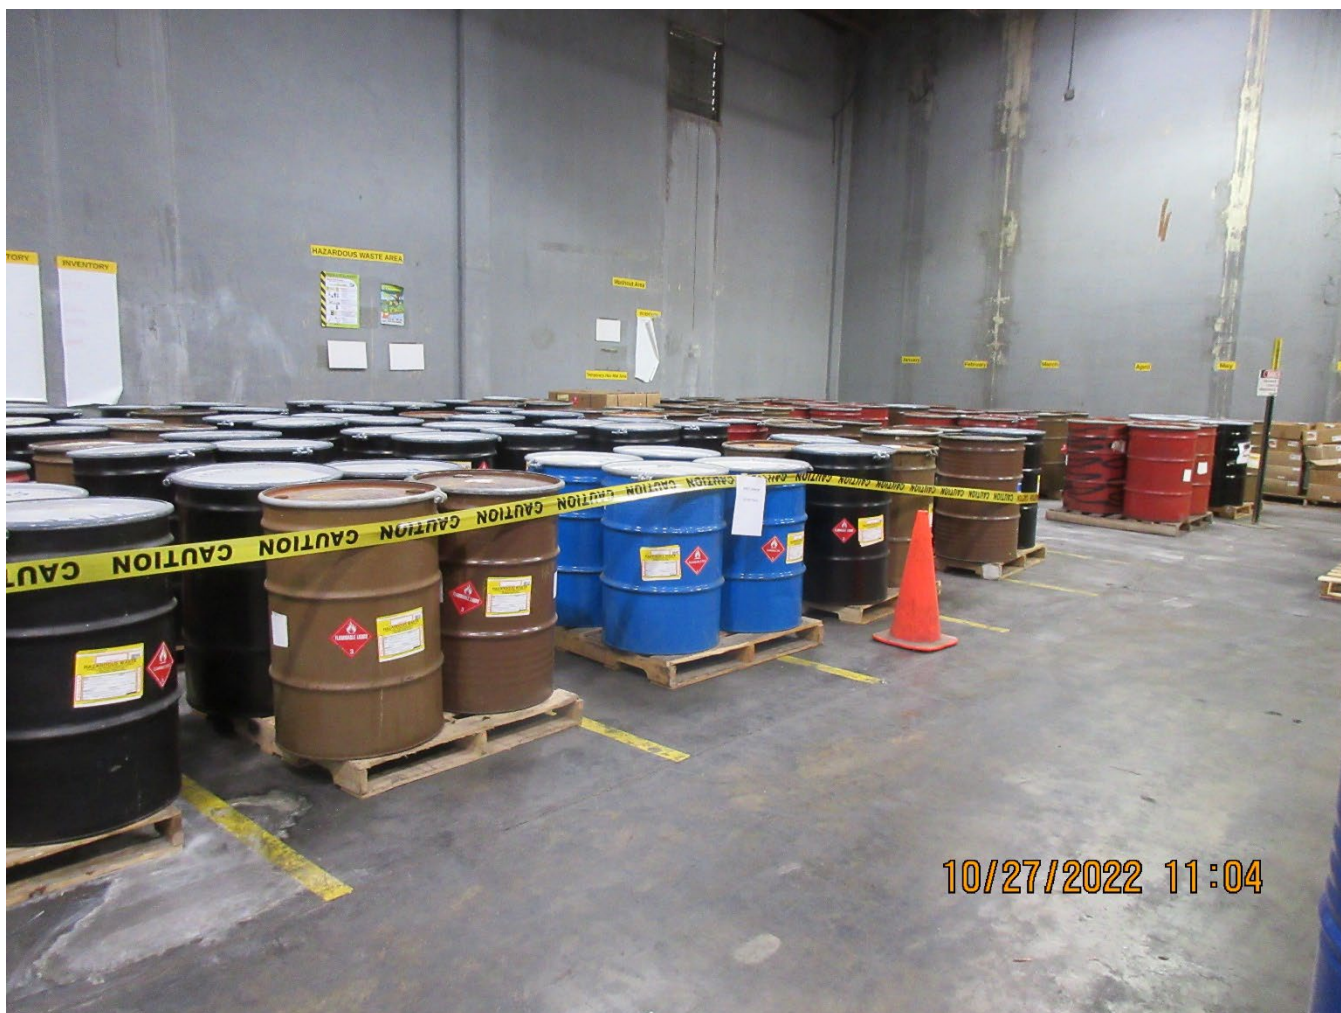
The facility's CAA was also located in this area. One hundred fifty-two 55-gallon waste containers were observed in this area (Photos 3 – 5). One hundred nine of the containers managed hazardous waste. Forty-three of the containers managed nonhazardous wastes. Weekly inspection logs for the past year were observed in this area at the time of the inspection. No discrepancies were observed.

**Photo 3 – Drums of Hazardous Waste in Central Accumulation Area**

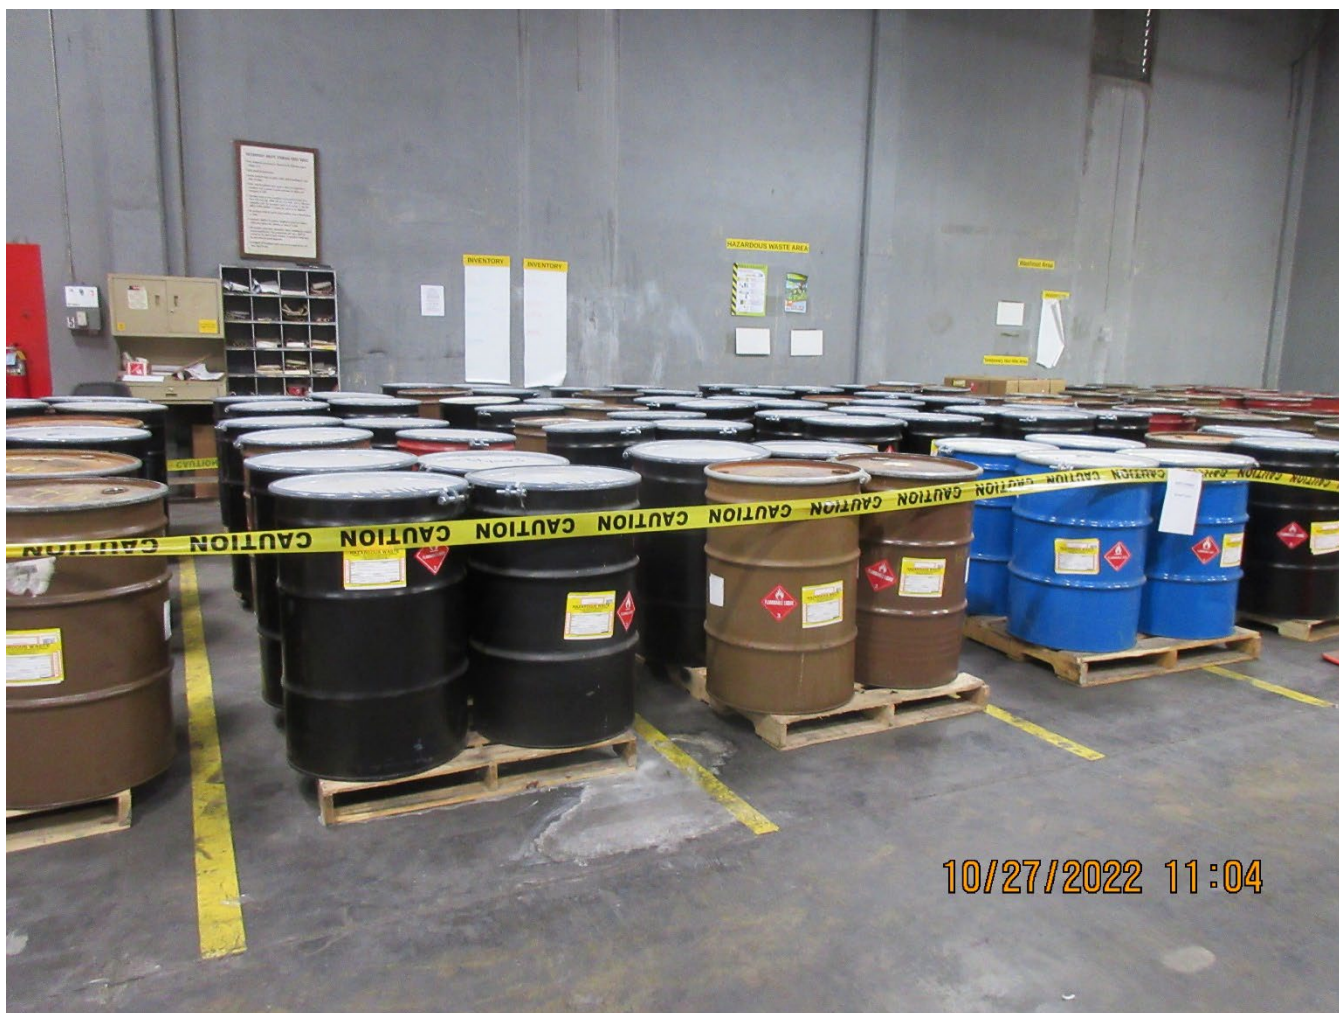
**Photo 4 – Drums of Hazardous Waste in Central Accumulation Area**

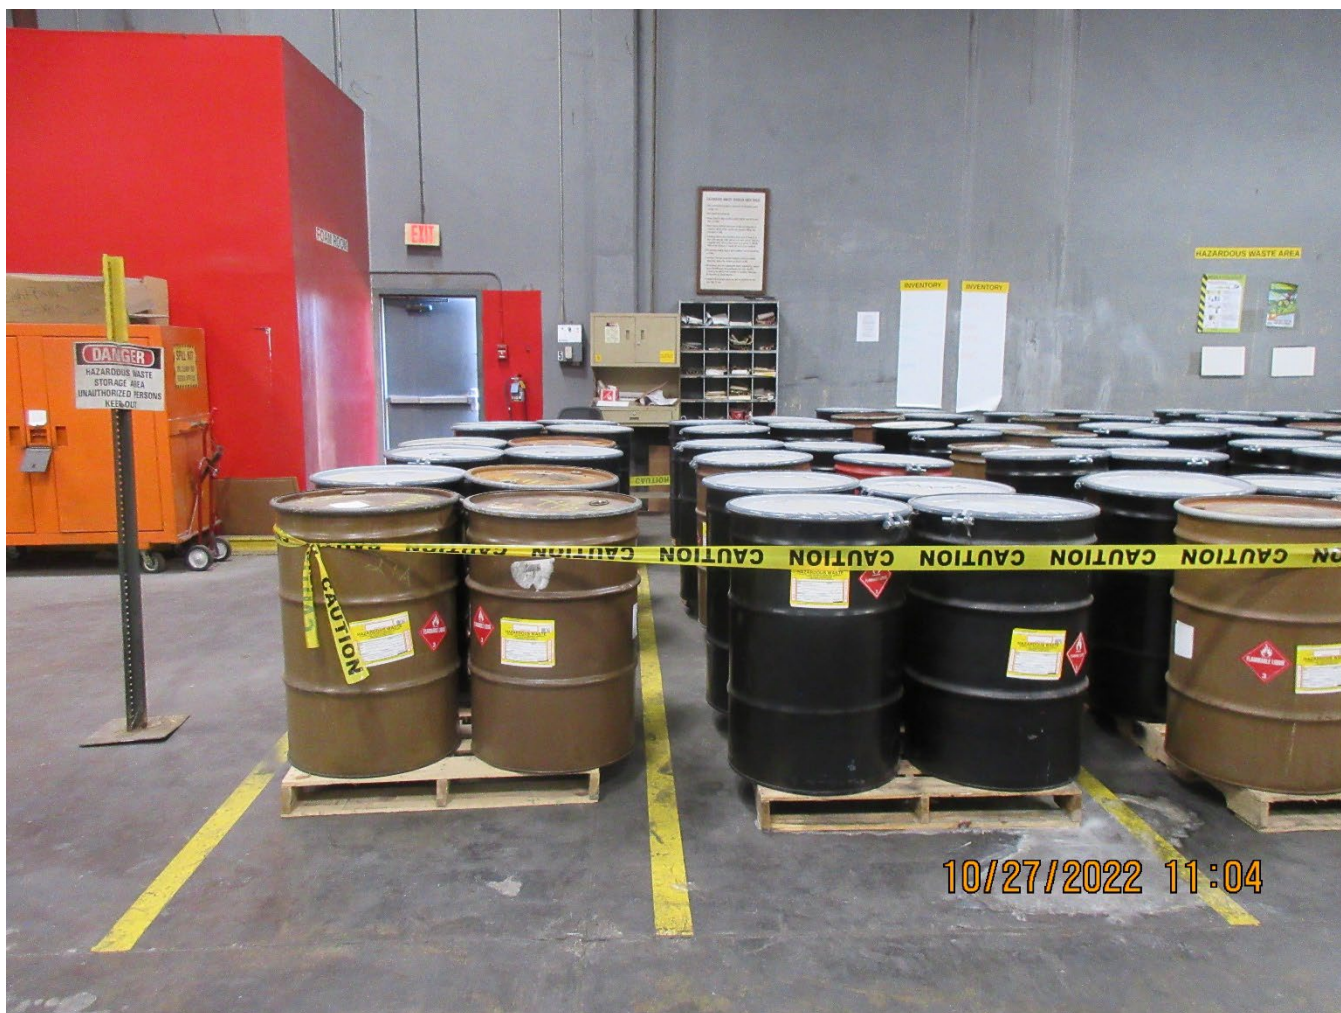
**Photo 5 – Drums of Hazardous Waste in Central Accumulation Area**

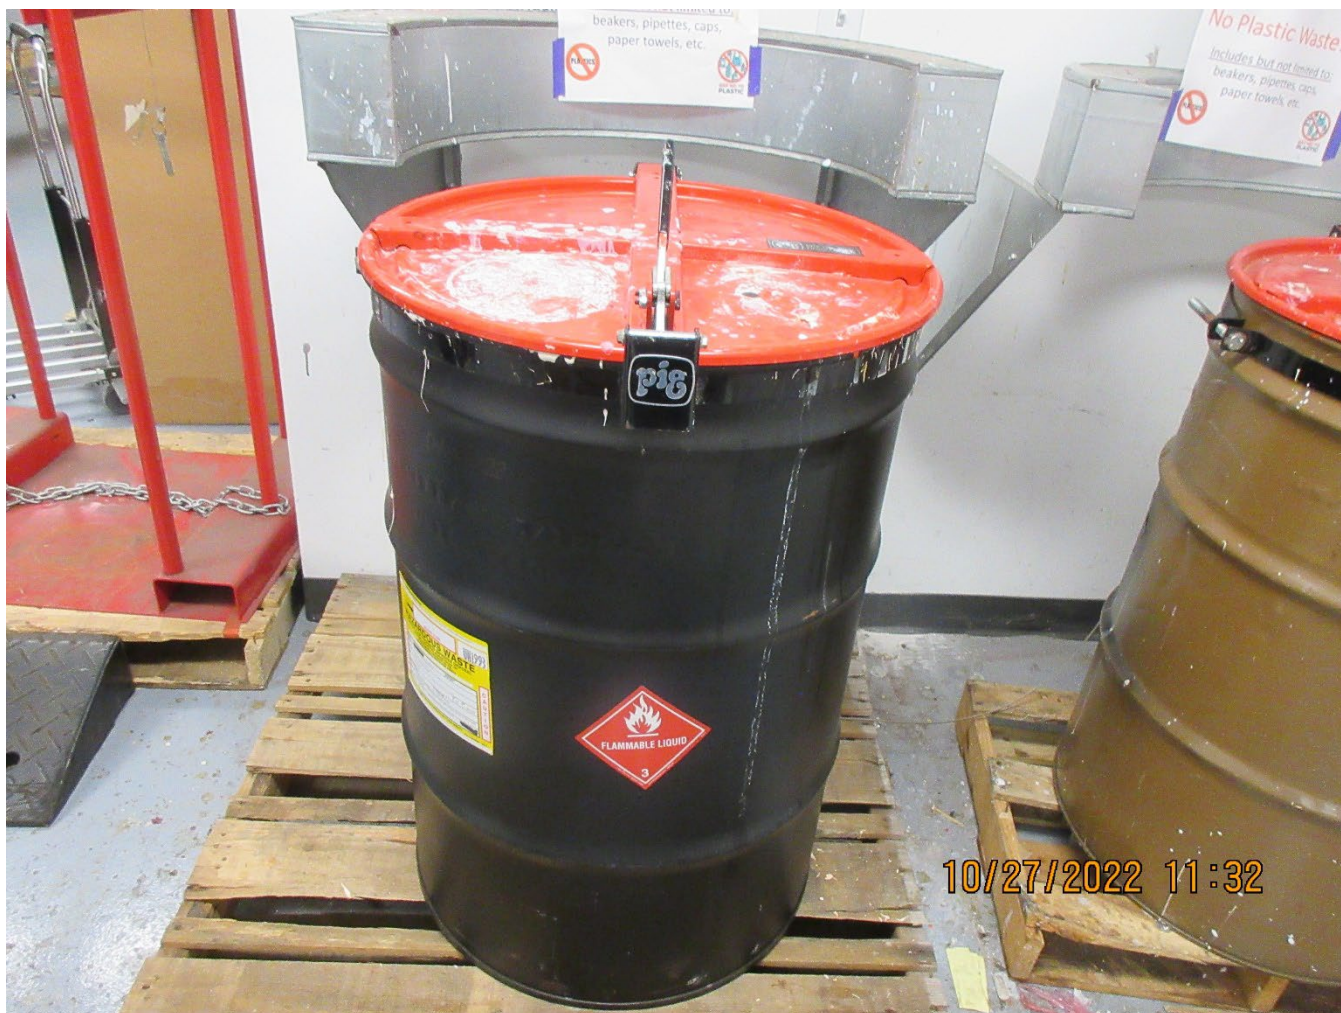
One 55-gallon container of spent hazardous waste rags (Photo 6) used for minor cleanup activities and lab wastes were observed within a SAA.

**Photo 6 – 55-gallon hazardous waste drum in Research and Development Lab**
