**Region 6 - Enforcement & Compliance Assurance Division**  
**INSPECTION REPORT**

| Company Name: | <b>City of Tucumcari</b> | |
| Facility Name: | <b>Tucumcari Wastewater Treatment Plant</b> | |
| Identification/Permit Number: | NM0020711 | |

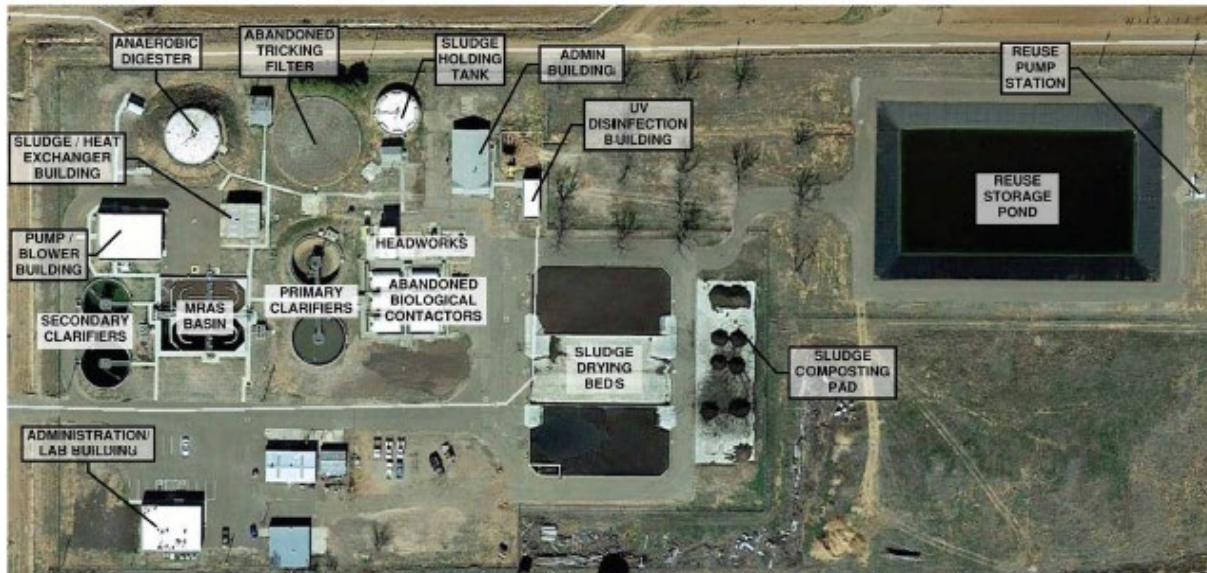
**Aerial Site Image #1:** Overall view of the City of Tucumcari Wastewater Treatment Plant

The WWTP is a major discharger with a design flow capacity of 1.2 MGD (million gallons per day) and an average influent flow of 0.4 MGD. The facility is located at 1700 North Rock Island Street, Tucumcari, Quay County, New Mexico (depicted in **Aerial Site Image #1** below). The WWTP also accepts approximately 3,500-gallons per day of septage from permitted waste haulers. The facility serves a population of approximately 5,000 residents and is operated by staff within the Public Works Department consisting of 5 full-time equivalent (FTE) positions, during the hours of 7:00 AM to 4:00 PM five (5) days during the regular work week and 1 FTE on weekends. On-call staff is available on an as needed basis.

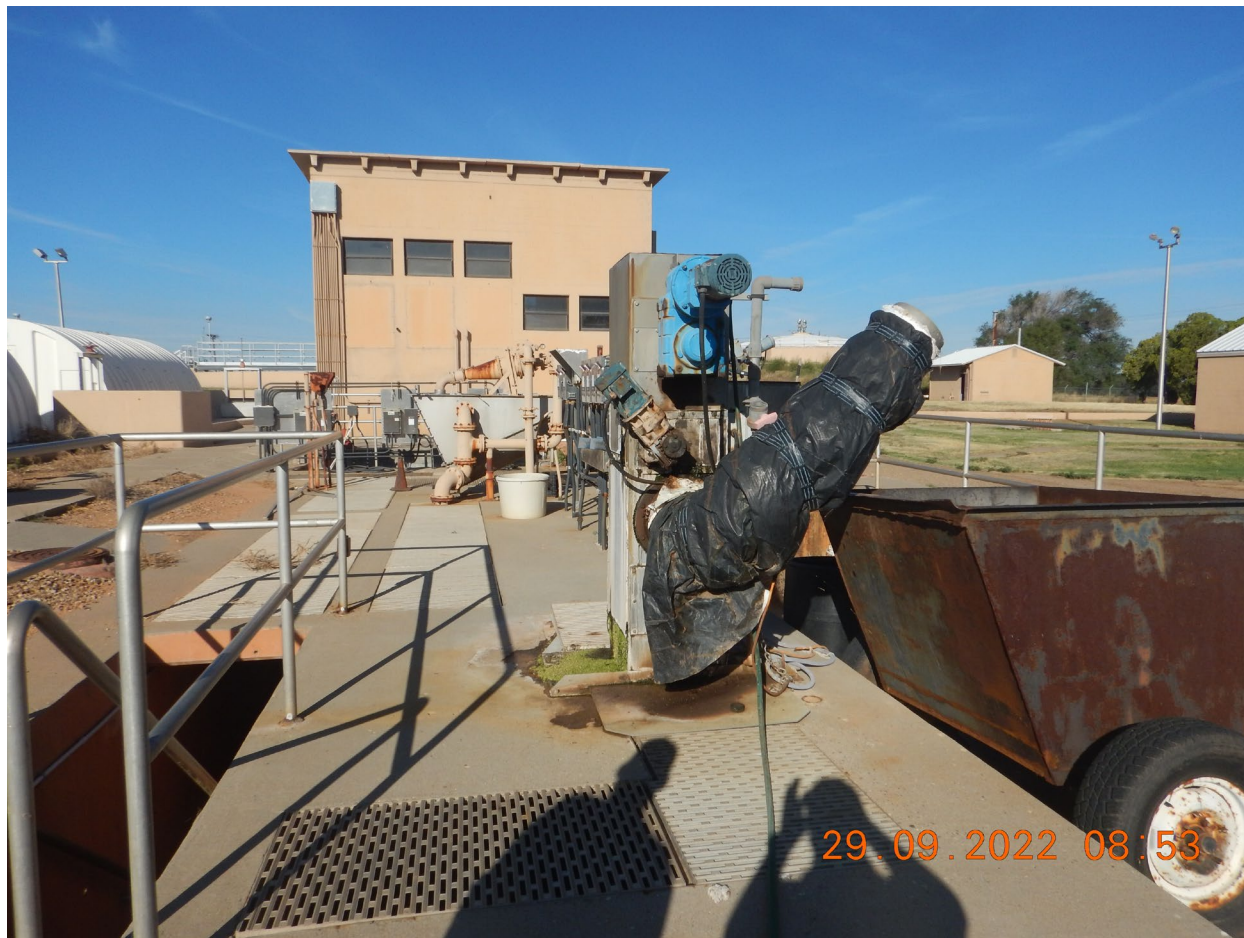
Photo No. 1

View of the WWTP's Headworks. The WWTP Supervisor stated that locating replacement parts for the existing facility equipment in general was getting extremely difficult. (DSCN2348) Photographed by D. Esparza

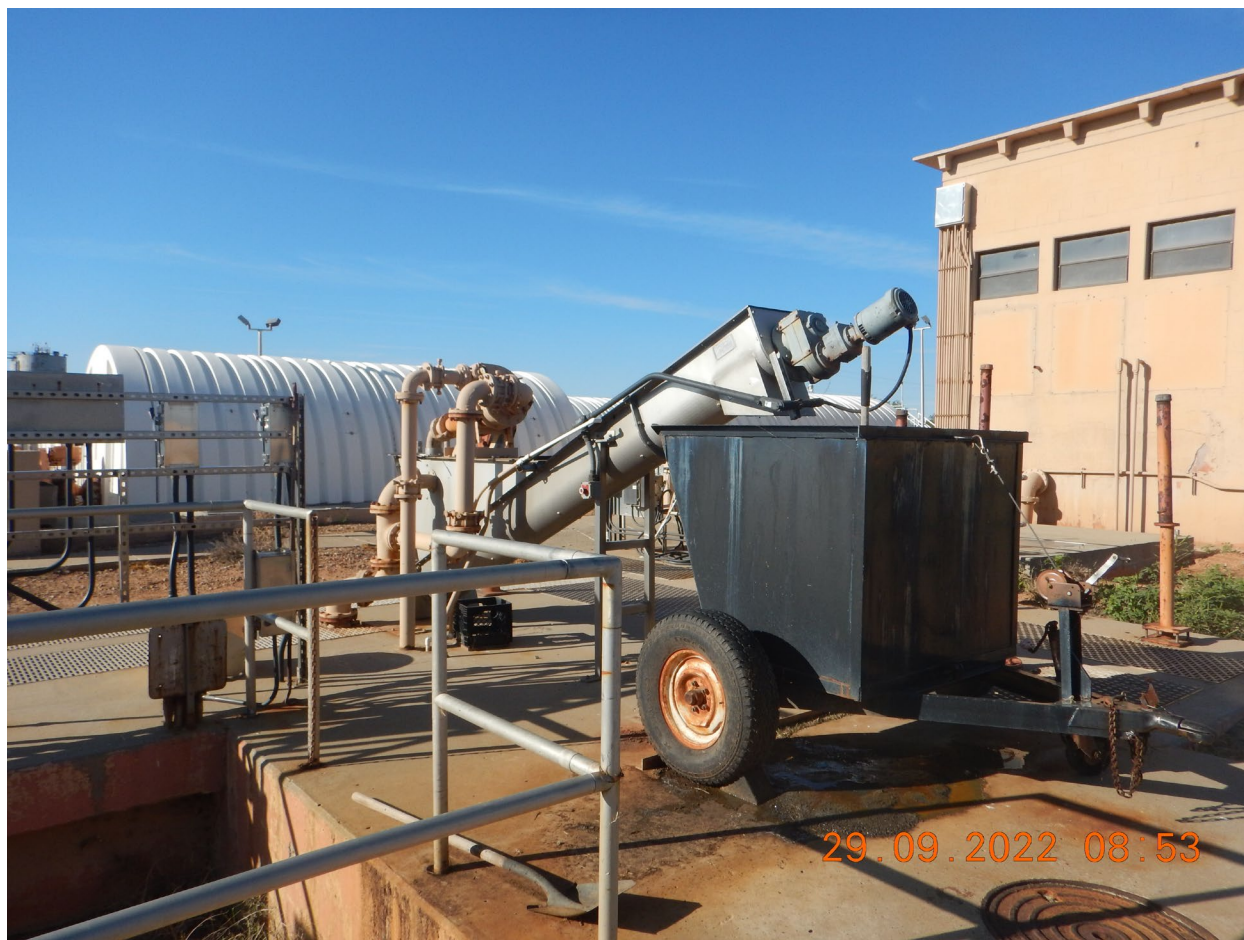
Photo No. 2

View of the grit screen removal equipment. (DSCN2349) Photographed by D. Esparza

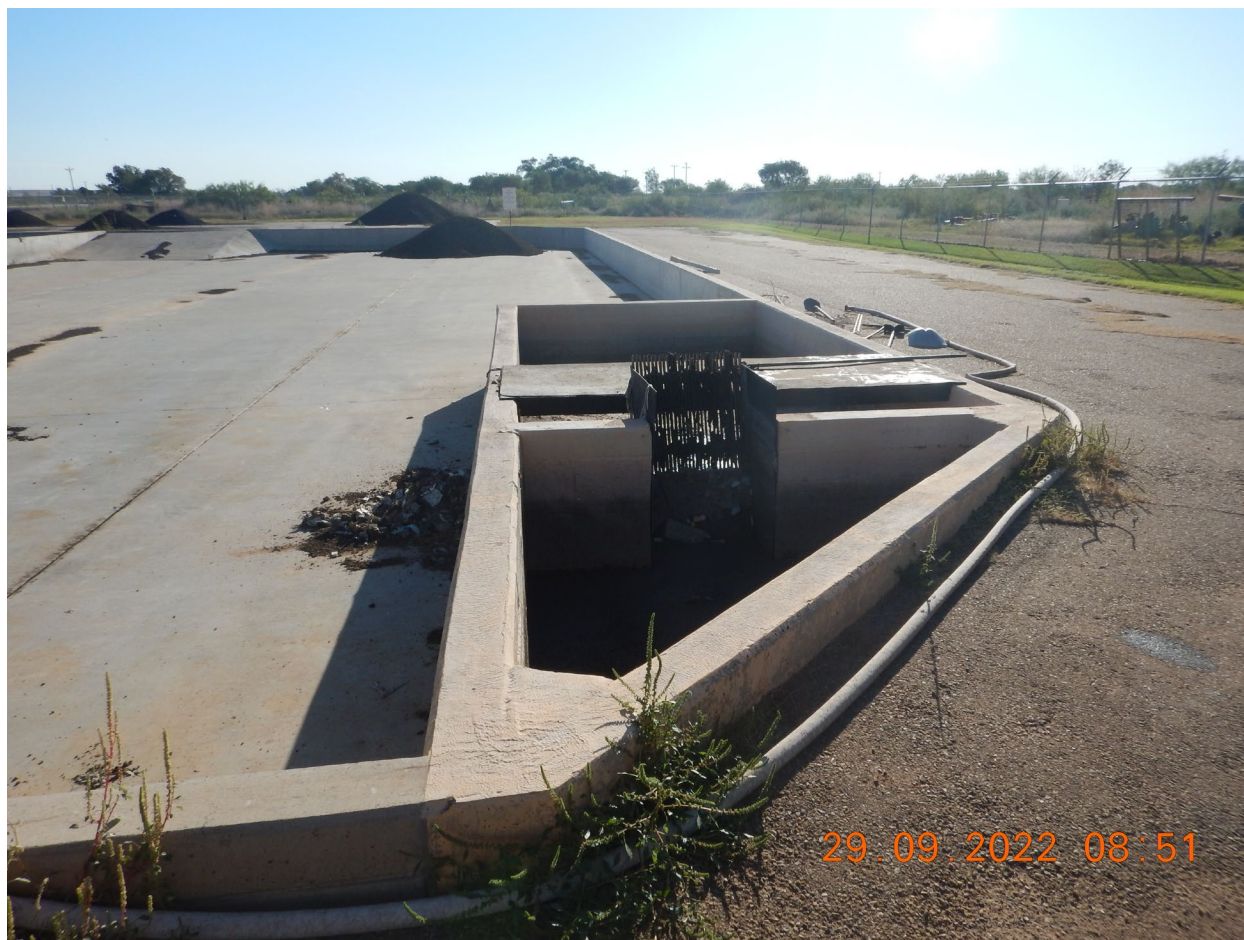
Photo No. 3

View of one (1) the three (3) sludge drying beds (located approximately at the southeast end of the facility) for composting into Class A sludge for land application and/or local agricultural purposes. These beds were originally constructed with underdrains to collect excess wastewater; thus, creating the ability to pump and/or return excess wastewater to the headworks. (DSCN2346) Photographed D. Esparza

To address their sludge management, the WWTP has and/or maintains three (3) concrete sludge drying beds (located approximately at the southeast end of the facility) for composting into Class A sludge for land application and/or local agricultural purposes. These beds were originally constructed with underdrains to collect excess wastewater; thus, creating the ability to pump and/or return excess wastewater to the headworks.

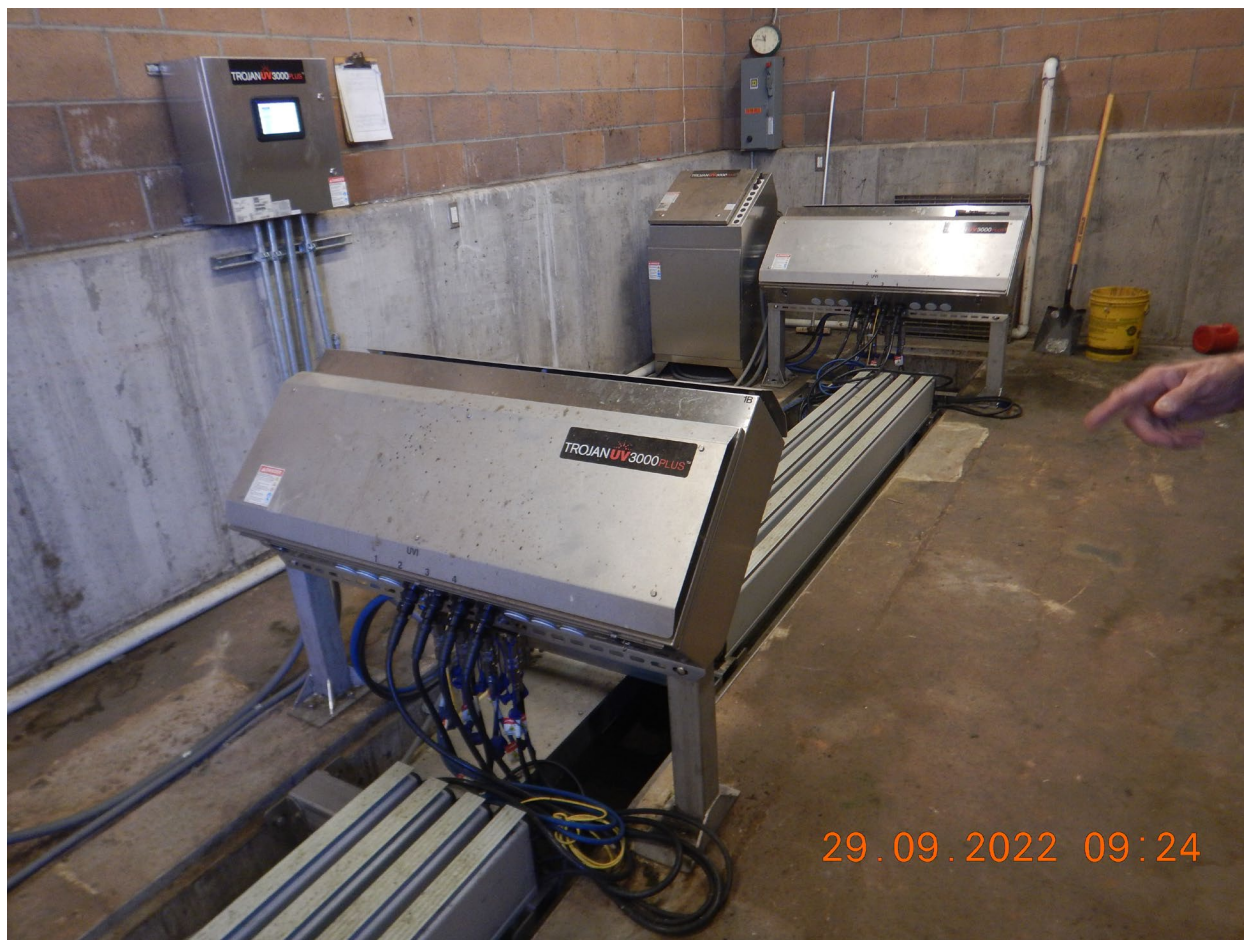
Photo No. 4

View of the two (2) banks of Trojan ultraviolet (UV) disinfection units included in the 2011 WWTP upgrades. (DSCN2350) Photographed by D. Esparza
