## INSPECTION REPORT

| <b>Type of Inspection</b> | CEI - Compliance Evaluation Inspection | |
| Purtee Acres WWTP | | |
| OH0050865 | | |

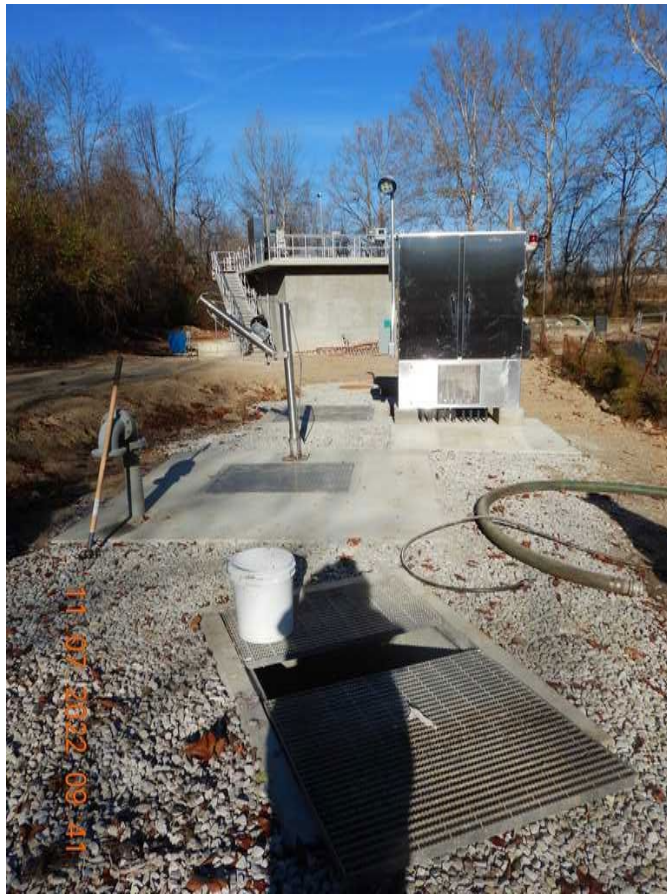
| Headworks | DSCN4063.JPG | |

| <p>Overview of the Headworks of the WWTP which includes an electronic control panel, manual bar screen, wet well, pump station, valve pit, and flow meter manhole for access to the in-line magmeter used for influent flow measurements.</p> | | |

During the inspection walk-through EPA observed the headworks, headworks control panel, manual bar screen, wet well/pump station, valve pit (Photograph DSCN4063.JPG and DSCN4078.JPG), and influent flowmeter access manhole for the newly constructed WWTP. EPA observed liquid in the bottom of the access manhole for the in-line flowmeter location (Photograph DSCN4076.JPG). Ryan Smith explained that the water was from groundwater infiltration into the new manhole structure. EPA did not observe any leakage from around the in-line magmeter location in the sewage pipe.

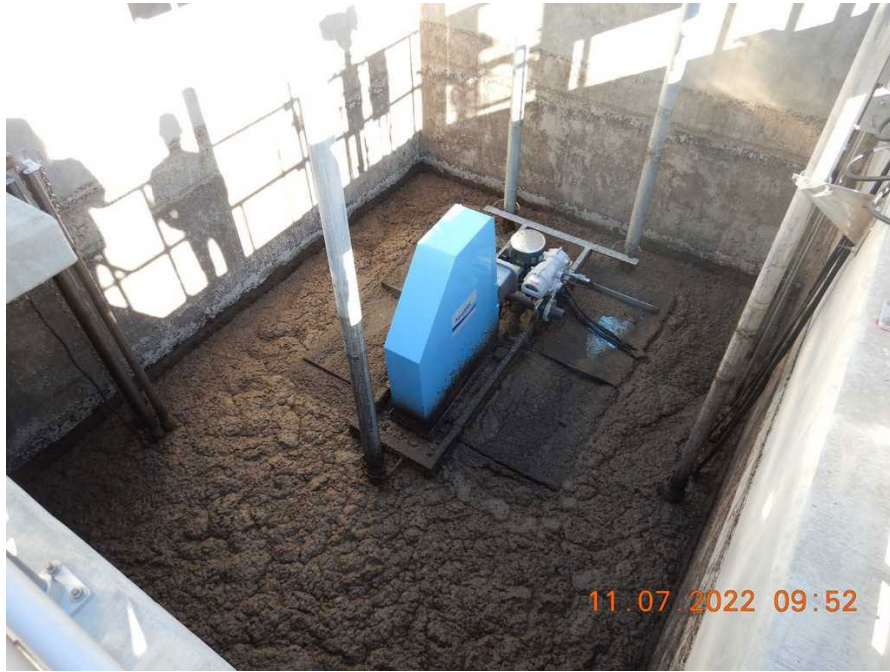
| SBR 1 | DSCN4064.JPG | |

| SBR 1 was in the react mode during the inspection. | | |

EPA observed SBR 1, SBR 2, the sludge holding tank/digester, the connection for sludge withdrawal and the control panels for SBR 1 and SBR2. SBR 1 was in the React mode and SBR 2 was in the Mix/Fill mode at the time of the inspection (Photographs DSCN4064.JPG and DSCN4067.JPG). SBR 1 and SBR 2 each have an enclosed control panel and operations screen on the upper platform of the WWTP structure (Photograph DSCN4065.JPG). The sludge holding tank/digester was designed and constructed without a decanter (Photograph DSCN4066.JPG). According to Mr. Smith, the sludge holding tank is decanted manually, using a submersible pump that is lowered into the sludge holding tank to pump decant water into one of the two SBRs. EPA observed some foam in the sludge holding tank/digester. Ryan Smith stated that the foam in the sludge holding tank/digester is a result of the units not wasting sludge yet in order to increase the sludge volume and increase the young sludge age in the sludge holding tank/digester of the new WWTP. On the north side of the WWTP structure, EPA observed the pump-out connection (Photograph DSCN4068.JPG) used to withdraw sludge from the sludge holding tank/digester. EPA did not observe any evidence of hydraulic overloading issues at the new WWTP. There were no noxious odors observed. The new WWTP had no visible signs of leakage from pipes or evidence of corrosion. The area of the new WWTP on site was generally clean and free from trash or debris. Due to the recent construction of the new WWTP, the construction area around the new plant was still denuded and had not yet been reseeded with grass cover.

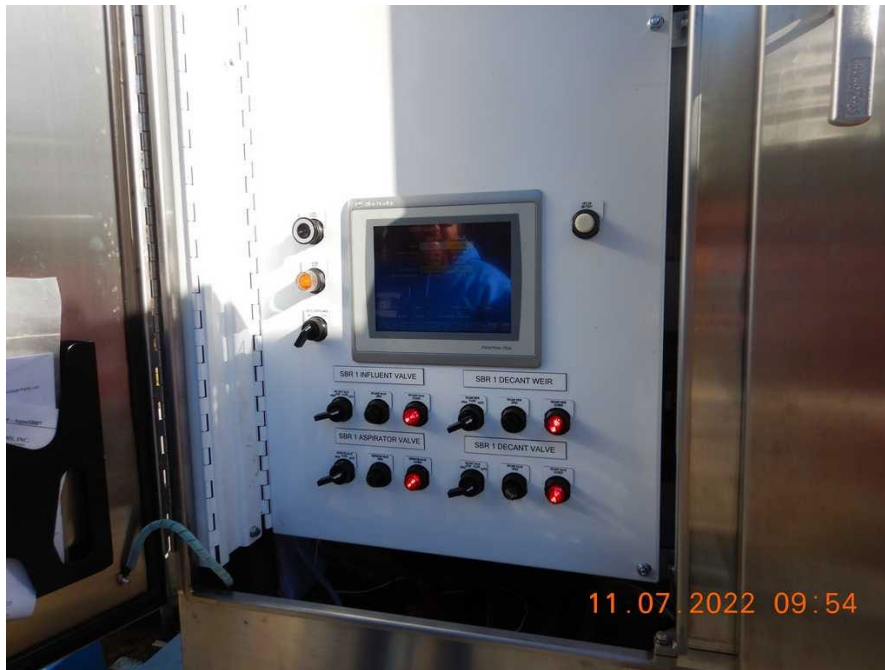
| Control Panel and Operations Screen for SBR 1 | DSCN4065.JPG | |

| SBR 1 and SBR 2 each have an enclosed control panel and operations screen on the upper platform of the WWTP structure. This photograph is of the control panel and operations screen for SBR1. | | |

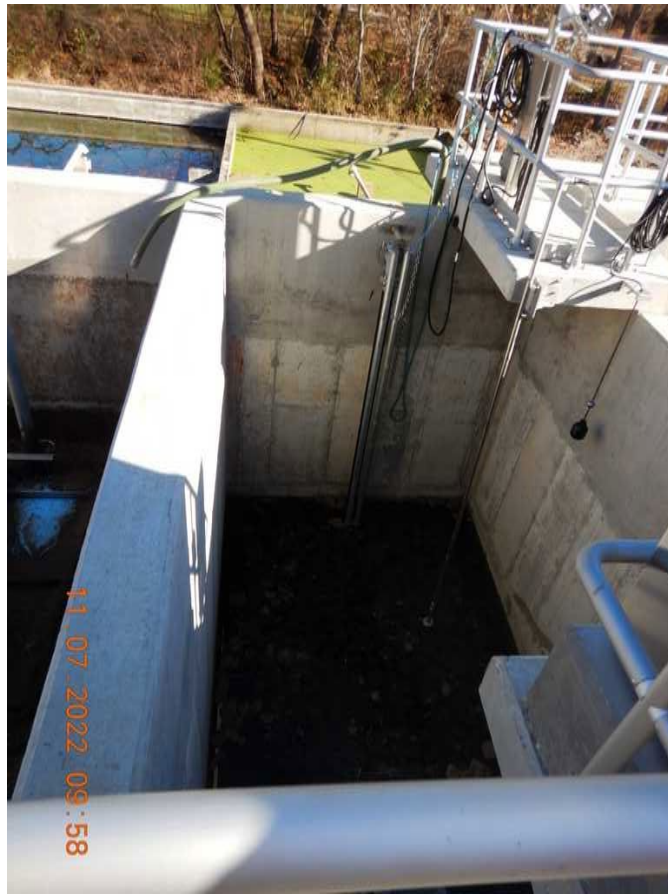
| Sludge Holding Tank | DSCN4066.JPG | |

| The WWTP is designed with a sludge holding tank/digester located between SBR 1 and SBR 2. A decanter was not included in the design for the sludge holding tank or in its final construction. Decanting must be done manually with a submersible pump. | | |

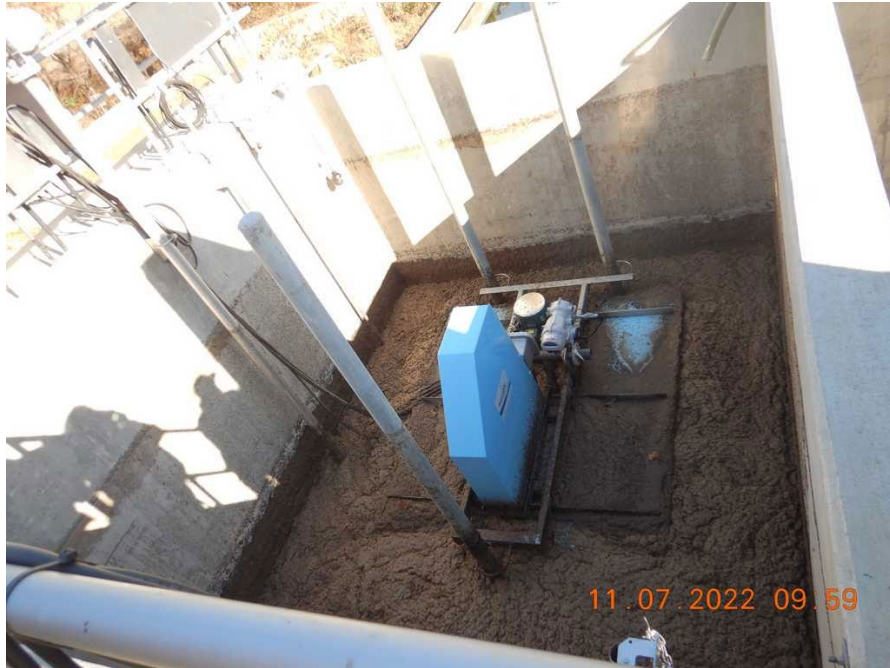
| SBR 2 | DSCN4067.JPG | |

| SBR 2 was in the Mix/Fill mode at the time of the inspection. | | |

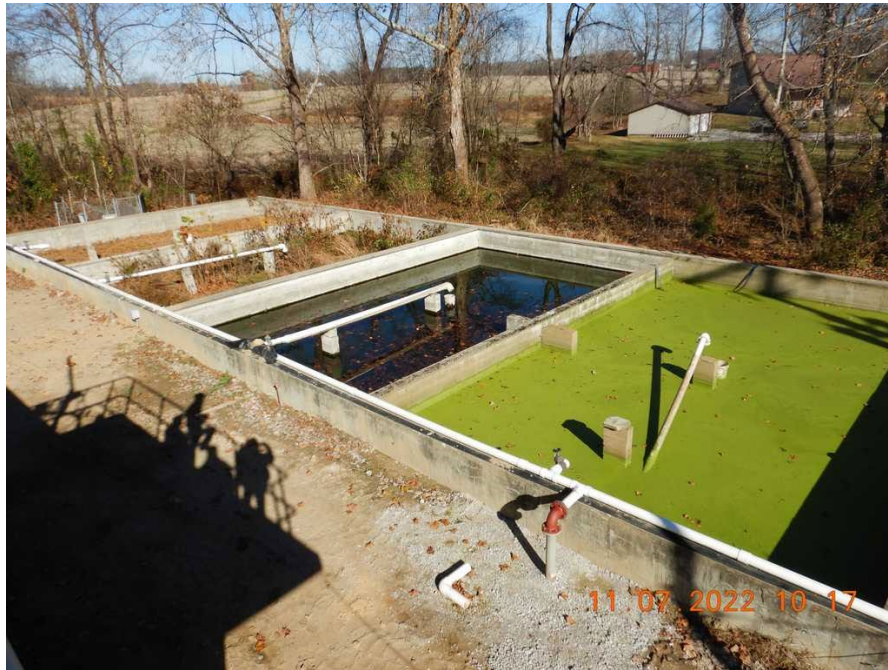
| Sand Filter Beds | DSCN4069.JPG | |

EPA observed that 2 of the 4 sand filter beds (Photograph DSCN4069.JPG) still contained decant water that was filtering through the sand beds. These four sand filter beds from the original WWTP are no longer receiving decant water flow from the previous WWTP clarifier. The filtered decant water from the sand filter beds flows to the chlorination/de-chlorination contact chamber. SBR 1 and SBR 2 decant water is not plumbed to the sand filter beds, but instead flows directly to the chlorination/de-chlorination contact chamber. The new WWTP was not designed to be used with sand filter beds and as such, the sand filter beds are not connected to the new WWTP.

| <p>The sand filter beds from the original WWTP are no longer receiving any decant water flow from the previous WWTP clarifier. At the time of the inspection, the decant water remaining in two of the four sand filter beds was still filtering through the beds. Filtered water then flows to the chlorination/de-chlorination contact chamber. Decant water from SBR 1 and SBR 2 flows directly to the chlorination/de-chlorination contact tank via the white PVC pipe running along the top of the sand filter bed sidewall.</p> | | |

| Location/Area/Sub-area | Description |
|--|---|
| Previous WWTP Units | The previous WWTP system is scheduled to be demolished, except for the sand filter beds which may be cleaned and re-used in conjunction with the newly built SBR treatment system. The sand beds may be re-used if they can be added to the NPDES permit as optional operational units for storm event situations where large inflow volumes may cause short cycling. |

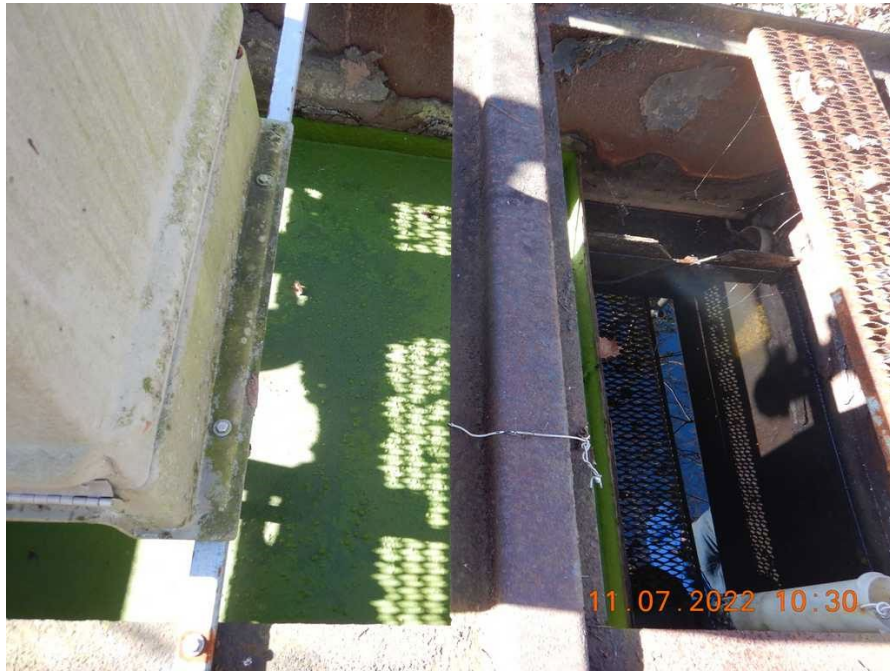
| Chlorination Contact Chamber | DSCN4070.JPG | |

| <p><b>AOC:</b></p> <p>EPA also observed aquatic vegetation (possibly duck weed) floating on the surface of the water in the chlorination side of the chlorination/de-chlorination contact chamber.</p> | |

2. Aquatic vegetation (possibly duck weed) was observed floating on the surface of the water in the chlorination side of the chlorination/de-chlorination contact chamber.

| <p>Chlorination tablets are added manually to the chlorination contact chamber (left side of photograph). Note the green aquatic vegetation floating on the surface of the water in the chamber. The de-chlorination side of the unit is on the right side of the photograph. Aquatic vegetation was not observed on the de-chlorination side of the chamber.</p> | | |

| <b>Location:</b> Chlorination/De-chlorination Contact Chamber with Post-Aeration | | |
|---|---|---|
| <p>During the site walk-through, EPA observed the chlorination/de-chlorination contact chamber and the post-aeration unit (Photographs DSCN4070.JPG and DSCN4071.JPG). The post-aeration unit at the chlorination/de-chlorination contact chamber was not operational at the time of the inspection. EPA also observed aquatic vegetation (possibly duck weed) floating on the surface of the water in the chlorination side of the chlorination/de-chlorination contact chamber. A PVC pipe runs along the top of the old sand filter beds' southern sidewall to transport decant water from SBR1 and SBR2 directly to the chlorination/de-chlorination contact chamber.</p> | | |

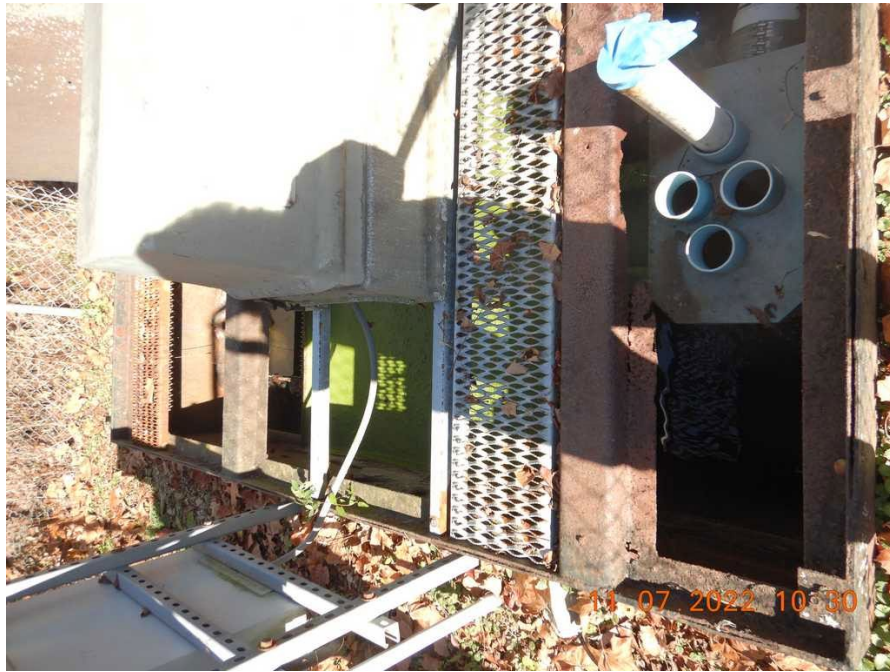
| Chlorination Contact Chamber with De-chlorination | DSCN4071.JPG | |

| The chlorination/de-chlorination contact chamber is equipped with a post-aeration unit that is currently off-line. New electric lines need to be hooked up to make the post-aeration unit operational. | | |

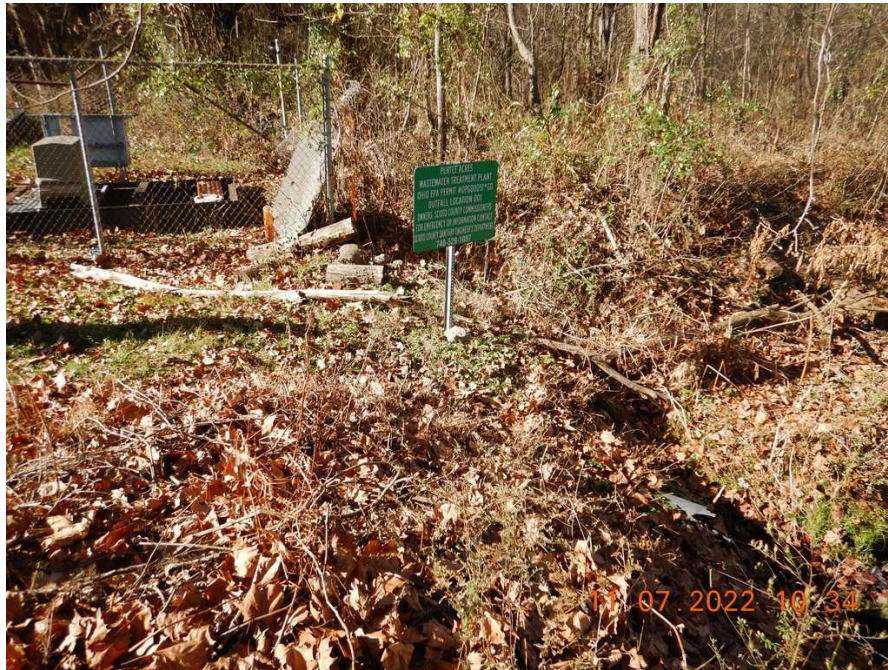
| Outfall 001 | DSCN4072.JPG | |

EPA observed Outfall 001. The Outfall 001 marker sign was in place. The printed side of the marker sign was positioned to face towards the receiving stream and the outfall pipe was visible (Photograph DSCN4072.JPG). Outfall 001 was actively flowing (Photograph DSCN4073.JPG). EPA observed that the effluent from Outfall 001 appeared clear with no visible floating solids or oil sheen present; and, there were no observable discolorations, foam, or odors evident in the receiving stream from the effluent.

| The marker sign for Outfall 001 was present at the outfall. The printed side of the sign was positioned to face towards the receiving stream. The broken PVC outfall pipe can be seen in the lower right corner of the photograph. | | |

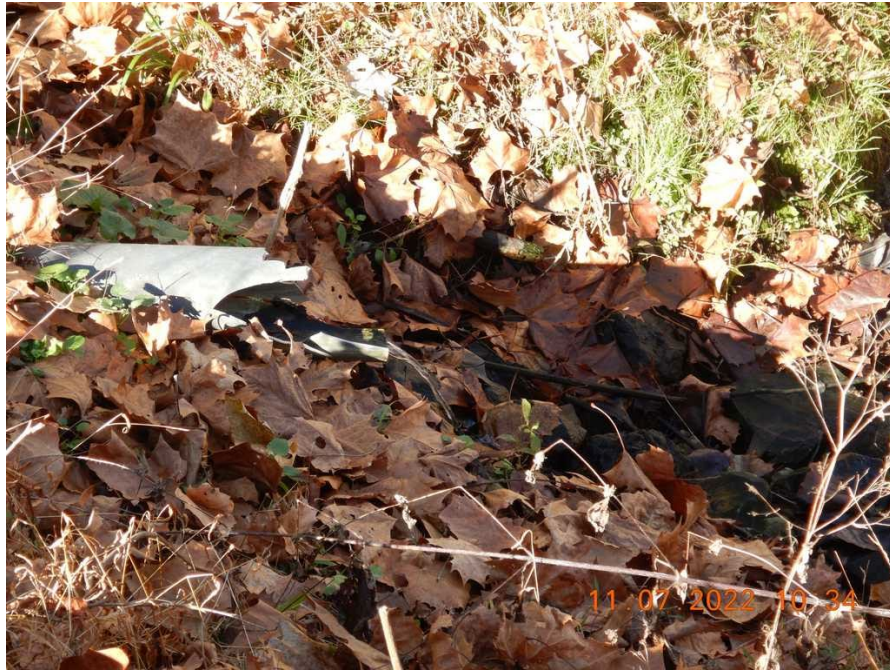
| Outfall 001 | DSCN4073.JPG | |

| Outfall 001 was flowing at the time of the inspection. Effluent appeared clear. No observable discoloration, foam, or odors from the effluent. | | |

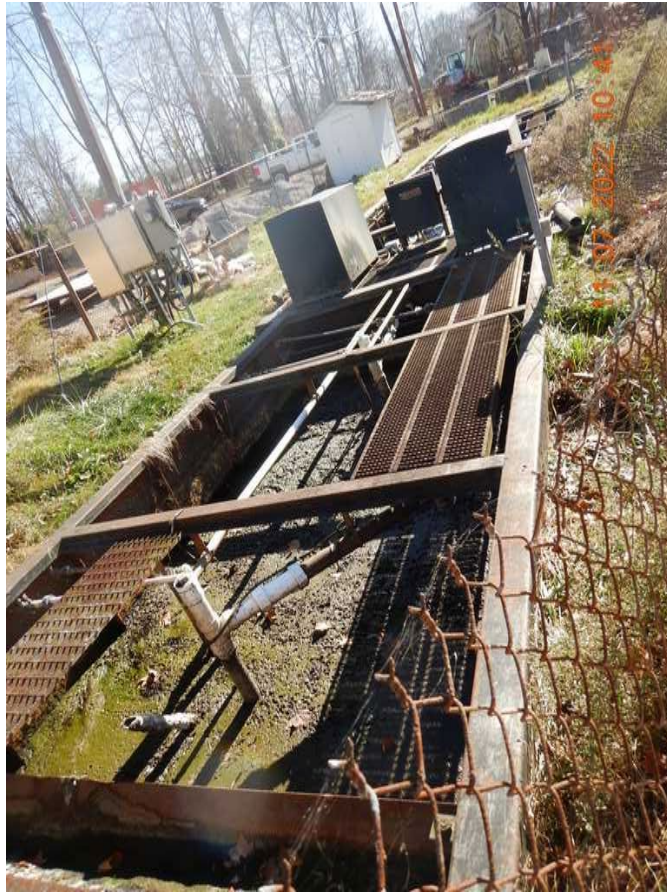
| Original WWTP | DSCN4074.JPG | |

The previous WWTP treatment units which are still present onsite showed signs of corrosion and excessive wear due to age. The previous WWTP is set to be demolished after the remaining wastewater and sludge are removed.

| <p>The clarifier from the original WWTP still has sludge in it. The sludge will be removed for processing at the Wheelersburg WWTP prior to the original WWTP being demolished in the next few months.</p> | | |

4. The old WWTP treatment units are still in place onsite, but are scheduled to be demolished in the coming months depending on weather and site conditions. Prior to demolition, wastewater remaining in the treatment units will be treated through the new WWTP and the sludge remaining in the old clarifier will be transported and processed at the Wheelersburg WWTP for disposal.

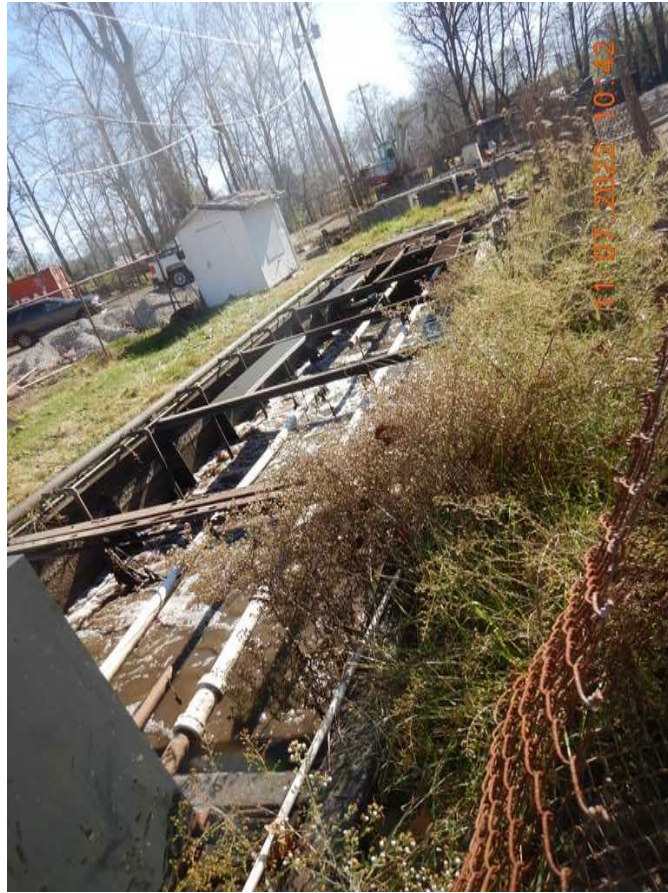
| Original WWTP | DSCN4075.JPG | |

EPA observed that the previous WWTP was still in place and had not yet been removed (Photograph DSCN4078.JPG). EPA observed that wastewater was still present in the original WWTP treatment units (Photograph DSCN4075.JPG). According to Ryan Smith, the remaining wastewater will be pumped to the headworks of the new WWTP (prior to the bar screen) before the treatment units are demolished. The previous treatment units are no longer receiving influent flow since the new SBR WWTP began operating. EPA observed that the clarifier for the previous WWTP still contains sludge (Photograph DSCN4074.JPG). According to Ryan Smith, the sludge in this clarifier will be removed for processing at the Wheelersburg WWTP prior to the original WWTP being demolished.

| Wastewater remaining in the original WWTP treatment units will be pumped into the headworks to the new WWTP prior to the bar screen before the units are demolished. | | |

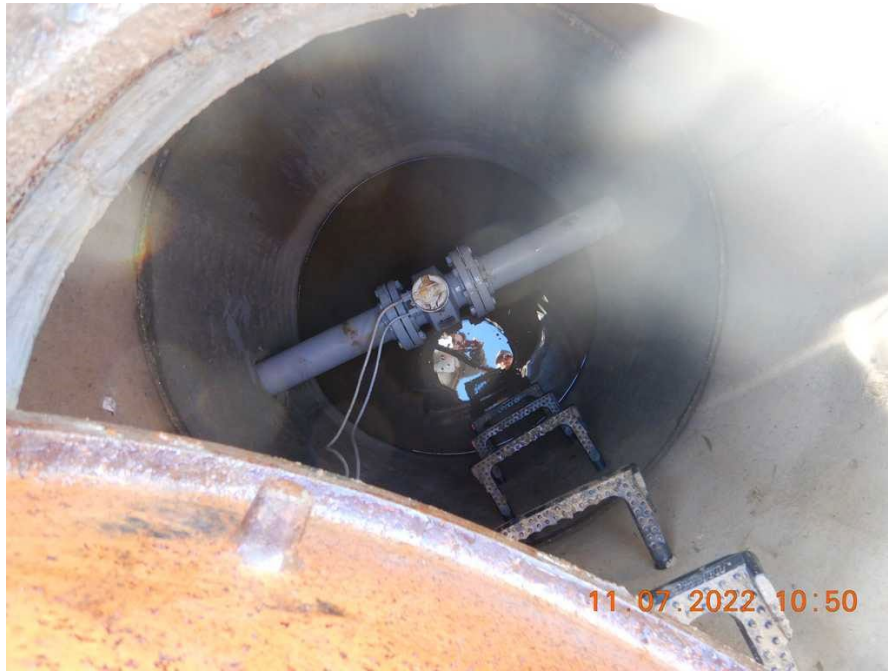
| Influent Flow Measurement | DSCN4076.JPG | |

| <p><b>AOC:</b></p> <p>EPA observed liquid in the bottom of the newly installed manhole for the in-line flowmeter location (Photograph DSCN4076.JPG). Ryan Smith explained that the water was from groundwater infiltration into the manhole structure.</p> | |

| An in-line magmeter is used to measure influent flow to the new WWTP. The water in the bottom of the manhole was described by Ryan Smith as being from groundwater infiltration into the manhole. | | |

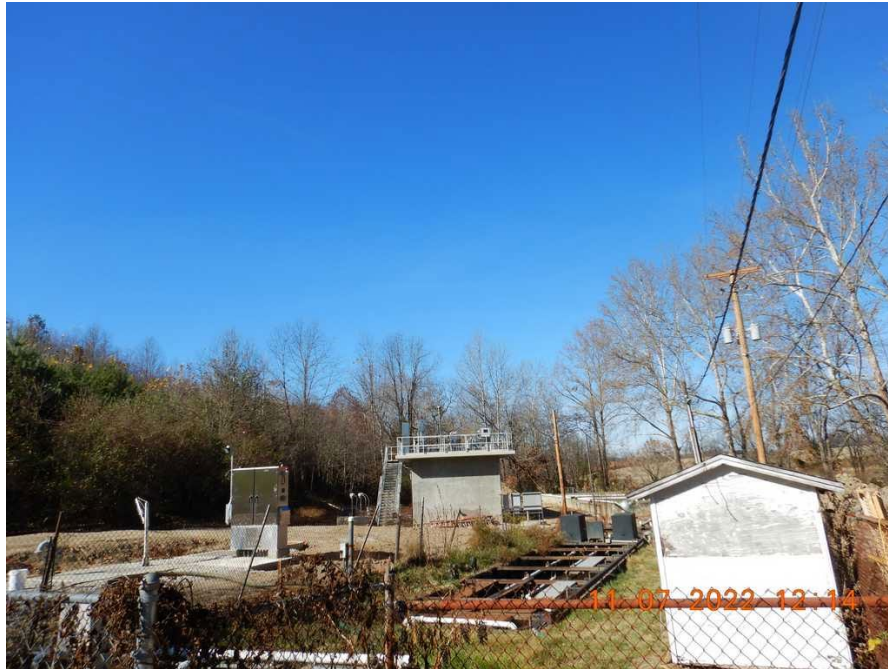
| Overview of Previous WWTP and New Upgraded WWTP | DSCN4078.JPG | |

| Overview photograph showing both the previous WWTP units (lower edge, center-right) and the locations of the new upgraded WWTP headworks and headworks control panel (lower left corner); and new dual SBR and sludge holding tank/digester structure (center). | | |
