## **RCRA Inspection Report**

Ascend Elements Discharge and  
Disassembly Facility (AEDDF)  
10157 Industrial Drive, NE  
Covington, GA 30014  
Newton County

January 18, 2024, at 10:00 a.m.

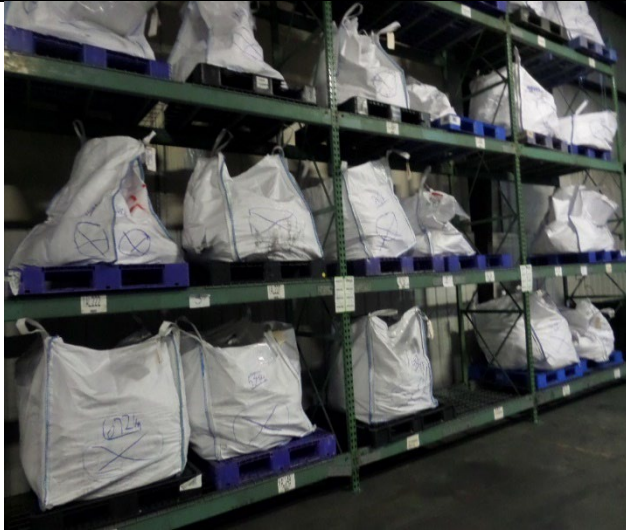
Ascend Elements Discharge and Disassembly Facility (AEDDF). Warehouse. Storage Area Row L. The inspectors observed dry and wet battery in white one cubic yard bags and in large cardboard boxes. Inspectors observed the bags and boxes were not closed, were not labeled, or not marked as universal waste. Photograph 1 taken at 11:29 a.m.

The inspectors observed several supersacks on pallets storing dry battery and wet noncharged battery in all the racks. The inspectors observed the supersacks were marked with the weight. The inspectors observed the supersacks were not closed and not labeled or marked clearly with words identifying the content of the supersack (Attachment 1 Photographs 1, 2, and 4 and Attachment 2 Photograph 10).

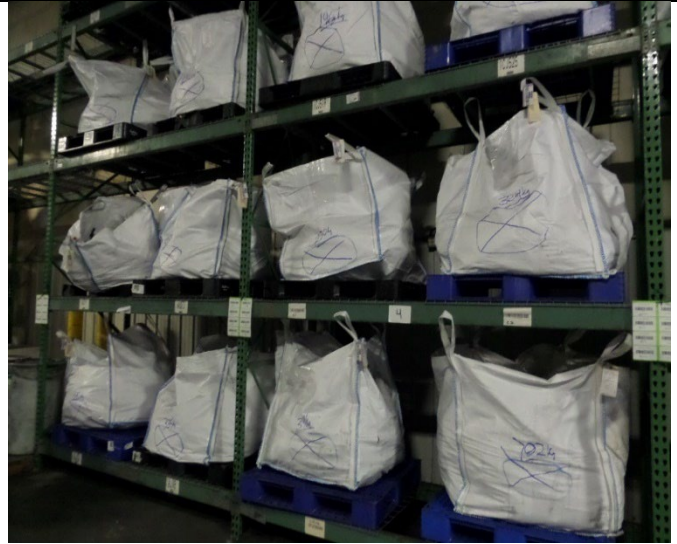
AEDDF. Warehouse. Storage Area Row L. The inspectors observed dry and wet battery in white one cubic yard bags and in large cardboard boxes. Inspectors observed the bags and boxes were not closed, were not labeled, or not marked as universal waste. Photograph 2 taken at 11:29 a.m.

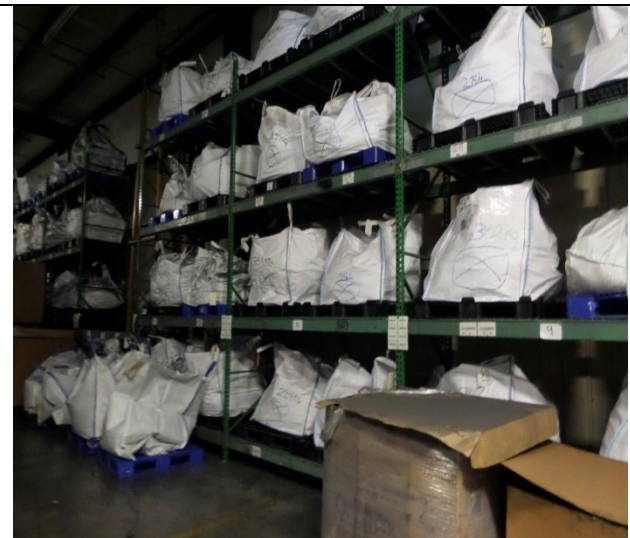
AEDDF. Warehouse. Storage Area Row L. The inspectors observed dry and wet battery in white one cubic yard bags and in large cardboard boxes. Inspectors observed the bags and boxes were not closed, were not labeled, or not marked as universal waste and not marked with a date. Photograph 4 taken at 11:29 a.m.

Inspectors observed three large cardboard boxes on pallets on the floor labeled with the words "jelly roll". Two boxes were approximately three-feet high, and one box was approximately five-feet high. The inspectors observed that the three boxes were not closed and two boxes were damaged (Attachment 1 Photographs 4 and 6 and Attachment 2 Photograph 8).

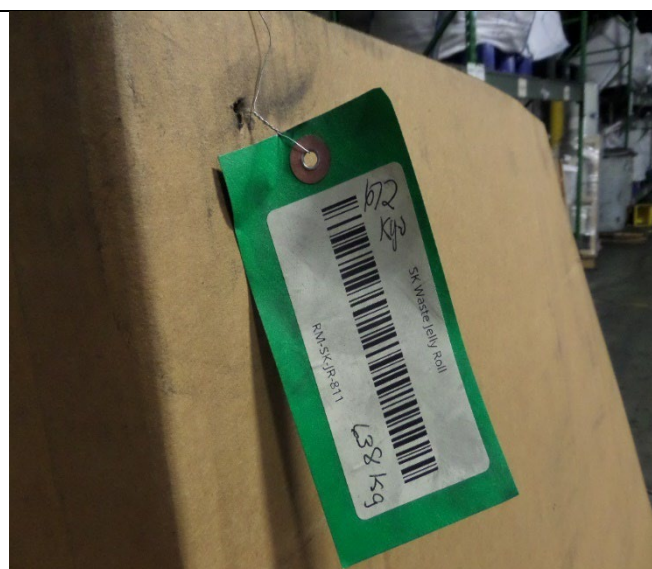
AEDDF. Warehouse. Storage Area Row L. The inspectors observed the tag attached to the large cardboard boxes is marked with the quantity (lbs/kgs) description of the battery, and a bar code. A dry battery is described as ("jelly roll"). Photograph 6 taken at 11:32 a.m.

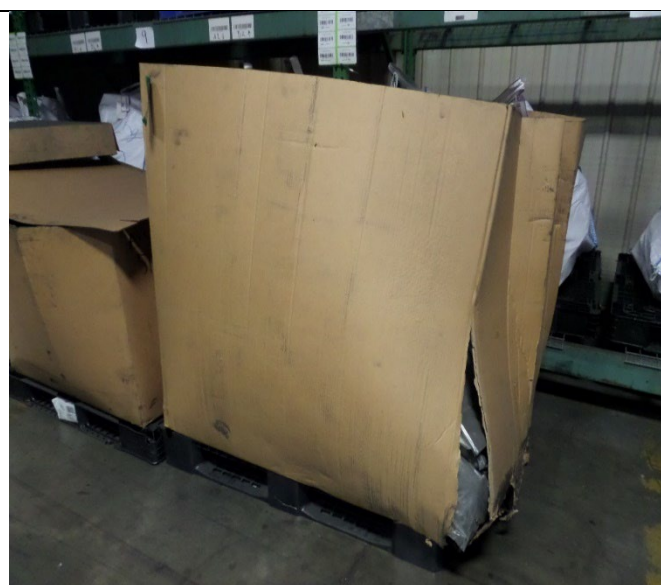
AEDDF. Warehouse. Storage Area Row L. Inspectors observed three boxes in Row L. storing dry battery. Inspectors observed the three boxes were not closed and two boxes were not structurally sound and were damaged. Inspectors observed the boxes were not labeled or marked clearly with the phrase Universal Waste. Photograph 8 taken at 11:32 a.m.

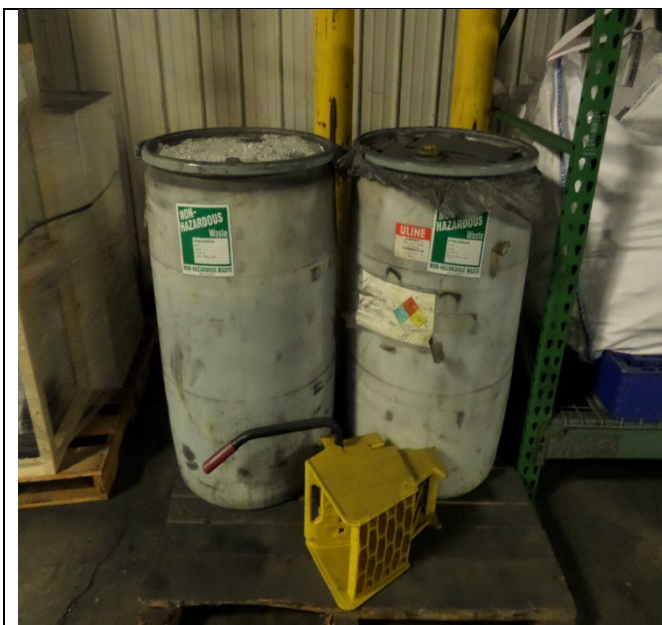
AEDDF. Warehouse. Storage Area Row L. Inspectors observed two 55-gallon containers labeled with words non-hazardous waste on a pallet on the floor. The containers were marked with words “battery water”. A container was marked with the words graphite leach (lead)? and wash – slightly acidic” Photograph 9 taken at 11:38 a.m.

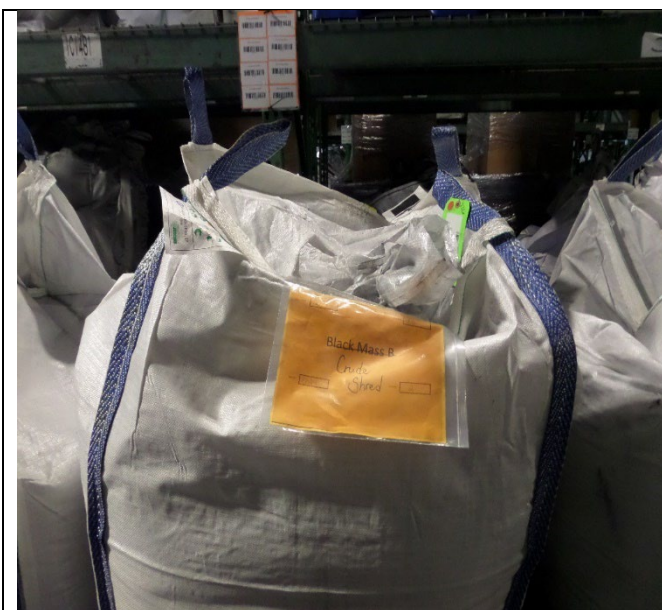
The inspectors observed nine supersacks on pallets on the floor storing black mass in Row K. The inspectors observed the supersacks were not closed and were labeled with the words “black mass”, “black mass crude shred” or “crude shred” and labeled with a barcode. The inspectors did not observe a tag attached to the supersacks (Attachment 1 Photographs 10, 11, and 12). The inspectors also observed several supersacks of mixed metals.

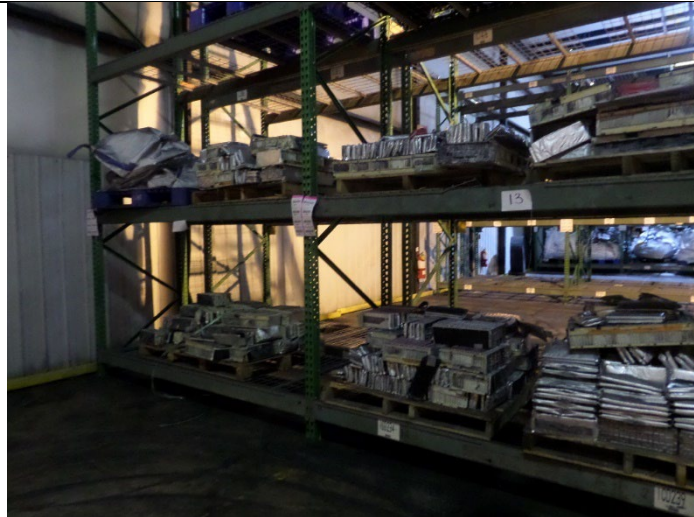
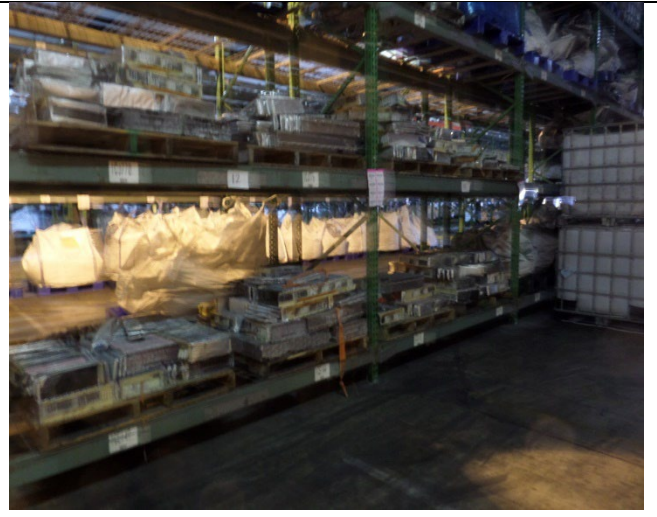
The inspectors observed several supersacks on pallets storing dry battery and wet noncharged battery in several rows and racks. The inspectors also observed the wet batteries stored on the racks were not contained in a supersack or in a tote. AEDDF representatives indicated because it is an intact cell the battery is harder to process on the conveyer if it is in a supersack. The inspectors observed the supersacks and wet batteries were not labeled or marked clearly with words identifying the content of the supersack and the wet batteries (Attachment 1 Photographs 21 and 22) and (Attachment 2 Photographs 11 and 14).

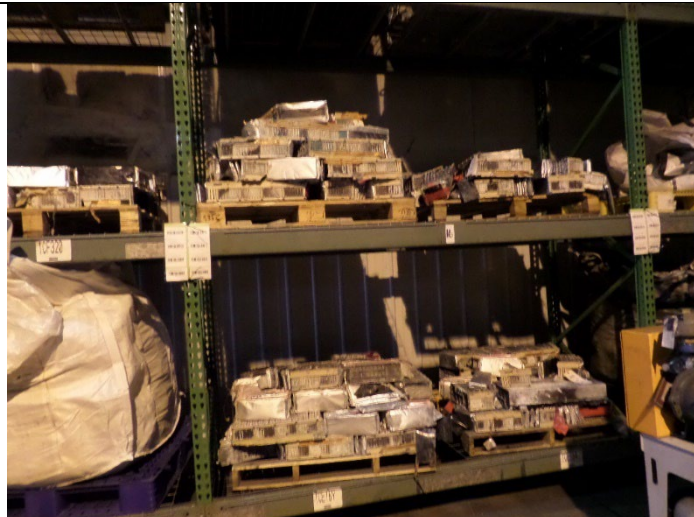
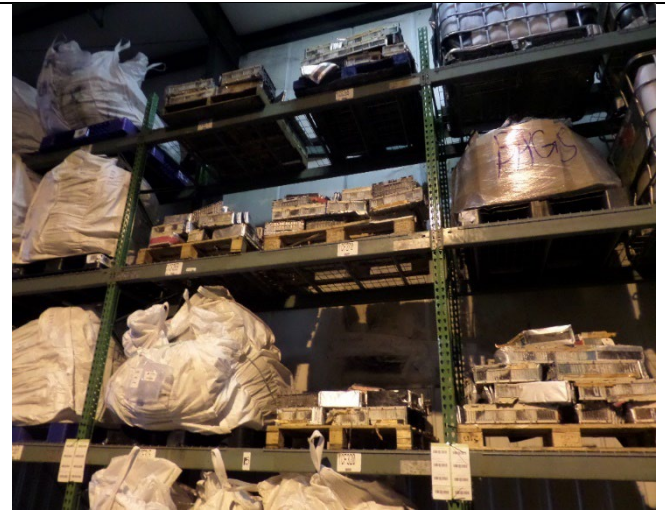
The inspectors observed several supersacks on pallets storing dry battery and wet noncharged battery in several rows and racks. The inspectors also observed the wet noncharged batteries stored on the racks were not contained in a supersack or in a tote. AEDDF representatives indicated because it is an intact cell the battery is harder to process on the conveyer if it is stored in a supersack. The inspectors observed the supersacks and wet batteries were not labeled or marked clearly with words identifying the content of the supersack and the wet batteries (Attachment 1 Photographs 23 and 24) and (Attachment 2 Photographs 12 and 13).

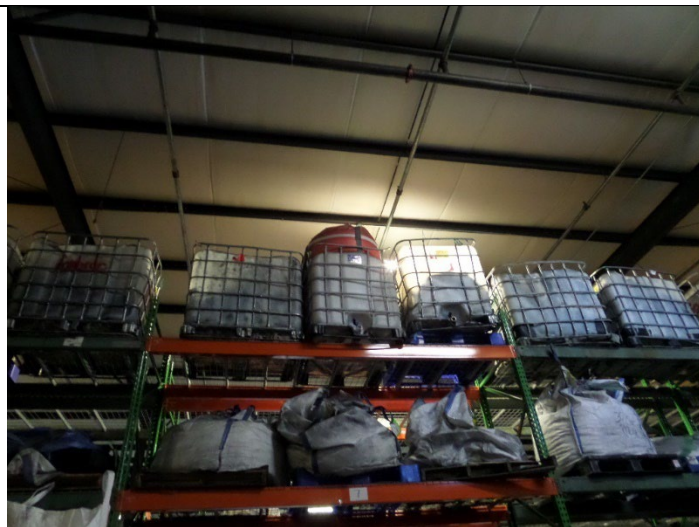
AEDDF. Warehouse. Storage Area Row B. Photograph 25 taken at 12:04 p.m.

The inspectors observed a 250-gallon tote covered with an orange lid on the top rack storing anode powder. AEDDF representatives indicated anode powder can be sold for reuse (Attachment 1 Photograph 25) and (Attachment 2 Photographs 15 and 16).

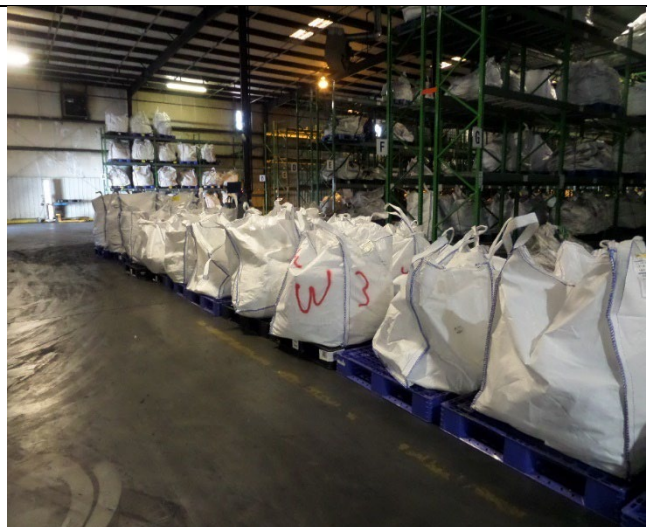
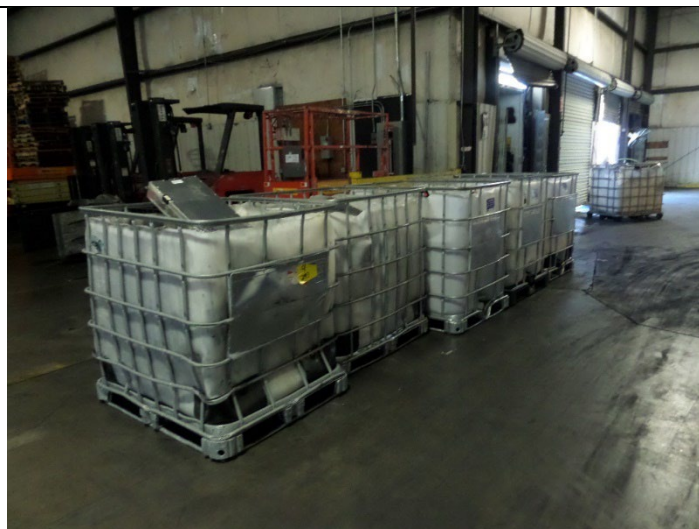
This area is located adjacent to the loading dock. The inspectors observed two rows of batteries on pallets for a total of approximately 24 pallets of supersacks and totes storing dry battery and wet battery. AEDDF representatives indicated the batteries were received on January 17, 2024. The inspectors observed the supersacks and totes were not closed, and not labeled or marked clearly with words identifying the content of the supersacks and totes (Attachment 1 Photographs 26 and 27) and (Attachment 2 Photographs 18, 19, 20, 21, and 23).

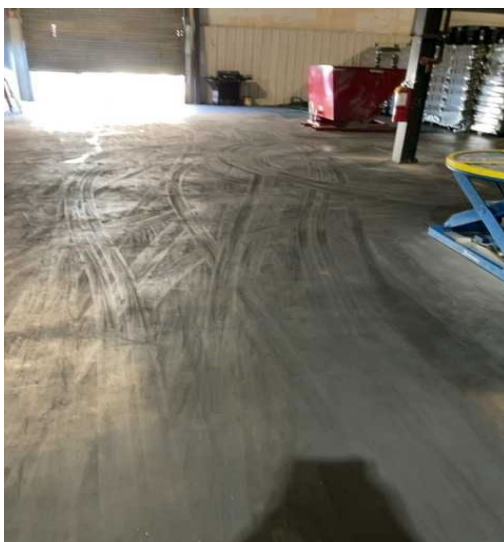
The inspectors observed black material on the floor in the front area between Row K and Row L and observed tire tracks on the floor in several areas between Row K and Row L (Attachment 2 Photograph 1). The inspectors observed a layer of black material on the floor in the rear area of the row between Row K and Row L (Attachment 1 Photographs 16 and 17 and Attachment 2 Photograph 9). The inspectors asked the facility to clean up the black material on the floor.

| The inspectors observed black material on the floor adjacent to the break room and near the overhead door. | | | |

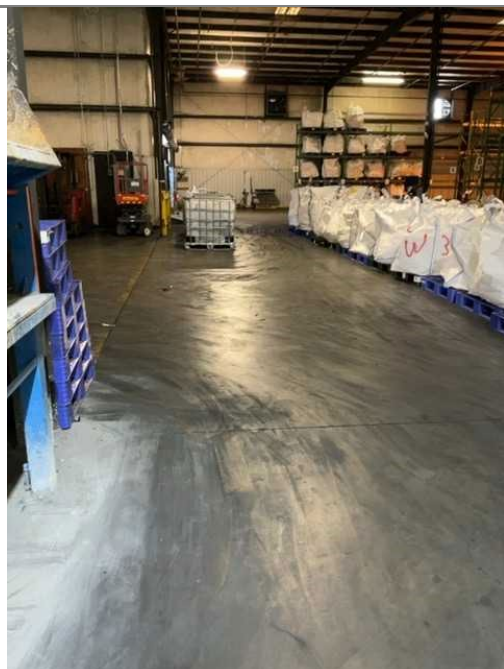
| The inspectors observed black material on floor in the battery staging area. | | | |

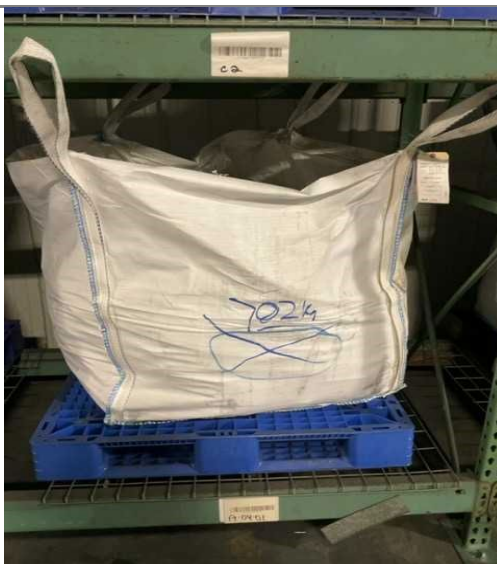
| | | | The inspectors observed the supersack of wet battery was marked with its weight, was not closed, and was not labeled or marked clearly with one of the following phrases: "Universal Waste Battery(ies)", or "Waste Battery(ies)", or "Used Battery(ies)". |

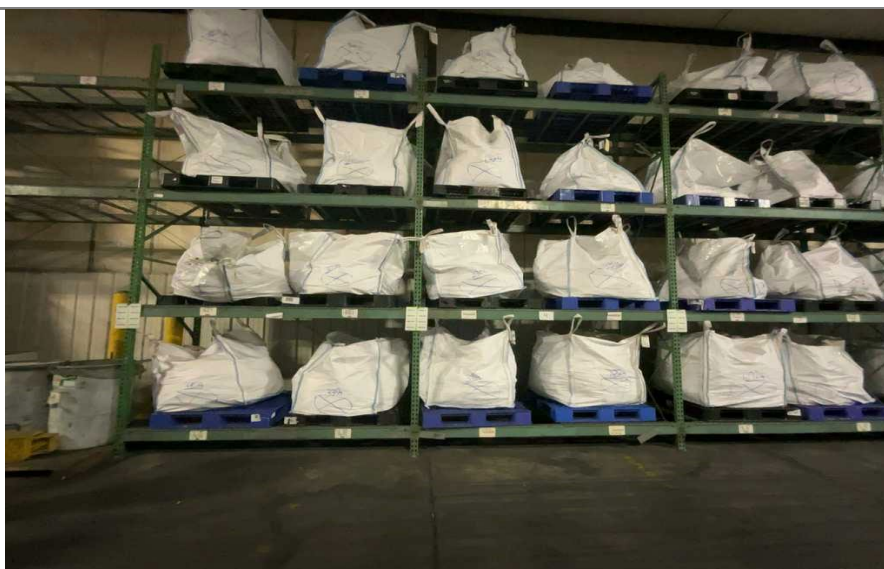
| The inspectors observed the supersack of dry and wet battery was marked with its weight, was not closed and was not labeled or marked clearly with one of the following phrases: "Universal Waste Battery(ies)", or "Waste Battery(ies)", or "Used Battery(ies)". | | | |

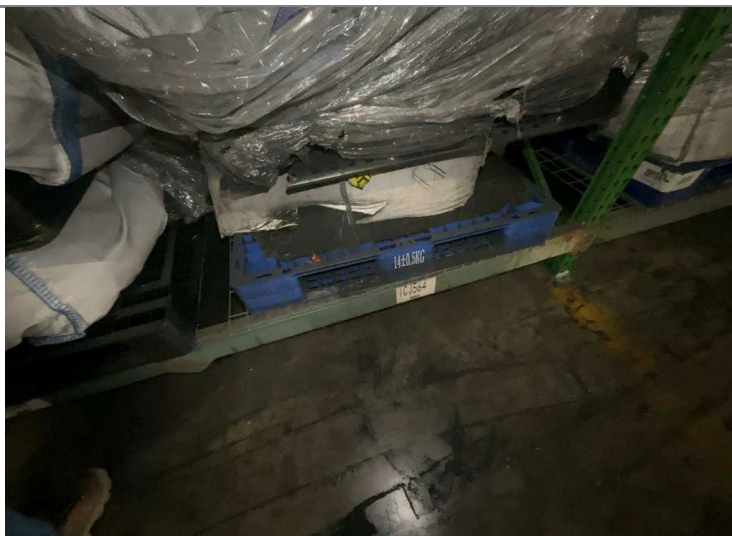
| The inspectors observed the supersacks of dry and wet battery were not closed and not labeled or marked clearly with one of the following phrases: "Universal Waste Battery(ies)", or "Waste Battery(ies)", or "Used Battery(ies)". | | | |

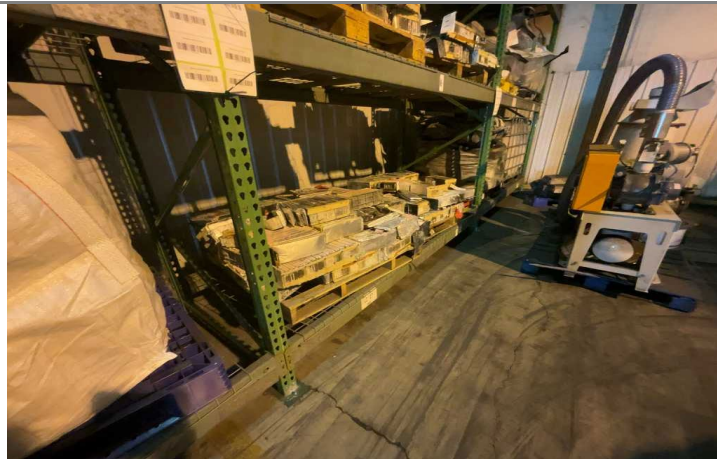
| The inspectors observed the dry and wet battery were not marked with dates, and not labeled or marked clearly with one of the following phrases: "Universal Waste Battery(ies)", or "Waste Battery(ies)", or "Used Battery(ies)". | | | |

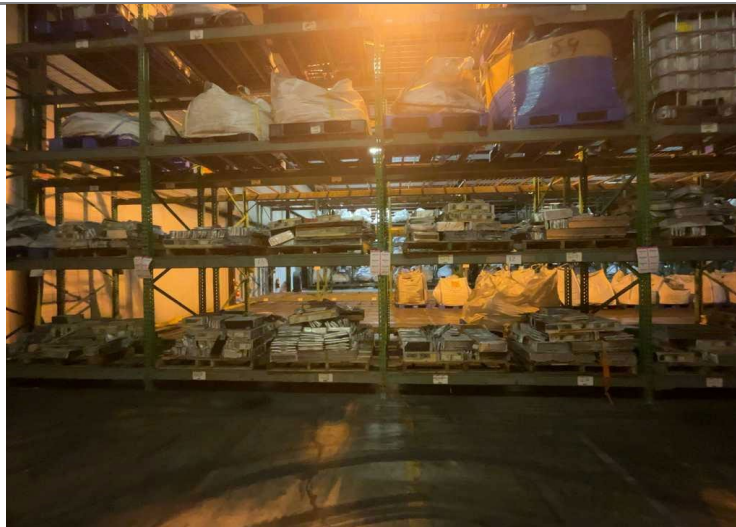
| The inspectors observed the supersacks of dry and wet battery were not marked with dates and not labeled or marked clearly with one of the following phrases: "Universal Waste Battery(ies)", or "Waste Battery(ies)", or "Used Battery(ies)". | | | |

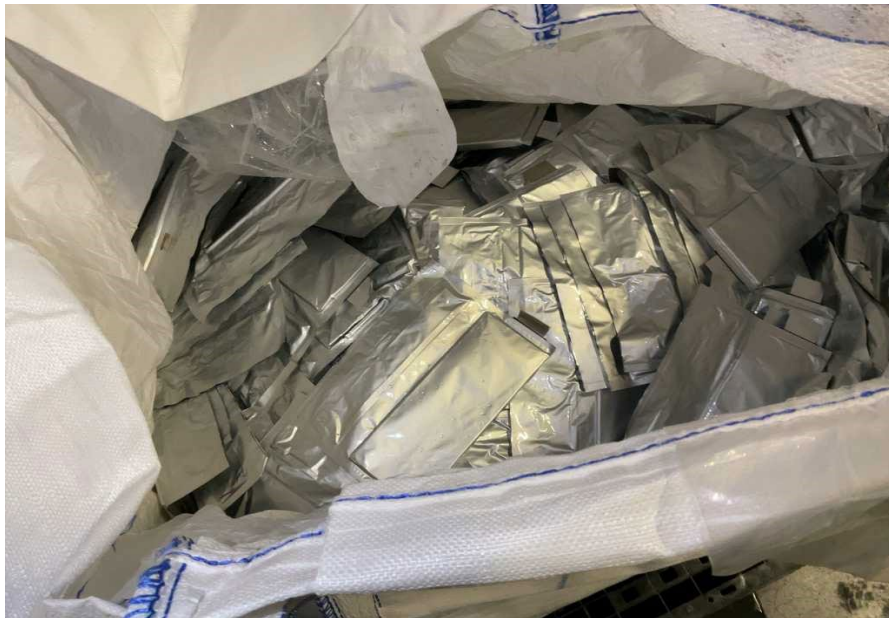
| The inspectors observed supersacks and totes of dry and wet battery (mylar cells) staged in this area. AEDDF indicated the battery was received on January 17, 2024. The inspectors observed the dry and wet battery were not marked with dates and not labeled or marked clearly with one of the following phrases: "Universal Waste Battery(ies)", or "Waste Battery(ies)", or "Used Battery(ies)". | | | |

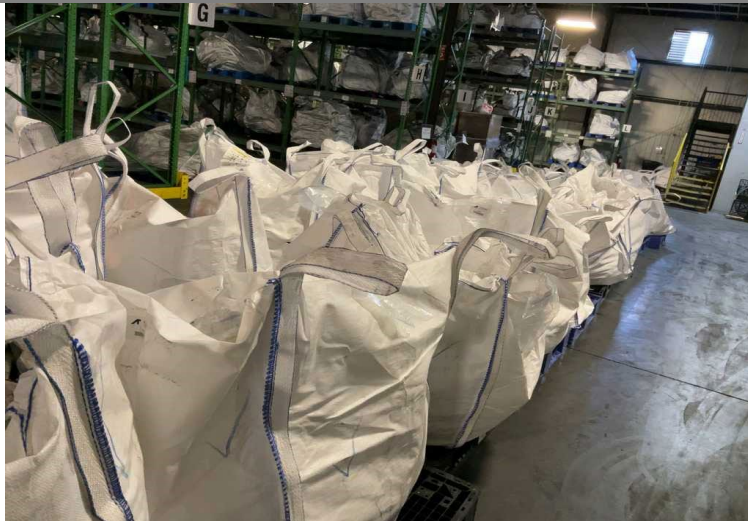
| The inspectors observed supersacks and totes of dry and wet battery (mylar cells) staged in this area. The inspectors observed the dry and wet battery were not marked with dates and not labeled or marked clearly with one of the following phrases: "Universal Waste Battery(ies)", or "Waste Battery(ies)", or "Used Battery(ies)". | | | |

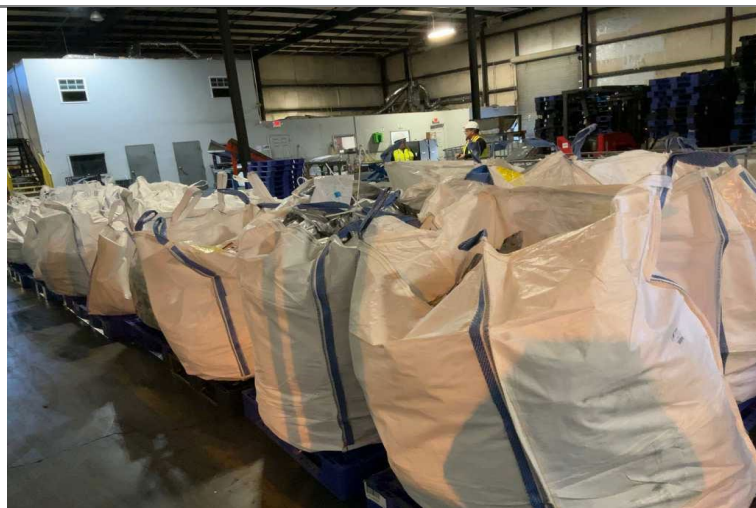
| The inspectors observed supersacks and totes of dry and wet battery (mylar cells) staged in this area. The inspectors observed the dry and wet battery were not marked with dates and not labeled or marked clearly with one of the following phrases: "Universal Waste Battery(ies)", or "Waste Battery(ies)", or "Used Battery(ies)". | | | |

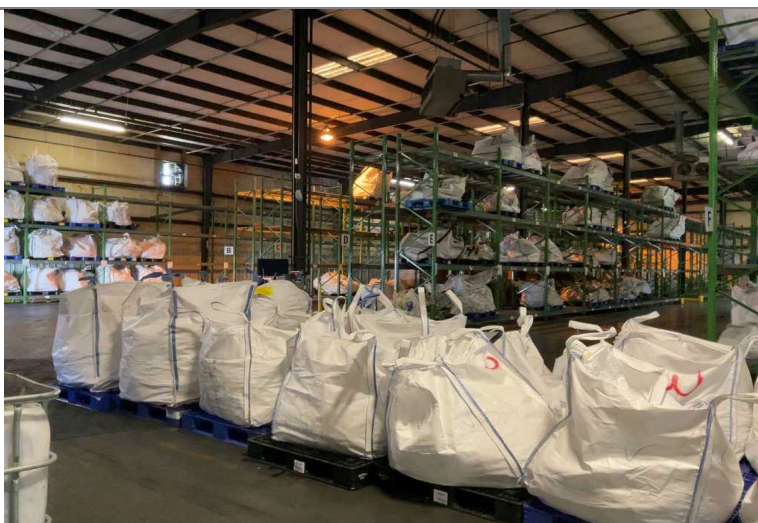
| | | | The inspectors observed supersacks and totes of dry and wet battery (mylar cells) staged in this area. The inspectors observed the dry and wet battery were not marked with dates and not labeled or marked clearly with one of the following phrases: "Universal Waste Battery(ies)", or "Waste Battery(ies)", or "Used Battery(ies)". |
