## **RCRA Inspection Report**

Metal Coaters  
951 Prisock Road  
Jackson, Mississippi 39272  
Hinds County

EPA ID No.: MSD985980481

October 19, 2021, at 9:00 a.m.

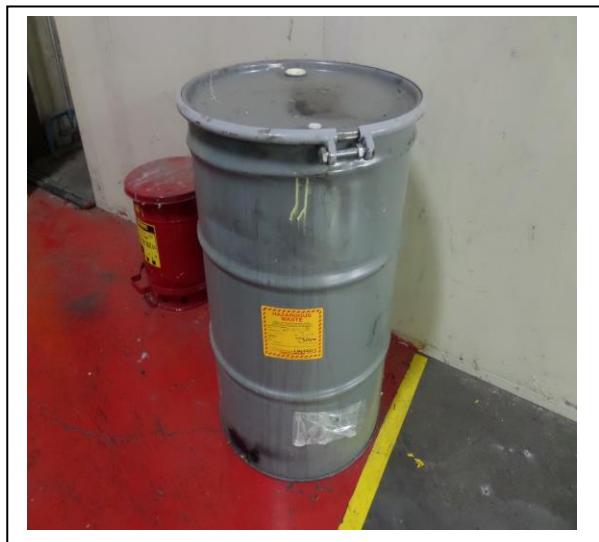
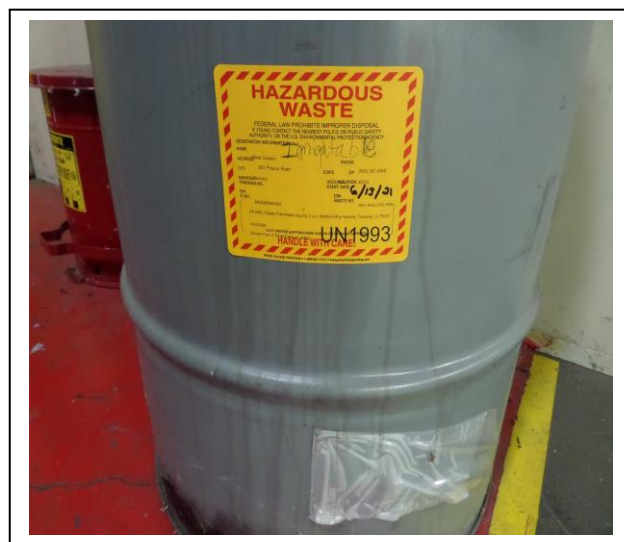
Samples from the chemical process are tested for the quality control conditions in an adjoining laboratory. Inspectors observed a 55-gallon satellite accumulation area (SAA) container outside the laboratory accumulating waste toluene and MEK from testing the samples. The container was closed, in good condition, labeled with the words hazardous waste and marked with the date June 13, 2021. The container was not marked or labeled with an indication of the hazard of the contents (Photograph 1). The facility marked the container with the word "ignitable", prior to inspectors leaving this area (Photograph 2). Mr. Fero explained, based on the RCRA CEI conducted in 2016, they thought containers were required to be dated as soon as hazardous waste was accumulated in the container. The inspectors discussed the regulatory issue with Mr. Fero and Mr. Thornburg and was reviewed during the closing conference.

Metal Coaters. Core Room/Laboratory. The container was not marked or labeled with a hazard indicator. Photograph 1 taken at 10:58 a.m.

Metal Coaters. Core Room/Laboratory. The container was not marked or labeled with a hazard indicator. Photograph 2 taken at 10:58 a.m.

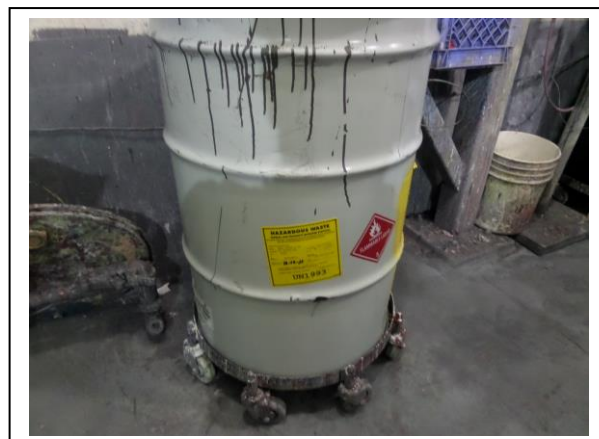
The final paint coat is applied in this area. Waste paint related material is accumulated in 55-gallon SAA containers. Inspectors observed a 55-gallon container accumulating waste paint and solvent contaminated rags. The container was closed, in good condition, labeled with the words hazardous waste (D001, D007, F003, F005), labeled with a hazard indicator and marked with the date October 18, 2021 (Photograph 3). Inspectors also observed a 55-gallon container accumulating waste paint and solvent. The container was closed, in good condition, labeled with the words hazardous waste (D001, D007, F003, F005), labeled with a hazard indicator and marked with the date October 19, 2021 (Photograph 4).

Metal Coaters. Finish Paint Coater #1. Waste paint and solvent dated 10/19/21. Photograph 4 taken at 11:12 a.m.

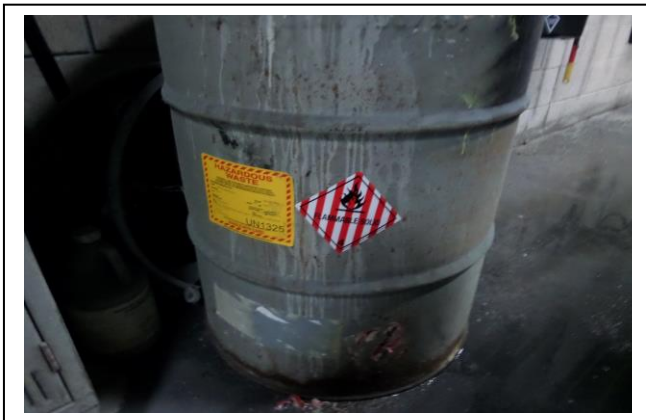
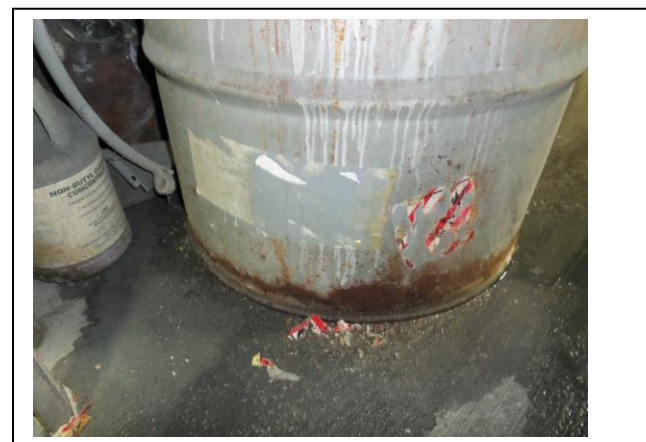
Inspectors observed the 55-gallon container was surrounded by an apparent condensate release

from nearby equipment. The bottom of the container appeared to be rusted. The inspectors observed no apparent release of hazardous waste from the container (Photographs 5, 6, and 7). The facility transferred the hazardous waste to a new container and moved the container to a dry concrete floor prior to the completion of this inspection.

Metal Coaters. Rolle Grind Room. Rusted container dated 10/5/21. Transferred contents to a new container. Photograph 5 taken at 11:18 a.m.

Metal Coaters. Rolle Grind Room. Rusted container dated 10/5/21. Transferred contents to a new container. Photograph 6 taken at 11:18 a.m.

Metal Coaters. Rolle Grind Room. Rusted container dated 10/5/21. Transferred contents to a new container. Photograph 7 taken at 11:18 a.m.

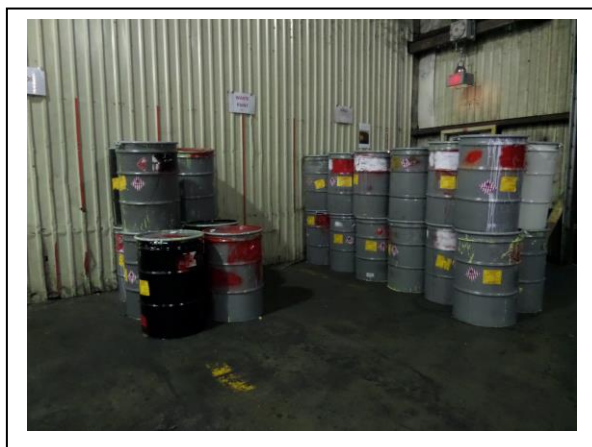
Inspectors observed 33 55-gallon containers in rows stacked two high. The containers were accumulating waste rags contaminated with solvent (MEK and toluene). The containers were closed, in good condition with aisle space, labeled with the words hazardous waste, labeled with a hazard indicator, and marked with dates in September or October 2021 (Photographs 8 and 9).

Metal Coaters. Paint 90-Day or Less Accumulation Area (Paint 90-Day). Waste rags row. Photograph 8 taken at 11:30 a.m.

Metal Coaters. Paint 90-Day. Waste rags row. Photograph 9 taken at 11:30 a.m.

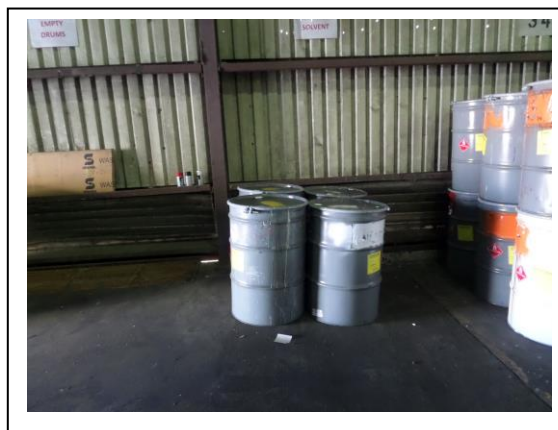
Inspectors observed four 55-gallon containers in this area. The containers were accumulating waste lacquer thinner (MEK and xylene). The containers were closed, in good condition with aisle space, labeled with the words hazardous waste, labeled with a hazard indicator, and marked with dates in October 2021 (Photograph 10).

Metal Coaters. Paint 90-Day. Recycle solvent row. Photograph 10 taken at 11:42 a.m.

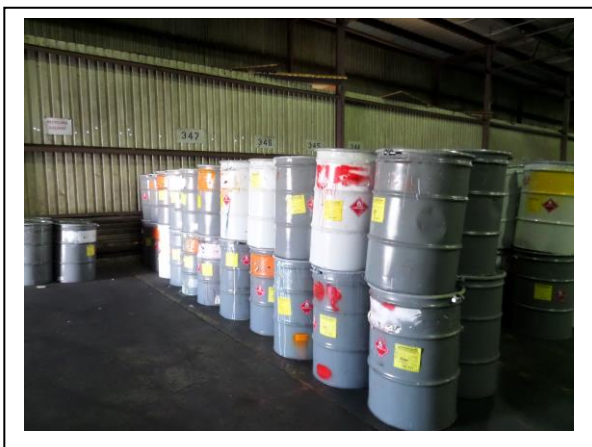
Inspectors observed 44 55-gallon containers in rows stacked two high. The containers were accumulating waste lacquer thinner (MEK and xylene). The containers were closed, in good condition with aisle space, labeled with the words hazardous waste, labeled with a hazard indicator, and marked with dates in August, September or October 2021 (Photograph 11).

Metal Coaters. Paint 90-Day. Row 346. Photograph 11 taken at 11:43 a.m.

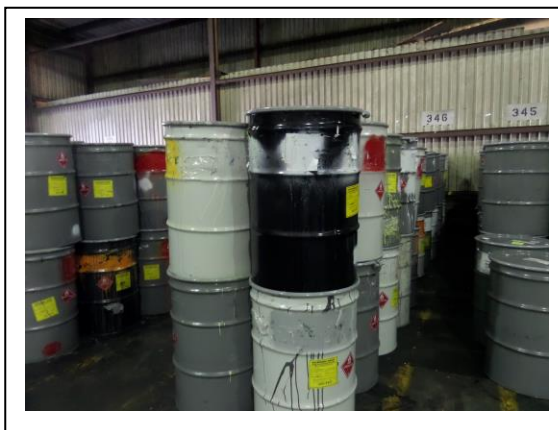
Inspectors observed 44 55-gallon containers in rows stacked two high. The containers were accumulating waste lacquer thinner (MEK and xylene). The containers were closed, in good condition with aisle space, labeled with the words hazardous waste, labeled with a hazard indicator, and marked with dates in August, September or October 2021 (Photograph 12). Inspectors observed three 55-gallon containers were not marked with the year. The facility marked the year 2021 on the three containers, prior to leaving this area.

Metal Coaters. Paint 90-Day. Row 347. The facility marked three 55-gallon containers with the year 2021. Photograph 12 taken at 11:43 a.m.

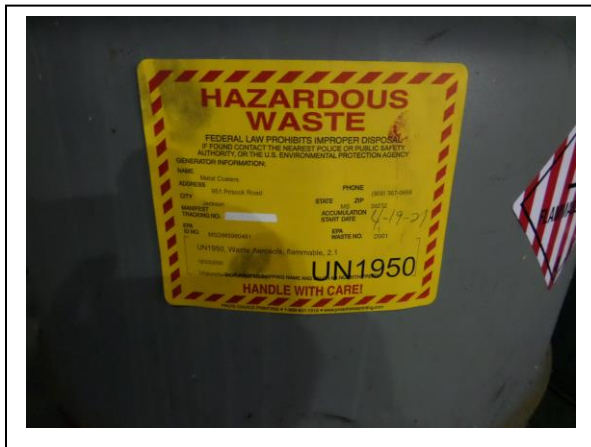
Inspectors observed five 55-gallon containers in this area. The containers were accumulating non-punctured waste aerosol paint cans. The containers were closed, in good condition with aisle space, labeled with the words hazardous waste and labeled with a hazard indicator (Photograph 15). Inspectors observed four 55-gallon containers were marked with dates in October 2021 and

one 55-gallon container of hazardous waste was marked with the date April 19, 2021 (Photographs 13 and 14).

Metal Coaters. Aerosols and Small Paint Can Area. The inspectors observed the container's labeled marked with the date 4/13/21. Photograph 13 taken at 11:52 a.m.

Metal Coaters. Aerosols and Small Paint Can Area. The inspectors observed the container's labeled marked with the date 4/13/21. Photograph 14 taken at 11:52 a.m.

**Pursuant to 11 Miss. Admin. Code Pt. 3, R. 1.3 [40 C.F.R. § 262.17(b)], an LQG who accumulates hazardous waste for more than 90 days is an operator of a storage facility and is subject to the requirements of MHWMR, 11 Miss. Admin. Code Pt. 3, R. 1.1-1.20, 1.23, and 1.24 [40 C.F.R. Parts 124, 264 through 268 and Part 270].**

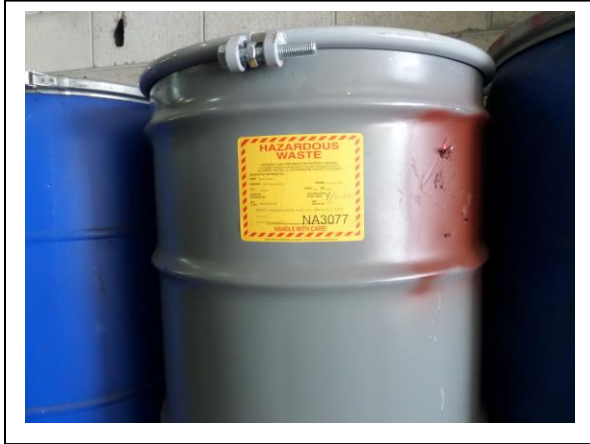
Inspectors also observed a 55-gallon container accumulating crushed mercury fluorescent lamps. The container was closed, in good condition with aisle space, labeled with the words hazardous waste and marked with date September 21, 2021. The inspectors observed the container was not marked or labeled with a hazard indicator (Photograph 17). The facility marked the container with the word "toxic", prior to inspectors leaving this area.

Metal Coaters. Universal Waste Accumulation Area. Inspectors observed a 55-gallon container accumulating hazardous waste crushed lamps with no hazard indicator. Photograph 17 taken at 12:01 p.m.

**Pursuant to 11 Miss. Admin. Code Pt. 3, R. 1.3 [40 C.F.R. § 262.17(a)(5)(i)(B)], which is a condition of the LQG Permit Exemption, a generator must mark or label its containers with the following: an indication of the hazards of the contents (examples include, but are not limited to, the applicable hazardous waste characteristic(s) (i.e., ignitable, corrosive, reactive, toxic); hazard communication consistent with the Department of Transportation requirements at 49 CFR part 172 subpart E (labeling) or subpart F (placarding); a hazard statement or pictogram consistent with the Occupational Safety and Health Administration Hazard Communication Standard at 29 CFR 1910.1200; or a chemical hazard label consistent with the National Fire Protection Association code 704).**

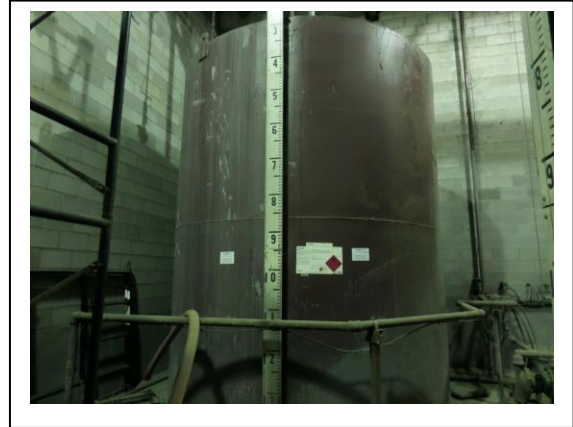
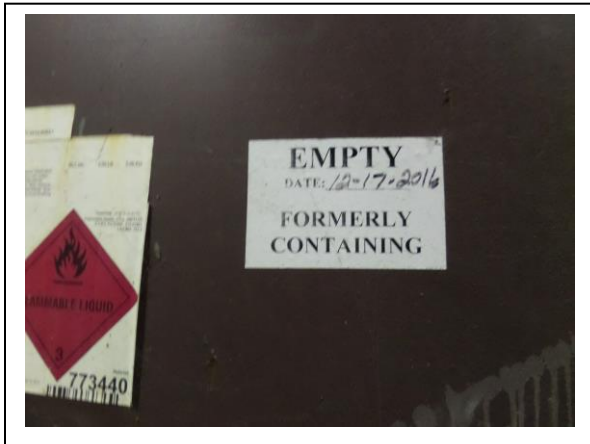
and Mr. Fero indicated hazardous waste is not accumulated in the tank and it was closed in 2016. Inspectors observed the tank was labeled as “EMPTY DATE: 12/17/2016, FORMALLY CONTAINING” (Photographs 18 and 19). The inspectors observed the concrete floor and floor-level sump appeared dry (Photographs 20 and 21).

Metal Coaters. Solvent Storage Room. 90-day accumulation tank. Inspectors observed the tank labeled empty on 12/17/16. Photograph 18 taken at 12:08 p.m.

Metal Coaters. Solvent Storage Room. 90-day accumulation tank. Inspectors observed the tank labeled empty on 12/17/16. Photograph 19 taken at 12:08 p.m.

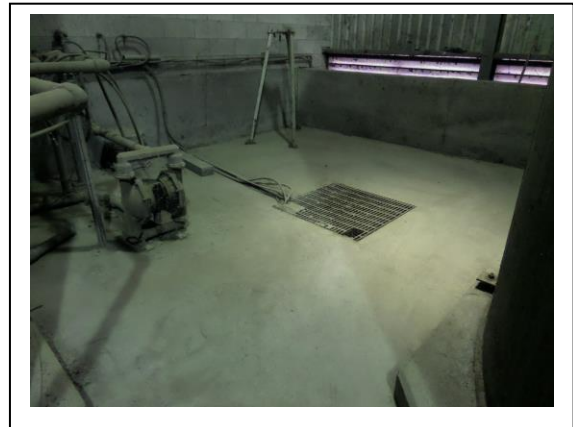
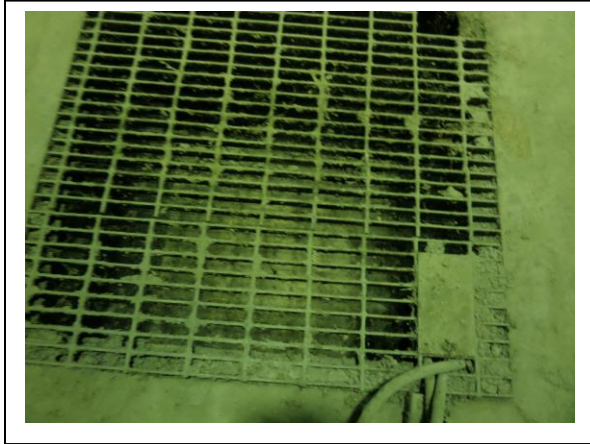
Metal Coaters. Solvent Storage Room. Inspectors observed floor level concrete sump. Photograph 20 taken at 12:08 p.m.

Metal Coaters. Solvent Storage Room.  
Inspectors observed floor level concrete  
sump. Photograph 21 taken at 12:09 p.m.

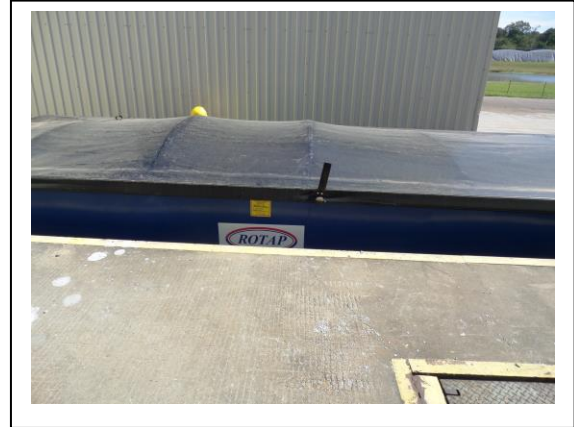
The container is located outdoors next to a loading dock. The facility accumulates hazardous waste filter cake (F006) generated from the WWPT. The inspectors observed the container was closed, labeled with the words hazardous waste, and marked with the date October 3, 2021. The inspectors observed the container was not marked or labeled with a hazard indicator (Photograph 22). The facility marked the container with an indication of the hazards of the content, prior to the completion of this inspection.

Metal Coaters. WWPT Outdoor 30 Cubic  
Yard Container. Facility marked a hazard  
indicator on the container. Photograph 22  
taken at 12:28 p.m.

**Pursuant to 11 Miss. Admin. Code Pt. 3, R. 1.3 [40 C.F.R. § 262.17(a)(5)(i)(B)], which is a condition of the LQG Permit Exemption, a generator must mark or label its containers with the following: an indication of the hazards of the contents (examples include, but are not limited to, the applicable hazardous waste characteristic(s) (i.e., ignitable, corrosive, reactive, toxic); hazard communication consistent with the Department of Transportation requirements at 49 CFR part 172 subpart E (labeling) or subpart F (placarding); a hazard statement or pictogram consistent with the Occupational Safety and Health Administration Hazard Communication Standard at 29 CFR 1910.1200; or a chemical hazard label consistent with the National Fire Protection Association code 704).**
