# Compliance Evaluation Inspection Report

## Westchester County - Yonkers

### Joint Wastewater Treatment Plant

November 15, 2022

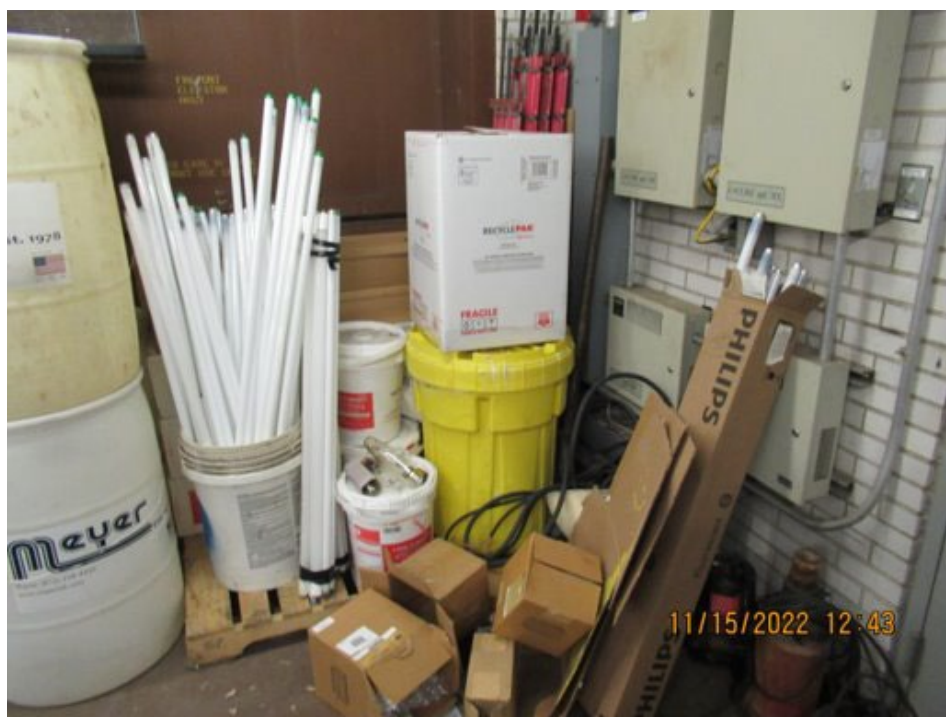
Photograph #2 – Universal waste storage

I requested to inspect any area where hazardous or certain solid waste, such as used oil, universal waste, and other industrial waste, are generated. We initially headed to the electrician shop to view the storage of universal waste lamps. There were numerous universal waste lamps found that were not in containers, as well as lamps that were in open containers and lacking "Universal Waste" labels (See, Photograph #2). These lamps are packaged into Grainger-supplied mailing

| REGULATORY, STATUTORY OR PERMIT REFERENCE | FIELD OBSERVATION |
|---|---|
| In accordance with 6 NYCRR 374-3.2 (d)(4)(i), a small quantity handler of universal waste must contain any lamp in containers or packages that are structurally sound, adequate to prevent breakage, and compatible with the contents of the lamps. Such containers and packages must remain closed and must lack evidence of leakage, spillage or damage that could cause leakage under reasonably foreseeable conditions. | At the time of the inspection, universal waste lamps were stored uncontainerized or in open containers ( <u>See</u> , Photograph #2). |

| REGULATORY, STATUTORY OR PERMIT REFERENCE | FIELD OBSERVATION |
|---|---|
| In accordance with 6 NYCRR 374-3.2 (e)(5), a small quantity handler of universal waste must clearly label or mark each [universal waste] lamp or a container or package in which such lamps are contained with one of the following phrases: Universal Waste-Lamp(s), or Waste Lamp(s), or Used Lamp(s). | At the time of the inspection, at least one container of universal waste lamps was not labeled or marked clearly with one of the following phrases: Universal Waste-Lamp(s), or Waste Lamp(s), or Used Lamp(s) ( <u>See</u> , Photograph #2). |

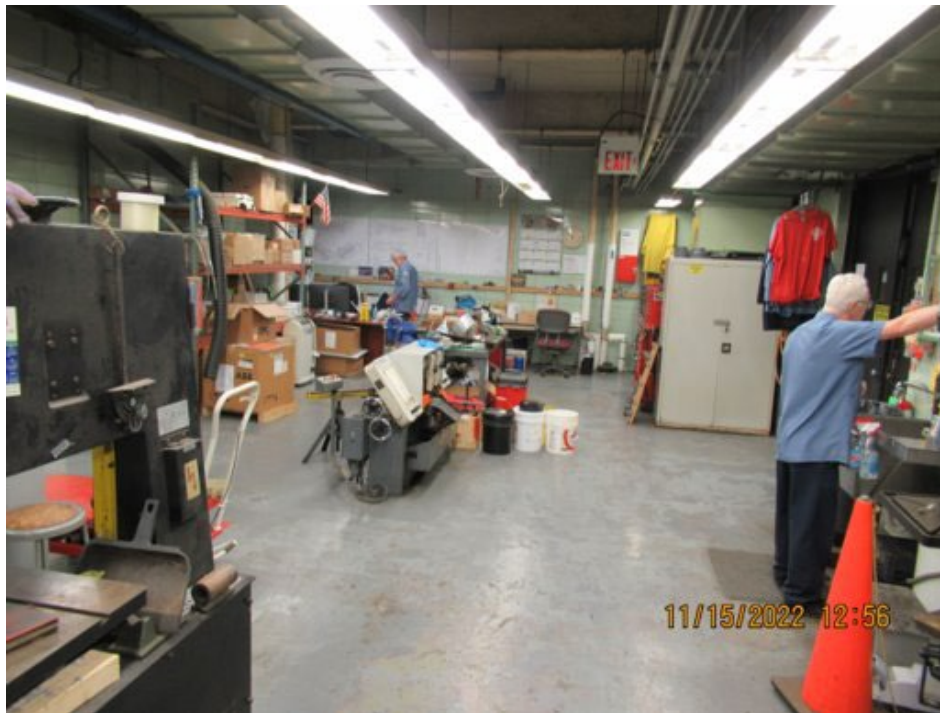
Photograph #3 – Machine shop

Next, we proceeded to the machine shop where a Safety Kleen Model 16 parts washer is in use and used oils are generated from the machining of parts (See, Photographs #3 and #4). Used parts washer fluid is picked up by Clean Harbors and taken to the Safety Kleen facility in Linden, New Jersey where it is reclaimed via distillation. The used oils are sent to Enviro Waste Oil Recovery of Mahopac, New York. The used oils are taken from the machine shop via small containers and consolidated in a 500-gallon fiberglass tank located on the ground floor of the nearby co-generation room (See, Photograph #6). The used oil tank is Tank #19 on the facility's New York State Petroleum Bulk Storage registration certificate. Tank#19 is in secondary containment, and there is a "Used Oil" sign on the wall, but not on the tank, which is a requirement. The smaller containers used to transport the used oil to Tank #19 also do not have "Used Oil" labels. Within the same secondary containment curbing is a new horizontal steel tank that has not yet been put into service.

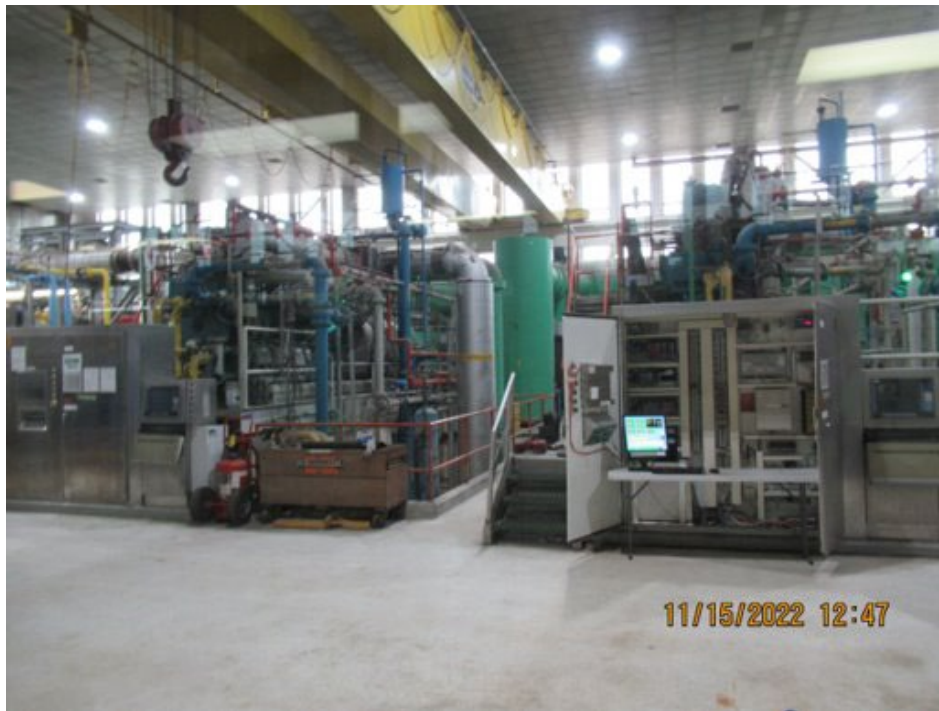
Photograph #5 – Cogen plant

According to the facility representatives no hazardous waste is generated at this location. Their normal solid waste streams are digester biosolids, which are taken by Casella Waste Systems, Inc. for landfilling. In the past, sludge may have been used for land application as a soil amendment in agriculture; however, that is not done anymore. Screenings from their bar rack is either sent to Spectraserve of South Kearny, New Jersey or burned at Westchester County's Charles Point Waste-to-Energy Facility located in Peekskill, New York. Oily rags and electronic waste are sent to the Household-Material Recovery Facility (H-MRF) located at the County's Grasslands Campus in Valhalla, New York. There is a 30-yard roll-off that receives scrap metal from the plant. That roll-off is taken to the County's Material Recovery Facility (MRF) in Yonkers. The facility also collects biogas from its digesters and sends the gases to an on-site cogeneration plant. The Yonkers Joint WWTP has several 1-megawatt MWM V16 engines running on biogas and generating power.

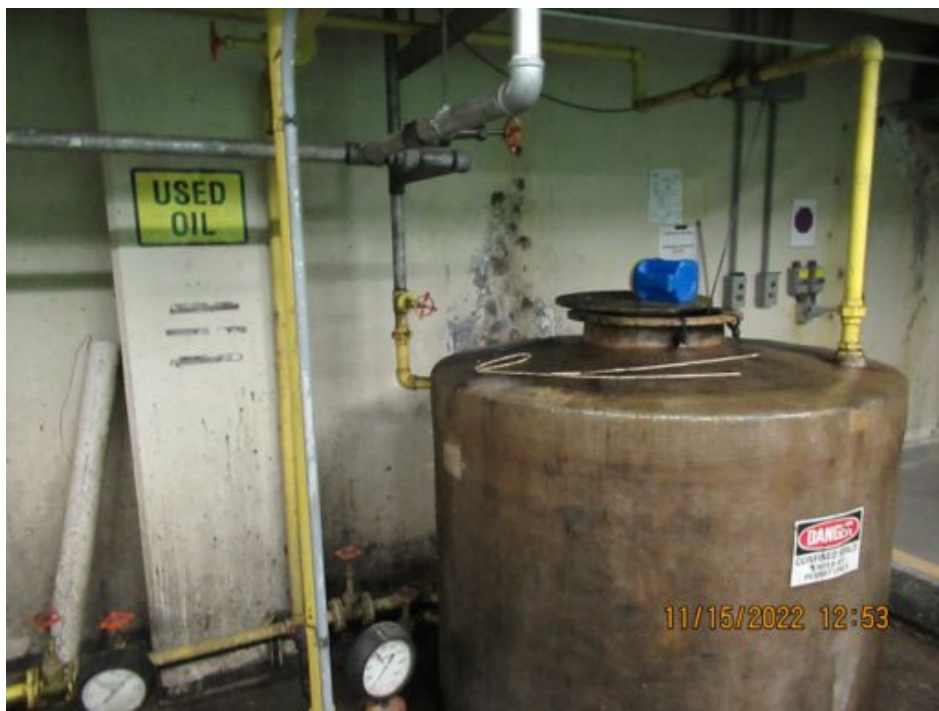
Photograph #6 – Used oil tank

| REGULATORY, STATUTORY OR PERMIT REFERENCE | FIELD OBSERVATION |
|---|---|
| In accordance with 6 NYCRR 374-2.3 (c)(4)(i), every container and aboveground used oil tank used to store used oil at a generator facility must be clearly labeled or marked with the words "Used Oil." In addition, every aboveground tank used to store oil at a generator facility must be labeled with the design capacity and working capacity of the tank. | At the time of the inspection, Tank #19, a 500-gallon used oil tank, and several small containers in the Machine Shop were not clearly labeled or marked with the words "Used Oil." |
