**Region 6 - Enforcement & Compliance Assurance Division**  
**INSPECTION REPORT**

| Inspection Date(s): | 4/3/24 | |
| Company Name: | <b>Rebel Producing, LLC</b> | |
| Facility Name: | <b>Exxon Lease Tank Battery</b> | |

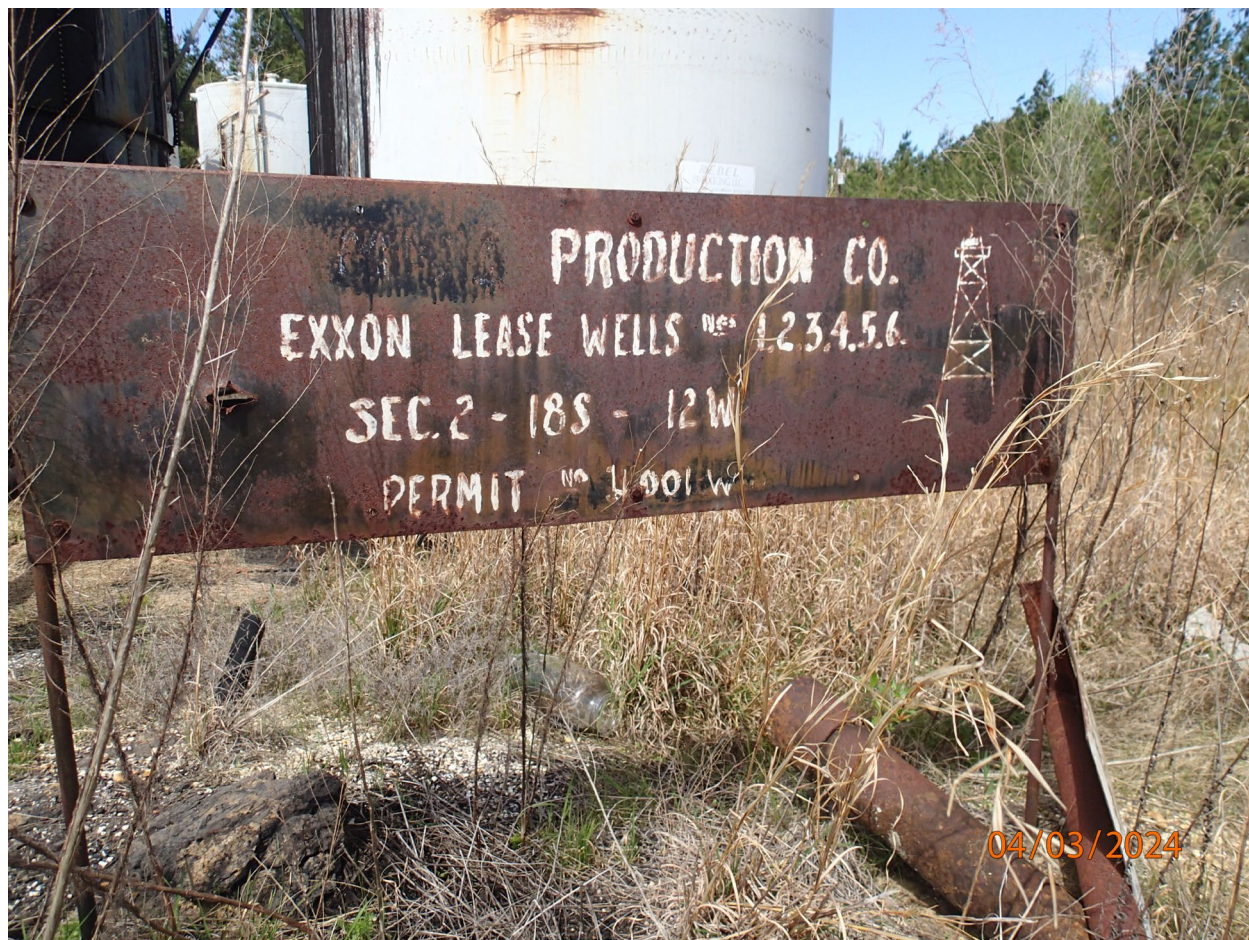
Photo No. 1

**Description:** Looking ESE, this photo showed the signage at the facility.

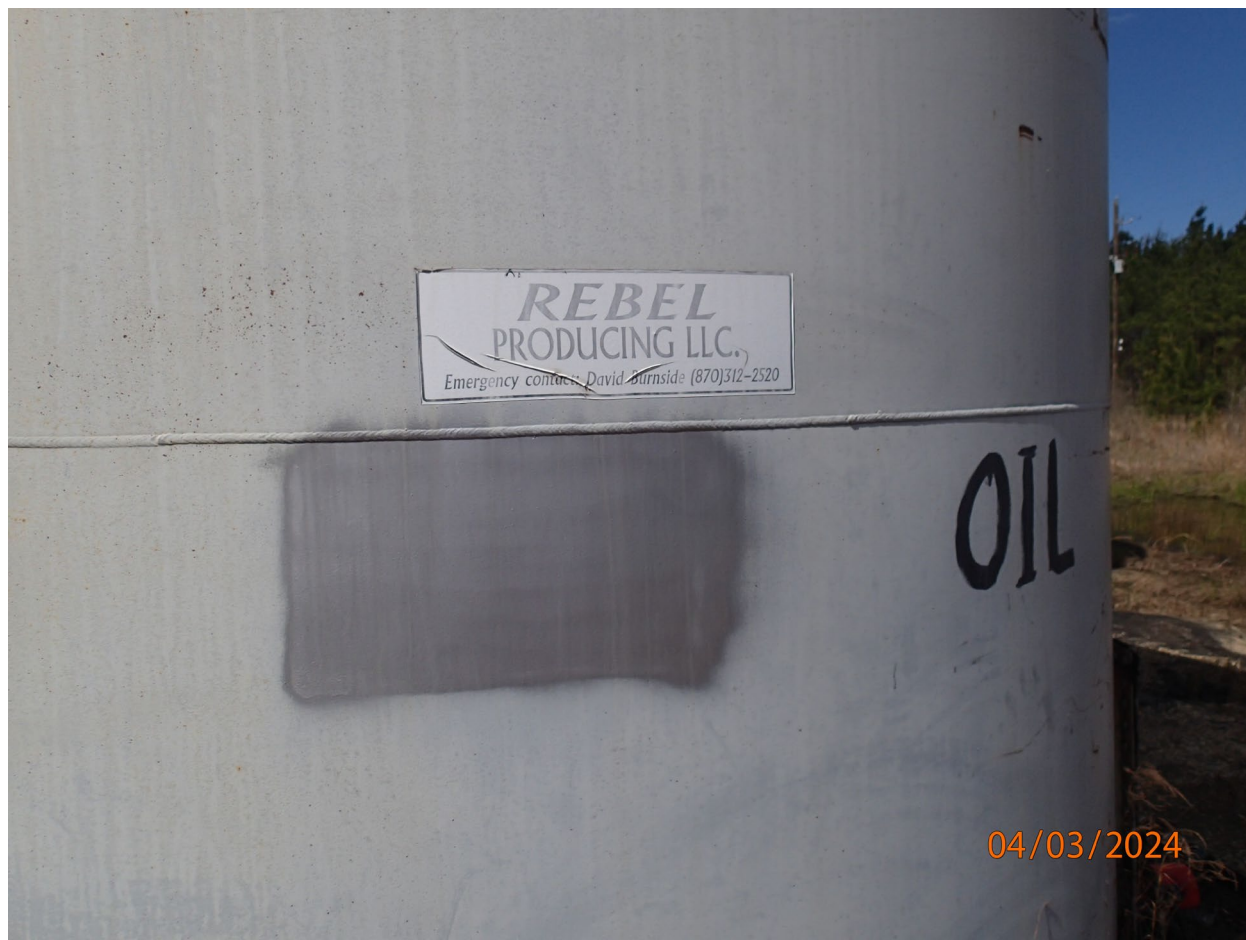
Photo No. 2

**Description:** Looking SE, this photo showed additional signage at the facility.

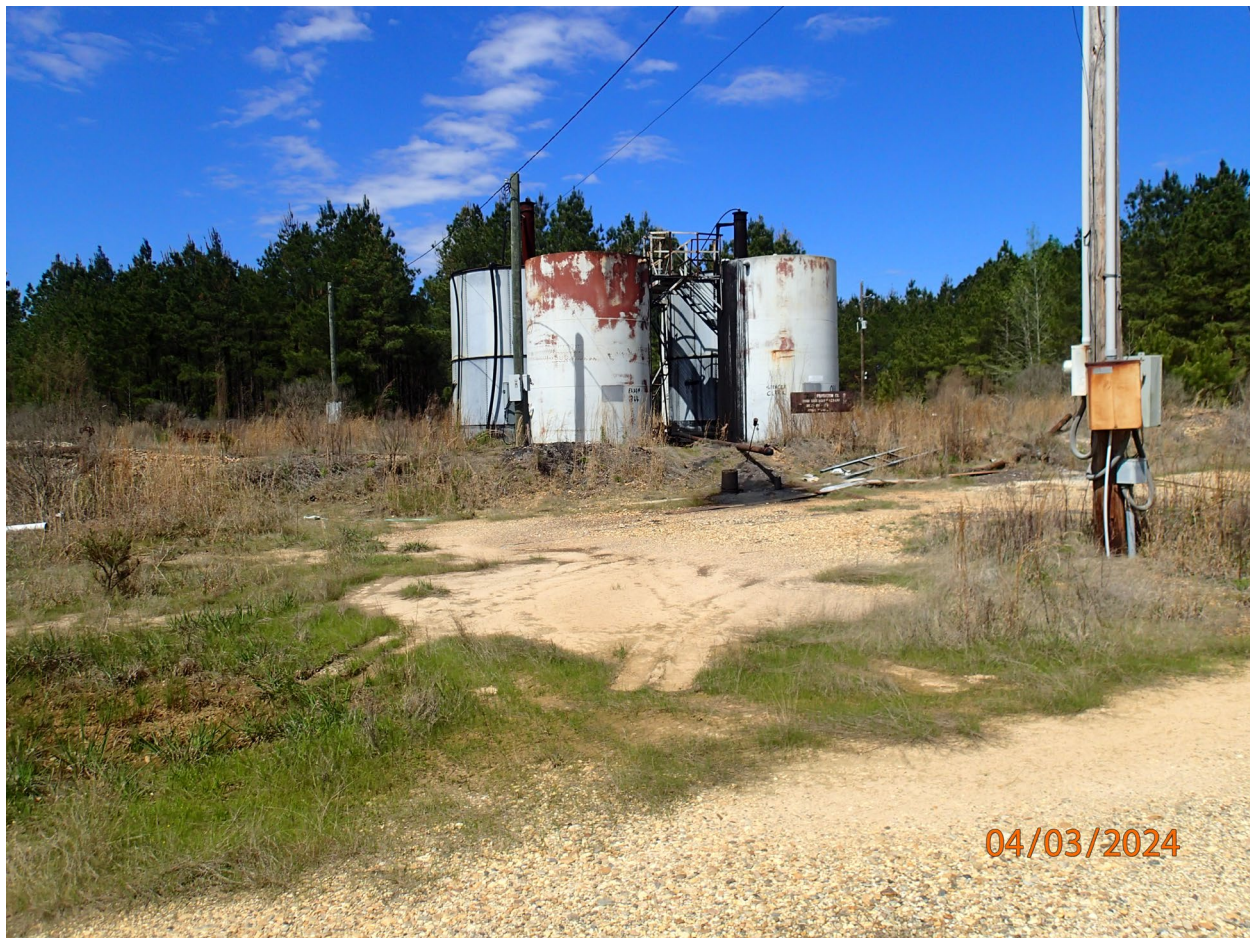
Photo No. 3

**Description:** Looking ESE, this photo showed an overview of the facility.

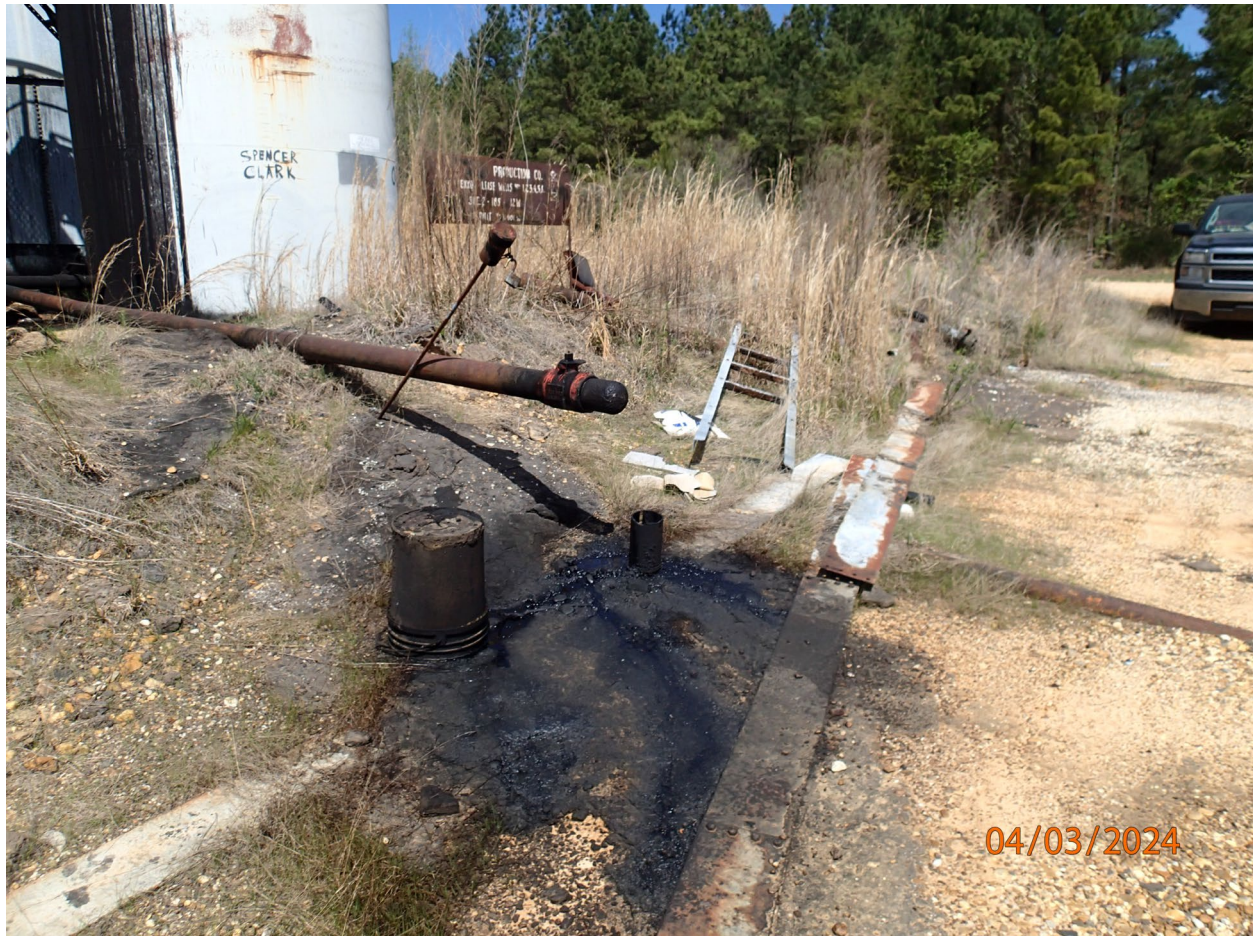
Photo No. 4

I observed a transfer pipe over secondary containment without a catch bucket and loose oil on the ground, see Photo No. 4.

**Description:** Looking ENE, this photo showed a transfer pipe over secondary containment with no catch bucket and loose oil on the ground.

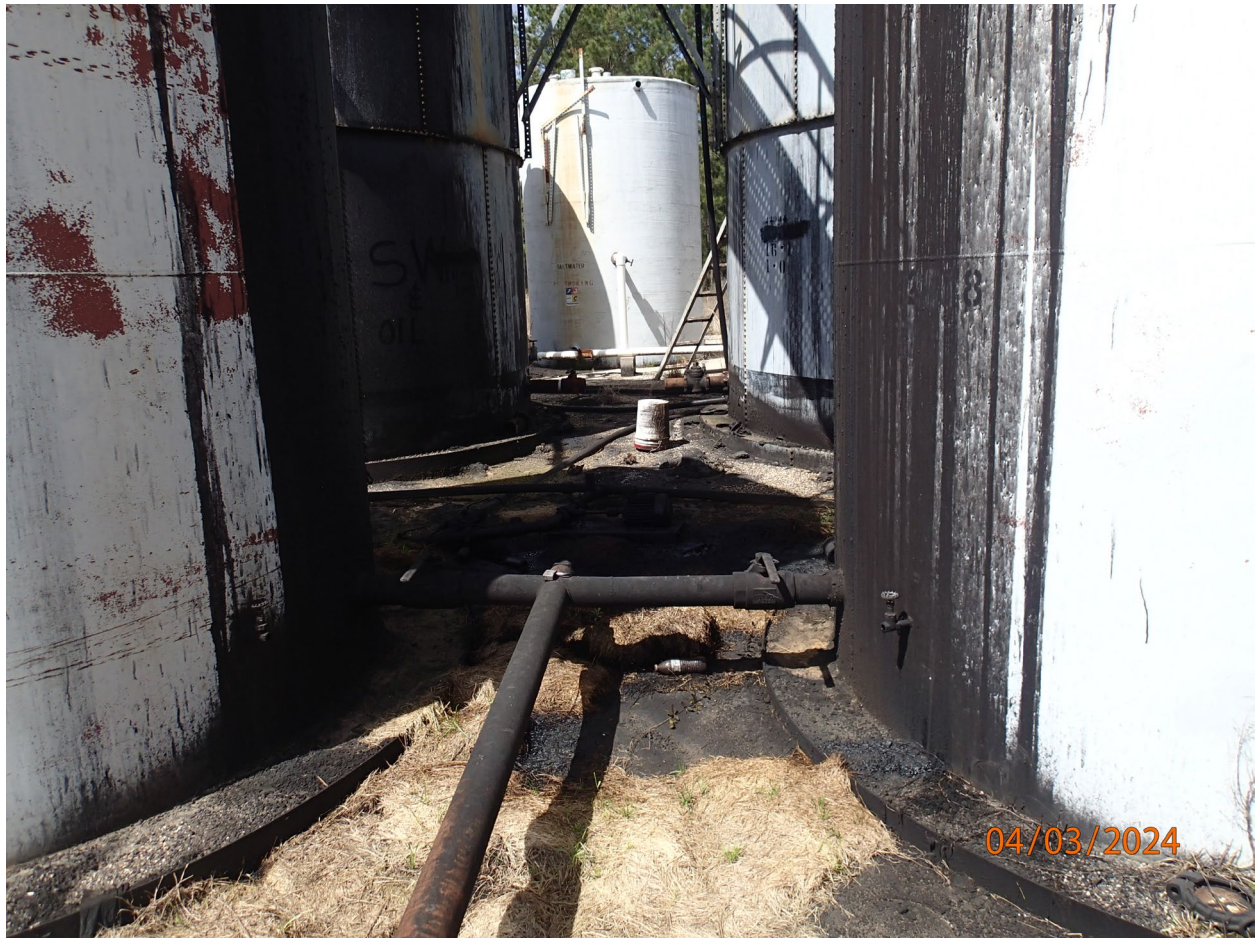
I observed an active leak of crude oil and loose oil inside secondary containment, see Photo No. 5 through No. 7.

**Description:** Looking SE, this photo showed loose oil around conduits for the storage tanks inside secondary containment.

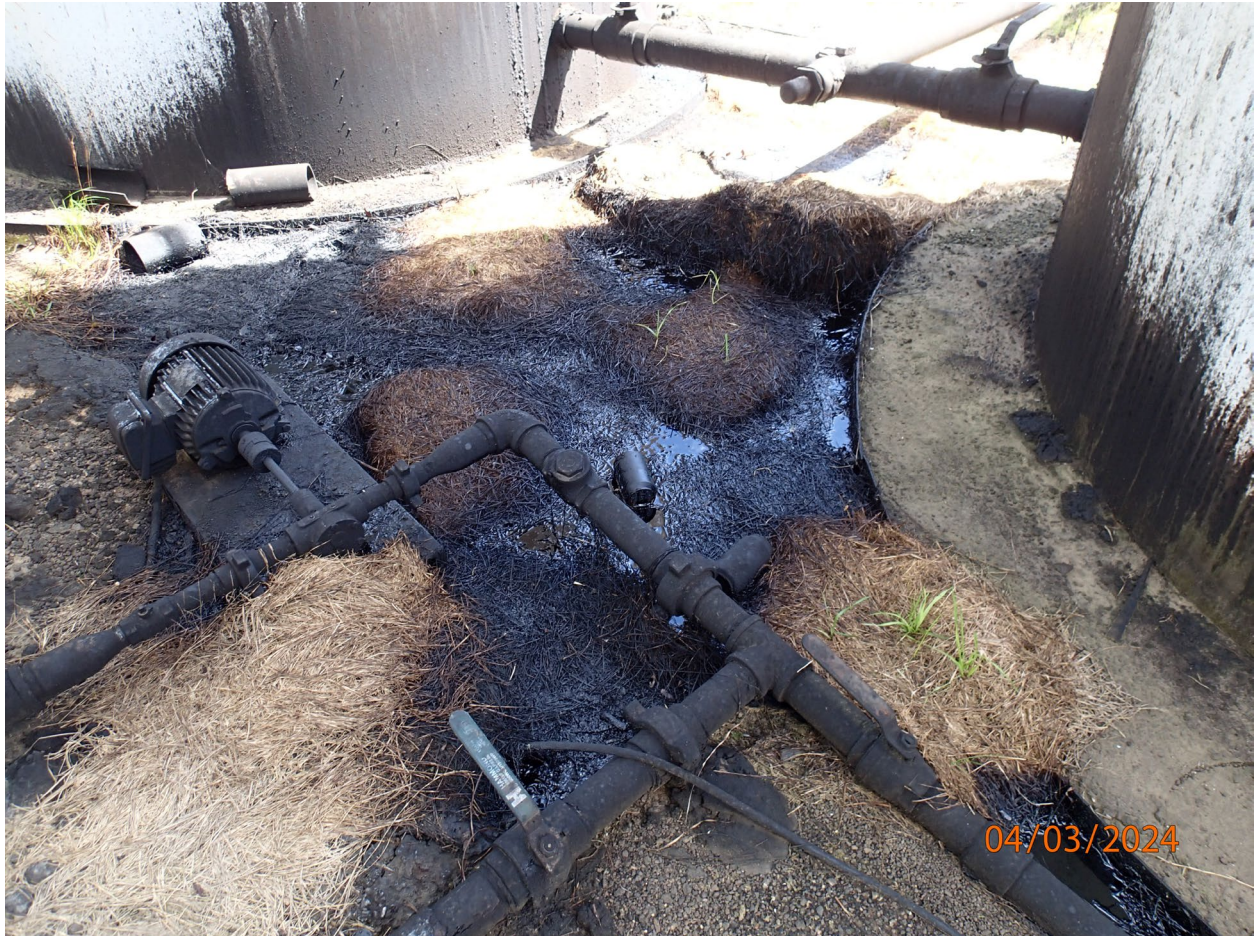
Photo No. 6

**Description:** Looking NW, this photo showed an additional view of the loose oil around conduits for the storage tanks from Photo No. 5.

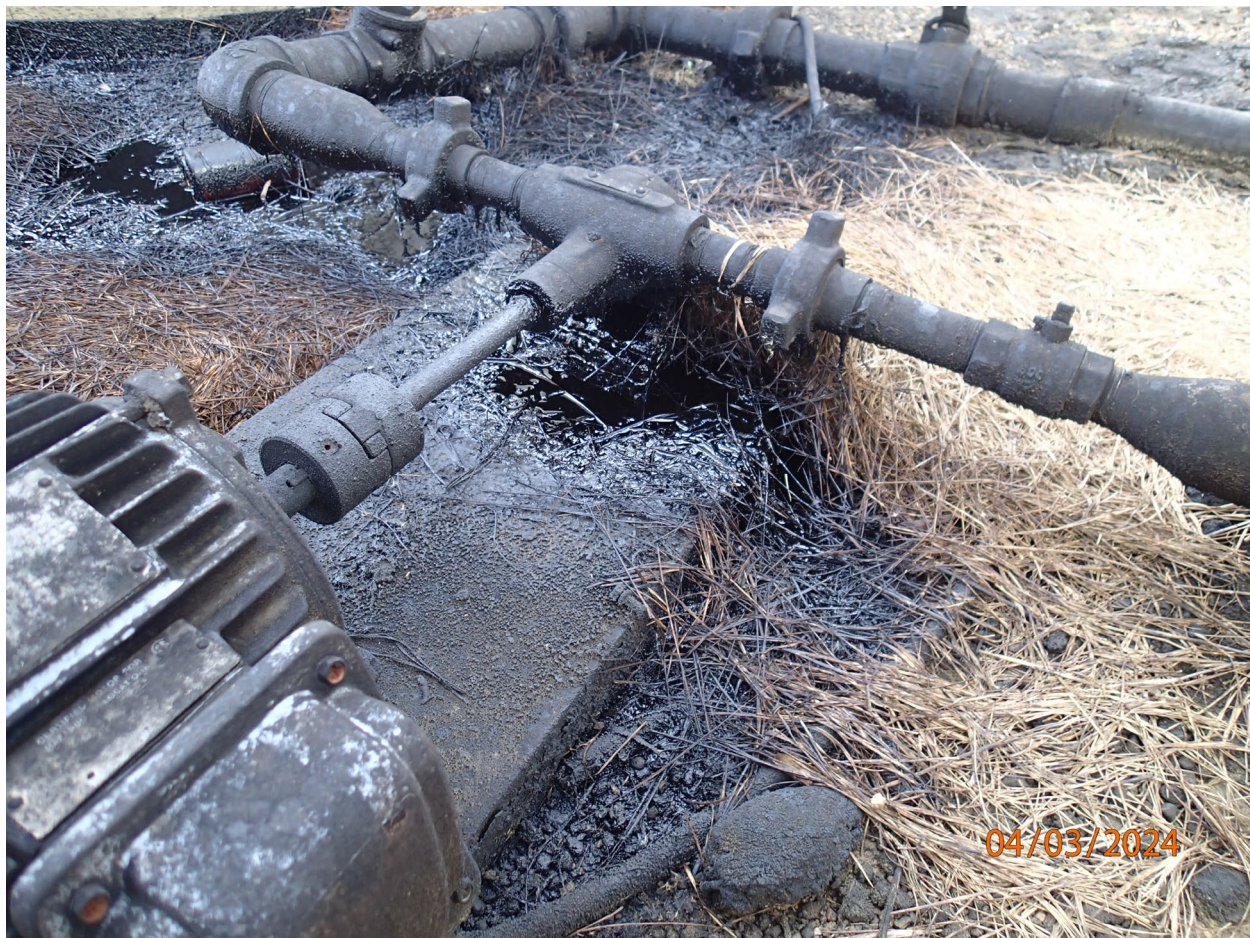
Photo No. 7

**Description:** Looking SSW, this photo showed a closeup of the loose oil around conduits for the storage tanks from Photo No. 5.

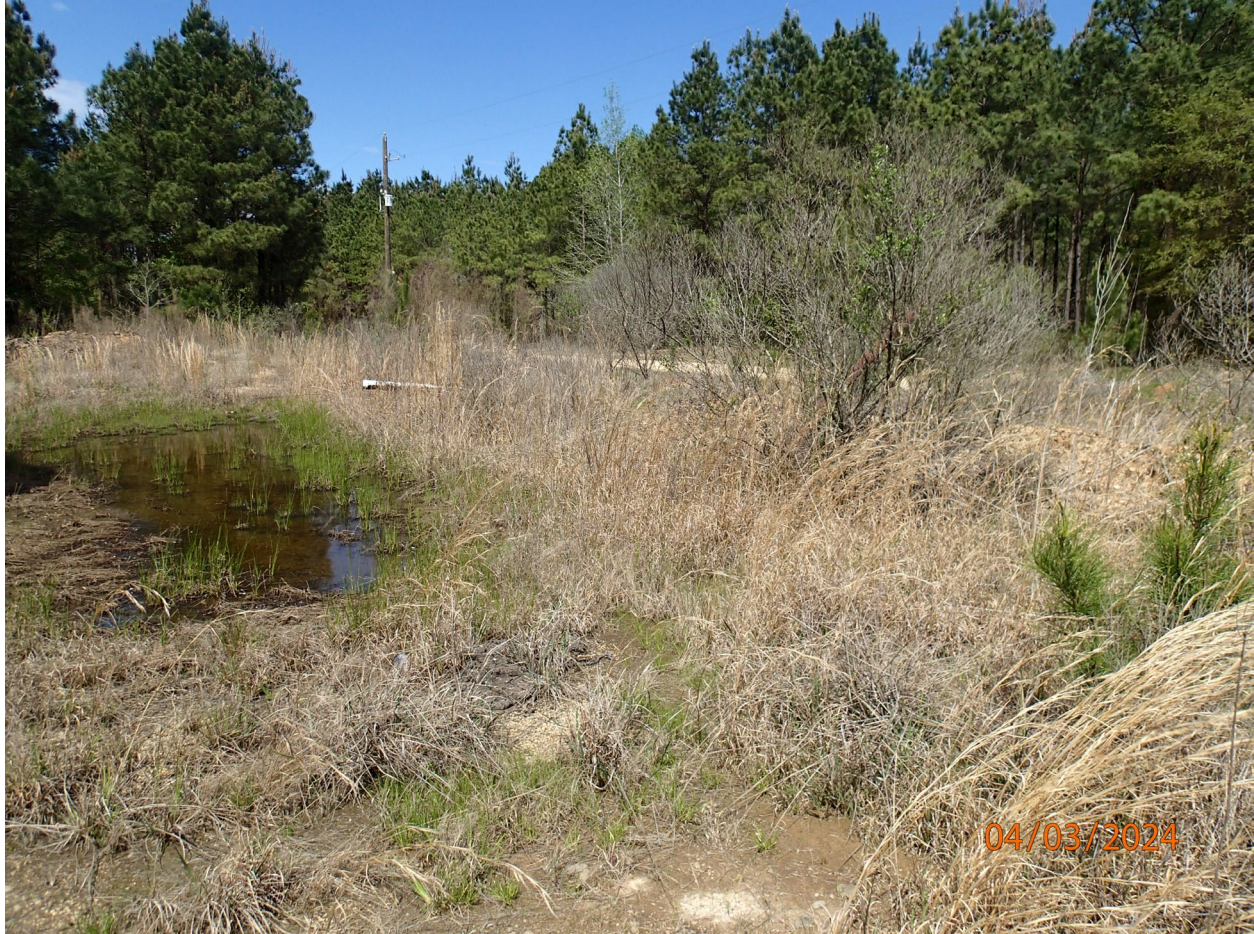
Photo No. 8

I observed woody vegetation growing in the firewall berm (secondary containment), see Photo No. 8.

**Description:** Looking E, this photo showed woody vegetation growing in the firewall (secondary containment).

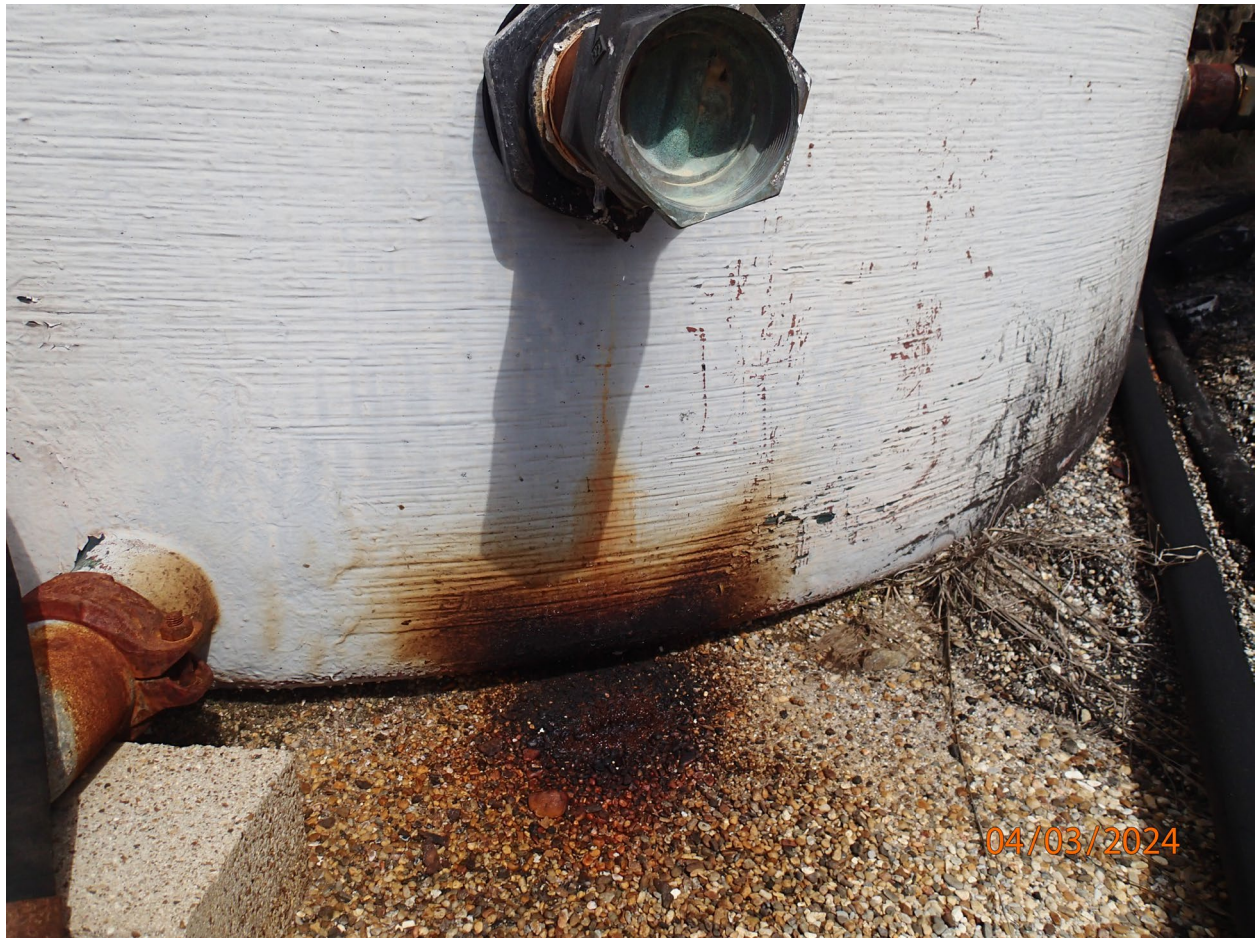
Photo No. 9

I observed an active leak of saltwater from one of the storage tanks inside secondary containment, see Photo No. 9.

**Description:** Looking N, this photo showed an active leak from one of the storage tanks inside secondary containment.

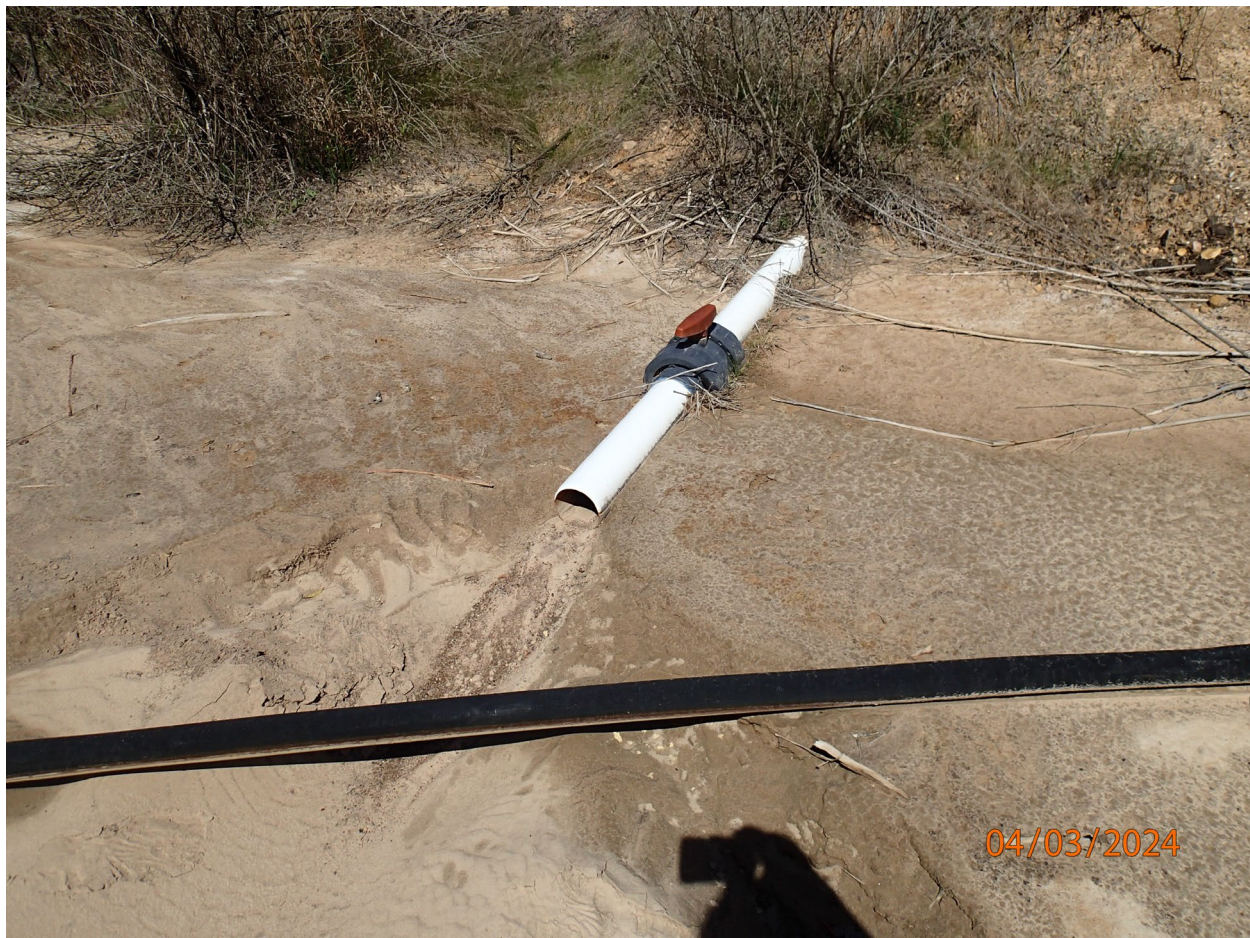
I observed the drainpipe for secondary containment with an open valve and no cap on the pipe; salt crystals were observed on the ground around the drainpipe; see Photo No. 10 and No. 11.

**Description:** Looking ENE, this photo showed the drainpipe for secondary containment with an open valve and no cap on the pipe.

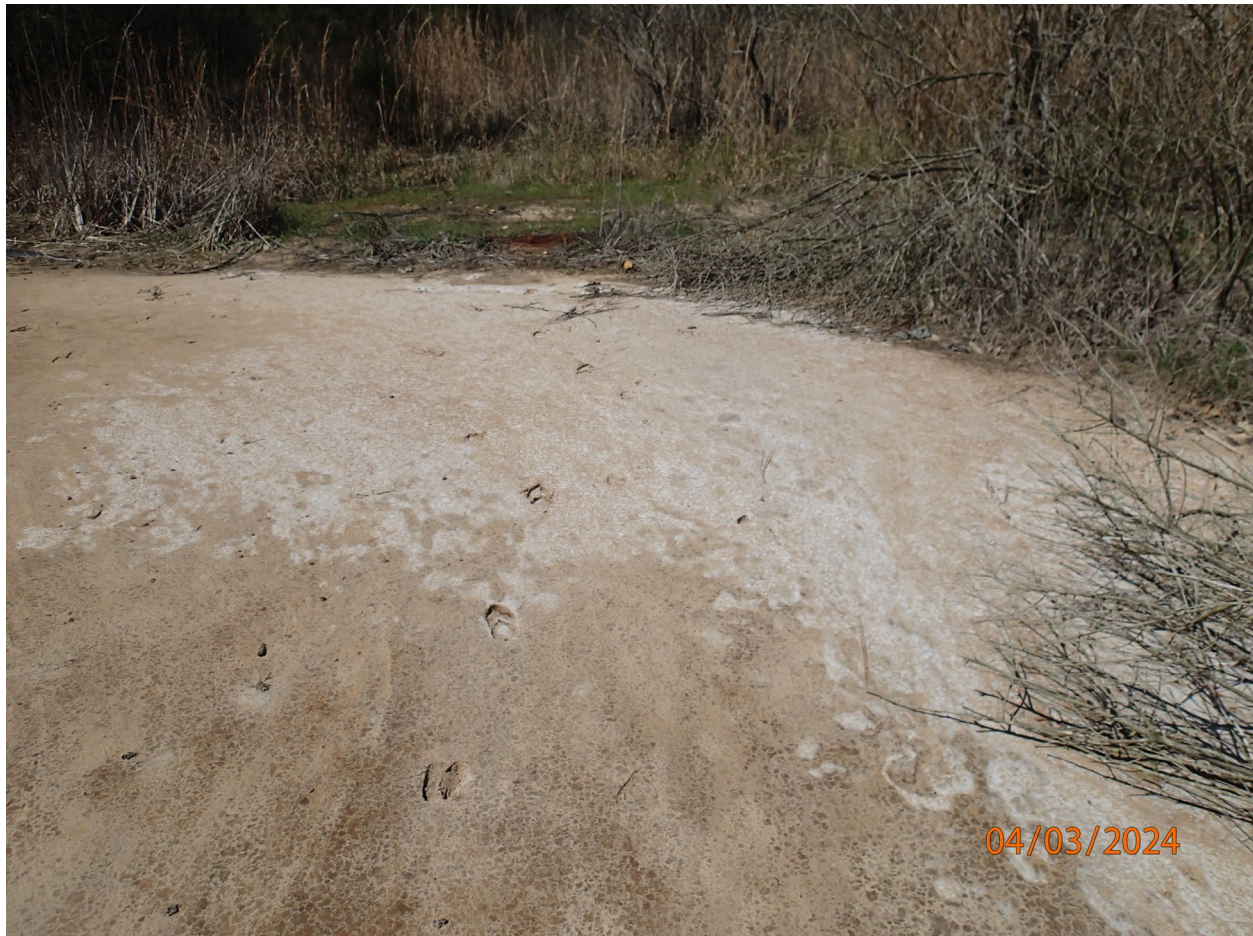
Photo No. 11

**Description:** Looking SW, this photo showed salt crystals in the sand in the area that the drainpipe discharges.
