# JOHNS-MANVILLE

## RESEARCH & ENGINEERING CENTER

An Industrial Hygiene Survey of the Libby, Montana Mine and Mill was conducted during the week of July 15, 1968. The survey was conducted by R. D. Hindmarch, Supervisor, Industrial Hygiene, Johns-Manville Products Corporation, with assistance from P. Kostic, Safety Administrator, Dewey and Almy Chemical Division.

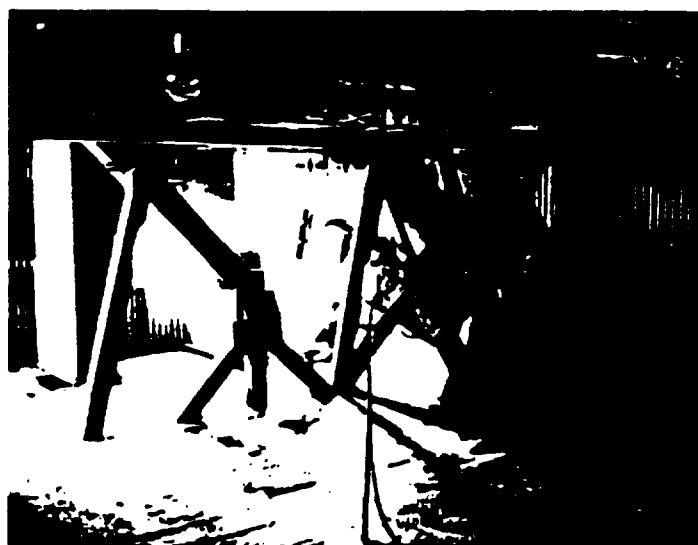
Photo 4-3

| <u>Station Number</u> | <u>Station Location</u> | <u>First Sample</u> | <u>Second Sample</u> |
|---|---|---|---|
| 4-3 | Fourth Floor - Approximately 10' East of 619 Elevator | 2.8 " | 3.6 " |

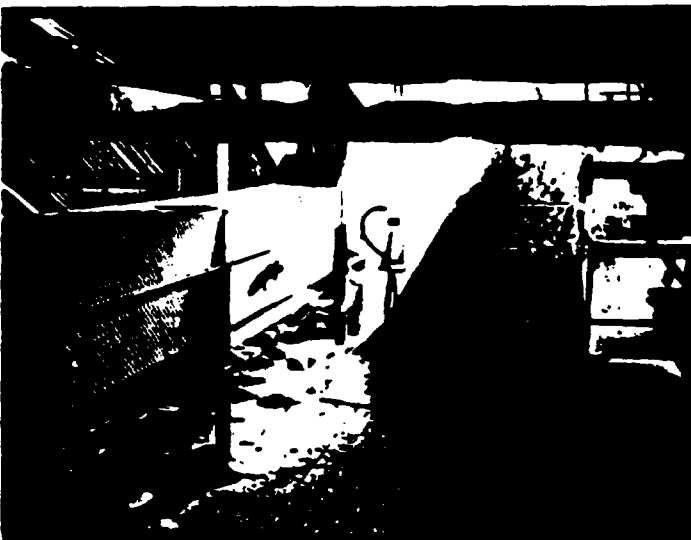
Photo 6-1

| <u>Station Number</u> | <u>Station Location</u> | <u>First Sample</u> | <u>Second Sample</u> |
|---|---|---|---|
| 6-1 | Sixth Floor - Halfway between 615 Elevator and 611 Drag | 5.4 " | 5.0 " |

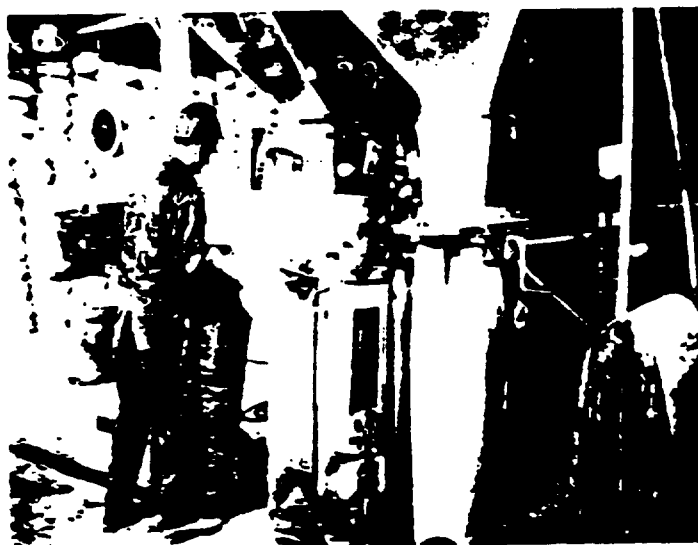
| <u>Station Number</u> | <u>Station Location</u> | <u>First Sample</u> | <u>Second Sample</u> |
|---|---|---|---|
| | Expanding Plant - at bagging unit | 0.9 " | 1.3 " |
