INSPECTION REPORT

| <b>Facility or Site Name:</b> | TESORO ALASKA COMPANY LLC - KENAI REFINERY | | |
| <b>Type of Operation:</b> | Petroleum Refinery | | |

Type of inspection: CEI - Compliance Evaluation Inspection

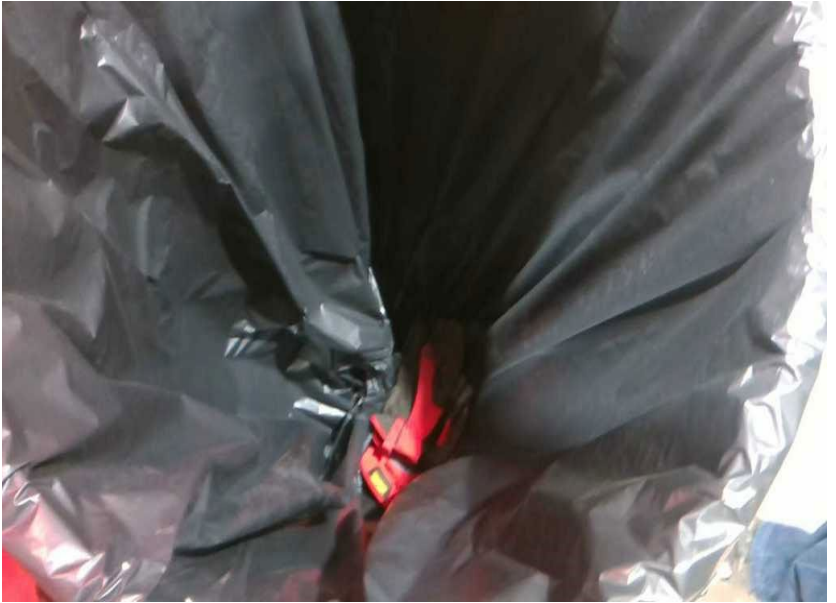
| <p>While inspecting the Fabrication Shop, I saw some work gloves in a trash receptacle. The work gloves looked like they were made with a combination of both man-made materials and leather parts. I explained to Messrs. Warrick and Harper that welding accessories, such as leather chaps and gloves, when tested by other facilities, using the Toxicity Characteristic Leaching Process (TCLP) testing method have been failing for chromium (D007). I asked if they knew how many pairs of leather gloves were provided to Tesoro employees each year and both gentlemen said they would need to check with the issuing department in the Warehouse. I told both gentlemen they may want to make a hazardous waste determination on the leather items issued/provided to Tesoro personnel. At the time this report was written, no information was provided to me by the facility regarding the</p> | |

| <b>Building:</b> Fabrication Shop <b>Area:</b> <b>Sub-area:</b> | | |
|---|---|---|
| While in the Fabrication Shop, I saw some gloves in the trash that may have contained leather parts. Leather gloves and welding accessories, made of leather, such as welding chaps, when tested, using the Toxicity Characteristic Leaching Process (TCLP) testing method have been failing for chromium (D007). At the time of the inspection, the facility had not made a hazardous waste determination. | <b>Citation:</b> | <b>Section:</b> |

| <div data-bbox="70 315 154 351" data-label="Text"><i>[Title]</i></div> <div data-bbox="70 369 515 445" data-label="Text">Observation_Image-202104261054505450326188.jpg</div> <div data-bbox="70 459 443 495" data-label="Text">04/26/2021 10:54 AM (AKT)</div> <div data-bbox="70 510 201 544" data-label="Text">Jon Jones</div> <div data-bbox="70 562 296 598" data-label="Text">Fabrication Shop</div> <div data-bbox="70 616 165 649" data-label="Text">No CBI</div> <div data-bbox="70 669 156 703" data-label="Text">No PII</div> <div data-bbox="70 723 515 761" data-label="Text">View of waste gloves in the trash.</div> | |

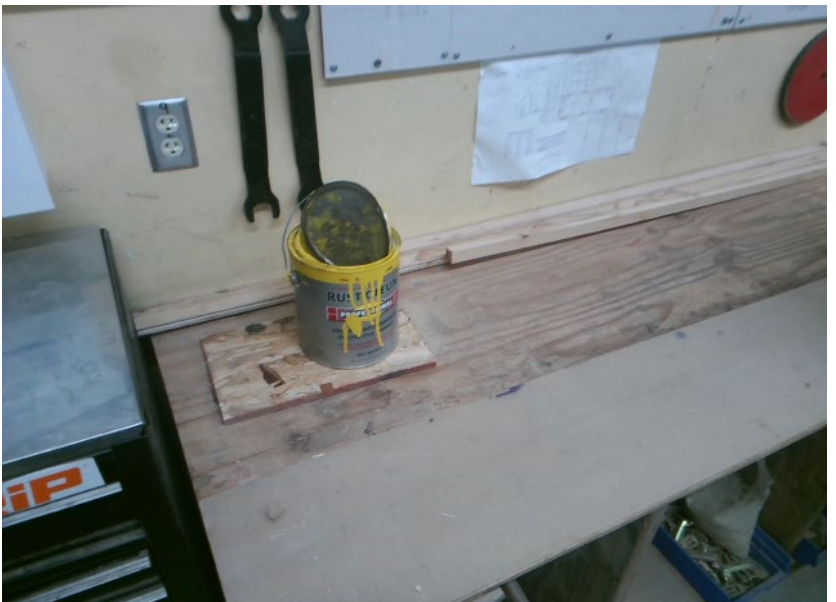
| <p>While inspecting the Carpenter Shop, I saw a one-gallon can of Rust-Oleum, oil-based coating that was on a work bench. I saw about one inch of paint in the bottom of the container that was more solid than liquid, and still exhibited a strong solvent odor. Mr. Warrick said that they just dry out the paint when the paint cans are "RCRA Empty", but he said this paint can didn't look "RCRA Empty." At the time of the inspection, the container was not closed and appeared to me to have been left open to evaporate and dry out. . There was not a hazardous waste, risk, or accumulation state date label on the paint can. I asked for a copy of the Safety Data Sheet (SDS) for the paint and was provided with a copy prior to departing the facility. According to the information contained within the SDS, the paint has a flash point of 40° C (104° F) and is ignitable (D001).</p> <p>Mr. Harper followed up with a response letter that was provided as an attachment in an email dated 05/06/2021. The waste paint identified in the Carpenter Shop was addressed with the following response:</p> <p>"The one-gallon (dry) oil-based paint can was removed and disposed of as a non-hazardous material. Discussions were had with the Fabrication Shop employees that paint cans need to be RCRA empty and dry before disposal."</p> | |

| <b>Building:</b> Fabrication Shop <b>Area:</b> <b>Sub-area:</b> | | |
|---|---|---|
| While in the Carpenter Shop, I saw a one-gallon can of Rust-Oleum, oil-based coating that was on the work bench. At the time of the inspection, the container was not closed and appeared to be left open to evaporate and dry out. I observed the contents of the container and saw that it contained approximately one inch of waste paint in the bottom of the container and was not "RCRA Empty." Mr. Warrick stated , during the inspection, that the container was not "RCRA Empty." | <b>Citation:</b> | <b>Section:</b> |

| <div data-bbox="70 1032 154 1068" data-label="Text"><i>[Title]</i></div> <div data-bbox="70 1086 515 1162" data-label="Text">Observation_Image-202104261127402740246218.jpg</div> <div data-bbox="70 1176 443 1211" data-label="Text">04/26/2021 11:27 AM (AKT)</div> <div data-bbox="70 1229 201 1263" data-label="Text">Jon Jones</div> <div data-bbox="70 1281 512 1319" data-label="Text">Fabrication Shop/Carpenter Shop</div> <div data-bbox="70 1337 165 1370" data-label="Text">No CBI</div> <div data-bbox="70 1391 156 1424" data-label="Text">No PII</div> <div data-bbox="70 1444 668 1523" data-label="Text">View of a gallon can of Rust-Oleum, oil-based paint/coating that was on the work bench.</div> | |

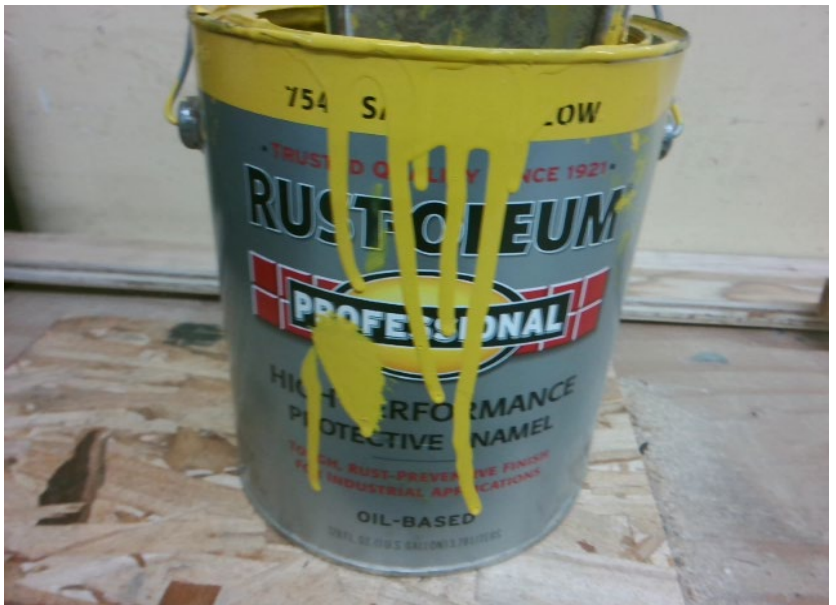
| Observation_Image-202104261127512751282040.jpg | |

| Close-up view of the label on a gallon can of Rust-Oleum, oil-based paint/coating that was on the work bench. | |

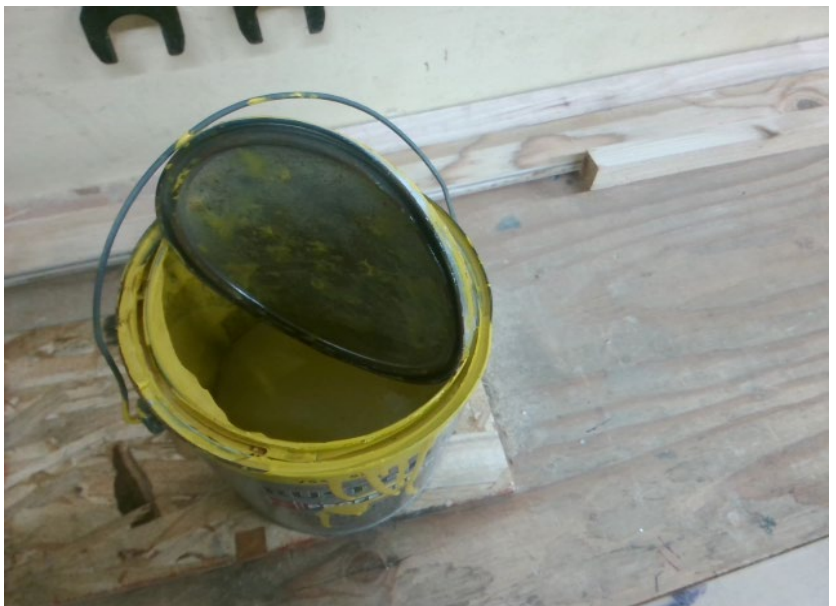
| Observation_Image-20210426112808288258566.jpg | |

| Close-up view of a gallon can of Rust-Oleum, oil-based paint/coating that was on the work bench | |

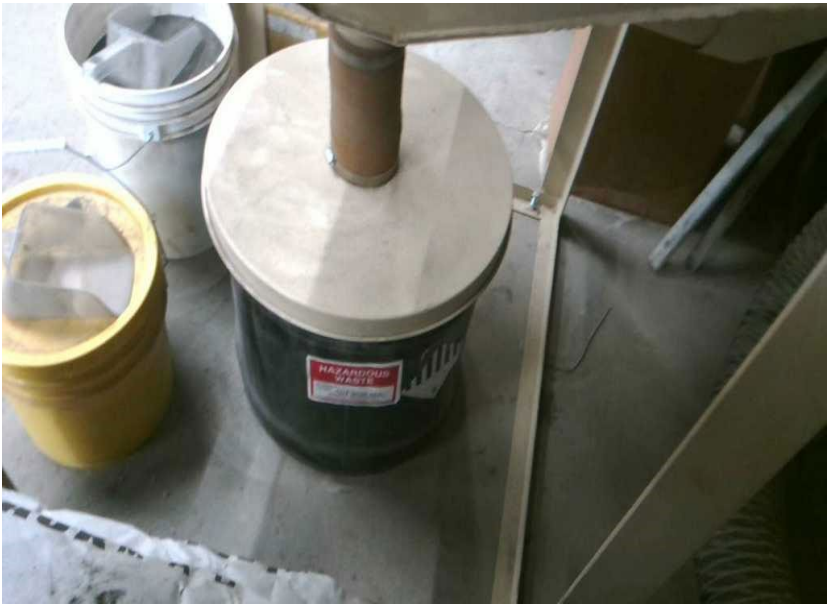
| <p>While in the Fabrication Shop, I saw a 55-gallon container located in the satellite accumulation area (SAA). According to Mr. Warrick, the facility manages the 55-gallon container as a hazardous waste SAA container to accumulate spent sandblast media. He said once full, it gets tested.</p> <p>While still in the Fabrication Shop, Messrs. Warrick and Harper took me over to the sandblast cabinet. There was a sandblast air filter system adjacent to the blast cabinet and beneath the filtering system I saw a 15-gallon container affixed to the sandblast air filter. Mr. Warrick said the 15-gallon container was also a SAA container. Mr. Warrick said that when full, the 15-gallon satellite container is emptied into the 55-gallon SAA container.</p> <p>At the time of the inspection, the 55-gallon container was in an area that was clearly delineated with yellow floor markings and signage indicating that it was a SAA. The hazardous waste marking on the container was also not marked with an accumulation start date which is indicative of being a SAA container. I asked Mr. Warrick when the last time was that the 55-gallon container was moved to the CAA. He told me that he would have to check and get back with me.</p> <p>Mr. Harper followed up with a response letter that was provided as an attachment in an email dated</p> | |

Mr. Warrick said that when full, the 15-gallon satellite container of spend sandblast media is emptied into another 55-gallon SAA container of spent sandblast media.

| <p>[Title]</p> <p>Observation_Image-20210426110820820343944.jpg</p> <p>04/26/2021 11:08 AM (AKT)</p> <p>Jon Jones</p> <p>Fabrication Shop/NE corner by insulator door</p> <p>No CBI</p> <p>No PII</p> <p>View of a 15-gallon satellite accumulation container that was being used to accumulate waste sandblast media.</p> | |

- 55-gallon drum removed from SAA to hazardous waste accumulation slab on 4/27/2021. Samples from both SAA drums were sent out for RCRA TCLP metals analysis on 4/27/2021 (**see photos 2a and 2a-2**).
- Small drum was checked for content volume. Only a small amount of powder was observed (**see photo 2b**).
- Total contents of both drums were less than 55 gallons.

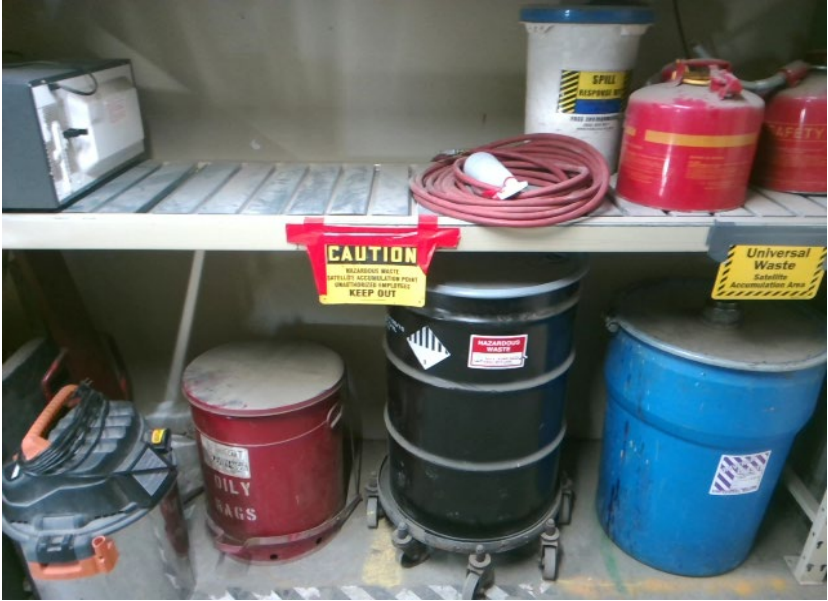
| <p>[Title]</p> <p>Observation_Image-20210426110945945306544.jpg</p> <p>04/26/2021 11:09 AM (AKT)</p> <p>Jon Jones</p> <p>Fabrication Shop/NE corner by insulator door</p> <p>No CBI</p> <p>No PII</p> <p>View of a 55-gallon SAA container, holding waste sandblast media, in the SAA of the Fabrication Shop.</p> | |

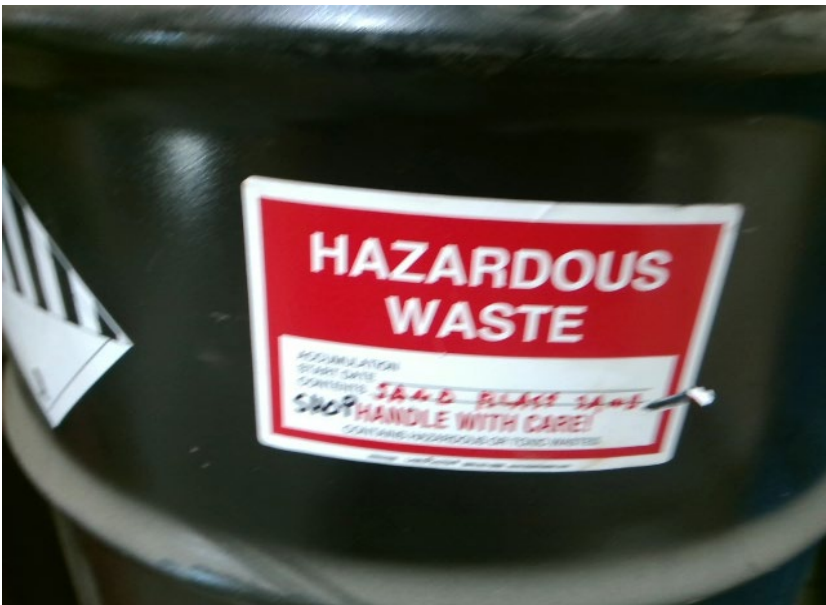
| Observation_Image-20210426111003103247394.jpg | |

| Close-up (Blurry) view of the label on the 55-gallon SAA container of waste sandblast media. | |

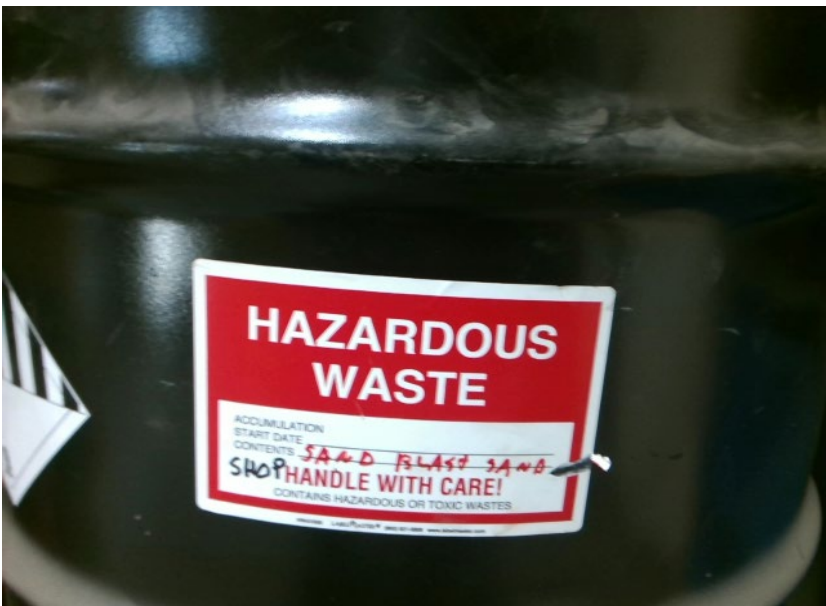
| Observation_Image-202104261110201020246290.jpg | |

| Another close-up view of the label on the 55-gallon SAA container of waste sandblast media. | |

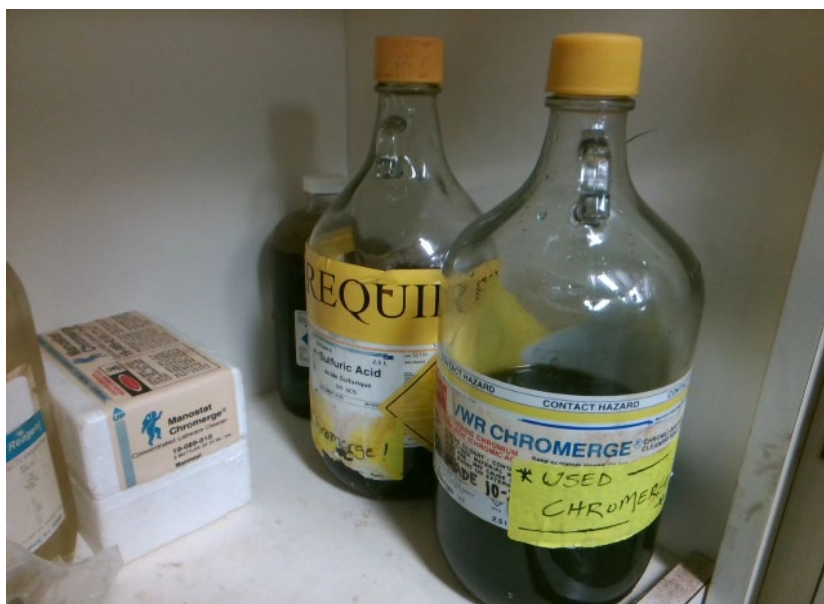
| Observation_Image-20210426100342342276262.jpg |

| <p>While in the Refinery lab, I went to the lab storage supply room. While in the supply room, I opened an acid/corrosives locker to inspect the contents. While inspecting the contents of the locker I saw several containers that were labeled with the words "Used Chromerge" and both Toxic and Oxidizer hazard indicators.</p> <p>There were two, 2.5-liter containers and a smaller 1-liter container. At the time of the inspection, Mr. Phillip Carpenter, Lab Supervisor, said it's used as a cleaning agent.</p> <p>Upon closer inspection, I saw that only two of the three containers were marked as "Used Chromerge." The 1-liter container and one of the 2.5-liter containers were marked as "Used." According to one of the Lab Technicians, they mix up a batch of the Chromerge and then they use small amounts of it in certain lab equipment to clean certain internal sections of the equipment. According to the Lab technician I was speaking with, the Chromerge can be used multiple times until it becomes too dirty to use. That being the case, I was concerned about there being two containers of the used Chromerge in the acid/corrosives locker. My thought process being that one container might contain Chromerge that was still in-use and one might contain waste Chromerge.</p> <p>I asked for a copy of the SDS for the Chromerge and Mr. Carpenter provided a copy during the inspection. A cursory review of the SDS indicated that Chromerge contained 25 – 50% chromium (VI) trioxide (D007) with additional hazards including, oxidizer and corrosivity.</p> <p>Following the inspection, I sent an email to Mr. Harper requesting the following information:</p> <ul style="list-style-type: none"> <li>List of each piece of lab equipment where Chromerge is used.</li> <li>Provide any Chromerge mixing instructions or instructions for use.</li> <li>Provide any lab standard operating procedures (SOP) in place for the use of Chromerge.</li> <li>Provide frequency of use in the lab, how long the used Chromerge has been in the locker and the date it was last generated and shipped out.</li> <li>If you find that it was previously disposed of in a Labpack, please include a copy of the disposal</li> </ul> | |

There were two, 2.5 liter containers and a smaller 1 liter container. Upon closer inspection, I saw that only two of the three containers were marked as "Used Chromerge." The 1-liter container and one of the 2.5-liter containers were marked as "Used." According to one of the Lab Technicians, they mix up a batch of the Chromerge and then they use small amounts of it in certain lab equipment to clean certain internal sections of the equipment. According to the

| Lab technician I was speaking with, the Chromerge can be used multiple times until it becomes too dirty to use. That being the case, I was concerned about there being two containers of the used Chromerge in the acid/corrosives locker. My thought process being that one container might contain Chromerge that was still in-use and one might contain waste Chromerge. | | |

| View of the three containers holding Chromerge. Seen in the photo here is a 1-Liter bottle of "Used Chromerge" in the back, a 2.5-Liter bottle of Chromerge in the middle, and another 2.5-Liter bottle of "Used Chromerge" seen in the front. |

- Chromerge solutions in storage room were relabeled for clarification on 4/29/2021 (**see photo 1c**).
  - o These solutions are still in use by the lab and are not considered a waste. The solution is used and transferred back into the bottles until such time that a lab technician has determined it is no longer effective.

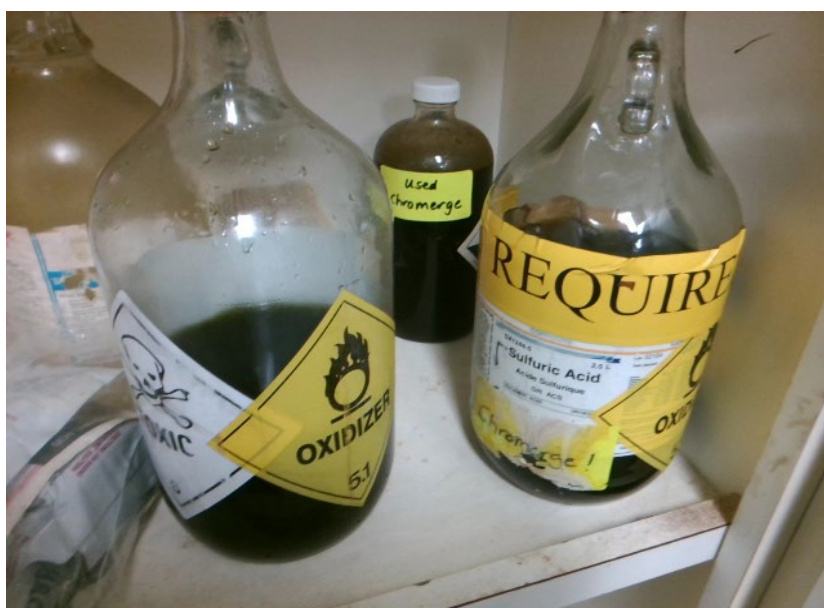
| Observation_Image-2021042610050757294519.jpg |

| This is another view showing a 1-Liter bottle of "Used Chromerge" in the back, a 2.5-Liter bottle of Chromerge on the right, and another 2.5-Liter bottle of "Used Chromerge" seen on the left. |

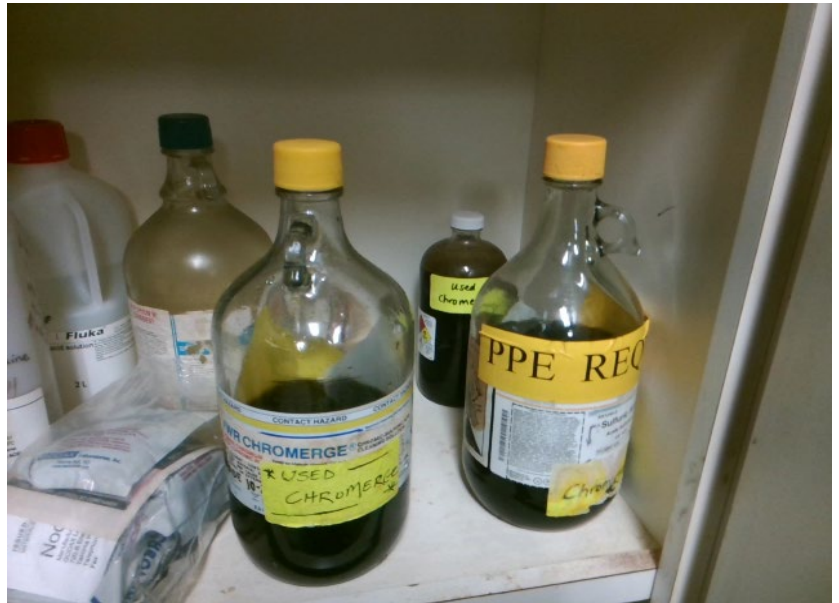
This is another view showing the labeling on a 1-Liter bottle of "Used Chromerge" in the back, a 2.5-Liter bottle of Chromerge on the right, and another 2.5-Liter bottle of "Used Chromerge" seen on the left.

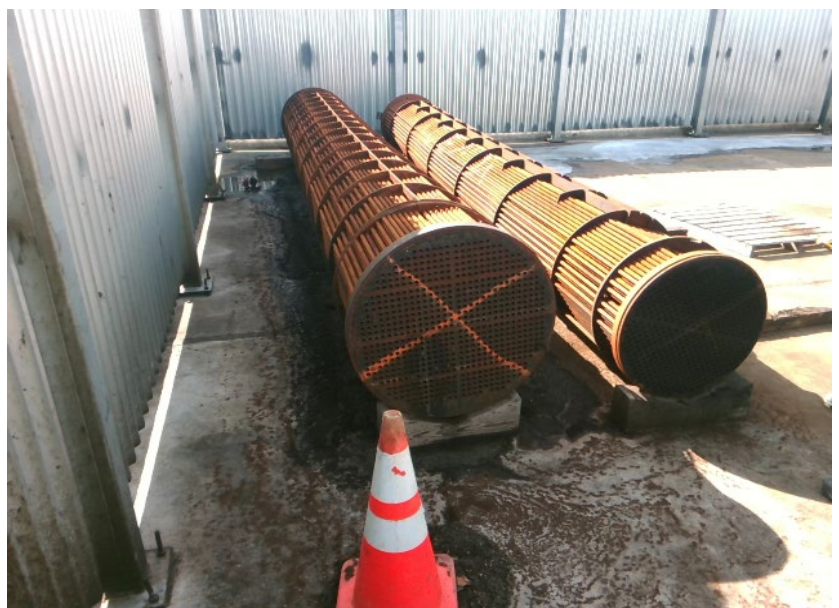
Observation\_Image-  
20210426120720720368320.jpg

| <p>While inspecting the Pad, I saw two heat exchanger bundles that, according to Messrs. Warrick and Harper, had been pressure washed to remove the solids. The solids removed from heat exchanger bundles are a K-listed (K050) waste. At the time of the inspection, I saw some waste debris and staining on the pad around the bundles which looked like it could have come off the heat exchanger bundles.</p> <p>Upon closer inspection, Mr. Warrick said the heat exchanger bundle on the right (toward center of pad) looked like the interior of the bundle had not been cleaned out. I asked Mr. Warrick about the volume of waste solids inside the heat exchanger bundle and he told me the volume of the material appeared to be about 10 gallons. I asked how long the heat exchanger bundles had been on the pad and Messrs. Warrick and Harper said the bundle cleaning crew cleaned them in September 2020 and that they had been on the pad since then.</p> <p>Mr. Harper followed up with a response letter that was provided as an attachment in an email dated 05/06/2021. The two heat exchanger bundles identified on the New Hazardous Waste Pad were addressed with the following response:</p> <ul style="list-style-type: none"> <li>• The bundles were moved, cleaned, and material on waste slab was removed and containerized on 4/28/2021(<b>see photos 4a, 4a-2, 4a-3</b>).</li> </ul> | |

While inspecting the New hazardous waste pad, I saw two heat exchanger bundles that had been pressure washed to remove the solids (K050). At the time of the inspection, I saw this K050 waste on the pad around the bundles.

Mr. Warrick said the bundle on the right (toward center of pad) looked like the interior of the bundle had not been cleaned out. He said the bundle cleaning crew cleaned them in September 2020.

View of two heat exchanger bundles as well as debris and staining on the pad around the bundles.

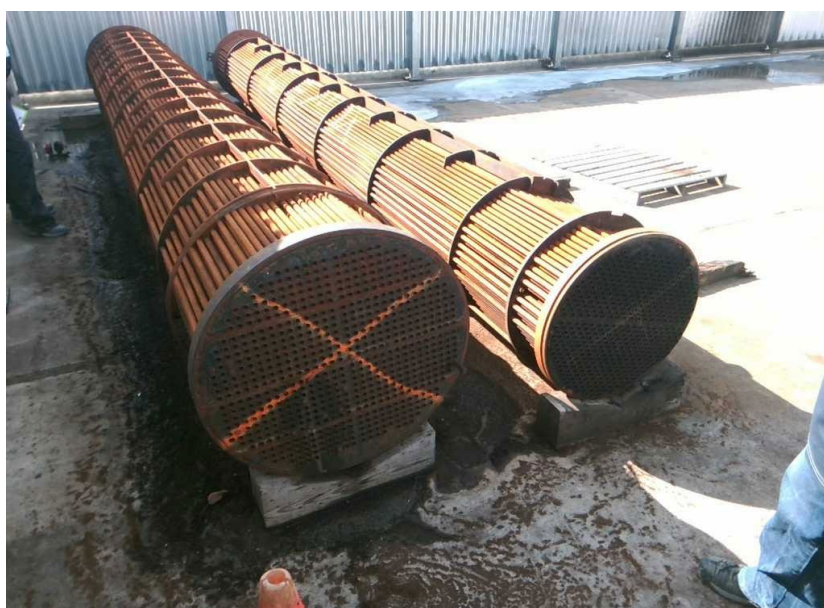
| Observation_Image-202104261208168161228133.jpg |

| Another view of two heat exchanger bundles. |

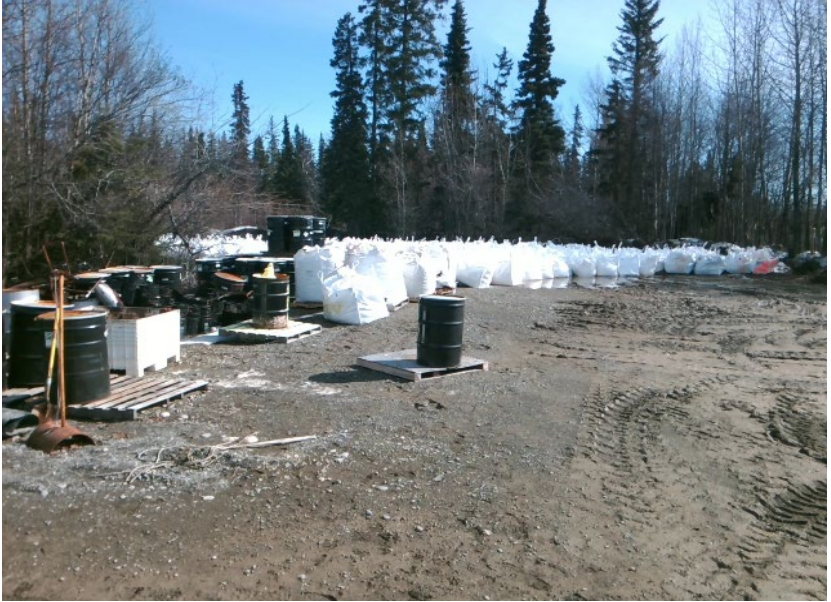
| Observation_Image-20210426114907497413954.jpg | |

| <p>While walking around the facility, we passed by an area where non-hazardous waste asphalt was being accumulated. I observed asphalt containers off their containment area and asphalt on ground.</p> <p>Mr. Harper followed up with a response letter that was provided as an attachment in an email dated 05/06/2021. The non-hazardous waste asphalt drums observed off containment and asphalt on ground was addressed with the following response:</p> <ul style="list-style-type: none"> <li>The non-hazardous waste was cleaned, and dripping asphalt containers were moved onto the waste slab to lined containment on 4/27/2021 (<b>see photo 3a and 3a-2</b>)</li> </ul> | |

| Non-hazardous waste asphalt seen here on the left in the photo. | |

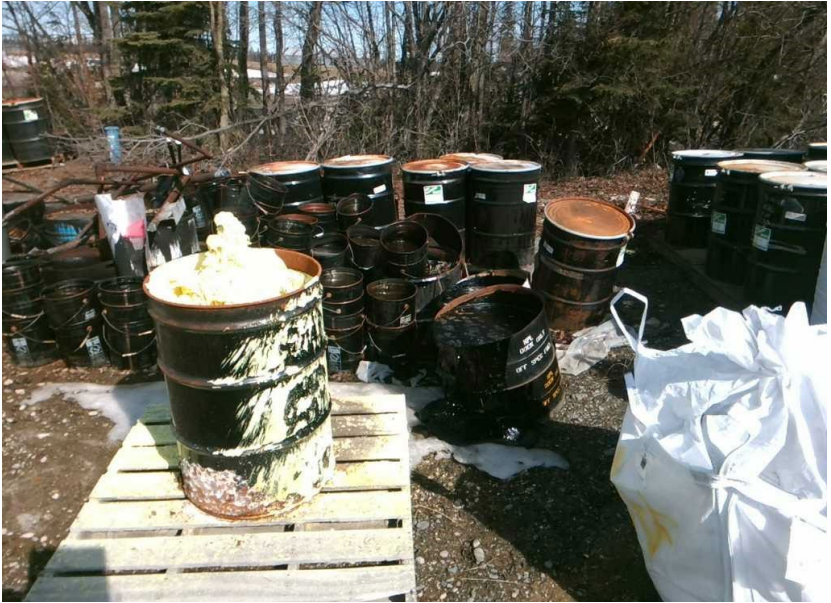
| Observation_Image-2021042611493749371265659.jpg | |

| Close-up view of the Non-hazardous waste asphalt. | |

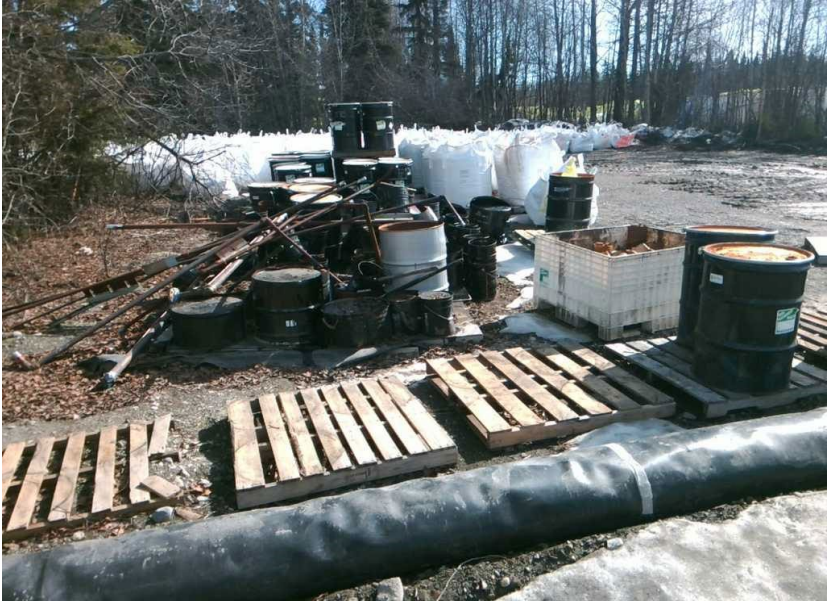
| Observation_Image-2021042611502050201297047.jpg | |

| Another view of the Non-hazardous waste asphalt. | |
