# NPDES Compliance Sampling Inspection Report

City of Salamanca Wastewater  
Treatment Plant (WWTP)

NPDES Permit: NY 0020508

Inspection Dates: June 21-22, 2023

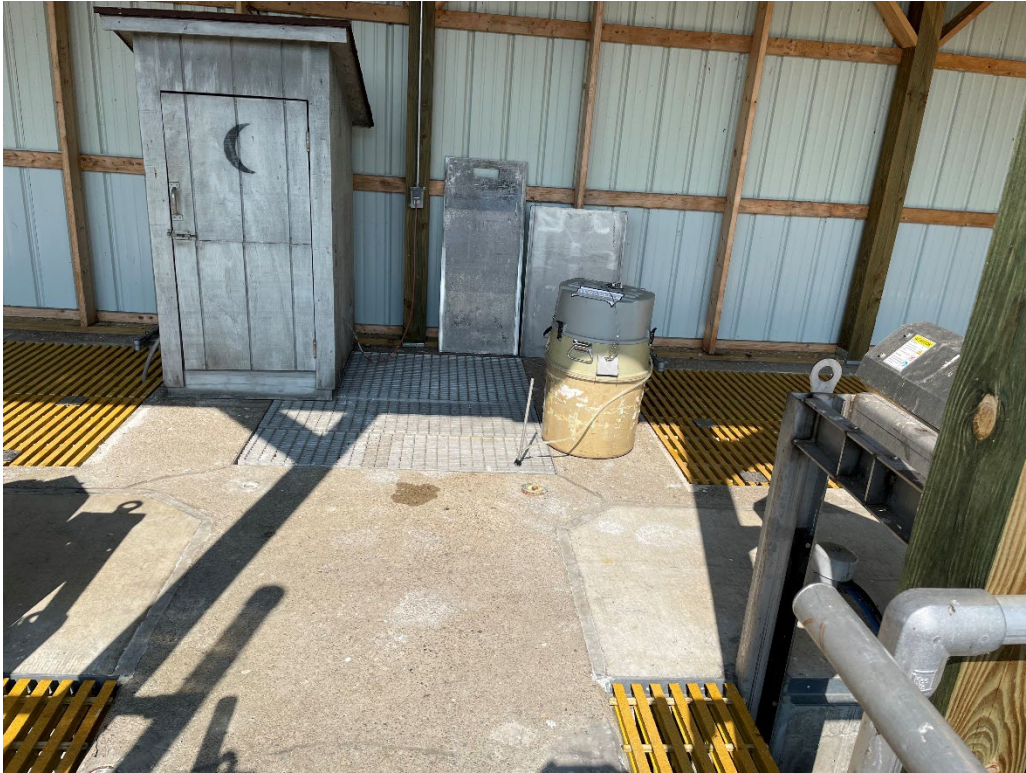
**Photo #1.** An automatic composite sampler was set-up at the effluent receiving pit.

**Photo #1.** EPA automatic composite sampler was set-up at the effluent receiving pit.

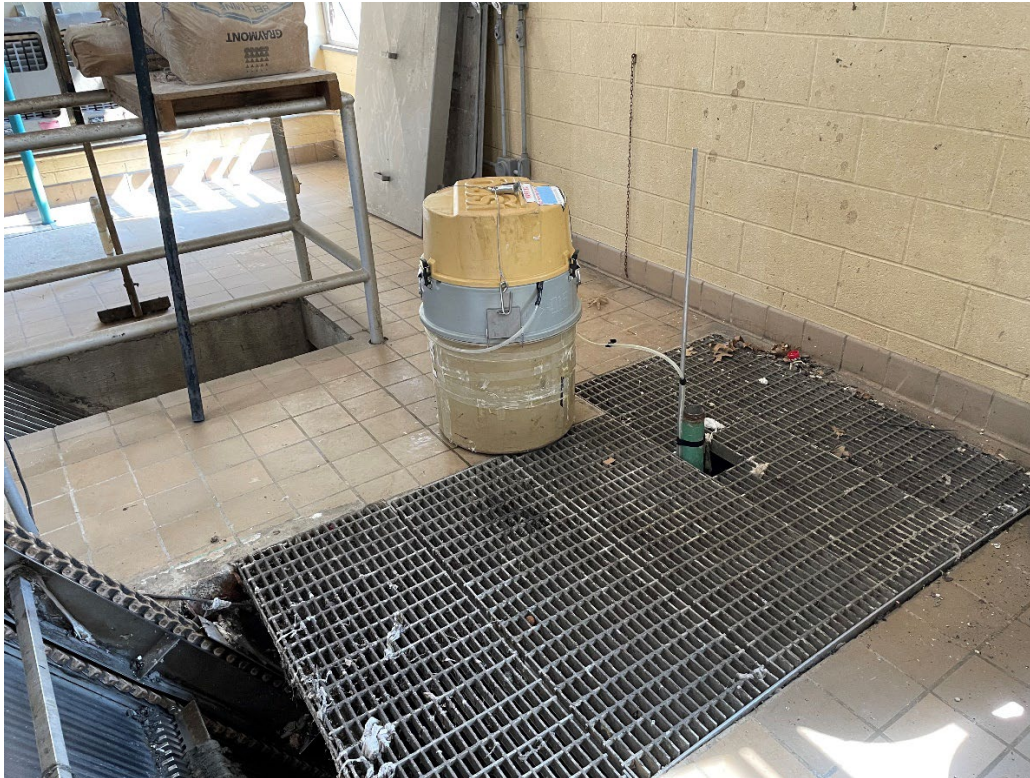
**Photo #2.** An automatic composite sampler was set-up at the influent.

**Photo #2.** EPA automatic composite sampler was set-up at the influent sampling point.

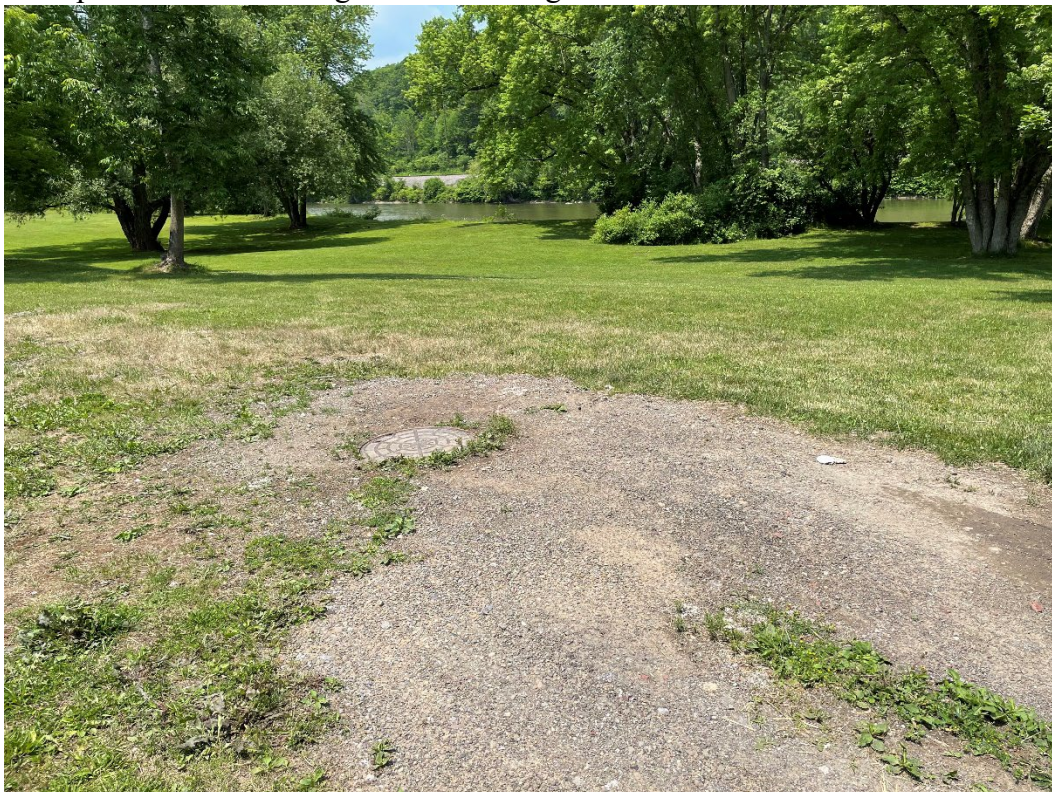
**Photo #4.** Septic waste is drained into the designated manhole near the boat launch.

**Photo #4.** Septic waste is discharged into the designated sewer manhole near the boat launch.

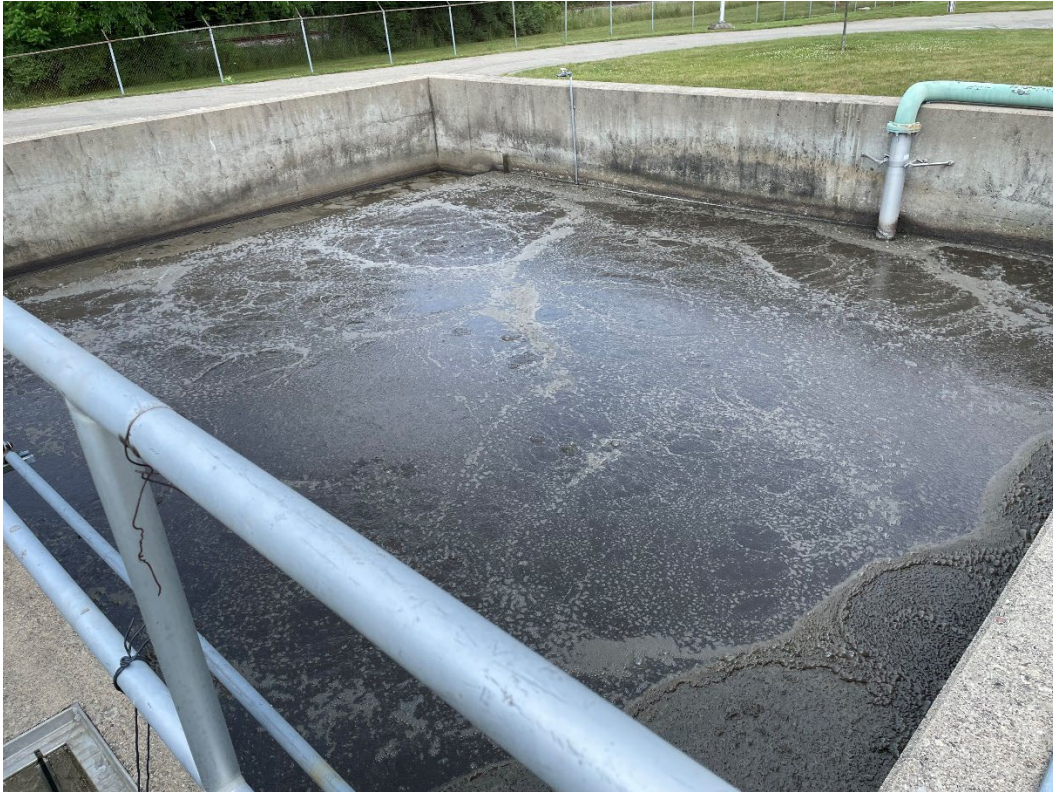
6.2.7 It was observed that the Mixed Liquor Suspended Solids (MLSS) in the aeration tanks was dark grey. The MLSS should be tan or muddy in color to ensure a healthy population of microbes. Furthermore, the DO level of 5.0 milligrams per liter (mg/L) or greater is maintained in the aeration tanks. Ideally, the DO concentration should be maintained between 1-3 mg/L. According to 40 CFR Part 122.41 (e) Proper Operation and Maintenance under Subpart C – Permit Condition, it states, *“The permittee shall at all times properly operate and maintain all facilities*

**Photo #5.** The MLSS in the Contact Stabilization Process is dark grey in color.

**Photo #5.** The color of the MLSS in the aeration tank was observed to be dark grey.

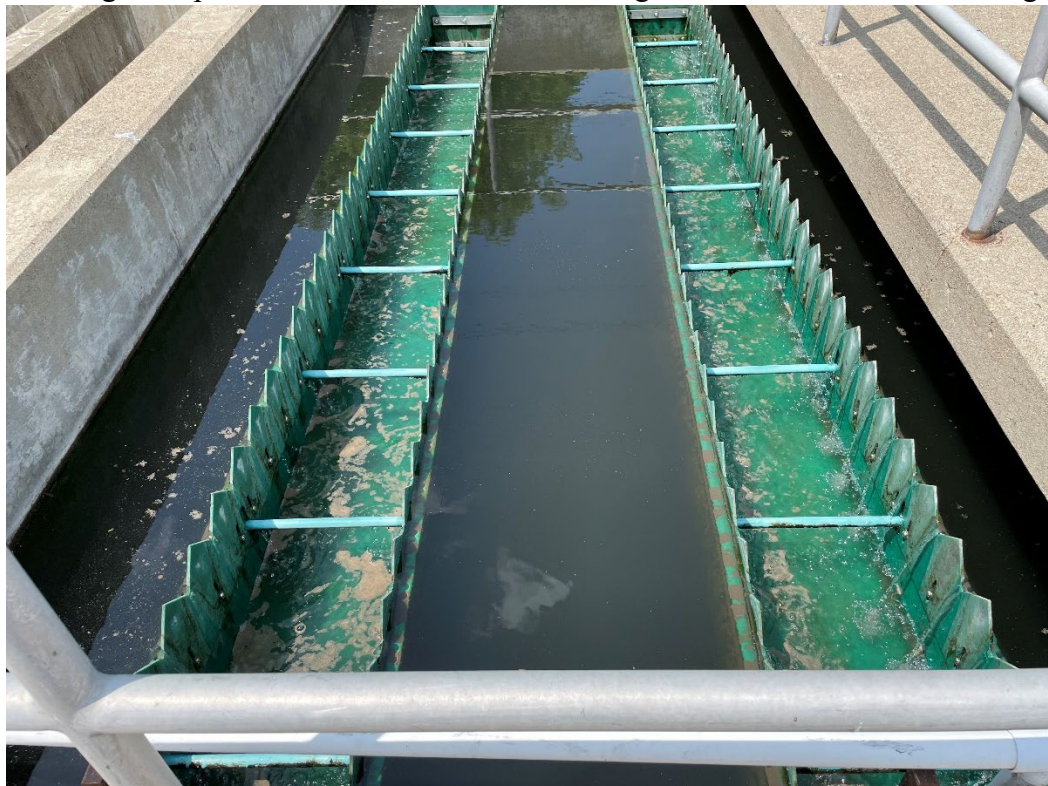
6.2.8 Instead of settling out in the rectangular clarifiers, pin floc was observed overflowing the V-Notch weirs into the effluent trough that leads into the polishing chambers. According to 40 CFR Part 122.41 (e) Proper Operation and Maintenance under Subpart C – Permit Condition, it states, “*The permittee shall at all times properly operate and maintain all facilities and systems of treatment and control (and related appurtenances) which are installed or used by the permitted to achieve compliance with the conditions of this permit. Proper operation and maintenance also includes adequate laboratory controls and appropriate quality assurance procedures.”*

**Photo #6.** Solids are overflowing the V-Notch weirs into the clarifier effluent trough.

**Photo #6.** Sludge and pin floc were observed overflowing into the clarifier effluent trough.

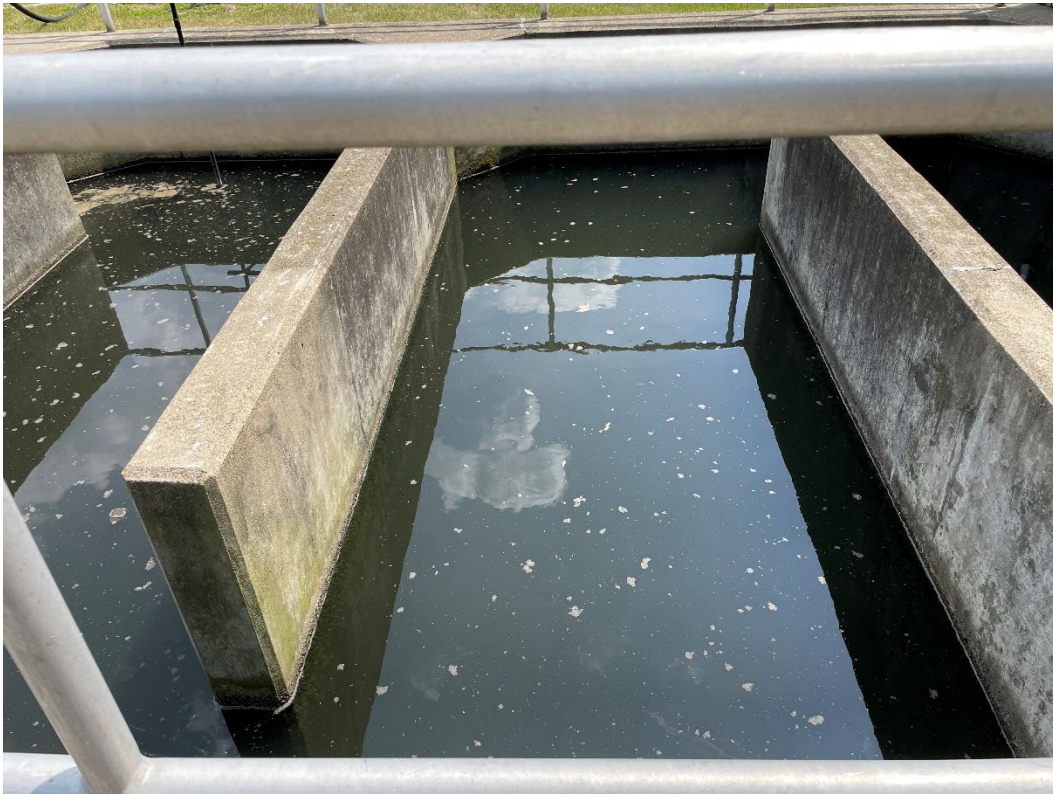
6.2.9 Sludge bulking and bubbles were observed rising to the surface in the polishing chambers. These are indicators of a potential septic condition. Sludge should be removed from the polishing chambers. According to 40 CFR Part 122.41 (e) Proper Operation and Maintenance under Subpart C – Permit Condition, it states, “*The permittee shall at all times properly operate and maintain all facilities and systems of treatment and control (and related appurtenances) which are installed or used by the permitted to achieve compliance with the conditions of this permit. Proper operation and maintenance also includes adequate laboratory controls and appropriate quality assurance procedures.”*

**Photo #7.** Floating solids are observed in the former chlorine contact chamber.

**Photo #7.** Solids were observed in the polishing chambers.

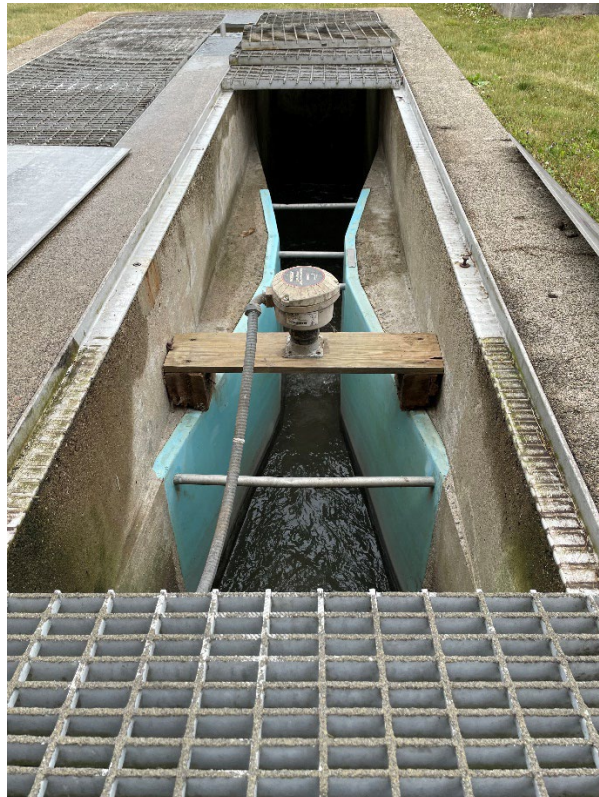
6.2.6 The approaching flow to the Parshall Flume is turbulence. As a result, the ultrasonic flow sensor is recording higher flow. According to the ISCO Open Channel Flow Measurement Handbook, Fifth Edition, Page 73 of Chapter 4: Flumes, it states, *“The approaching flow should enter the converging section reasonably well distributed across the entrance width, and the flowlines should be essentially parallel to the flume centerline. Surges and waves of any appreciable size should be eliminated. Also, the flow at the flume entrance should be free of “white” water and free from turbulence in the form of visible surface boils.”* Furthermore 40 CFR Part 122.41 (e) Proper Operation and Maintenance under Subpart C – Permit Condition, it states, *“The permittee shall at all times properly operate and maintain all facilities and systems of treatment and control (and related appurtenances) which are installed or used by the permitted to achieve compliance with the conditions of this permit. Proper operation and maintenance also includes adequate laboratory controls and appropriate quality assurance procedures.”*

**Photo #8.** Higher flow is recorded by the ultrasonic sensor due to turbulence.

**Photo#8.** The approaching flow to the Parshall Flume was turbulence.
