## **RCRA Inspection Report**

CERF Shelby LLC  
7103 Old Millington Rd  
Millington, TN 38053

EPA ID#: TNR000041806  
NAICS #: 221210 – Natural Gas Distribution

August 23, 2023, at 9:00 AM

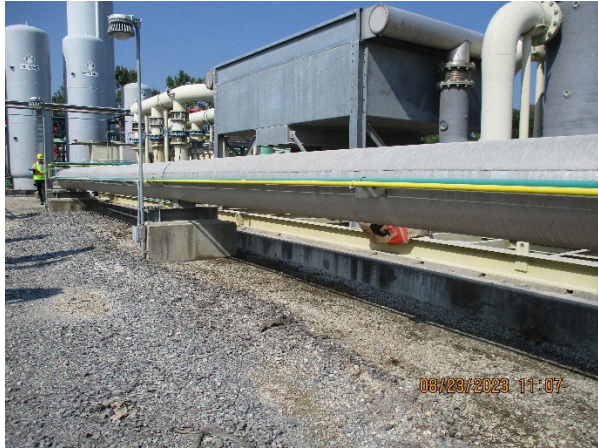
Condensate from the skid system (Photo 1) enters an oil water separator and is then pumped into a holding tank and then pumped into one of the two hazardous waste tanks. The oily water from the oil-water separator is transferred to a 250-gallon tote. The inspectors observed a 250-gallon plastic tote full of oily water which was not labeled (Photo 2).

**Photo 1:** Skid system for turning landfill gas into clean natural gas.

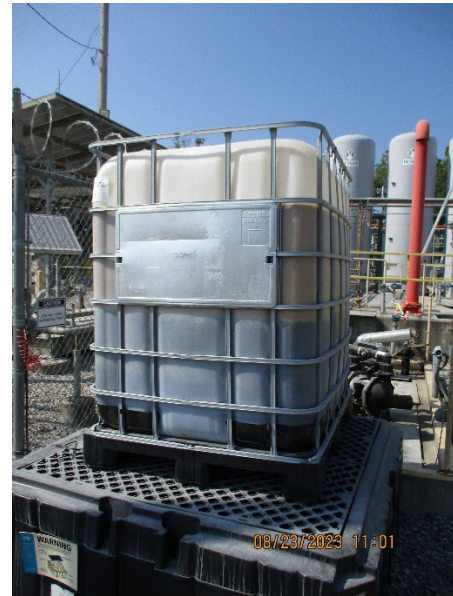
**Photo 2:** Oily water tote with no label.

**Pursuant to Tenn. Comp. R. & Regs. 0400-12-01-.11(3)(c)(3)(i)[40 C.F.R. § 279.22(c)(1)], containers and aboveground tanks used to store used oil at generator facilities must be labeled or marked clearly with the words “Used Oil.”**

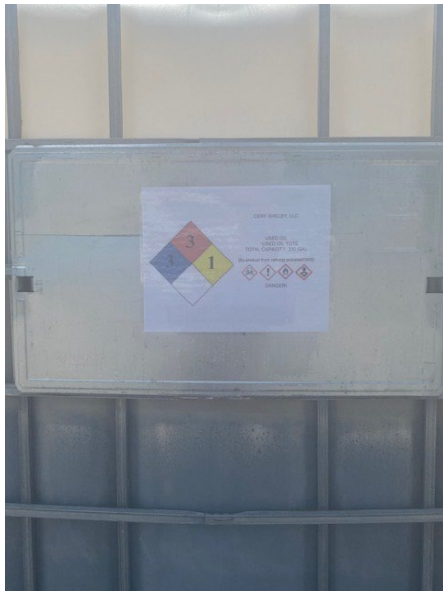
**Photo 3:** Used Oil label placed on oily water tote.

The facility placed a Used Oil label on the tote and sent a photo via email the same day (Photo 3).

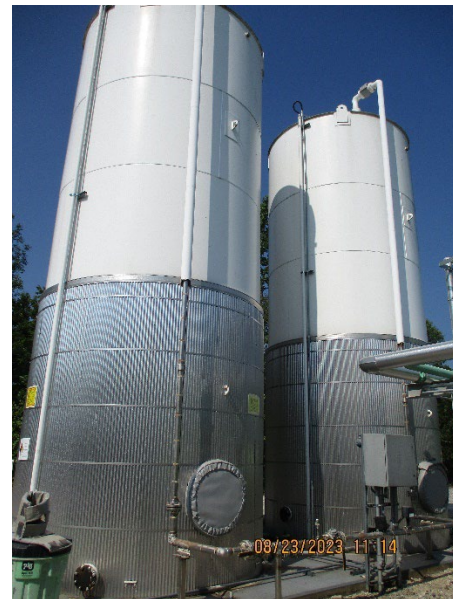
The tank farm houses two (2) 15,000-gallon double-walled ASTs named Condensate Tank 1 (T-1) and Condensate Tank 2 (T-2) that are used to store D004 hazardous waste condensate from the skid system (Photo 4). The ASTs sit on limestone gravel which covers the majority of the facility. The tanks are double walled with the exterior wall acting as secondary containment for the primary tank itself. However, the tank piping and other ancillary equipment do not have secondary containment. Both ASTs were labeled “Hazardous Waste RNG Condensate” and were marked with an indication of the hazard of the contents (Photo 5). A level gauge on the tank showed the tank levels in feet. T-1 had a reading of 8.2 and T-2 had a reading of 15.0 (Photo 6). According to the facility, 8 feet on the tank level gauge is equivalent to approximately 5,000 gallons of hazardous waste, which gets shipped offsite by tanker at least weekly. The ASTs appeared to be in good condition at the time of the inspection with no visible signs of leaks or corrosion on the tanks or tank piping (Photos 7, 8, 9, and 10). A spill kit was observed near the tank farm.

**Photo 4:** T-1 and T-2 hazardous waste tanks. 15,000-gallon double-walled ASTs.

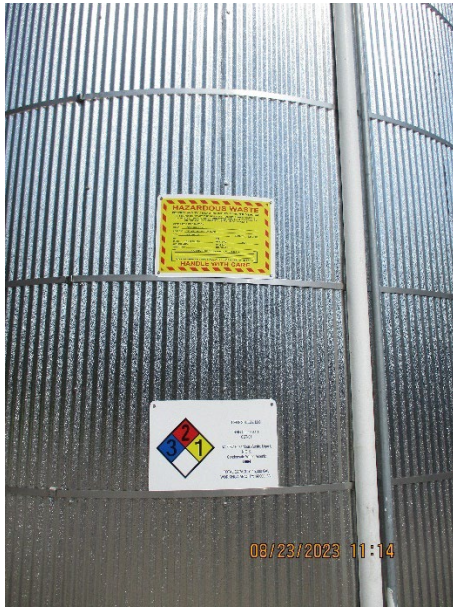
**Photo 5:** Hazardous waste labels, content information, and indication of the hazard of the contents posted on the tanks.

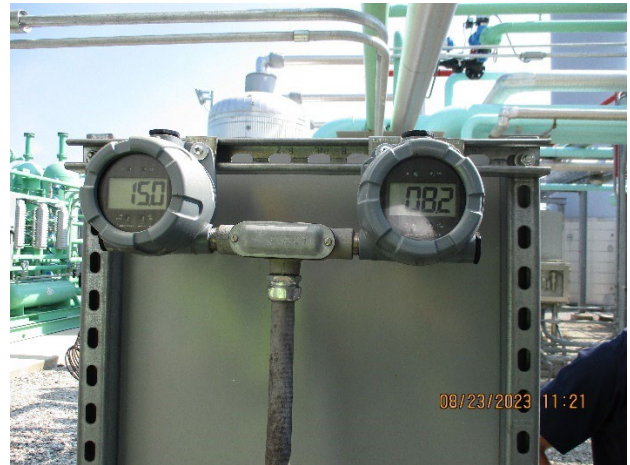
**Photo 6:** Tank level gauges.

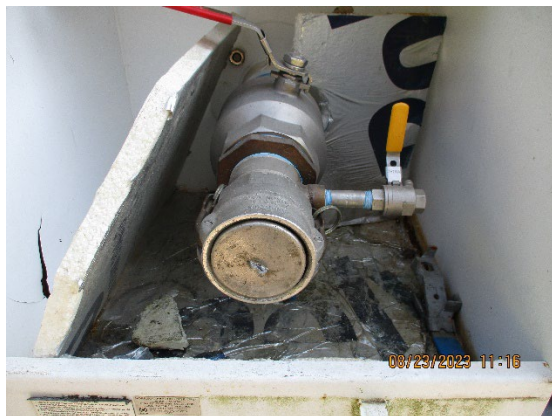
**Photo 7:** Fill Port 1

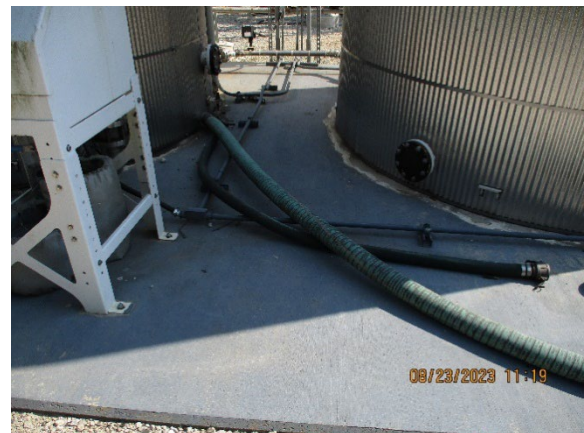
**Photo 8:** Tank Piping

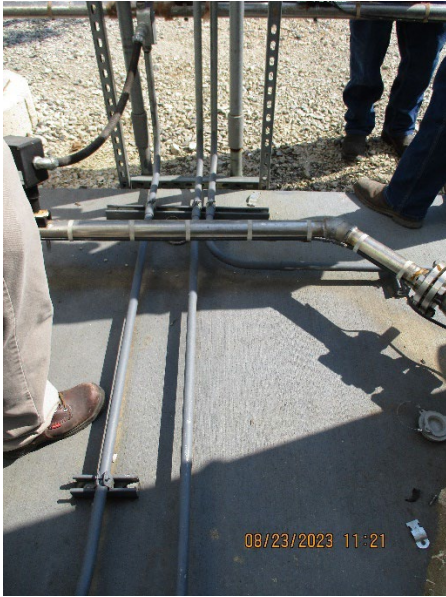
**Photo 9:** Tank piping

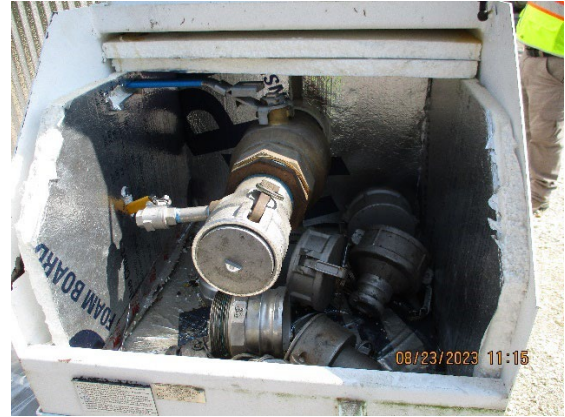
**Photo 10:** Fill Port 2

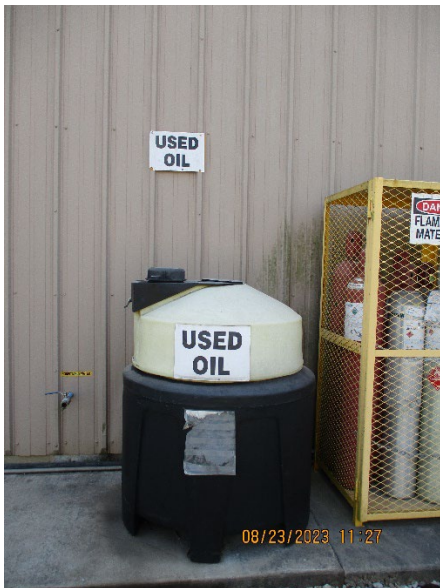
Next to the maintenance warehouse the inspectors observed a 300-gallon used oil tank labeled “Used Oil” (Photo 11). Inside the maintenance warehouse the inspectors observed one (1) 20-gallon container for draining used oil. The container was not labeled. This was corrected on the same day and a photo sent via email (Photo 12).

**Photo 11:** Used oil tank outside of Maintenance Warehouse.

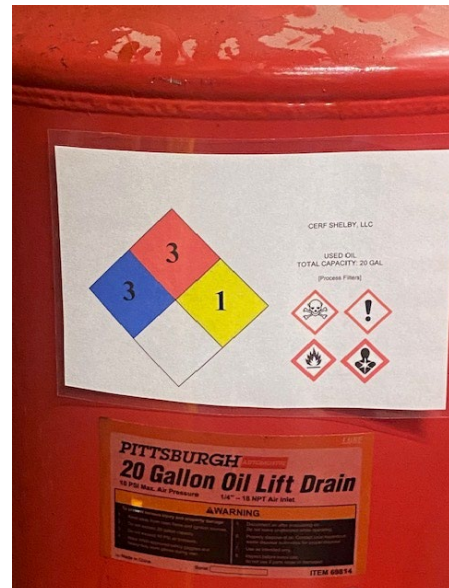
**Photo 12:** 20-gallon used oil container inside Maintenance Warehouse.
