### INSPECTION REPORT

| Company Name: | Cleco Power, LLC | | |
| Facility Name: | Brame Energy Center | | |
| Identification/Permit Number: | LA0008036 (AI No. 2922) | | |

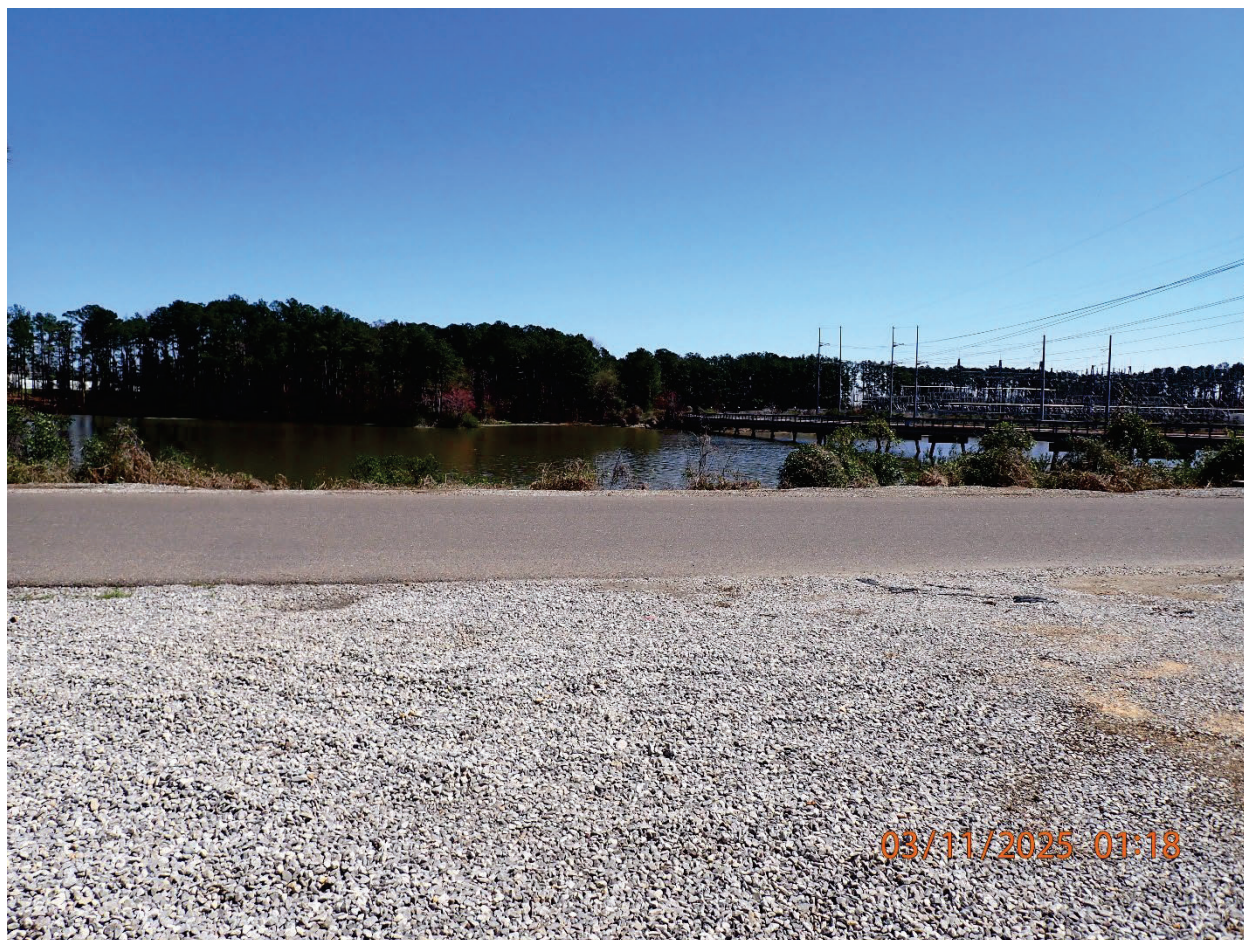
Photo No. 1

Photograph File Name: P3110044.JPG  
Date of Photograph: 03/11/2025  
Latitude & Longitude: 31.400881, -92.725100  
Orientation: N  
Map Datum: WGS-84  
Time of Photo: 01:18 PM  
Photographer: Jack Arias  
Description: This image shows the entrance and the facility.

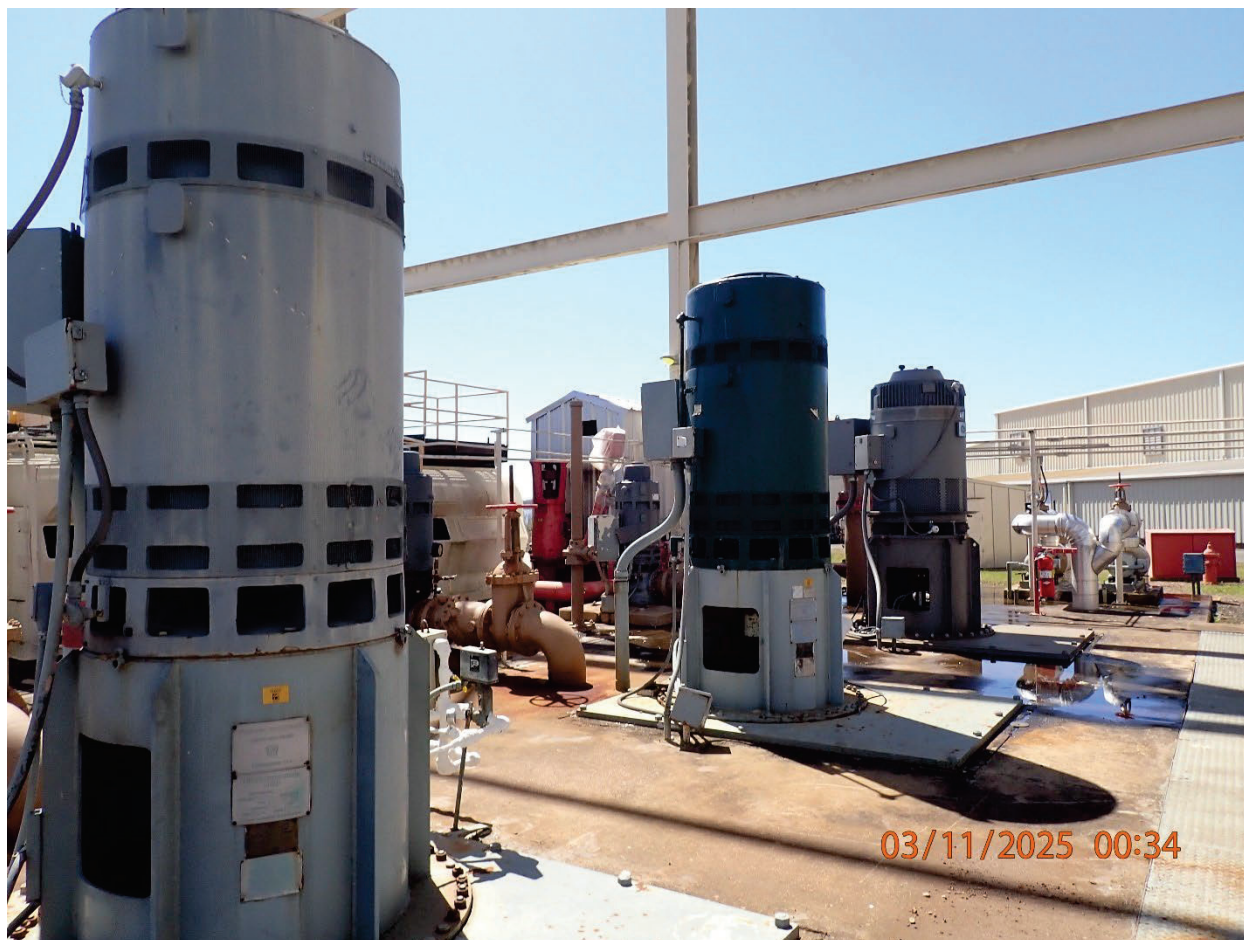
Photo No. 2

Photograph File Name: P3110023.JPG  
Date of Photograph: 03/11/2025  
Latitude & Longitude: 31.394797, -92.716369  
Orientation: NW  
Map Datum: WGS-84  
Time of Photo: 12:34 PM  
Photographer: Jack Arias  
Description: This image show water intake pumps from Unit 1 intaking water from private Lake Rodemacher for cooling and industrial processes at the facility.

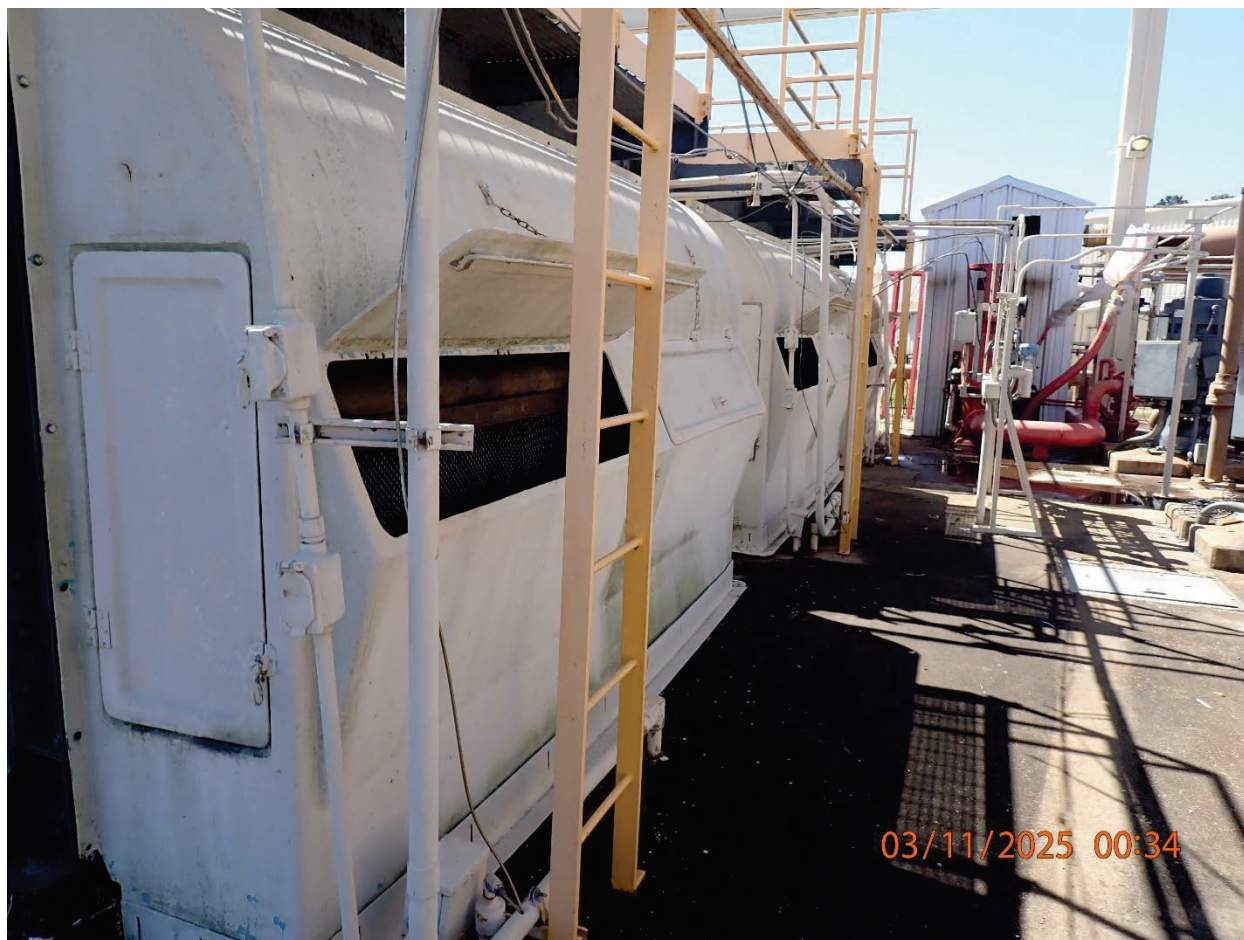
Photo No. 3

This image shows the intake screen system. This is a filter designed to prevent debris and contaminants from entering a system and to protect equipment from damage.

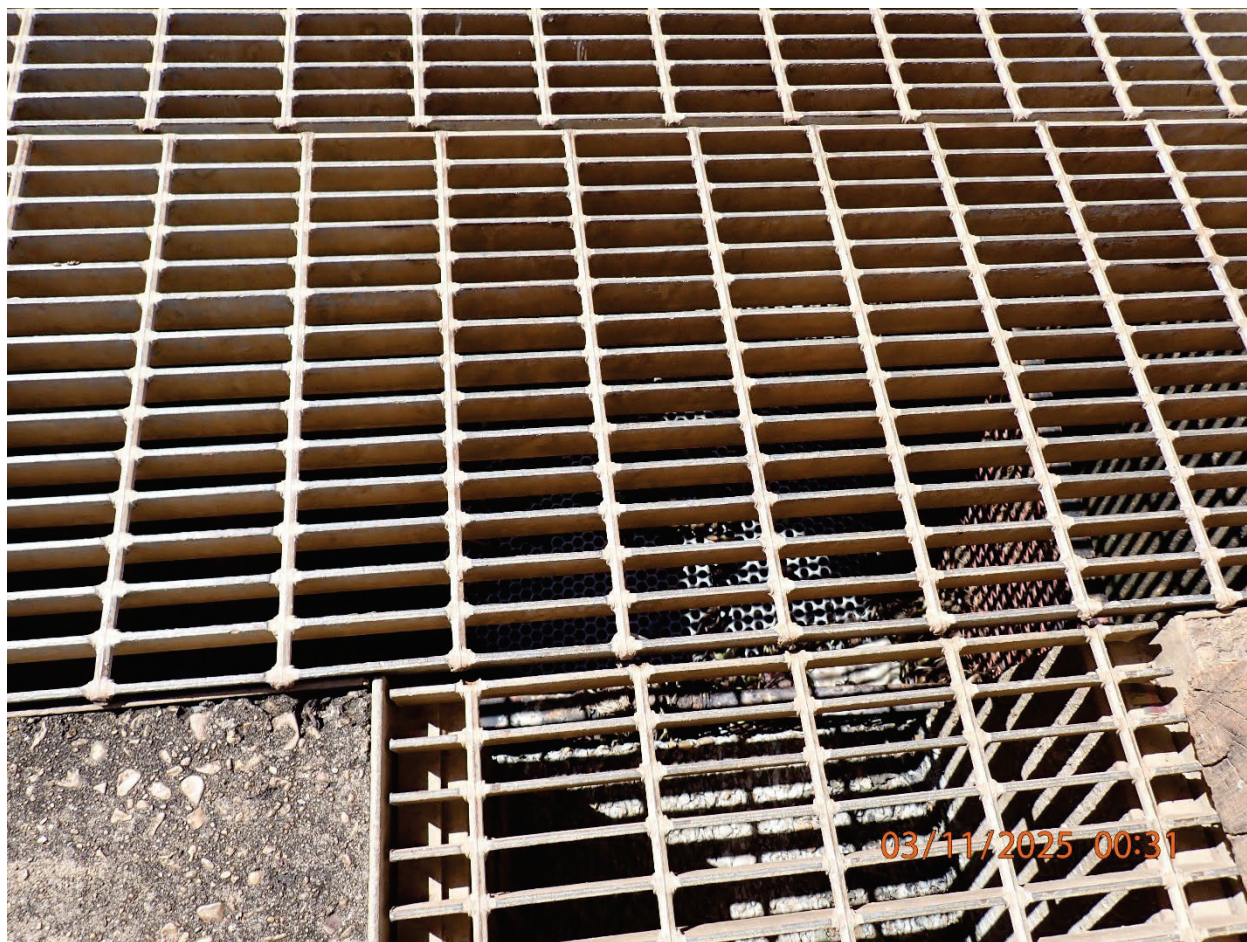
Photo No. 4

Photograph File Name: P3110020.JPG  
Date of Photograph: 03/11/2025  
Latitude & Longitude: 31.394797, -92.716369  
Orientation: NW  
Map Datum: WGS-84  
Time of Photo: 12:31 PM  
Photographer: Jack Arias  
Description: This image shows the screen system before water return to Lake Rodemacher.

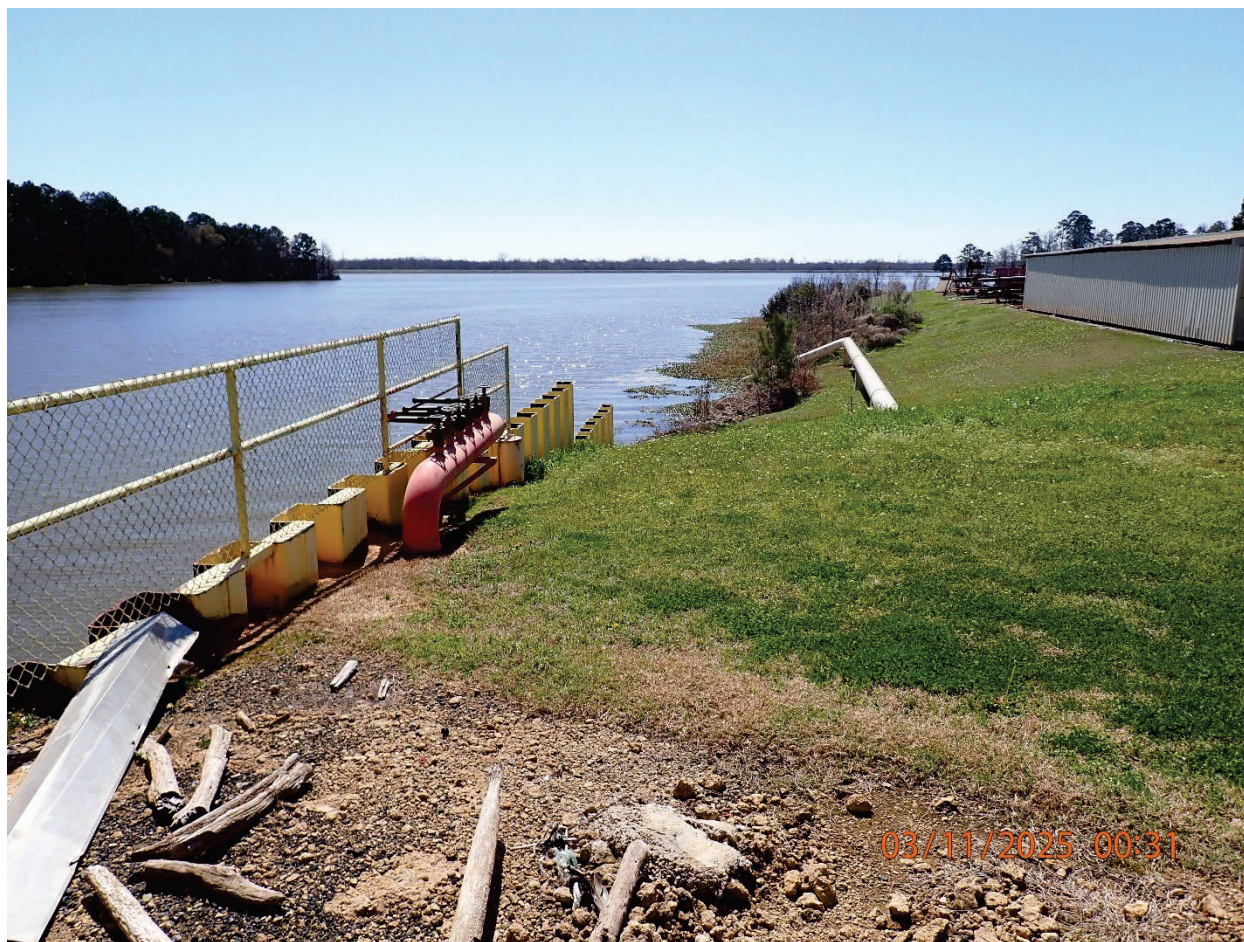
Photo No. 5

Photograph File Name: P3110021.JPG  
Date of Photograph: 03/11/2025  
Latitude & Longitude: 31.394328, -92.716385  
Orientation: NW  
Map Datum: WGS-84  
Time of Photo: 12:11 PM  
Photographer: Jack Arias  
Description: This image shows the intake water returning to Lake Rodemacher.

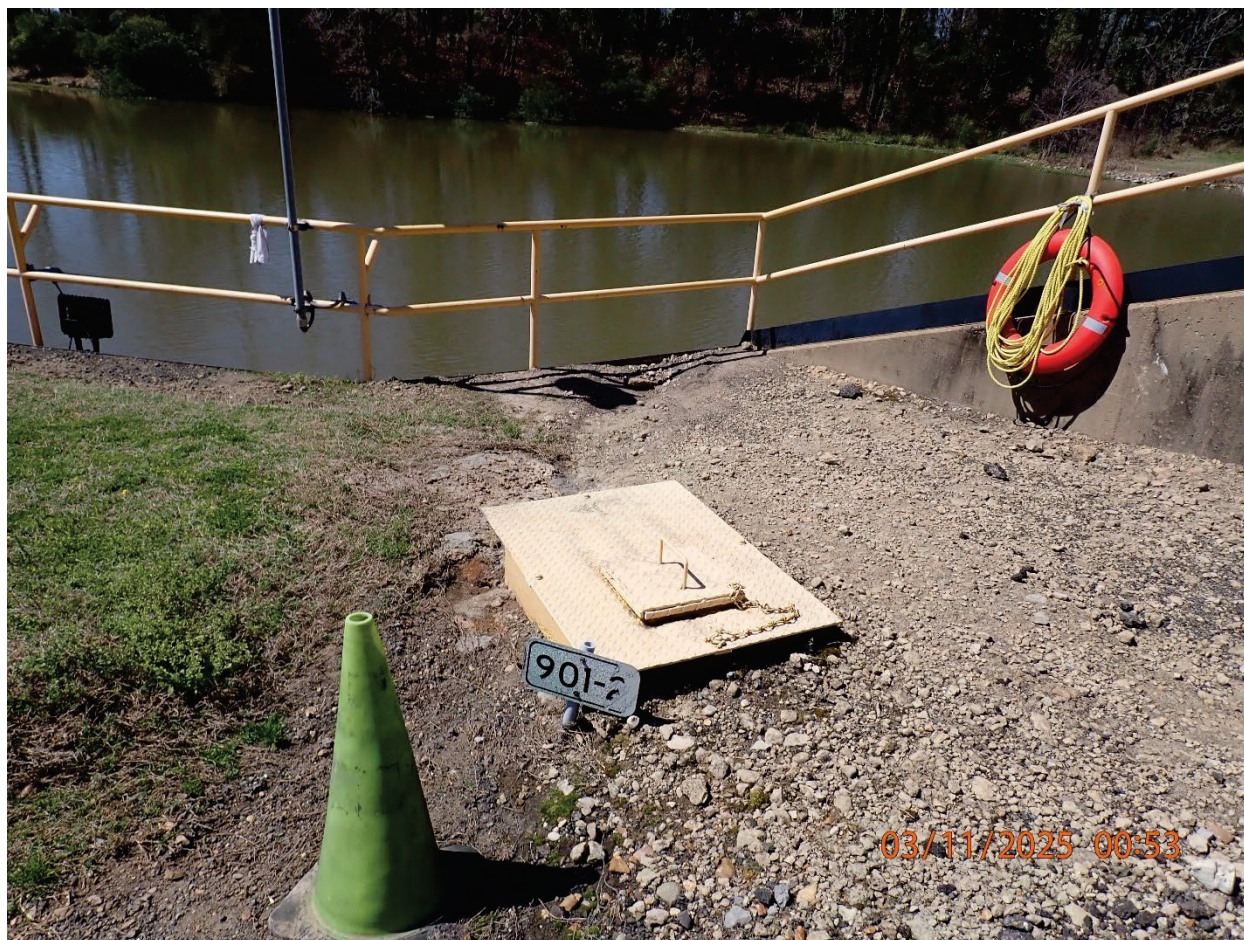
Photo No. 6

routed to the bottom ash pond (Outfall 401) or Outfall 901. At the time of the inspection, we did not observe any deficiencies (See Photo Nos. 6 - 11 in Appendix 1).

Description: This image shows a filter system 901 that softens water for the boilers and other plant water needs. This is an internal outfall and discharge into lake Rodemacher.

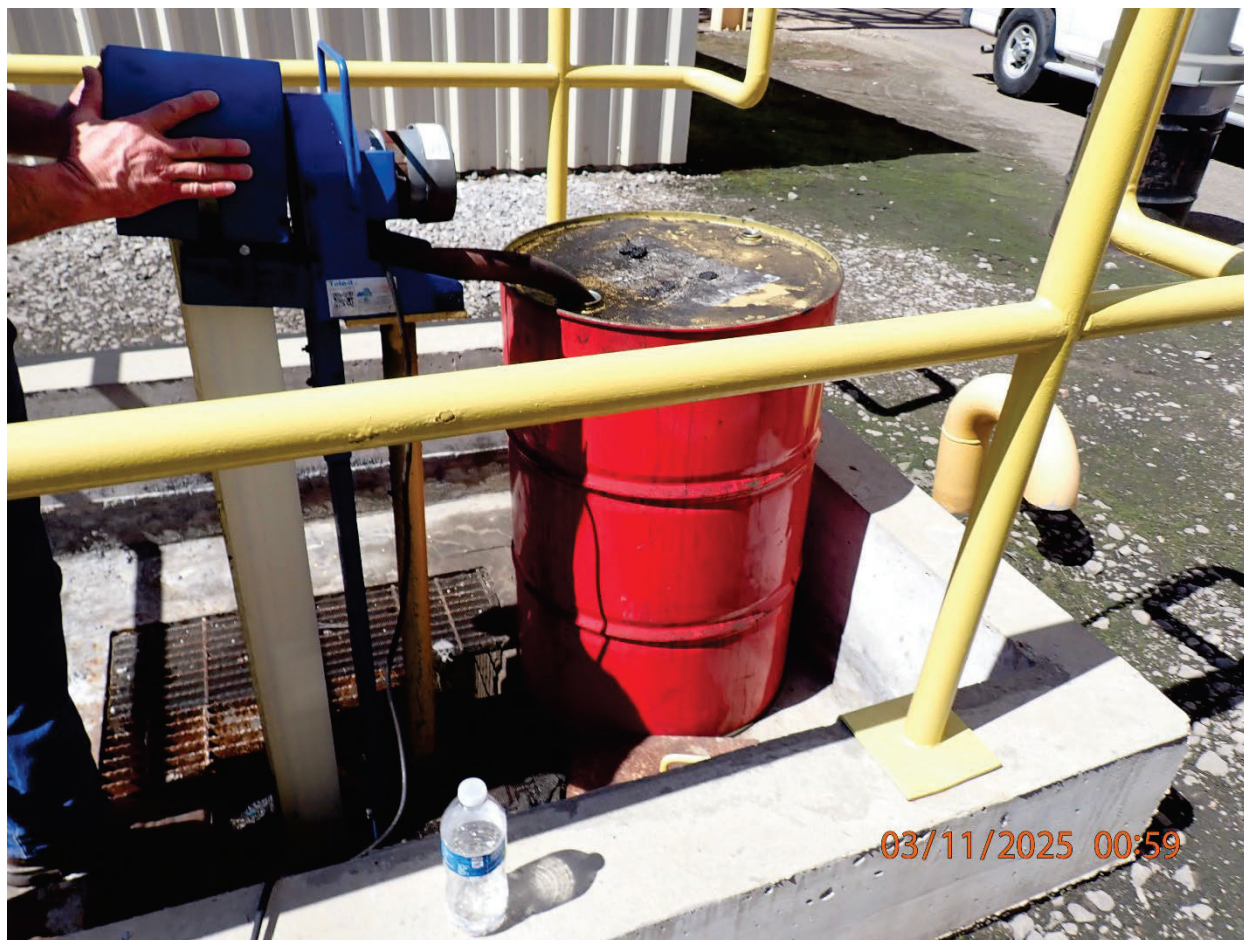
Photo No. 7

Photograph File Name: P3110031.JPG  
Date of Photograph: 03/11/2025  
Latitude & Longitude: 31.395385, -92.718021  
Orientation: W  
Map Datum: WGS-84  
Time of Photo: 12:59 PM  
Photographer: Jack Arias  
Description: This image shows an oil filter system that separate oil material from process water.

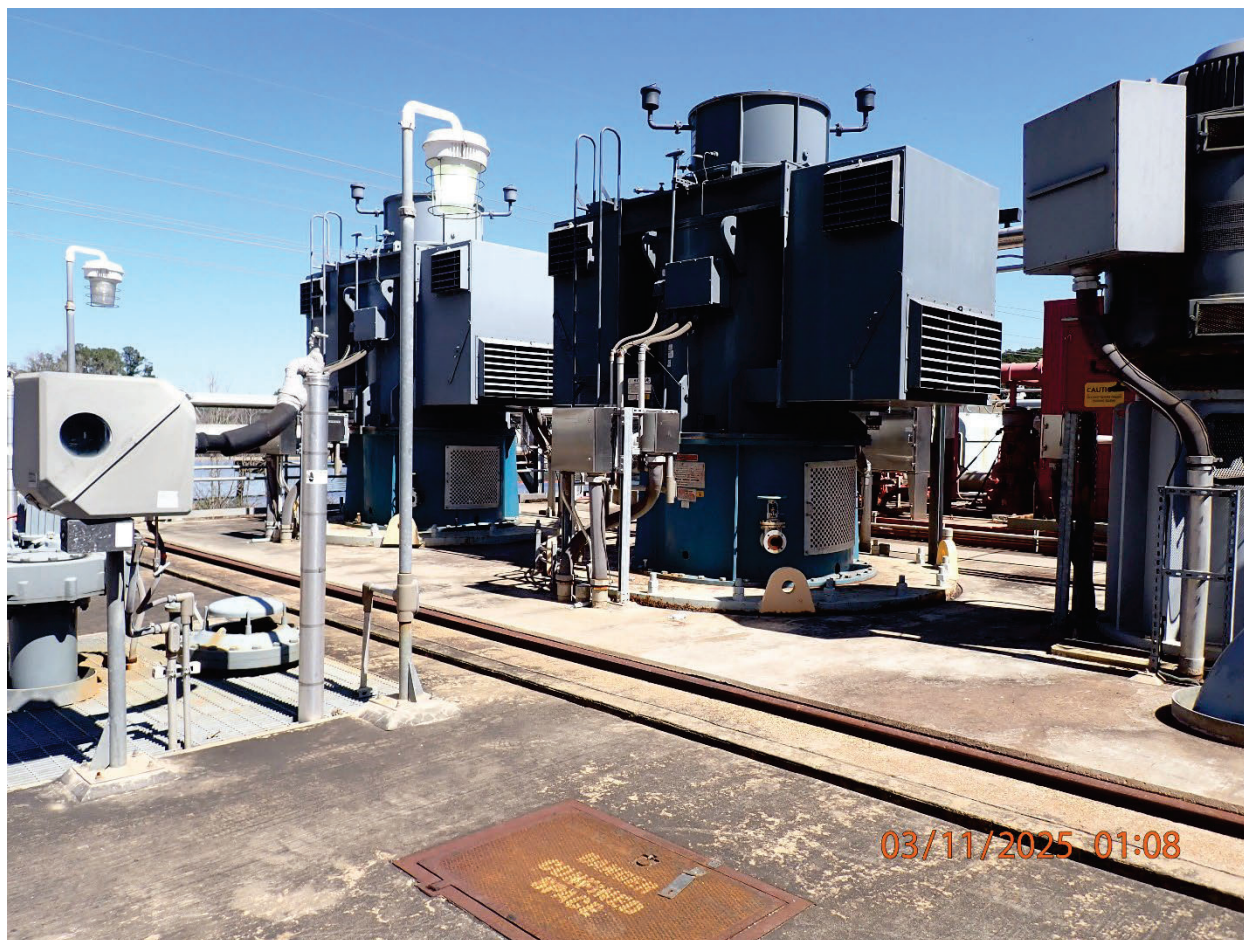
Photo No. 8

This image shows water intake pumps from Unit 2 intaking water from private Lake Rodemacher for cooling and industrial processes at the facility.

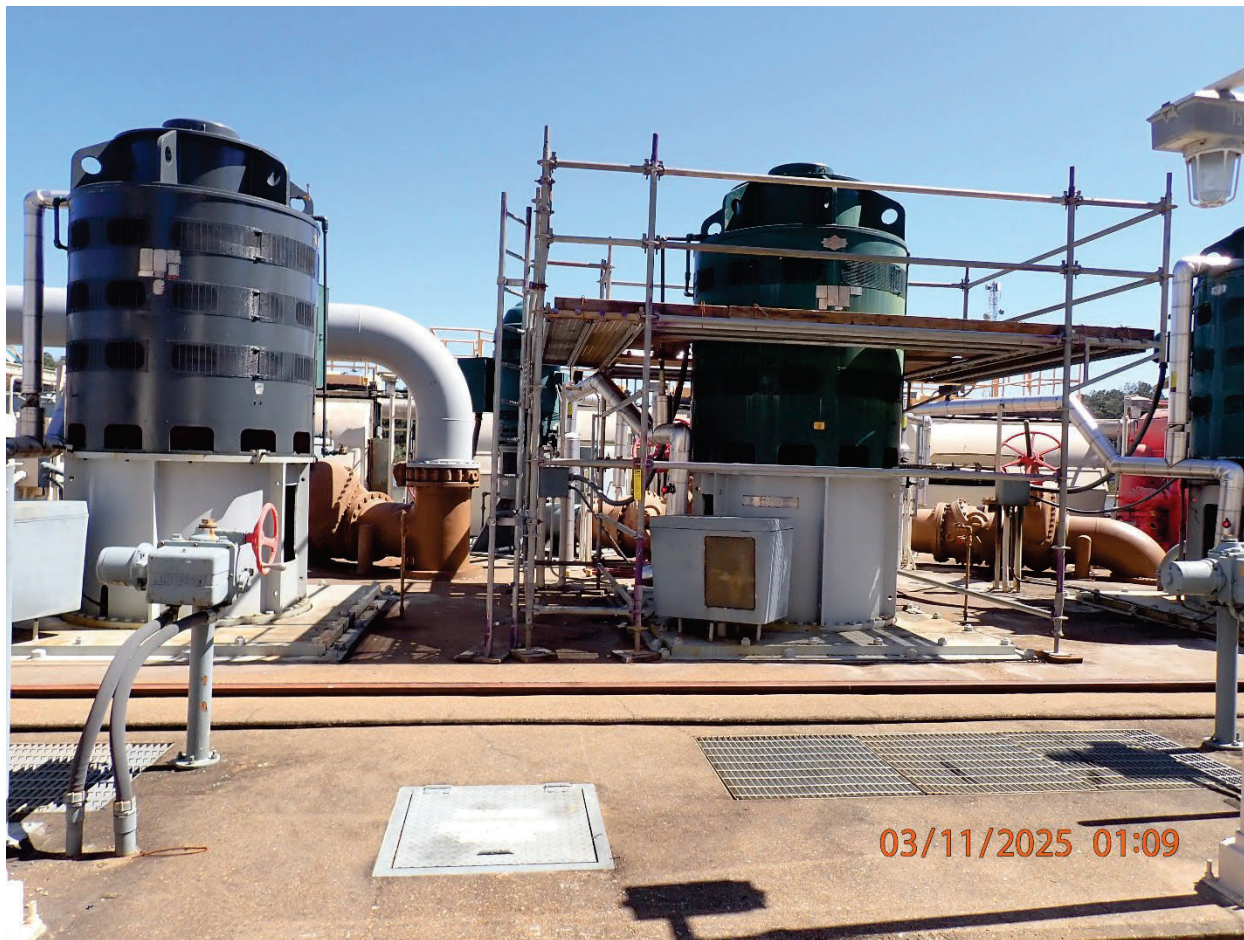
Photo No. 9

Description: This image shows water intake pumps from Unit 3 intaking water from private Lake Rodemacher for cooling and industrial processes at the facility.

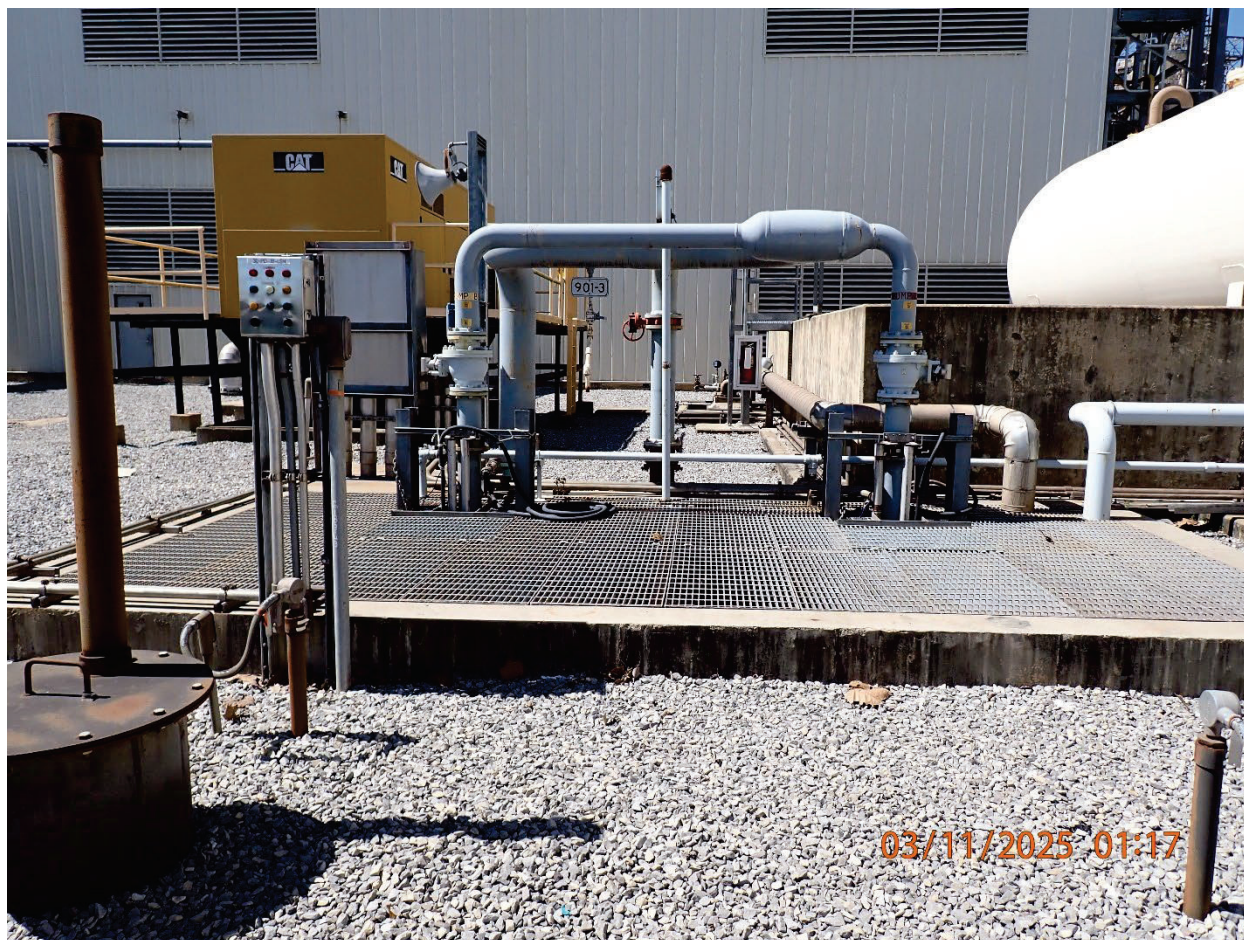
Photo No. 10

Photograph File Name: P3110038.JPG  
Date of Photograph: 03/11/2025  
Latitude & Longitude: 31.397805, -92.717053  
Orientation: SE  
Map Datum: WGS-84  
Time of Photo: 01:09 PM  
Photographer: Jack Arias  
Description: This image shows an oil and water filter system that separate oil material and others from process water.

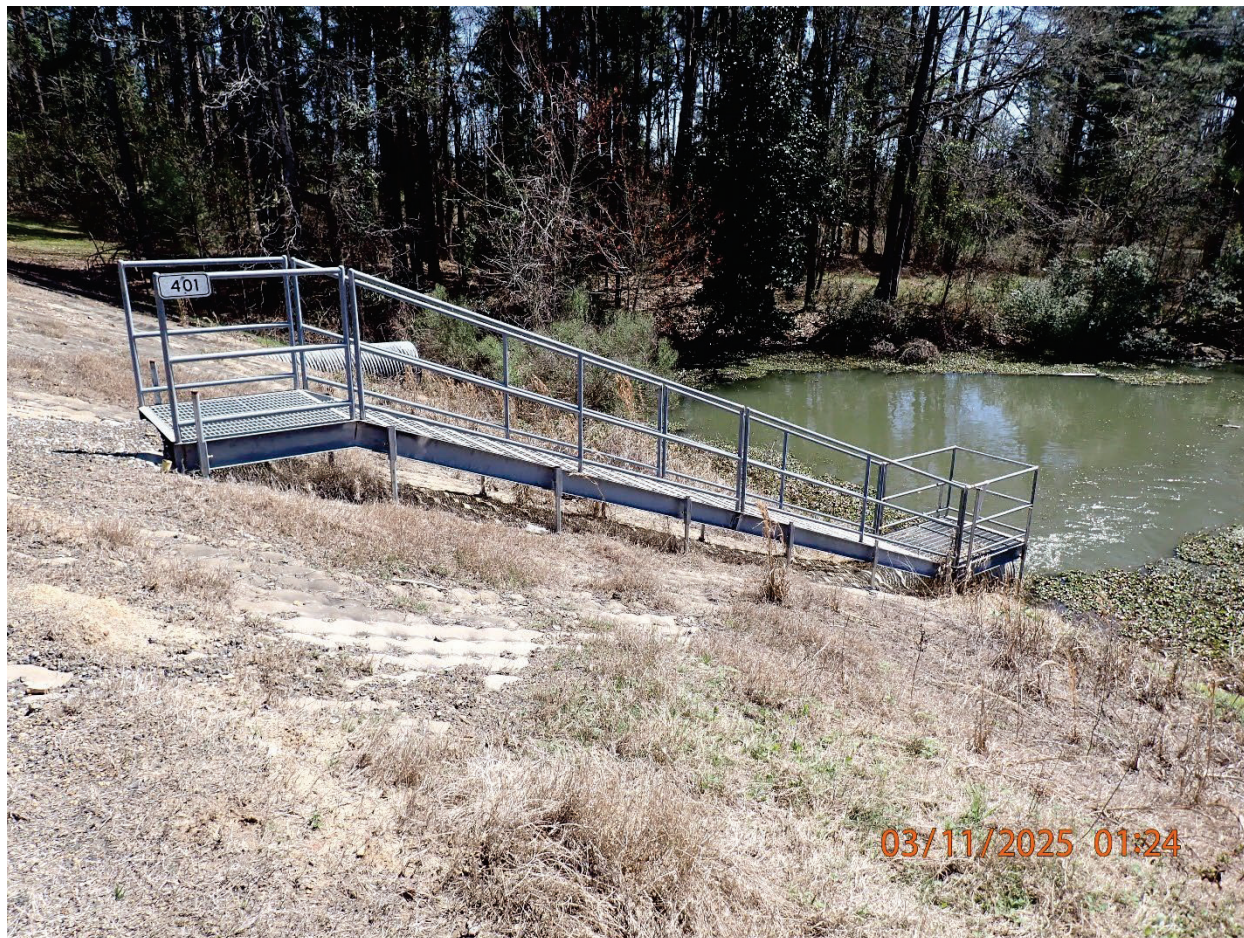
washwater. At the time of the inspection, we did not observe any deficiencies (See Photo No. 11 in Appendix 1).

Photograph File Name: P3110045.JPG  
Date of Photograph: 03/11/2025  
Latitude & Longitude: 31.395385, -92.718021  
Orientation: S  
Map Datum: WGS-84  
Time of Photo: 01:24 PM  
Photographer: Jack Arias  
Description: This image shows internal outfall 401. This outfall discharges bottom ash water, fly ash pond wastewaters, and others.

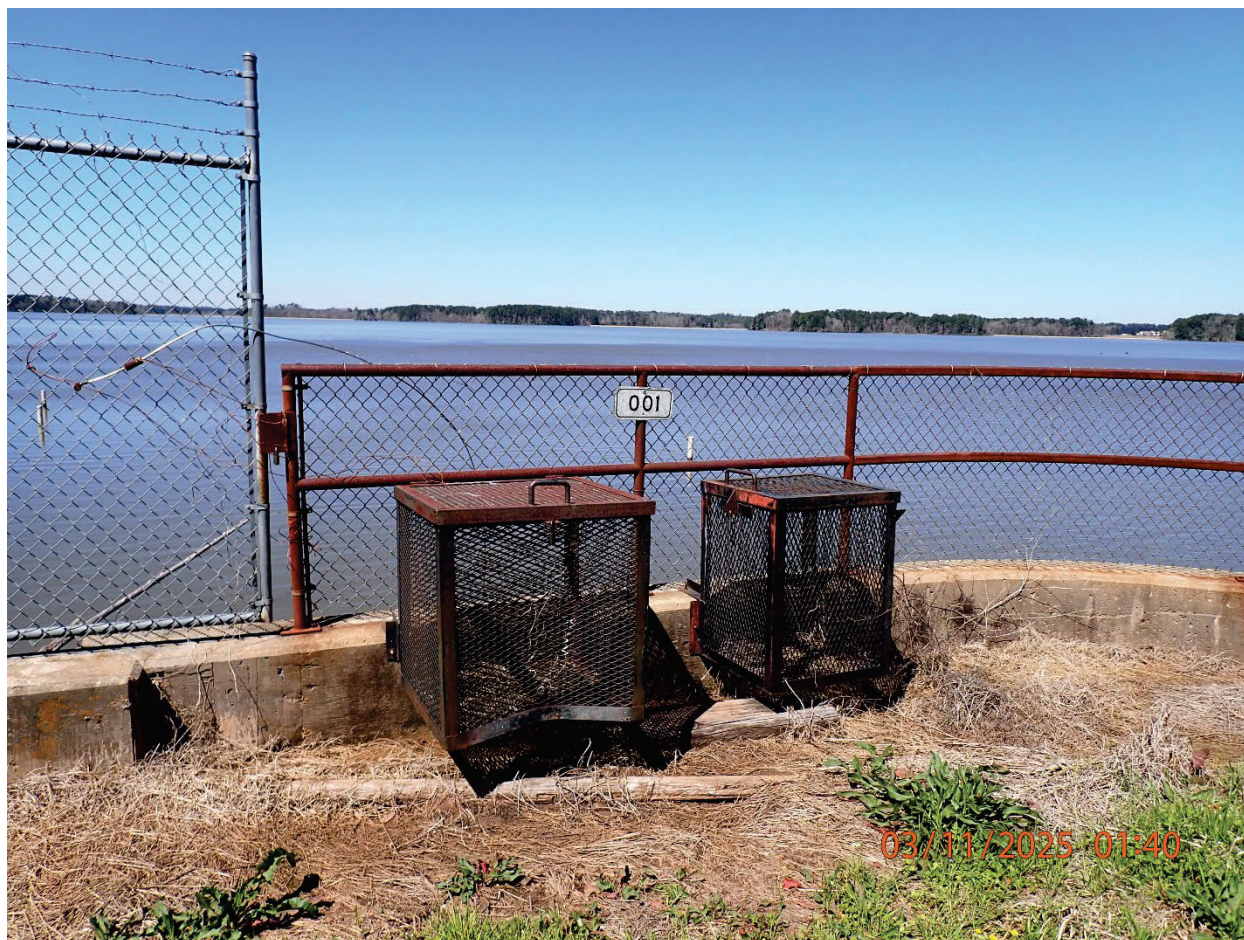
Photo No. 12

- ✚ **Outfall 001** consists of the intermittent cooling impoundment discharge consisting of previously monitored Outfalls 101, 201, 301, 401, 501, 601, 701, 801, 901, and 111, storm water runoff, and miscellaneous wastewaters which include, but are not limited to, fire system test water, eye wash station and safety shower water, steam condensate, and general facility washwater. At the time of the inspection, we observed that the outfall 001 consist of a large discharge area approximately 9,141.80 ft<sup>2</sup>. We did not observe any device or system that control the discharge volume going to water to Bayou Jean de Jean thence Red River (See Photo Nos. 12 - 14 in Appendix 1).

Description: This image shows external outfall 001. This outfall discharges intermittent cooling impoundment process water consisting of previously monitored Outfalls 101, 201, 301, 401, 501, 601, 701, 801, 901, and 111, storm water runoff, and miscellaneous wastewaters.

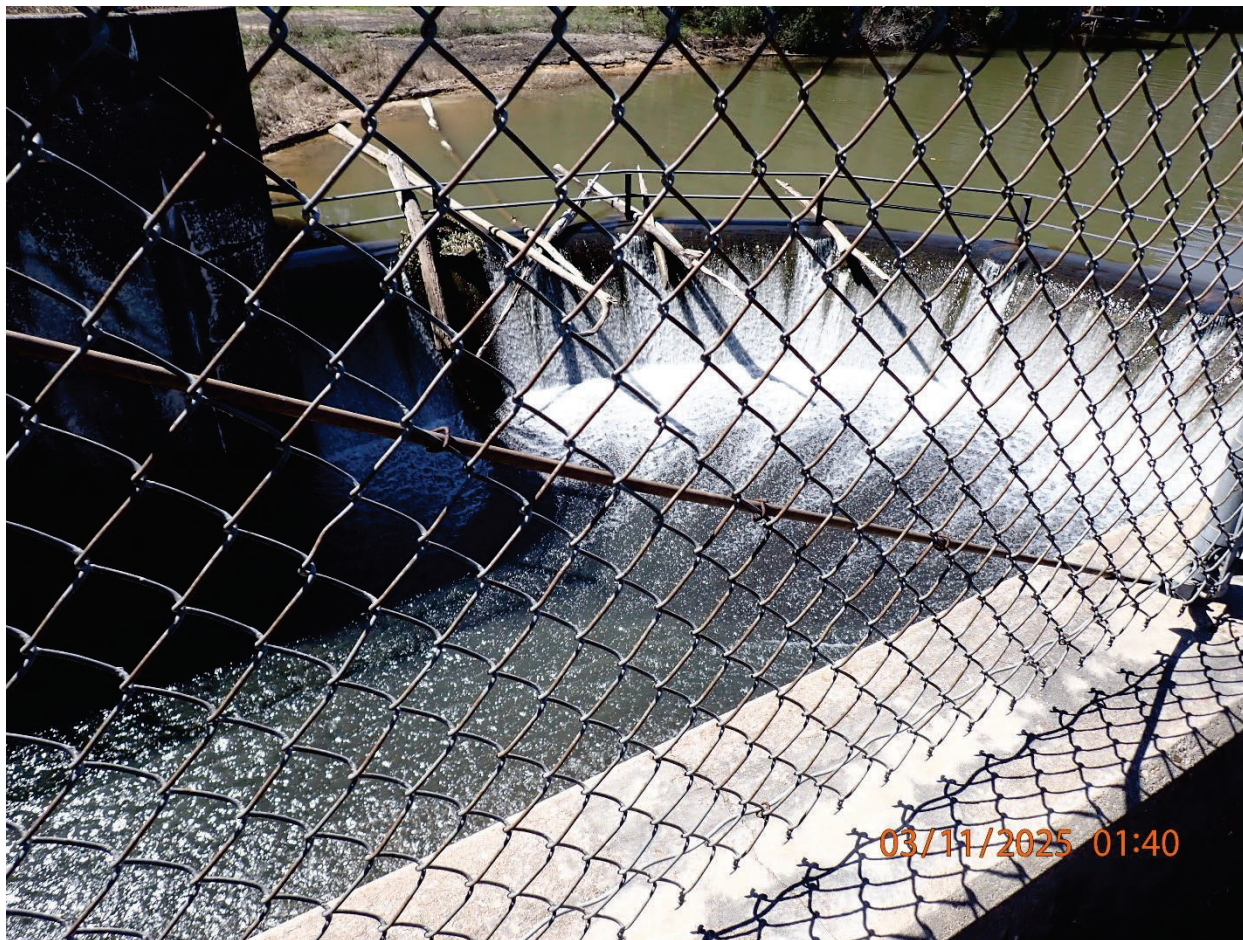
Photo No. 13

Photograph File Name: P3110050.JPG  
Date of Photograph: 03/11/2025  
Latitude & Longitude: 31.377269, -92.725360  
Orientation: SE  
Map Datum: WGS-84  
Time of Photo: 01:40 PM  
Photographer: Jack Arias  
Description: This image shows external outfall 001. The discharge area is approximately 9,141.80 ft<sup>2</sup>.

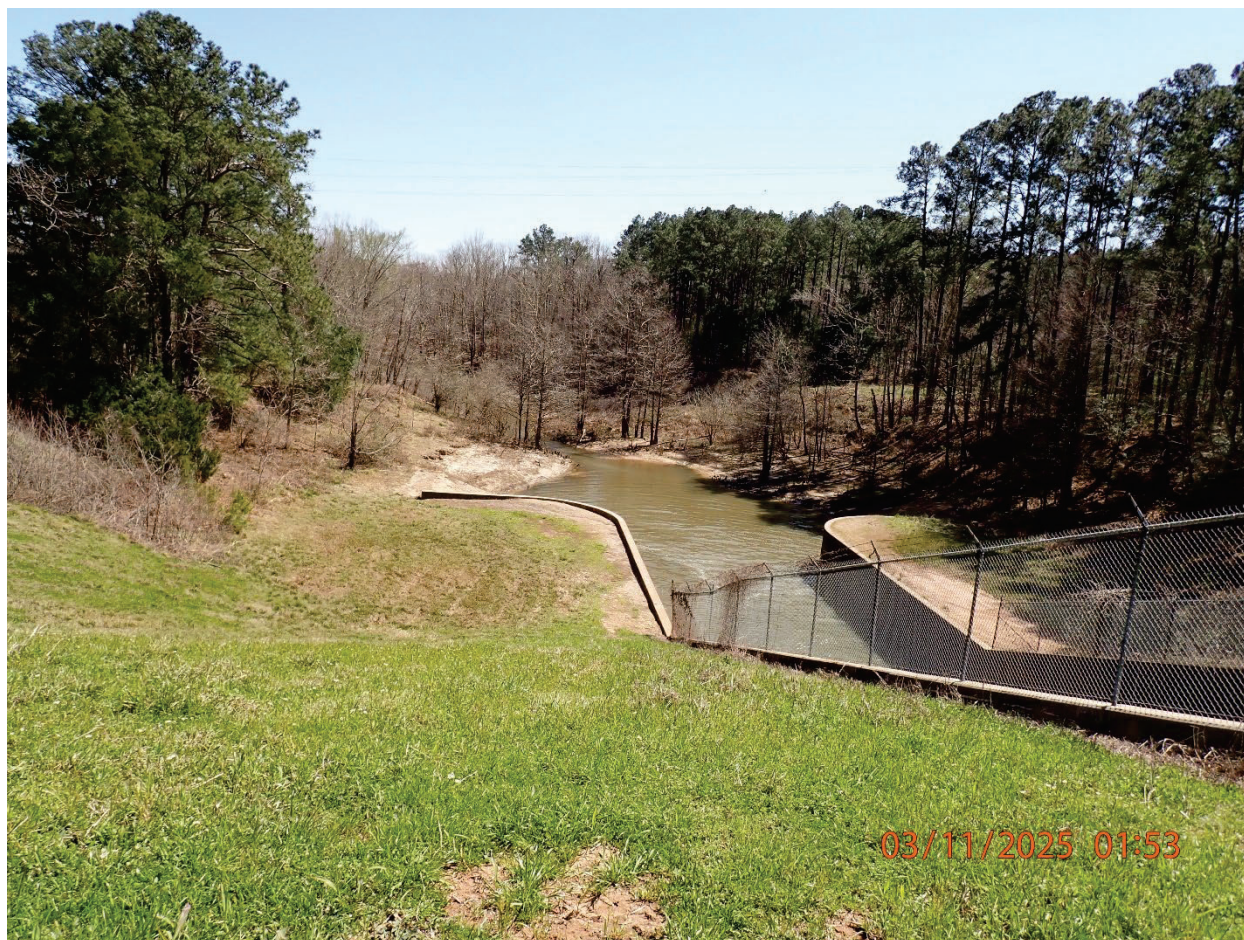
Photo No. 14

Photograph File Name: P3110053.JPG  
Date of Photograph: 03/11/2025  
Latitude & Longitude: 31.376701, -92.724662  
Orientation: SE  
Map Datum: WGS-84  
Time of Photo: 01:53 PM  
Photographer: Jack Arias  
Description: This image shows external outfall 001 and the discharge flow going to Bayou Jean de Jean thence Red River.

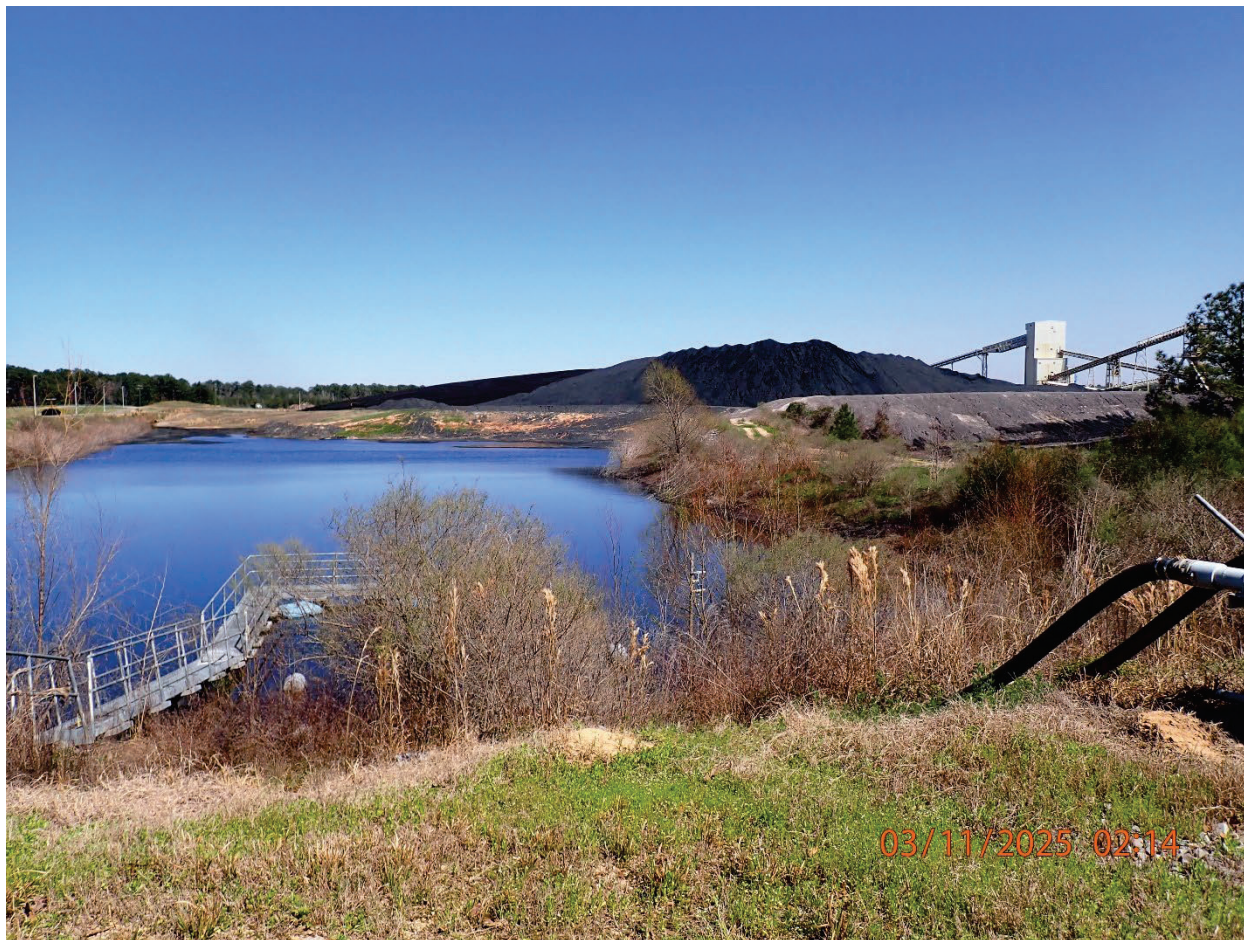
Photo No. 15

✚ **Outfall 501** consists of the intermittent discharge of storm water runoff from the petcoke/coal pile runoff and limestone runoff pond, ash loading silo washwater from Unit 3, barge river water, barge rain water, barge washwater, dock and equipment washwater, storm water runoff, and miscellaneous wastewaters which include, but are not limited to, filter backwash, fire system test water, eye wash station and safety shower water, steam condensate, and general facility washwater. Petroleum coke (petcoke) is used as the primary fuel source. Facility monitor flow, TSS, and pH effluents. According to the EPA under the CWA, when analyzing petroleum material such as Petco for EPA Clean Water Act (CWA) compliance, the key parameters to measure include Total Petroleum Hydrocarbons (TPH), Oil and Grease, and potentially Adsorbable Organic relevant to the specific CWA permit (See Photo Nos. 15 - 17 in Appendix 1).

Photograph File Name: P3110066.JPG  
Date of Photograph: 03/11/2025  
Latitude & Longitude: 31.400312, -92.724400  
Orientation: N  
Map Datum: WGS-84  
Time of Photo: 02:14 PM  
Photographer: Jack Arias  
Description: This image shows petcoke/coal and limestone pond and internal outfall 501. This consists of the intermittent discharge of storm water runoff from the petcoke/coal pile runoff and limestone runoff pond and others.

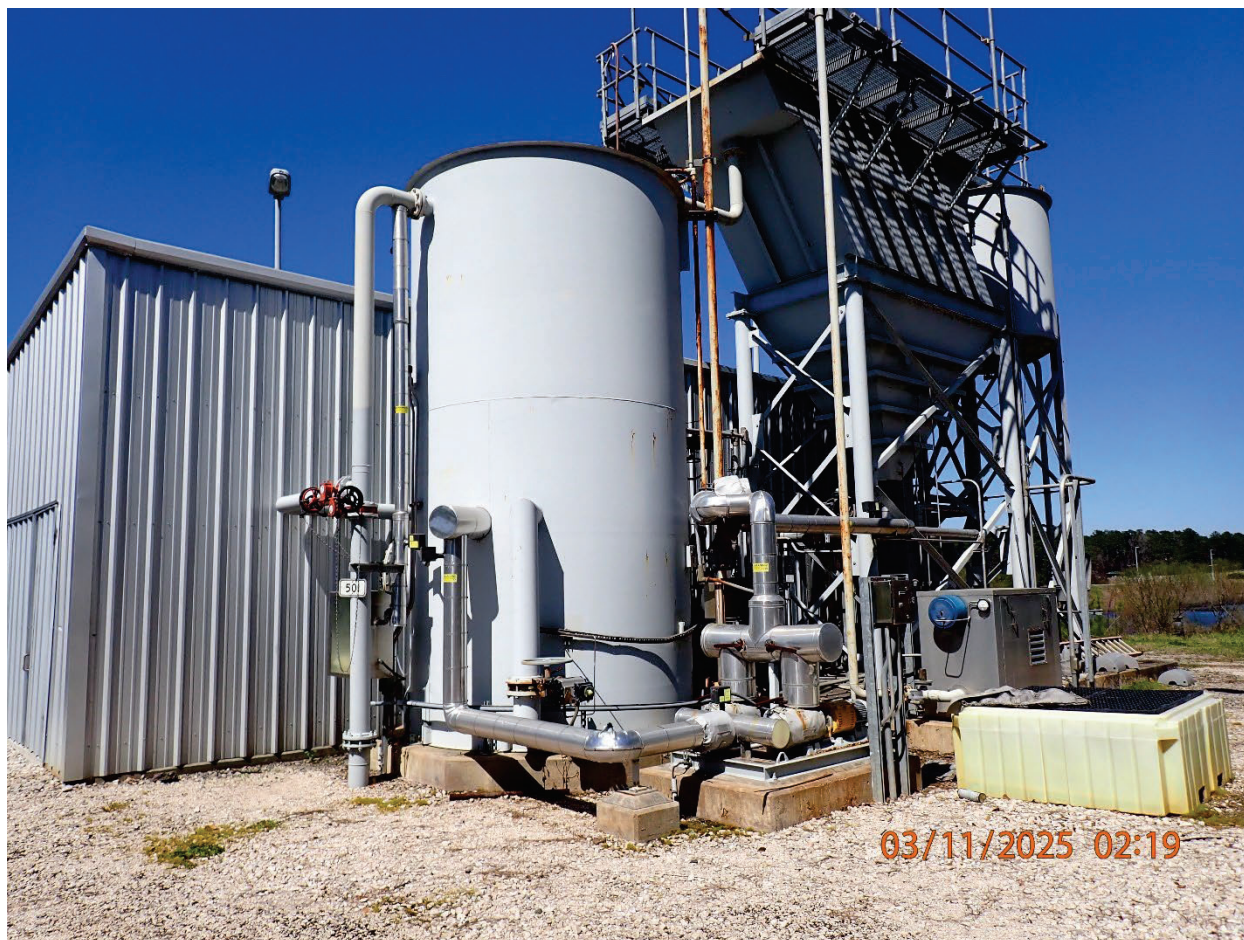
Photo No. 16

This image shows wastewater treatment system to condition and/or remove pollutants to improve water quality at the petcoke/coal and limestone pond.

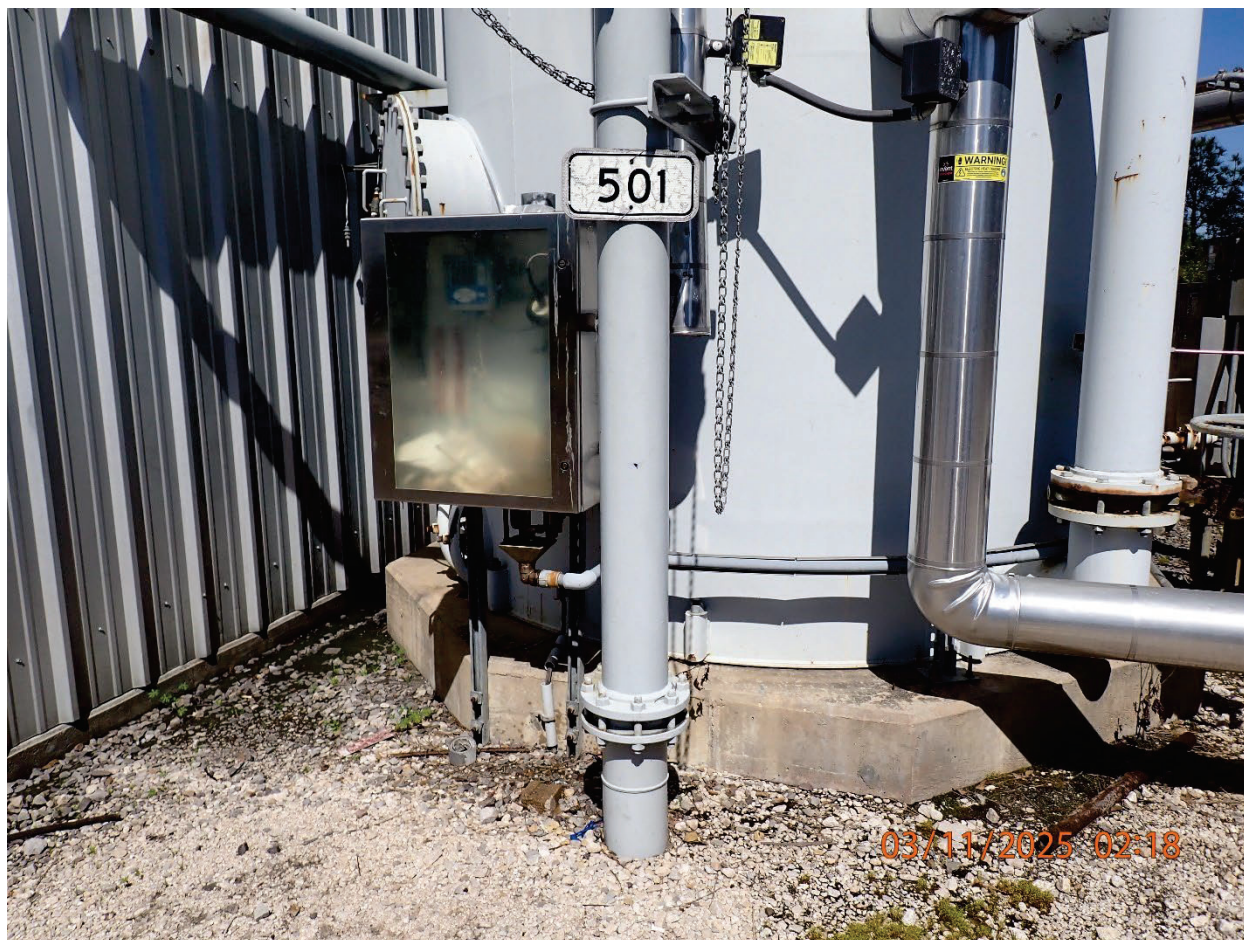
Photo No. 17

Photograph File Name: P3110068.JPG  
Date of Photograph: 03/11/2025  
Latitude & Longitude: 31.400312, -92.724400  
Orientation: SE  
Map Datum: WGS-84  
Time of Photo: 02:18 PM  
Photographer: Jack Arias  
Description: This image shows outfall 501 and wastewater treatment system at the petcoke/coal and limestone pond.

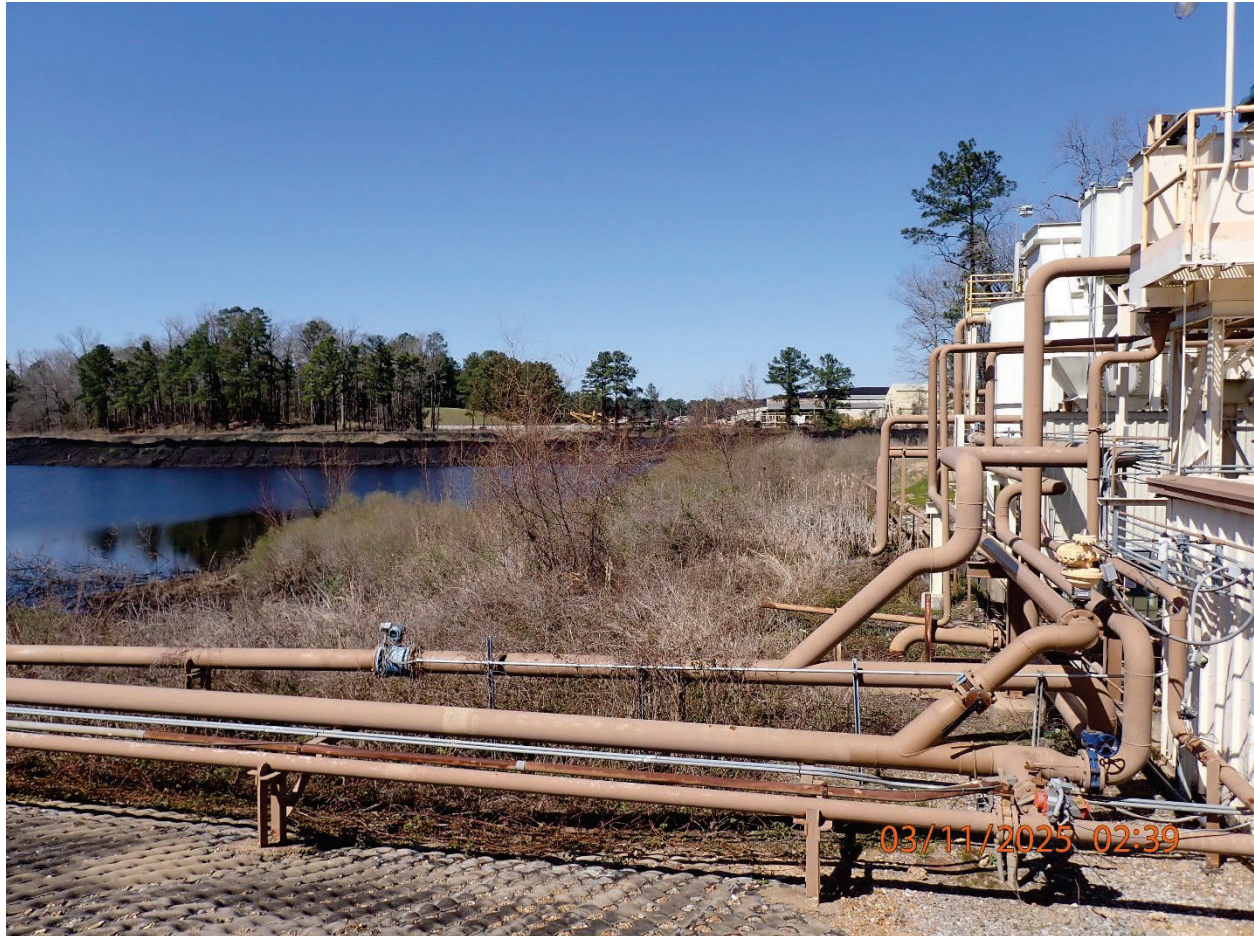
Photo No. 18

- ✚ **Outfall 201** consists of the intermittent discharge of coal sedimentation pond effluent, emergency overflow from the petcoke/coal and limestone pond, storm water runoff, ash loading silo washwater from Unit 3, and miscellaneous wastewaters which include, but are not limited to, fire system test water, eye wash station and safety shower water, steam condensate, and general facility washwater. At the time of the inspection, we did not observe any deficiencies (See Photo Nos. 18 - 19 in Appendix 1).

This image shows the coal sedimentation pond effluent. This is connected to outfall 201 that receive an intermittent discharge of coal sedimentation pond effluent, emergency overflow from the petcoke/coal and limestone pond, storm water runoff, ash loading silo washwater from Unit 3, and miscellaneous wastewaters.
