### INSPECTION REPORT

| Company Name: | Cleco Power, LLC | | |
| Facility Name: | Brame Energy Center | | |
| Identification/Permit Number: | LA0008036 (AI No. 2922) | | |

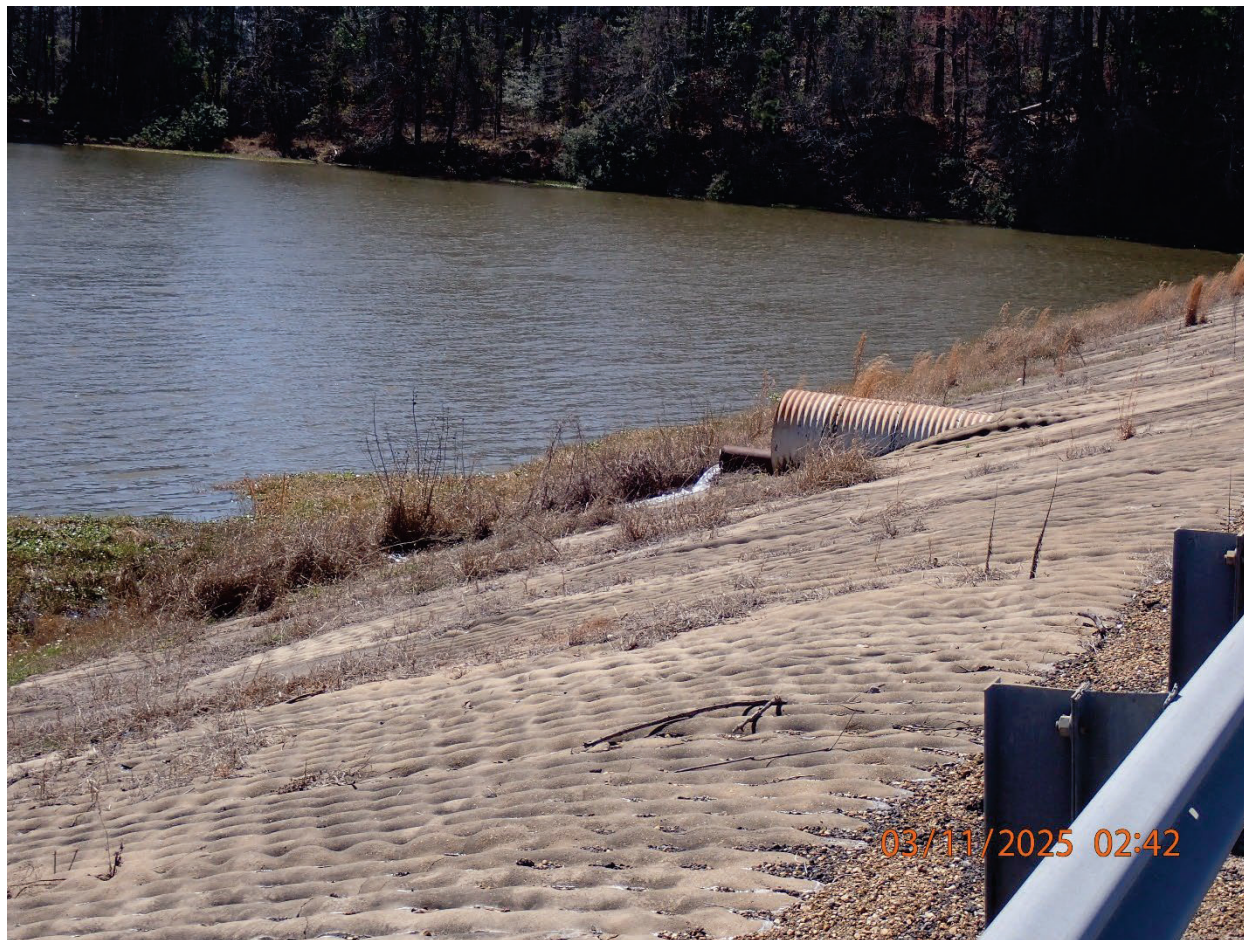
Photo No. 19

Photograph File Name: P3110081.JPG  
Date of Photograph: 03/11/2025  
Latitude & Longitude: 31.394346, -92.722666  
Orientation: S  
Map Datum: WGS-84  
Time of Photo: 02:42 PM  
Photographer: Jack Arias  
Description: This image shows treated wastewater at outfall 201 returning to Lake Rodemacher.

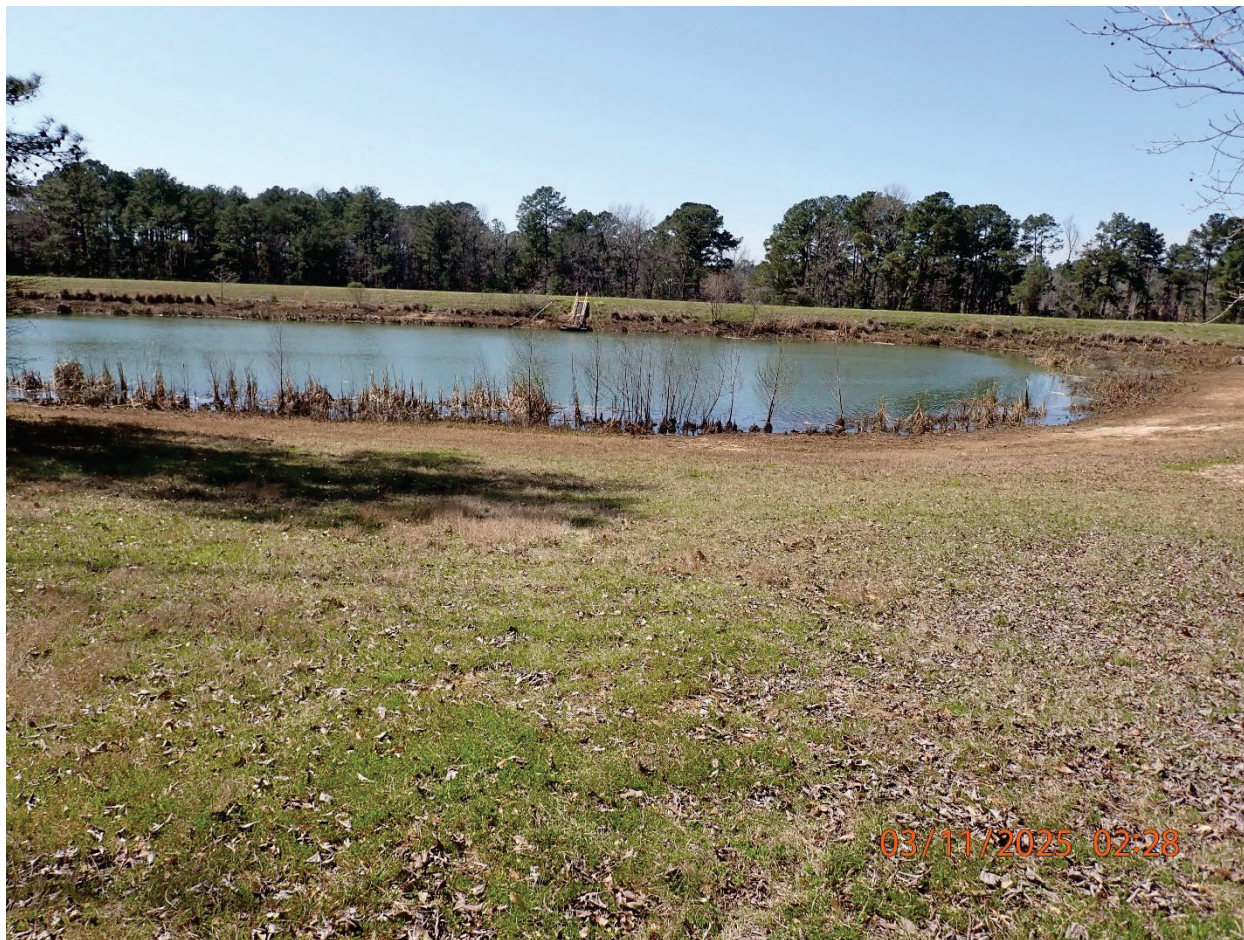
✚ **Outfall 601** consists of the intermittent discharge of chemical and non-chemical metal cleaning wastewater, air heater washwater, boiler cleaning wastewater, and storm water runoff. At the time of the inspection, we did not observe any deficiencies (See Photo No. 20 in Appendix 1).

This image shows the chemical and non-chemical metal cleaning pond and outfall 601. This consists of the intermittent discharge of chemical and non-chemical metal cleaning wastewater, air heater washwater, boiler cleaning wastewater, and storm water runoff.

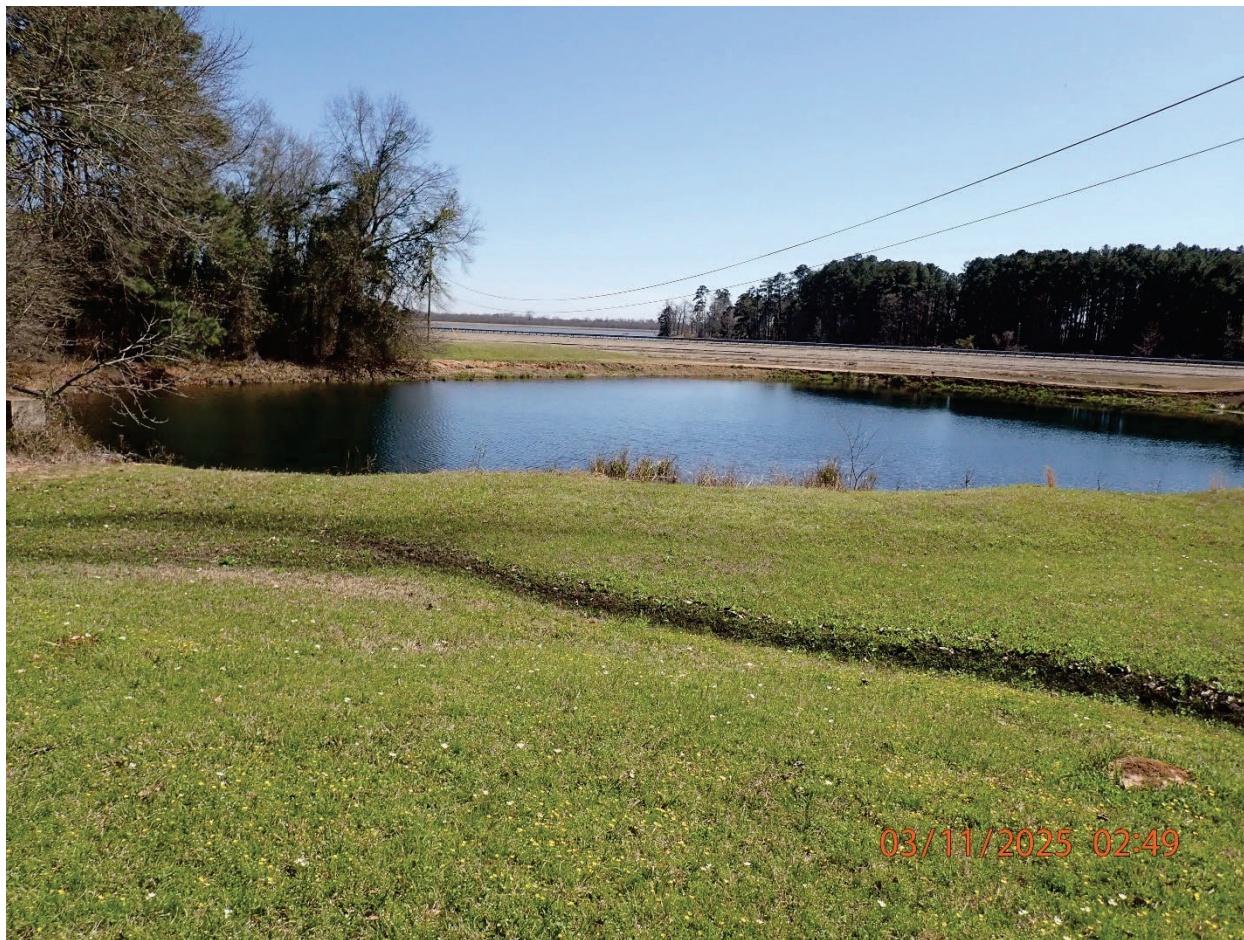
✚ **Outfall 701** consists of the intermittent discharge of clarifier sludge pond effluent, storm water runoff, and miscellaneous wastewaters which include, but are not limited to, fire system test water, eye wash station and safety shower water, steam condensate, and general facility washwater. At the time of the inspection, we did not observe any deficiencies (See Photo No. 21 in Appendix 1).

This image shows the clarifier sludge pond and outfall 701. This consists of the intermittent discharge of clarifier sludge pond effluent, storm water runoff, and miscellaneous wastewaters.

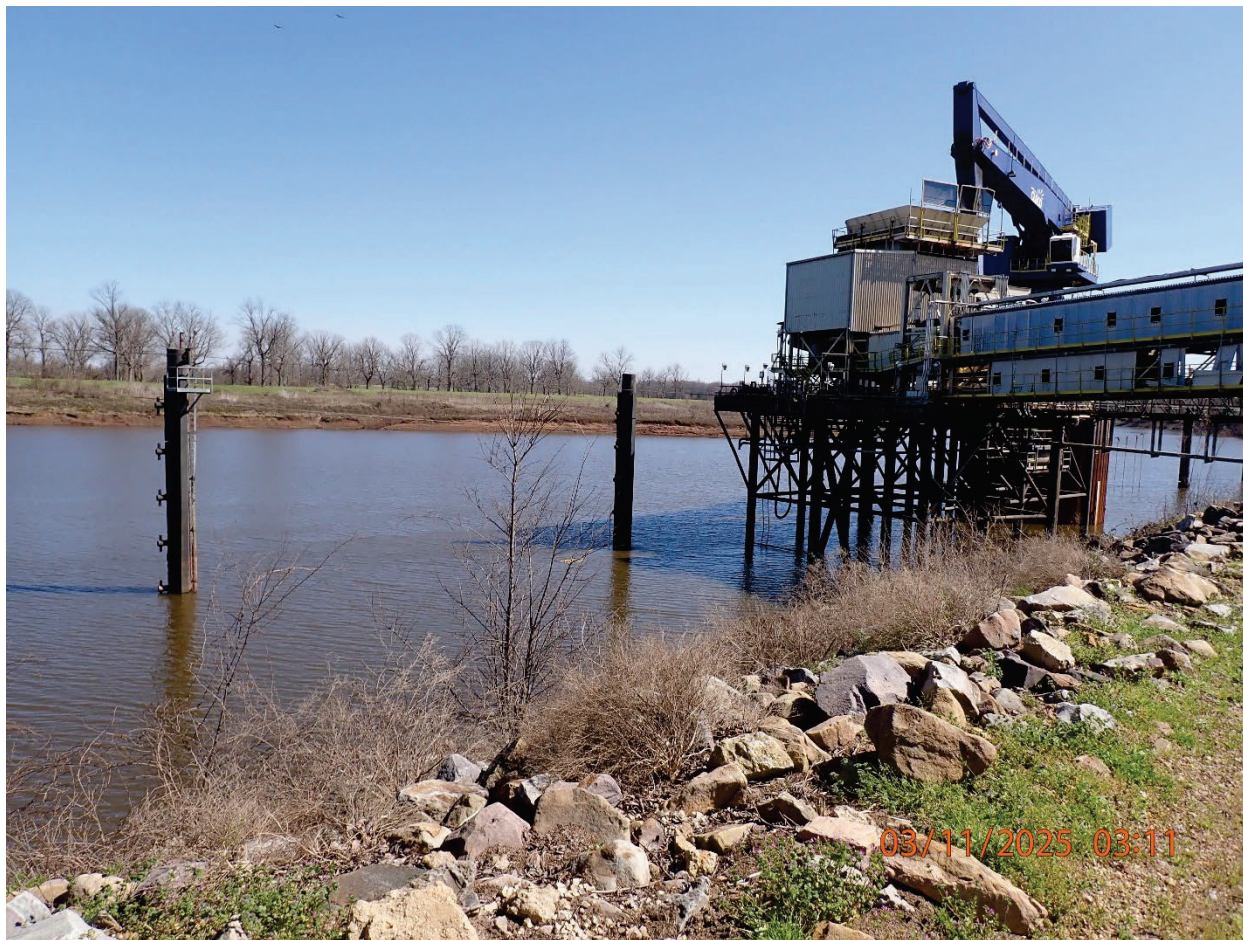
Photo No. 22

2. Petroleum coke (petcoke) is used as the primary fuel source. Facility monitors flow, TSS, and pH effluents “EPA under the CWA, when analyzing petroleum material such as Petco for EPA Clean Water Act (CWA) compliance, the key parameters to measure include Total Petroleum Hydrocarbons (TPH), Oil and Grease, and potentially Adsorbable Organic relevant to the specific CWA permit”.

Photograph File Name: P3110087.JPG  
Date of Photograph: 03/11/2025  
Latitude & Longitude: 31.405504, -92.698031  
Orientation: W  
Map Datum: WGS-84  
Time of Photo: 03:09 PM  
Photographer: Jack Arias  
Description: This image shows the collection area for Petroleum coke (petcoke) material. This is used as the primary fuel source at the facility.

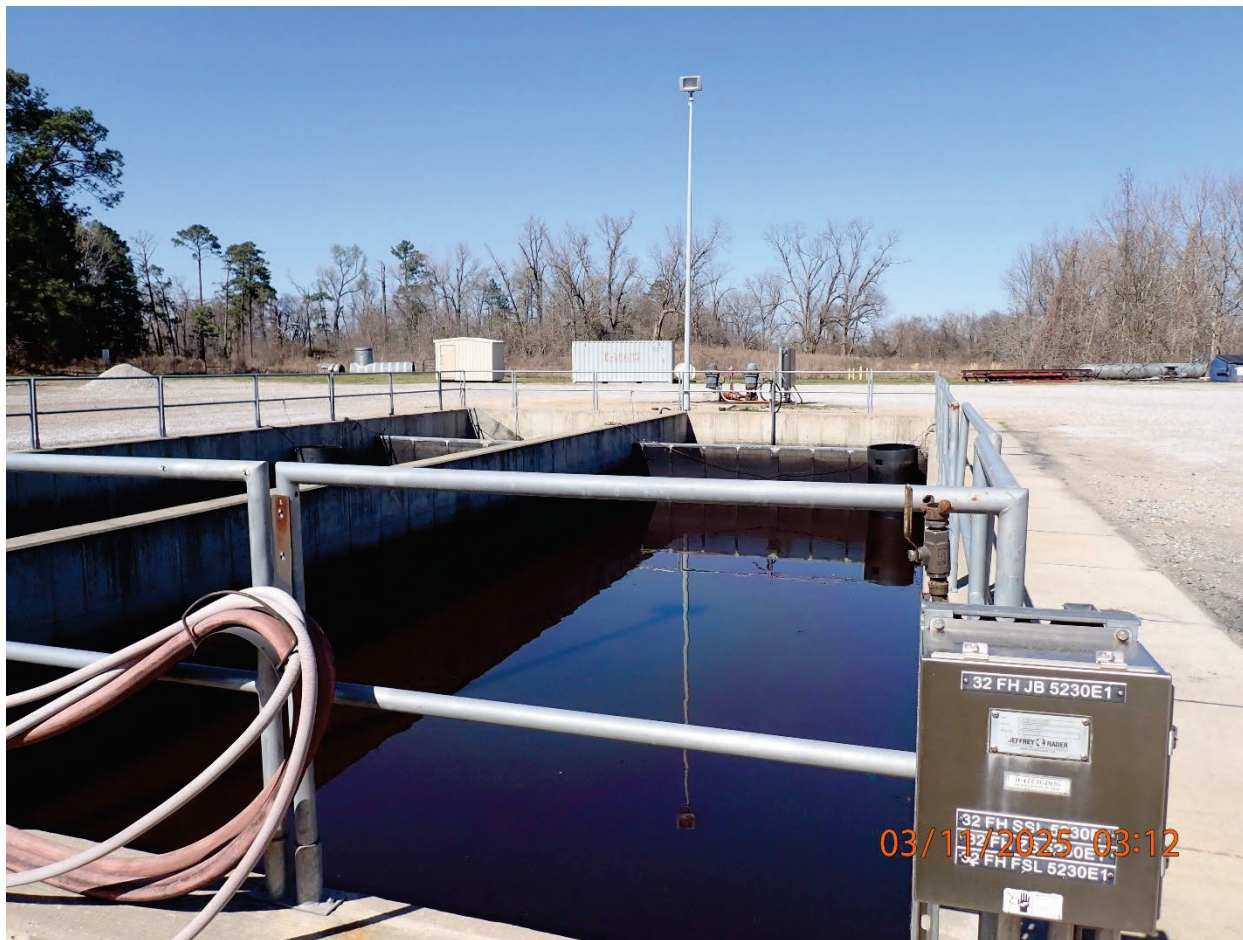
Photo No. 23

Photograph File Name: P3110090.JPG  
Date of Photograph: 03/11/2025  
Latitude & Longitude: 31.405757, -92.698589  
Orientation: W  
Map Datum: WGS-84  
Time of Photo: 03:12 PM  
Photographer: Jack Arias  
Description: This image shows the treatment area for Petroleum coke (petcoke) material.
