## Clean Water Act Section 404: Site Visit/Case Development

| Site Name | Hartz Mountian Industries, Inc. Mori Warehouse Site | | | | |

## Clean Water Act Section 404 Inspection September 14, 2023

EPA CWA 404 Inspection Photolog  
Hartz Mountain Industries  
Mori Tract, Secaucus, NJ

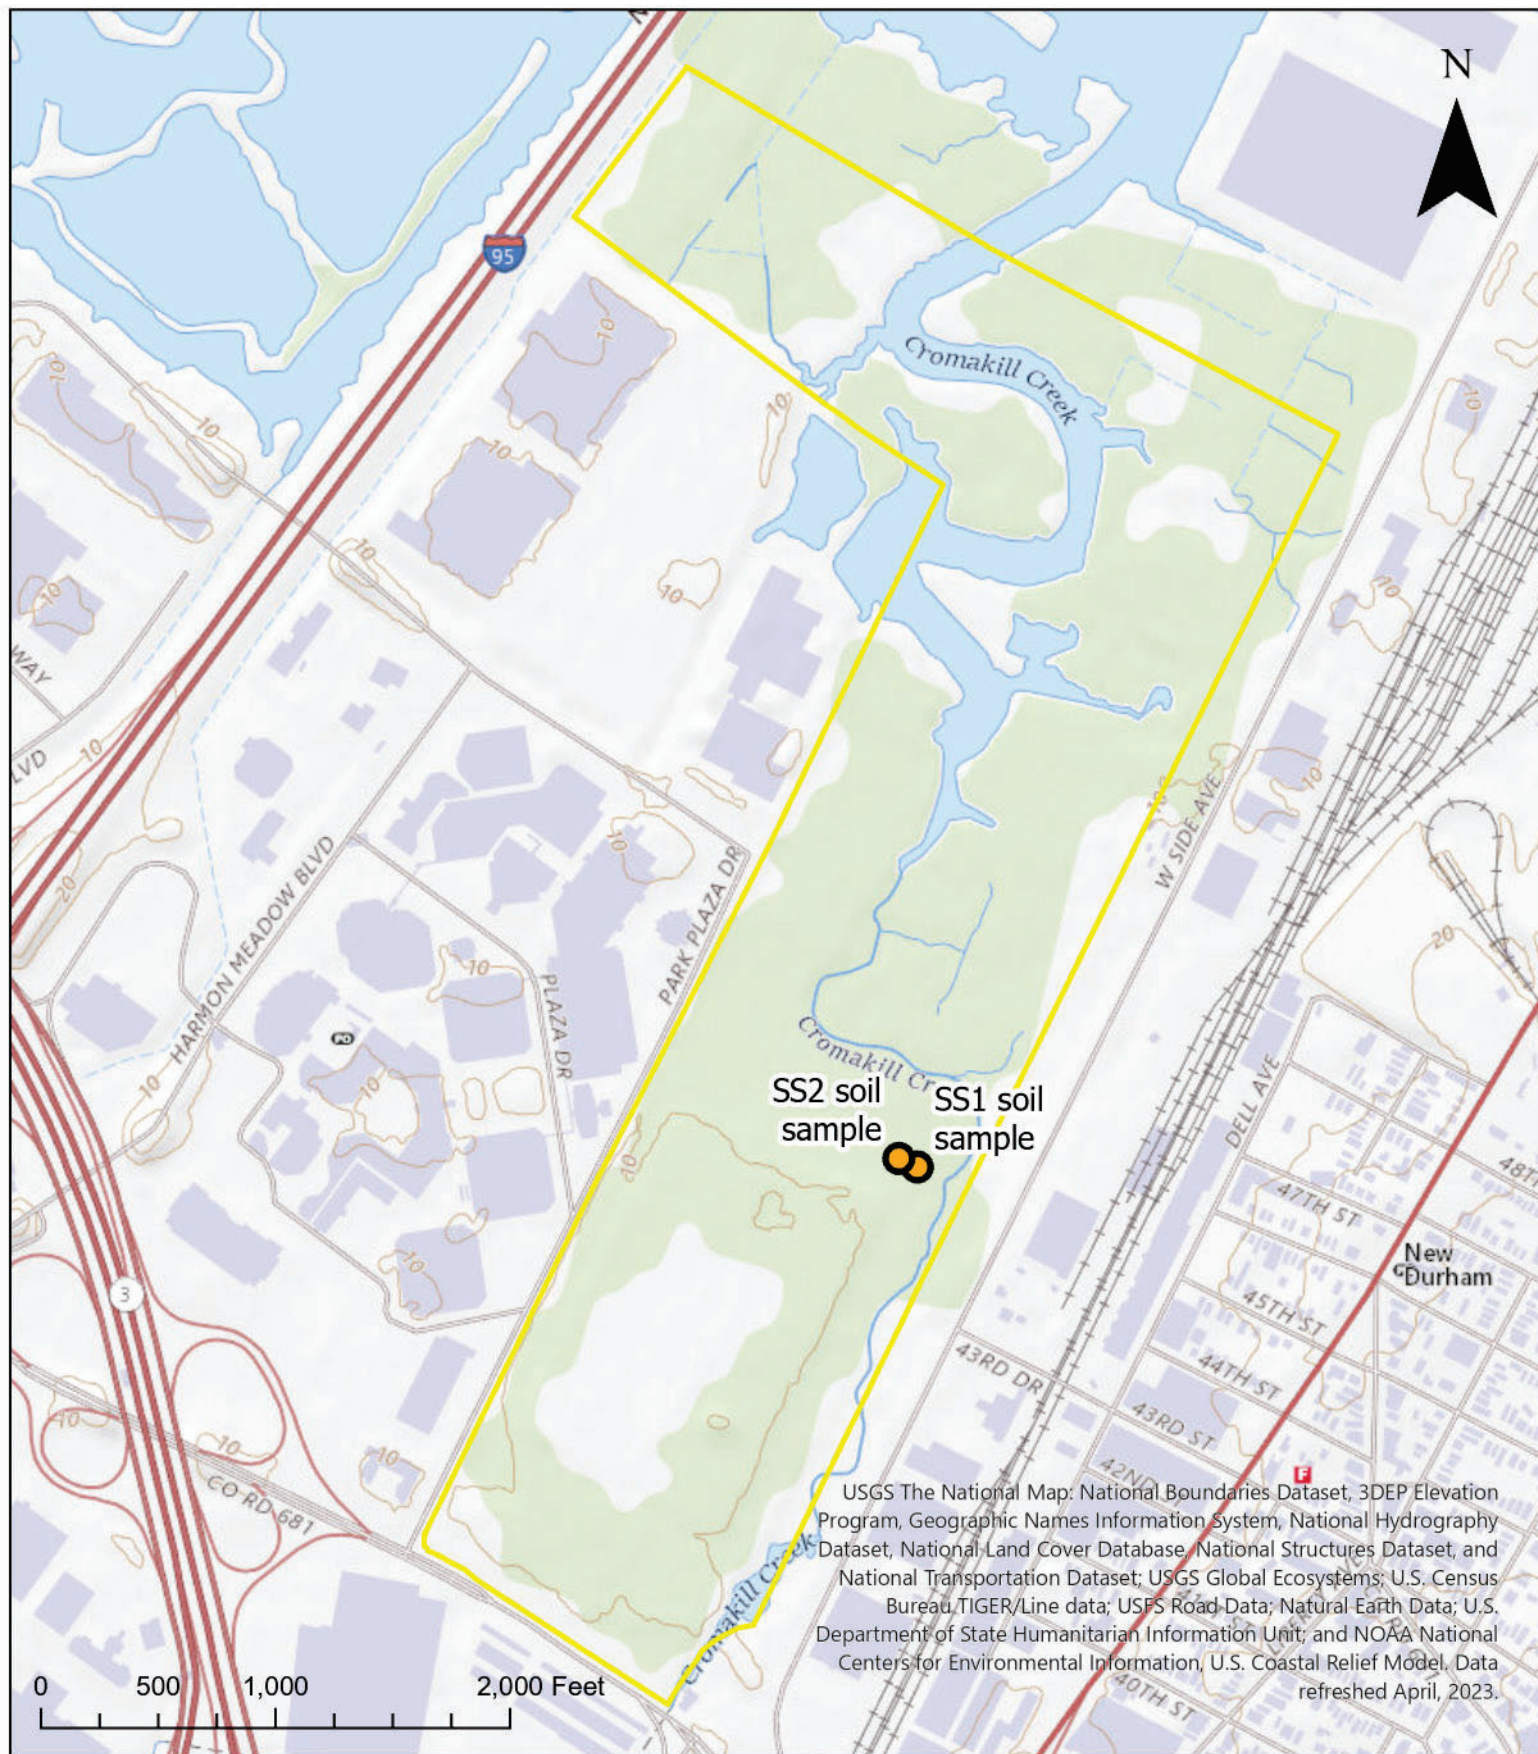
Hartz Mountain Industries Property, Mori Tract  
Secaucus, NY  
(40.78618, -74.03903)

- 9/14/23 EPA GPS Point
- Site Boundary

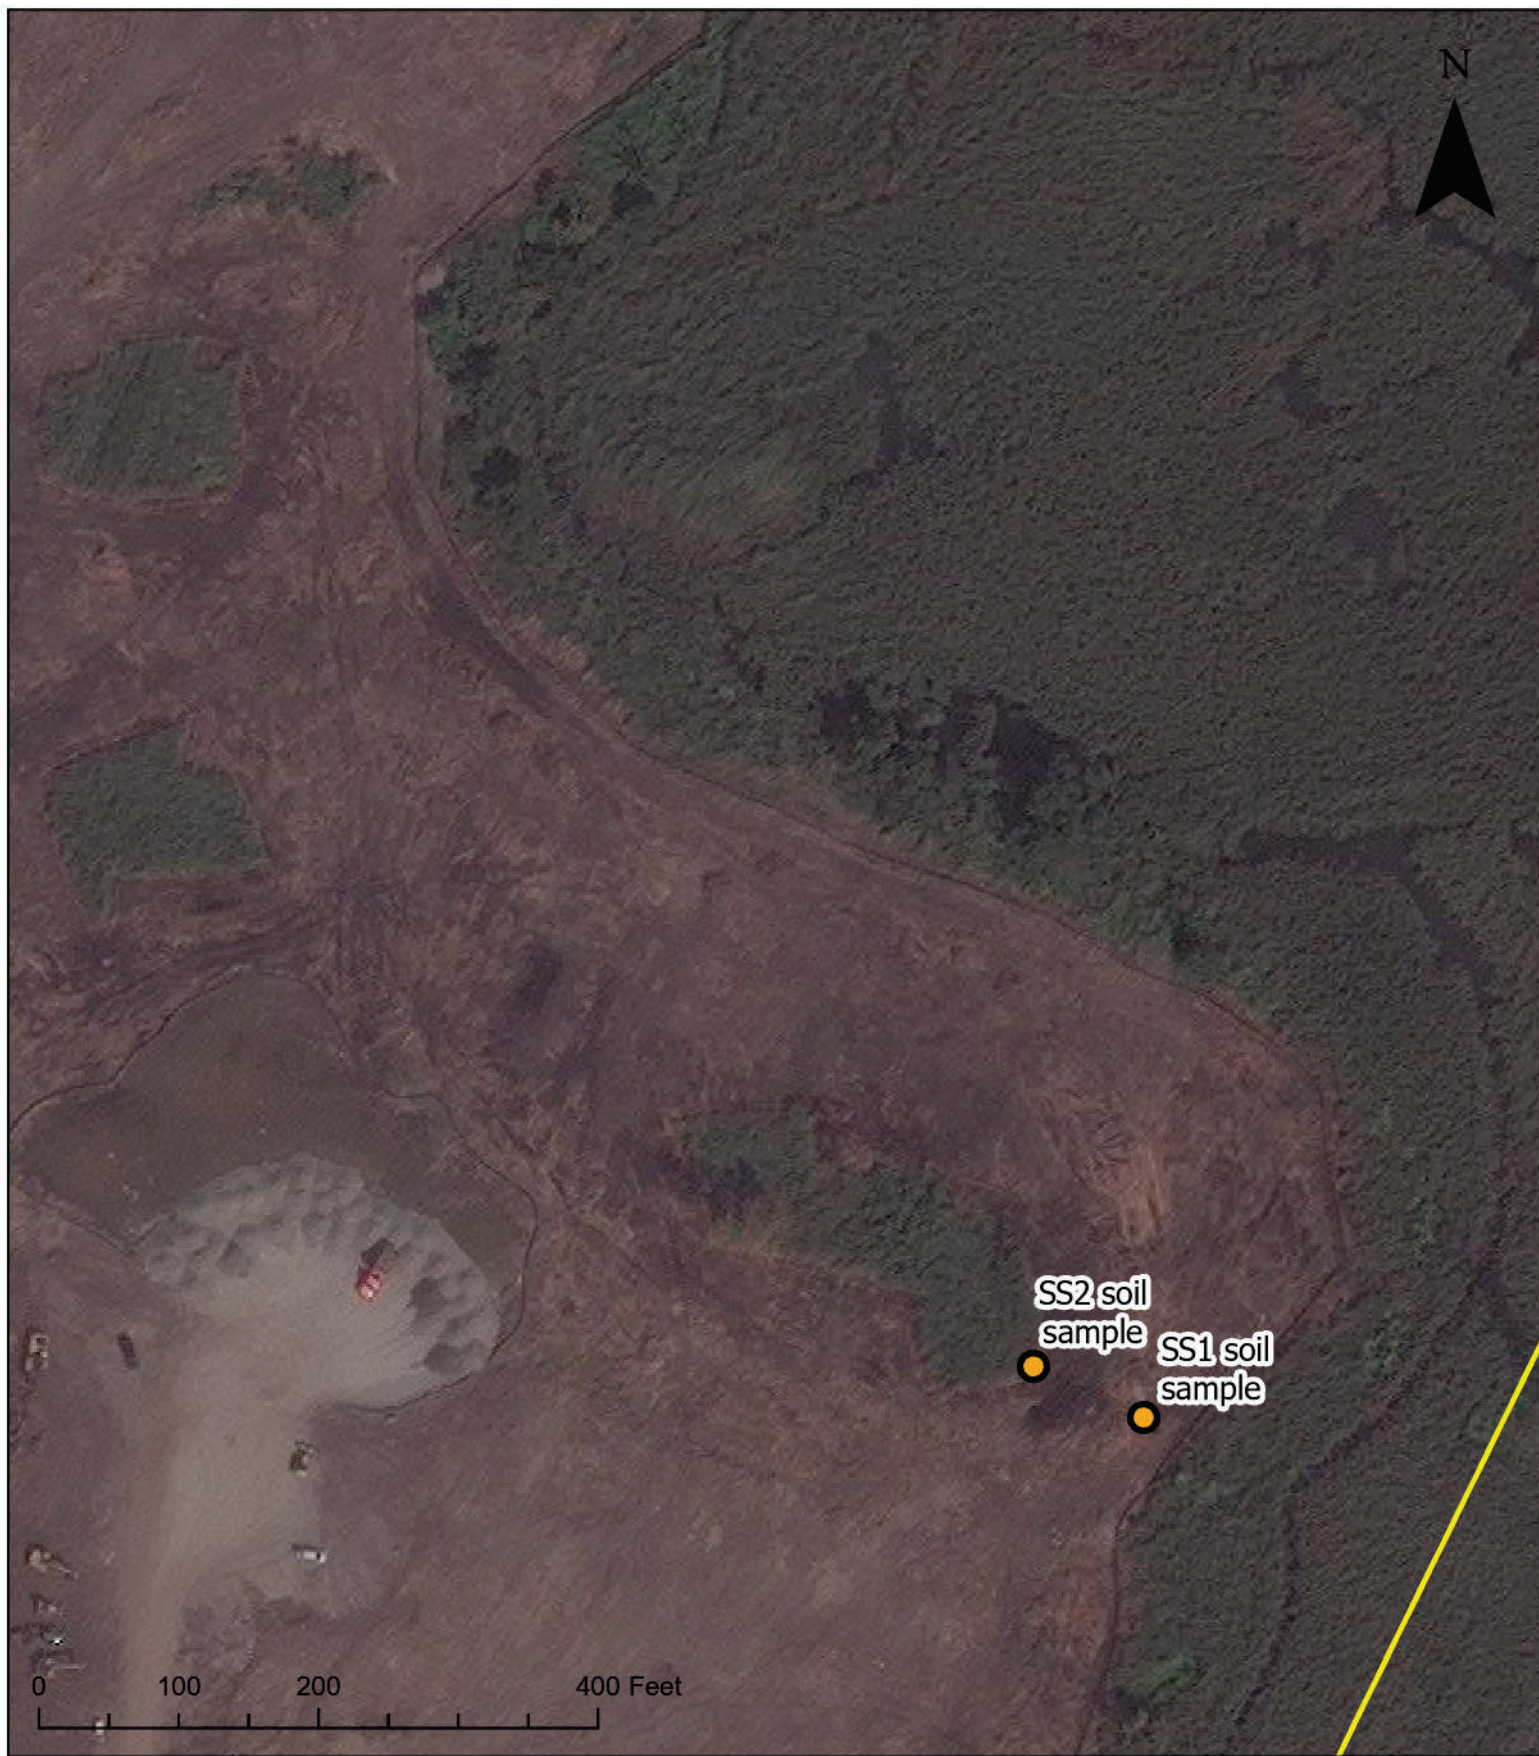
**Clean Water Act Section 404 Inspection  
September 14, 2023**

Hartz Mountain Industries Property, Mori Tract  
Secaucus, NY  
(40.78618, -74.03903)

Parcel Boundary
-

9/14/23 EPA GPS Point

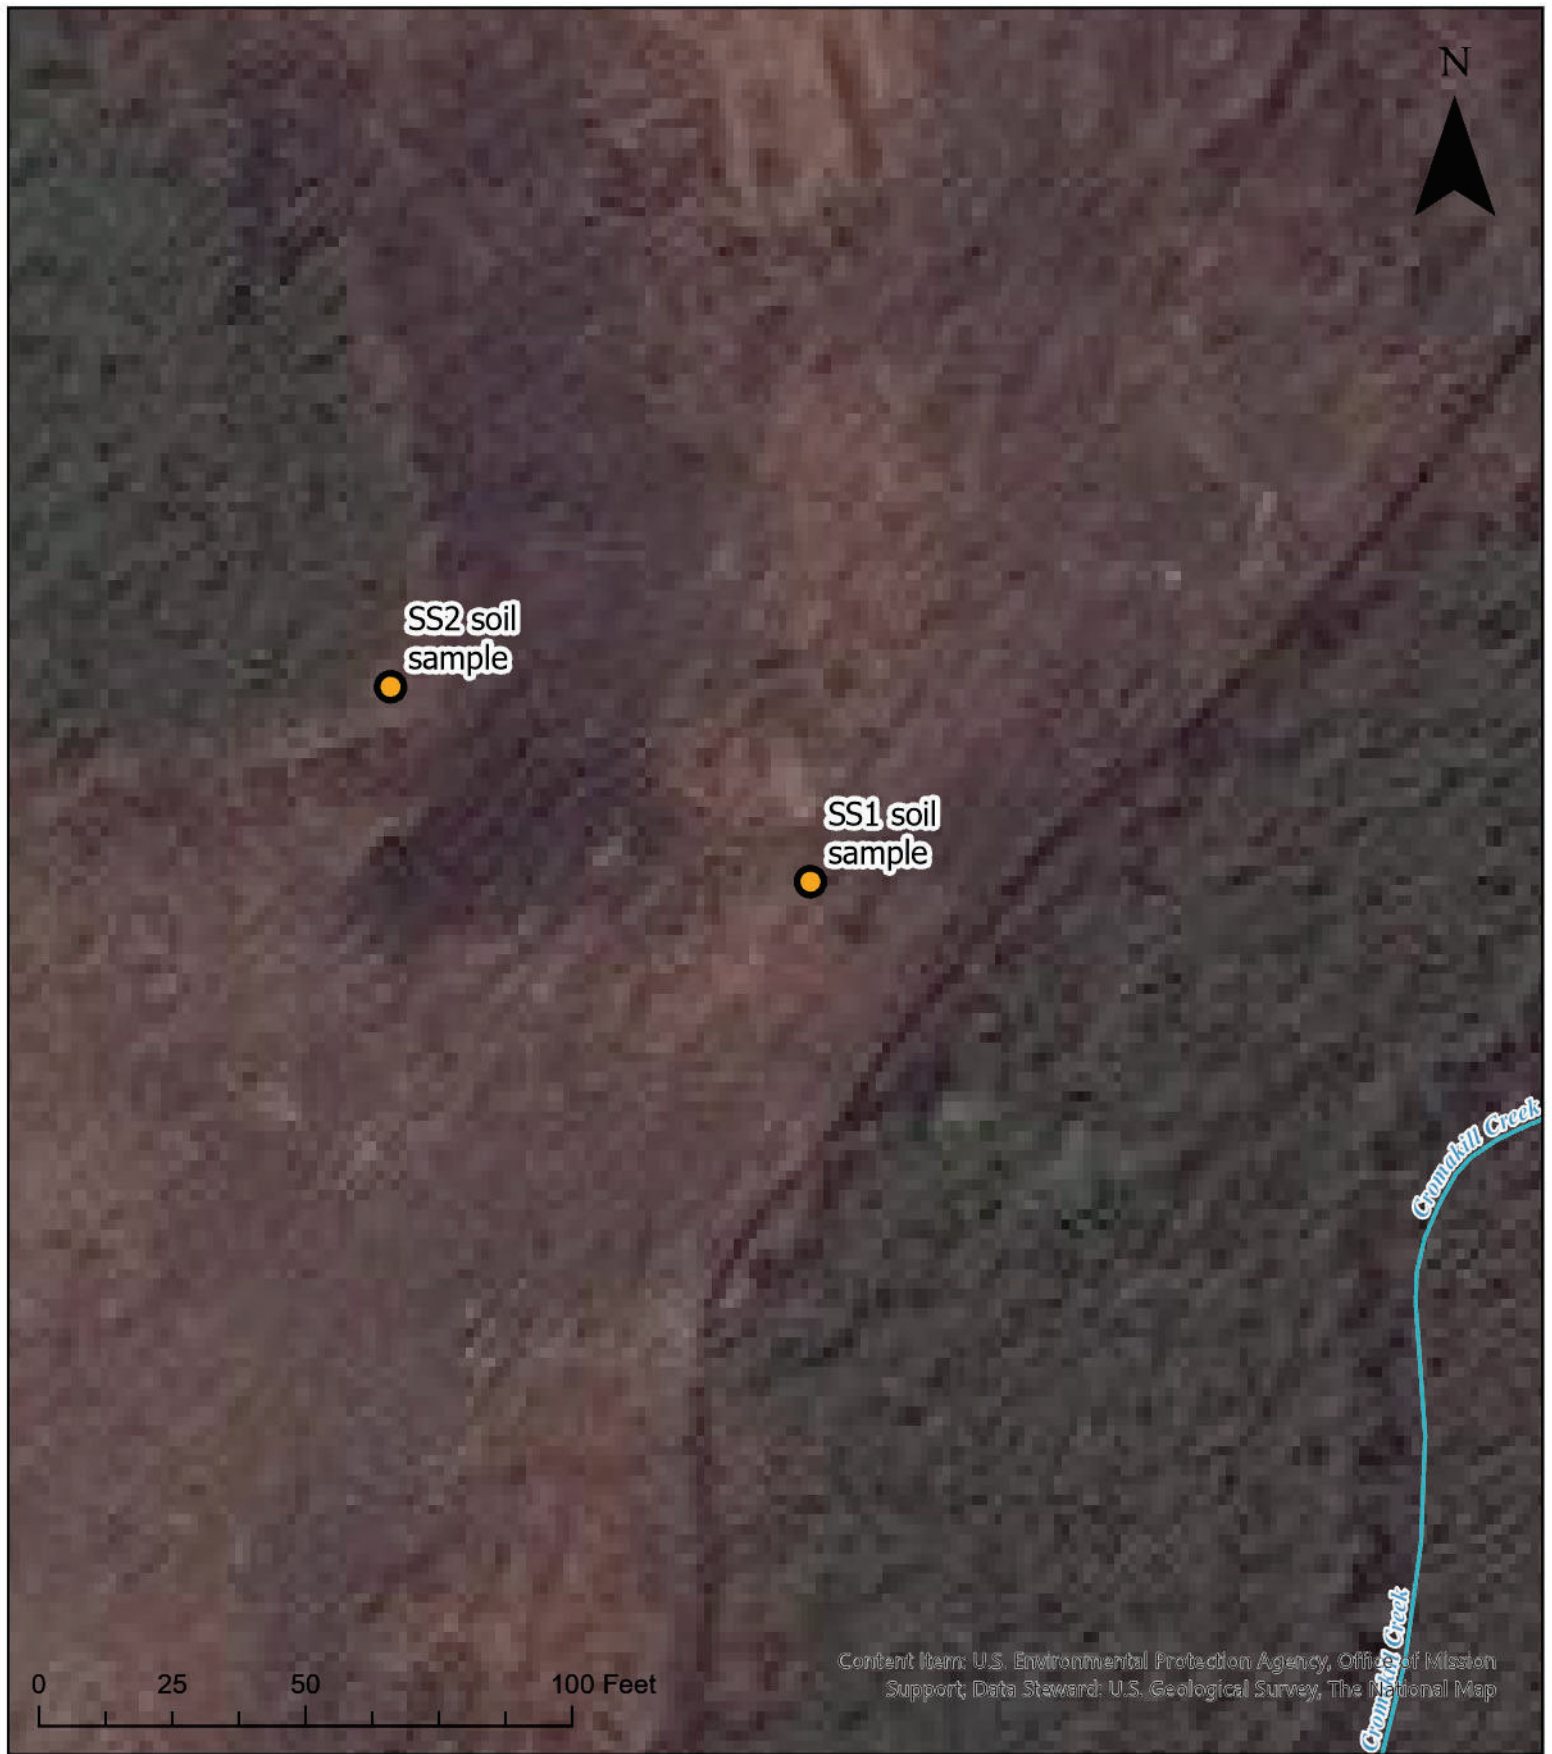
**Clean Water Act Section 404 Inspection  
September 14, 2023**

Hartz Mountain Industries Property, Mori Tract  
Secaucus, NY  
(40.78618, -74.03903)

Parcel Boundary
-

9/14/23 EPA GPS Point

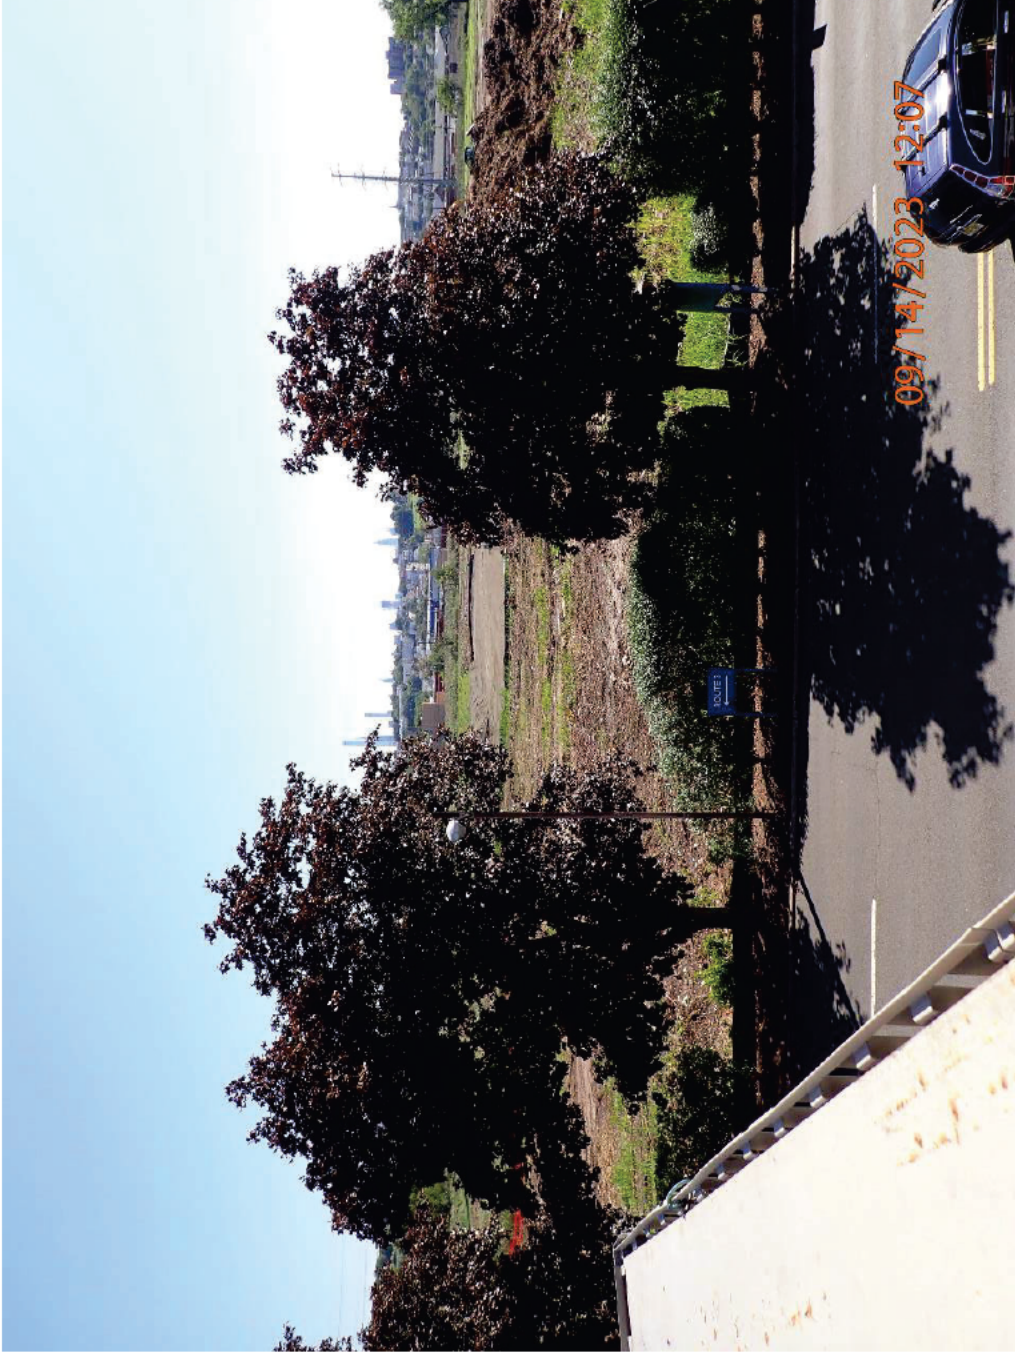
**Date:** 9/14/2023  
**Time:** 12:07 PM  
**Photographer:** S. Andreescu  
**Photo ID:** 1 – P9140204

(1/2) Photo taken from roof of parking garage of Mori Tract

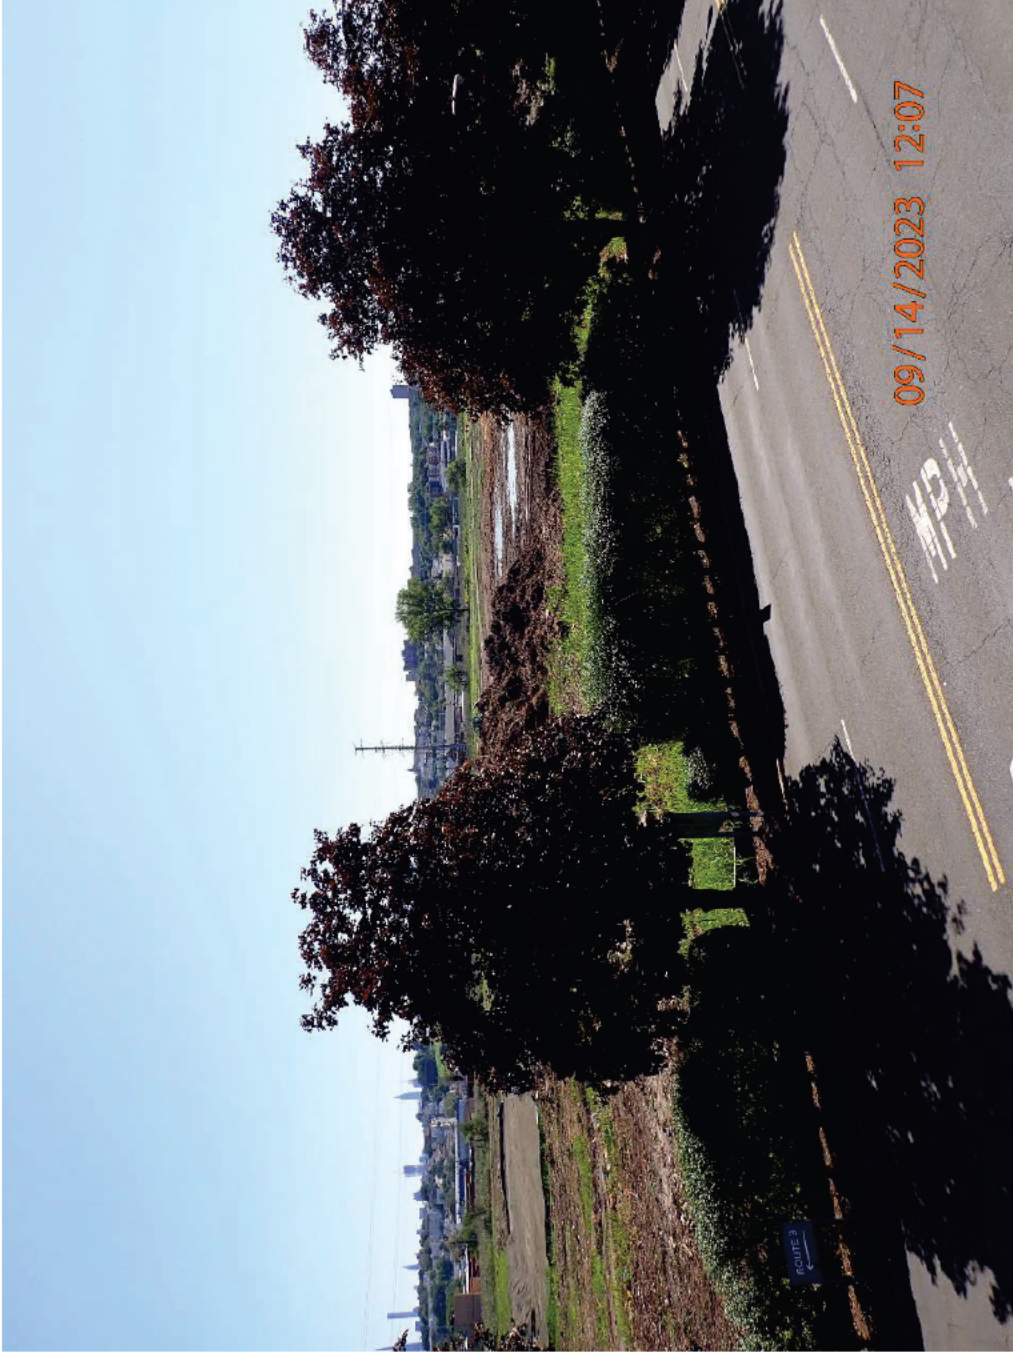
**Date:** 9/14/2023  
**Time:** 12:07 PM  
**Photographer:** S. Andreescu  
**Photo ID:** 2 – P9140205

(2/2) Photo taken from roof of parking garage of Mori Tract

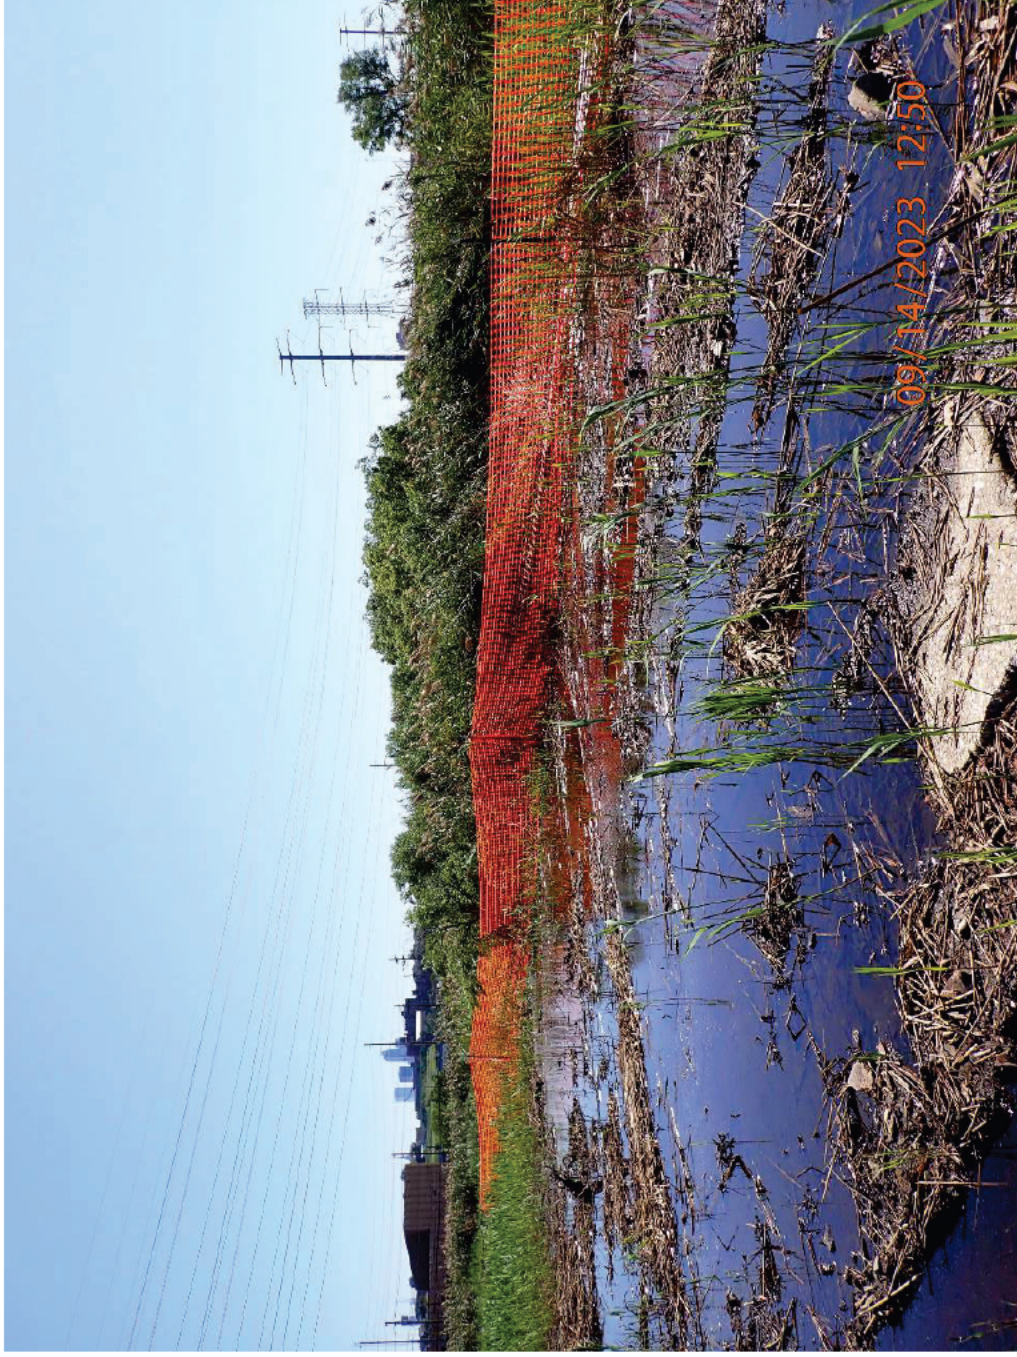
**Date:** 9/14/2023  
**Time:** 12:50 PM  
**Photographer:** S. Andreescu  
**Photo ID:** 3 – P9140206

(1/3) Panorama of wetlands “C”  
and “D” delineated by Hartz  
Mountain

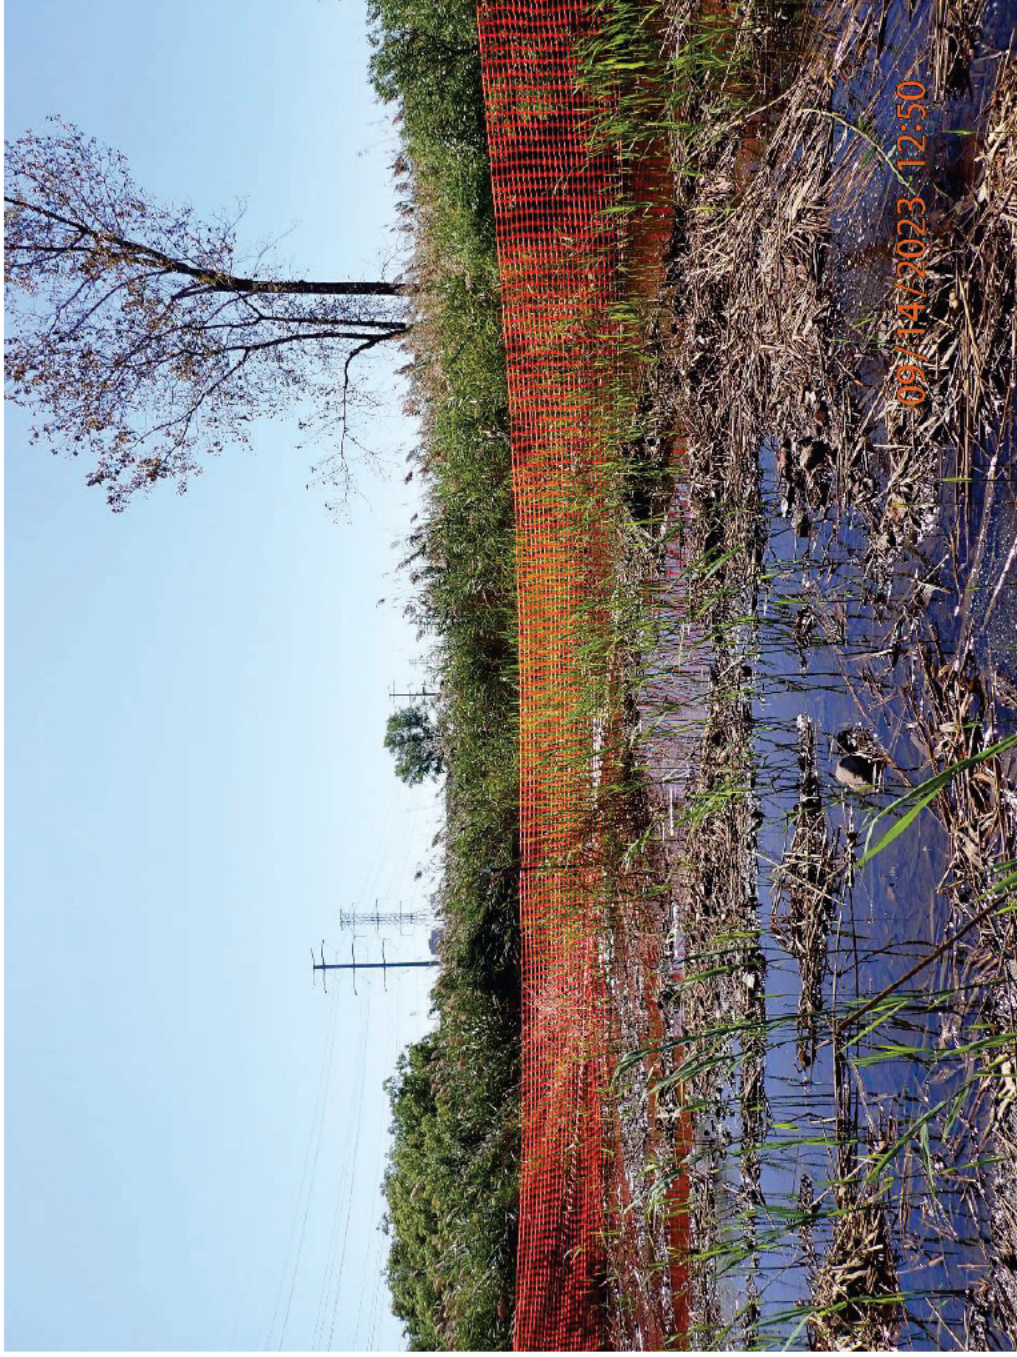
**Date:** 9/14/2023  
**Time:** 12:50 PM  
**Photographer:** S. Andreescu  
**Photo ID:** 4 – P9140207  
**Description:**  
(2/3) Panorama of wetlands “C”  
and “D” delineated by Hartz  
Mountain

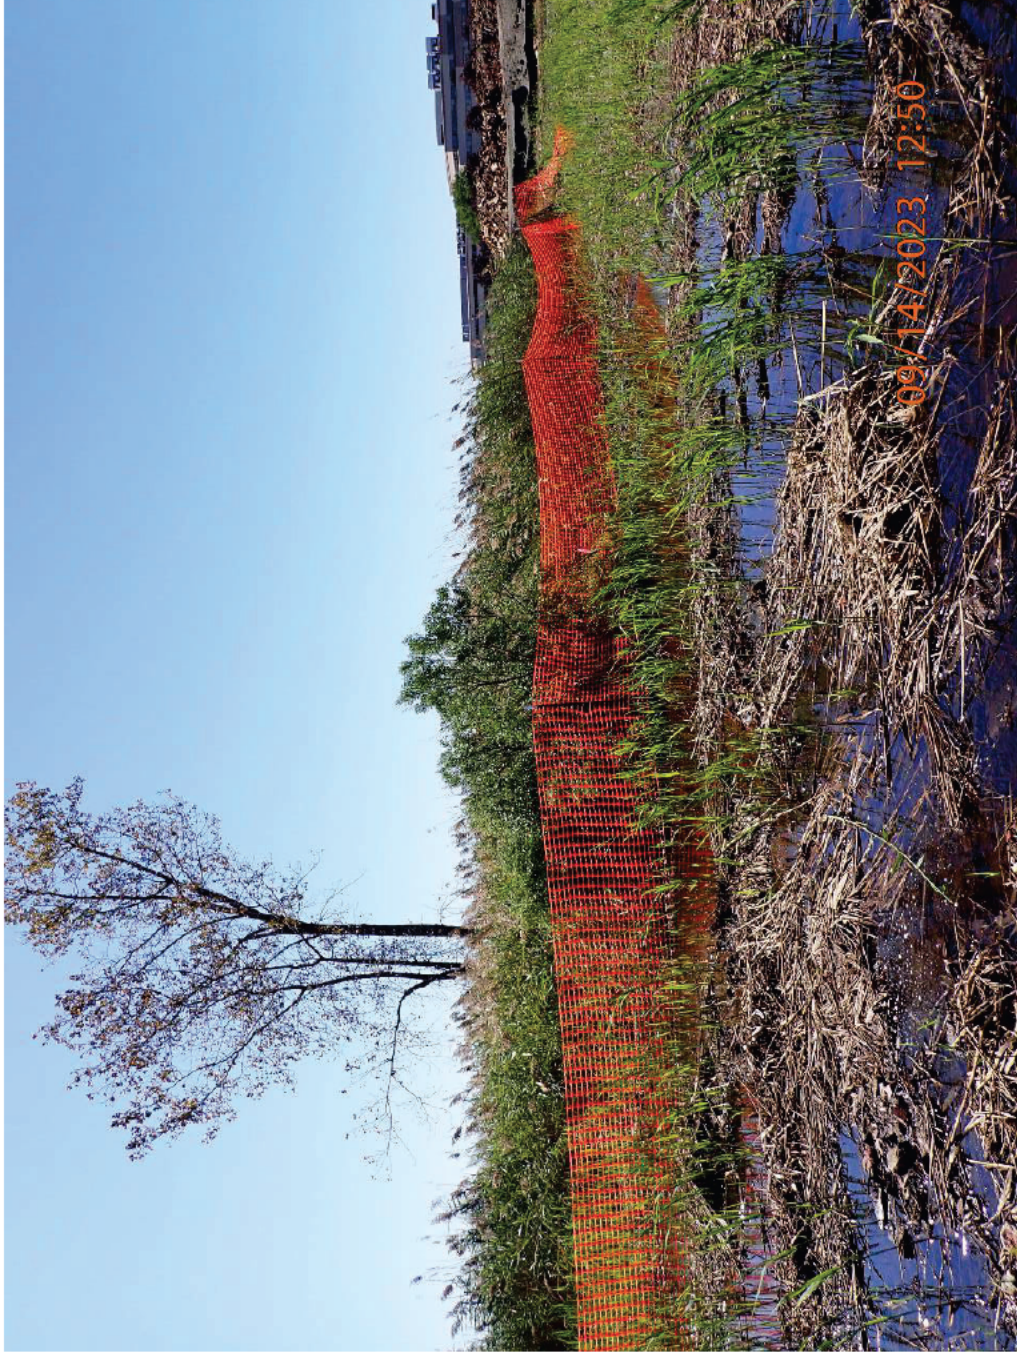
**Date:** 9/14/2023  
**Time:** 12:50 PM  
**Photographer:** S. Andreescu  
**Photo ID:** 5 – P9140208  
**Description:**  
(3/3) Panorama of wetlands “C”  
and “D” delineated by Hartz  
Mountain

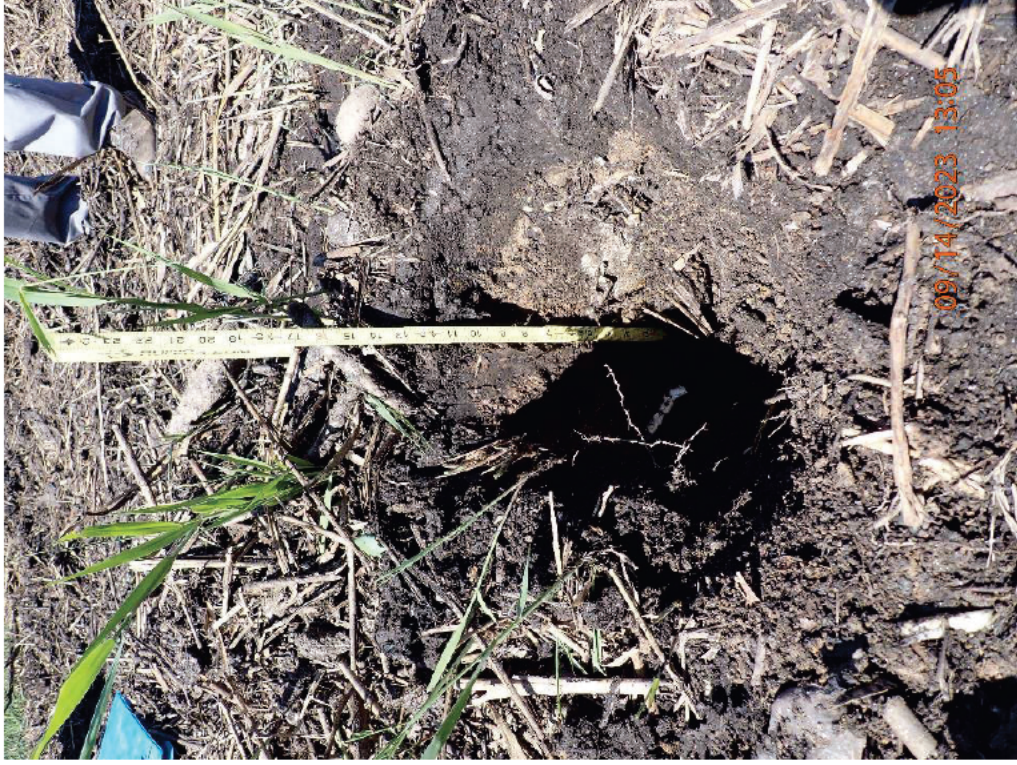
**Date:** 9/14/2023  
**Time:** 1:05 PM  
**Photographer:** S. Andreescu  
**Photo ID:** 6 – P9140209  
**Description:**  
Soil Sample Location #1 (SS1)

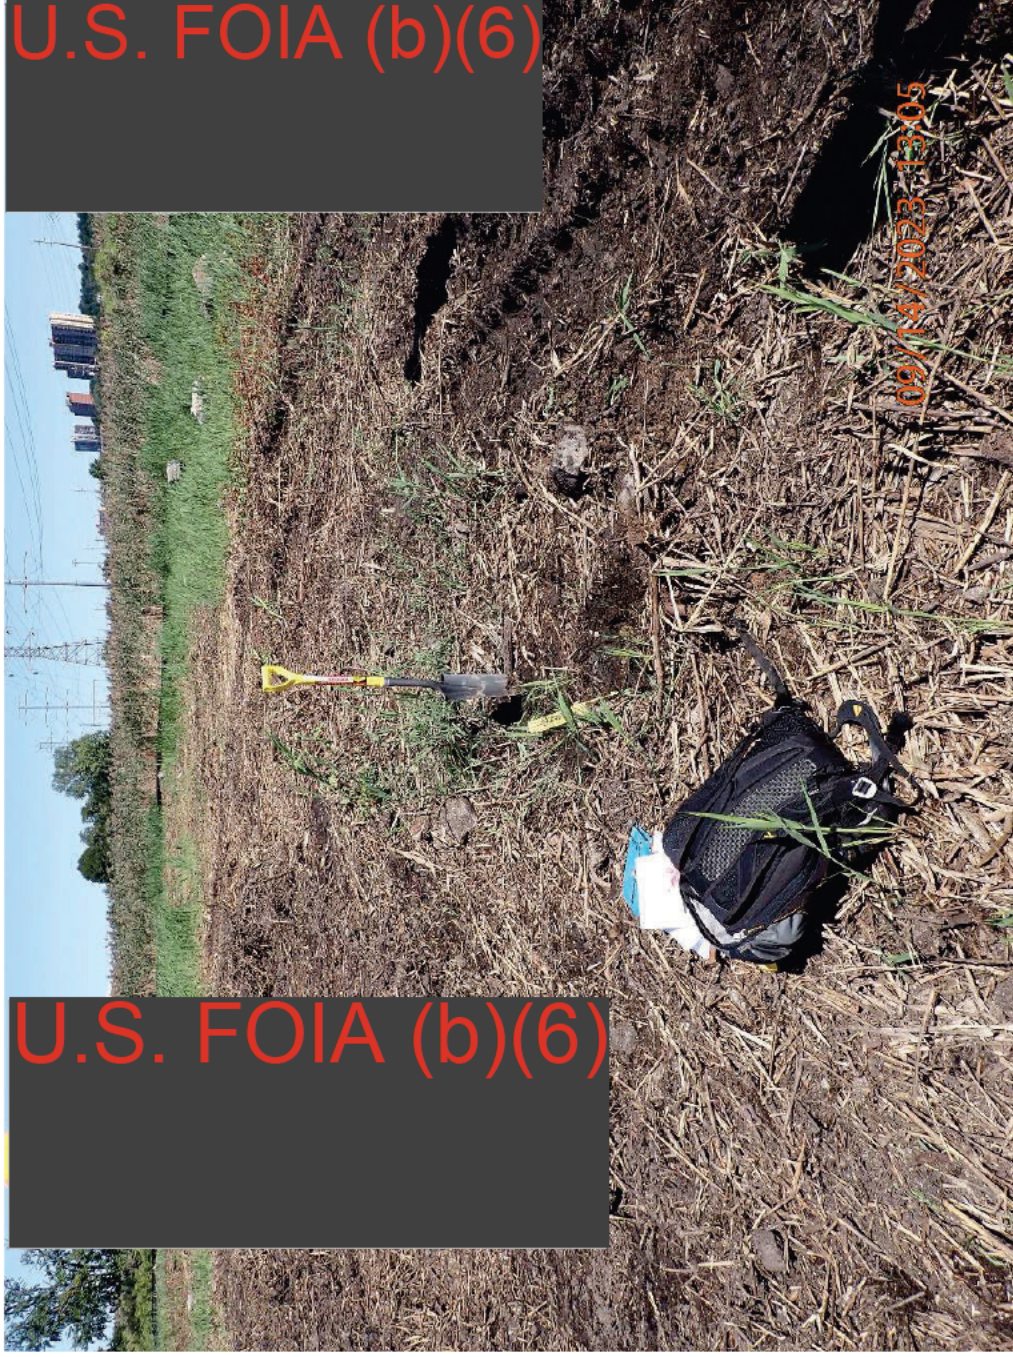
**Date:** 9/14/2023  
**Time:** 1:05 PM  
**Photographer:** S. Andreescu  
**Photo ID:** 7 – P9140210

Soil Sample Location #1 (SS1)  
and surrounding area

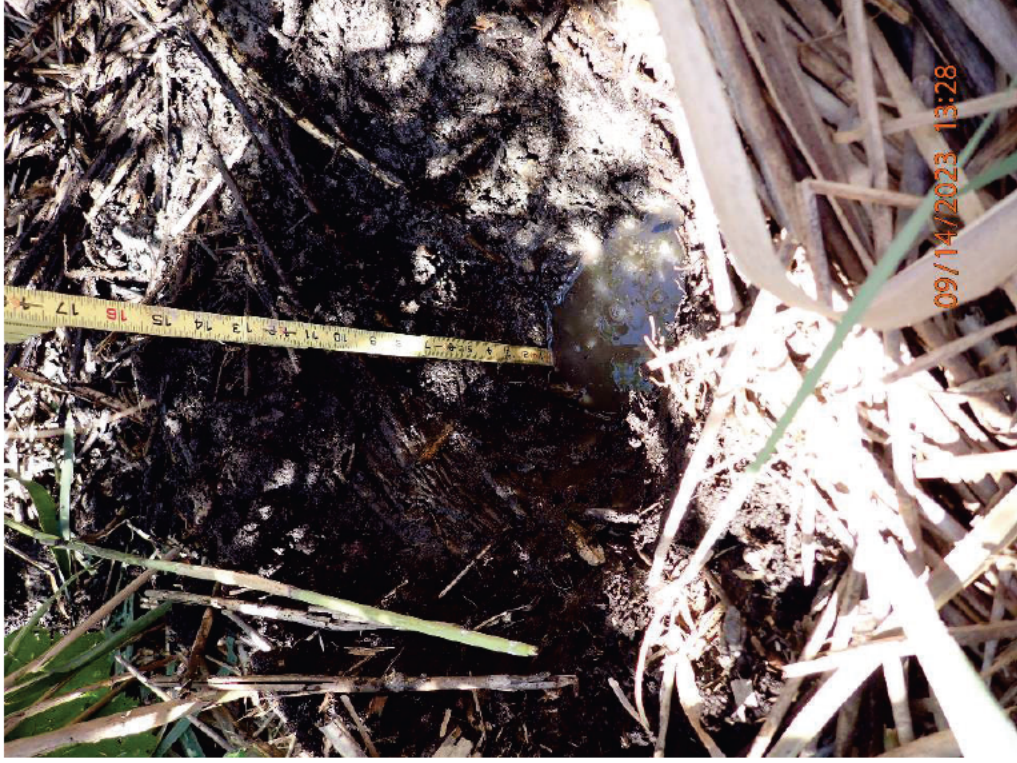
**Date:** 9/14/2023  
**Time:** 1:28 PM  
**Photographer:** S. Andreescu  
**Photo ID:** 8 – P9140211  
**Description:**  
Soil Sample Location #2 (SS2)

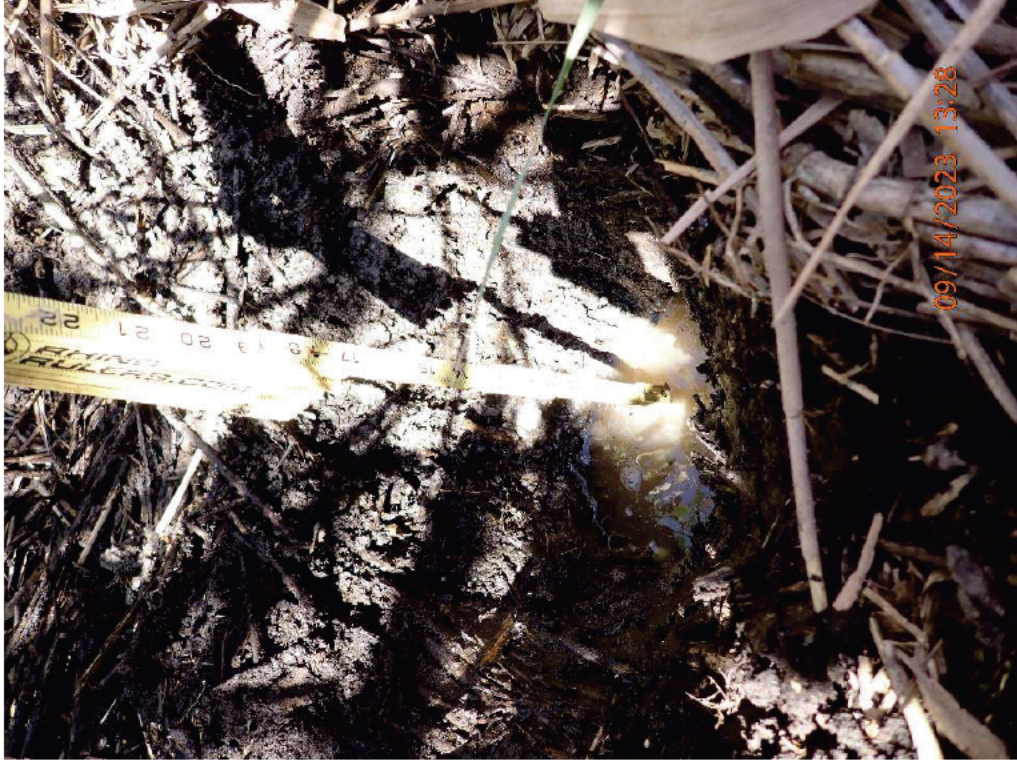
**Date:** 9/14/2023  
**Time:** 1:28 PM  
**Photographer:** S. Andreescu  
**Photo ID:** 9 – P9140212  
**Description:**  
Soil Sample Location #2 (SS2)

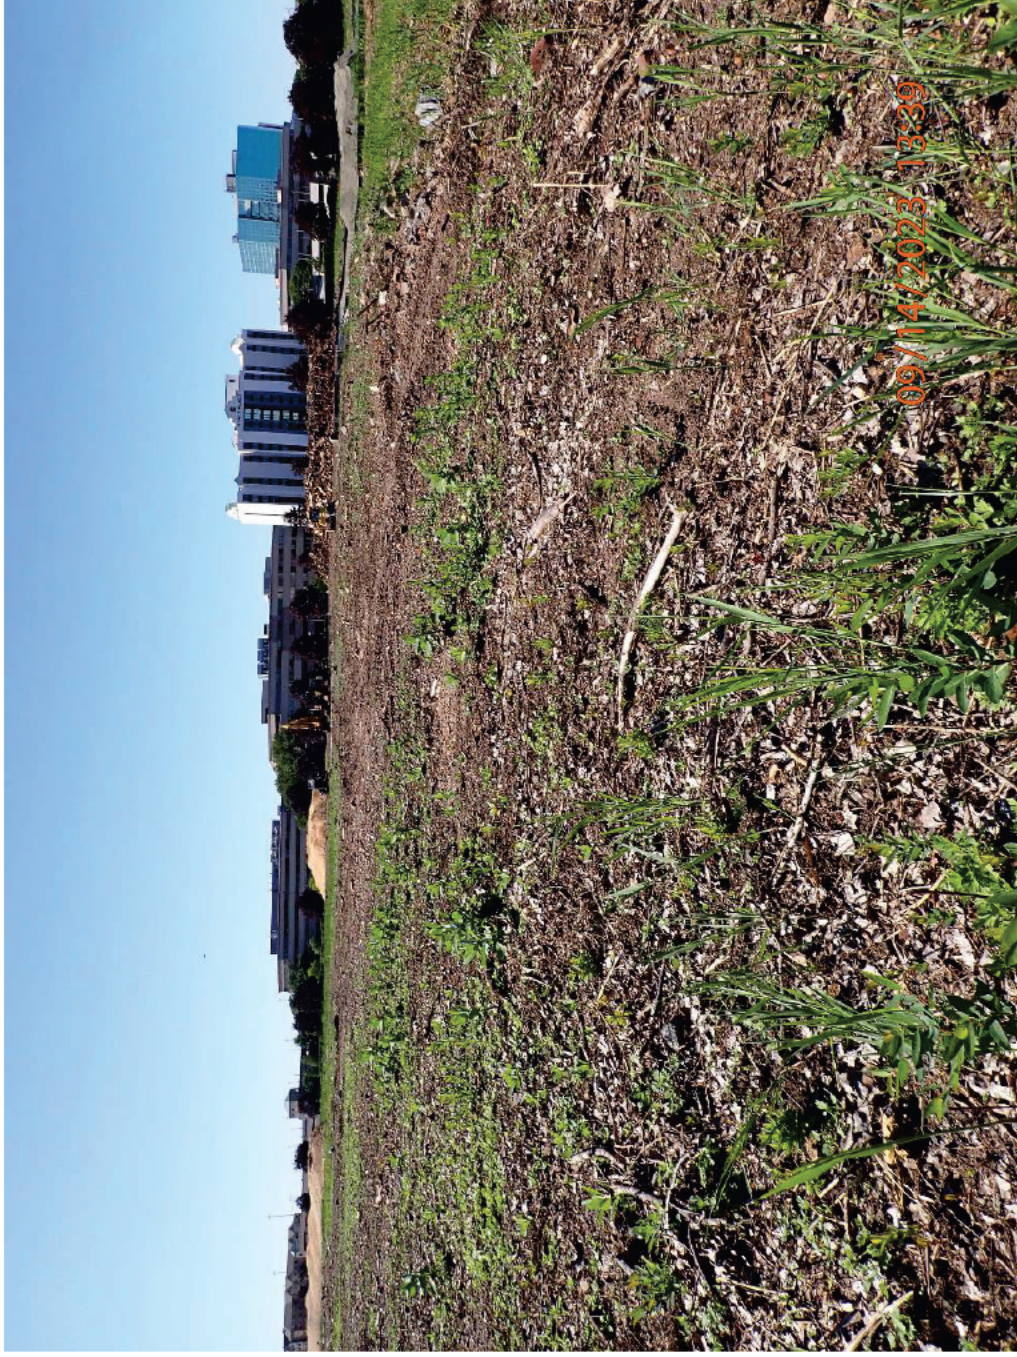
**Date:** 9/14/2023  
**Time:** 1:39 PM  
**Photographer:** S. Andreescu  
**Photo ID:** 10 – P9140213

**Description:**  
(1/5) Panorama of site and elevation break

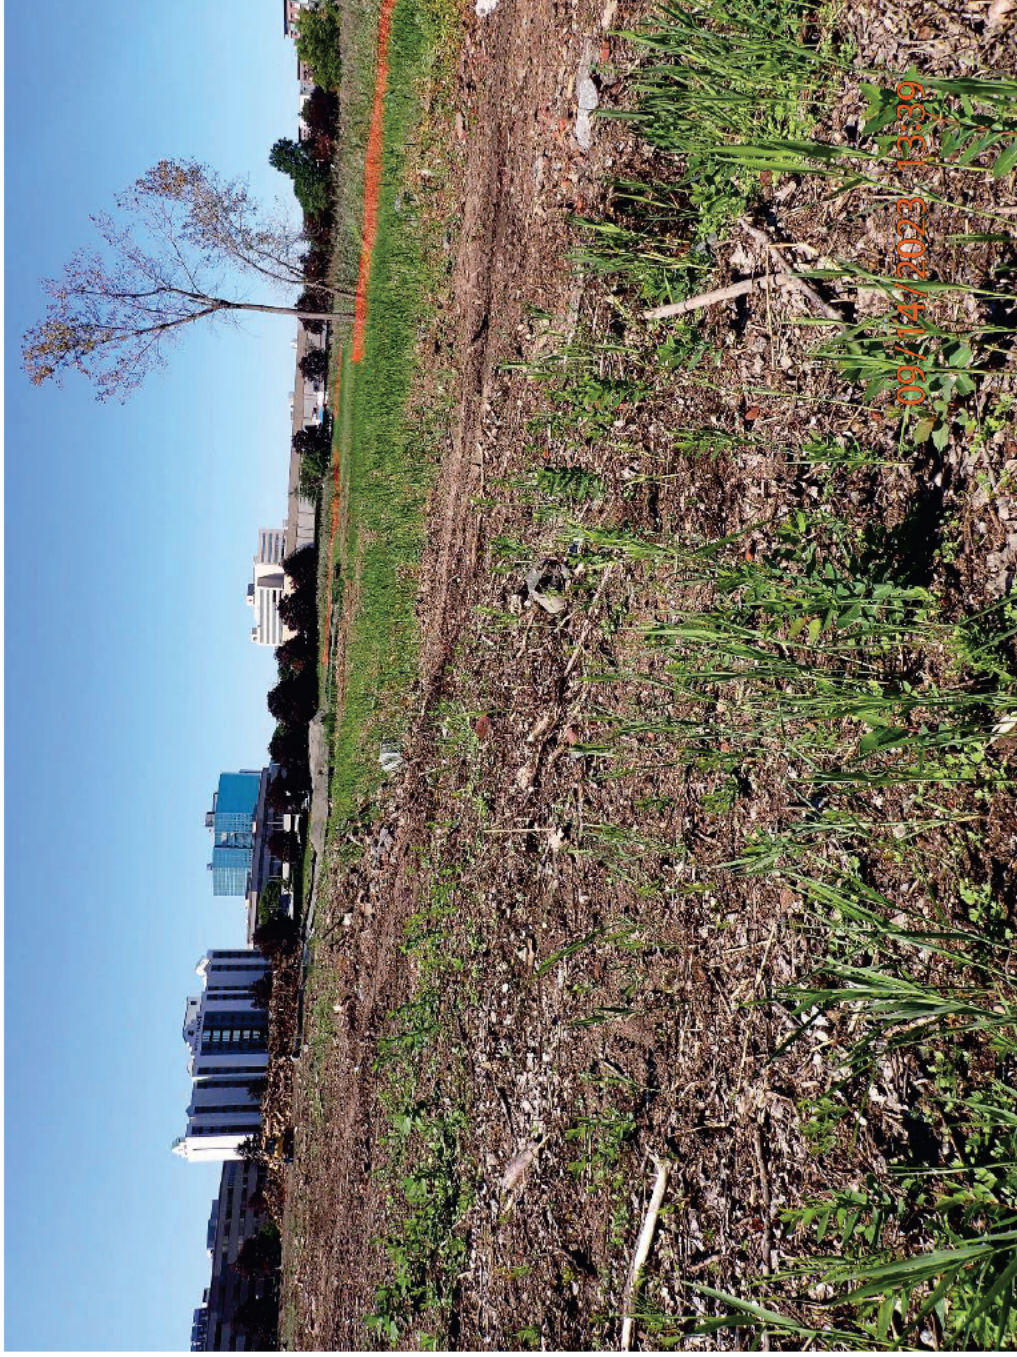
**Date:** 9/14/2023  
**Time:** 1:39 PM  
**Photographer:** S. Andreescu  
**Photo ID:** 11 – P9140214

(2/5) Panorama of site and elevation break  
Delineated wetlands in the background
