## Clean Water Act Section 404: Site Visit/Case Development

| Site Name | Hartz Mountian Industries, Inc. Mori Warehouse Site | | | | |

## Clean Water Act Section 404 Inspection September 14, 2023

EPA CWA 404 Inspection Photolog  
Hartz Mountain Industries  
Mori Tract, Secaucus, NJ

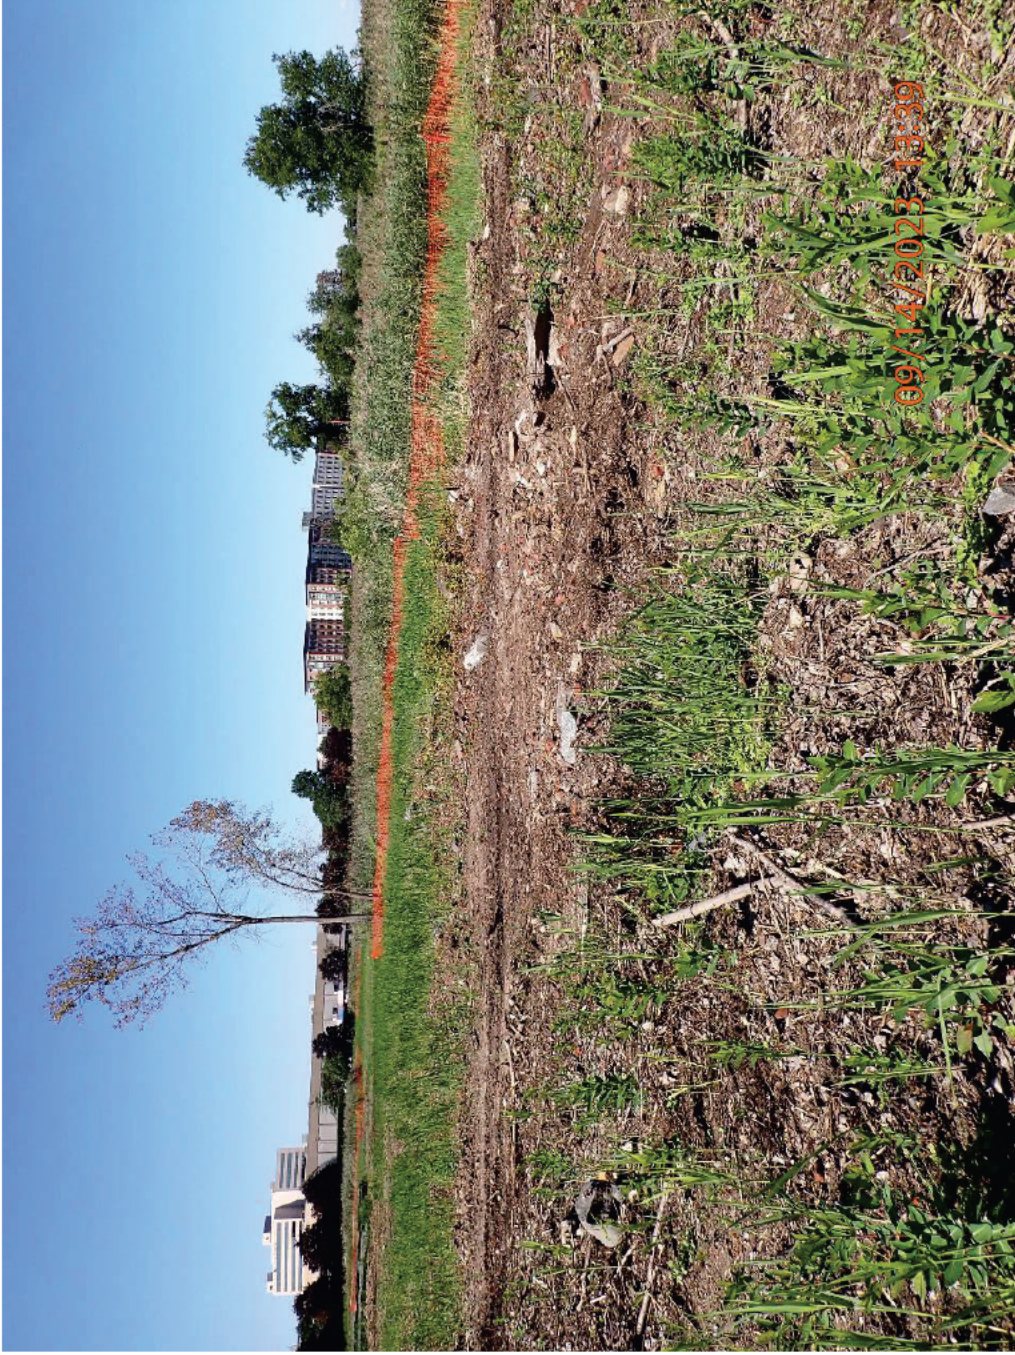
**Date:** 9/14/2023  
**Time:** 1:39 PM  
**Photographer:** S. Andreescu  
**Photo ID:** 12 – P9140215

(3/5) Panorama of site and elevation break  
Delineated wetlands in the background

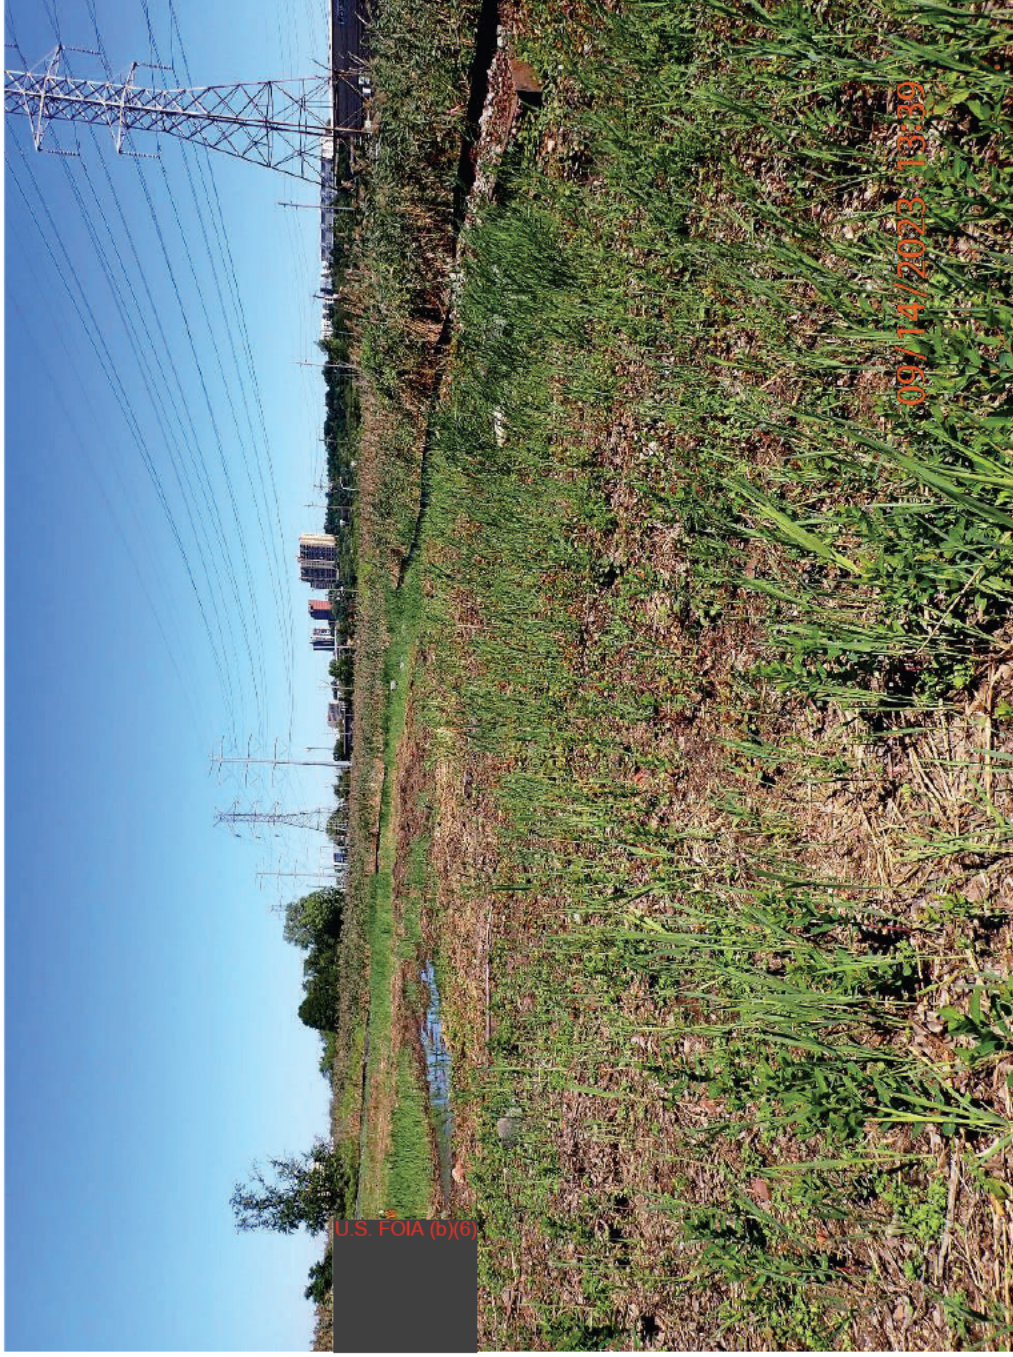
**Date:** 9/14/2023  
**Time:** 1:39 PM  
**Photographer:** S. Andreescu  
**Photo ID:** 14 – P9140217

**Description:**  
(5/5) Panorama of site and  
elevation break

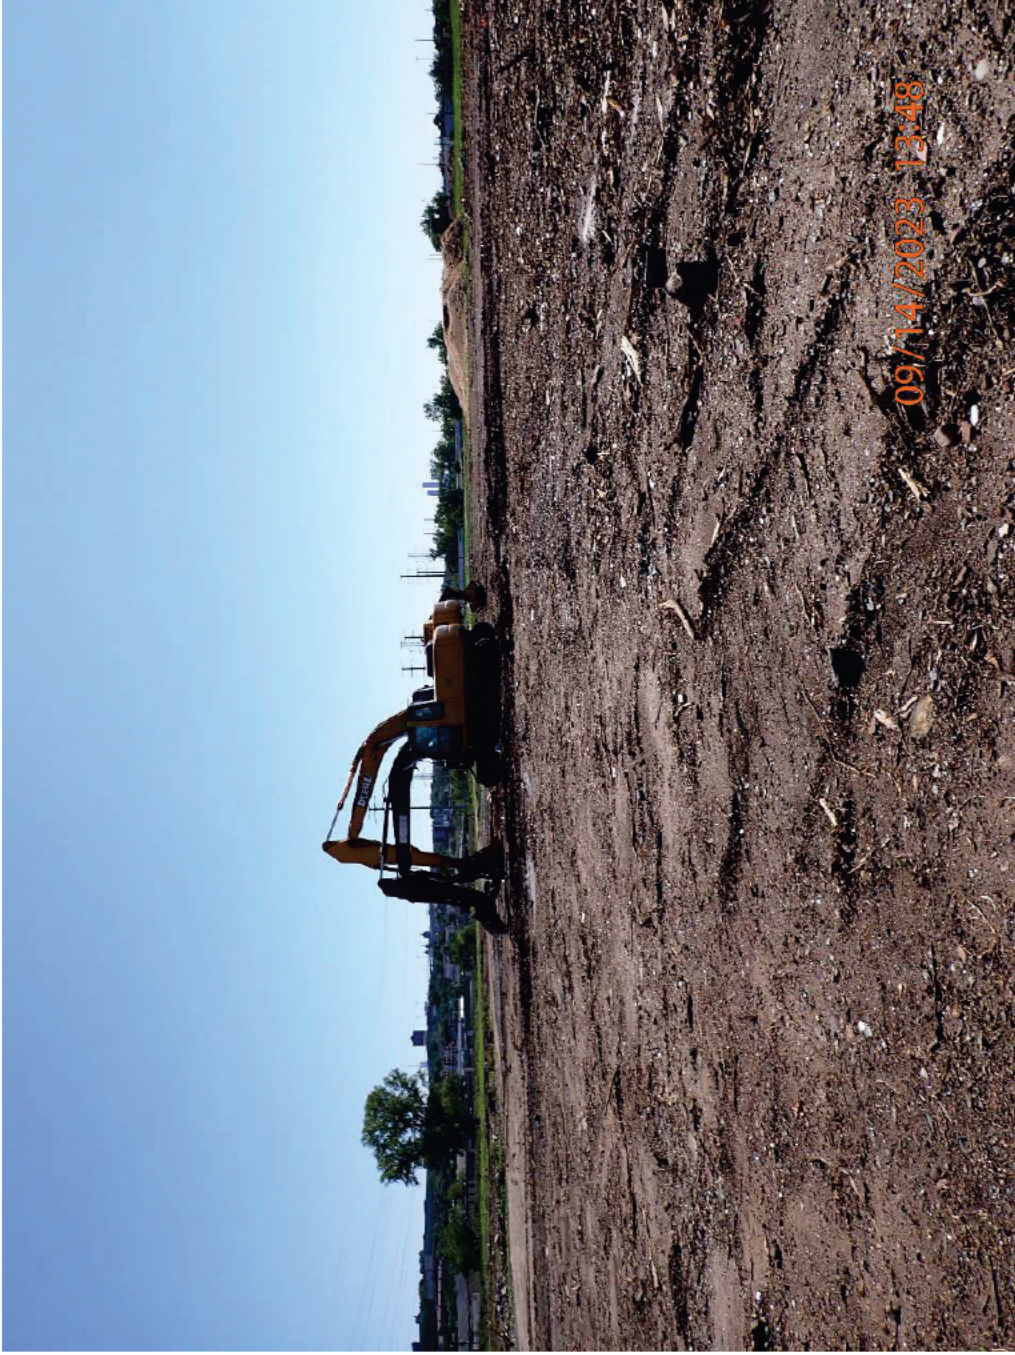
**Date:** 9/14/2023  
**Time:** 1:48 PM  
**Photographer:** S. Andreescu  
**Photo ID:** 15 – P9140218  
**Description:**  
Equipment on-site

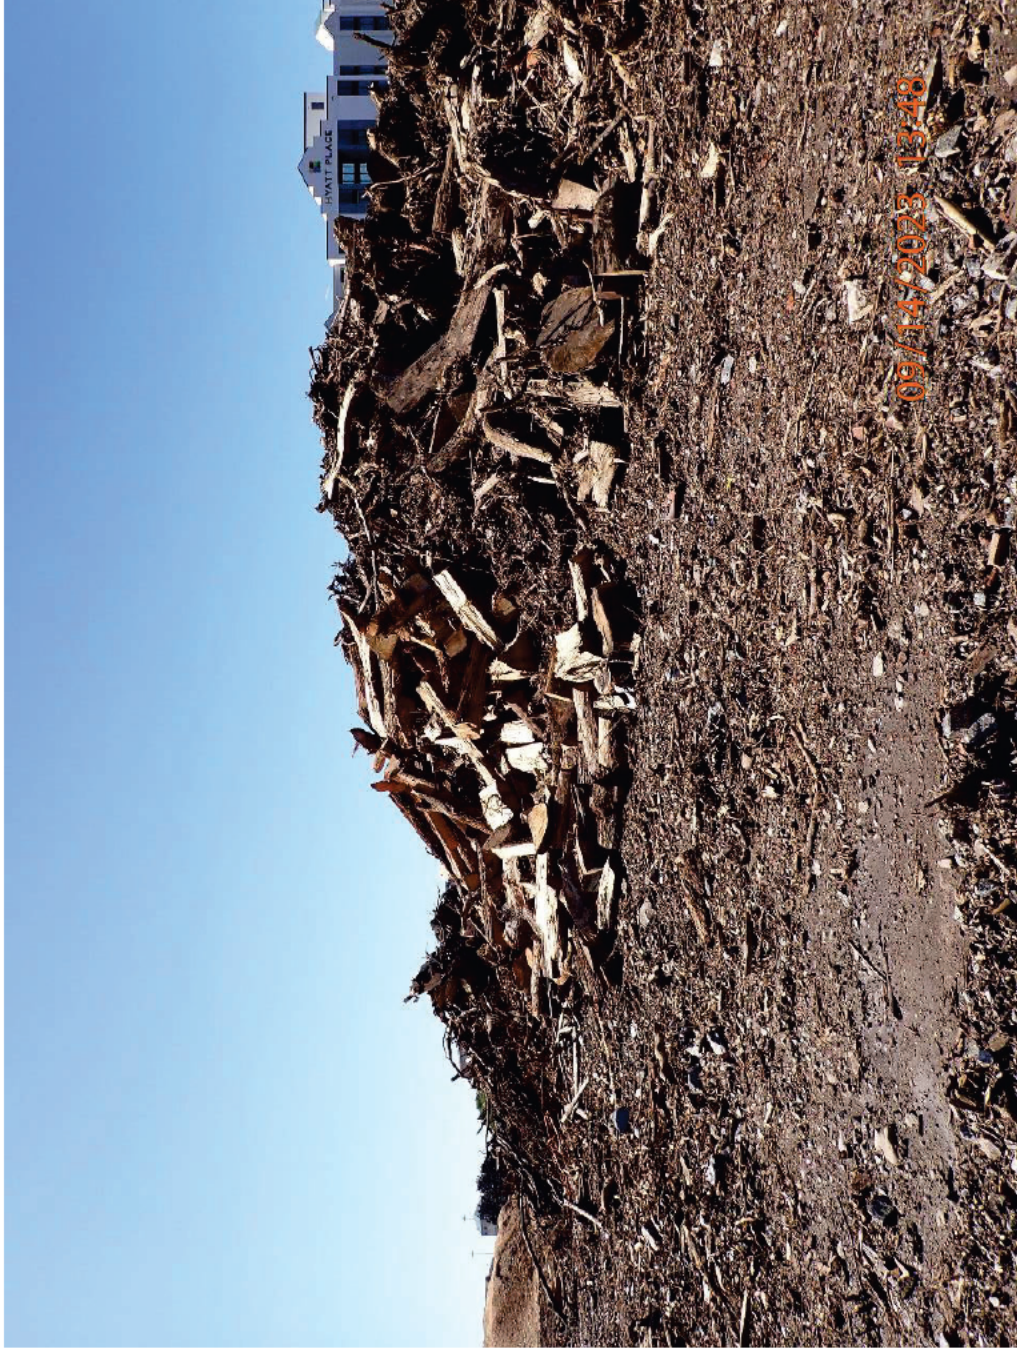
**Date:** 9/14/2023  
**Time:** 1:48 PM  
**Photographer:** S. Andreescu  
**Photo ID:** 16 – P9140219

| <p>The purpose of the inspection was to document whether there had been a discharge of dredged/fill material into waters of the United States without proper Corps authorization.</p> <p>Data recorded during the inspection included GPS data; handwritten notes of observations; and photographs.</p> <p>Prior to inspecting the property, EPA viewed it from the roof of a parking garage off of Park Plaza Drive.</p> <p>EPA inspected areas in and around four wetlands delineated by Hartz Mountain environmental consultants. These delineated wetlands were identified as Wetlands "B", "C", "D", and "F" by Hartz Mountain and are located near the center of the parcel, west of Cromakill Creek. Safety fencing had been put around the delineated wetlands. Two of the wetlands (Wetlands C and D) had been fenced together due to their proximity to one another.</p> <p>Areas outside of the fencing had been cleared of vegetation with the exception of riparian areas adjacent to Cromakill Creek. Within the safety fencing, dominant vegetation consisted of common reed (<i>Phragmites australis</i>). Vegetation was regrowing in the cleared areas.</p> <p>EPA took a soil sample (SS1) between the Cromakill Creek riparian area and Hartz Mountain's Wetland "D". EPA recorded a GPS point at this location. Soils were disturbed and auger refusal occurred at 14". The top 5" of soil had a Munsell soil color of 7.5 YR 2.5/1. Below that layer was a near equal mixture of Munsell soils colors 10 YR 4/3, 10 YR 5/3, and 10 YR 4/1. Common reed was observed revegetating in the vicinity. While there was some standing water in the vicinity, soil in the pit was dry and no water table was observed.</p> <p>EPA took a second soil sample (SS2) within the fenced area delineated by Hartz Mountain as Wetland "D". EPA recorded a GPS point at this location. Soils were disturbed and generally characterized by a muck layer with a Munsell soil color of 10 YR 2/1. Below this layer, soils were more mineral with a Munsell soil color of 10 YR 3/1. The soil sample met the Black Histic hydric soil indicator. Historic fill material consisting of dirt, concrete, brick, and stones of various sizes was observed. Dominant vegetation within the fenced area consisted of common reed. Water was observed in the soil pit approximately 12.5" below the surface. Based on the presence of wetland vegetation, hydric soils, and hydrology, EPA confirmed that this location was within a wetland.</p> <p>Outside of the fencing, EPA observed vehicle ruts and standing water. EPA observed topography to be at a slightly higher elevation just south of Wetlands C and D.</p> <p>Large piles of woody debris - tree branches, trunks, stumps, and roots - were observed west of Wetlands C and D.</p> | | | |

| Potential issues of concern included the discharge of fill material into wetlands (via grubbing) without prior Corps authorization. | | | |

Stumps and woody debris from trees taken down at the site

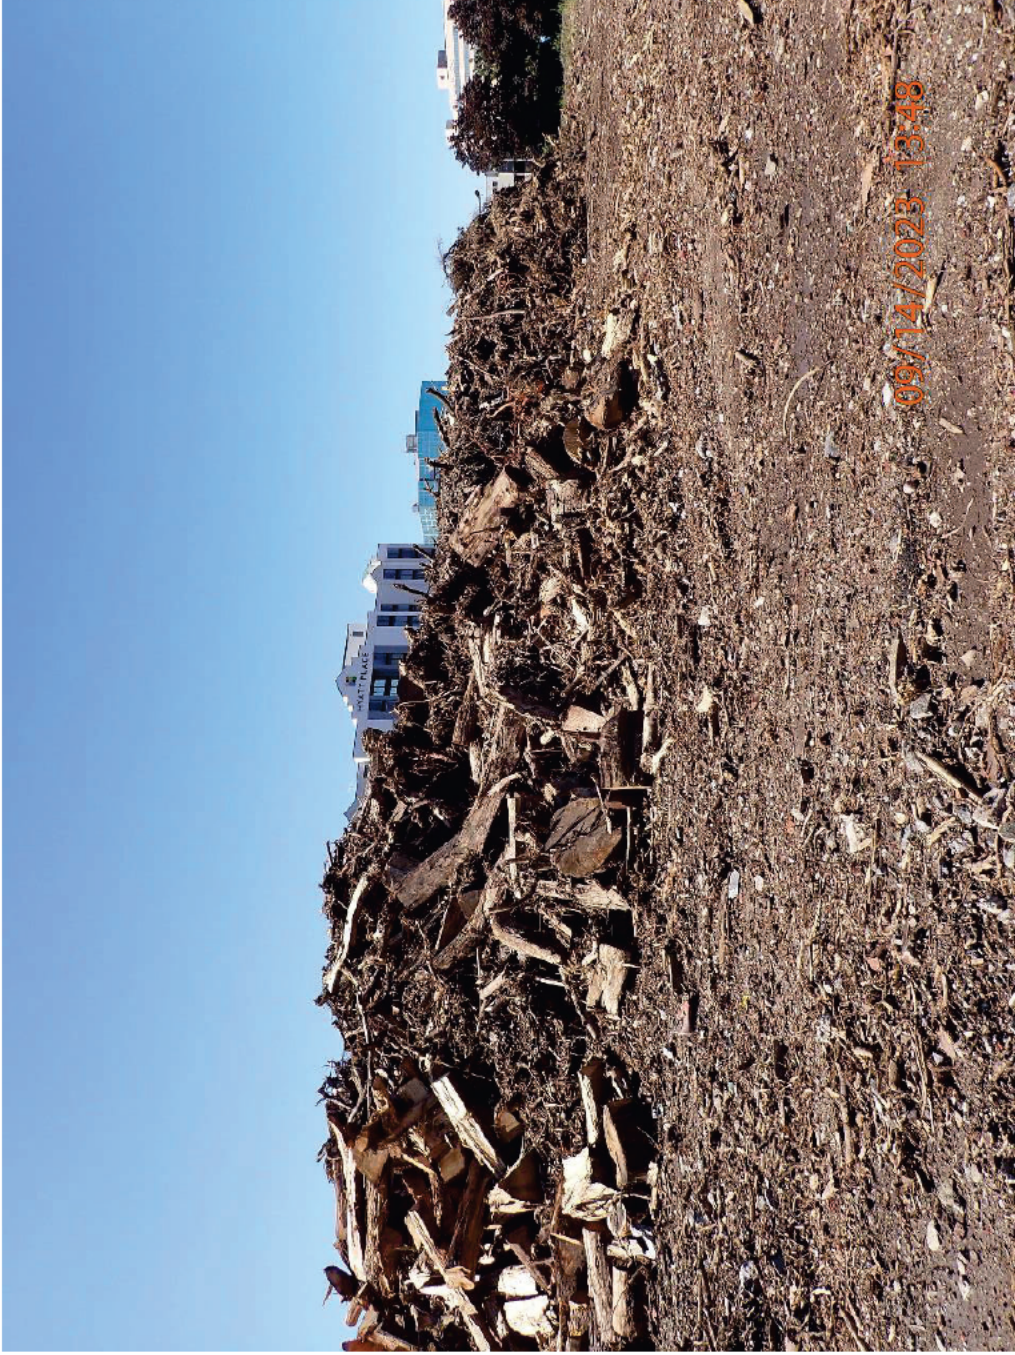
**Date:** 9/14/2023  
**Time:** 1:48 PM  
**Photographer:** S. Andreescu  
**Photo ID:** 17 – P9140220

Stumps and woody debris from trees taken down at the site

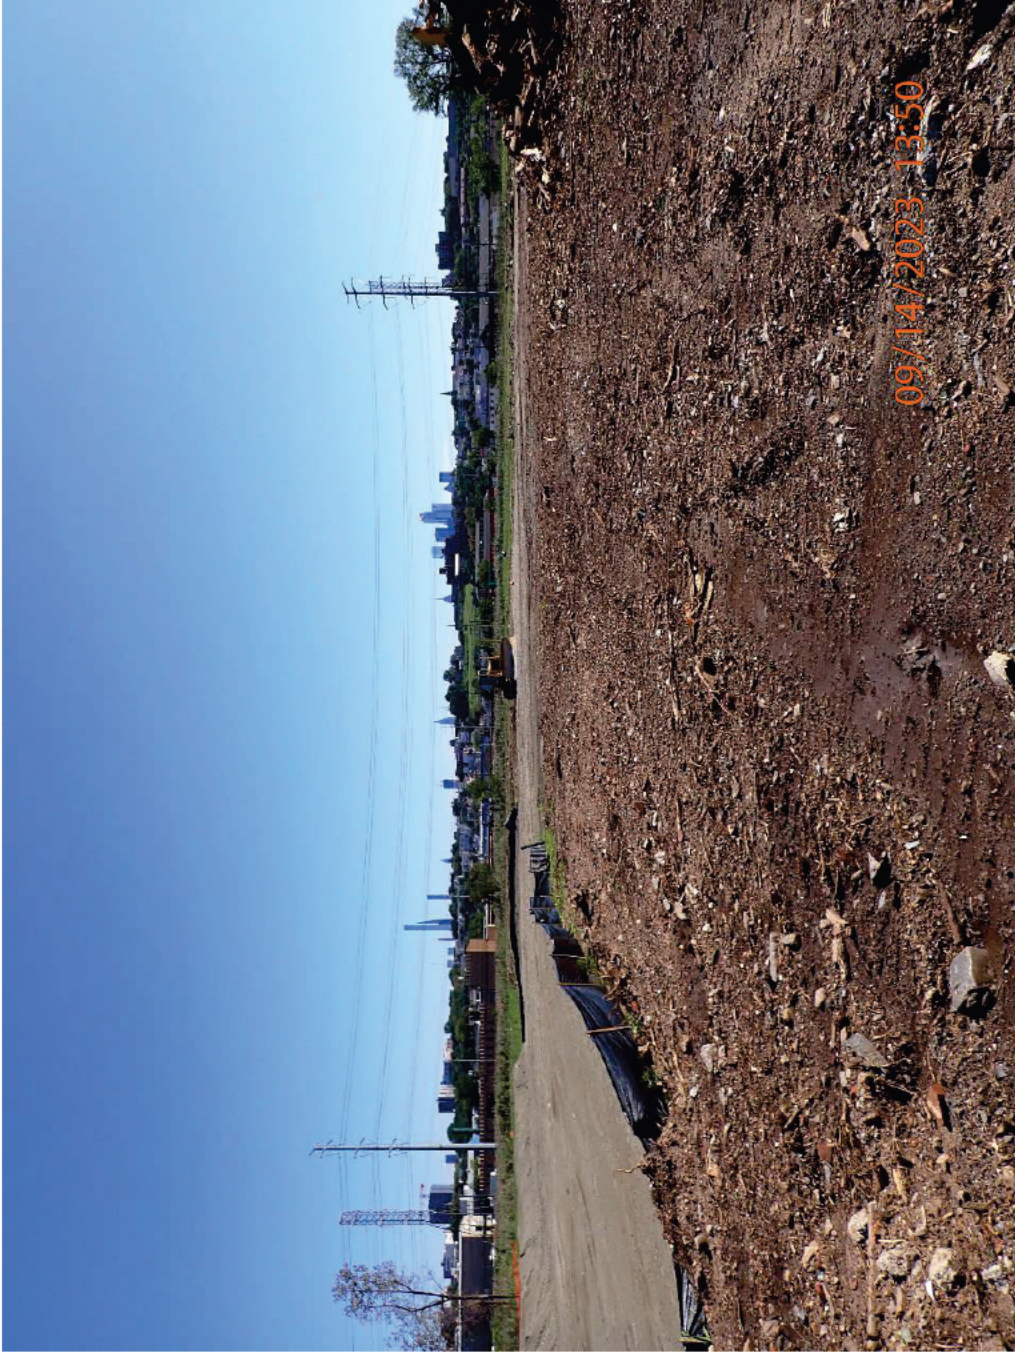
**Date:** 9/14/2023  
**Time:** 1:50 PM  
**Photographer:** S. Andreescu  
**Photo ID:** 18 – P9140221

Machinery on-site and Area of Concern

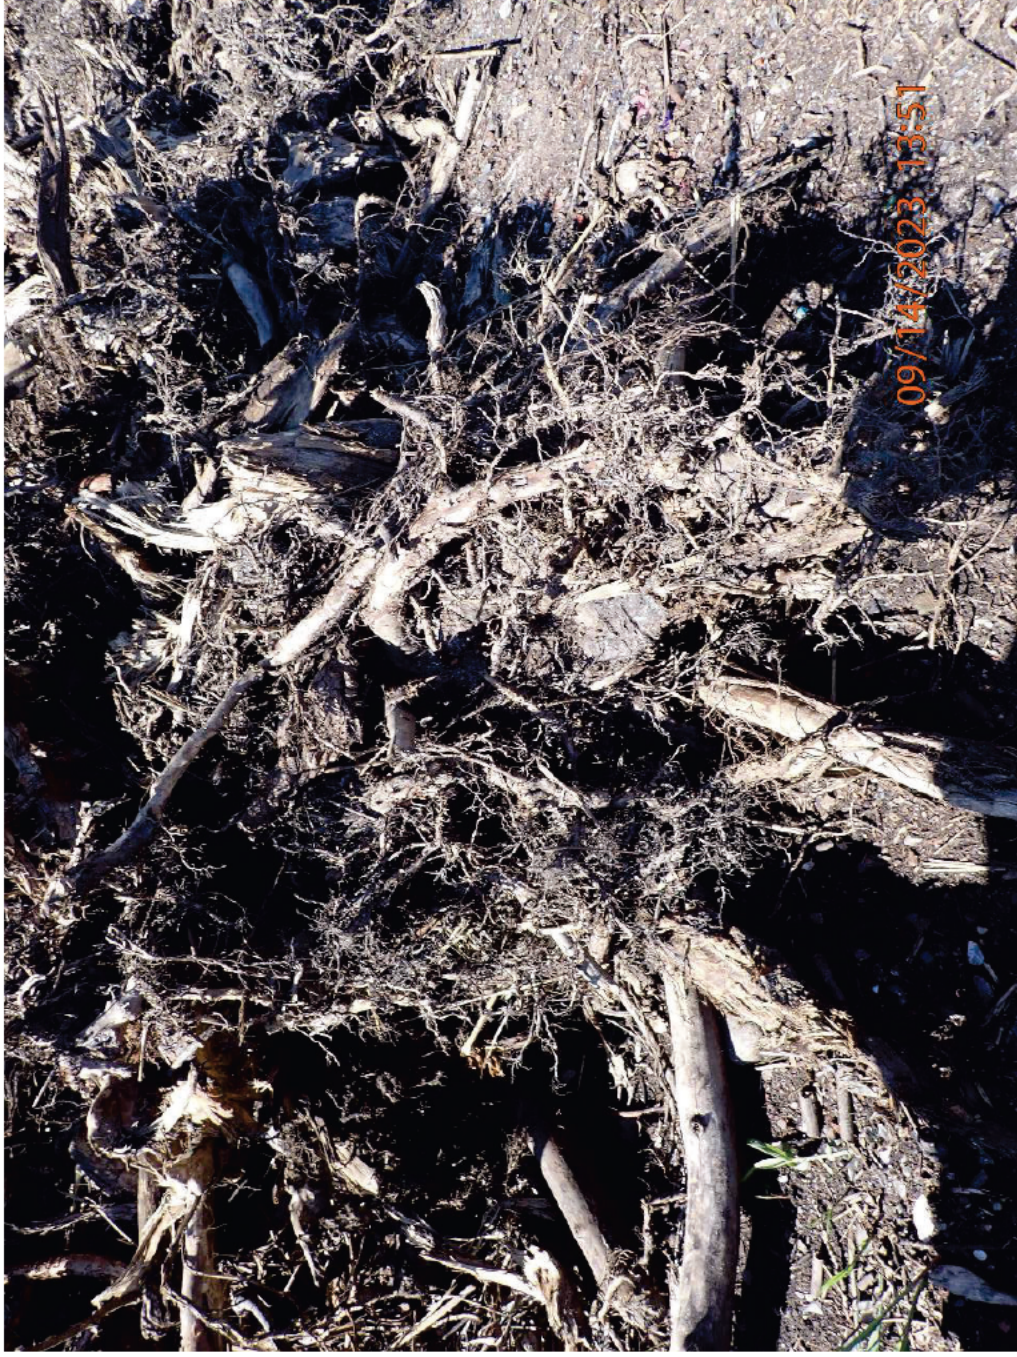
**Date:** 9/14/2023  
**Time:** 1:51 PM  
**Photographer:** S. Andreescu  
**Photo ID:** 19 – P9140222

Roots from trees removed from the site

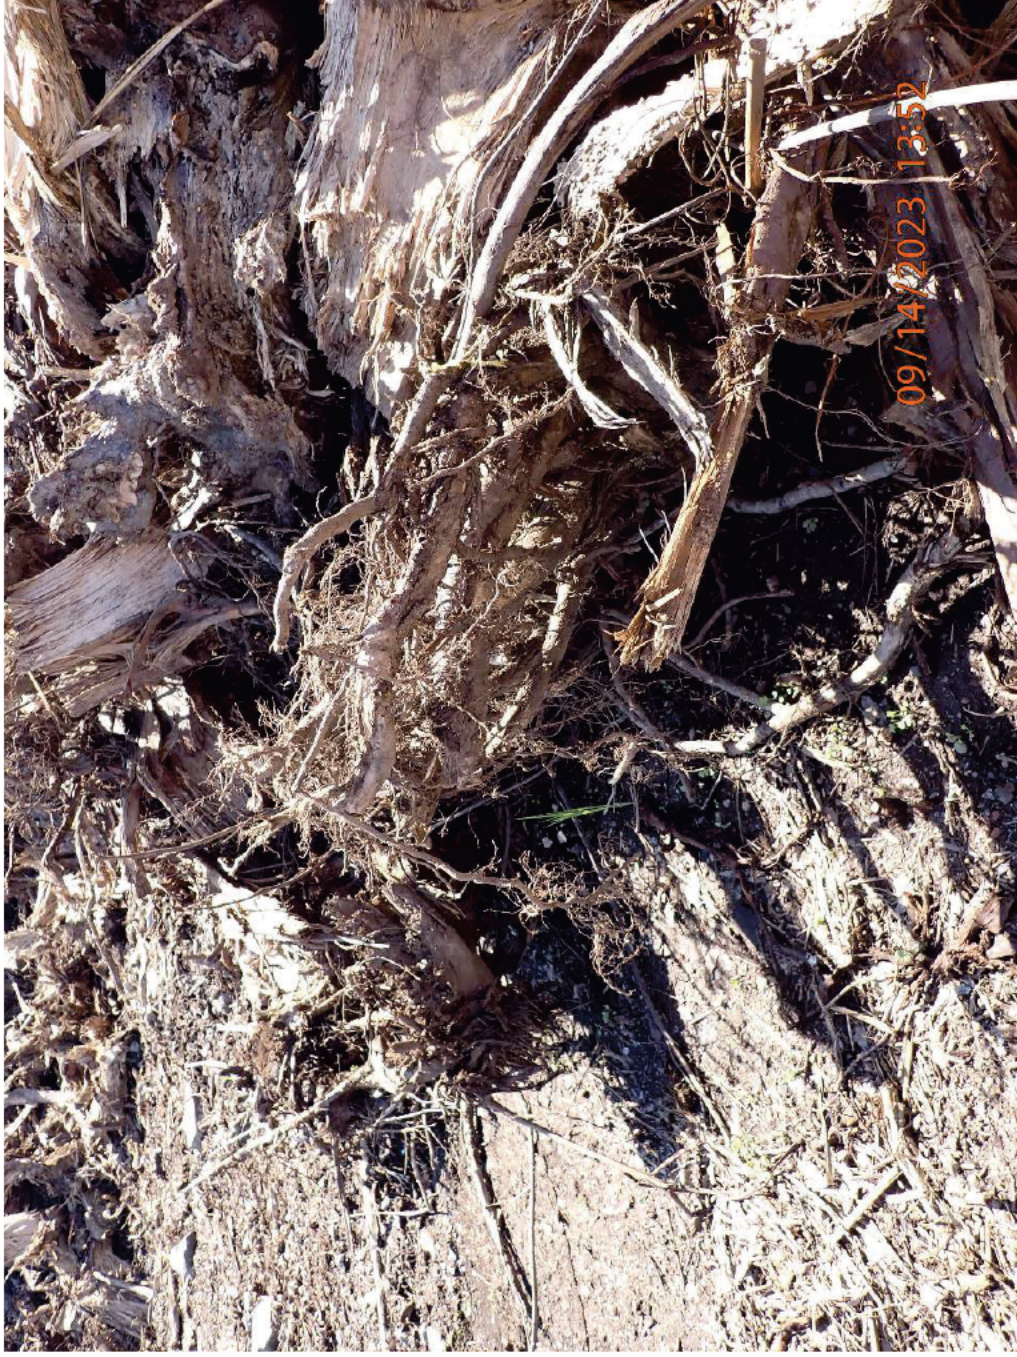
**Date:** 9/14/2023  
**Time:** 1:52 PM  
**Photographer:** S. Andreescu  
**Photo ID:** 20 – P9140223  
**Description:**  
Roots from trees removed from  
the site
