## EPA REGION 10 Enforcement Division

### INSPECTION REPORT

| <b>Regulatory Program</b> | Resource Conservation and Recovery Act (RCRA) | | |
| <b>Company Name</b> | Providence Alaska Medical Center | | |

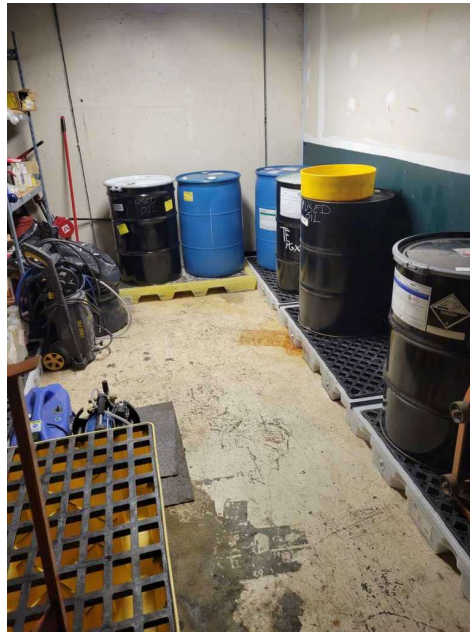
| Photo No. 1 | | | Used Oil Room 5.9.24.jpg |

| Photo of the oil room provided by the facility showing that the oil spill on the floor has been cleaned up. Photo no. IMG-2024050610344034401341876 shows the spilled oil before it was cleaned up. | | | |

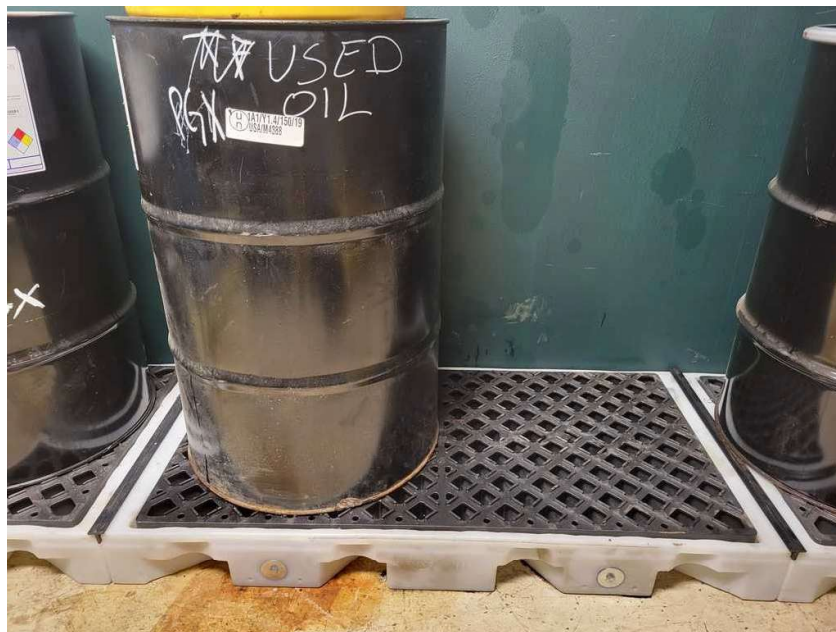
| Photo No. 2 | | | Clean used oil 5.9.24.jpg |

| This photo was sent by the facility showing that this 55-gallon closed top style drum of used oil that previously had not been labeled or marked "Used Oil" has now been marked "Used Oil." | | | |

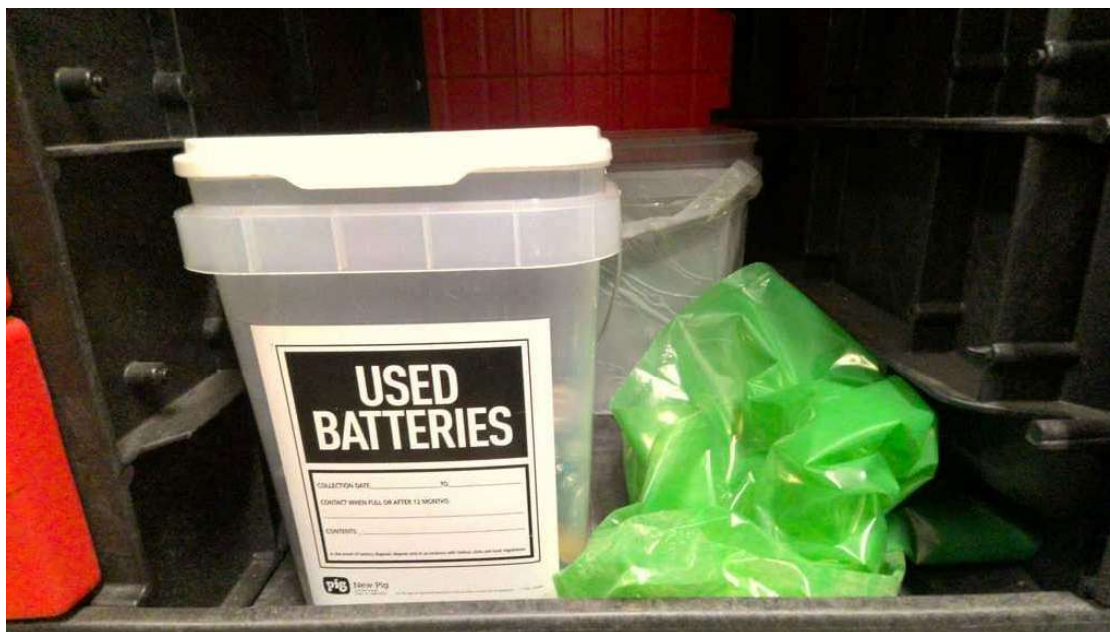
| Photo No. 3 | | | IMG-202405060930083081346063.jpg |

| Container marked used batteries with a mix of various alkaline batteries. Container is not marked with the accumulation start date. | | | |

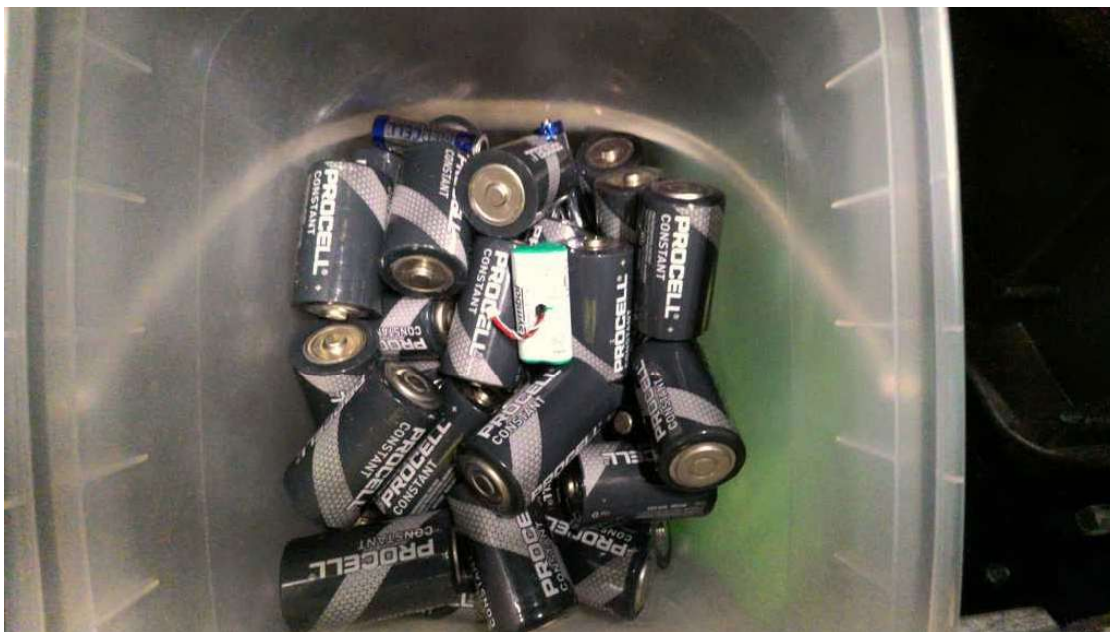
| Photo No. 4 | | | IMG-2024050609313631361249341.jpg |

| View of nickel metal hydride battery mixed with alkaline batteries. | | | |

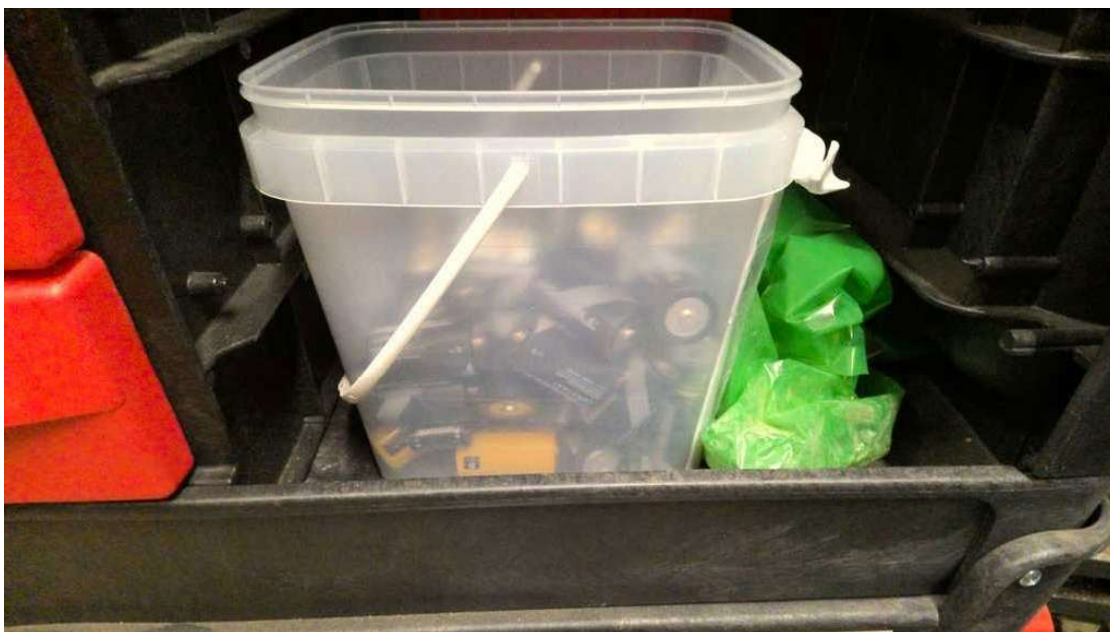
| Photo No. 5 | | | IMG-2024050609321132111214276.jpg |

| View of container for collecting batteries not labeled or marked as “Universal Waste – Batteries,” “Waste Batteries,” or “Used Batteries” and is not dated. (Side 1) | | | |

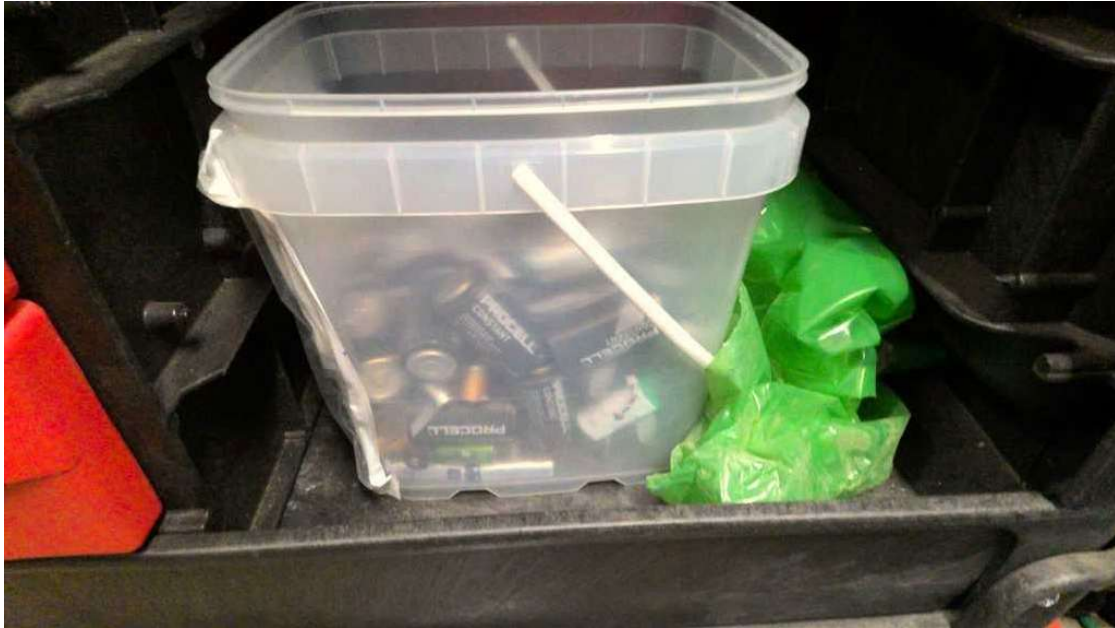
| Photo No. 6 | | | IMG-2024050609322532251167841.jpg |

| Picture showing container for collecting batteries was not labeled and did not have an accumulation start date on it. (Side 2) Different view of same container. | | | |

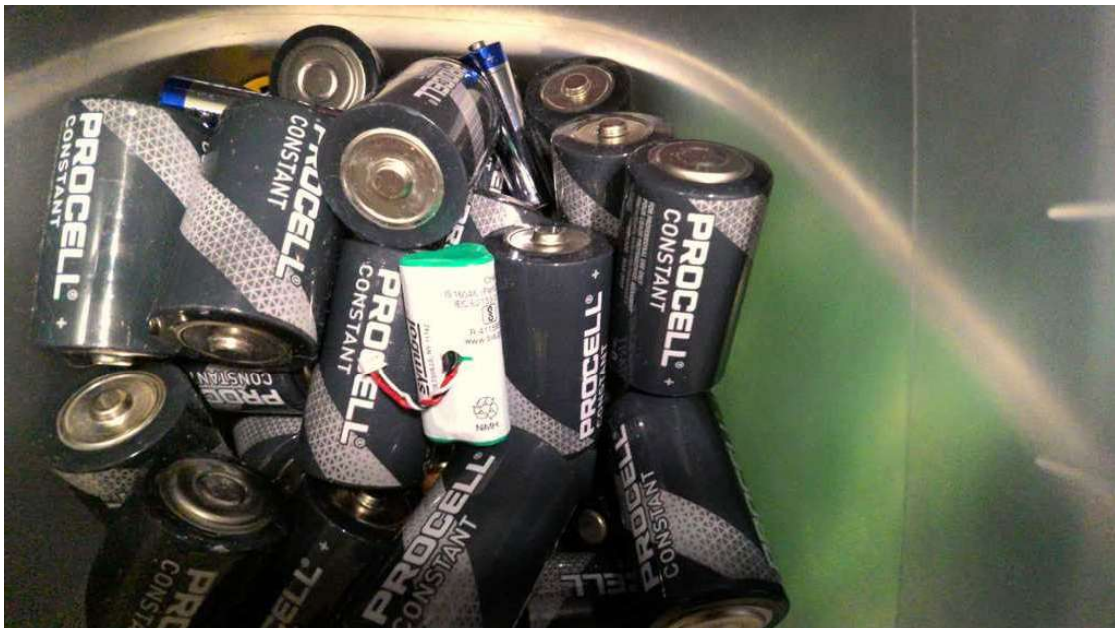
| Photo No. 7 | | | IMG-2024050609315631561363757.jpg |

| Close up photo showing the nickel metal hydride battery mixed with alkaline batteries. | | | |

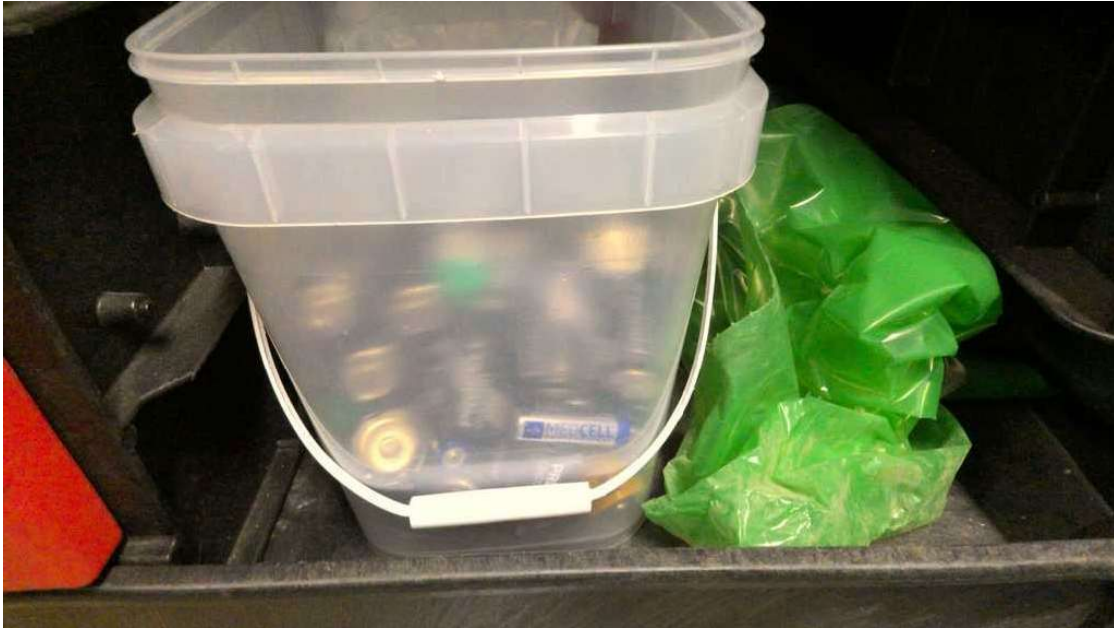
| Photo No. 8 | | | IMG-2024050609323832381216569.jpg |

| Picture showing container for collecting batteries was not labeled and did not have an accumulation start date on it. (Side 3) | | | |

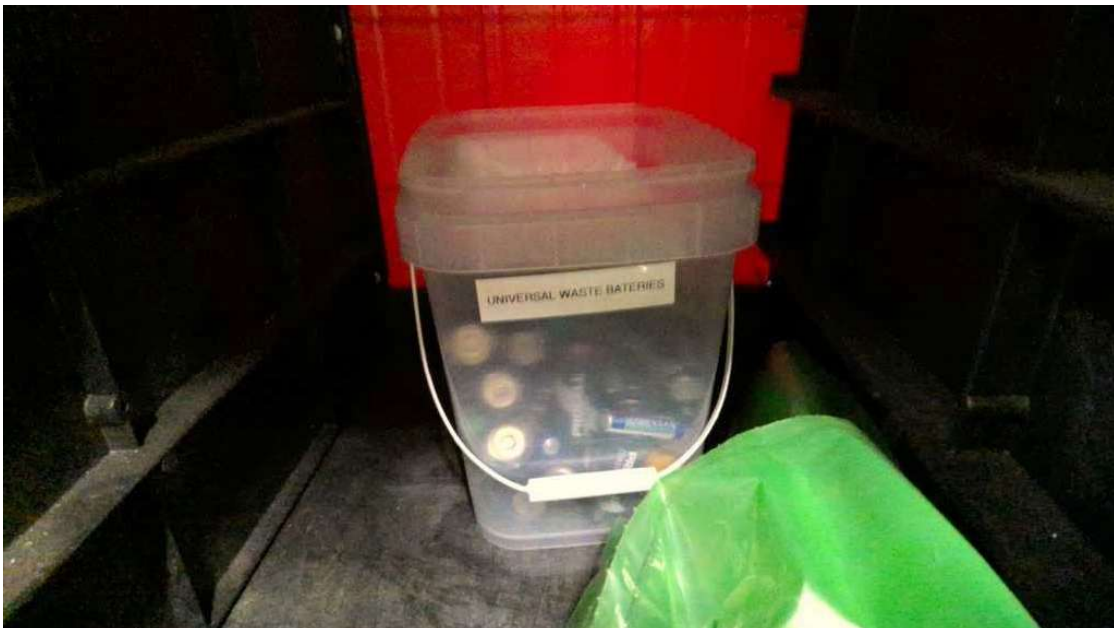
| Photo No. 9 | | | IMG-2024050609451045101012958.jpg |

| Container for collecting batteries with a contents label of "Universal Waste Batteries" was applied and witnessed by the inspection team | | | |

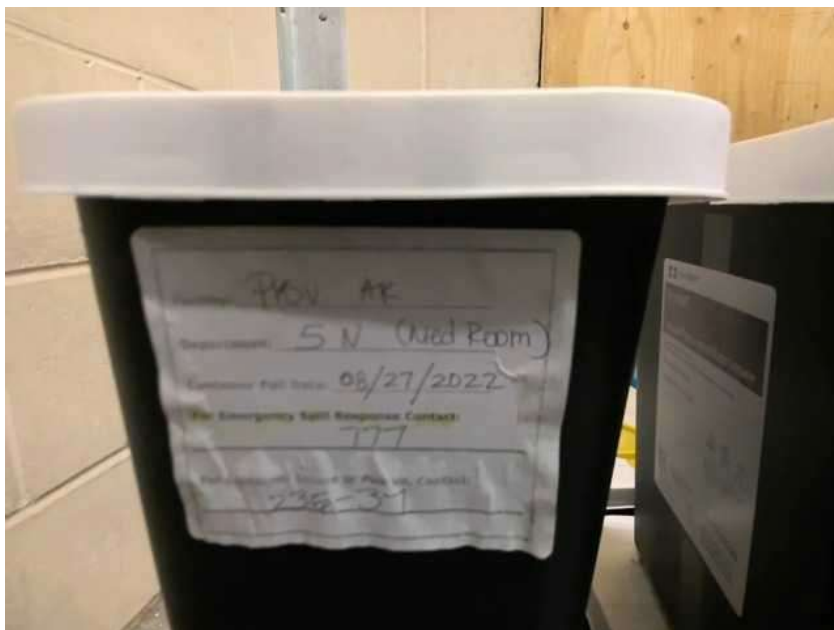
| Photo No. 10 | | | IMG-202405061005025242942.jpg |

| Black and white container of hazardous waste pharmaceuticals with an accumulation start date of 8/27/2022. | | | |

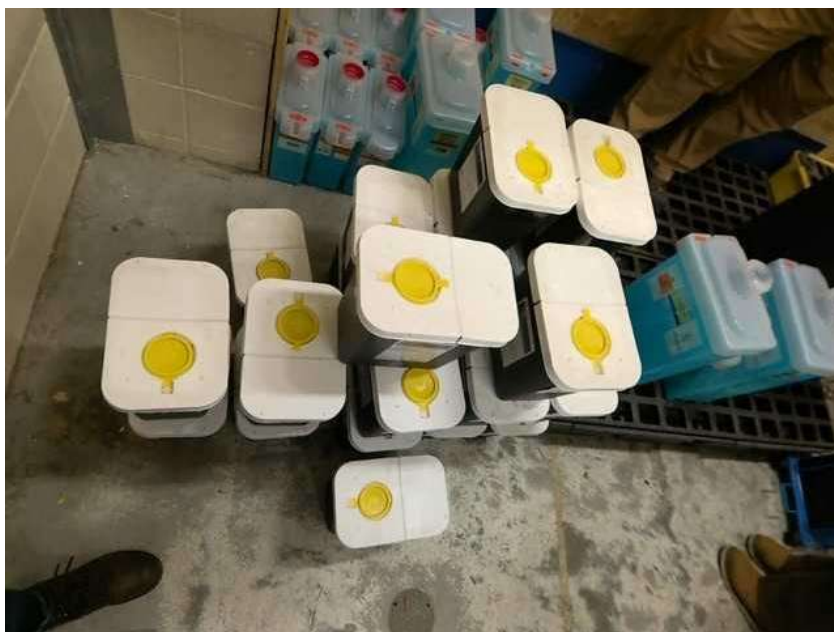
| Photo No. 11 | | | IMG-2024050610042742779586.jpg |

- All 23 HWPharms containers were labeled incorrectly. We observed a label on the containers with the words "Universal Pharmaceutical Waste Container." A healthcare facility must label or clearly mark each container of non-creditable hazardous waste pharmaceuticals with the phrase “Hazardous Waste Pharmaceuticals.” (Photo Nos. 11, 15)

| This photo is another view of the black and white containers of hazardous waste pharmaceuticals. | | | |

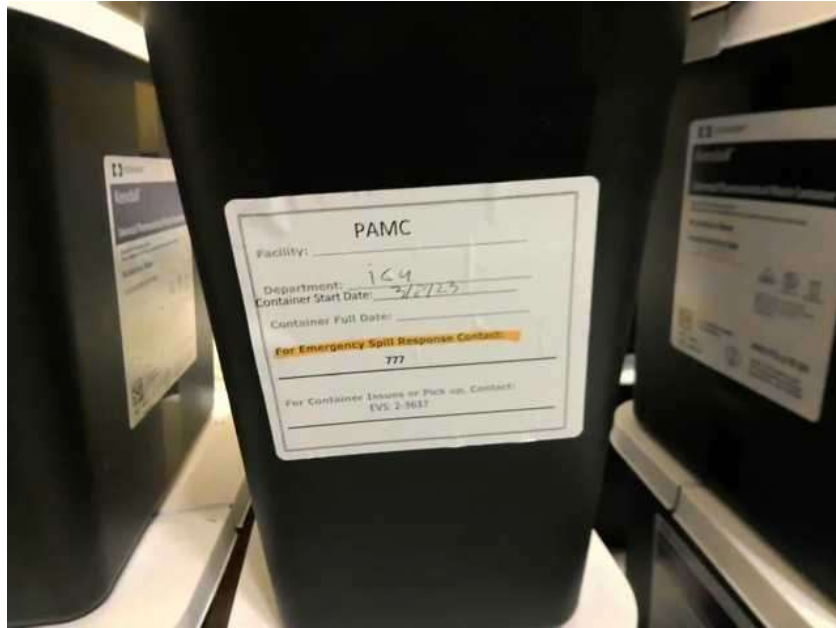
| Photo No. 12 | | | IMG-2024050610043643647488.jpg |

| Black and white container of hazardous waste pharmaceuticals with an accumulation start date of 3/8/2023. | | | |

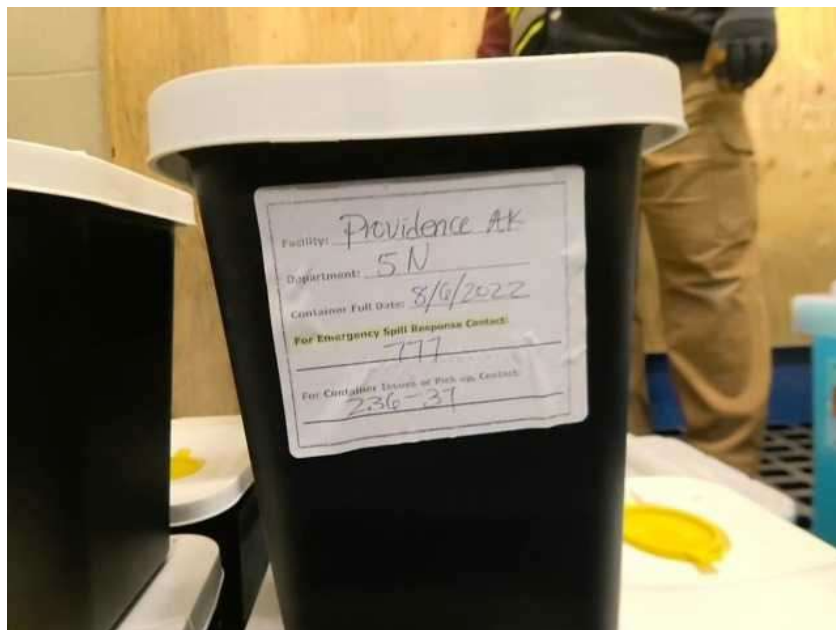
| Photo No. 13 | | | IMG-2024050610044544549231.jpg |

| Black and white container of hazardous waste pharmaceuticals with an accumulation start date of 8/6/2022. | | | |

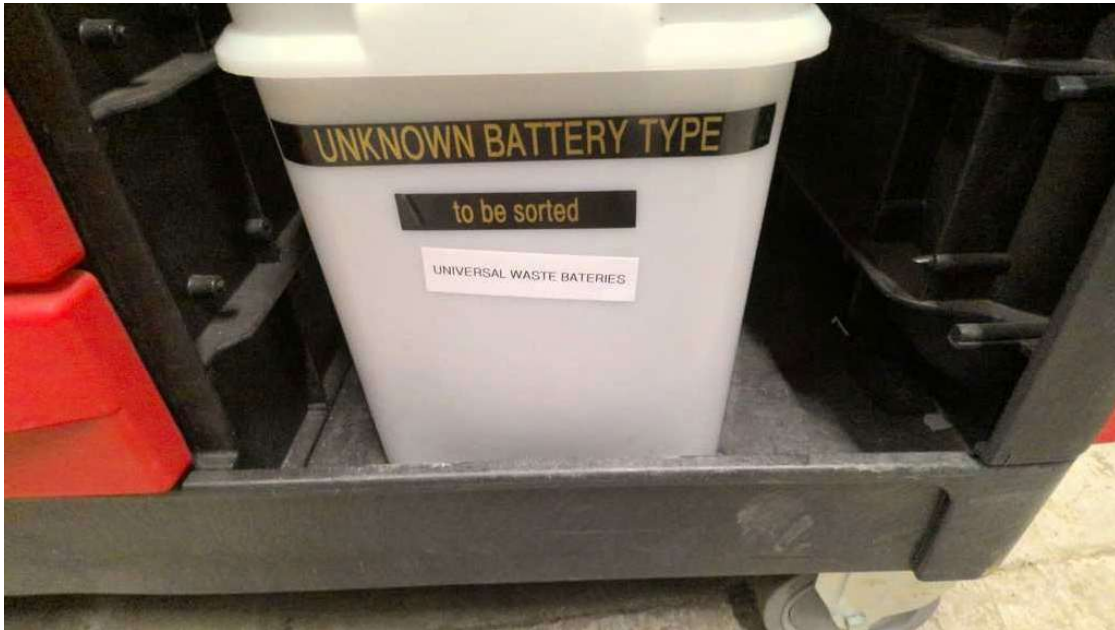
| One (1) container marked “unknown battery type to be sort” had what appeared to be alkaline batteries in it. Container is not marked with the accumulation start date. Contents label of “Universal Waste Batteries” was applied and witnessed by the inspection team. | | | |

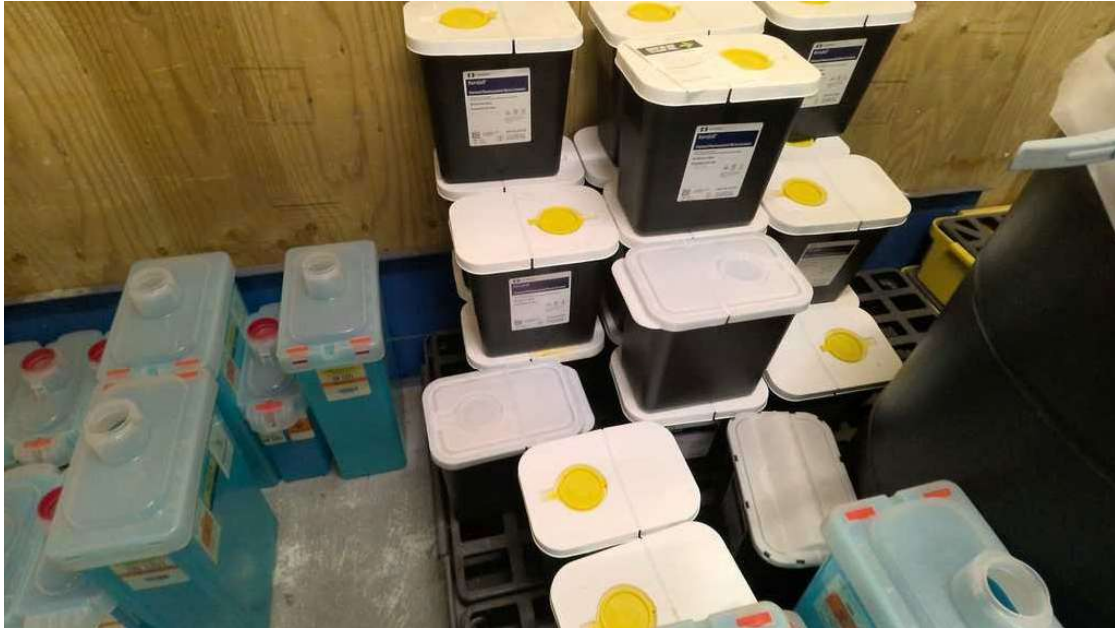
| Photo No. 15 | | | IMG-202405060958475847984173.jpg |

| <b>Building:</b> Providence | <b>Area:</b> Facilities Loading Dock | <b>Sub-area:</b> |
|---|---|---|
| <p>23 containers that held non-creditable hazardous waste pharmaceuticals were not labeled with the words "Hazardous Waste Pharmaceuticals."</p> <p>Ten (10) of the 23 containers were not marked with the date that the non-creditable hazardous waste pharmaceuticals became a waste and there was nothing in the specific Cage Area, that identified the earliest date that any of the non-creditable hazardous waste pharmaceuticals in the area became a waste. The facility did not appear to maintain, nor did they demonstrate that they have an inventory system that identified the date the non-creditable hazardous waste pharmaceuticals being accumulated first became waste.</p> | <b>Regulations:</b> | <b>Sections:</b> |

| View of 23 black containers holding HWPharms that were not labeled or marked with the words “Hazardous Waste Pharmaceuticals.” | | | |

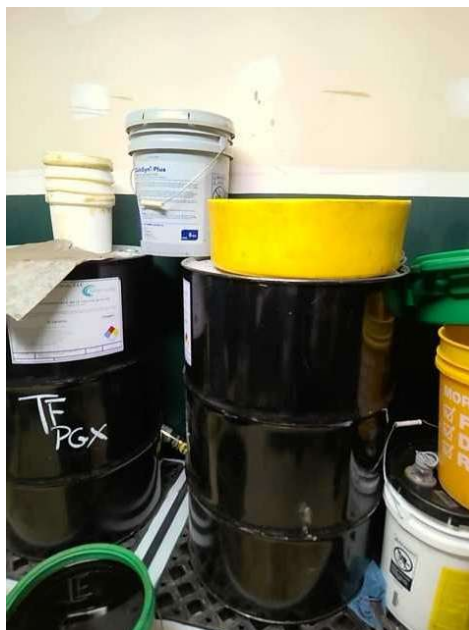
| Photo No. 16 | | | IMG-20240506103357335762263.jpg |

- One (1) full 55-gallon drum we were told this drum contained used oil. The drum was not labeled or marked clearly with the words "Used Oil." (Photo No. 16)
- Two (2) Five-gallon pails, that held used oil were not labeled or marked clearly with the words "Used Oil." (Photo Nos. 17, 22)
- Spill pallets for the used oil drums contained some used oil but were not labeled or marked with the words "Used Oil." (Photo Nos. 24, 29)
- Facility staff marked the containers and spill pallets as discussed above with the words "Used Oil" during the inspection. (Photo Nos. 2, 26, 27, 28, 32, 33)
- We noted that there was used oil on the floor, demonstrating that there had been a release of used oil that, at the time of the inspection, had not been cleaned up and managed properly. No spill kits were observed in the Oil Room. (Photo No. 23)

| One (1) each full 55-gallon closed top style drum of used oil drum was not labeled or marked "Used Oil." | | | |

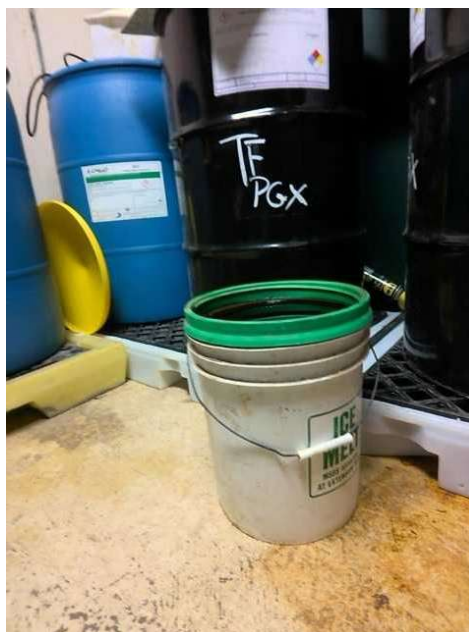
| Photo No. 17 | | | IMG-20240506103352335275340.jpg |

| View of a five-gallon container of used oil. The container seen here is full and not labeled or marked with the words "Used Oil." | | | |

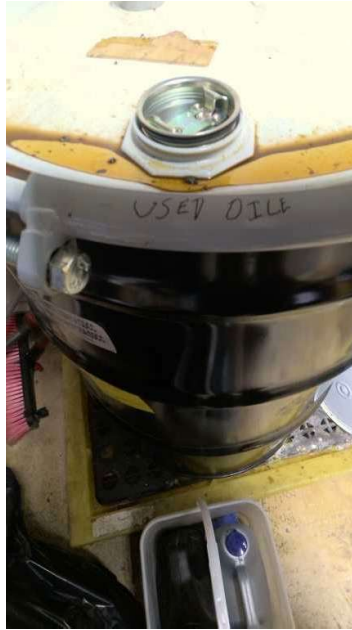
| Photo No. 18 | | | IMG-202405061025392539779397.jpg |

| Open top style drum and the words "Used Oile" (actual wording) written on the ring. Marking is acceptable, facility staff improved the marking on the drum which can be seen in Photo No. IMG-20240506104140414079675. | | | |

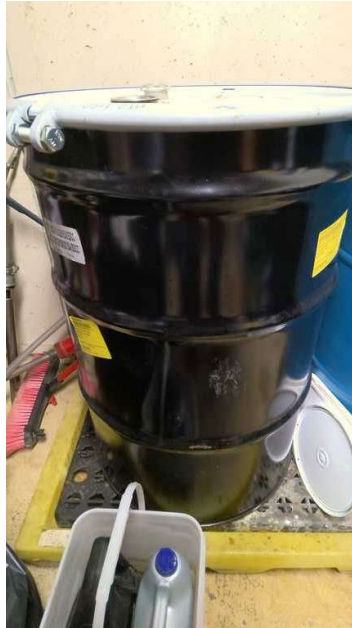
| Photo No. 19 | | | IMG-202405061025222522950094.jpg |

| One (1) each 55-gallon open top drum of used oil with the words "Used Oile" (actual wording) written on the ring. Marking is acceptable, facility staff improved the marking on the drum which can be seen in Photo No. IMG-20240506104140414079675 | | | |

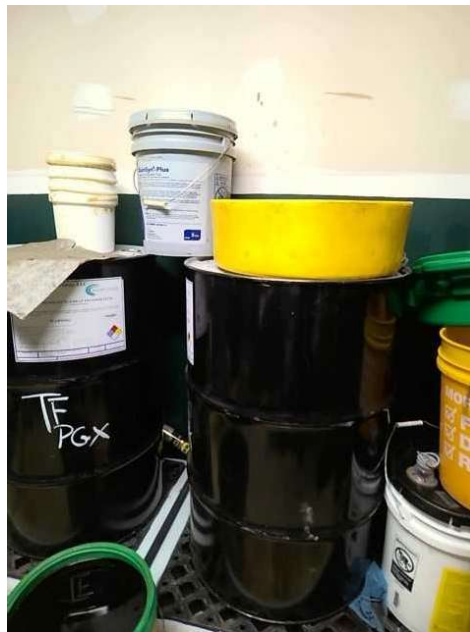
| Photo No. 20 | | | IMG-20240506103358335863348.jpg |

| One (1) each full 55-gallon closed top style drum of used oil drum was not labeled or marked "Used Oil." | | | |

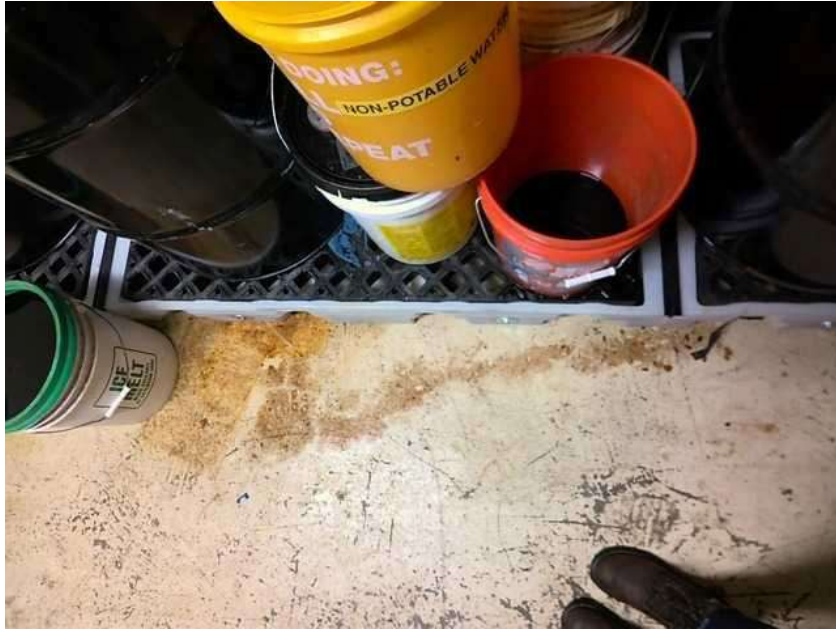
| Photo No. 21 | | | IMG-20240506104131413196787.jpg |

| Picture of used oil on the floor of the oil room. | | | |

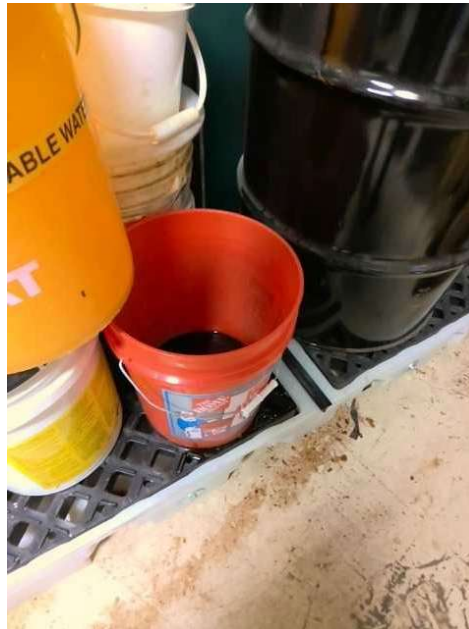
| Photo No. 22 | | | IMG-2024050610350835869717.jpg |

| One (1) each five (5) gallon Home Depot container with a small amount of used oil in it, not labeled or marked "Used Oil." | | | |

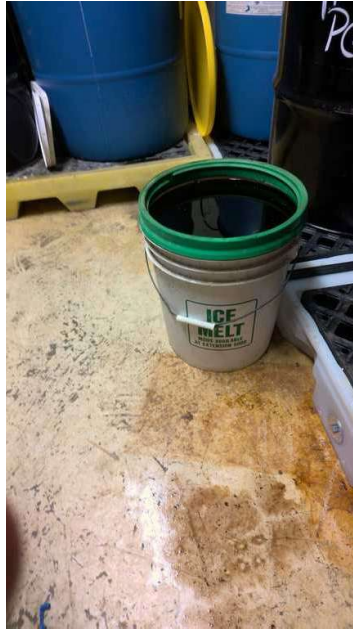
| Photo No. 23 | | | IMG-2024050610344034401341876.jpg |

| This is another view of the used oil on the floor of the oil room. This picture also shows a five (5) gallon container of used oil that is not labeled or marked with the words "Used Oil." | | | |

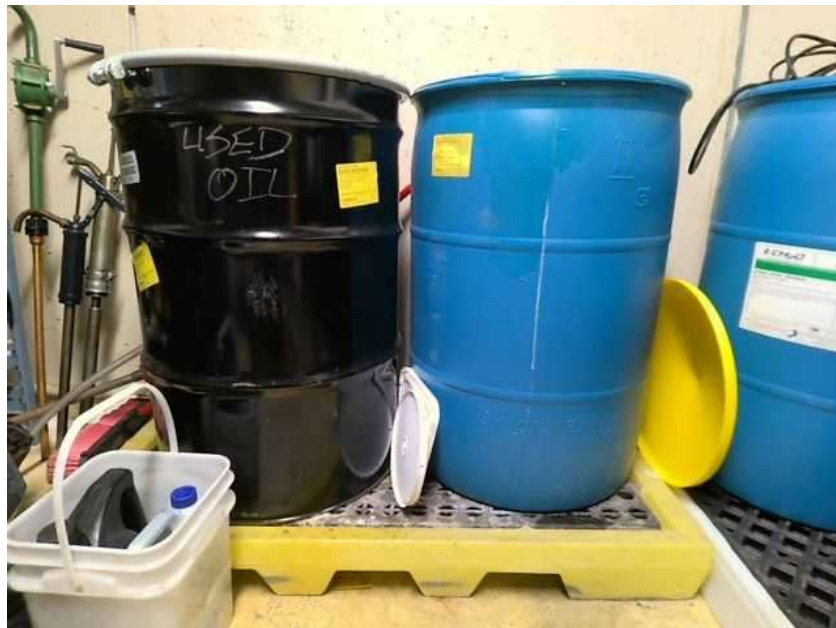
| One (1) each 55-gallon drum containing used oil with an open top style drum. Facility staff wrote the words "Used Oil" on the drum as witnessed by the inspection team. This picture also shows that the spill containment pallet is not labeled or marked "Used Oil." | | | |

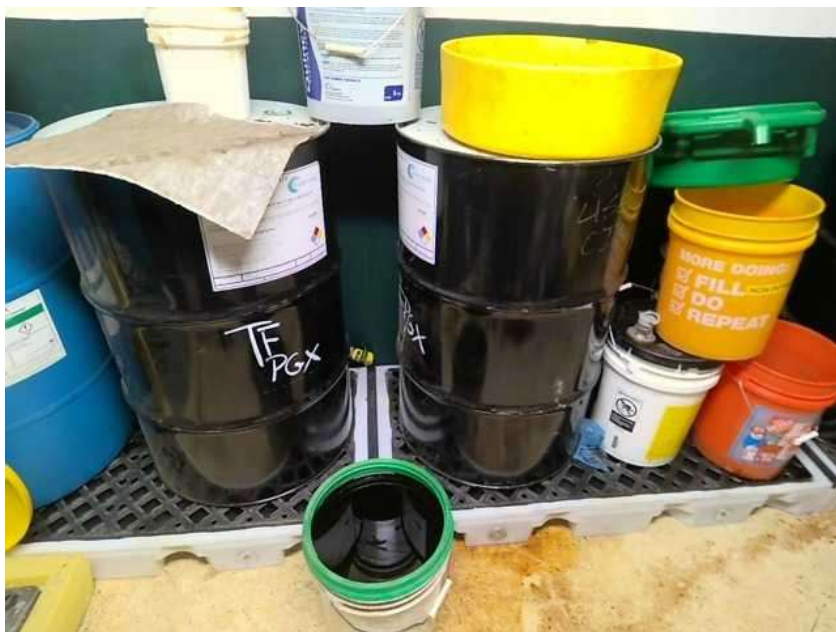
| Photo No. 25 | | | IMG-20240506104148414889743.jpg |

| One (1) each 55-gallon drum containing used oil with a closed top style drum. Facility staff wrote the words "Used Oil" on the drum as witnessed by the inspection team. | | | |

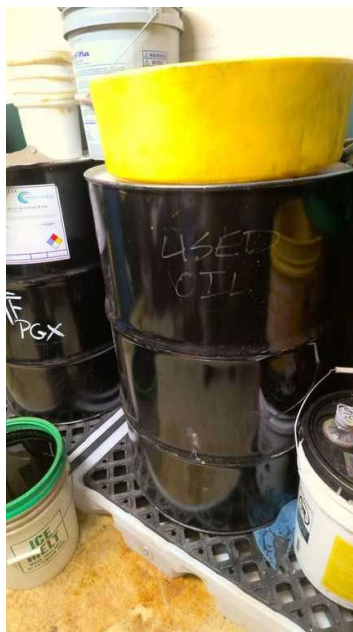
| Photo No. 26 | | | IMG-202405061045584558960325.jpg |

| View of container after facility personnel marked it with the words "Used Oil." | | | |

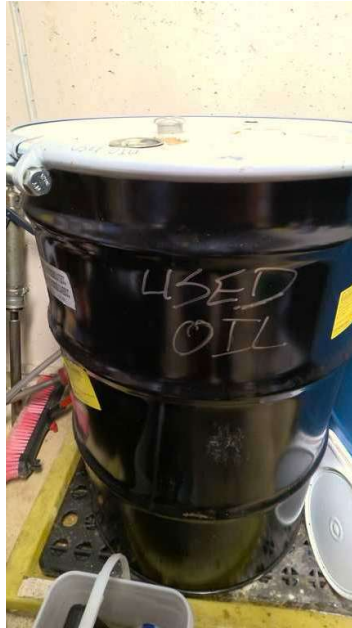
| Photo No. 27 | | | IMG-202405061046264626883377.jpg |

| Additional photo of the One (1) each 55-gallon drum containing used oil with an open top style drum. Facility staff wrote the words "Used Oil" on the drum as witnessed by the inspection team. | | | |

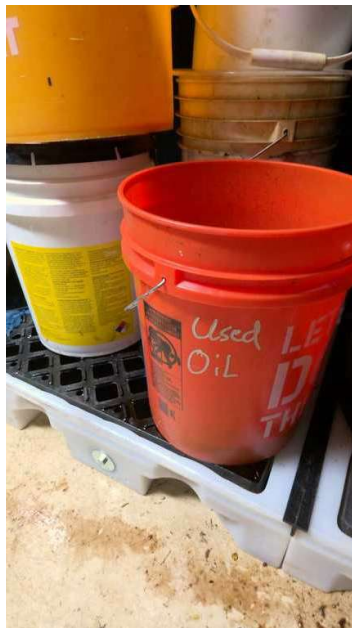
| Photo No. 28 | | | IMG-202405061046564656984677.jpg |

| One (1) each five (5) gallon pail Home Depot container with a small amount of used oil. Facility staff wrote the words "Used Oil" on the container as witnessed by the inspection team. | | | |

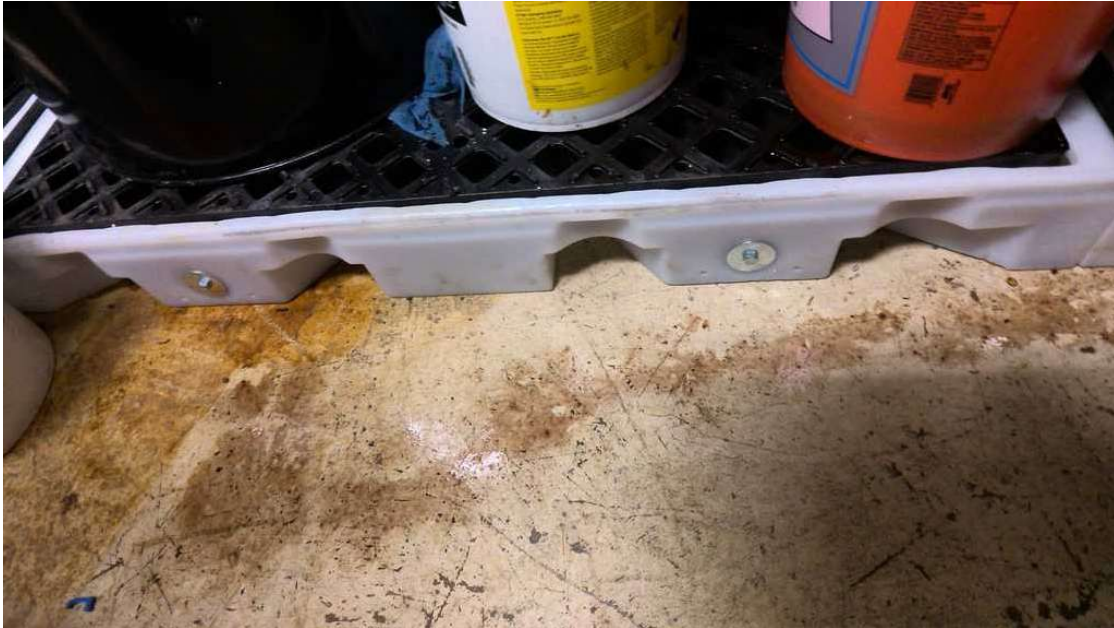
| Photo No. 29 | | | IMG-2024050610472847281389001.jpg |

| This picture shows that the spill containment pallet does not have the words "Used Oil" written on the outside, the pallet had a small amount of used oil in it. | | | |

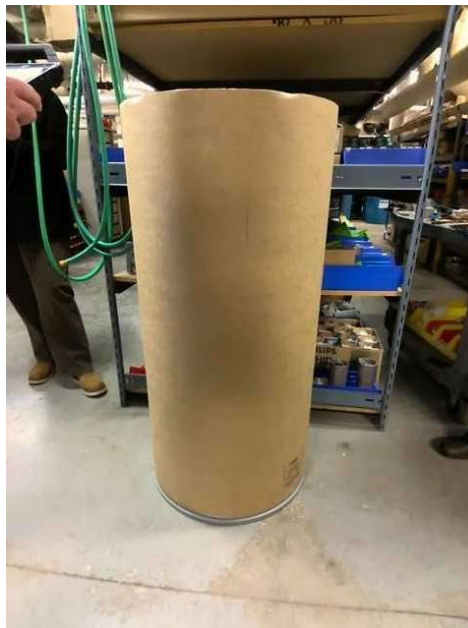
| Cardboard cylinder with 14 each four (4) foot used fluorescent lamps, no lid on container, and the container was not labeled or marked "Universal Waste-Lamps," "Waste Lamps", or "Used Lamps," and not marked with the earliest date that any of the lamps contained within became a waste. | | | |

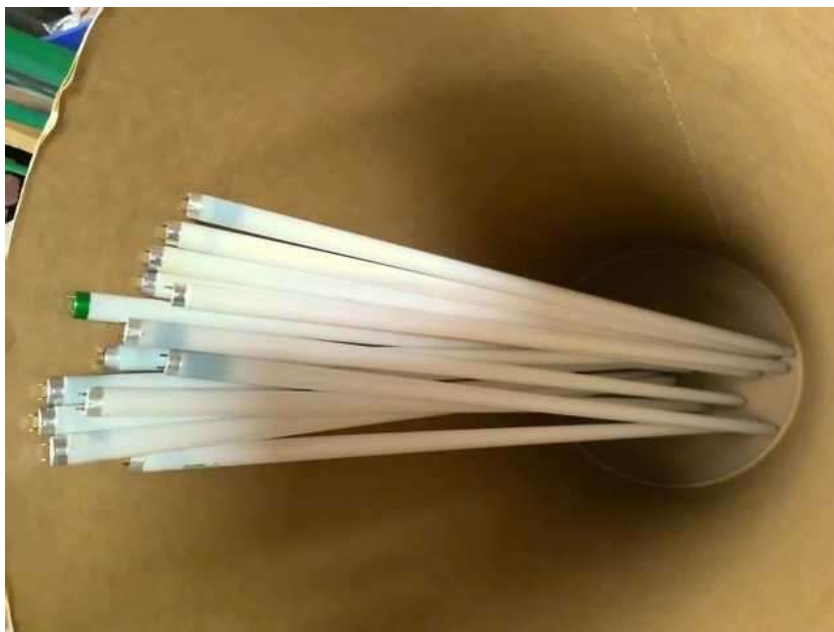
| Photo No. 31 | | | IMG-20240506111011101145951.jpg |

| Picture taken of the inside of the aforementioned cardboard cylinder showing the used fluorescent lamps inside. | | | |

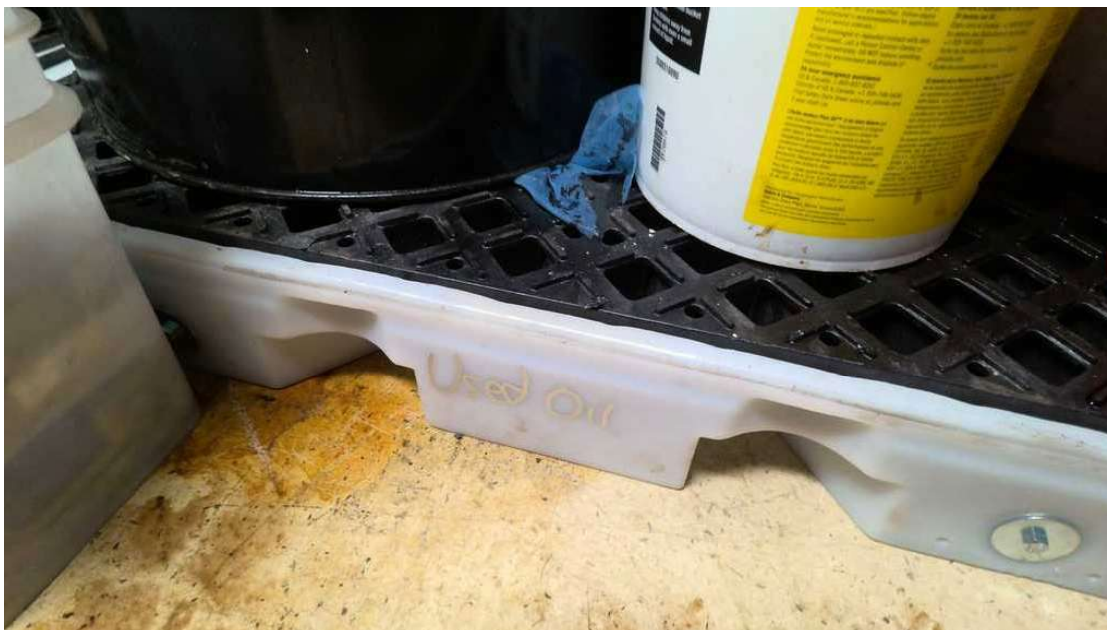
| Photo No. 32 | | | IMG-2024050610492849281086042.jpg |

| The spill containment pallet had some oil in it but was not labeled or marked with the words "Used Oil." This picture shows the pallet after staff had labeled it as witnessed by the inspection team. | | | |

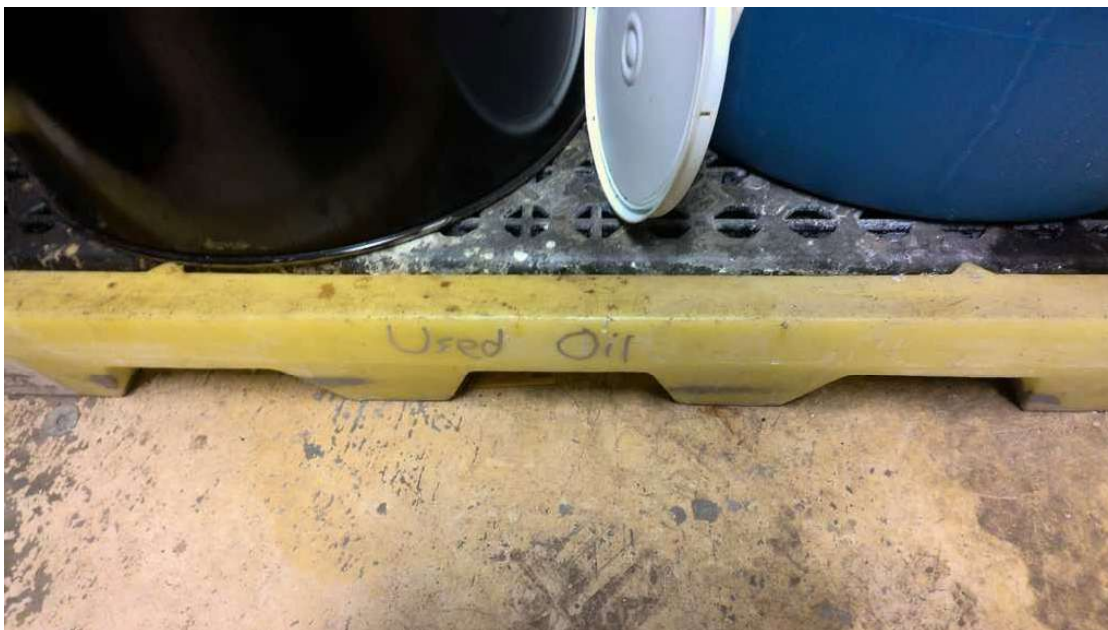
| Photo No. 33 | | | IMG-2024050610494349431232173.jpg |

| The spill containment pallet had some oil in it but was not labeled or marked with the words "Used Oil." This picture shows the pallet after staff had labeled it as witnessed by the inspection team. | | | |

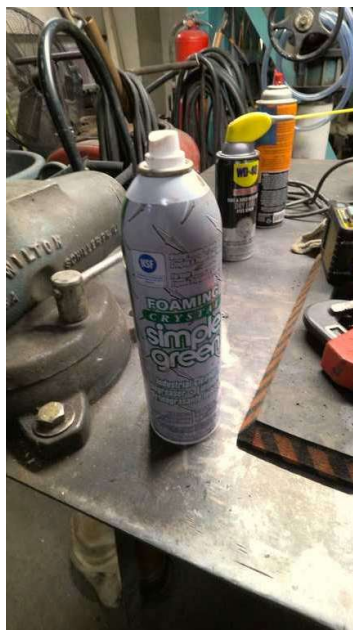
| Photo No. 34 | | | IMG-20240506110002021176256.jpg |

| View of a waste aerosol can, found on a cart, in the boiler room outside of the oil room. | | | |

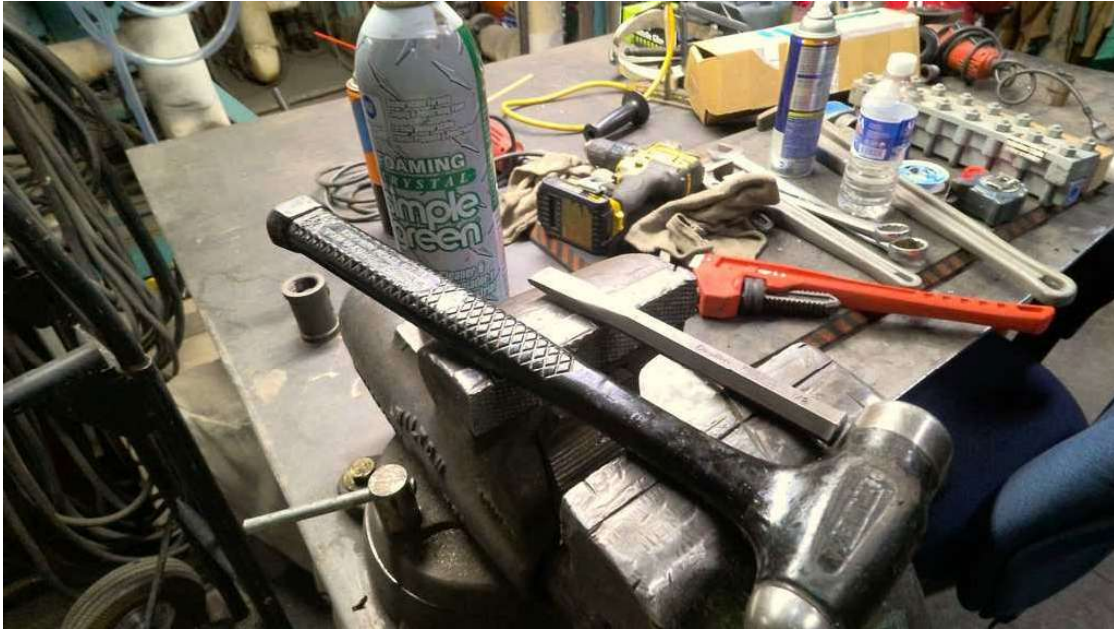
| Photo No. 35 | | | IMG-202405061101141141337539.jpg |

| View of the waste aerosol can along with the tools that are used to punch a hole in the can before the can is put in the trash. | | | |

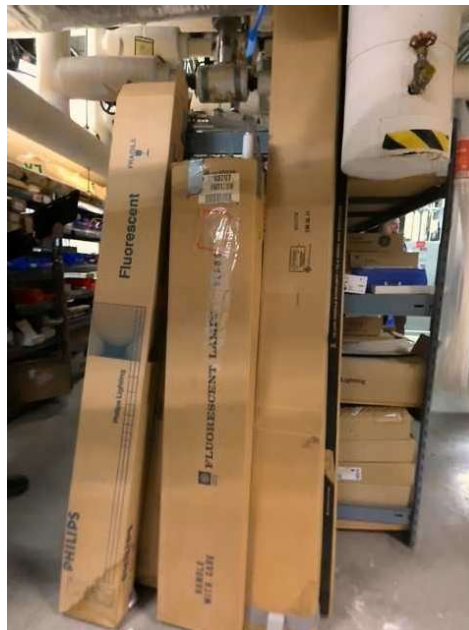
| Photo No. 36 | | | IMG-20240506112346234668326.jpg |

| Five (5) boxes of older mercury fluorescent tubes while still usable we were told they are no longer being used at the facility. The facility needs to decide if they use can them. If they are not going to use them then they need to either manage them as hazardous waste or as universal waste lamps. | <b>Regulations:</b> | <b>Sections:</b> |

| Five (5) cardboard containers of older high mercury content fluorescent tubes, employee says they still useable, but they are a type of fluorescent lamp that the facility is phasing out. Facility needs to make a waste determination. | | | |

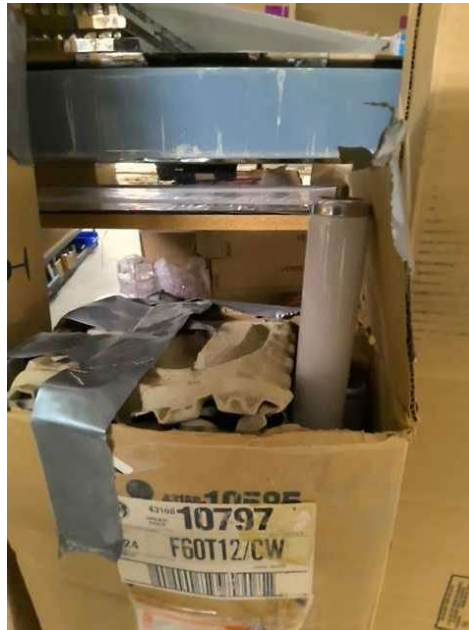
| Photo No. 37 | | | IMG-20240506112355235565678.jpg |

| Close up picture of one of the fluorescent lamps that the inspection team was told were still usable but are being phased out of service. | | | |

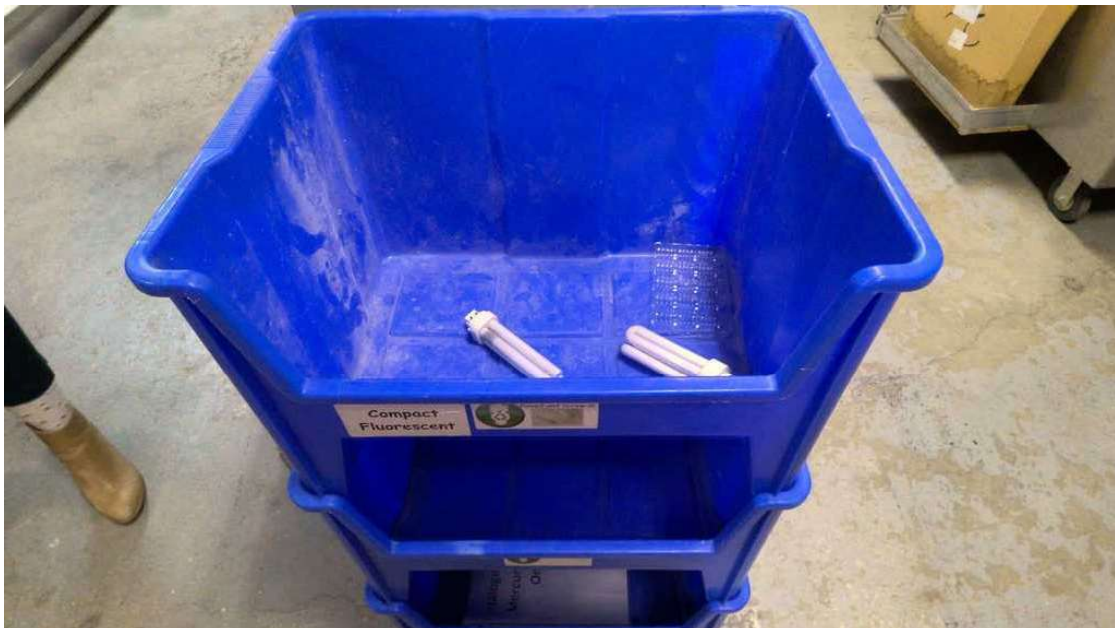
Lamp(s)," or "Used Lamp(s)." At the time of the inspection, the bin was improperly marked with the words "Compact Fluorescent" and not marked or labeled with the earliest date that any universal waste in the container became a waste or was received. (Photo No. 38)

| View of a blue plastic bin, containing two waste compact fluorescent light (CFL) bulbs that are not packaged to prevent breakage, labeled or marked "Universal Waste-Lamps," "Waste Lamps," or "Used Lamps", and not marked with the date they became a waste. | | | |

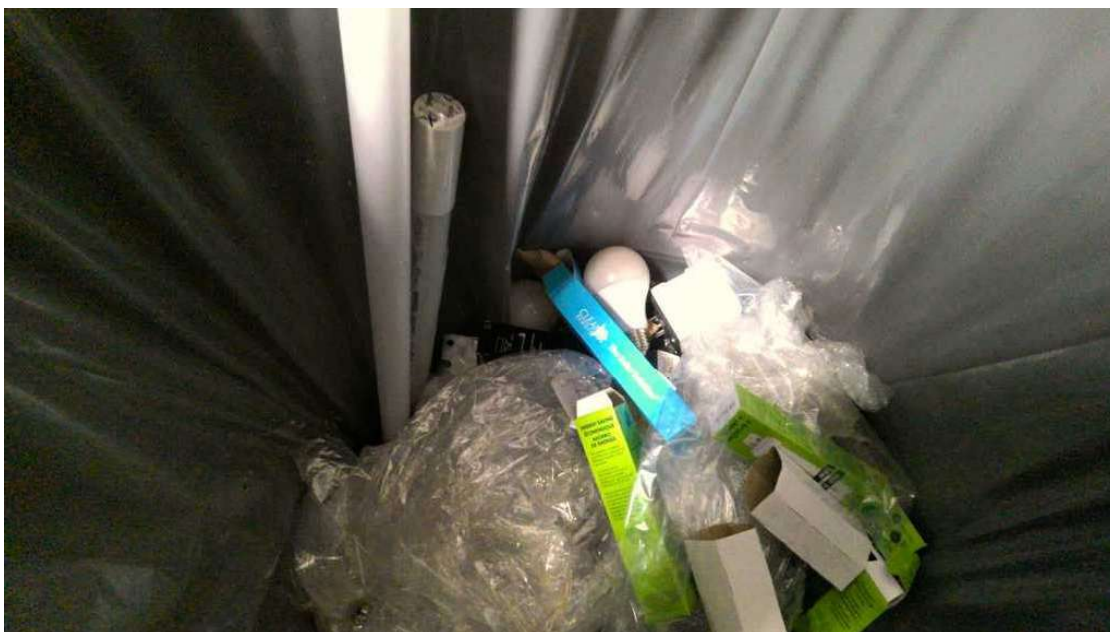
- Two (2) waste lamps that were either fluorescent or LED and two (2) waste bulbs that were fluorescent or LED observed in a trash can. The lamps and bulbs were not in a container or packaging that was adequate to prevent breakage and was not closed. The waste lamps and bulbs were also not labeled or marked clearly with one of the following phrases: "Universal Waste-Lamp(s)," "Waste Lamp(s)," or "Used Lamp(s)." (Photo No. 40)

| Two (2) waste lamps that were either fluorescent or LED and two (2) waste bulbs that were fluorescent or LED observed in a trash can. The lamps and bulbs were not in a container or packaging that was adequate to prevent breakage and was not closed. The waste tubes and bulbs were also not labeled or marked clearly with one of the following phrases: "Universal Waste-Lamp(s)," "Waste Lamp(s)," or "Used Lamp(s)." | <b>Regulations:</b> | <b>Sections:</b> |

| Two (2) waste lamps that were either fluorescent or LED and two (2) waste bulbs that were fluorescent or LED observed in a trash can. The lamps and bulbs were not in a container or packaging that was adequate to prevent breakage and was not closed. The waste lamps and bulbs were also not labeled or marked clearly with one of the following phrases: "Universal Waste-Lamp(s)," "Waste Lamp(s)," or "Used Lamp(s)." | | | |
