## EPA REGION 10 Enforcement Division

### INSPECTION REPORT

| <b>Regulatory Program</b> | Resource Conservation and Recovery Act (RCRA) | | |
| <b>Company Name</b> | Providence Alaska Medical Center | | |

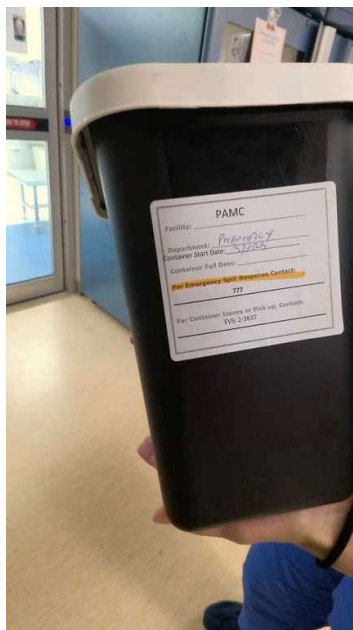
| Photo No. 41 | | | IMG-20240506120539539862649.jpg |

Two (2) black containers with translucent lids that held HWPharms. At the time of the inspection, they were closed; however, they were not labeled or clearly marked with the phrase "Hazardous Waste Pharmaceuticals" and were not marked with the date that the non-creditable HWPharms became a waste. Both containers were improperly labeled "Incompatible Pharmaceutical Wastes- Corrosives." We explained the labeling requirement to facility personnel and were told that pharmacy staff would label the containers with the words "Hazardous Waste Pharmaceuticals." (Photo Nos. 46, 47) One (1) black container with a translucent lid was closed and labeled "Hazardous Waste Pharmaceuticals," but was dated 3/8/2023 demonstrating that it had been on site for greater than one year without a permit or interim status. (Photo Nos. 43, 45) One (1) black container with a white lid was closed but was not labeled or clearly marked with the phrase "Hazardous Waste Pharmaceuticals." This container was also dated 3/8/2023, demonstrating that it had been on site for greater than one year without a permit or interim status. Both HWPharms containers, dated 3/8/23, had been accumulated on site for approximately a year and 2 months. (Photo No. 41)

| One (1) black container with a white lid not labeled "Hazardous Waste Pharmaceuticals" dated 3/8/2023. The container was closed. | <b>Regulations:</b> | <b>Sections:</b> |

| One (1) each black container with a white lid not labeled "Hazardous Waste Pharmaceuticals" dated 3/8/2023. The container was closed. | | | |

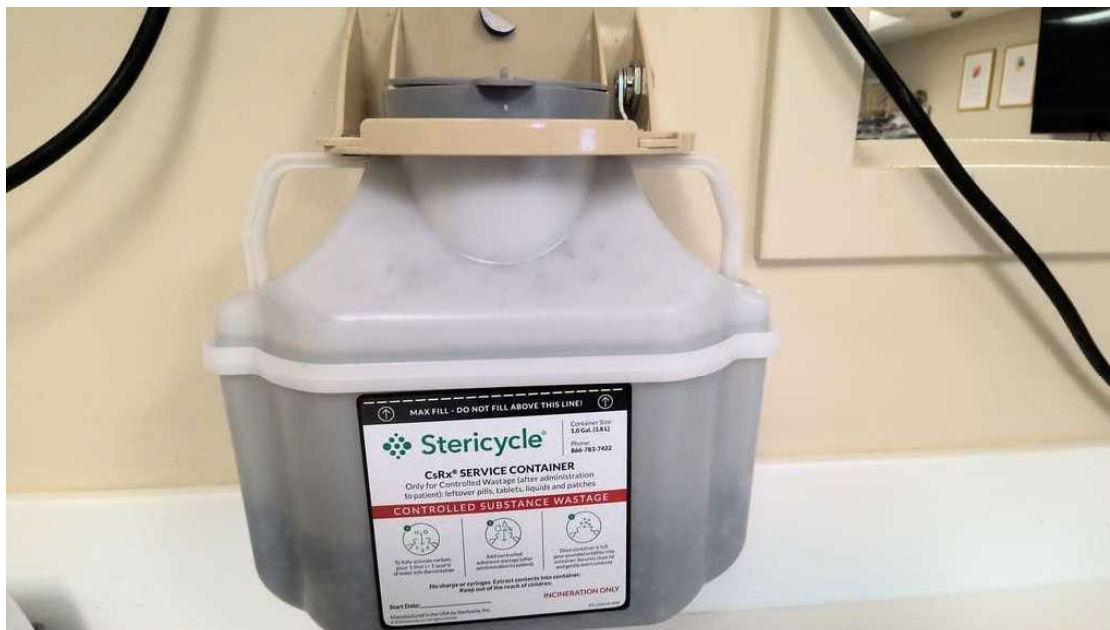
| Photo No. 42 | | | IMG-202405061212351235899479.jpg |

| Photo of a controlled substance disposal container used to neutralize DEA drugs. | | | |

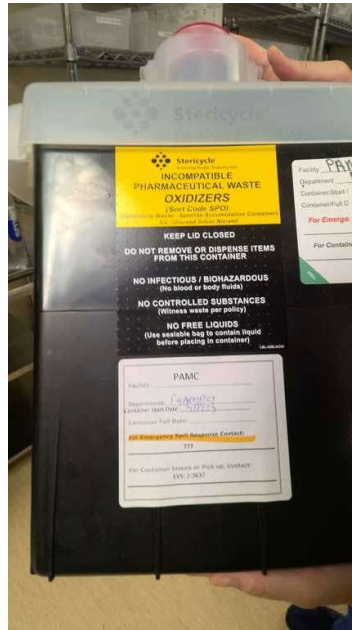
| Observed a black container with a translucent lid used for collecting hazardous waste pharmaceuticals that is dated 3/8/23 and has been accumulated for over a year this is a violation of the one-year accumulation limit for hazardous waste pharmaceuticals. | <b>Regulations:</b> | <b>Sections:</b> |

| One (1) each black container with a translucent lid labeled Hazardous Waste Pharmaceuticals dated 3/8/2023. The container was closed. This photo shows the date, photo no. IMG-202405061204504501049842 shows the container is labeled "Hazardous Waste Pharmaceuticals." | | | |

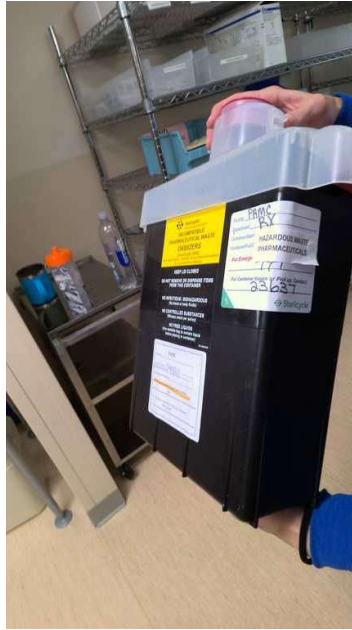
| Photo No. 45 | | | IMG-202405061204504501049842.jpg |

| One (1) each black container with a translucent lid. This photo shows the container is labeled "Hazardous Waste Pharmaceuticals." Photo No. IMG-20240506120437437974321 shows this container is dated 3/8/2023. | | | |

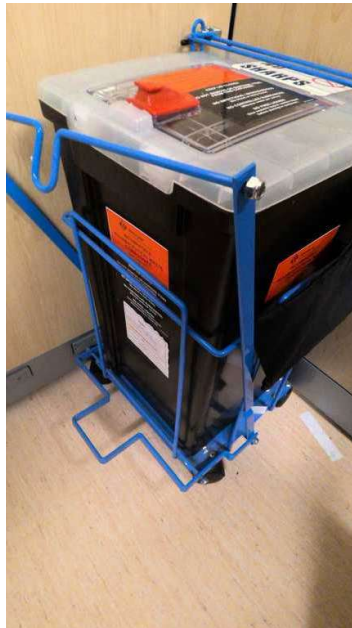
| Photo No. 46 | | | IMG-2024050611564756471271764.jpg |

| Two (2) black containers with translucent lids for hazardous waste pharmaceuticals they were closed but not dated and improperly labeled "Incompatible Pharmaceutical Wastes- Corrosives". | <b>Regulations:</b> | <b>Sections:</b> |

| One (1) of two (2) black containers with translucent lids for hazardous waste pharmaceuticals they were closed but not dated and improperly labeled "Incompatible Pharmaceutical Wastes- Corrosives". | | | |

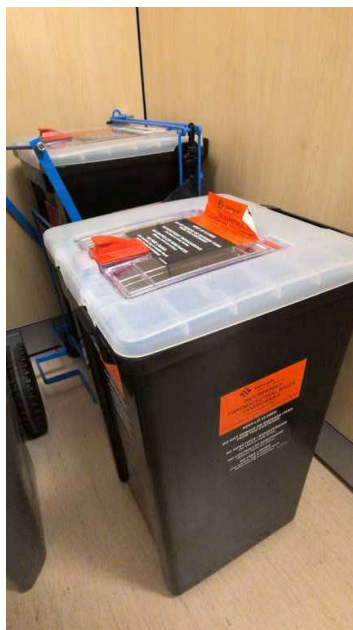
| Photo No. 47 | | | IMG-2024050611562656261244252.jpg |

| One (1) of two (2) black containers with translucent lids for hazardous waste pharmaceuticals they were closed but not dated and improperly labeled "Incompatible Pharmaceutical Wastes- Corrosives." | | | |

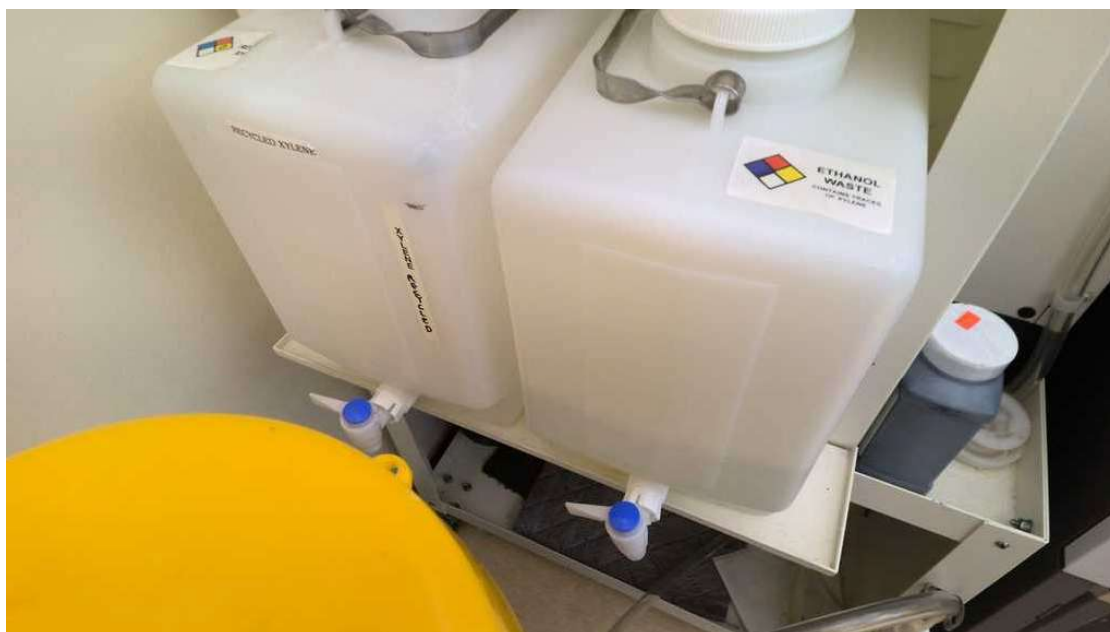
| Photo No. 48 | | | IMG-202405061352175217778765.jpg |

Ms. Jacobs provided an explanation of processes and chemicals used throughout the process of tissue staining. She told us formalin and xylene are used in the tissue processor. She told us xylene clears tissues and formalin fixes tissues. She also said the xylene is recycled. Ms. Jacobs said that waste xylene is placed in the recycling machine and when it is refreshed it then goes to a hood for use. The supervisor said the waste from the xylene recycler is paraffin and ethanol and that the ethanol is put down the sink. Per Ms. Jacobs waste formalin is placed in a bag in a five (5)-gallon box and is then treated with Aldex to neutralize the formalin. We observed a box labeled "Aldex added 4/22/24." Per Ms. Jacobs this waste is then placed down the drain. We asked if the facility has a wastewater pre-treatment permit with the municipality, we were informed that they do not. Manual staining is also performed in this lab. The lab supervisor states that xylene is placed in a container which appeared to be a plastic carboy type container capable of holding approximately 5 gallons for recycling, and that all other reagents (water, alcohols) are placed down the drain at the end of the week. The pathology lab discharges about 50ml alcohol per week to the drain. SDS were requested for all reagents and SOPs for all the processes discussed during the inspection. We requested SOP documents directing employees to discharge waste from the Pathology Lab to the drain. During the inspection we requested the quantity of waste disposed of to the drain. The facility did not make this information available during the inspection (Photo Nos. 48, 49, 56, 61)

| Photo shows a container of recycled xylene and a container of ethanol waste. We were informed that the recycled xylene is re-used while the ethanol is poured down a sink drain. | | | |

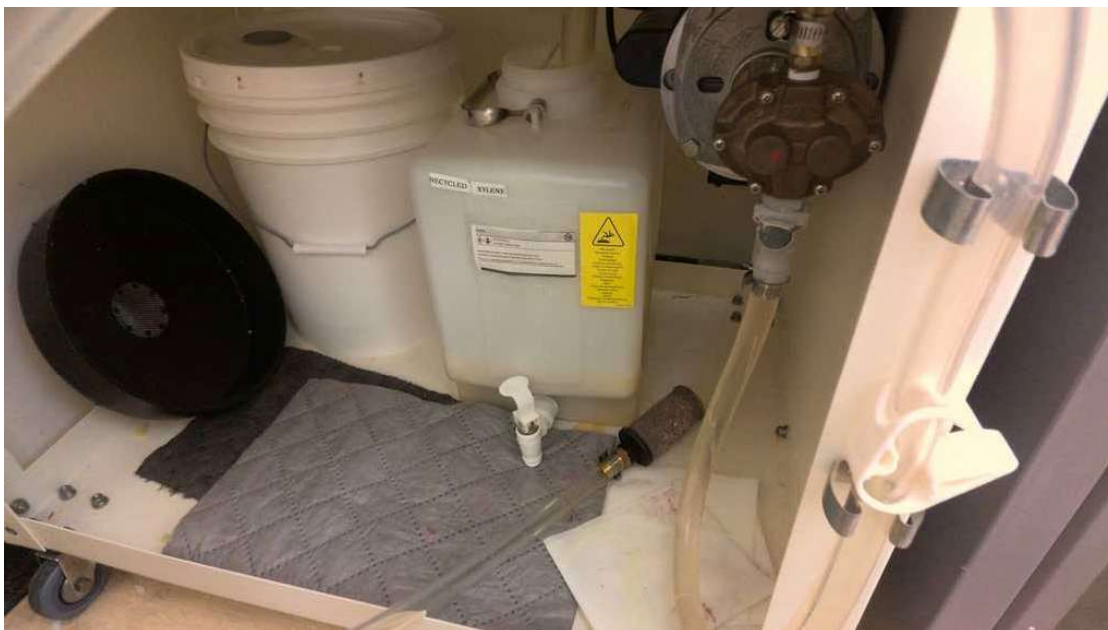
| Photo No. 49 | | | IMG-202405061352325232980321.jpg |

| The inspection team was told that the waste from xylene recycler is paraffin and ethanol, and that the ethanol is put down the sink. This is a container with paraffin in it. | | | |

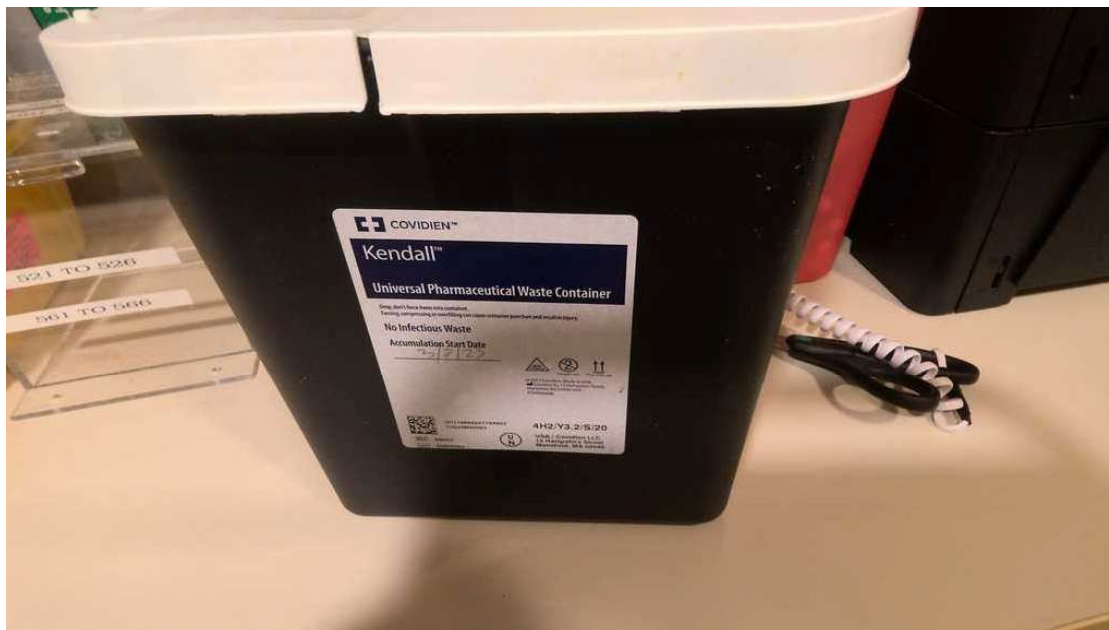
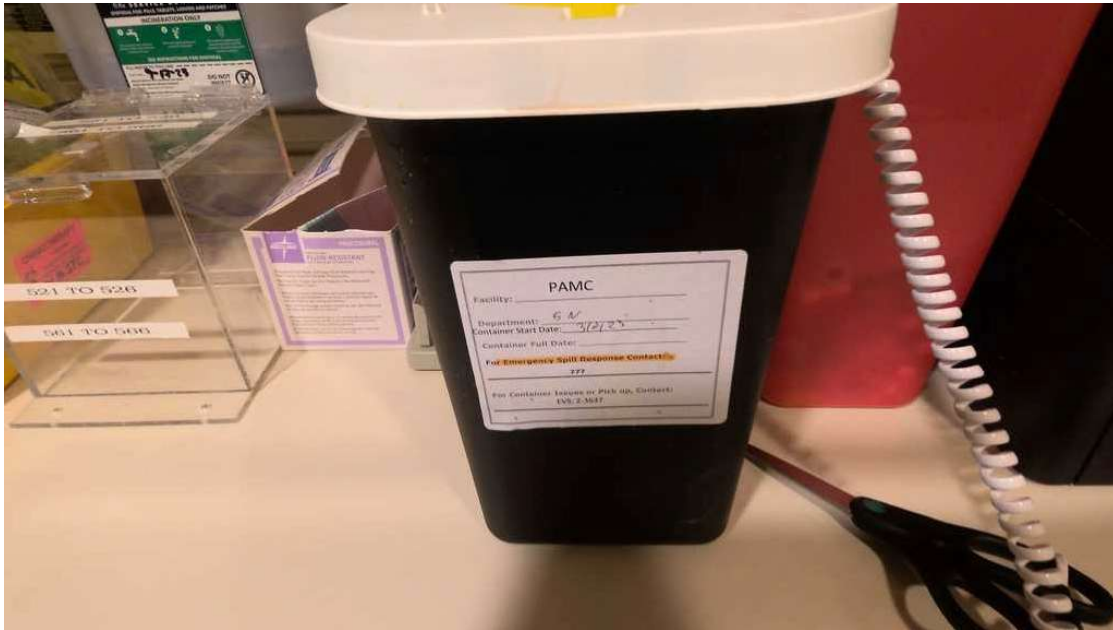
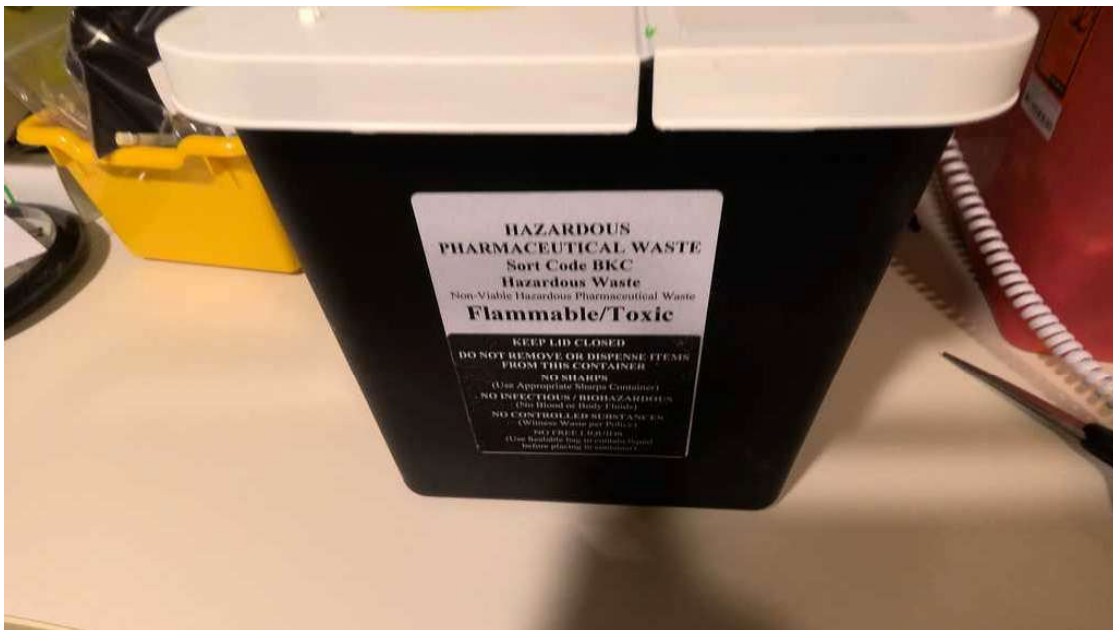
| We observed one (1) hazardous waste pharmaceuticals container present in this nursing station. The container is labeled incorrectly with the words "Hazardous Pharmaceutical Waste." It was dated 3/8/23 and has been in accumulation for greater than one year. We observed a controlled substance disposal container which is used to neutralize DEA regulated drugs. (Photo Nos. 57, 58, 59) | | | |

| Container of hazardous waste pharmaceuticals not labeled "Hazardous Waste Pharmaceuticals." Container is dated 3/8/23 the inspection occurred on 5/6/2024 this is a violation of the one-year accumulation limit for hazardous waste pharmaceuticals. | <b>Regulations:</b> | <b>Sections:</b> |

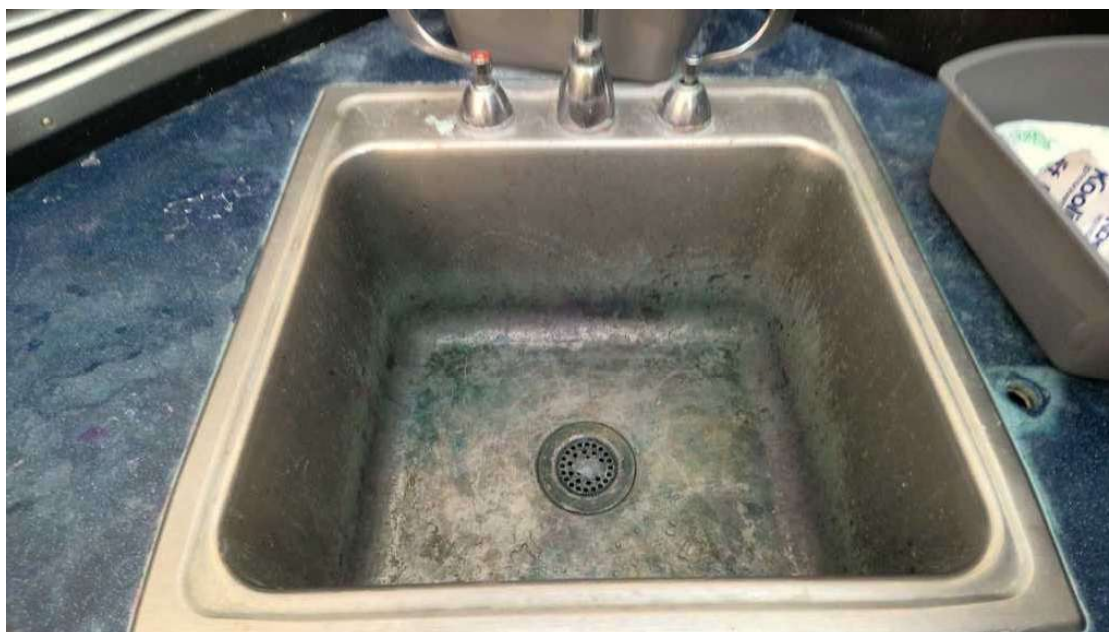
| Photo No. 61 | | | IMG-2024050613573157311120478.jpg |

| In the Pathology Laboratory waste formalin treated with "Aldex" is poured down the drain. The facility needs to make a hazardous waste determination. | <b>Regulations:</b> | <b>Sections:</b> |

| Ethanol waste from the xylene recycling machine is poured down this drain. | | | |

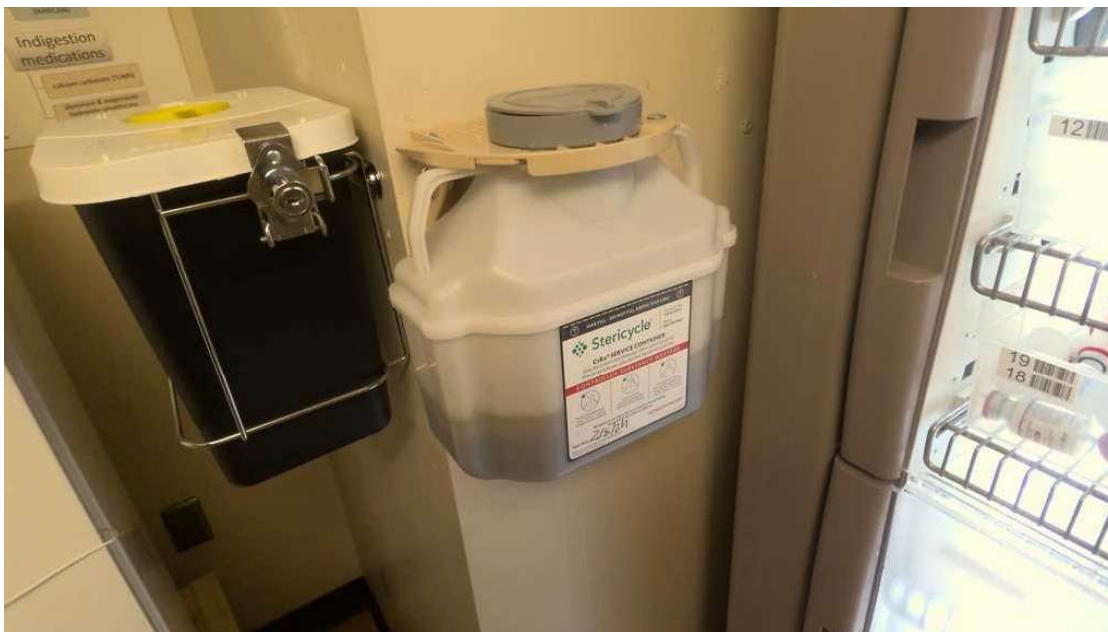
| Photo No. 64 | | | IMG-202405061426432643820877.jpg |

| <ul style="list-style-type: none"><li>• We observed one (1) hazardous waste pharmaceuticals container present in this nursing station. This container was not labeled “Hazardous Waste Pharmaceuticals.” It was dated 9/16/23 and is within one year of accumulation. We pointed out to the hospital staff that the containers used for hazardous waste pharmaceuticals have lids hinged near the middle, the construction of the lid appears to prevent it from maintaining a full seal when closed. It is recommended that the facility consider using other containers. (Photo No. 63)</li><li>• We observed a controlled substance disposal container which is used to neutralize DEA drugs. (Photo No. 64)</li></ul> | | | |

| Hazardous waste pharmaceuticals container not labeled "Hazardous Waste Pharmaceuticals." | <b>Regulations:</b> | <b>Sections:</b> |
