## RCRA Compliance Evaluation Inspection Report

Univar Solutions USA Inc. Birmingham  
3300 Ball Street  
Birmingham, Alabama 35243  
County: Jefferson  
Latitude: 33.331026  
Longitude: -86.47121

June 16, 2021, 9:00 a.m.

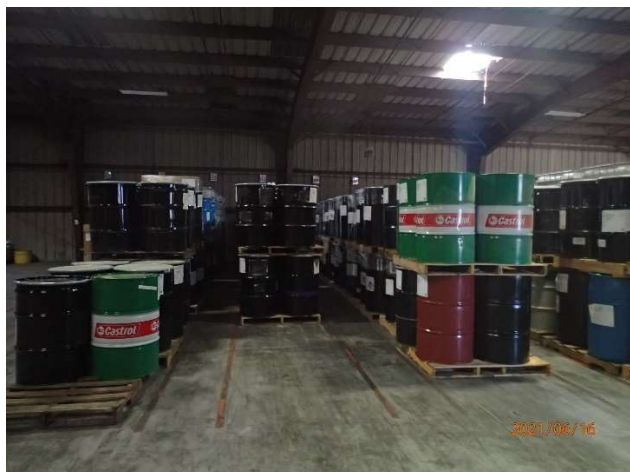
The Main Warehouse is a 25,600 square feet corrugated metal building with a coated concrete floor and five truck loading/un-loading bays. The warehouse houses chemical formulations ingredients, packaged products (corrosives), non-hazardous and universal wastes. During the inspection, the inspectors observed various sizes of containers (250-gallon totes, 55-gallon drums, 5-gallon containers, etc.) holding chemical ingredients, packaged chemical products in 250-gallons totes and 55-gallons drums, various non-hazardous wastes (neutralized sulfuric acid in 250-gallon totes) and used oil in 55-gallon drums staged throughout the warehouse (Photograph #1). The non-hazardous waste containers were closed and marked with the words "Non-RCRA Material" and "Non-Regulated Material." All used oil containers were closed and marked "Used Oil." No universal wastes were present at the time of the inspection.

Photo #1 – Main Warehouse storage area.

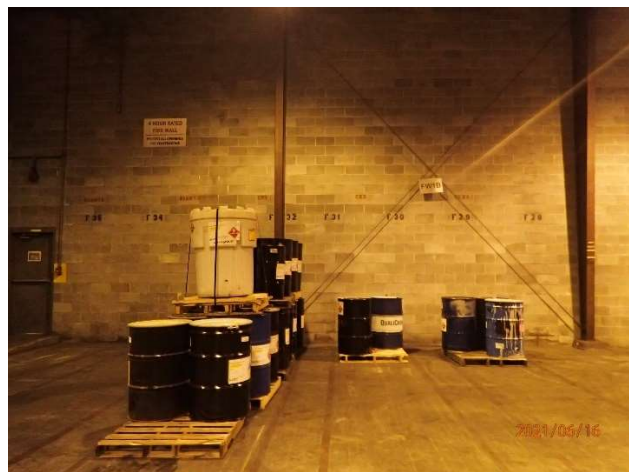
Ms. Dooley next escorted the inspectors to a cinderblock building housing Univar's 90-Day hazardous waste storage and 10-Day hazardous waste transfer areas (Photograph #2). The Flammable Materials warehouse occupies approximately 5,000 square feet. A pair of doors (one personnel door and one roll-up door) on one side of the building connected it to the product storage warehouse. A pair of doors (one personnel door and one roll-up door) on the opposite side of the building connected it to the product packaging area. Warning signs were posted near both sets of doors. The room was equipped with a coated concrete floor which functioned as a secondary containment system. This section of the warehouse is equipped with heat rise

- No containers were stored in the 90-Day hazardous waste “FW1B” area;
- Twenty-three 55-gallon containers in Aisle F-32 and three 55-gallon containers in Aisle F-31 contained various types of hazardous waste (aerosol can liquids, contaminated PPE, nickel filter waste, waste paint, waste resin, and waste solvent); and
- Three 55-gallon containers contained paint and solvent waste in Aisle F-29.

All 10-Day transfer area waste containers were closed, marked “Hazardous Waste,” with an indication of the hazards of the contents, and transfer facility arrival date of less than ten days.

Photo #2 – 55-gallon containers stored in 10-Day Transfer Area.

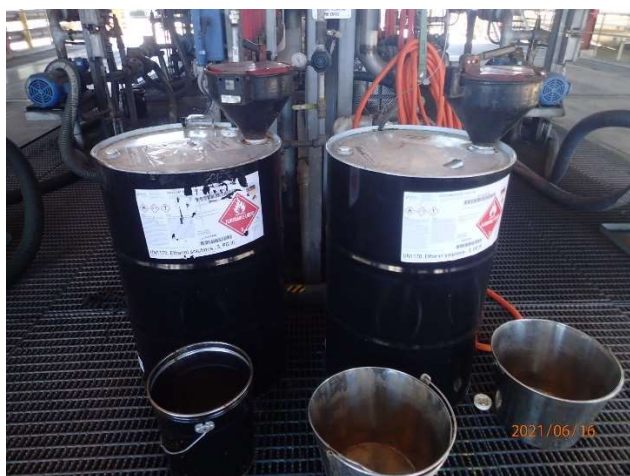
- One closed metal 55-gallon drum contained solvent-contaminated rags (U002, U159, U220, and U235) marked “Hazardous Waste,” and “Flammable Solids;”
- One closed 55-gallon drum contained line flush waste and marked “Flammable Liquids.” The container was half full but was not marked “Hazardous Waste” (Photograph #3);
- One closed 55-gallon drum marked “Flammable Liquids.” The container was empty. Ms. Dooley explained that the empty drum would be used as a satellite accumulation container for line flush waste after the existing container of line flush waste was filled. Ms. Dooley placed “Hazardous Waste” label on the containers at the time of the inspection.

**Pursuant to ADEM Admin. Code r. 335-14-3-.01(5)(a)5. [40 C.F.R. § 262.15(a)(5)], which is a condition of the SAA Permit Exemption, a generator is required to mark or label its containers (i) with the words “Hazardous Waste.”**

Photo #3 – One half full and one empty 55-gallon containers of line flush waste stored in the Off-Loading Area.
