## **RCRA Inspection Report**

Penn A Kem, LLC  
3324 Chelsea Avenue  
Memphis, Tennessee 38108

EPA ID#: TND120603170  
NAICS #: 325199 – All Other Basic Organic  
Chemical Manufacturing

April 09, 2024, at 9:45 A.M.

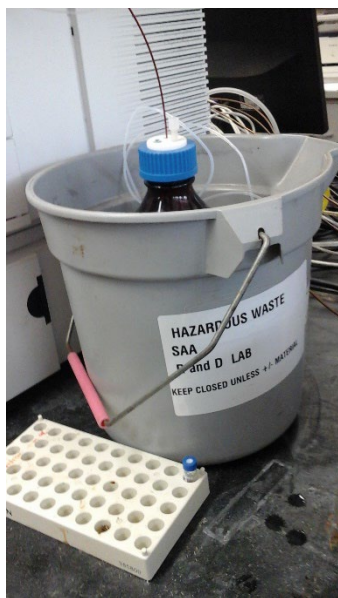
Inside the R&D Laboratory in the Northwest Lab Station the inspectors observed a satellite accumulation area (SAA) for a liquid chromatography mass spectrometry (LCMS) machine which contained an 1800-mL glass container of laboratory waste inside a secondary containment gallon-sized bucket. The 1800-mL container was closed and labeled "Hazardous Waste" but was not marked with an indication of the hazard of the contents (Photo 3).

**Pursuant to Tenn. Comp. R. & Regs. 0400-12-01-.03(1)(f)1.(v) [40 C.F.R. § 262.15(a)(5)(ii)], A generator must mark or label its container with the following: (ii) An indication of the hazards of the contents (examples include, but are not limited to, the applicable hazardous waste characteristic(s) (i.e., ignitable, corrosive, reactive, toxic); hazard communication consistent with the Department of Transportation requirements at 49 CFR part 172 subpart E (labeling) or subpart F (placarding); a hazard statement or pictogram consistent with the Occupational Safety and Health Administration Hazard Communication Standard at 29 CFR 1910.1200; or a chemical hazard label consistent with the National Fire Protection Association code 704).**

At the time of the CEI, the inspectors observed a closed 1800-mL container in the R&D Laboratory, labeled “Hazardous Waste” but it was not marked with an indication of the hazard of the contents.

**Photo 3:** SAA 1800-mL container in R&D laboratory, missing an indication of the hazard of the contents.

During the inspection, Facility representatives labeled the SAA container with an indication of the hazard of the contents (flammable).

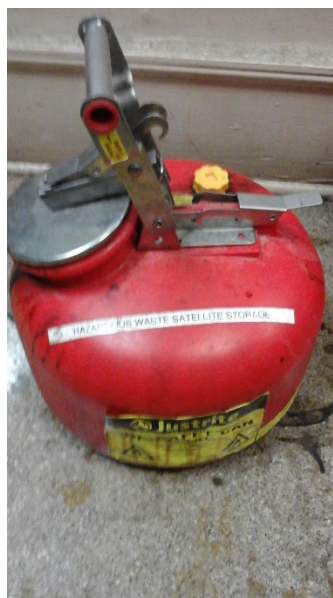
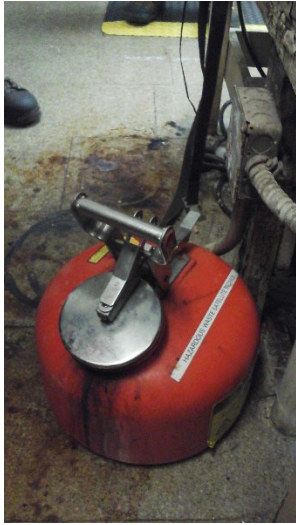
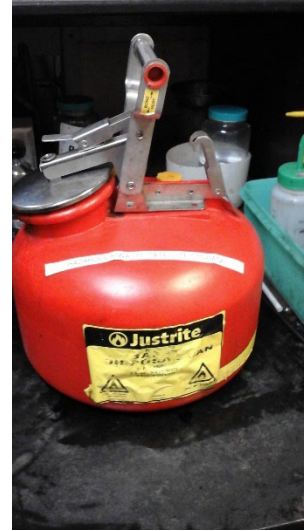
In the East Lab Station of the R&D Laboratory, the inspectors observed three two-gallon red containers for flammable hazardous waste in SAAs. Each container was closed, labeled "Hazardous Waste," and marked with an indication of the hazard of the contents (flammable). In the South Lab Station, the inspectors observed two 2-gallon red containers for flammable hazardous waste in SAAs. Each container was closed, labeled "Hazardous Waste," and marked with an indication of the hazard of the contents (flammable) (Photos 4-6).

**Photo 4:** SAA in R&D laboratory for flammable waste.

**Photo 5:** SAA in R&D laboratory for flammable waste.

**Photo 6:** SAA in R&D laboratory for flammable waste.

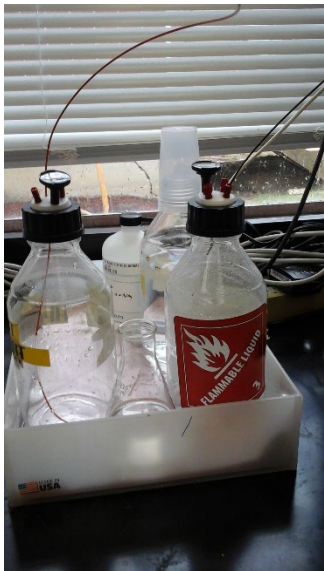
The QC Laboratory is used to take samples of products for quality control. The inspectors observed one 2.5-gallon red container for flammable hazardous waste. The container was closed, labeled "Hazardous Waste," and marked with an indication of the hazard of the contents (flammable). The inspectors also observed one high performance liquid chromatography (HPLC) machine which was connected to a 1000-mL container in a SAA for laboratory waste. The container was closed and marked with an indication of the hazard of the contents, but the container was not labeled with the words "Hazardous Waste" (Photo 7).

**Pursuant to Tenn. Comp. R. & Regs. 0400-12-01-.03(1)(f)1.(v) [40 C.F.R. § 262.15(a)(5)(i)], a generator must mark or label its container with the following: (i) The words "Hazardous Waste".**

At the time of the CEI, the inspectors observed one 1,000-mL container of laboratory waste from an HPLC machine in the QC Laboratory that was closed, marked with an indication of the hazard of the contents (flammable) but was not labeled “Hazardous Waste.”

**Photo 7:** 1000-mL SAA container in QC Laboratory missing a hazardous waste label.

During the inspection, Facility representatives labeled the container with the words "Hazardous Waste."

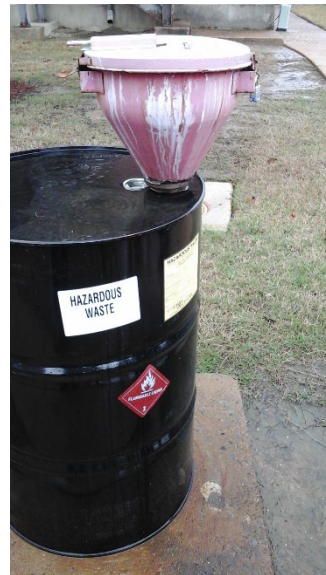
The inspectors observed one 55-gallon hazardous waste container of laboratory waste labeled "Hazardous Waste," in the CAA. The container was closed, dated 02/23/2024, and marked with an indication of the hazard of the contents (Photo 8).

**Photo 8:** QC Laboratory CAA.

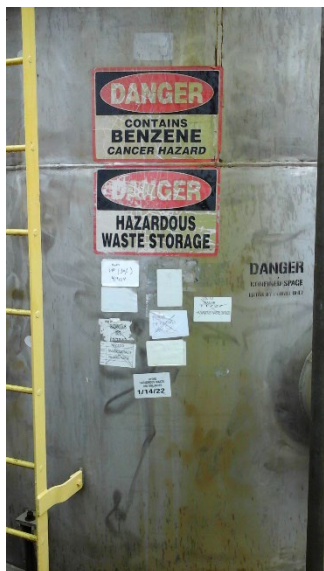
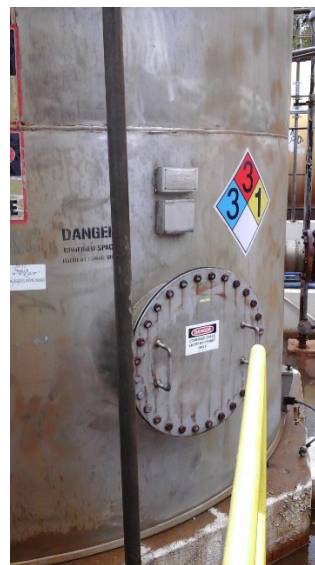
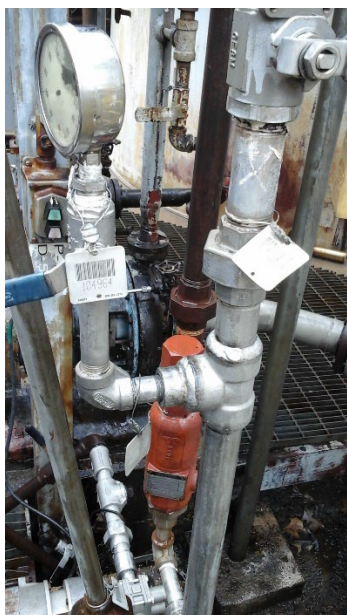
The Facility operates two hazardous waste tanks. Tank D-50 is a 10,000-gallon above ground storage tank and Tank D-60 is a 3,500-gallon above ground storage tank. Both tanks are equipped with a high-level alarm for overfill prevention and are situated inside a concrete secondary containment pad which appeared in good condition and free of cracks. According to the Facility’s hazardous waste tank inventory tracking logs, Tank D-50 was last emptied on 03/19/2024 and contained 3,000 gallons of hazardous waste at the time of the inspection. Tank D-60 is currently out of service and was emptied on 03/10/2024. Both tanks were labeled with the words “Hazardous Waste” and marked with an indication of the hazard of the contents (NFPA Placards). Hazardous waste tank ancillary equipment was observed to be tagged with barcodes and serial numbers as a part of leak detection and repair (LDAR) standards for organic air emissions. No issues were noted for tank D-50’s pumps, flanges, valves, endcaps, screws, and bolts. Since it was raining during the inspection, the inspectors did not climb up the ladder to inspect the top of the tanks but did review hazardous waste tank inspection records during the records review (Photos 9-11).

**Photo 9:** Tank Farm

**Photo 10:** Tank Farm

**Photo 11:** Tank Farm

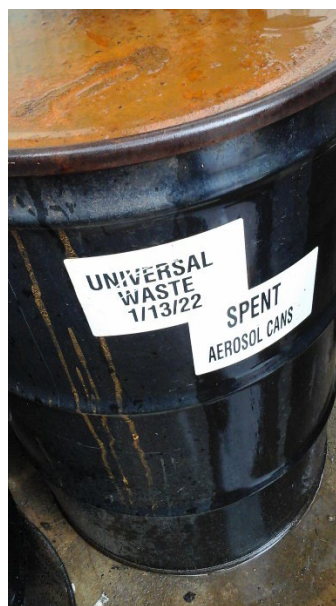
Outside of the Fine Chemicals Building, the inspectors observed one 55-gallon container of used aerosol cans (Photo 12). The container was closed, labeled “Universal Waste—Spent Aerosol Cans”, and dated 01/13/2022 (accumulating over one year).

**Photo12:** Outside of Fine Chemicals Building: 55-gallon universal waste spent aerosol cans container dated 01/13/2022.

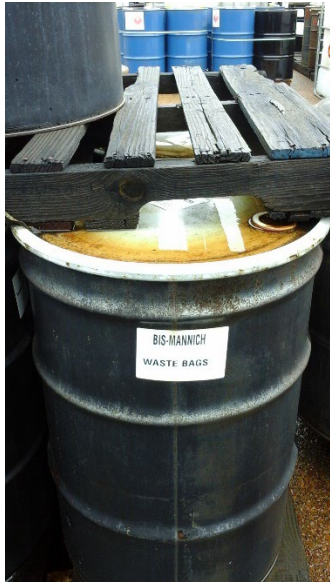
The inspectors observed one undated 55-gallon container labeled "BIS-Mannich Waste Bags" that was open and appeared to be leaking a black substance onto the concrete floor (Photo 13). The Facility had not made a determination if the material was hazardous waste or not. There was also one 55-gallon closed containers labeled "Waste Clean-Up" that was dated 09/13/2021 (Photo 14). The Facility had not determined if the container was a hazardous waste when asked by the inspectors. The inspectors requested a waste profile for these two containers. As of the drafting of this report, the requested waste profiles had not been received.

**Pursuant to Tenn. Comp. R. & Regs. 0400-12-01-.03(1)(b) [40 C.F.R. § 262.11], a person who generates a solid waste, as defined in 40 CFR 261.2, must make an accurate determination as to whether that waste is a hazardous waste in order to ensure wastes are properly managed according to applicable RCRA regulations. A hazardous waste determination is made using the steps listed in 40 C.F.R. § 262.11(a-g).**

**Pursuant to Tenn. Comp. R. & Regs. 0400-12-01-.03(1)(h)1.(vi) [40 C.F.R. § 262.17(a)(6)], which incorporates Tenn. Comp. R. & Regs. 0400-12-01-.03(12). [40 C.F.R. § 262.251], and is a condition of the LQG permit exemption, a large quantity generator must maintain and operate its facility to minimize the possibility of a fire, explosion, or any unplanned sudden or non-sudden release of hazardous waste or hazardous waste constituents to air, soil, or surface water which could threaten human health or the environment.**

**Photo 13:** Open leaking container labeled “BIS-Mannich Waste Bags” in product storage area on concrete floor North of Building 85.

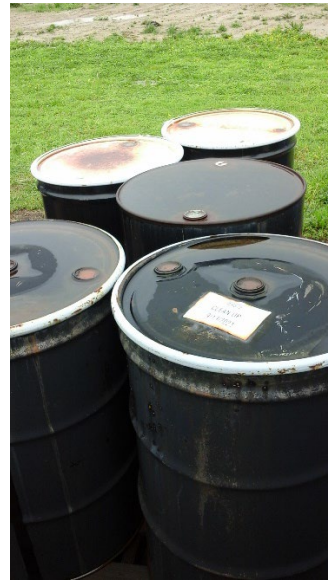
**Photo 14:** Container labeled “Waste Clean Up” and dated 09/13/2021 in product storage area on concrete floor North of Building 85.

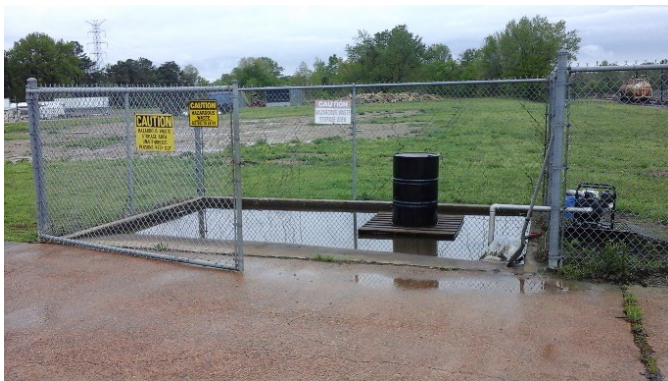
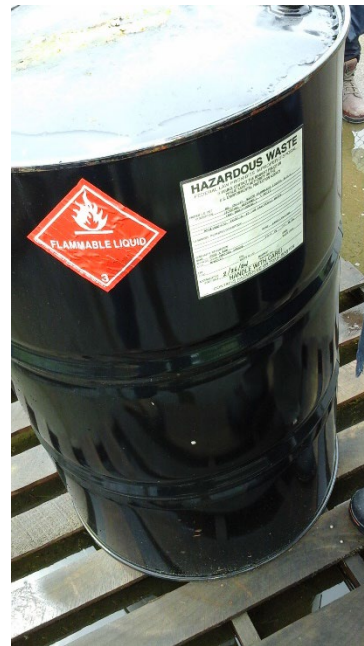
The Facility's main CAA is located Northeast of Building 85 next to the Concrete Pad North of Building 85. The CAA is enclosed with a secured perimeter fence and stores both hazardous and non-hazardous waste. The hazardous waste is separated from the non-hazardous waste within the CAA in a sloped area. The inspectors observed one 55-gallon container of acetone/methanol waste (Photo 15 & 16). The container was closed, labeled "Hazardous Waste—Acetone/ Methanol Waste Flammable Liquid," marked with an indication of the hazard of the contents, and dated 02/26/2024. The CAA containment appeared to be filled with rainwater. It was raining during the morning of the inspection. The facility does pump rainwater out from the containment area and analyzes it to determine how to manage the rainwater before disposal.

The inspectors also observed two 55-gallon closed containers labeled "Used Oil" and two 55-gallon closed containers labeled "Used Anti-freeze." The inspectors requested two waste profiles for two 55-gallon non-hazardous waste containers that were labeled "DFP B#3 Bottoms" (dated 04/20/2020) and "DFP Bottoms from D-50, B's #7, 8, 9" (dated 05/10/2021). The profiles were later provided to the inspectors via email and demonstrated that the wastes were non-hazardous. It was unclear why these containers had not yet been shipped offsite and appear to be accumulated speculatively.

It was noted that the CAA was equipped with a spill kit but did not have fire control equipment nearby.

**Photo 15:** Main CAA.

**Photo 16:** Main CAA.

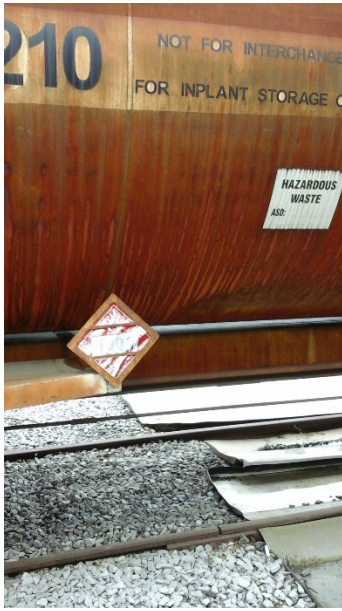
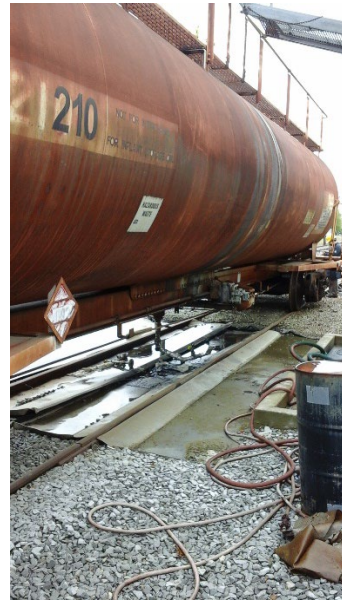
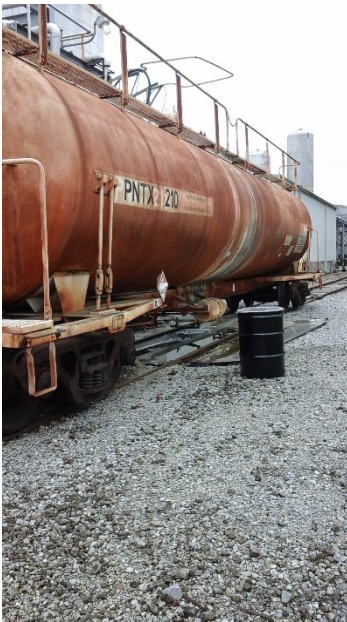
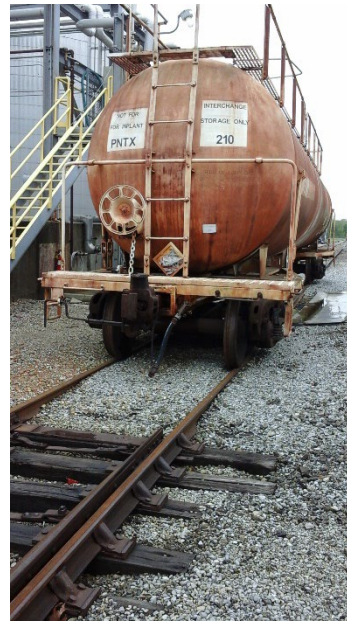
Located on the eastside of the Facility is a 20,737-gallon railcar used as a less than 90-day hazardous waste container (Photos 17-20). The railcar is used to store wash water collected from production campaigns. It has been in operation since April 2019. The wash water is transferred to the railcar via hose. The railcar was labeled "Hazardous Waste" and was marked with an indication of the hazard of the contents (flammability). The D.O.T. placards shown in Photos 17-20, which appeared to be heavily faded, were the only indication of hazards on the railcar. It is recommended that the facility place new placards on the railcar. The Facility uses a tracking inventory to track when the railcar is emptied (every 45-days). The railcar was last emptied on 03/23/2024 and was empty at the time of the inspection. The Facility representatives indicated that the railcar will be used for wash water until a new hazardous waste tank (currently being installed) is certified by a P.E. and placed into service.

It was noted by the inspectors that the railcar appears to exhibit signs of corrosion. Since the container was empty at the time of the inspection, it is recommended that the facility either conduct maintenance on the railcar to repair the corrosion issue before storing hazardous waste in the railcar again; or place hazardous waste in a different container that is in good condition pursuant to *Tenn. Comp. R. & Regs. 0400-12-01-.03(1)(h)1.(i)(II) [40 C.F.R. § 262.17(a)(1)(ii)]*, which states that if a container holding hazardous waste is not in good condition, or if it begins to leak, the large quantity generator must immediately transfer the hazardous waste from this container to a container that is in good condition, or immediately

**Photo 17:** Railcar CAA.

**Photo 18:** Railcar CAA.

**Photo 19:** Railcar CAA.

**Photo 20:** Railcar CAA.

*manage the waste in some other way that complies with the conditions for exemption of this section.*

The facility representatives did state that a new hazardous waste tank was in the process of being installed to store this waste stream. Once complete, the railcar would no longer be used to store hazardous waste.

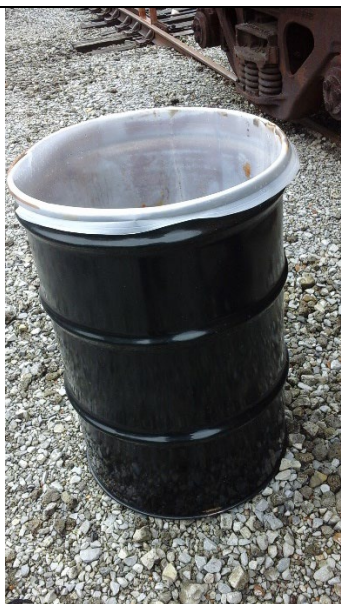
In addition to the railcar, the inspectors observed one 55-gallon container with no lid that had no label on it and appeared to have black liquid inside (Photo 21 & 22). The Facility representatives did not know the contents of the container when asked by the inspectors. There were also two additional 55-gallon drums next to the Railcar CAA which were closed but did not have any labels on them (Photo 23). These containers did not appear empty when the inspectors tried to tap and move the containers. The Facility representatives did not know if the containers were product or waste.

**Pursuant to Tenn. Comp. R. & Regs. 0400-12-01-.03(1)(b) [40 C.F.R. § 262.11], a person who generates a solid waste, as defined in 40 CFR 261.2, must make an accurate determination as to whether that waste is a hazardous waste in order to ensure wastes are properly managed according to applicable RCRA regulations. A hazardous waste determination is made using the steps listed in 40 C.F.R. § 262.11(a-g).**

**Photo 21:** Open 55-gallon container with black liquid in Railcar CAA.

**Photo 22:** Open 55-gallon container with black liquid in Railcar CAA.

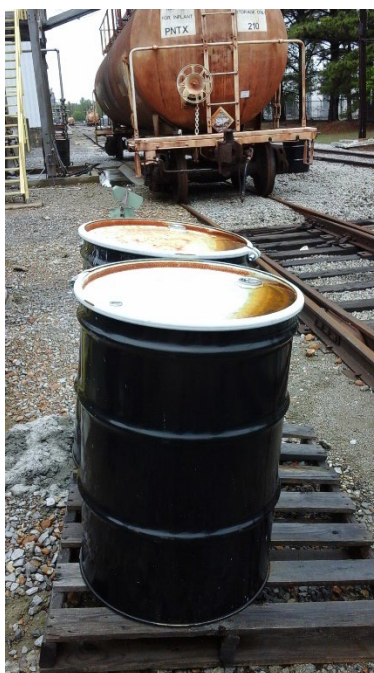
**Photo 23:** Two 55-gallon unlabeled containers in Railcar CAA.
