### INSPECTION REPORT

| Company Name: | CB Jeni Homes DFW, LLC dba Normandy Homes | |
| Facility Name: | Painted Tree (Lakeside South Phase 1 & 2) | |
| Identification/Permit Number: | TXR1538MP | |

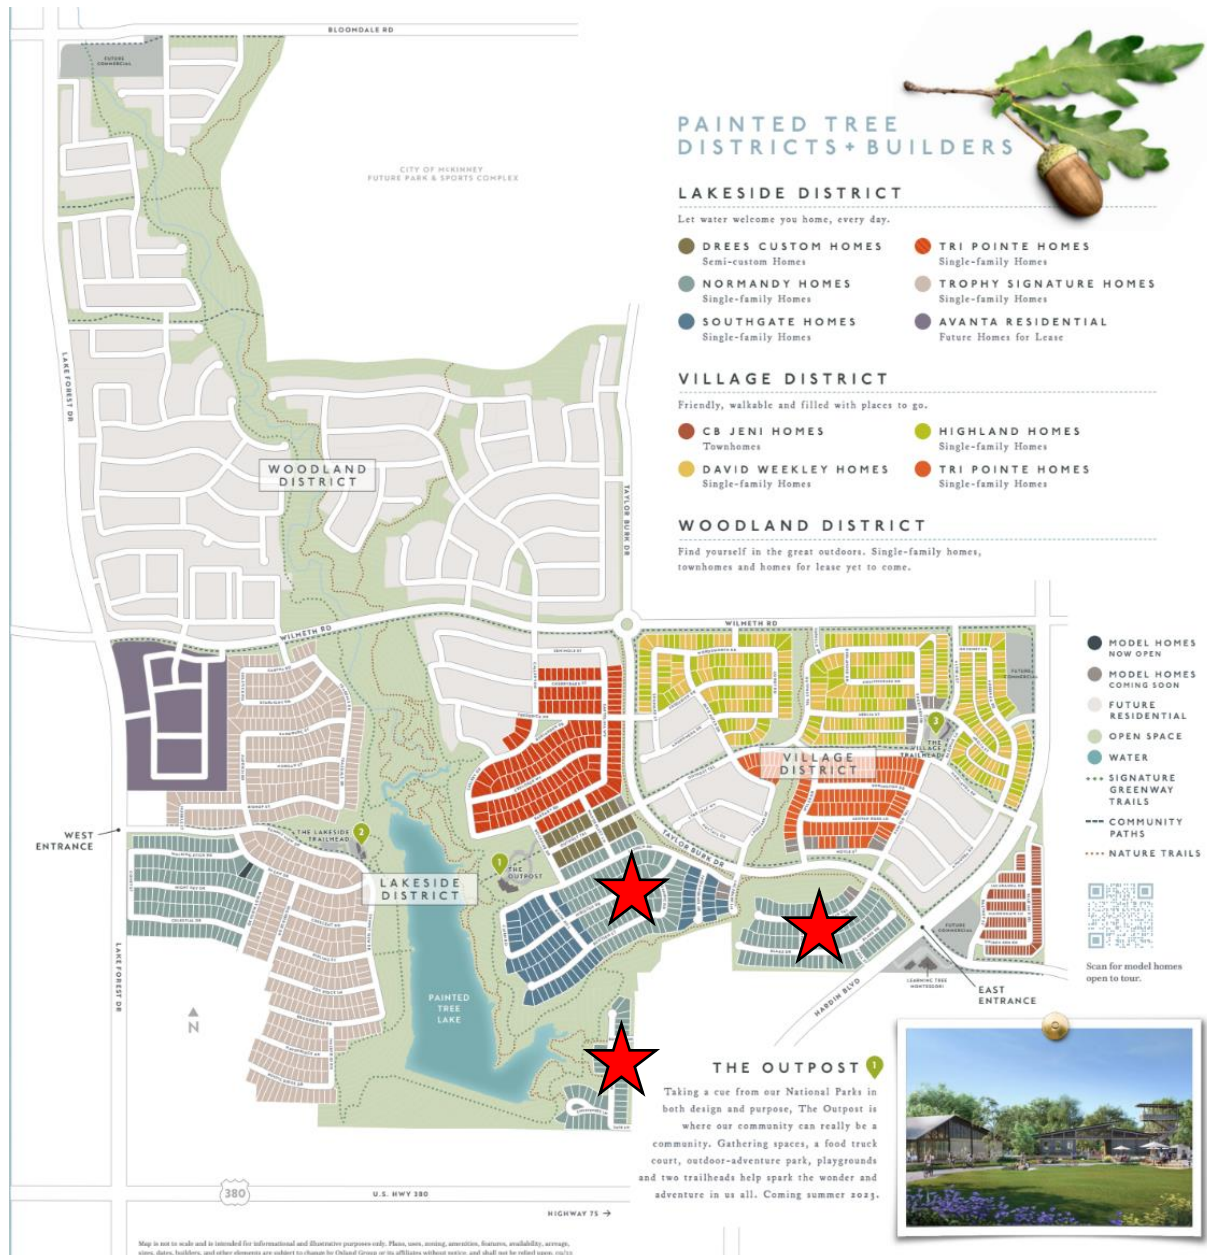
Painted Tree is a residential construction site consisting of three separate districts (the Lakeside District, Village District, and Woodland District) (shown in **Site Map 1** below). Painted Tree is a large common plan of development, with multiple operators developing and building within the community simultaneously. This inspection report focuses only on the construction activities of operator Normandy Homes (TCEQ permit number: TXR1538MP) in the Lakeside District (starred in **Site Map 1** below), which was in the building phase of construction at the time of inspection.

**Site Map 1:** The overall site map of the Painted Tree Community. The inspection area is in the Lakeside District by Normandy Homes. A red star has been added to the areas discussed in this report. The Normandy Homes lots located near the west entrance off Lake Forest Dr are not included in this report because they are covered under a different permit (TXR1551IQ), which was terminated July 31, 2024. The site map was obtained from the Painted Tree Digital Map Guide on the community [website](#).

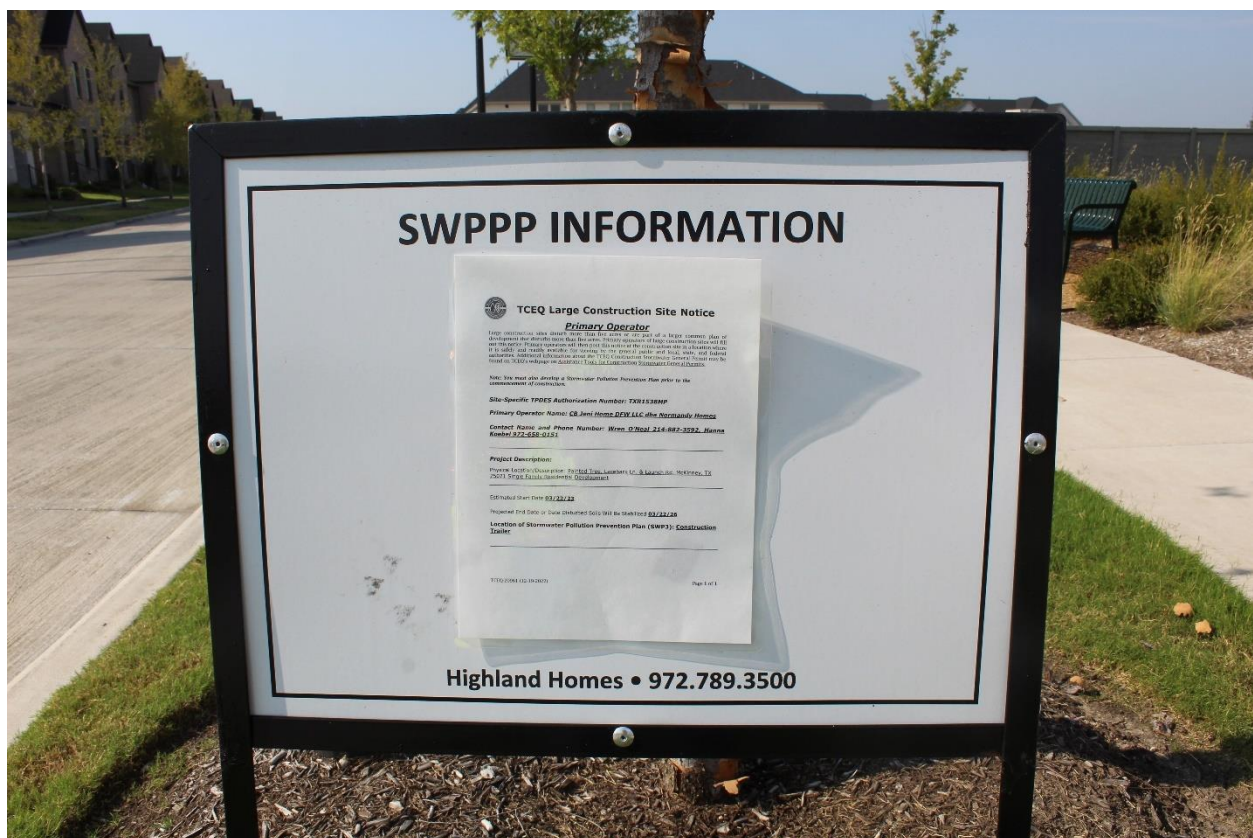
Photo no. 1

- The Large Construction Site Notice (CSN) (TXR1538MP) was posted near the intersection of Bluejack Rd and Marilanda Rd (**Appendix 1, Photo 1**). The CSN was issued by the Texas Commission on Environmental Quality (TCEQ) with an effective date of April 26, 2023, for coverage under the Construction General Permit (CGP).

Description: The Large Construction Site Notice (CSN) (TXR1538MP) posted near the intersection of Bluejack Rd and Marilanda Rd.

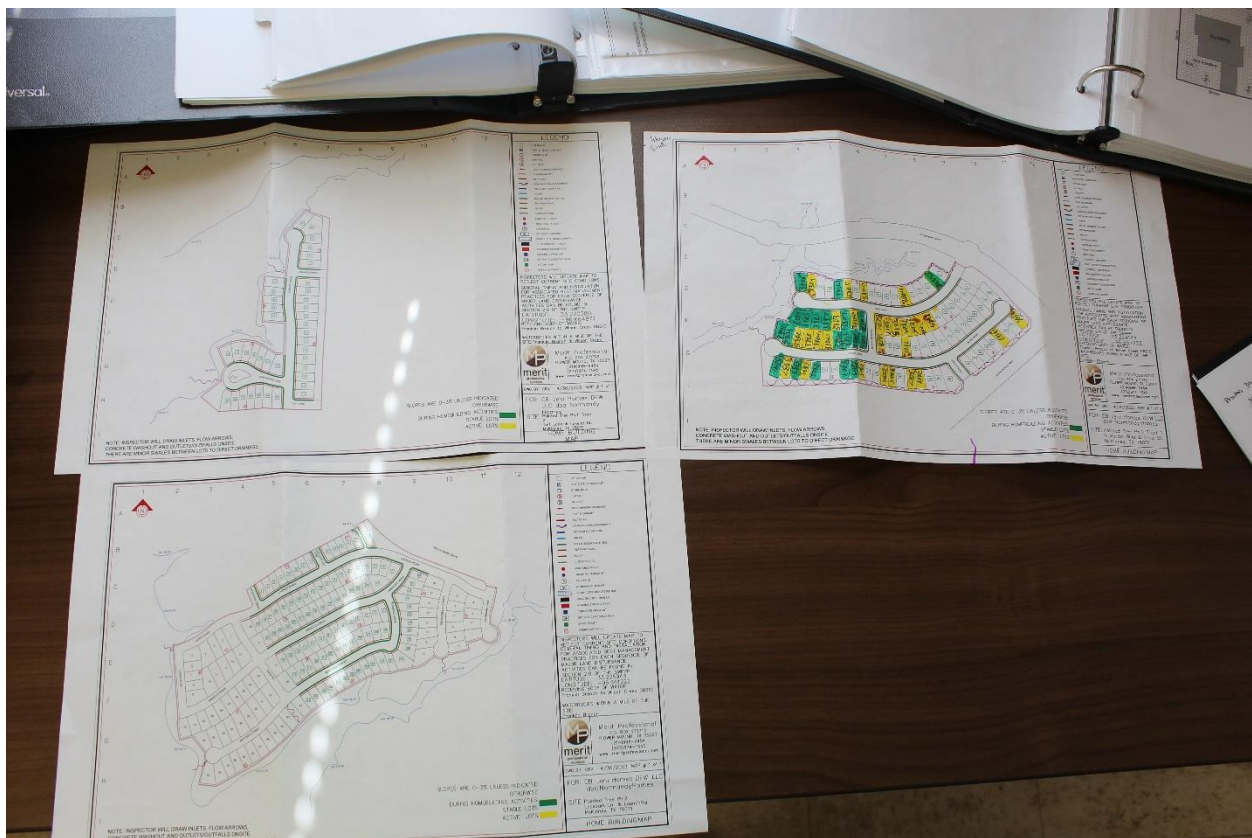
Photo no. 3

- The Stormwater Pollution Prevention Plan (SWPPP) was located in the construction trailer near the intersection of Bastrop St and Chisos Red Rd (**Appendix 1, Photo 2**). The site maps were not up-to-date (**Appendix 1, Photo 3**). The inspection reports available for review were from May 23, 2023, through June 18, 2024.

Description: The site maps located in the SWPPP on-site. Current site conditions were not reflected on the site maps.

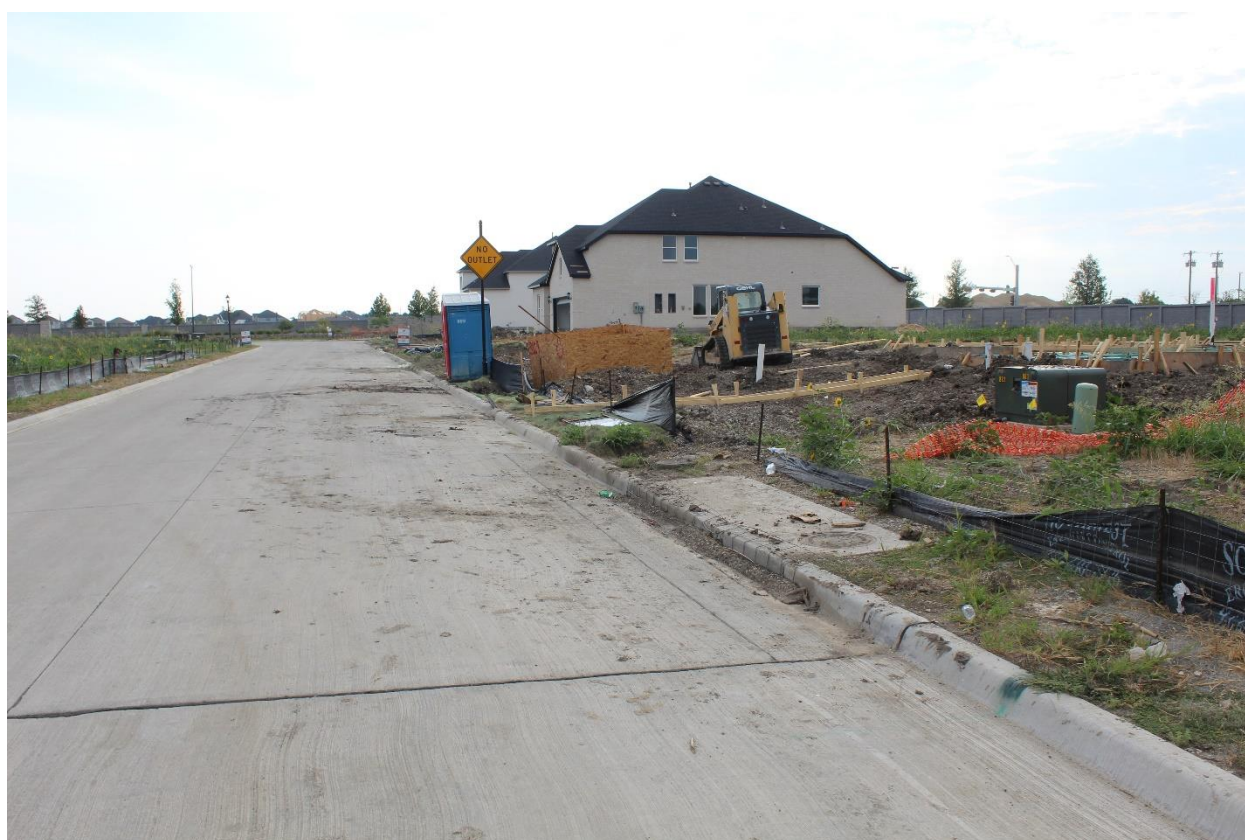
Photo no. 5

- I observed sections of damaged or worn BMPs (silt fence and erosion control blanket) along the front of some lots (**Appendix 1, Photos 5-6**).
- I observed sediment track-out on the street/Municipal Separate Storm Sewer System (MS4) (**Appendix 1, Photo 5**).
- I observed inlet protection that was not in effective operating condition or needed maintenance throughout the site (**Appendix 1, Photos 7-8**).
- I observed uncontained stockpiles and exposed sediment due to damaged or missing BMPs on multiple lots (**Appendix 1, Photos 9-10**).
- I observed improperly disposed of mortar and/or concrete mix on Blake Dr (**Appendix 1, Photo 11**).

Description: Damaged silt fence and vehicle/equipment track-out on Blake Dr.

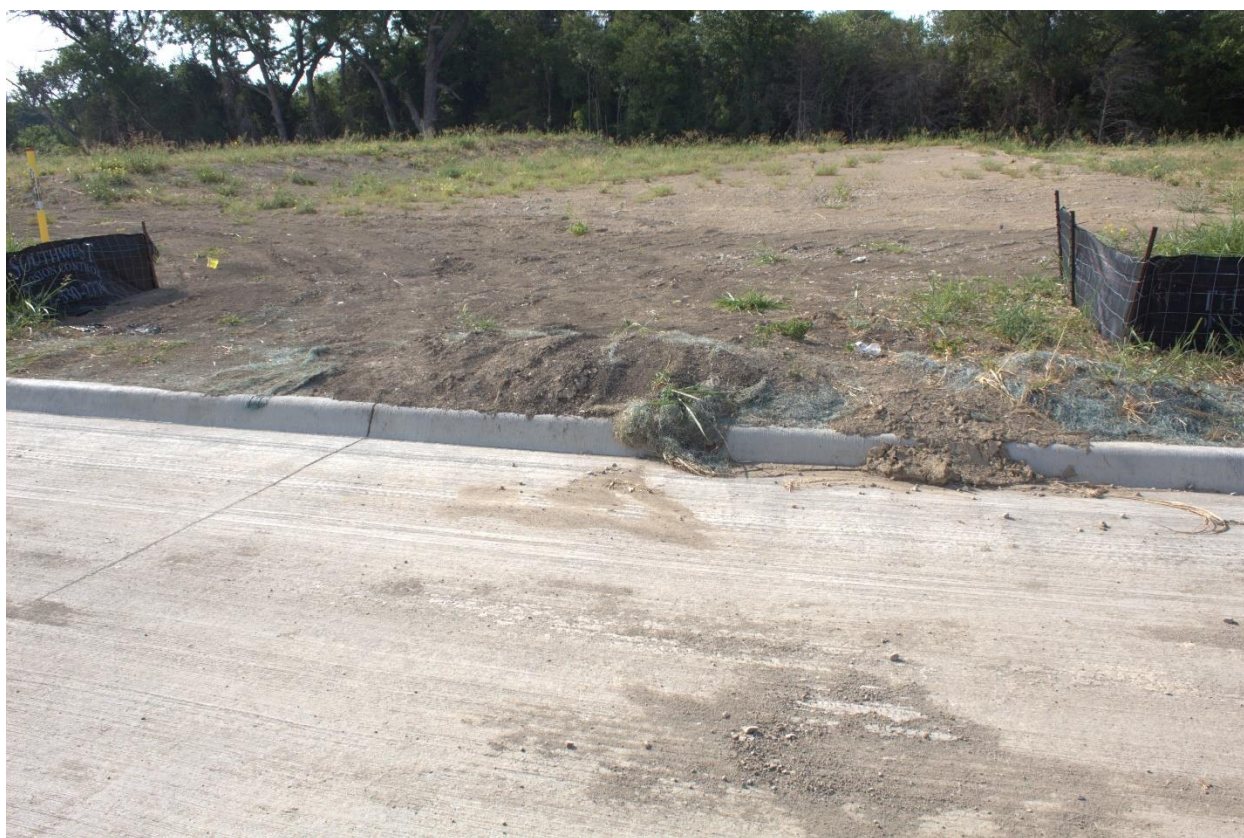
Photo no. 6

Description: Damaged/worn section of erosion control blanket on Launch Rd. Sediment was observed on the street.

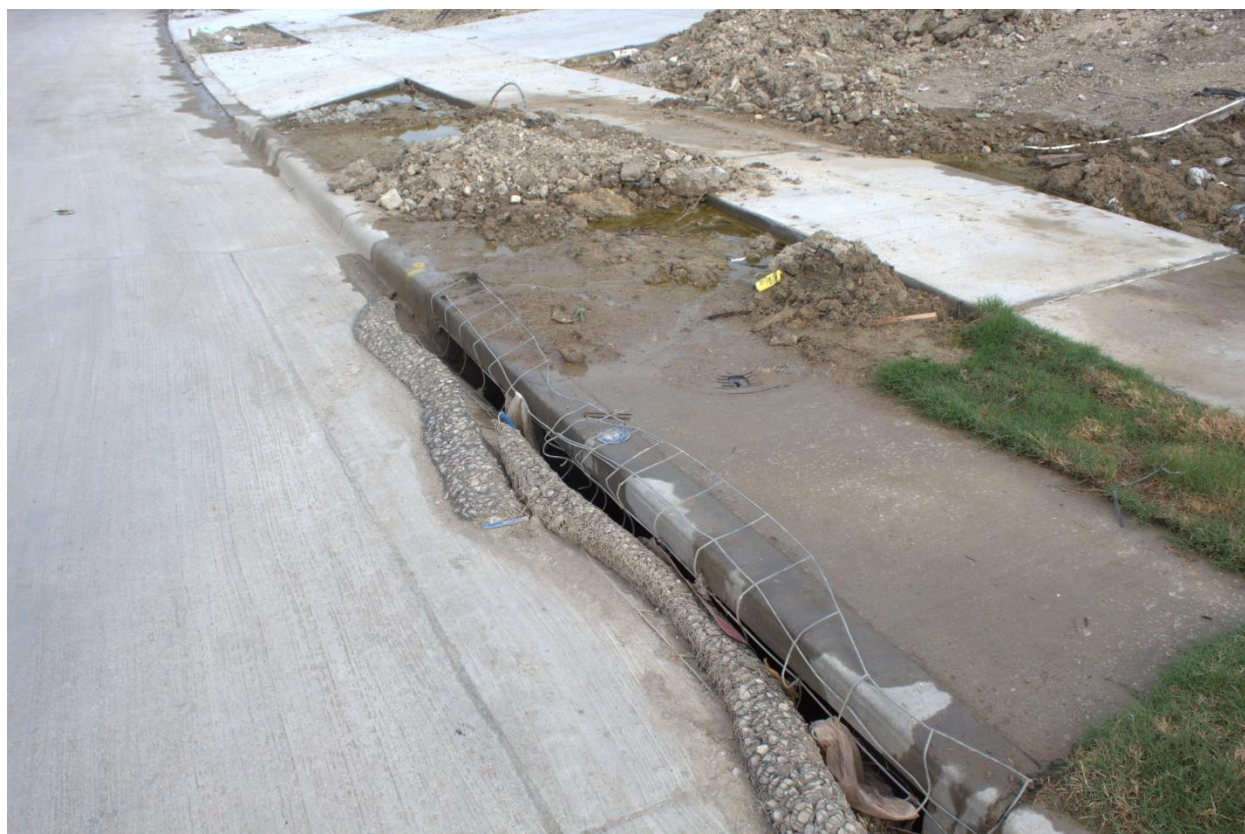
Photo no. 7

Description: Inlet protection that is not in effective operating condition next to exposed sediment on Blake Dr.

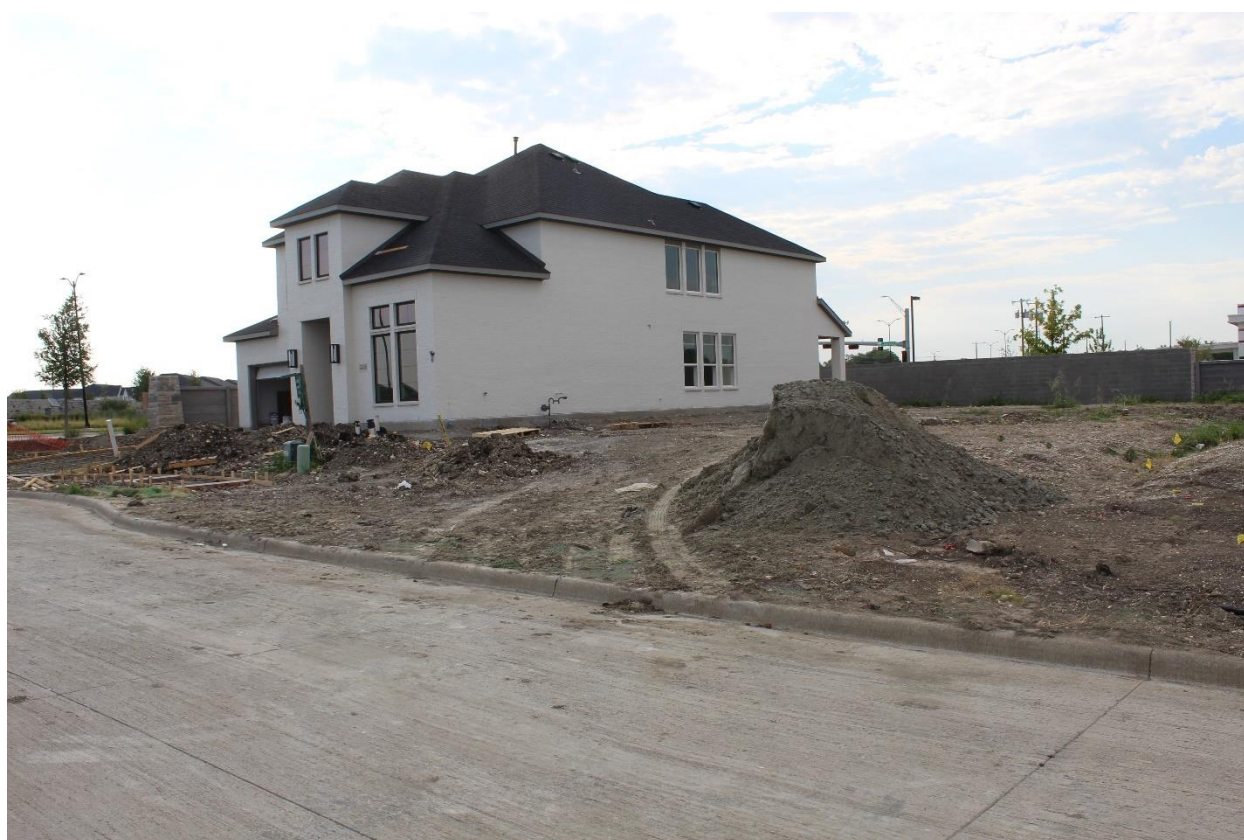
Photo no. 9

Description: Uncontained stockpile and exposed sediment on Blake Dr.

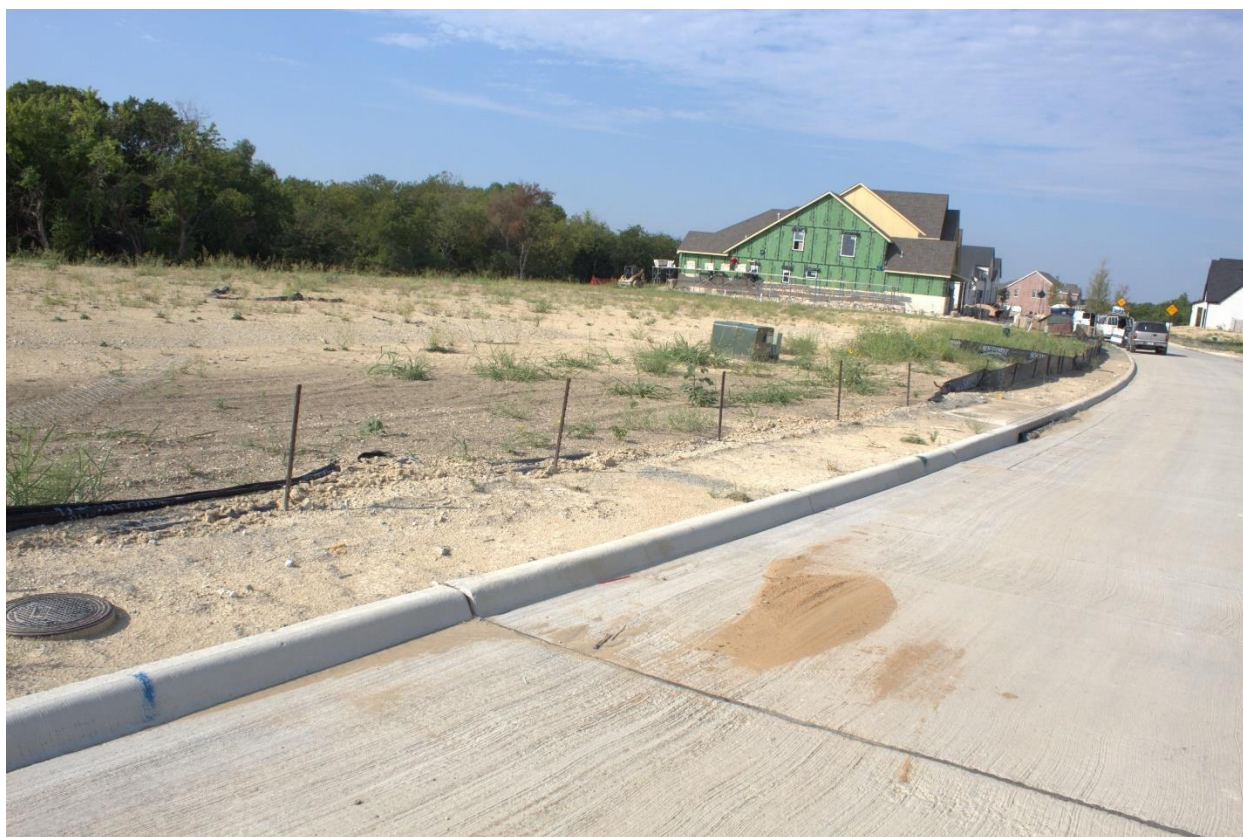
Photo no. 10

Description: Exposed sediment due to damaged silt fence on Launch Rd.

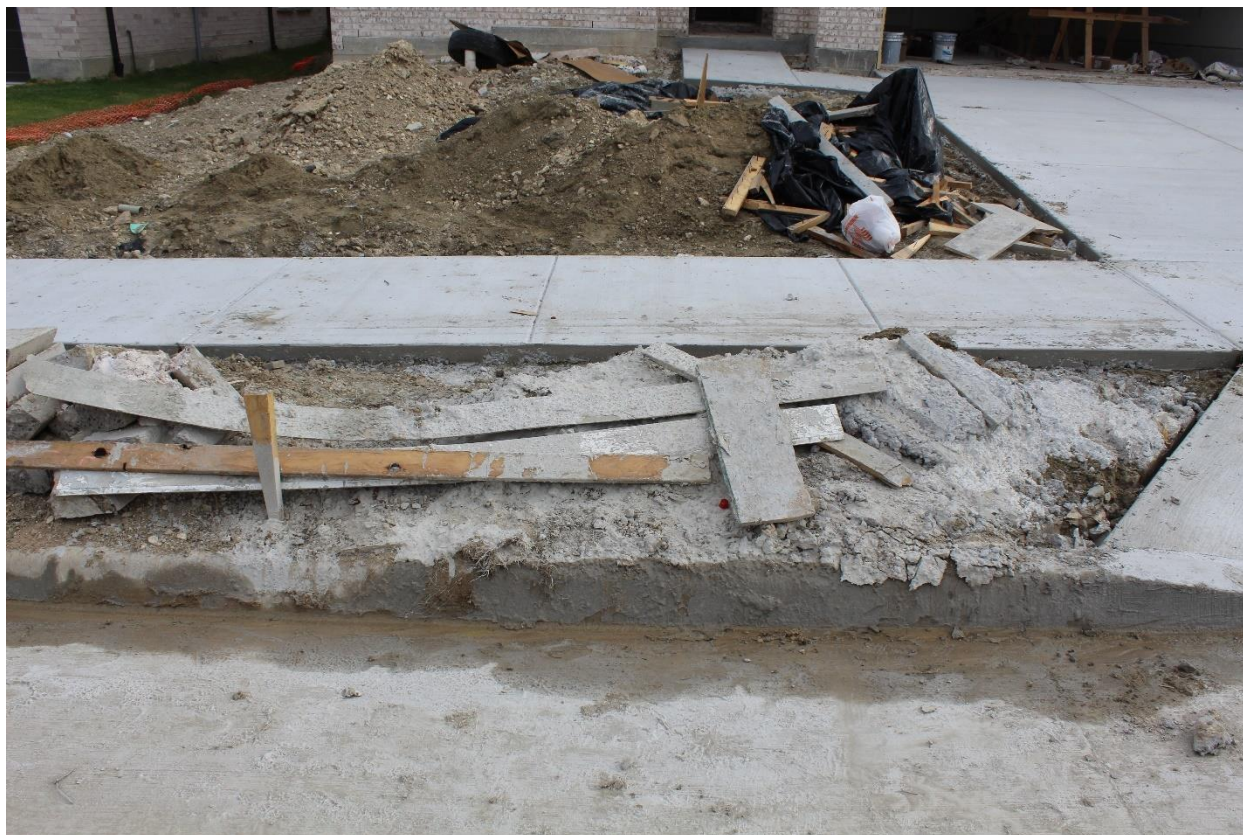
Photo no. 11

**Description:** Improperly disposed of concrete or mortar mix near the curb on Blake Dr.
