## **RCRA Inspection Report**

Colonial Terminals Inc.  
101 North Lathrop Avenue  
Savannah, GA 31415  
EPA ID Number # GAD006926430

**ATTACHMENT A**  
**COLONIAL TERMINALS INC.**  
**SAVANNAH, GA 31415**  
**EPA ID: GAD006926430**  
**RCRA COMPLIANCE EVALUATION INSPECTION**  
**AUGUST 25, 2021**

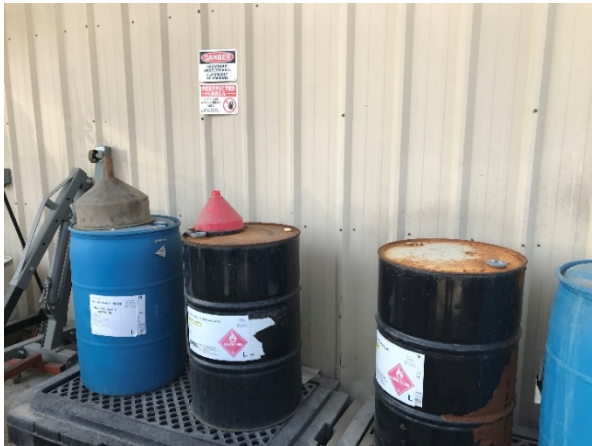
The inspectors observed three SAAs in the Truck Stop Area. There were two 55-gallon spent solvent (D001) drums on a spill pallet. One spent solvent drum contained hexane and methanol and the other 55-gallon spent solvent drum contained a mixture of wastewater, xylene and cumene (Picture-1). A third 55-gallon drum (D001) contained an aerosol can puncture device with a filter mounted on the drum (Picture-2). The drained aerosol containers are sent for metals recycling. All the SAA drums were observed to be closed and intact. The SAA drums were observed to be labeled with the words "Hazardous Waste" and an indication of hazards of the contents. There was a signage indicating "Danger" and "No Smoking" in the SAA. There were no leaks or spills observed near the SAA drums.

*Picture 1: Two SAA Drums (Truck Stop Area, Terminal Plant #2)*

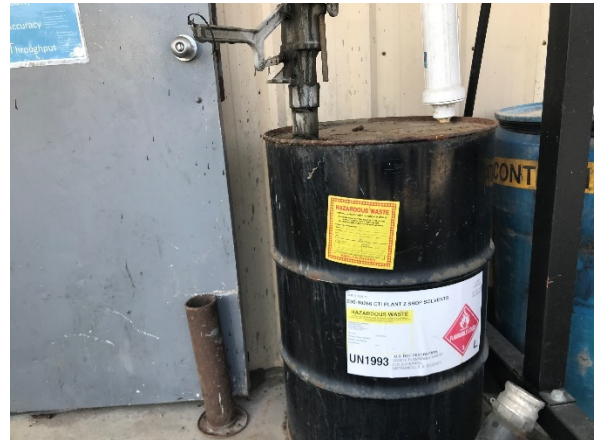
*Picture 2: One SAA Drum with Aerosol Can Puncture Device and a filter (Truck Stop Area, Terminal Plant #2)*

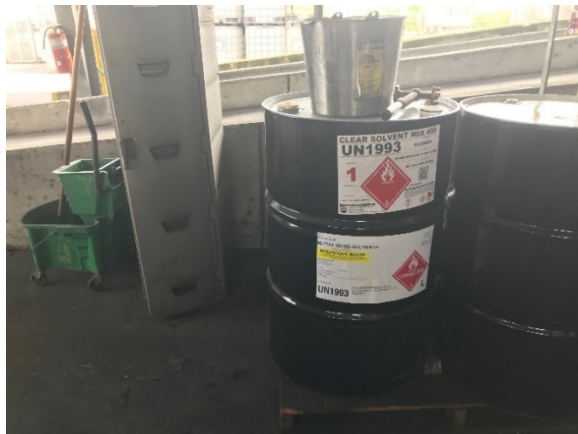
At the time of the inspection, the inspectors observed one SAA drum in the process area. The SAA drum contained mixed solvents, acetone, and butanol (D001) that was closed and properly labeled with the words “Hazardous Waste” and an indication of the hazards of the contents (Picture-3). There was no leaks or spills observed in the SAA.

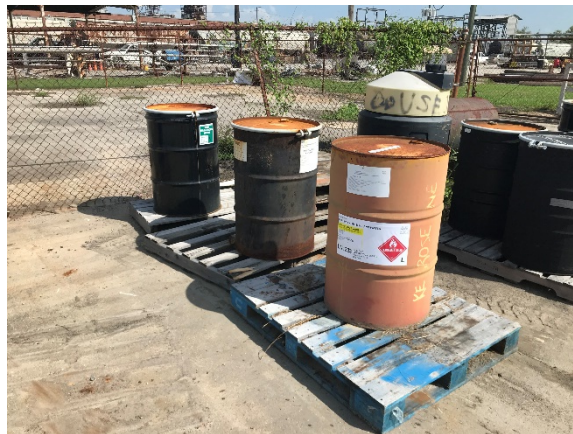
The inspectors observed a sign at the entrance indicating the hazardous waste storage and a “Danger” and “No Smoking” warning sign and a signage for Drum Storage Rules (Picture-4). The inspectors observed two 55-gallon hazardous waste drums containing water, sludge, and gasoline (D001, D018) and one 55-gallon hazardous waste drum of ethanol (D001, D018) generated as tank cleanout in storage at the time of inspection. All the drums were observed to be closed, dated, and labeled with the words “Hazardous Waste”. The hazard indication on the drums were observed to be “Flammable”. The oldest accumulation start date on the drum was observed to be 03/10/2021. There were no leaks or spills observed in the storage area. The CAA was equipped with a fire extinguisher.

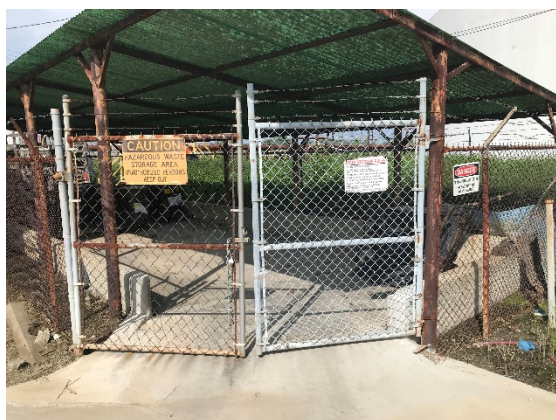
The storage area in Plant 2 is comprised of an area enclosed by a chain link fence on three sides and access through a locked chain-link gate (Picture-5). The inspectors observed a sign at the entrance indicating the hazardous waste storage and a “Danger” and “No Smoking” warning sign. At the time of the inspection, the CAA contained one 55-gallon drum of kerosene (D001) and water that was closed, dated, and properly labeled with the words “Hazardous Waste” (Picture-6). The hazard indication on the drums were observed to be “Flammable”. The inspectors also observed two 5-gallon jugs of low-pH corrosive waste pending analysis that were closed, dated, and properly labeled. There were no leaks or spills observed in the storage area. The CAA was equipped with a fire extinguisher.

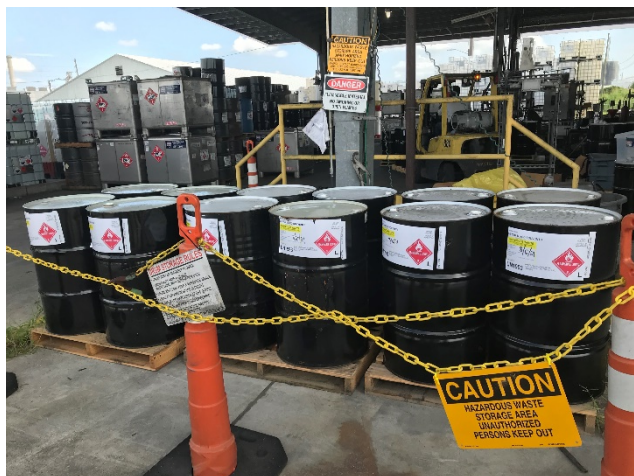
The inspectors observed a sign at the entrance indicating the hazardous waste storage and a “Danger” and “No Smoking” warning sign. At the time of the inspection, the CAA contained twelve 55-gallon drums of mixed solvents, acetone, and butanol in storage (Picture-7). All the drums were observed to be closed, labeled with the words “Hazardous Waste” and an indication of the hazards of the contents. The oldest accumulation date observed during the inspection was 7/24/21. There were no leaks or spills observed in the storage area.

*Picture 7: Central Accumulation Area - 90-day Storage  
(Colonial Chemical Solution)*

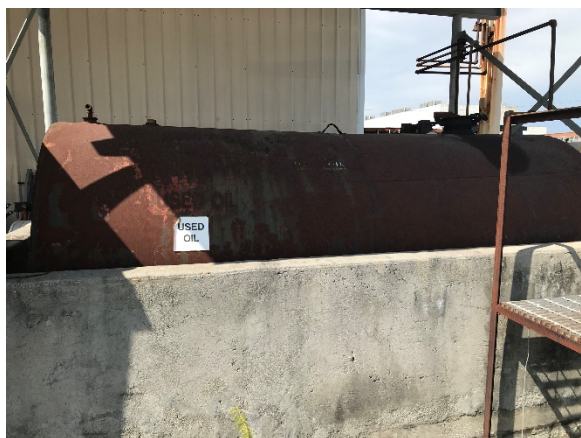
Used oil is generated through the regular facility and equipment maintenance. At the time of inspection, the Colonial Terminal Plant 2 Truck Shop contained a one 1,000-gallon tank of used oil that was labeled with the words “Used Oil” and was located within a secondary containment structure (Picture-8). There were no leaks or spills observed in the secondary containment. Used Oil is picked up and disposed by Coastal Refining Corporation (EPA ID GAD038921136).

*Picture 8: 1000 gallon Used Oil Tank with Secondary  
Containment (Terminal Plant #2)*
