**Region 6 - Enforcement & Compliance Assurance Division**  
**INSPECTION REPORT**

| Inspection Date(s): | 02/14/2024 | |
| Company Name: | TPC Group LLC | |
| Facility Name: | Port Neches Operations | |

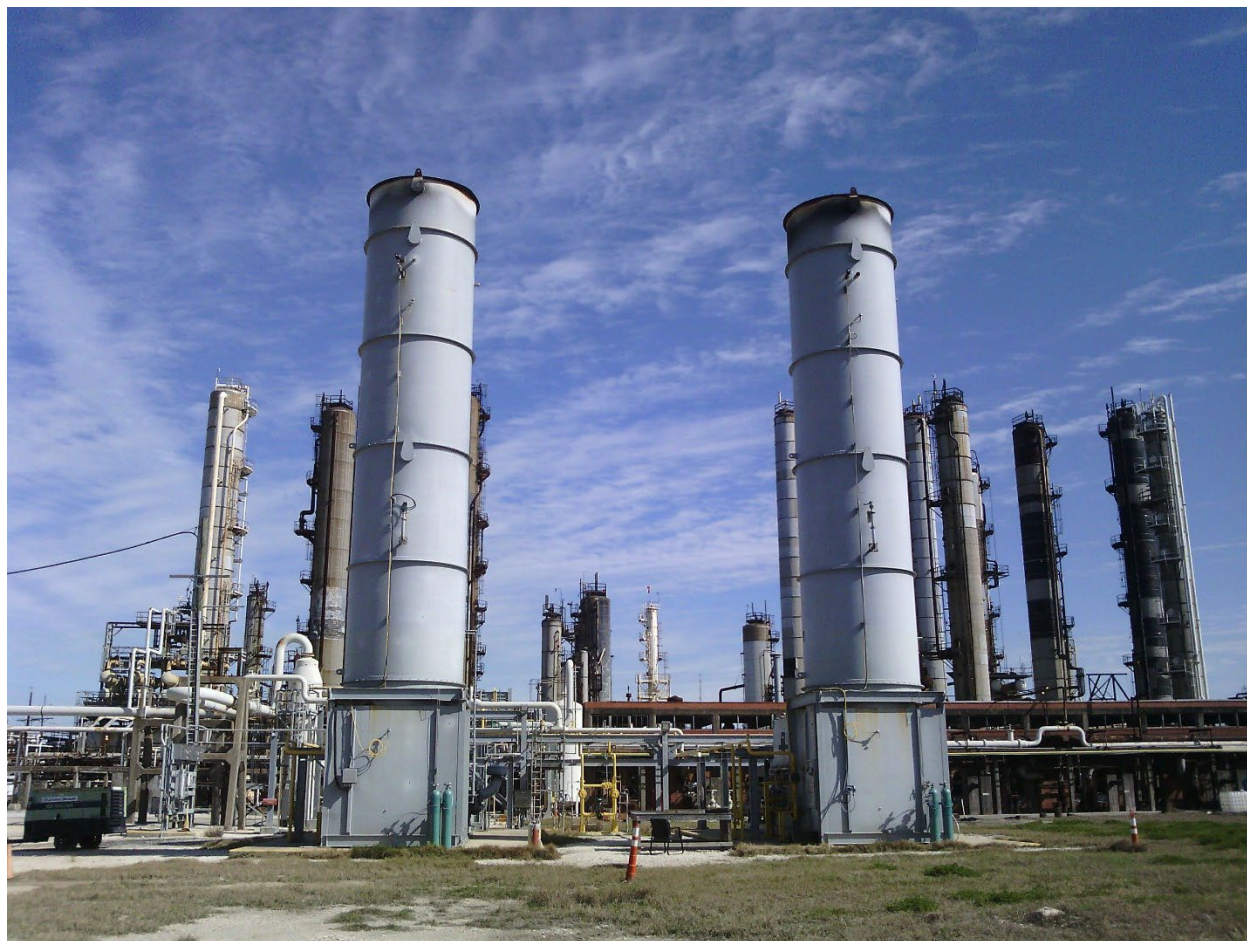
Photo No. 1

After obtaining the necessary permits, we observed several tanks and process equipment in Block 7. No hydrocarbon emissions were observed from any of the tanks in this Block. Following the activity in Block 7, we visited the control room and spoke with a Facility operator who described the control equipment and monitoring data collected for the #1 and #2 vapor combustion units (“VCU1” and “VCU2”). The VCU2 is the primary unit that controls emissions from the tanks, some of which are vented automatically while others are vented manually. The Facility operator showed us the temperature alarms set on the VCU1/VCU2. I noted that the Facility did not set a low temperature alarm for VCU2, and that there may not be any feedback to the control room operators when temperatures drop below a limit established during a performance test to ensure compliance. **[AOC 2]** We exited the control room and viewed the area of the Facility where VCU1/VCU2 are located. See Photo No. 1.

| Description: | VCU1 and VCU2 |
