**Compliance Evaluation Inspection Report**

Shannon Publicly Owned Treatment Works, East  
Shannon Publicly Owned Treatment Works, West

NPDES Permit No. MS0047988

NPDES Permit No. MS0027405

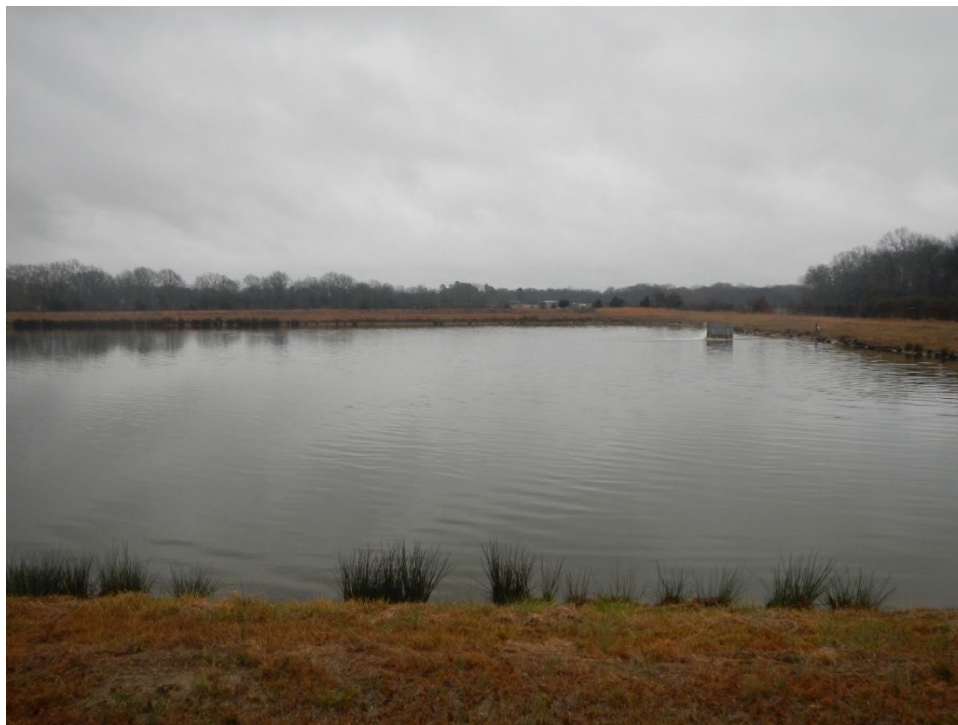
The Shannon POTW East consists of three lagoon cells totaling approximately 17 acres. Wastewater enters a 10-acre lagoon cell (Figure 1) then passes through two 3.3-acre lagoons cells (Figure 2). Each lagoon cell has one mechanical aerator. From the third lagoon cell, wastewater is pumped through a chlorine contact chamber. An inline flow meter is located between the third lagoon and the chlorine contact chamber. Chlorine and sulfur dioxide gas is supplied from tanks in a housing unit adjacent to the contact chamber (Figure 4). The chlorine chamber effluent flows over a v-notch weir (Figure 5) with a visible staff gauge.

Figure 1:Initial 10-acre lagoon.

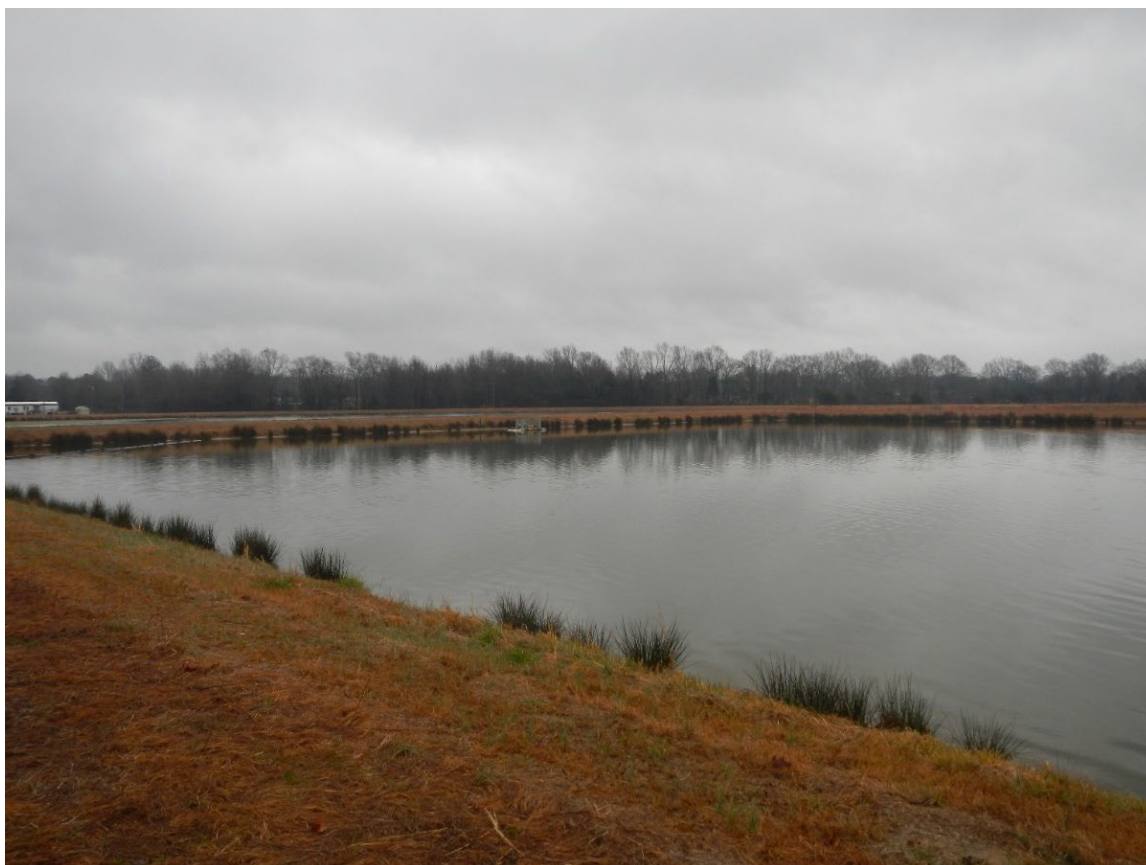
Figure 2:Second and third lagoons.

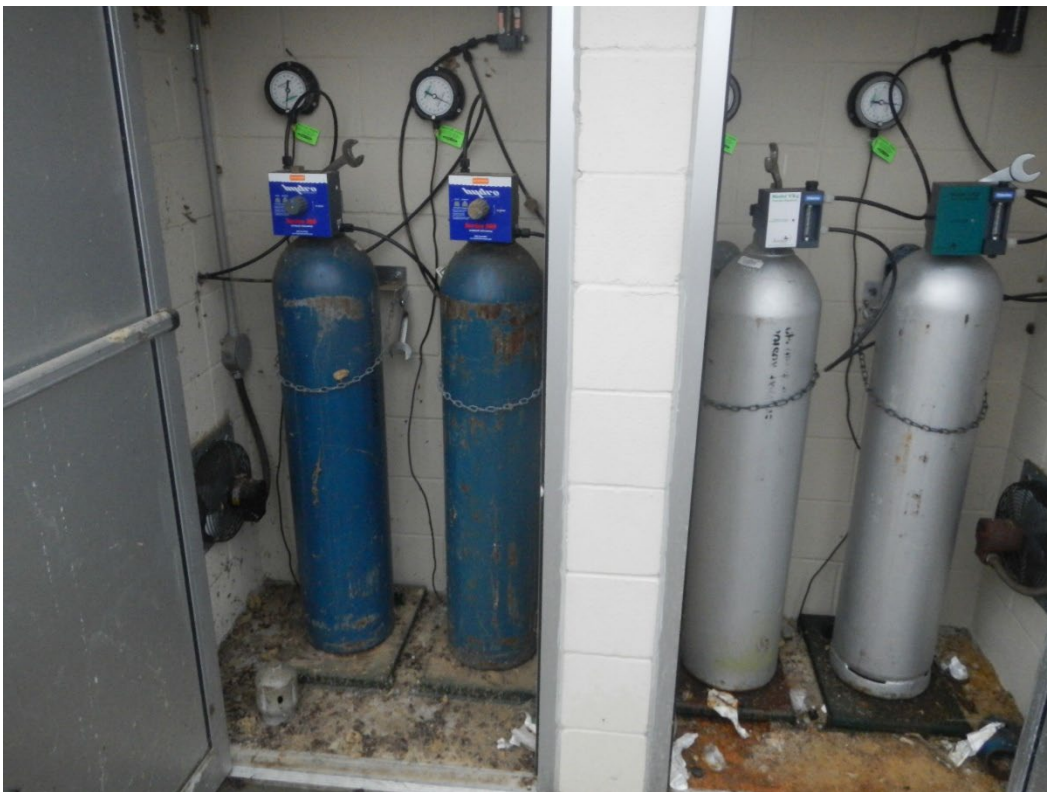
Figure 4: Chlorine (left) and sulfur dioxide gas (right) in shelter on site.

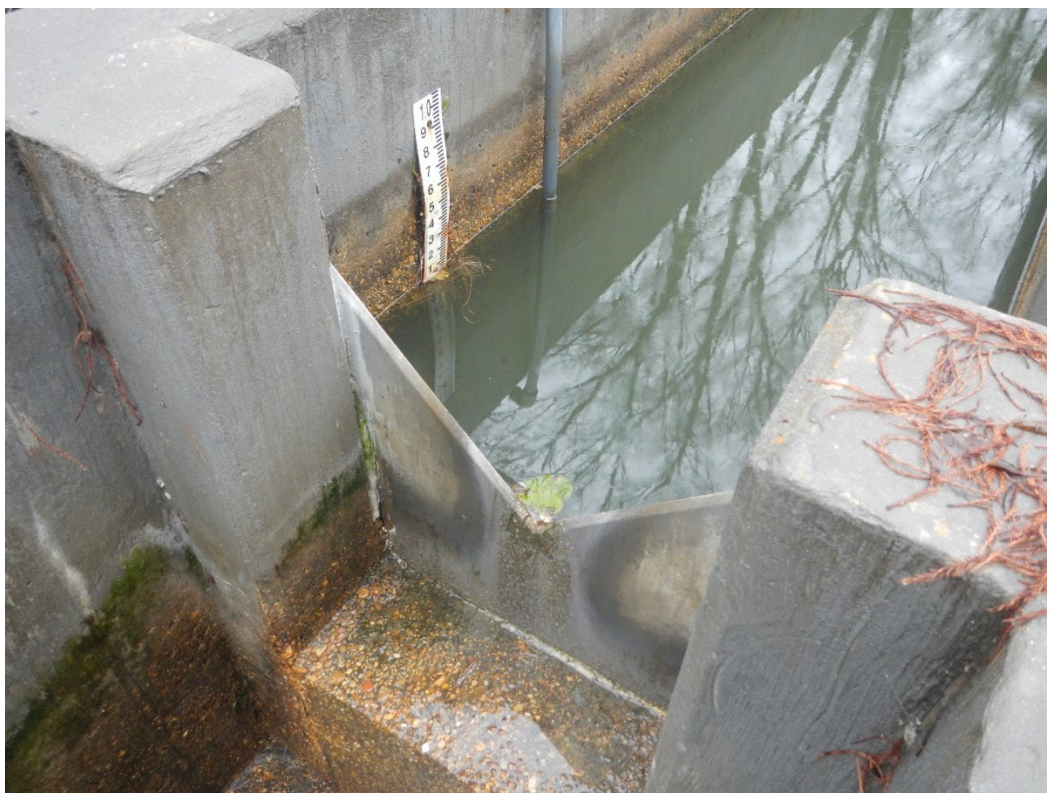
Figure 9: Effluent V-notch weir with staff gauge.

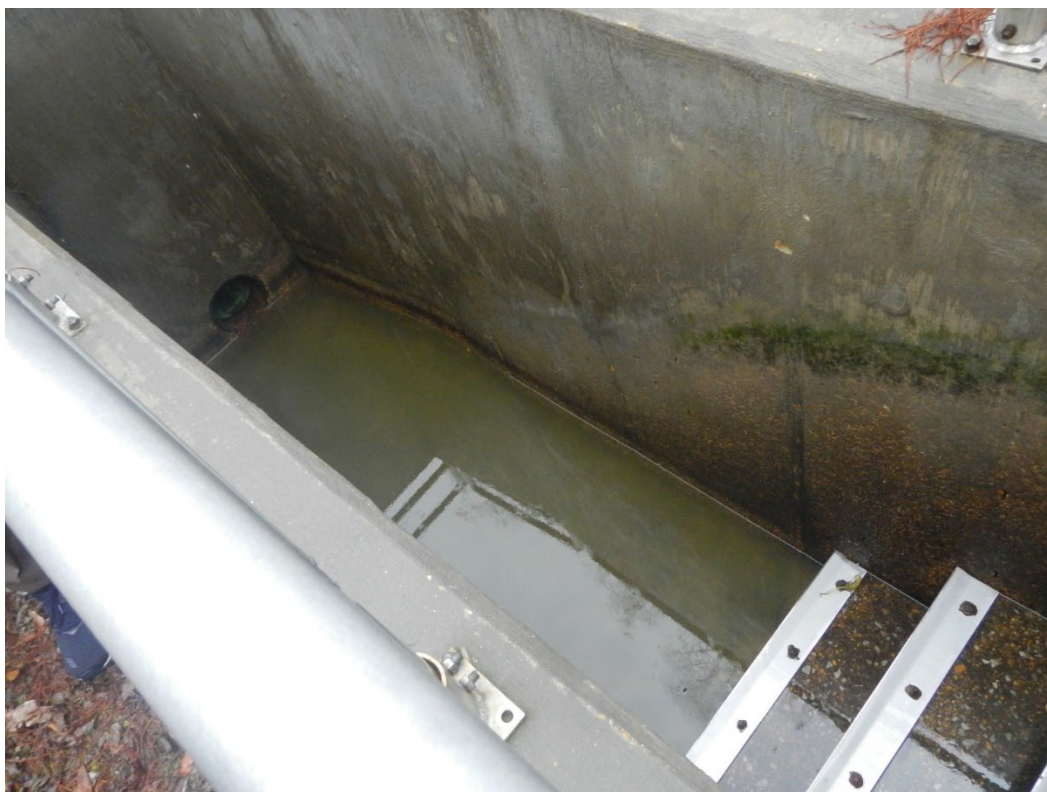
Figure 10: Effluent step aeration cascade where sample is taken.

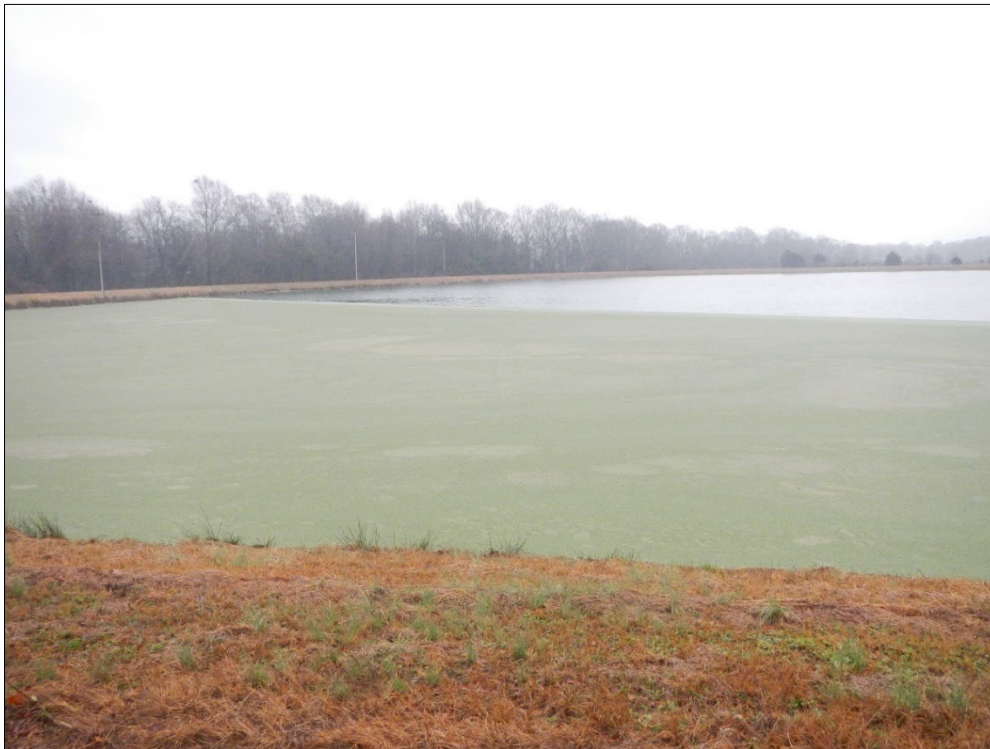
Plant personnel did not know the depth of any of the lagoons as no schematics were available. Town staff stated that they had just recently cleared the facility entrance and the area around the chlorine contact chamber of heavy vegetative growth. Of the three lagoon cells, aeration was operational only in the third cell. Duckweed was observed in the primary lagoon (Figure 11).

Figure 11: Considerable duckweed growing in first lagoon.

The permittee should develop and implement standard operating procedures to effectively operate the lagoon.

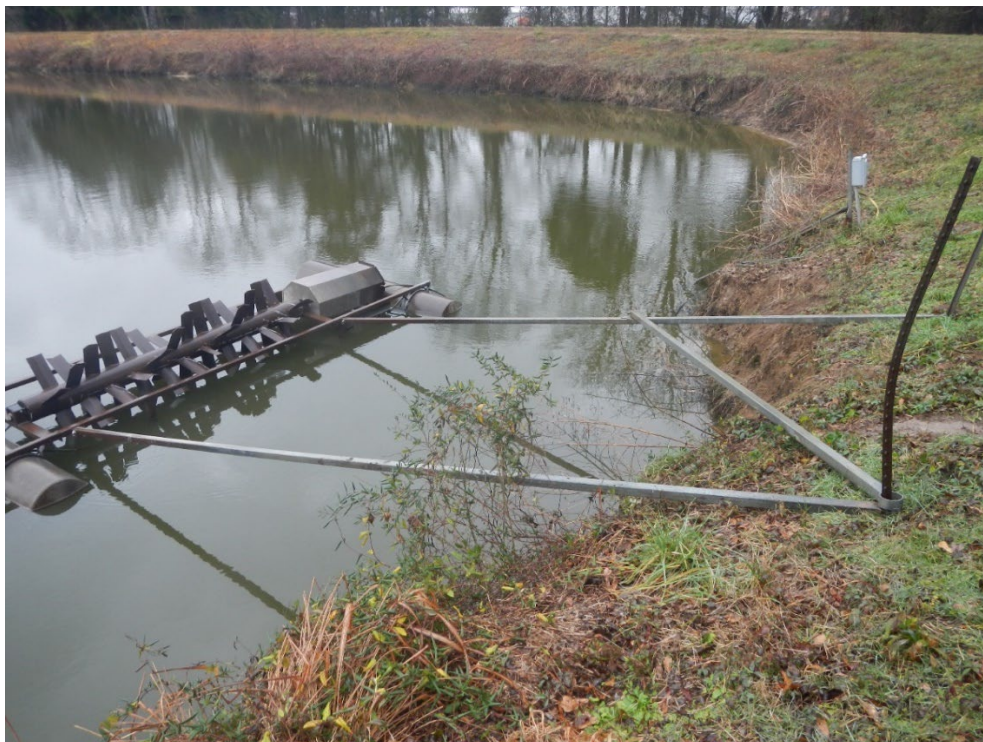
The facility is operated by the same personnel as the POTW East facility. The lagoon had one non-operating aerator (Figure 12). The rest of the lagoon appeared to be in good condition. Facility personnel stated that once the berms dry from recent rainfall they would repair the aerator.

Figure 12: Lagoon aerator was not operational.

- a. Establish Standard Operating Procedures to include procedures for routine operations and maintenance, sampling, and reporting.
- b. Establish record keeping procedures and keep records, as required by its NPDES permit.
- c. Repair aerators.
- d. Promptly secure or remove empty and partially empty chlorine tanks from the elements. Partially filled chlorine gas tanks can present a severe hazard if the tank is dropped or tipped over and damaged.
- e. Cap the POTW West influent manhole.
- f. Drain and clean flow meter chamber of the POTW West.
- g. Submit past due DMRs with available data.
- h. Submit overdue permit renewal applications for both lagoons.

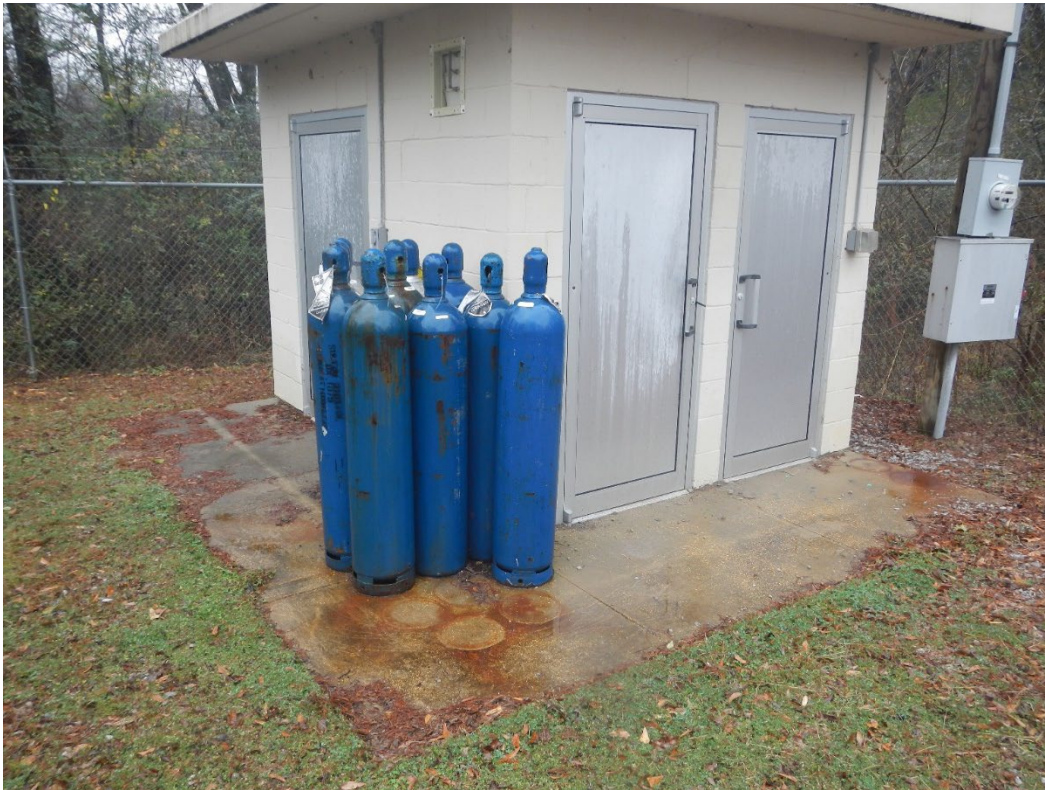
There were numerous empty and partially filled chlorine containers observed outside of the structure that were exposed to weather and showing signs of corrosion (Figure 13).

Figure 13: Empty and partially empty chlorine tanks
