INSPECTION REPORT

| Type of Inspection | Focused Compliance Inspection (FCI) | | | |
| Facility or Site Name | Miller Environmental Services | | | |

**SECTION I – INTRODUCTION****Site Entry and Purpose of the Inspection**

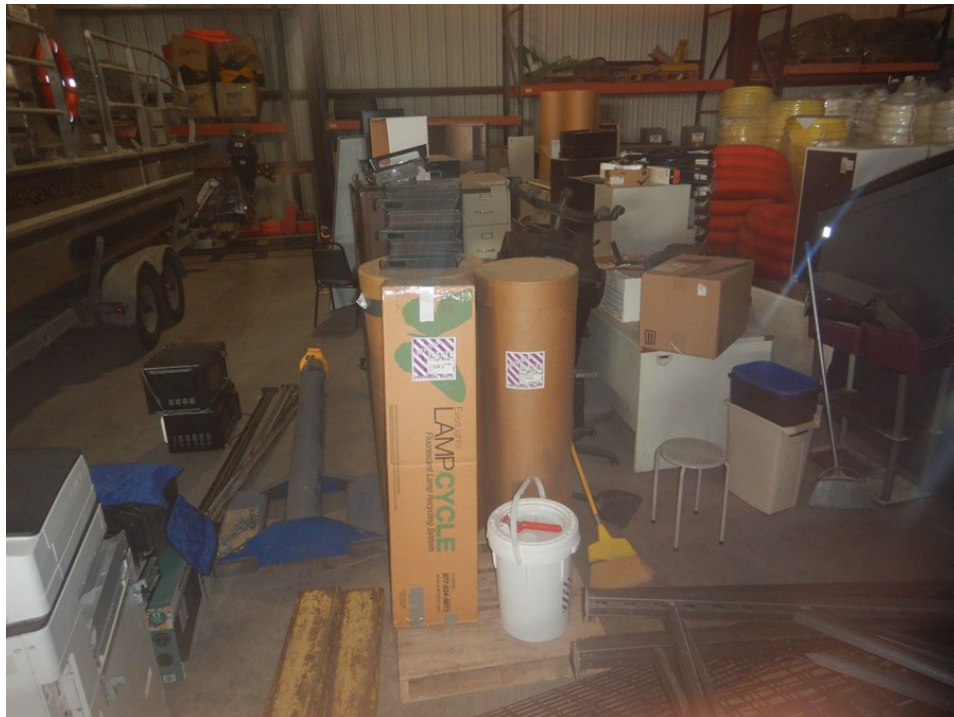
**Photo No. 1**

Description: Overview of universal waste lamps in Miller's warehouse (observed).

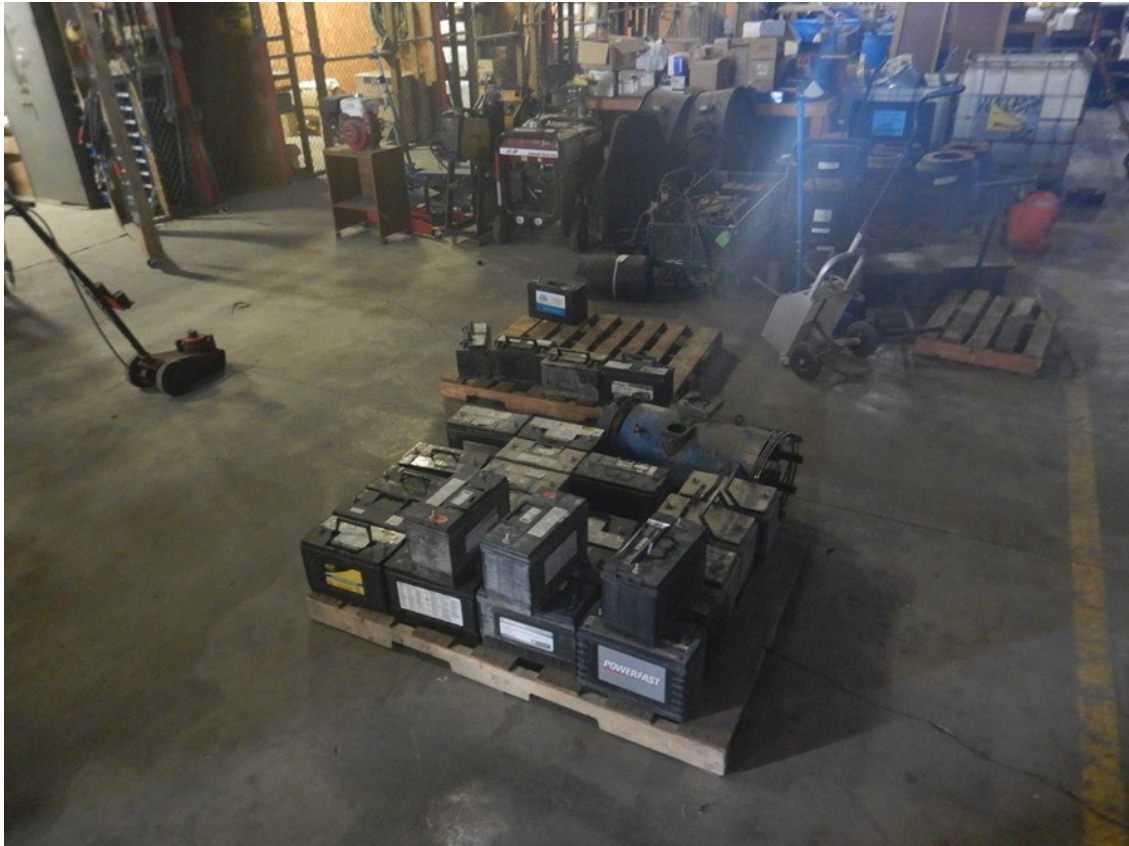
Photo No. 3

| <b>Tenant:</b> Miller Environmental Services | | |
|---|---|---|
| <b>AOC #1</b> – Miller did not label batteries being managed as universal waste properly or store the batteries in a properly labeled container. | <b>Citation:</b> 40 CFR 273.14(a) | Section: 2.1 |

Description: View of pallets of spent lead acid batteries that were not properly labeled in Miller's warehouse.

(see Appendix 2). In this response, Mr. Johnson indicated that Miller placed a sign designating the batteries as universal waste (see Appendix 2). He also included a photograph showing the sign (see Appendix 3 – Photo 1).

**We have placed a sign designating these as spent batteries for recycle. (photo attached)**

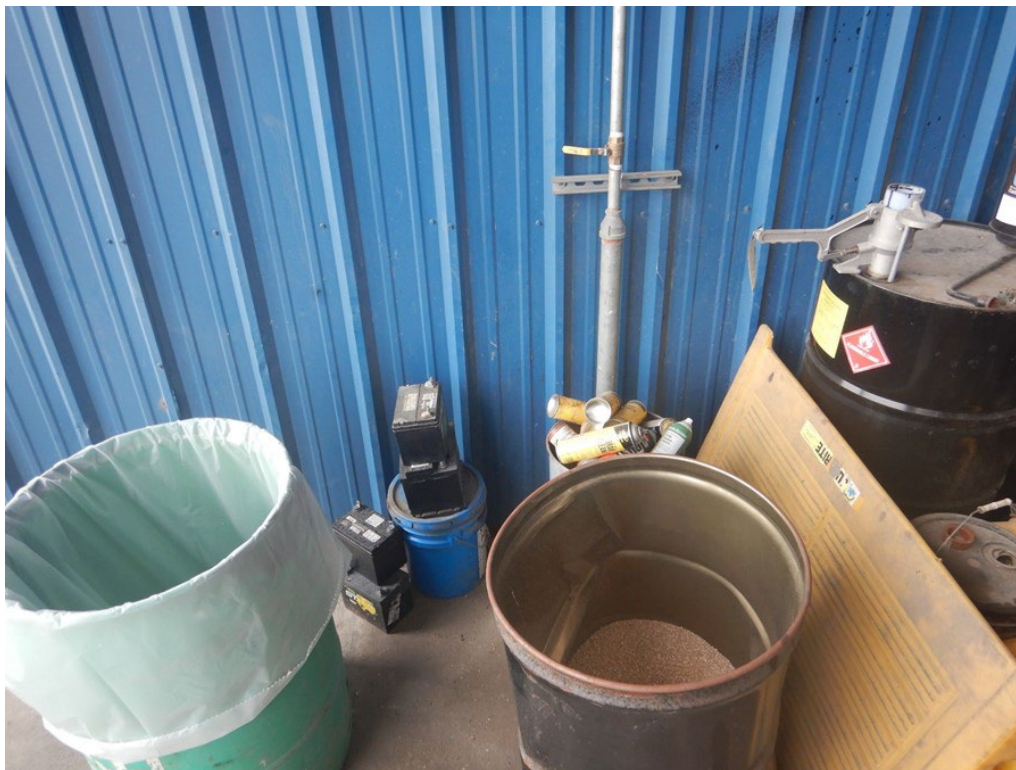
Photo No. 4

The inspection team also observed four additional spent lead acid batteries that were not properly labeled or otherwise identified as spent in the truck bay (see Appendix 1 – Photo 4) [see **AOC #1**]. In his response, Mr. Johnson indicated that Miller placed a sign designating the batteries as universal waste (see Appendix 2) and included a photograph showing the sign (see Appendix 3 – Photo 1). The team observed a tank of used oil generated by Miller that did not have a visible label (see Appendix 1 – Photos 5 and 6). The inspection team also observed several plastic carboys used to hold used oil that were not properly labeled (see Appendix 1 – Photo 7). [**AOC #2** – *Miller did not clearly label a tank and containers used to store used oil with the words “Used Oil” - 40 CFR 279.22(c)(1)*]. Mr. Johnson included photographs in his response email showing the used oil tank and used oil carboys with visible labels (see Appendix 3 – Photos 2 and 3).

Description: View of spent lead acid batteries that were not properly labeled in Miller's truck bay.

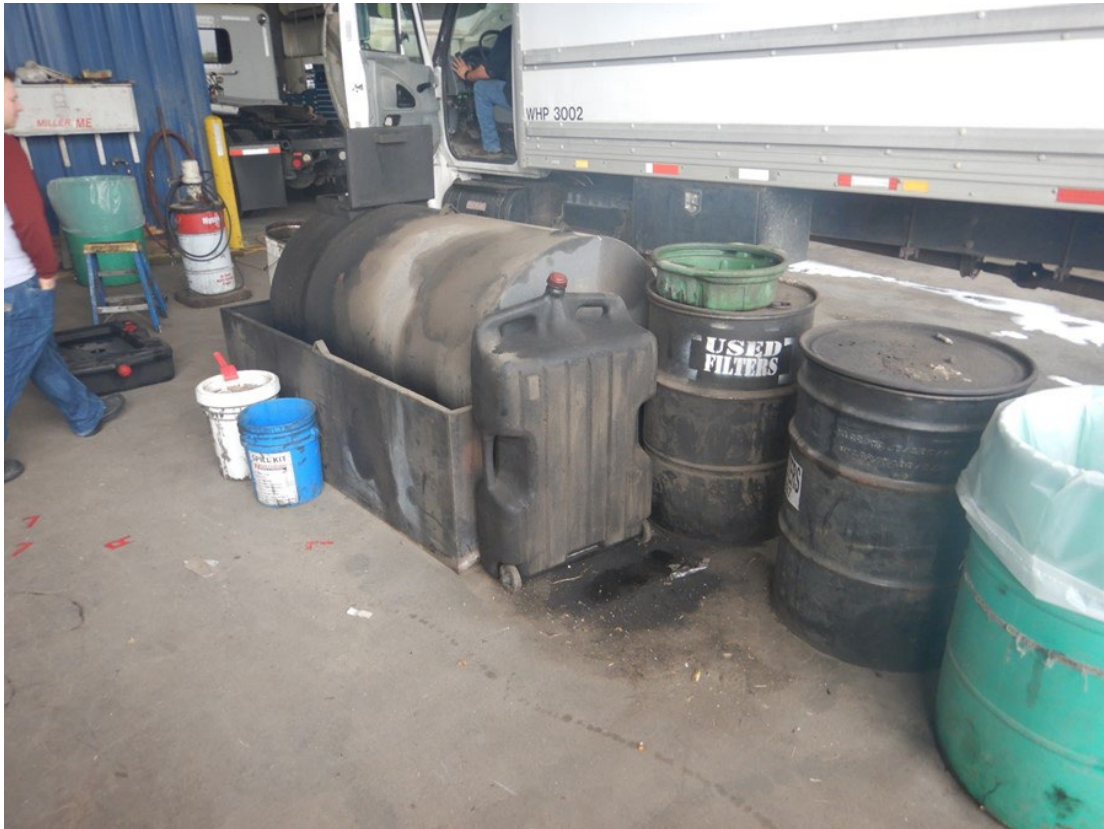
Photo No. 5

| <b>Tenant:</b> Miller Environmental Services | | |
|---|---|---|
| <b>AOC #2</b> – Miller did not label a tank and containers used to store used oil with the words "Used Oil". | <b>Citation:</b> 40 CFR 279.22(c)(1) | Section: 2.1 |

Description: View of used oil tank without a visible label in Miller's truck bay.

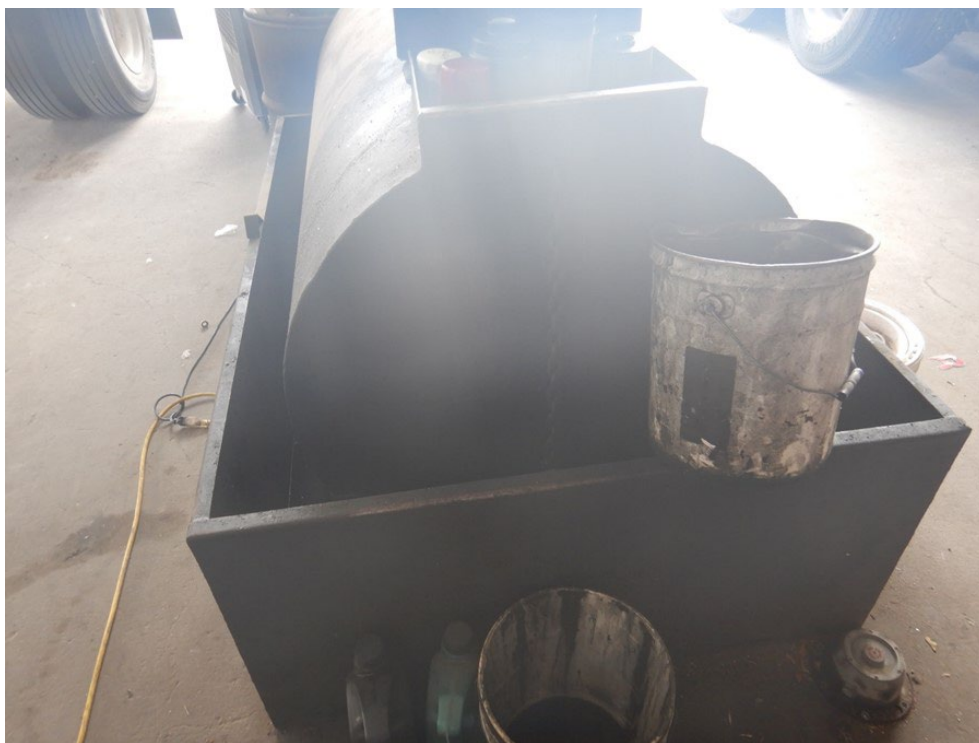
Photo No. 6

Description: Closeup view of used oil tank without a visible label in Miller's truck bay.

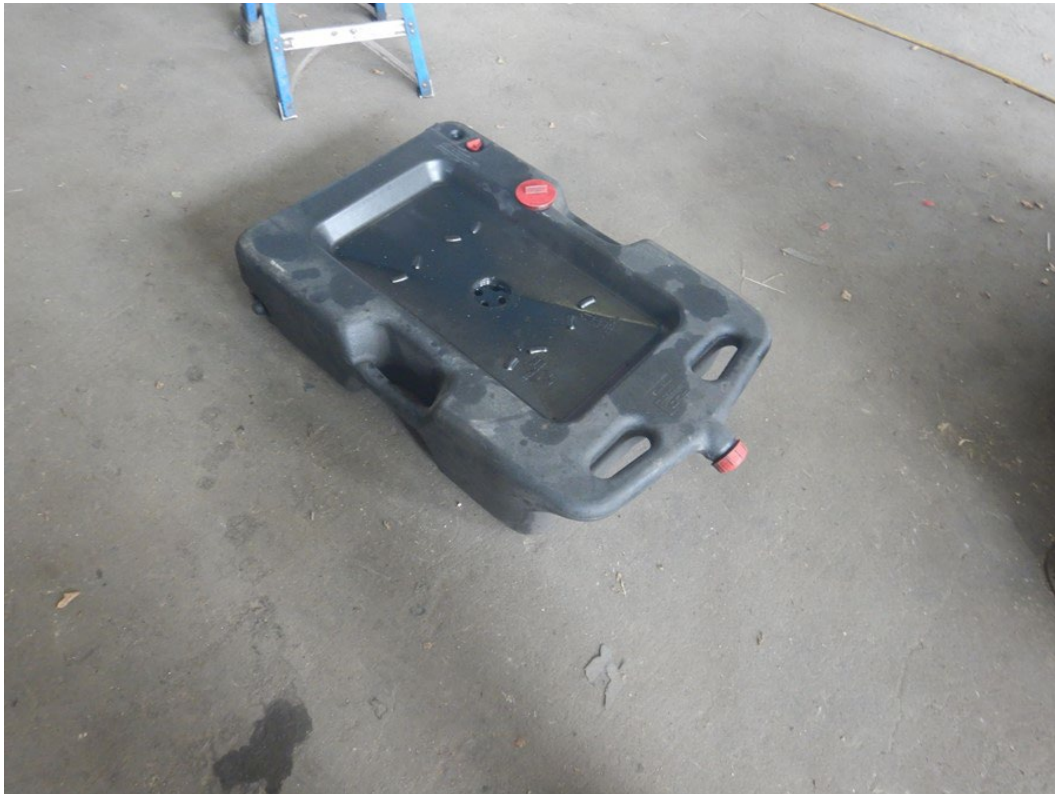
Photo No. 7

Description: View of one of the plastic carboys used to hold used oil in Miller's truck bay that was not properly labeled.

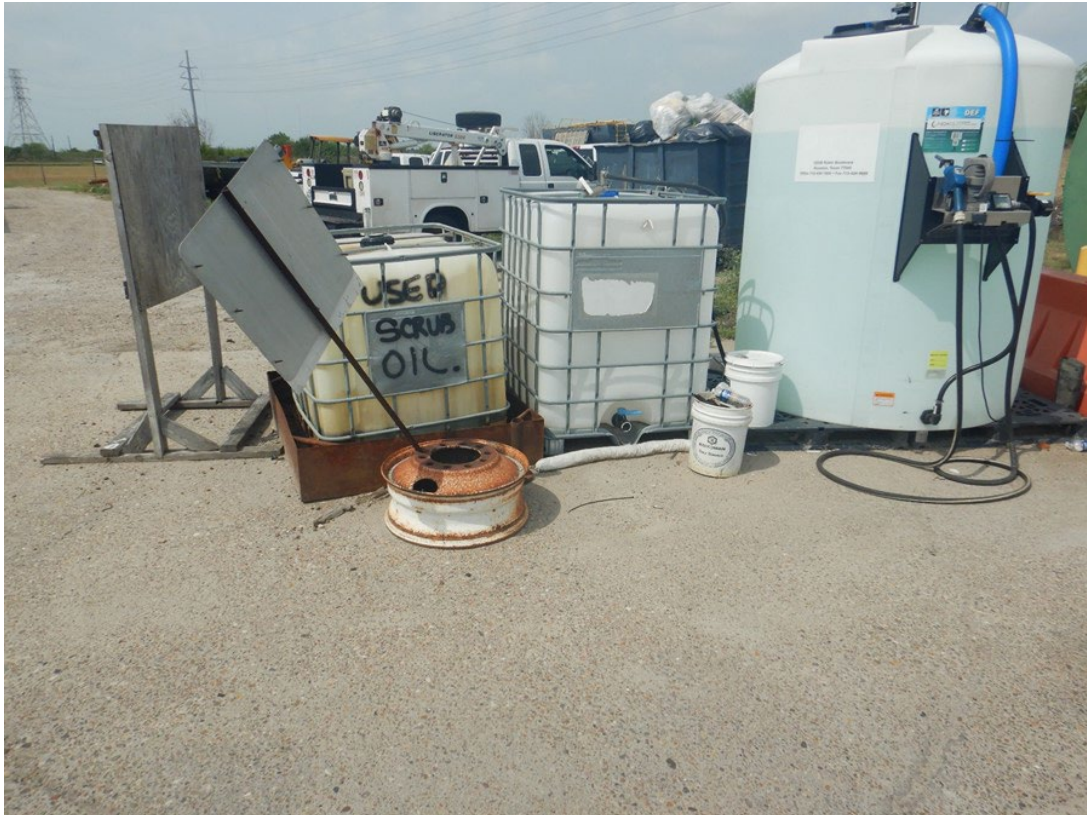
Photo No. 8

The inspection team observed a plastic tote labeled as “Used Scrub Oil” (see Appendix 1 – Photo 8) [see **AOC #2**]. Mr. Johnson indicated that the tote is used to hold used oil generated from vacuum pumps on their trucks and that it was not accumulating used oil at the time of the inspection. Mr. Johnson included a photograph in his response email showing the used oil tote with a visible label (see Appendix 3 – Photo 4).

Description: View of plastic tote labeled as "Used Scrub Oil" containing used oil in Miller's fueling area.

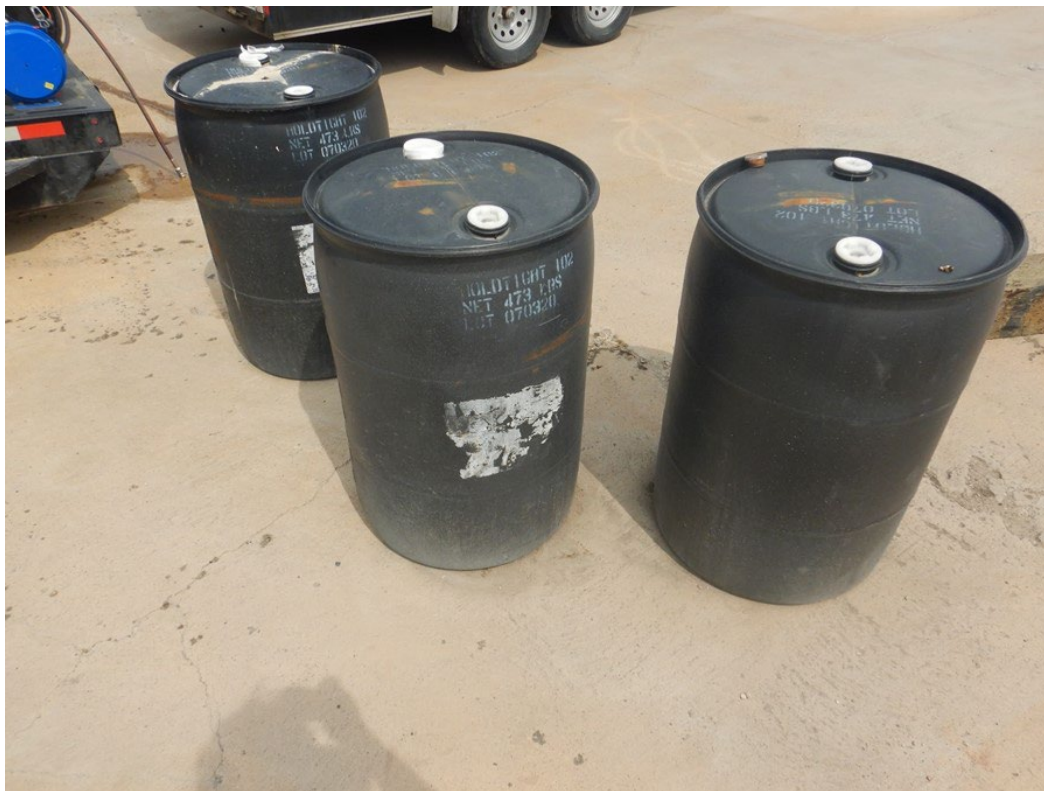
Photo No. 9

The inspection team observed three unlabeled black poly 55-gallon drums located in the yard and an unlabeled blue poly 55-gallon drum located in on the north side of the yard (see Appendix 1 – Photos 9 and 10). The inspection team asked for clarification on the contents of the poly drums. In his response, Mr. Johnson indicated that a sample was taken from the three black drums and the blue drum and sent to Western Gulf Recycling, who confirmed that the material was recyclable water at its lab (see Appendix 2). The drums were all recycled at Western Gulf Recycling and a transportation Bill of Lading (BOL) was included as Appendix 4. The inspection team observed a heat exchanger which contained visible solids/debris that was transported to the facility from a customer and stored on the north side of the yard adjacent to the blue poly drum. The debris within the heat exchanger was also observed deposited on the concrete adjacent to the heat exchanger (see Appendix 1 – Photo 10). A waste determination on the debris had not been conducted [**AOC #4** – *Miller did not make an accurate determination as to whether its waste is a hazardous waste in order to ensure wastes are properly managed according to applicable RCRA regulations. – 40 CFR 262.11*]. The inspection team asked for a waste characterization of the contents of the heat exchanger and the solids associated with it that had spilled onto the concrete. The inspection team also asked Miller for the date the heat exchanger was brought to the site, an explanation of how Miller would be managing the solids/debris associated with the heat exchanger, and any waste analytical results on the solids/debris from the heat exchanger. In his response email, Mr. Johnson indicated that the heat exchanger was brought onsite about 2 years ago, with the assumption that it was emptied and cleaned prior to shipment, to be used as a training fixture for the company’s hydro blasting personnel. Mr. Johnson’s email added that based on the manufacturer’s tag on the equipment, the unit was a Glycol Preheater manufactured in Beaumont, TX in 2002 (see Appendix 2). Mr. Johnson explained that samples of the material were collected from inside the equipment and on the concrete around it. In his 08/12/2024 email, Mr. Johnson provided the final laboratory report from Pace Analytical (see Appendix 6). Although Miller had received the final lab report, Mr. Johnson indicated that Miller personnel had not disposed of the drum because they were trying to determine whether the material was K050 listed hazardous waste (exchanger bundle cleaning sludge from a petroleum refinery) (see Appendix 5). In a second follow-up email from 08/12/2024, Mr. Johnson provided additional information

Description: View of three unlabeled black poly 55-gallon drums in Miller's yard area (observed).

**A sample was taken from the 3 black drums and the 1 blue drum and taken to Western gulf recycling and was confirmed to be recyclable water at their lab. All drums were recycled at western gulf recycling. BOL for transport provided.**

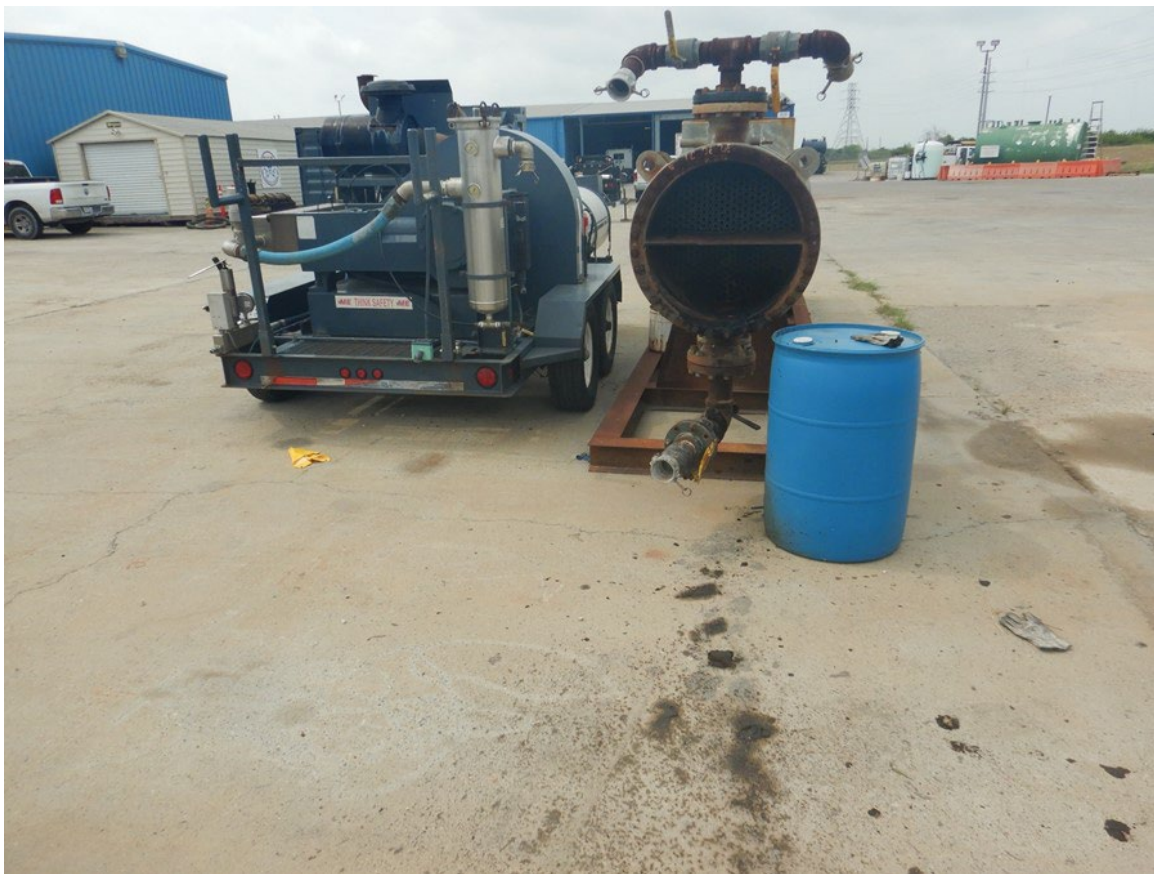
Photo No. 10

| <b>Tenant:</b> Miller Environmental Services | | |
|---|---|---|
| <b>AOC #3</b> – Miller did not make an accurate determination as to whether its waste is a hazardous waste in order to ensure wastes are properly managed according to applicable RCRA regulations. | <b>Citation:</b> 40 CFR 262.11 | Section: 2.1 |

Description: Overview of heat exchanger with visible solids/debris inside of it and on the adjacent concrete, and blue poly 55-gallon drum in Miller's yard area.

- A heat exchanger which contained visible solids/debris was transported to the facility from a customer. The debris within the heat exchanger was also observed deposited on the concrete adjacent to the heat exchanger. A waste determination on the debris had not been conducted.
- **Upon closer inspection there are only a couple of tubes with material in them which we estimate to be <200 lbs of waste.**

regarding the final lab report and Miller's waste determination for the material (see Appendix 7). Mr. Johnson also explained that Miller personnel removed the material from the heat exchanger and the concrete and placed it in a 55-gallon drum after sending a sample off for laboratory analysis (see Appendix 2). In a follow-up email dated 08/12/2024, Mr. Johnson stated that the cleanup generated less than 100 pounds of material (see Appendix 5). Mr. Johnson also included photographs of the side of the heat exchanger and the adjacent concrete following the cleanup (see Appendix 3 – Photos 5 and 6).

**We are managing the material as a hazardous waste until we receive final lab results on the sample. Lab results are preliminary and final results are pending. The lab results will determine if the material will be managed as a hazardous or non-hazardous waste.**

**We have removed the material that appears to have come from the equipment from the concrete area in front of the equipment. We have placed the recovered material and the material removed from the equipment into a 55 gallon drum prior to profiling and disposal at Republic Service US Ecology facility in Robstown, TX.**

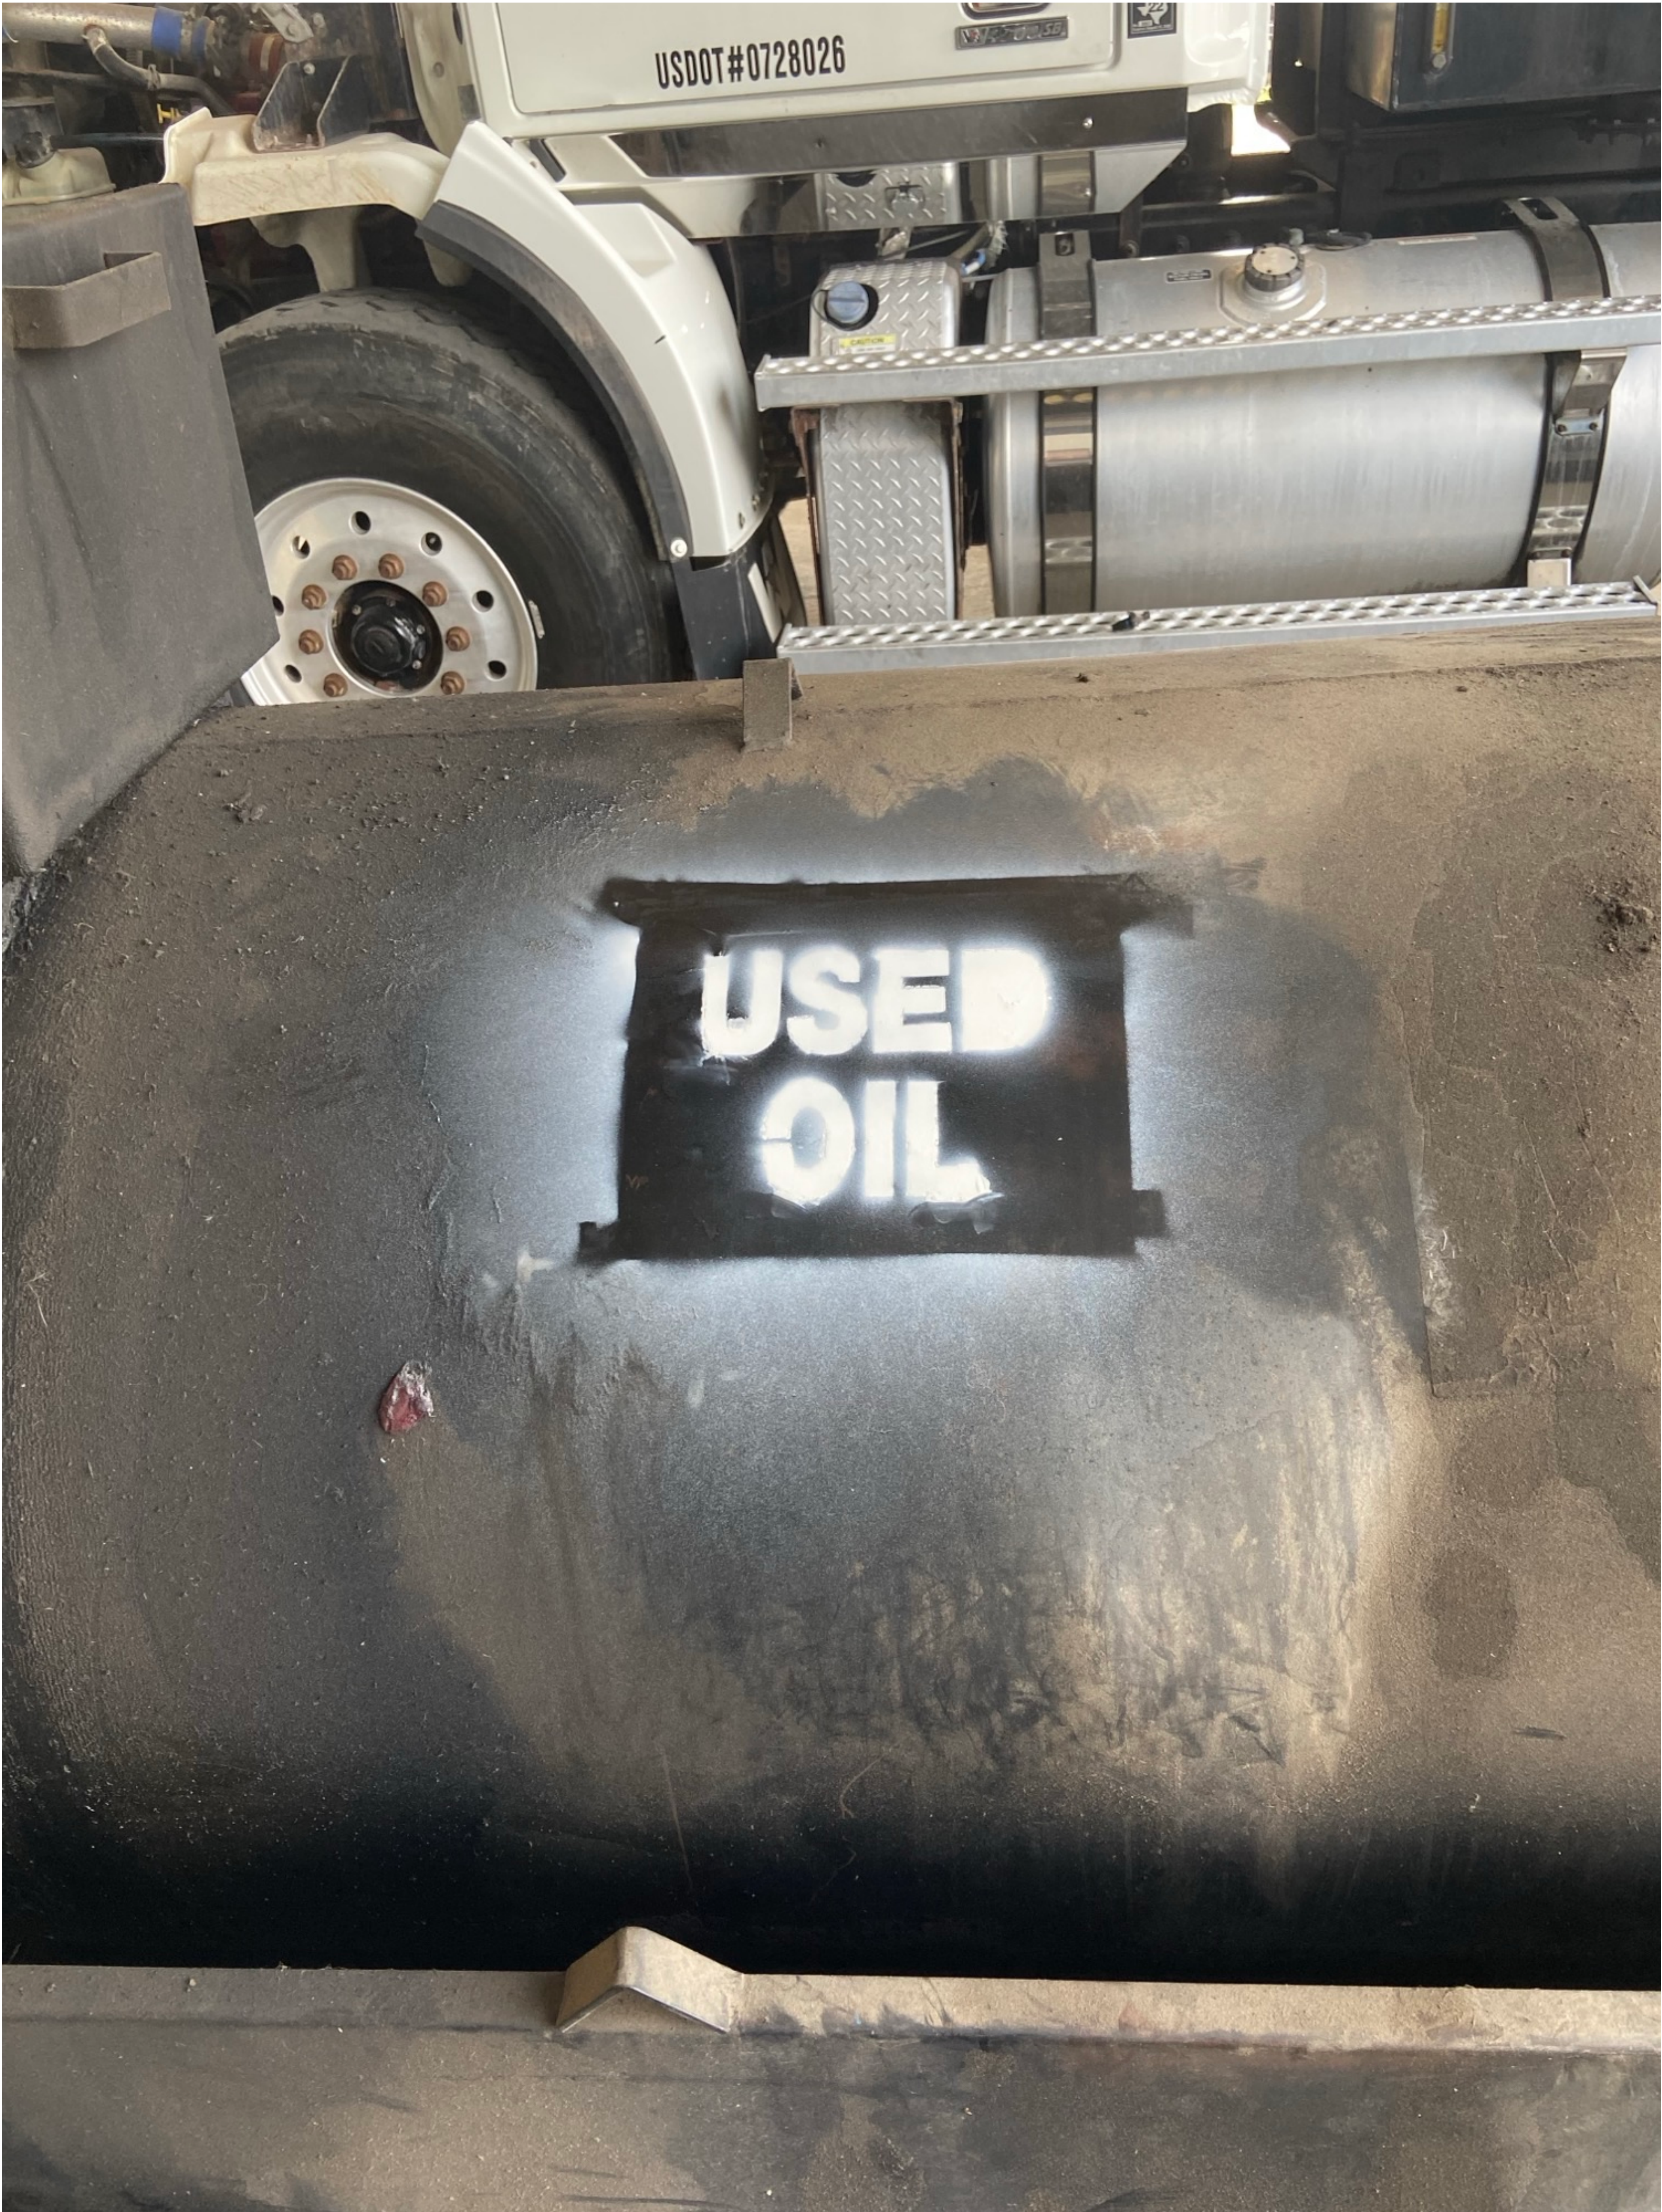
CONTENTS: Used Batteries

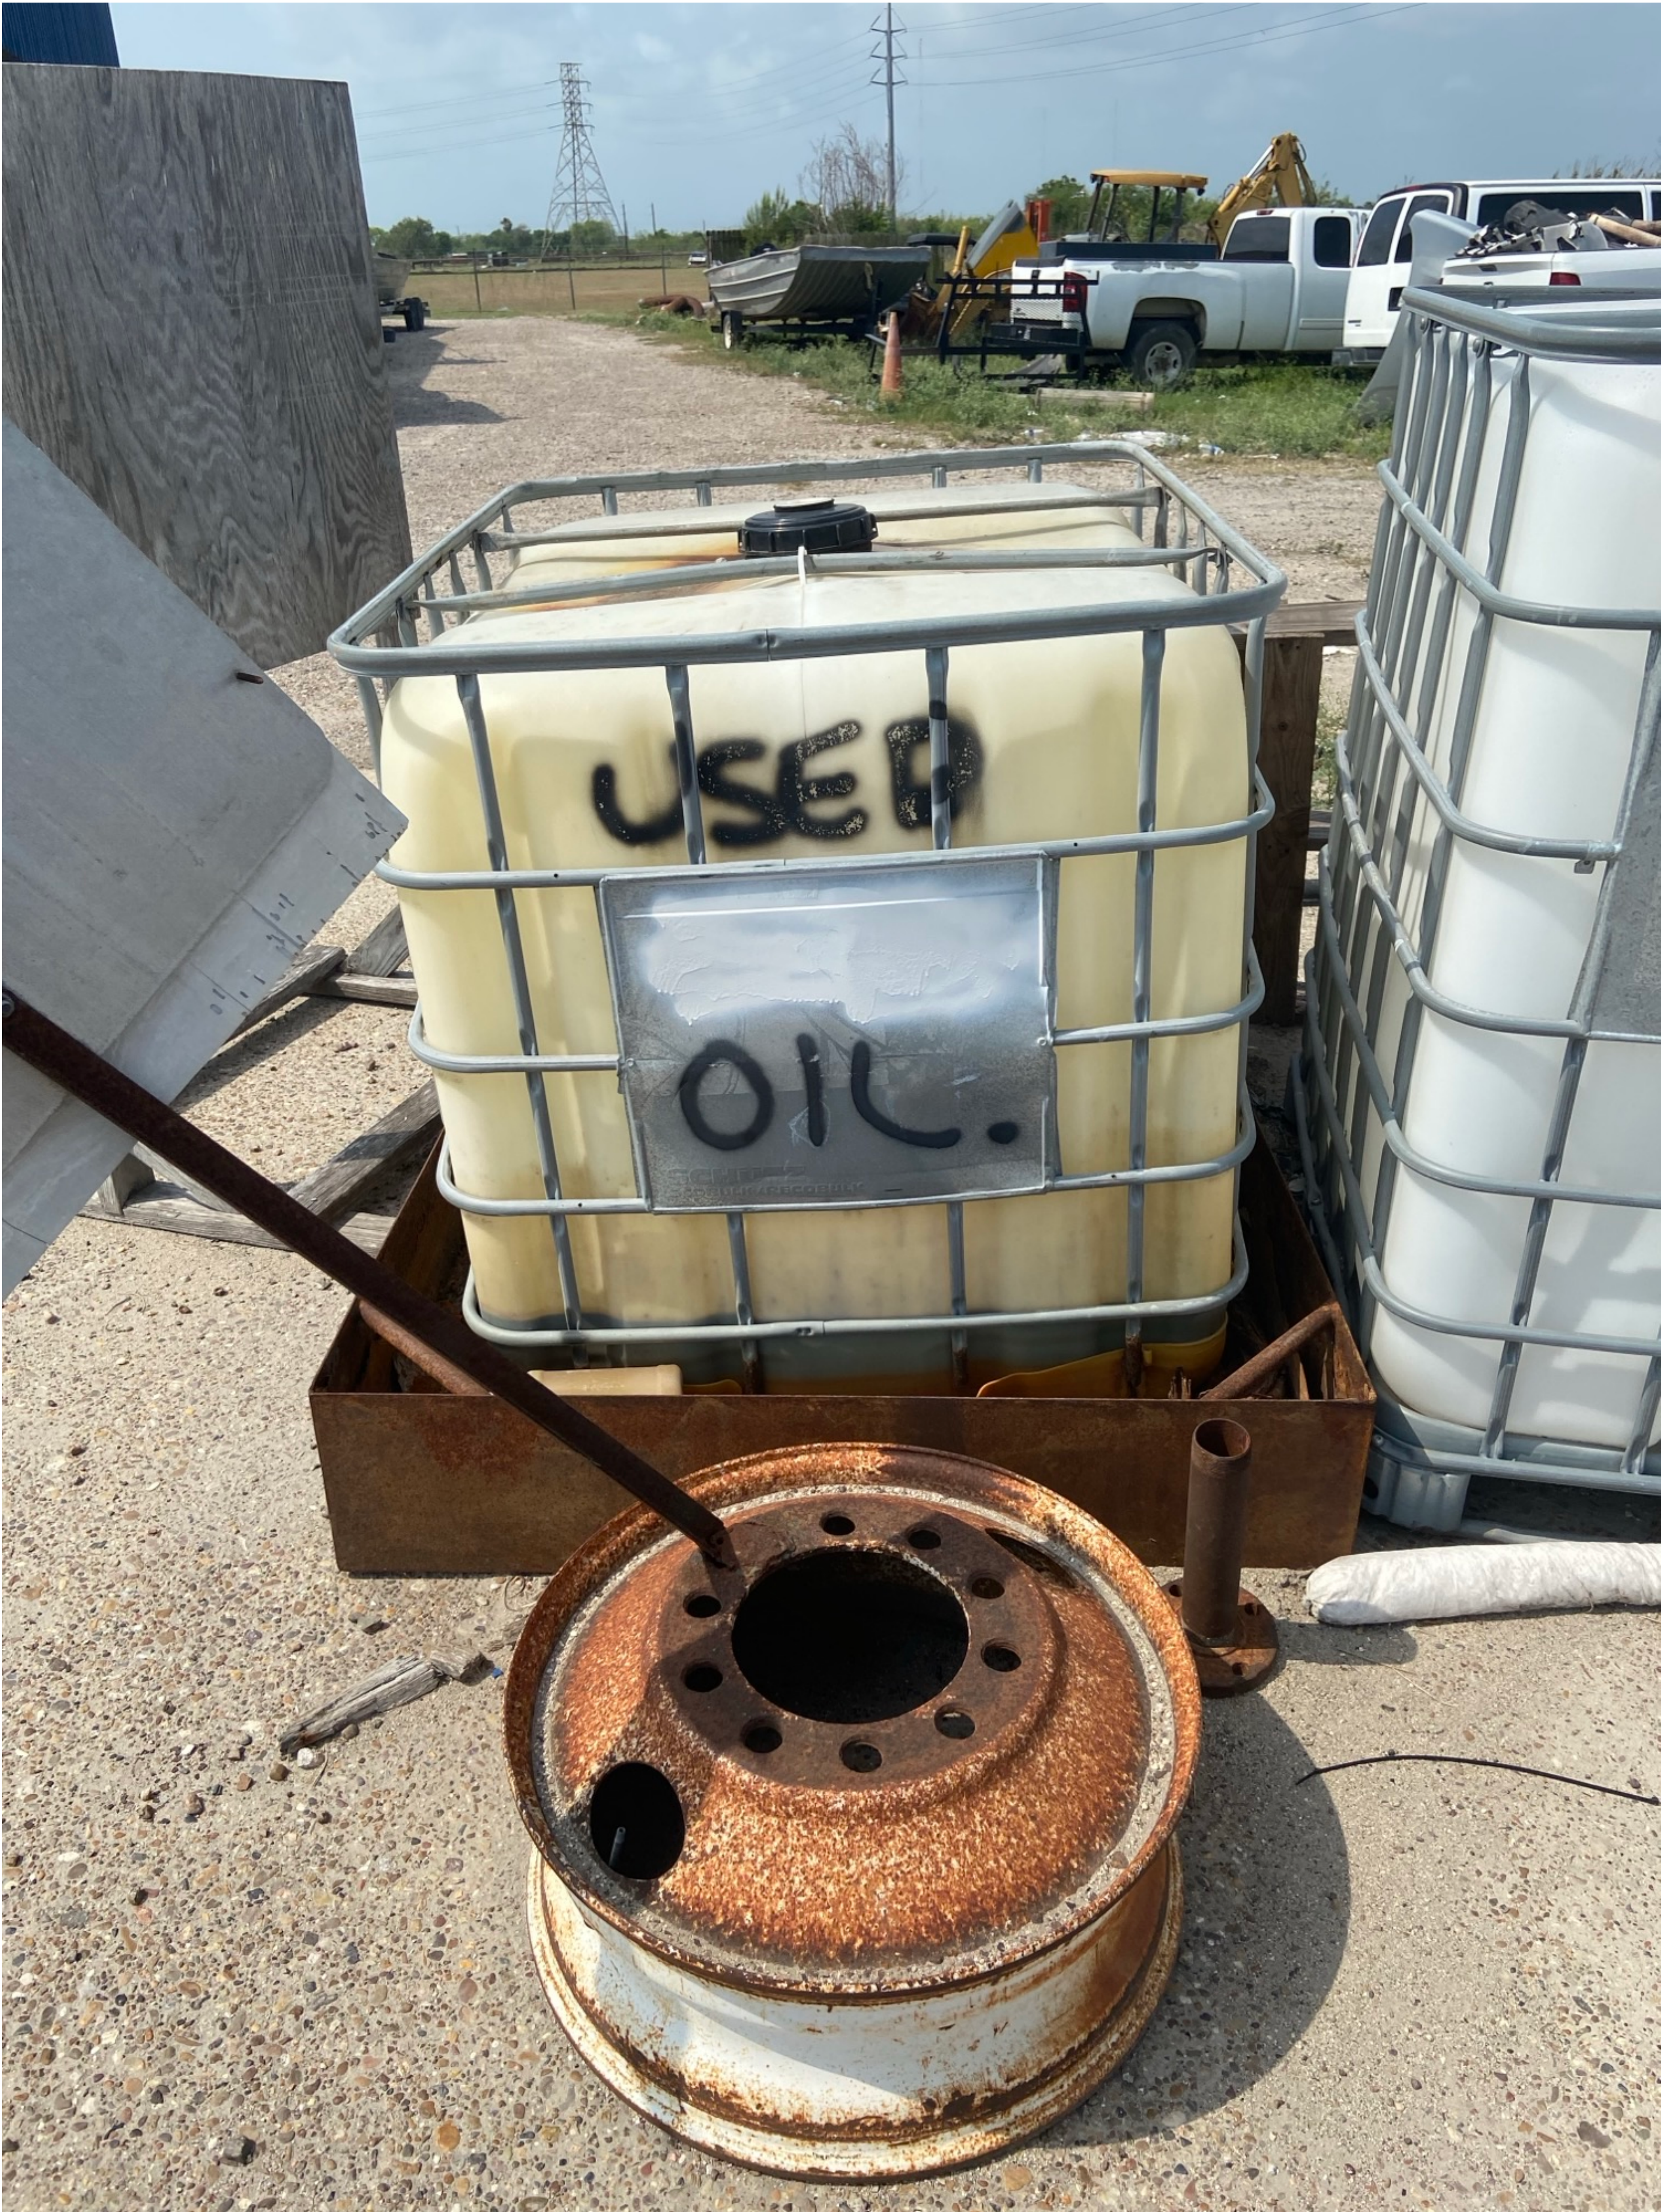
USED  
OIL
