## **RCRA Inspection Report**

Tennessee Valley Authority  
Environmental Research Center  
1010 Reservation Road  
Shoals, Alabama 35661  
Colbert County

EPA ID: AL3640090004  
NAICS: 81131 - Commercial and Industrial  
Machinery and Equipment (Except Muscle  
Automotive and Electronic) Repair  
and Maintenance

November 14, 2024, at 9:00 a.m. CST

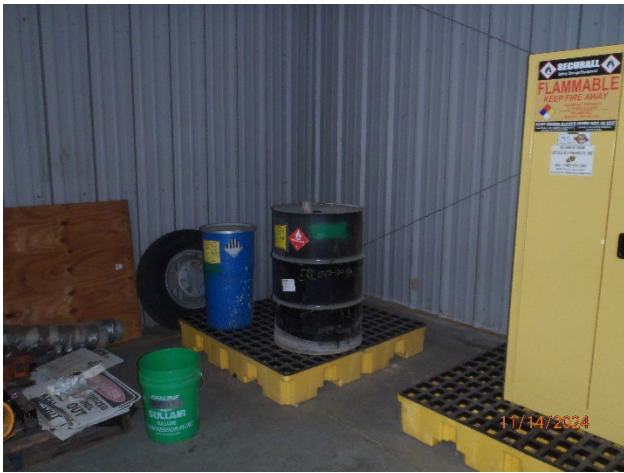
TVA ERC manages a temporary hazardous waste central accumulation area (CAA) in the Shop 2 Paint Shop. The Paint Shop contains painting supplies, a paint booth, and a blaster booth. The CAA was a secondary containment pallet with two containers, a 55-gallon container of paint waste (D001, F003, F005), and 15-gallon container of paint still bottoms (F003, F005) (Pictures 1-3). Both containers had a start accumulation date of September 25, 2024. The temporary CAA was in a corner inside the Paint Shop and was not identified with a sign which read "danger, hazardous waste storage." TVA ERC manages ignitable and toxic paint wastes in this CAA, and the inspectors did not observe "No Smoking" signs around the temporary CAA and/or the Paint Shop. However, the inspectors did observe signs (e.g., Danger Unauthorized Personnel Keep Out) laying on a wooden pallet next to the temporary CAA.

Picture 1 – Temporary Hazardous Waste Storage Area

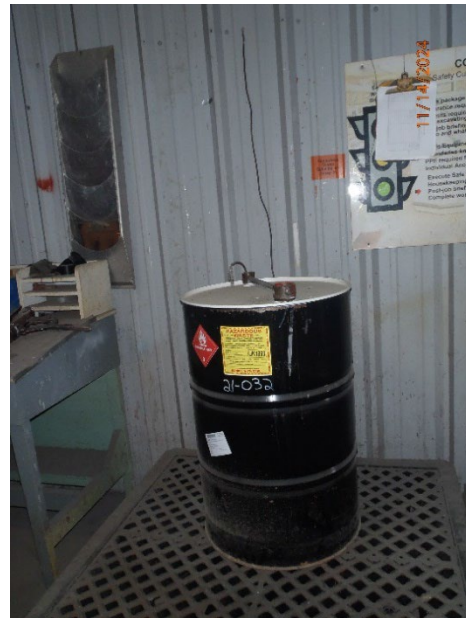
TVA ERC manages several satellite accumulation areas (SAAs) in Shop 2 Paint Shop. The first SAA was for managing hazardous waste aerosol can residue that is generated by puncturing discarded aerosol cans (Pictures 5-6). The inspectors observed a 55-gallon container in SAA #7. The container was located near the temporary CAA, and it was equipped with a closed top lid with a bung, which

Picture 4 – Paint Shop 2 SAA#7

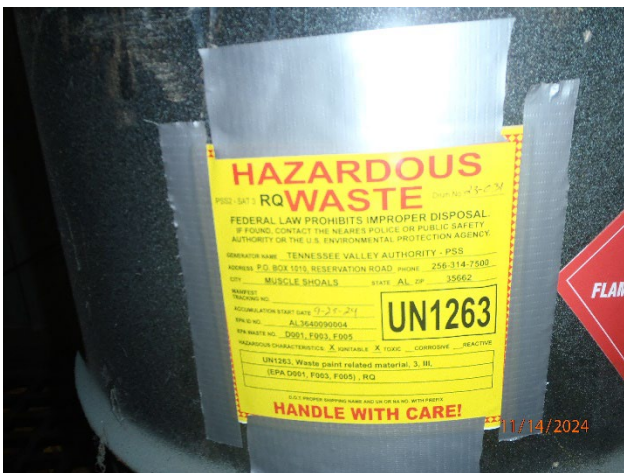
Picture 2 – Temporary Hazardous Waste Storage Area label

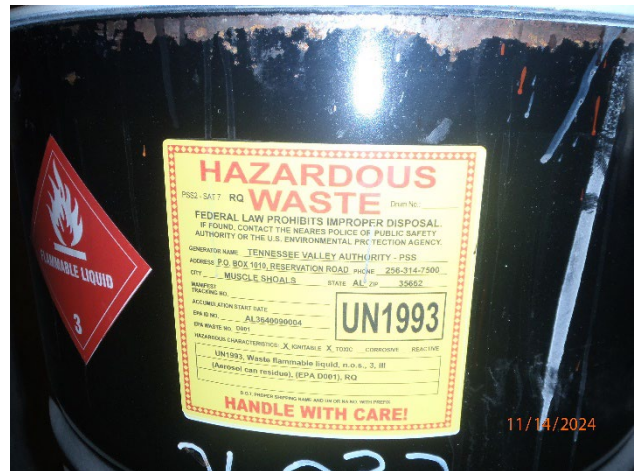
was closed. The container was marked as waste profile number 21-032, labeled D001 hazardous waste Aerosol Can Residue, and identified with a flammable hazard identification.

Picture 5 – Paint Shop 2 SAA#7 label

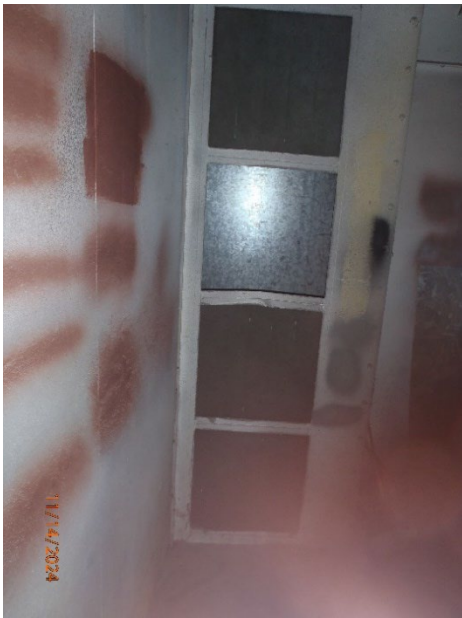
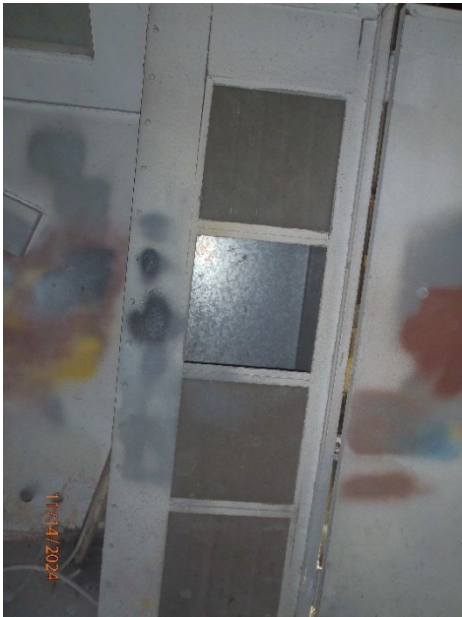
The Paint Shop held two paint booths but only one booth was active. The inspectors observed 14 paint filters in the walls inside the paint booth (Pictures 6-7). Leonard Caldwell explained that the paint filters are changed once a year. The discarded filters are managed as a paint solid, bagged and put into a hazardous waste Open Top roll-off.

Picture 6 – Paint Shop 2 paint filters in use

Picture 7 – Paint Shop 2 paint filters in use

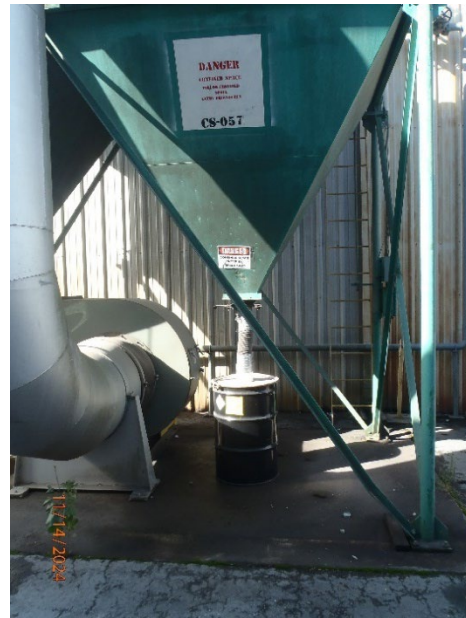
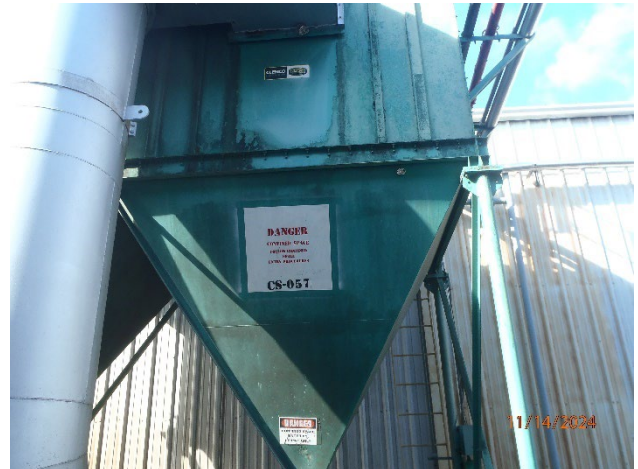
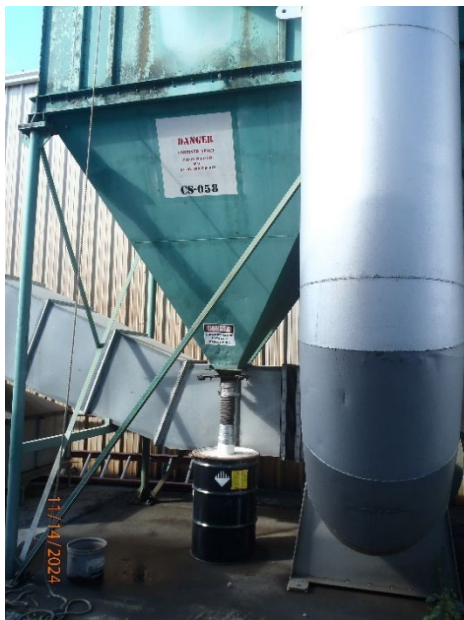
The second SAA was for managing hazardous waste baghouse dust that is generated by media blaster (Pictures 8-12). The inspectors observed two 55-gallon containers under the CLEMCO baghouses. The containers were located outside the Paint Shop, connected to the CLEMCO baghouses, and equipped with open top lids with hose connections, which were closed. The containers were marked as waste profile number CS-057 and CS-058, labeled D008 hazardous waste CLEMCO sandblast dust, and identified with a miscellaneous dangerous goods hazard identification. However, a miscellaneous dangerous good hazard identification is not sufficient but must have the hazardous properties of the waste (i.e., flammable, corrosive, reactive, toxic). The containers are required to have a toxic hazard identification.

Picture 8 – Blast Media Booth CLEMCO baghouse

Picture 9 – Blast Media Booth CLEMCO baghouse

Picture 10 – Blast Media Booth CLEMCO baghouse

Picture 11 – Blast Media Booth CLEMCO baghouse

**Pursuant to ADEM Admin. Code r. 335-14-3-.01(6)(b)6.(i) [40 C.F.R. § 262.15(a)(5)], which is a condition of the SAA Permit Exemption, a generator is required to mark or label its containers (i) with the words “Hazardous Waste” and (ii) with an indication of the hazards of the contents.**

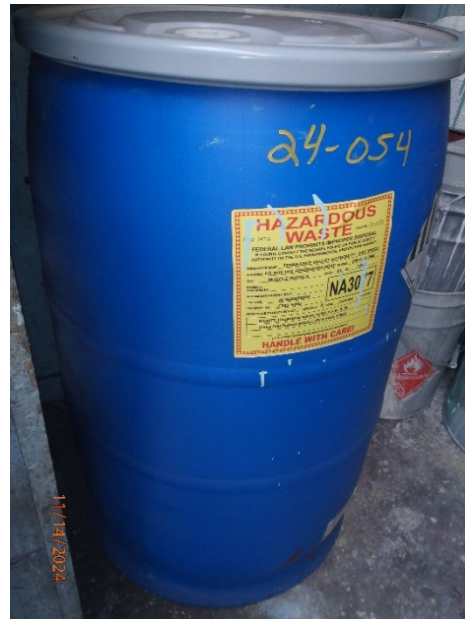
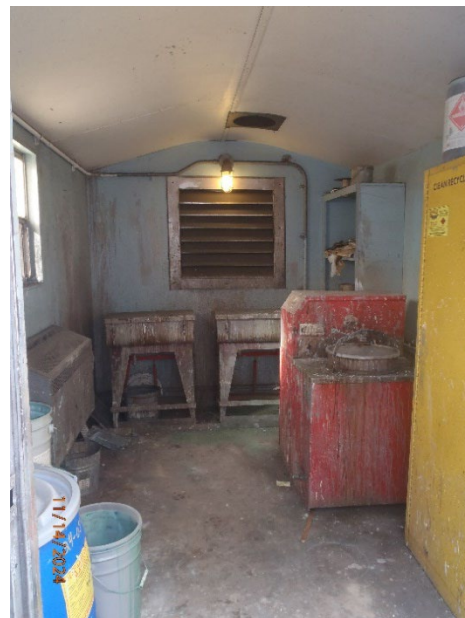
The SAA was for managing hazardous waste still bottoms that is generated by distilling the solvent from the paint waste (Pictures 13-14). The inspectors observed a 30-gallon container in the SAA. The container was located near the shed door, and it was equipped with an open top lid with a clamp, which was closed. The container was marked as waste profile number 24-054, labeled F003, F005 hazardous waste Paint Still Bottom Solids, and identified with a miscellaneous dangerous

goods hazard identification. However, a miscellaneous dangerous good hazard identification is not sufficient but must have the hazardous properties of the waste (i.e., flammable, corrosive, reactive, toxic). The containers are required to have a toxic hazard identification.

Picture 13 – Paint Distillation Shed SAA

Picture 14 – Paint Distillation Shed

**Pursuant to ADEM Admin. Code r. 335-14-3-.01(6)(b)6.(i) [40 C.F.R. § 262.15(a)(5)], which is a condition of the SAA Permit Exemption, a generator is required to mark or label its containers (i) with the words “Hazardous Waste” and (ii) with an indication of the hazards of the contents.**

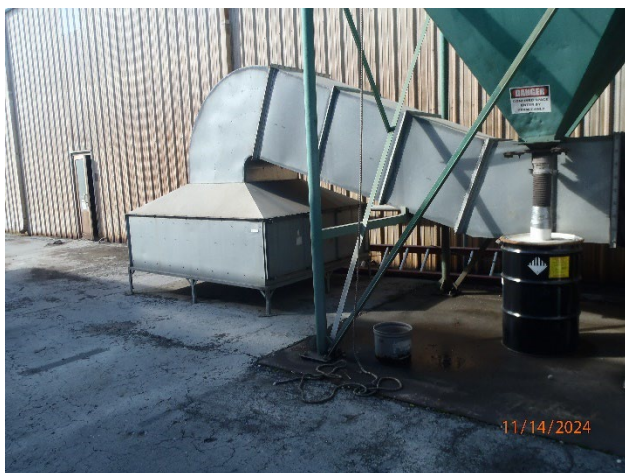
The dust collection system had twelve HEPA filters located inside. Leonard Caldwell explained that the discarded filters are collected as paint solids along with the forty sandblast media filters once a year, bagged and put into a hazardous waste Open Top roll-off.

Picture 12 – Blast Media Booth CLEMCO dust collection system

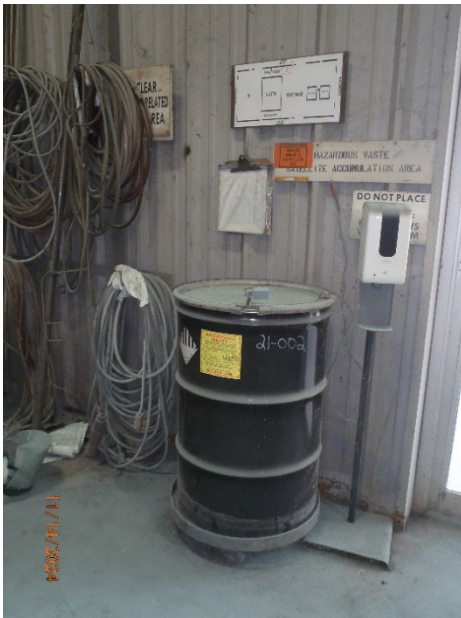
The third SAA was for managing hazardous waste paint cleanup and solids that is generated from the paint booth (Pictures 15-16). The inspectors observed a 55-gallon container in SAA #4. The container was located beside the paint booth, and it was equipped with an open top lid with a clamp, which was closed. The container was marked as waste profile number 21-002, labeled D008, F003, F005 hazardous waste Paint Cleanup and Solids, and identified with a miscellaneous dangerous goods hazard identification. However, a miscellaneous dangerous good hazard identification is not sufficient but must have the hazardous properties of the waste (i.e., flammable, corrosive, reactive, toxic). The containers are required to have a toxic hazard identification.

Picture 15 – Paint Cleanup and Solids SAA#4

Picture 16 – Paint Cleanup and Solids SAA#4 label

**Pursuant to ADEM Admin. Code r. 335-14-3-.01(6)(b)6.(i) [40 C.F.R. § 262.15(a)(5)], which is a condition of the SAA Permit Exemption, a generator is required to mark or label its containers (i) with the words “Hazardous Waste” and (ii) with an indication of the hazards of the contents.**

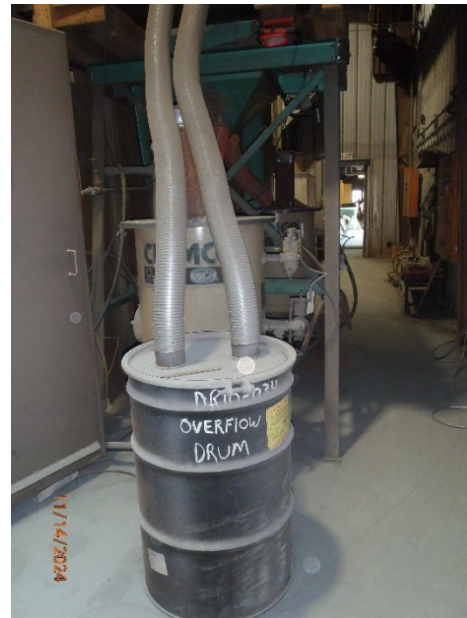
The sandblaster was across from the paint booth and took up a third of the building. Two SAAs were located near the sandblaster. The first SAA was for managing hazardous waste blaster solids that is generated from the sandblasting booth (Picture 17). The inspectors observed a 55-gallon container in the SAA with hoses attached to the lid. The container was located behind the sandblasting booth, and it was equipped with an open top lid, which was closed. The container was marked as waste profile number DR10-034, labeled D008, hazardous waste sandblast with metals, and identified with a miscellaneous dangerous goods hazard identification. However, a miscellaneous dangerous good hazard identification is not sufficient but must have the hazardous properties of the waste (i.e., flammable, corrosive, reactive, toxic). The containers are required to have a toxic hazard identification.

Picture 17 – Blaster Solid Waste SAA

**Pursuant to ADEM Admin. Code r. 335-14-3-.01(6)(b)6.(i) [40 C.F.R. § 262.15(a)(5)], which is a condition of the SAA Permit Exemption, a generator is required to mark or label its containers (i) with the words “Hazardous Waste” and (ii) with an indication of the hazards of the contents.**

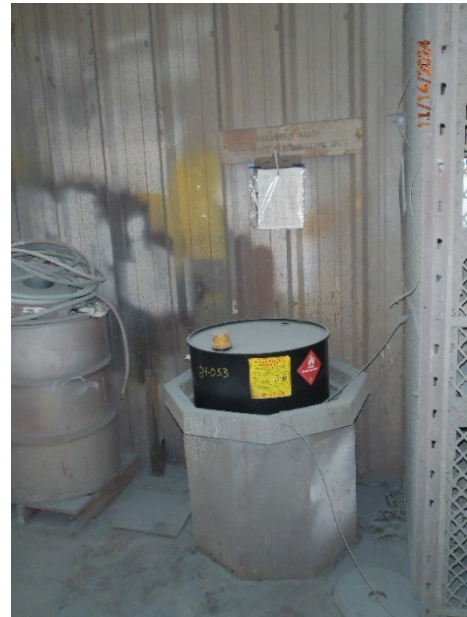
The second SAA was for managing hazardous waste paint related material that is generated from the sandblasting booth (Picture 18). The inspectors observed a 55-gallon container in SAA#3 inside a secondary containment. The container was located in the shop area beside the sandblasting booth, and it was equipped with a closed top lid with a bung, which was closed. The container was marked as waste profile number 24-053, labeled D001, F003, F005, hazardous waste paint related material, and identified with a flammable hazard identification. However, a miscellaneous dangerous good hazard identification is not sufficient but must have the hazardous properties of the waste (i.e., flammable, corrosive, reactive, toxic). The containers are required to have a toxic hazard identification.

Picture 18 – Blaster Waste Paint Related Material SAA#3

**Pursuant to ADEM Admin. Code r. 335-14-3-.01(6)(b)6.(i) [40 C.F.R. § 262.15(a)(5)], which is a condition of the SAA Permit Exemption, a generator is required to mark or label its containers (i) with the words “Hazardous Waste” and (ii) with an indication of the hazards of the contents.**

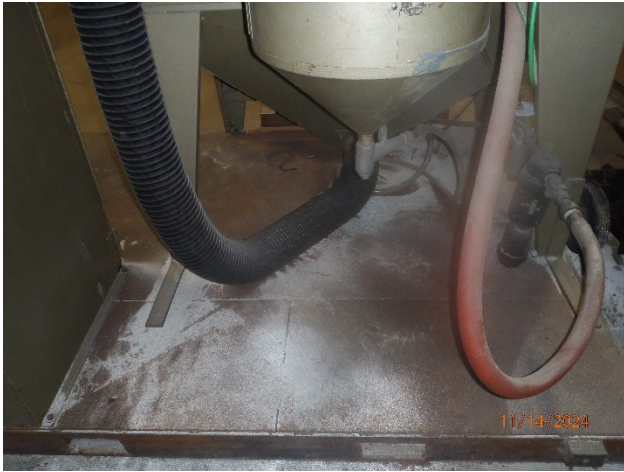
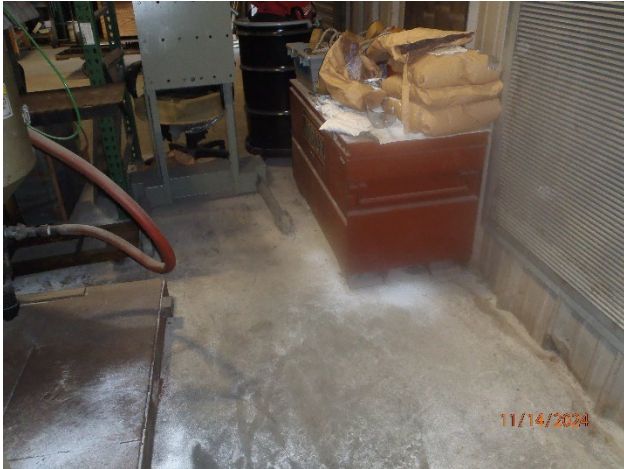
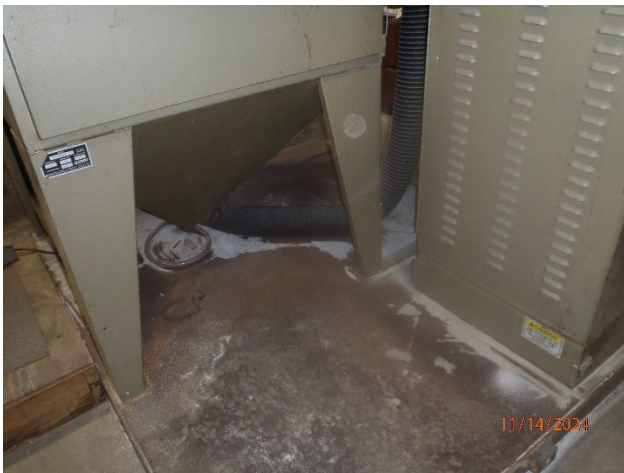
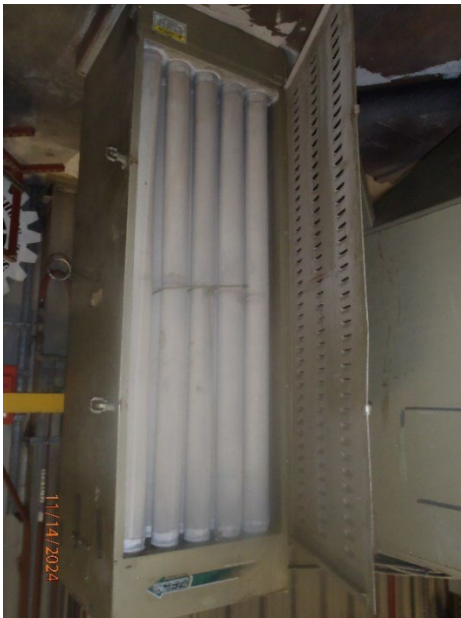
The inspectors observed a Zero Blast Cabinet with overspill underneath the cabinet and on the

floor around the cabinet (Pictures 25-27, 30). Brandon Williams spoke with shop personnel and was told that the material was non-hazardous and spilled clean sandblast media. The inspectors opened the cabinet and observed filters inside. Brandon Williams explained that the media is shaken from the filters and extracted from the bottom of the cabinet. The spent media is placed in the SAA #33. The filters are not replaced on a regular schedule but as needed and disposed of as hazardous waste. The inspectors recommended housekeeping of the spilled media to prevent cross contamination of clean and discarded media.

Picture 25 – Breaker Shop Zero Blast Cabinet spilled media

Picture 26 – Breaker Shop Zero Blast Cabinet spilled media

Picture 27 – Breaker Shop Zero Blast Cabinet spilled media

Picture 30 – Breaker Shop Zero Blast Cabinet filters

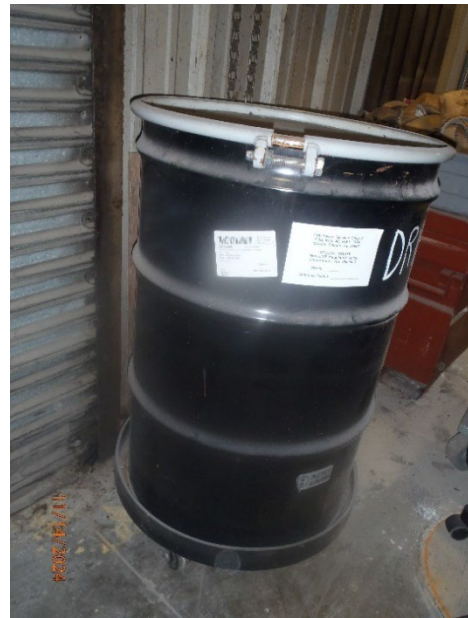
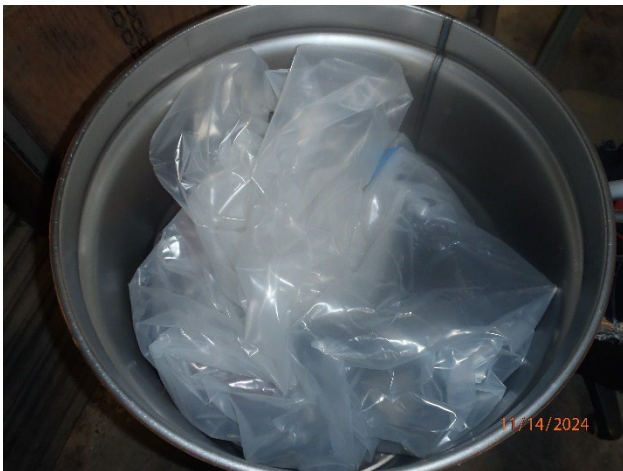
Near the rear roll up door was a 55-gallon container labeled Special Waste Asbestos Arc Shields (Pictures 28, 29, 31). The container contained fiberboard arc shields made of asbestos. The waste marked non-hazardous, and the container was closed and full. The shop personnel did not know how long the container had been staged in this area.

Picture 28 – Breaker Shop Special Waste – Asbestos Arc Shields

Picture 29 – Breaker Shop Special Waste – Asbestos Arc Shields label

Picture 31 – Breaker Shop Special Waste – Asbestos Arc Shields

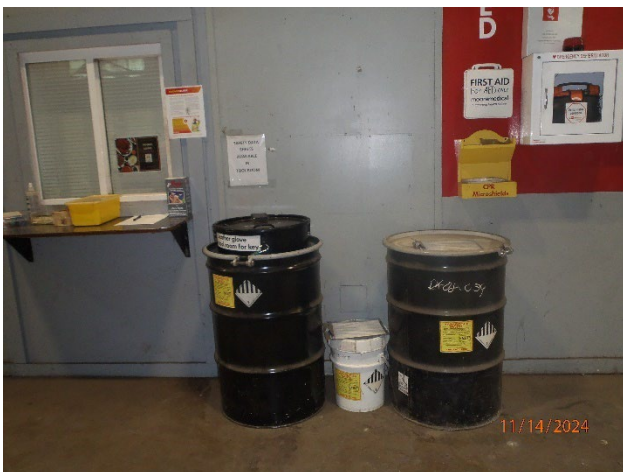
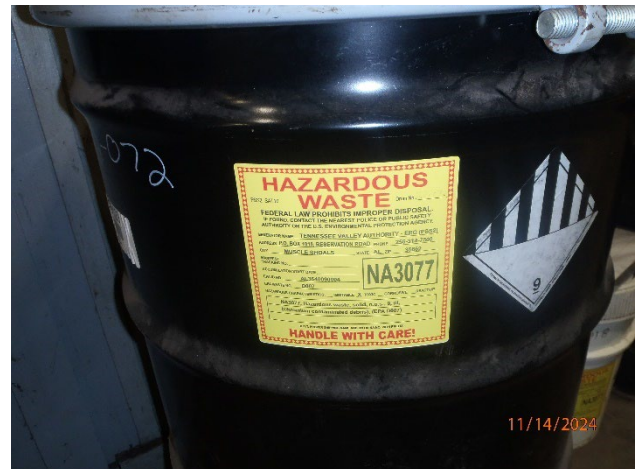
The Shop 2 SAA #11 had three containers. The first container was for managing hazardous waste broken bulbs that are generated from the shop (Pictures 32-35). The inspectors observed a 55-gallon container equipped with an open top lid, which was closed. The container was marked as waste profile number 08-039, labeled D009, hazardous waste broken bulbs with mercury, and identified with a miscellaneous dangerous goods hazard identification. However, a miscellaneous dangerous good hazard identification is not sufficient but must have the hazardous properties of the waste (i.e., flammable, corrosive, reactive, toxic). The containers are required to have a toxic hazard identification.

The second container was for managing hazardous waste anode dust that are generated from the shop (Pictures 32-35). The inspectors observed a white 5-gallon container, which was closed. The container was marked as waste profile number 13-018, labeled D003, hazardous waste anode dust, and identified with a miscellaneous dangerous goods hazard identification. However, a miscellaneous dangerous good hazard identification is not sufficient but must have the hazardous

properties of the waste (i.e., flammable, corrosive, reactive, toxic). The containers are required to have a toxic hazard identification.

Picture 32 – Shop 2 SAA #11

Picture 33 – Shop 2 SAA #11 label

Picture 34 – Shop 2 SAA #11

Picture 35 – Shop 2 SAA #11

**Pursuant to ADEM Admin. Code r. 335-14-3-.01(6)(b)6.(i) [40 C.F.R. § 262.15(a)(5)], which is a condition of the SAA Permit Exemption, a generator is required to mark or label its containers (i) with the words “Hazardous Waste” and (ii) with an indication of the hazards of the contents.**

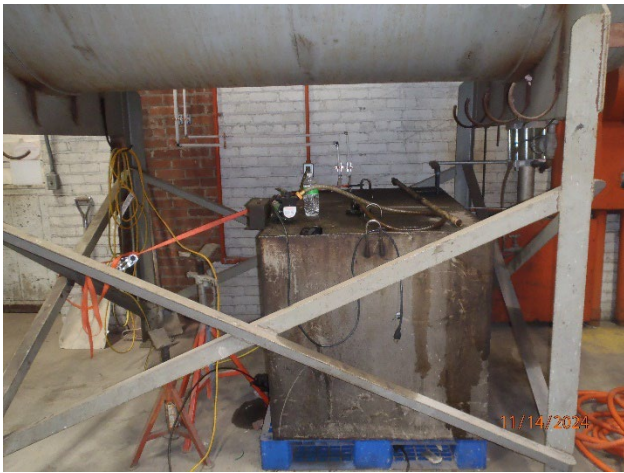
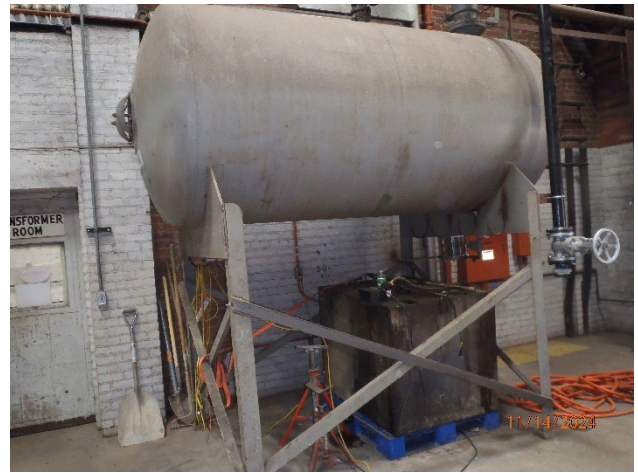
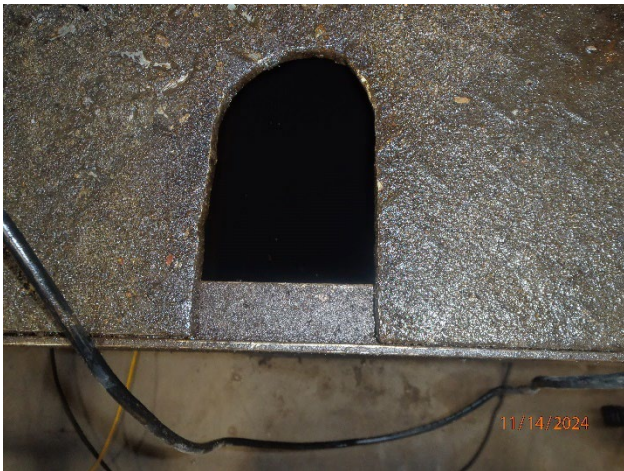
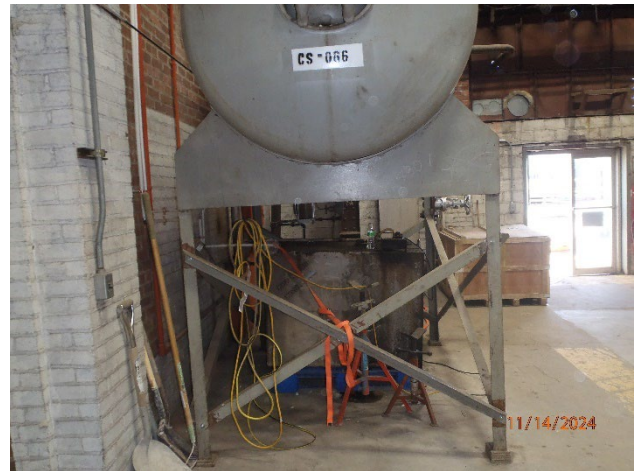
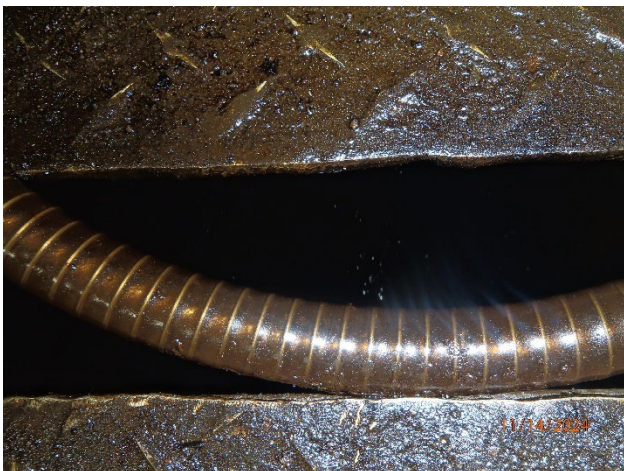
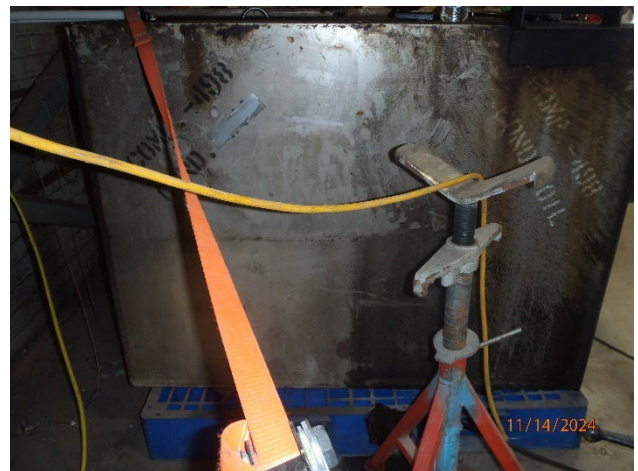
The Compressor room had recently been renovated and the old leaking equipment was removed. The inspectors observed underneath a tank an old condensate collection box filled with oily water (Pictures 36-41). Brandon Williams called around and verified that the tank and the collection box were still in use and that the oily water was being sent to the oil-water separator in Shop 1. The used oil was collected for disposal.

Picture 36 – Shop 2 Compressor Room condensate collection box

Picture 39 – Shop 2 Compressor Room condensate collection box

Picture 37 – Shop 2 Compressor Room condensate collection box oily water

Picture 40 – Shop 2 Compressor Room condensate collection box

Picture 38 – Shop 2 Compressor Room condensate collection box oily water

Picture 41 – Shop 2 Compressor Room condensate collection box

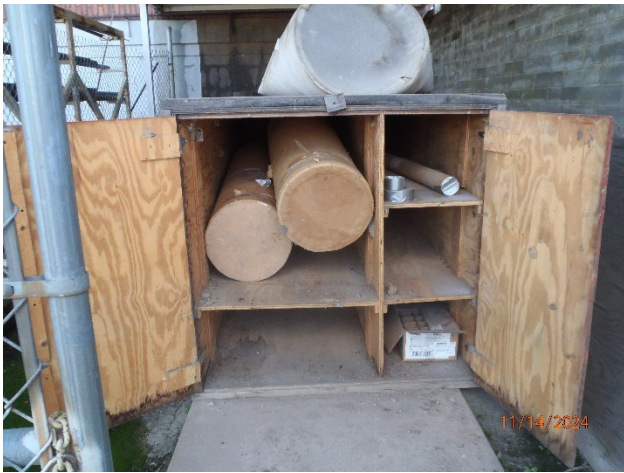
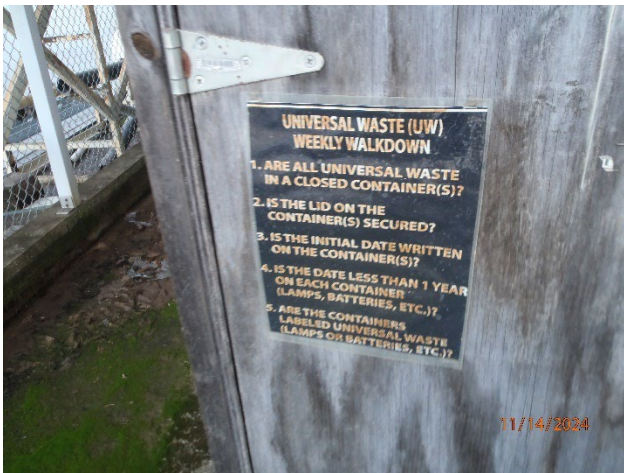
TVA ERC manages universal waste lamps in a fenced in enclosure with a sign on the gate. The universal waste lamps are stored in a wooden box until ready to ship. The inspectors observed two empty 4-foot fiberboard containers (Pictures 42-43). No lamps were in the storage area.

Picture 42 – Universal Waste Shed

Picture 43 – Universal Waste Shed label

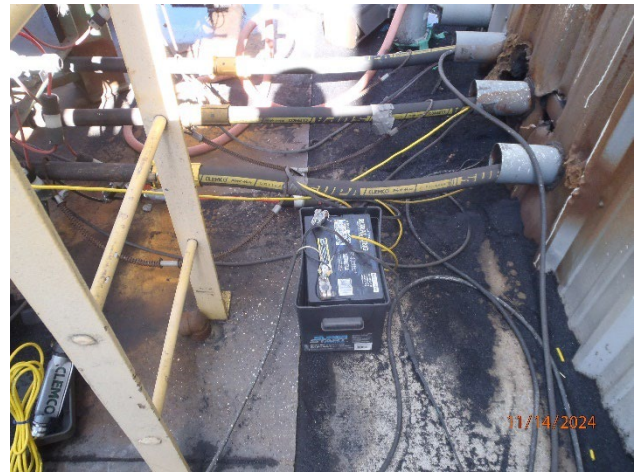
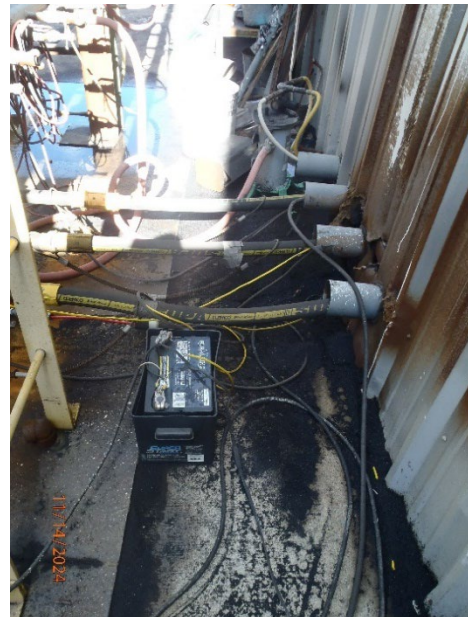
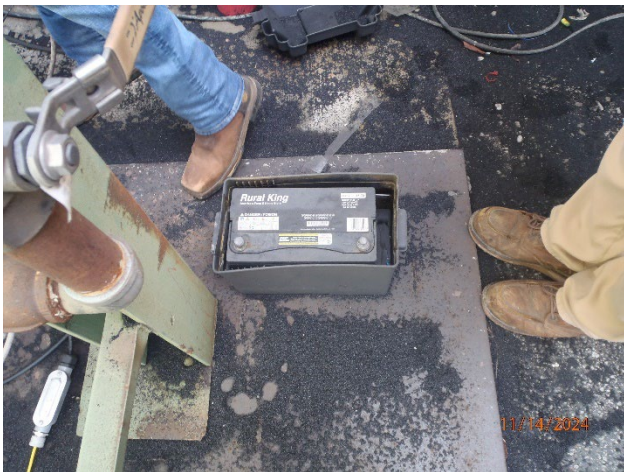
The Shop 2 sandblasting shop is a standalone hanger open at both ends. At the time of the inspection, the inspectors observed two lead acid batteries sitting in rainwater (Pictures 44-46). One of the batteries was connected to the sandblaster system. The inspectors expressed concern about worker safety of having the batteries exposed to wet weather and sitting in water as well as connected for use.

Picture 45 – Shop 2 Blaster Shop lead acid battery in water

Picture 46 – Shop 2 Blaster Shop lead acid battery in water

Picture 44 – Shop 2 Blaster Shop lead acid battery in water

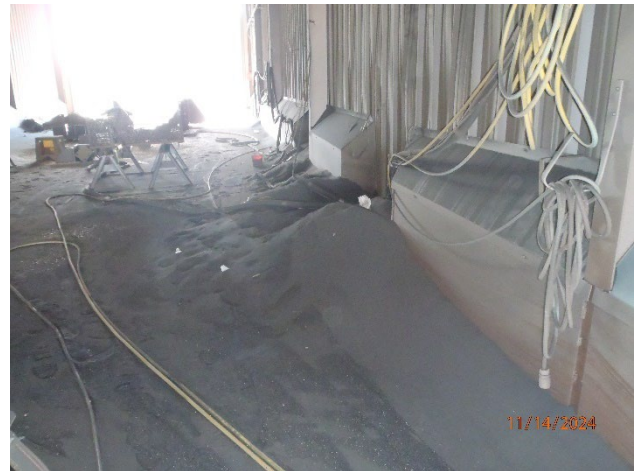
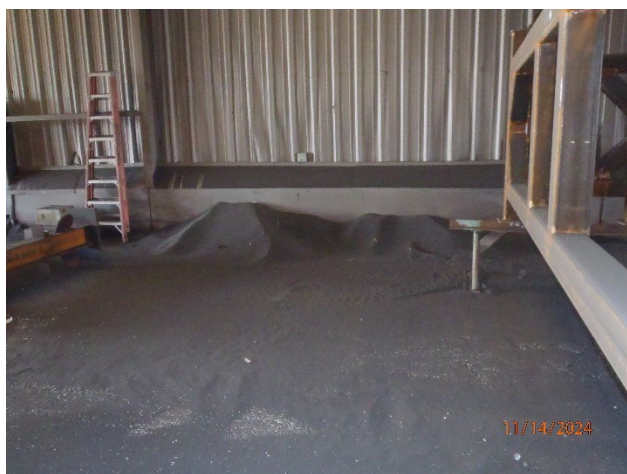
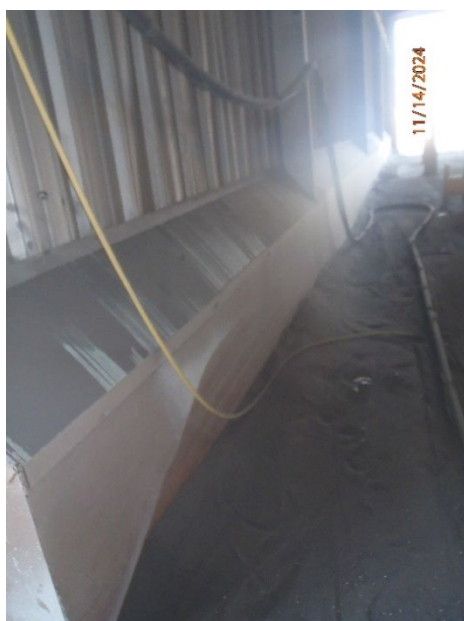
The inspectors observed spent black beauty sandblast media on the ground inside the hanger and releasing outside the hanger via the walls and entrances (Pictures 47-49). Brandon Williams explained that the spent media was non-hazardous but collected, stored in open top boxes in the yard, and labeled as hazardous waste until the analytical results for the pending boxes are returned. The inspectors expressed concern about the quantity of spent media allowed to gather on the floor of the sandblast, the amount spilling from the walls and the door, and the personnel that tracked the spent blast media from the hanger to other areas via shoes or vehicles. The EPA

During the records review, the inspectors requested the spent sandblast media waste profile and past analytical results. The 2022 and 2023 results for the Blast Media Roll-off had lead contamination and was disposed of as hazardous waste.

Picture 47 – Shop 2 Blaster Shop spent media from lead abatement

Picture 48 – Shop 2 Blaster Shop spent media from lead abatement

Picture 49 – Shop 2 Blaster Shop spent media from lead abatement

recommends a stronger housekeeping practice to prevent the release to spent sandblast media outside of the hanger.

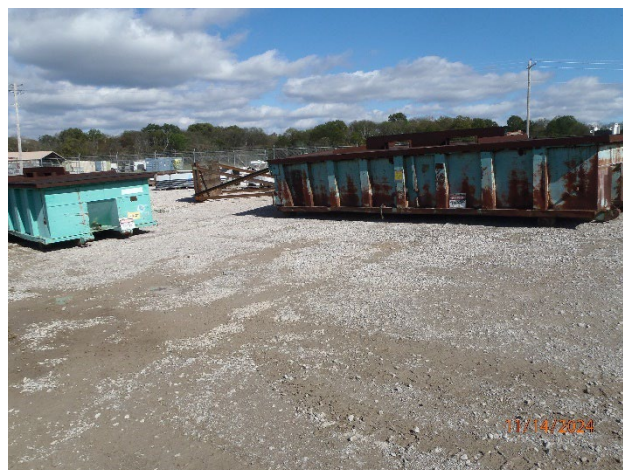
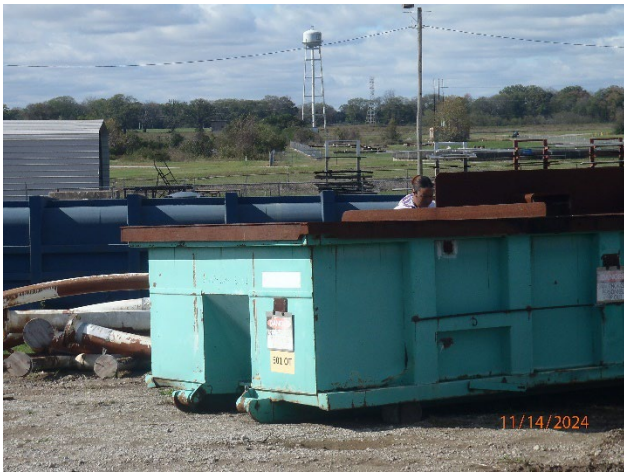
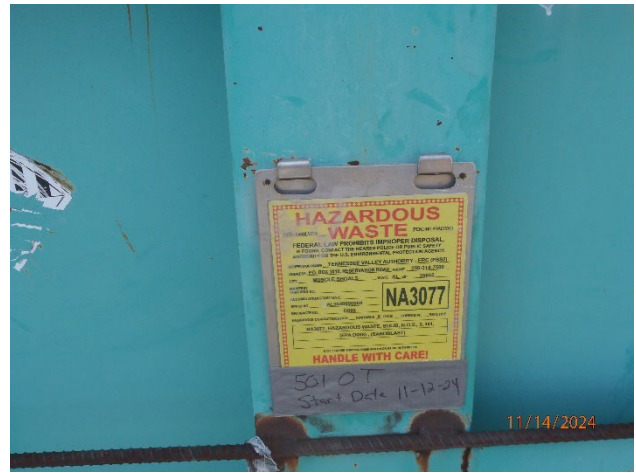
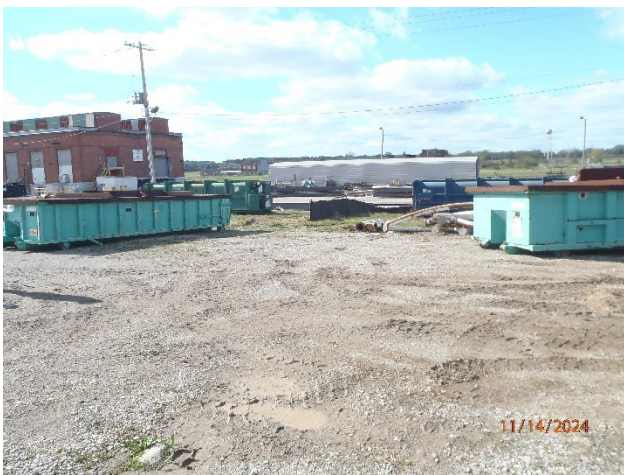
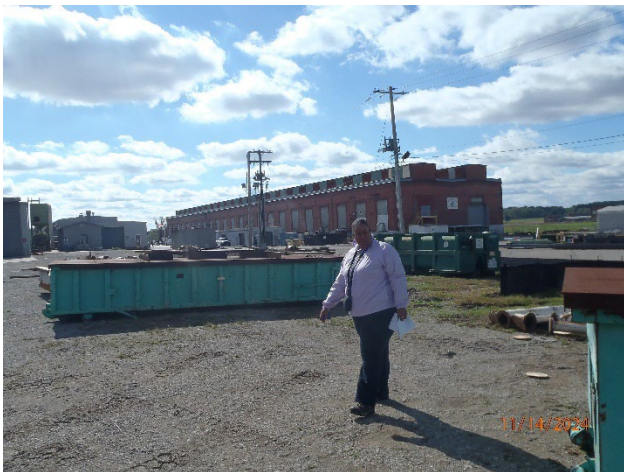
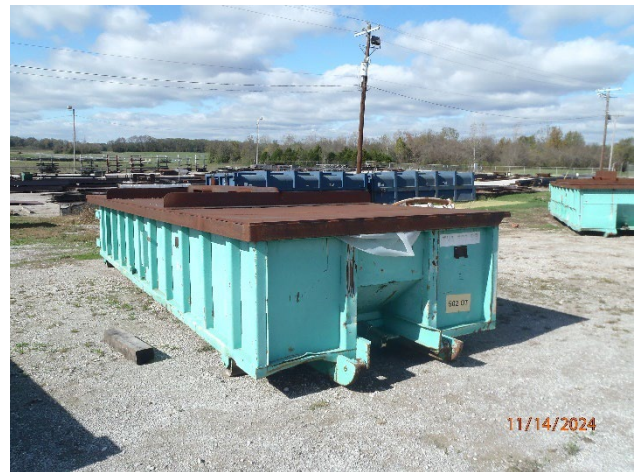
TVA ERC stores four open top (OT) boxes in the yard beyond the Shop 2 sandblasting hanger (Pictures 50-58). Brandon Williams explained that OT 501, 503 and 504 were waiting on Toxic Characteristic Leaching Procedure (TCLP) analytical results for metals. The containers were labeled as hazardous waste sandblast (D008) from lead abatement sandblasting. The containers were dated November 12, 2024. OT 502 results were non-hazardous, and the box was waiting on pickup.

Picture 50 – Open Top Box – Spent Blast Media

Picture 53 – Open Top Box – Spent Blast Media

Picture 56 – Open Top Box – Spent Blast Media label

Picture 54 – Open Top Box – Spent Blast Media

Picture 55 – Open Top Box – Spent Blast Media

Picture 58 – Open Top Box – Spent Blast Media

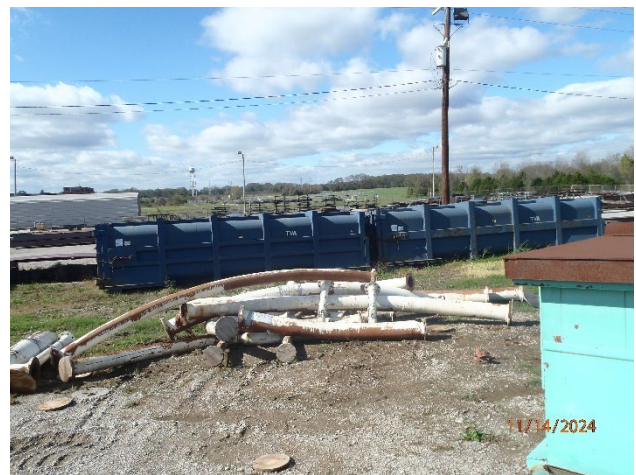
Picture 57 – Empty vac boxes
