## **RCRA Inspection Report**

Marine Corps Air Station Beaufort (MCASB)  
Highway 21  
Beaufort, South Carolina 29904  
Beaufort County

**COMPLIANCE EVALUATION INSPECTION**

**November 29, 2022**

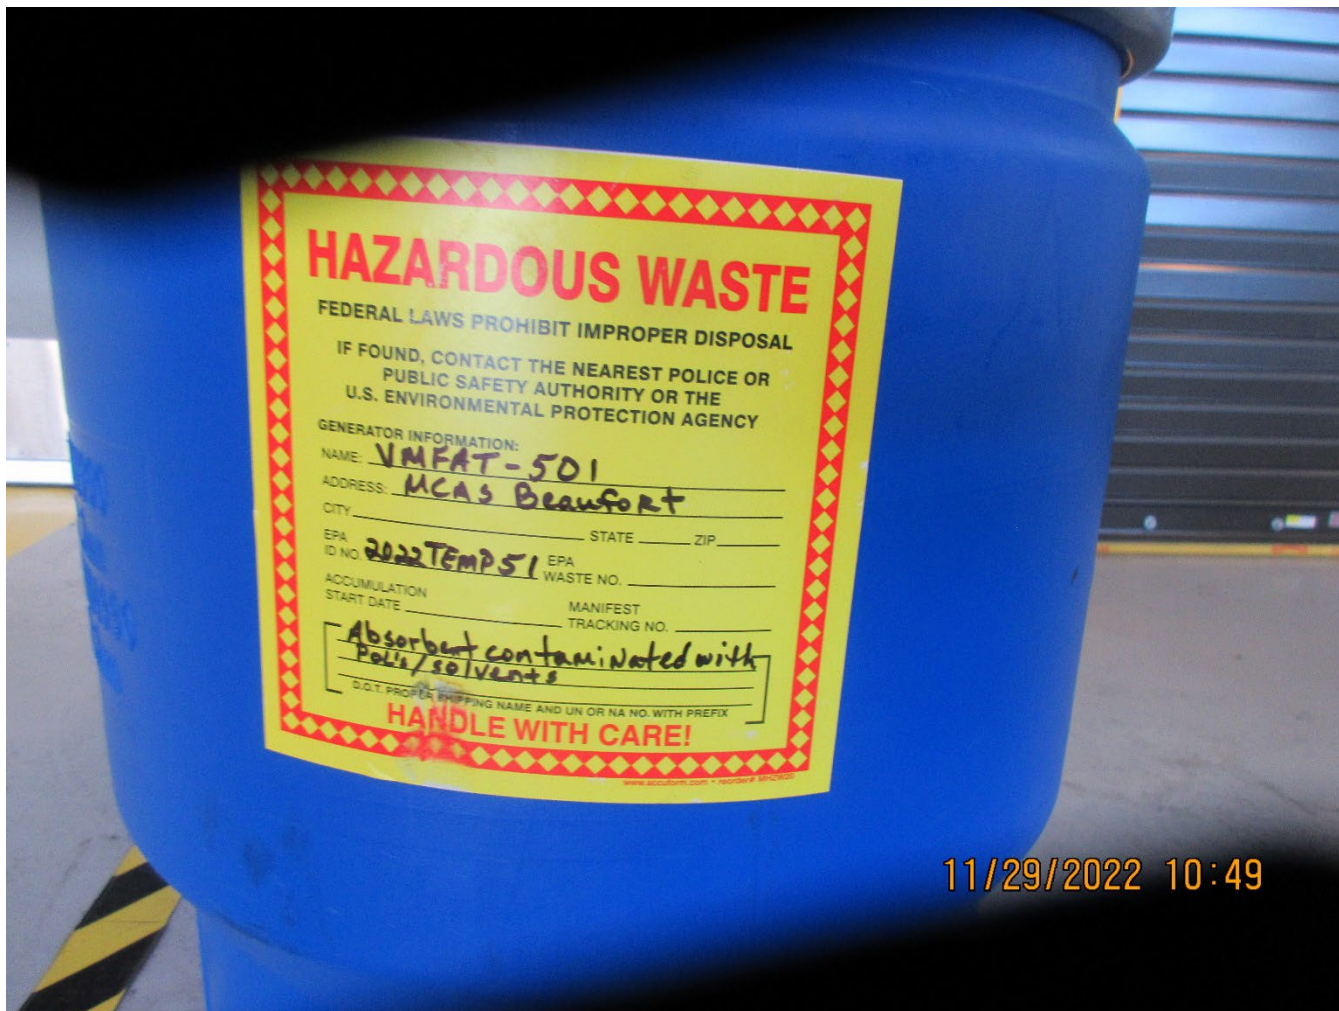
Within the hanger area of this building, which included eight aircraft maintenance bays, one 15-gallon container of hazardous waste absorbent contaminated with solvent was observed in a SAA. The container was not labeled with an indication of the hazard contents of the container (Photographs 1 and 2).

Photo 1 – Label on Container in VMFAT – 501 Area – Building 3090 without hazard indicator

**Pursuant to S.C. Code Ann. Regs. 61-79.262.15(a)(5)(ii) [40 C.F.R. § 262.15(a)(5)(ii)], which is a condition of the SAA Permit Exemption, a generator is required to mark or label its containers with an indication of the hazards of the contents.**

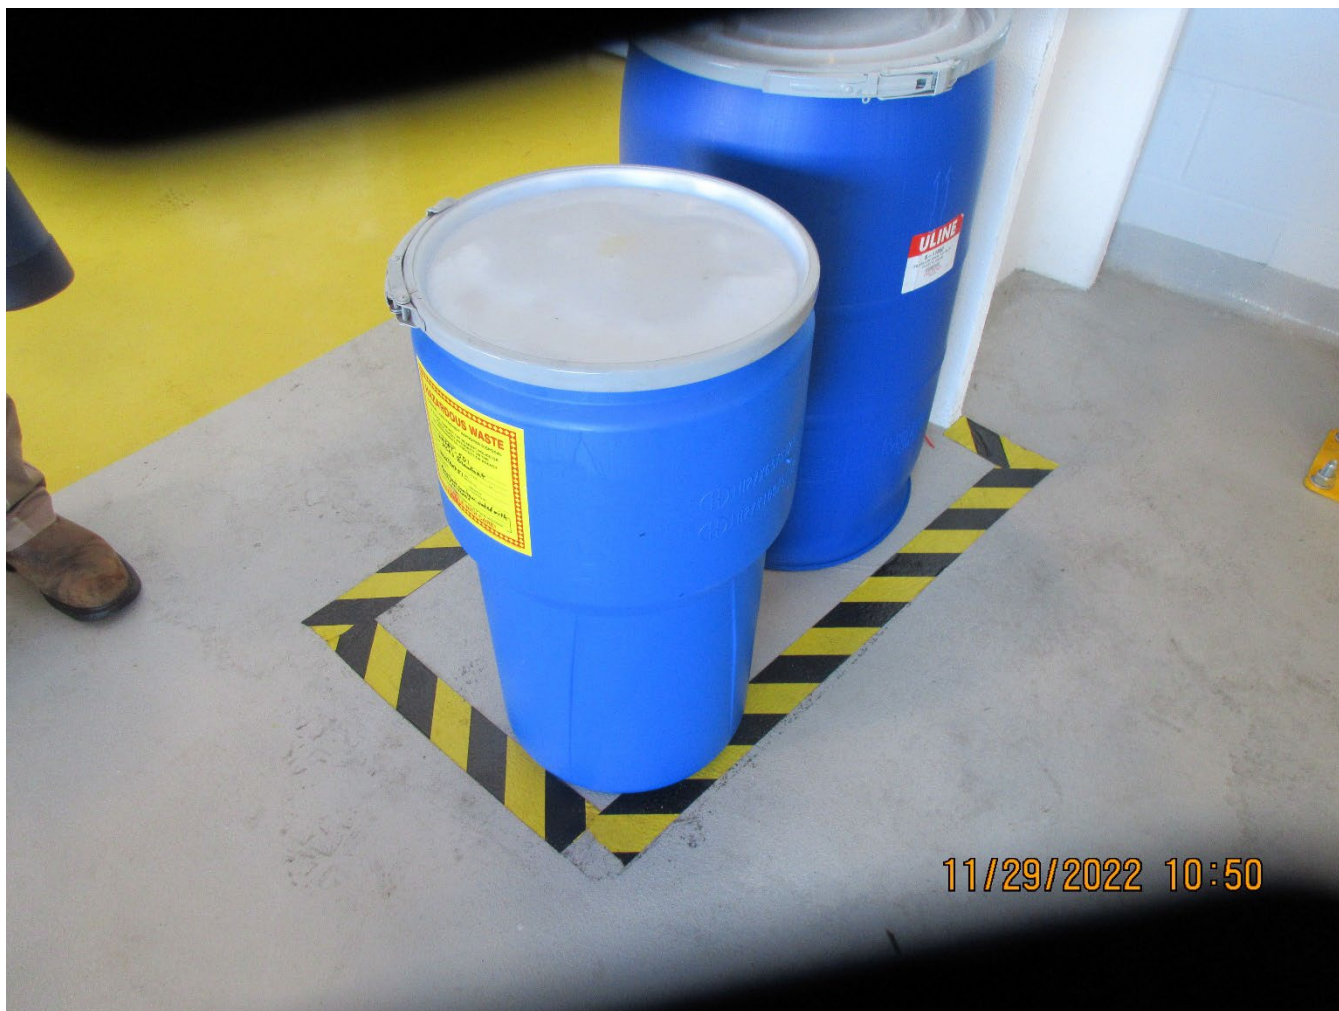
**Photo 2 – Container in VMFAT – 501 Area – Building 3090 without hazard indicator**

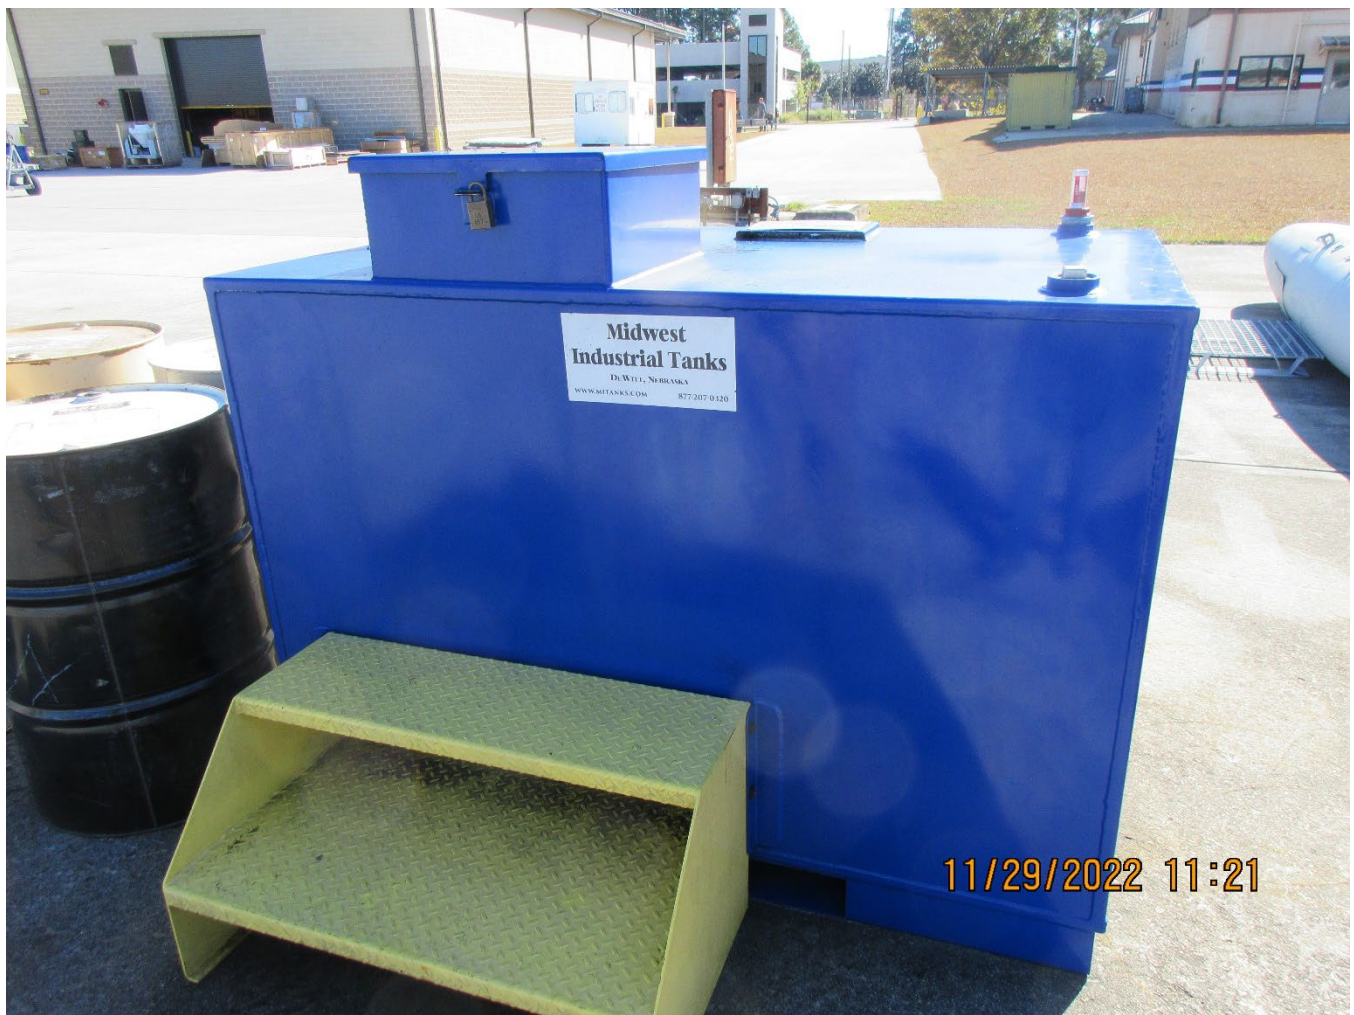
On the flight line for this building, the inspection team observed a 300-gallon container used for the collection of used oil (Photograph 3). The container was not labeled with words “Used Oil” at the time of the inspection.

**Photo 3 – Used Oil Container on flight line outside Hanger 414**

**Pursuant to S.C. Code Ann. Regs. 61-107.279.22(c)(1) [40 C.F.R. § 279.22(c)(1)], containers and aboveground tanks used to store used oil at generator facilities must be labeled or marked clearly with the words “Used Oil.”**

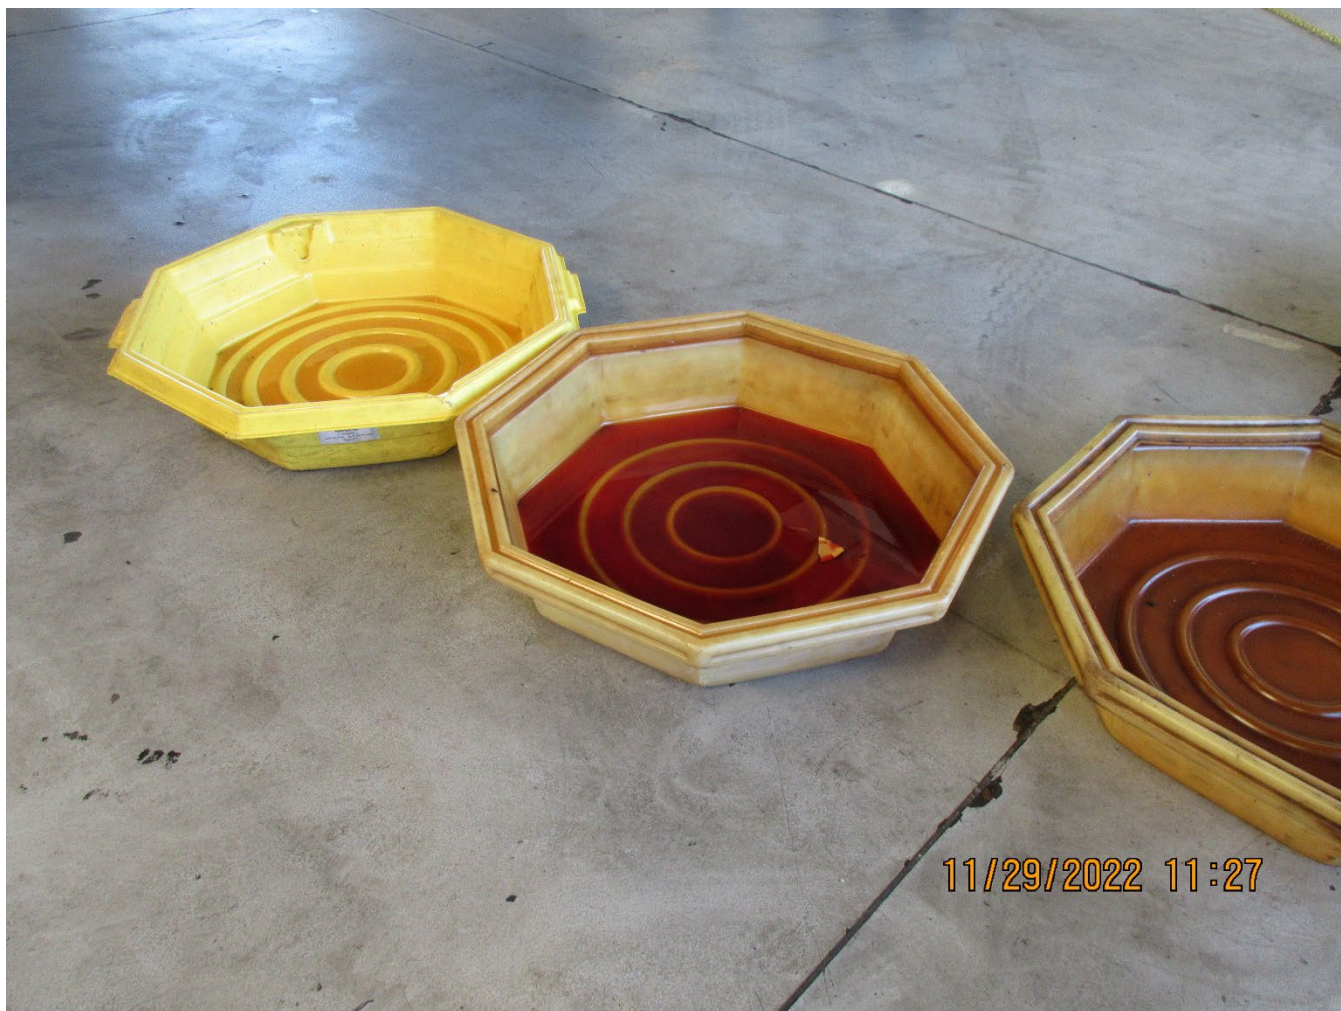
In addition, oil collection pans (Photograph 4) were observed beneath F-18s both on the flight line and within Hanger 414. The pans, some which contained used oil, were not labeled with the words “Used Oil.”

**Photo 4 – Examples of used oil collection pans used by MCASB**

**Pursuant to S.C. Code Ann. Regs. 61-107.279.22(c)(1) [40 C.F.R. § 279.22(c)(1)], containers and aboveground tanks used to store used oil at generator facilities must be labeled or marked clearly with the words “Used Oil.”**
