## **RCRA Inspection Report**

Holcim (US) Inc./Geocycle LLC.  
8677 Hwy 45 Alternate South  
Artesia, Mississippi 39736  
EPA ID# MSD077655876  
562211 – Hazardous Waste Treatment and Disposal

March 11, 2021, 09:30 hours

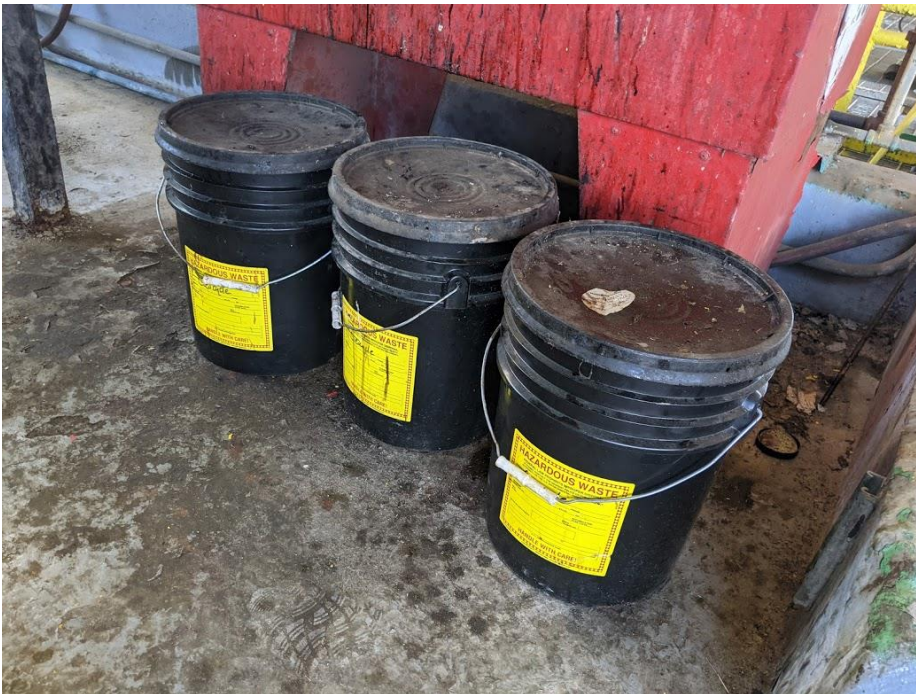
This area contains one SAA for accumulating retain samples. The inspectors observed three (3) 5-gallon containers of retain samples in this SAA. At the time of the inspection, the containers were not labeled with in indication of the hazards of its contents (Photograph 4).

Photograph 4 of 6: Three 5-gallon containers at the Retain Sample SAA Missing Characteristic Labels

**Pursuant to 11 Miss. Admin. Code Pt. 3, R. 1.3 [40 C.F.R. § 262.15(a)(5)(ii)], which is a condition of the SAA Permit Exemption, a generator is required to mark or label its containers with an indication of the hazards of the contents.**
