## **RCRA Inspection Report**

Kyocera AVX Components Corporation  
2201 Corporate Square BLVD  
Jacksonville, FL 32216  
Duval County

EPA ID#: FLD039677810  
NAICS #: 334416- Electronic Coil, Transformer,  
and other Inductor Manufacturing

March 4, 2025, 9:00am-5:00pm

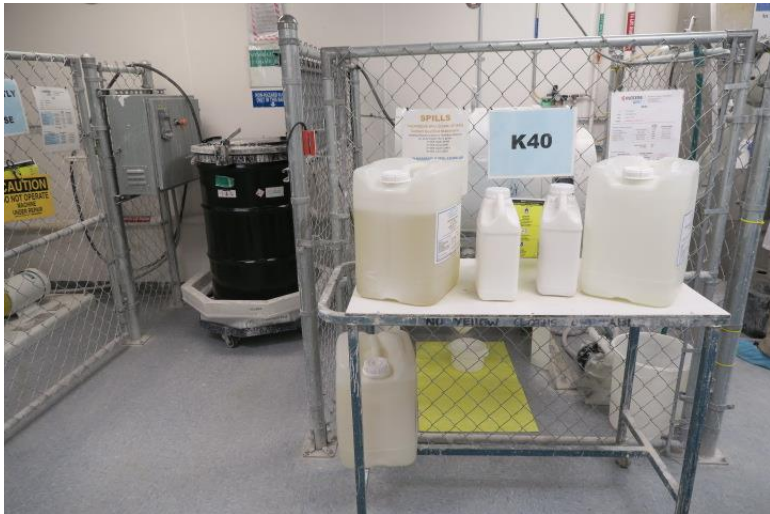
Photo 1: Ball mill within a caged area where K40 slurry is mixed, located in the Batch Mix Area.

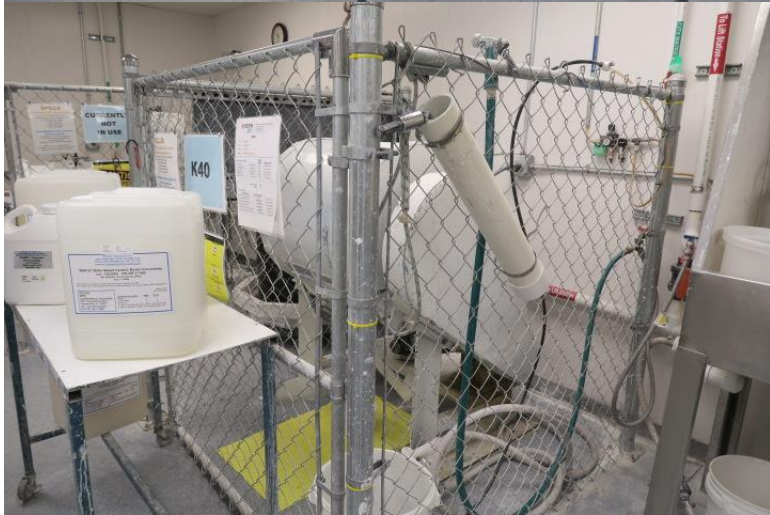
Photo 2: Another angle of the K40 ball mill.

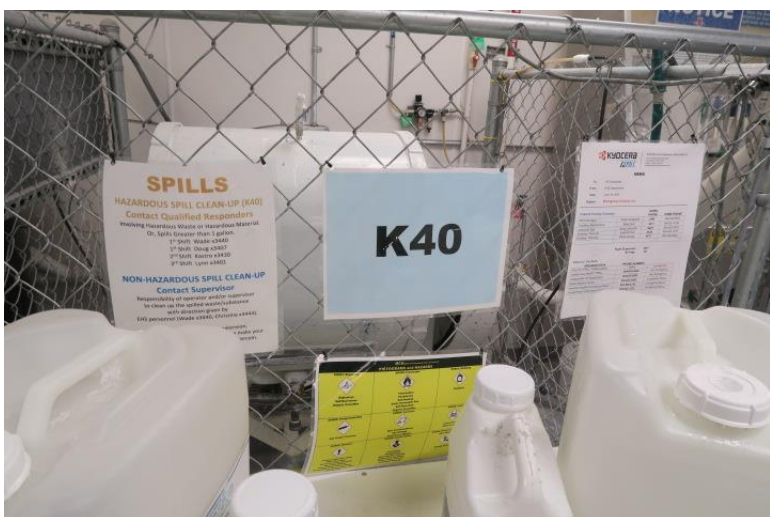
The K40 slurry is mixed in one ball mill within a caged area that is labeled with signage: “K40,” an emergency contact list, a spill protocol, and pictograms and hazards (Photos 1-3). Inspectors observed one 55-gallon container of non-hazardous ceramic slurry, to the left of the K40 caged area. Across from the K40 caged area was one 13-gallon container for satellite collection of K40 contaminated solids such as gloves or paper towels; the container was closed, labeled with the words hazardous waste, and three hazard indicator pictograms indicating a health hazard, harmful irritant, and aquatic toxicity (Photo 4). The Batch Mix Area also contained a sink where equipment that may be contaminated with K40 slurry is washed; rinsewater is piped directly to the onsite BWWTP (Photo 5). Another 13-gallon container for satellite collection of K40 contaminated solids was observed in the area; the container was closed, labeled with the words hazardous waste, and three hazard indicator pictograms indicating a health hazard, harmful irritant, and aquatic toxicity (Photo 6). Total capacity in the satellite area for hazardous waste was less than 55 gallons. A spill station and first aid kit were observed in the room.

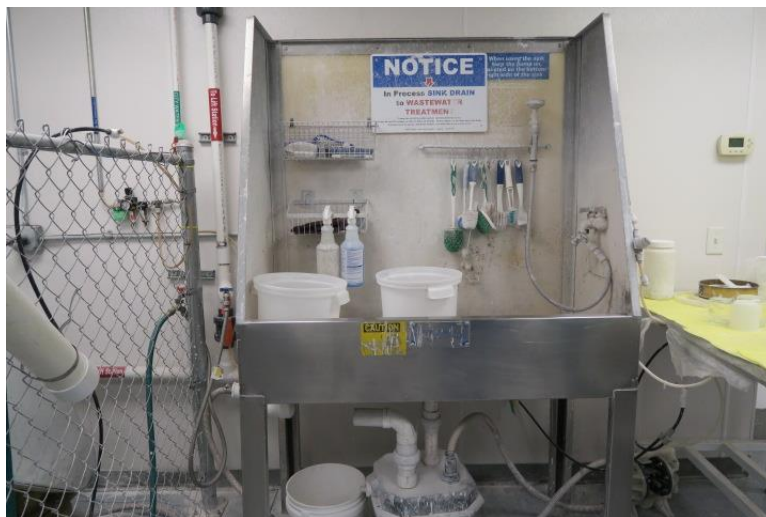
Photo 5: a sink where equipment that may be contaminated with K40 slurry is washed, located in the Batch Mix Area.

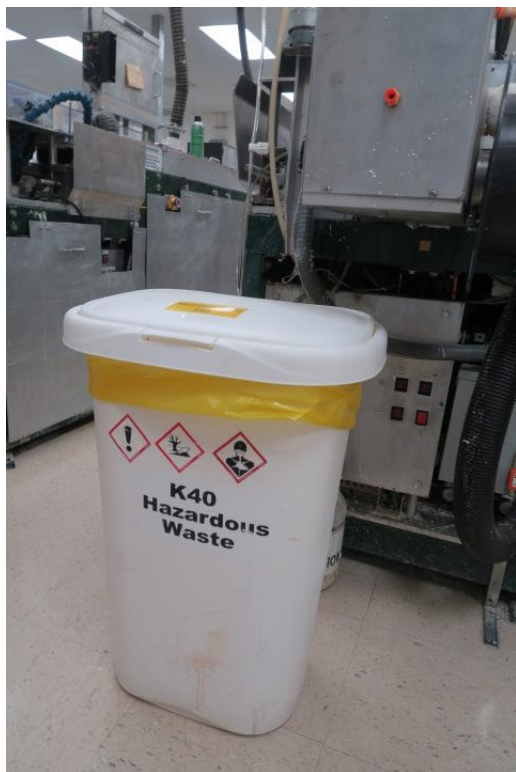
Photo 6: one 13-gallon satellite container for K40 contaminated solids, located in the Batch Mix Area.

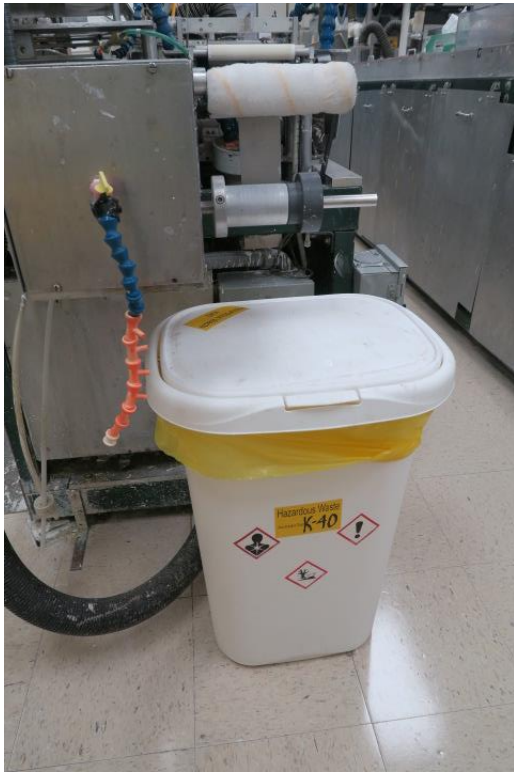
Photo 7: one 13-gallon satellite container for K40 contaminated solids, located in the Casting Rotary Room.

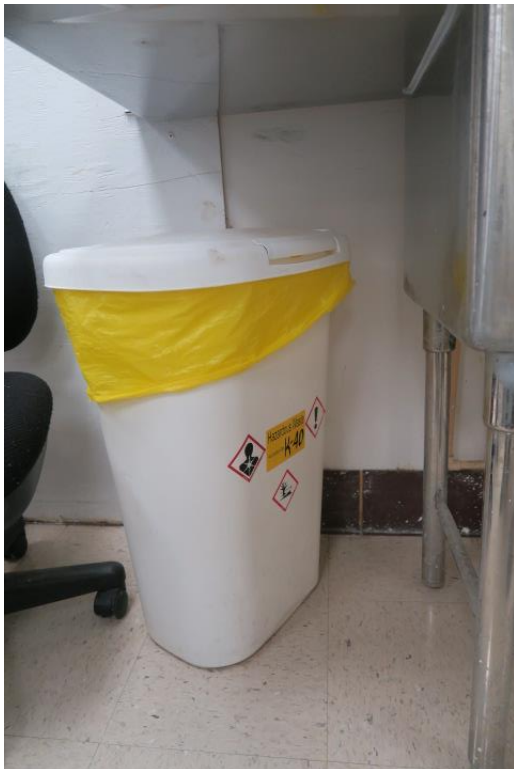
Photo 9: one 13-gallon satellite container for K40 contaminated solids, located in the Casting Rotary Room.

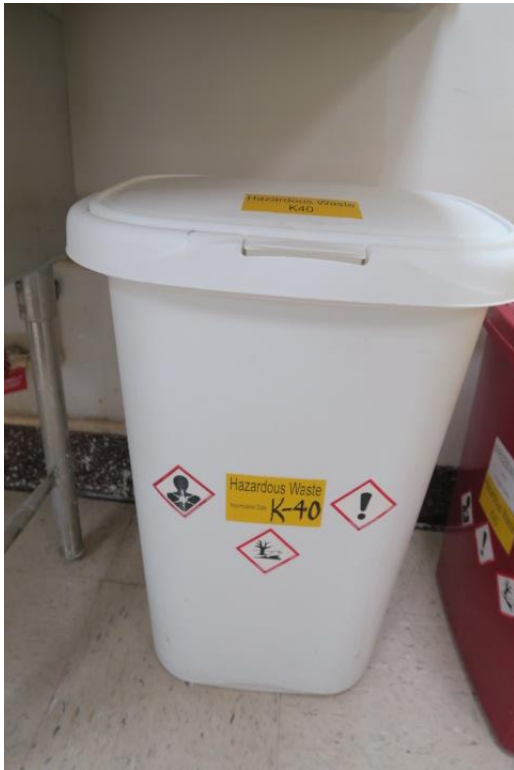
Photo 10: one 13-gallon satellite container for K40 contaminated solids, located in the Casting Rotary Room.

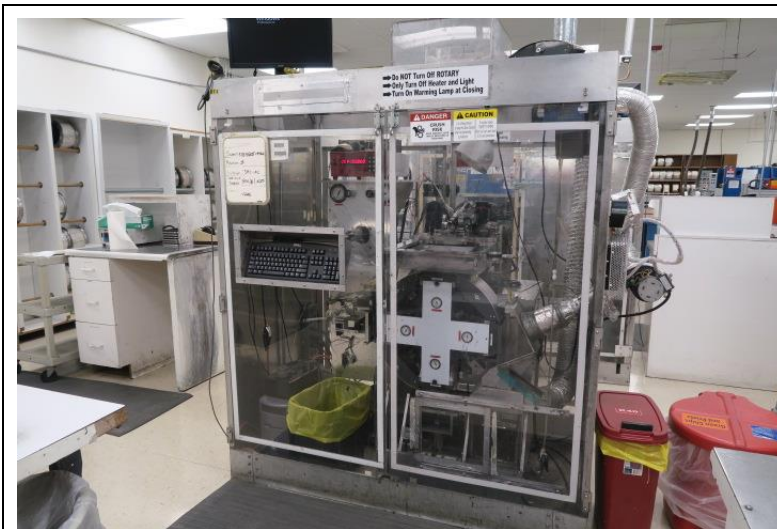
The process continues in this room for both non-hazardous ceramic slurry and hazardous K40 slurry. Four 13-gallon containers for satellite collection of K40 contaminated solids were observed in the area; all containers were closed, labeled with the words hazardous waste, and three hazard indicator pictograms indicating a health hazard, harmful irritant, and aquatic toxicity (Photos 7-10). One ~10-gallon container for satellite collection of K40 contaminated solids was also observed in the area; the container was closed, labeled with the words hazardous waste, and three hazard indicator pictograms indicating a health hazard, harmful irritant, and aquatic toxicity (Photo 11).

Photo 11: one ~10-gallon satellite container for K40 contaminated solids, located in the Casting Rotary Room.

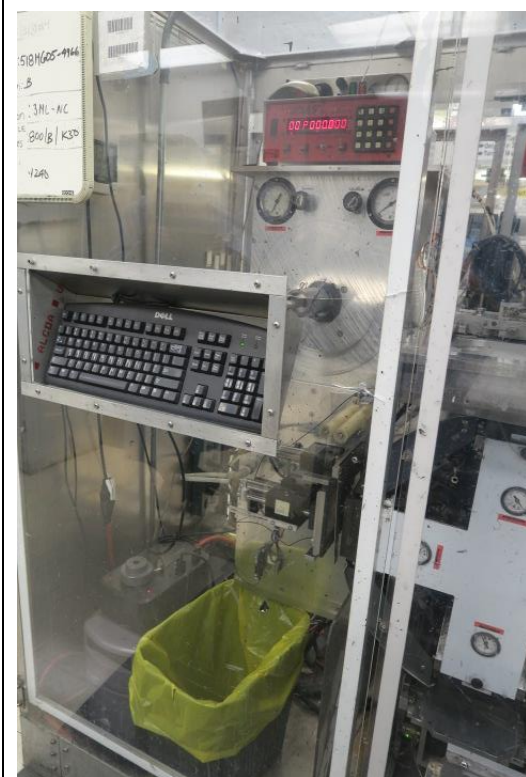
K40 slurry is processed inside of an enclosed rotary machine (Photo 12); there were four rotary machines in the room. The K40 ceramic tape is trimmed, and the waste (D005/D008) falls into an open 3-gallon hazardous waste container inside the rotary machine enclosure (Photo 13). At the time of the inspection, no K40 waste was accumulating in the container, but inspectors did observe that the container was not labeled with the words “Hazardous Waste” or an indication of the hazard(s). The facility was reminded that satellite containers must be labeled with the words “Hazardous Waste” and with an indication of the hazard of the contents.

Photo 12: enclosed rotary machine which processes K40 slurry is processed, located in the Casting Rotary Room.

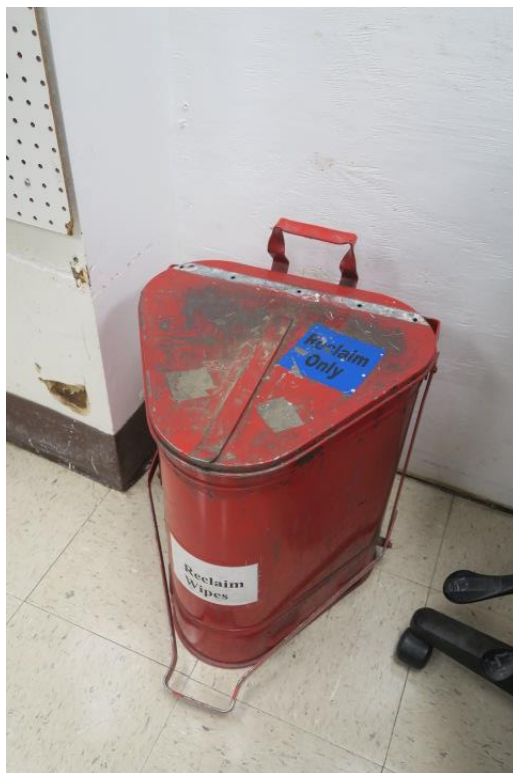
Next to the rotary machine was one, closed, ~10-gallon container for satellite collection of K40 hazardous waste. The container was not labeled with the words “Hazardous Waste” or an indication the hazard(s) (Photo 14).

**Pursuant to Fla. Admin. Code Ann. r. 62-730.160(1) [40 C.F.R. § 262.15(a)(5)], which is a condition of the SAA Permit Exemption, a generator is required to mark or label its containers (i) with the words “Hazardous Waste” and (ii) with an indication of the hazards of the contents.**

Photo 14: one, closed, ~10-gallon container for K40 hazardous waste. The container was not labeled with the words "Hazardous Waste" or indication the hazard(s), located in the Casting Rotary Room.

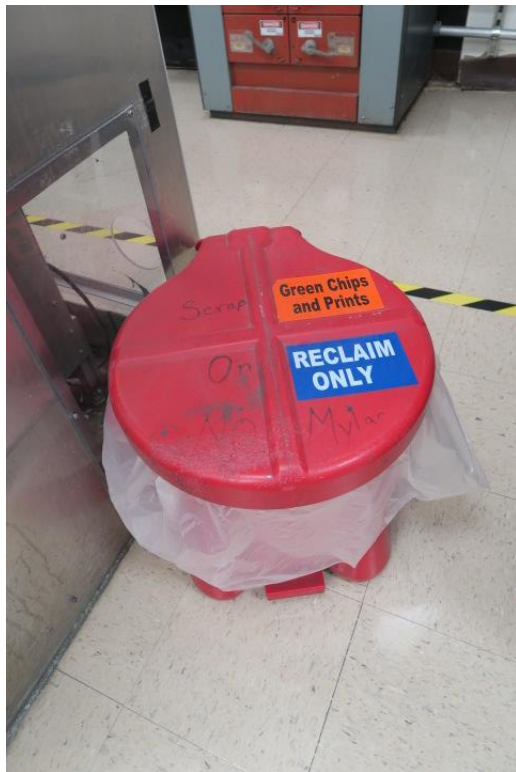
Throughout the Casting Rotary Room, inspectors observed 12 containers (~10 gallons) for materials with precious metals that will be sent for reclaim/recovery; labels included “reclaim wipes,” “reclaim only,” and “green chips and prints” (Photo 15 and 16).

Photo 15: ~10-gallon container for materials with precious metals that will be sent for reclaim/recovery; labels included "reclaim wipes," and "reclaim only," located in the Casting Rotary Room.

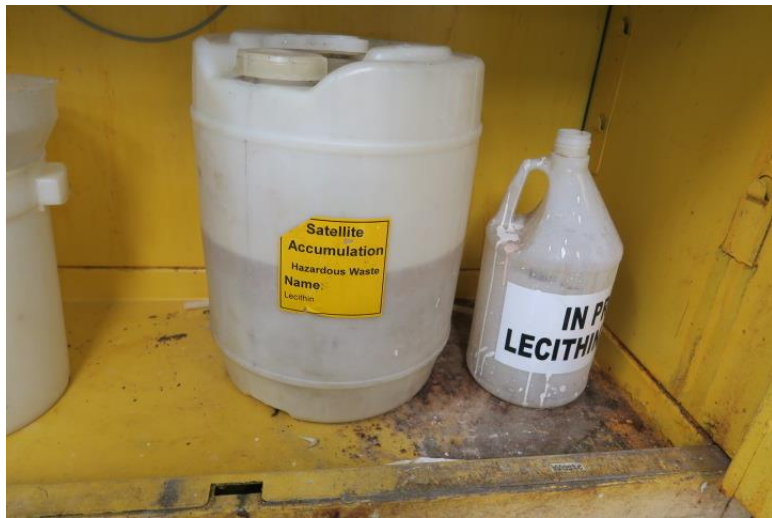
Within the room was a flammable cabinet with signage stating it was a satellite accumulation area for Lecithin hazardous waste (Photo 17). Inside the cabinet was one ~5-gallon container labeled as Lecithin hazardous waste. The container was closed and labeled with the words “Hazardous Waste” but was not labeled with an indication of the hazards (Photo 18). However, Wade Musgrave stated that Lecithin is non-hazardous and the container, as well as the flammable cabinet, was improperly labeled. Inspectors requested the Safety Data Sheet/Waste Profile for Lecithin during the closing conference and in a follow-up, email sent on March 6, 2025, to Wade Musgrave. Wade Musgrave provided the Safety Data Sheet for Lecithin via email on March 12, 2025, which indicates the substance, Standard Soy Lecithin Fluid, is non-hazardous. The facility stated the Lecithin container observed during the inspection was new product and not a waste. A photo was provided to demonstrate the container was relabeled simply as “Lecithin” and the hazardous waste label was removed (Photo 1B).

Photo 17: a flammable cabinet with signage stating it was a satellite accumulation area for Lecithin hazardous waste, located in the Casting Rotary Room.

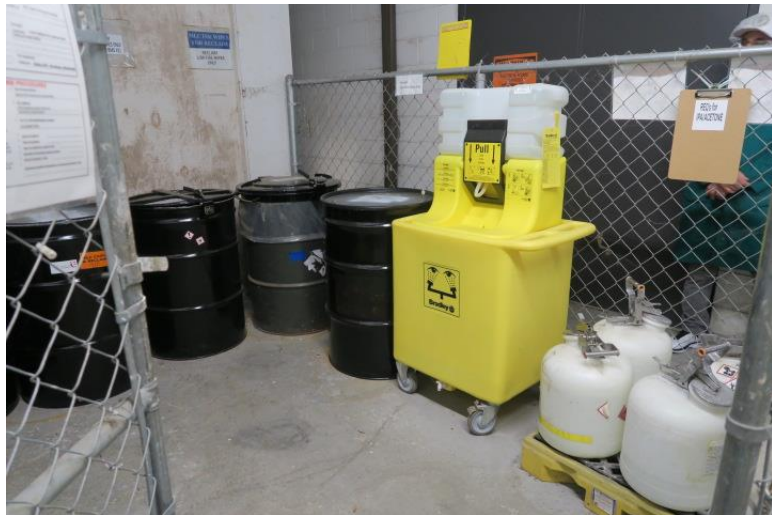
The facility manages two central accumulation areas (CAA) on site. One is located inside Building 1 and is designated as the MLC 90-day storage CAA which contains hazardous waste, reclaim material, and product (Photos 19 and 20). The CAA is located inside of a locked room that requires key card access for entry; in addition, the hazardous waste is contained within a locked, caged area. Inspectors observed a spill kit, eye wash station, a fire extinguisher (last inspected on 2/10/2025), no smoking sign, emergency contact list, and danger-keep out sign (Photos 21-25). The area has an alarm system in case of emergency and personnel have radios and cell phones as communication devices.

Photo 19: MLC 90-day storage CAA in building 1 which contains hazardous waste, reclaim material, and product.

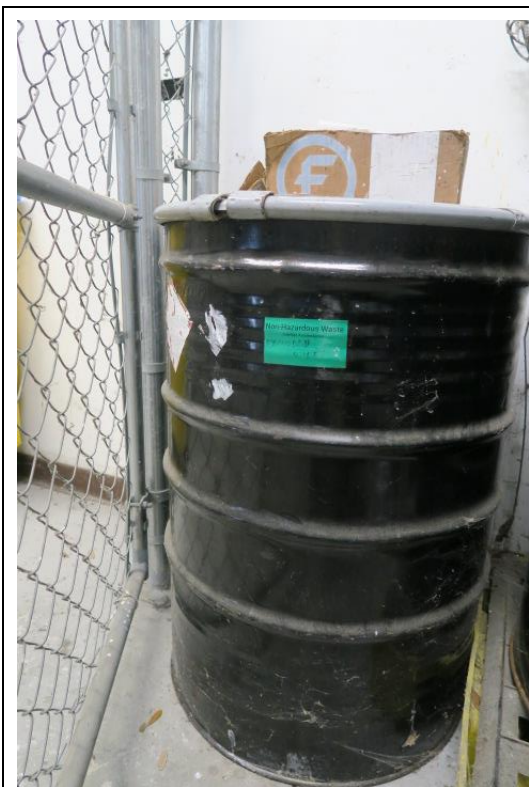
Photo 26: one 55-gallon, closed container of solvent contaminated wipes; the container was closed, labeled only as “non-hazardous waste excluded wipes” and was not labeled with an accumulation start date, located in the MLC 90-day CAA.

In a response document sent via email by Wade Musgrave on March 12, 2025, the facility stated that they completed a new waste determination based on generator knowledge on the excluded solvent contaminated wipes and determined that the wipes are precious metal recovery exclusion wipes due to their use as cleanup wipes for precious metal ink residue. The reclaim container in the Termination Area was relabeled as “reclaim wipes” (Photo 4B). The facility stated in the document that all employees were informed of the new determination and management of the wipes.

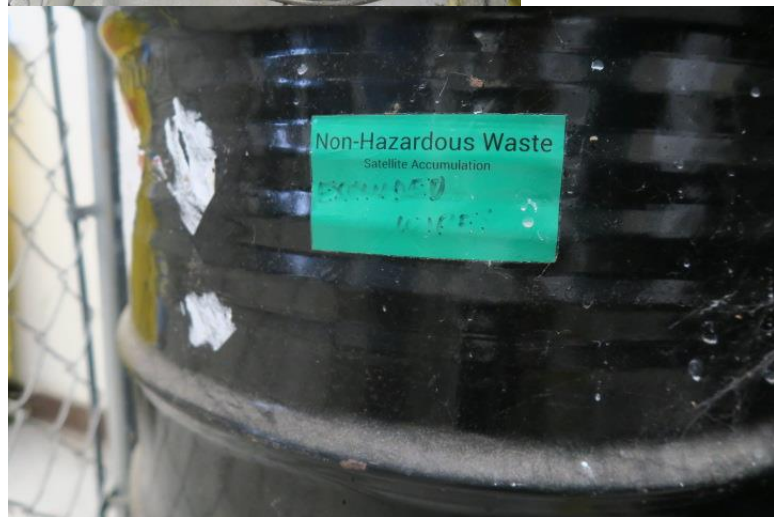
one 55-gallon, closed container of solvent contaminated wipes (typically IPA) which are generated in the machine shops and termination areas. The container was closed, labeled only as “non-hazardous waste excluded wipes” and was not labeled with an accumulation start date (Photos 26 and 27).

**Pursuant to Fla. Admin. Code Ann. r. 62-730.030(1) [40 CFR 261.4(b)(18)(i)] Solvent-contaminated wipes, except for wipes that are hazardous waste due to the presence of trichloroethylene, that are sent for disposal are not hazardous wastes from the**

**point of generation provided that (i) the solvent-contaminated wipes, when accumulated, stored, and transported, are contained in non-leaking, closed containers that are labeled “Excluded Solvent-Contaminated Wipes.”**

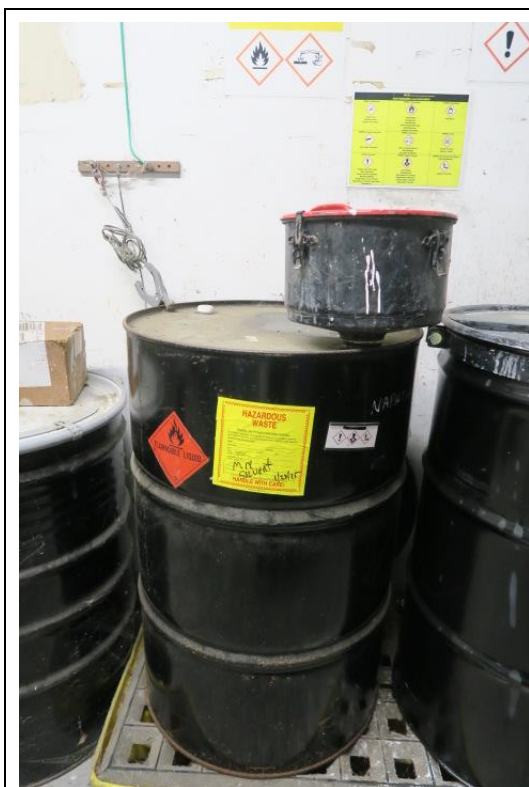
The CAA held three hazardous waste containers. On the wall above the storage area where the hazardous waste containers were located was signage indicating the type of hazardous waste (Photo 28). Container A was a 55-gallon closed container of mixed solvent (IPA/Naptha) waste generated in the ink lab; the container was labeled with the words “Hazardous Waste,” an accumulation start date of January 28, 2025, three hazard indicator pictograms indicating a health hazard, harmful irritant, and aquatic toxicity, and a flammable liquid hazard indicator. The container had a funnel attached and the lid was closed (Photos 29 and 30). Container B was a 55-gallon closed container of hazardous K40 ceramic slurry; the container was labeled with the words “Hazardous Waste,” an accumulation start date of January 22, 2025, and four hazard indicator pictograms indicating a health hazard, harmful irritant, corrosivity, and aquatic toxicity (Photos 31 and 32). Container C was a 55-gallon closed container of lead (D008), and barium (D005) contaminated ceramic tape; the container was labeled with the words “Hazardous Waste,” an accumulation start date of January 6, 2025, three hazard indicator pictograms indicating a health hazard, harmful irritant, and aquatic toxicity, and a flammable liquid hazard indicator (Photos 33 and 34).

Photo 28: signage indicating the type of hazardous waste on the wall above the storage area where the hazardous waste was located.

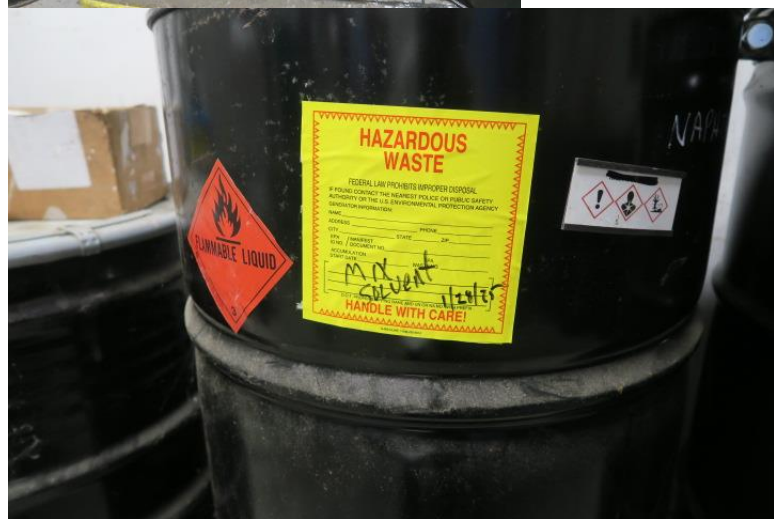
Photo 29: a 55-gallon closed container of mixed solvent (IPA/Naptha) waste; the container was labeled with the words “Hazardous Waste”, an accumulation start date of January 28, 2025, and three hazard indicator pictograms. The container had a funnel attached and the lid was closed, located in the MLC 90-day CAA.

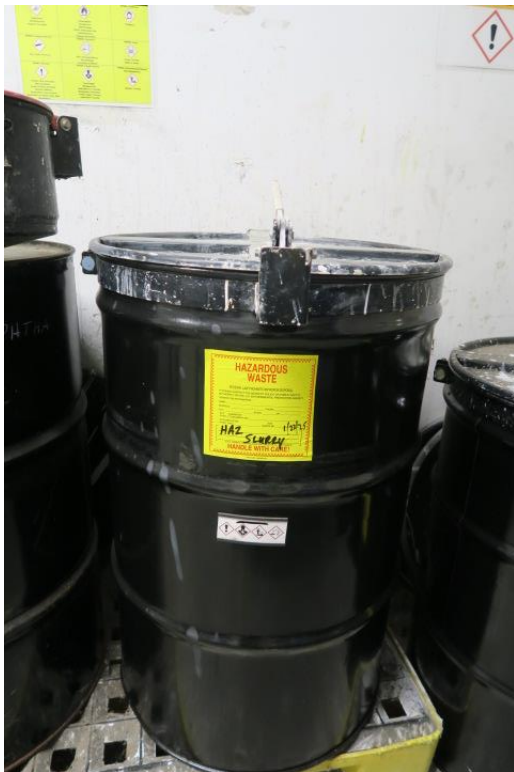
Photo 31: a 55-gallon closed container of hazardous K40 ceramic slurry; the container was labeled with the words “Hazardous Waste”, an accumulation start date of January 22, 2025, and four hazard indicator pictograms, located in the MLC 90-day CAA.

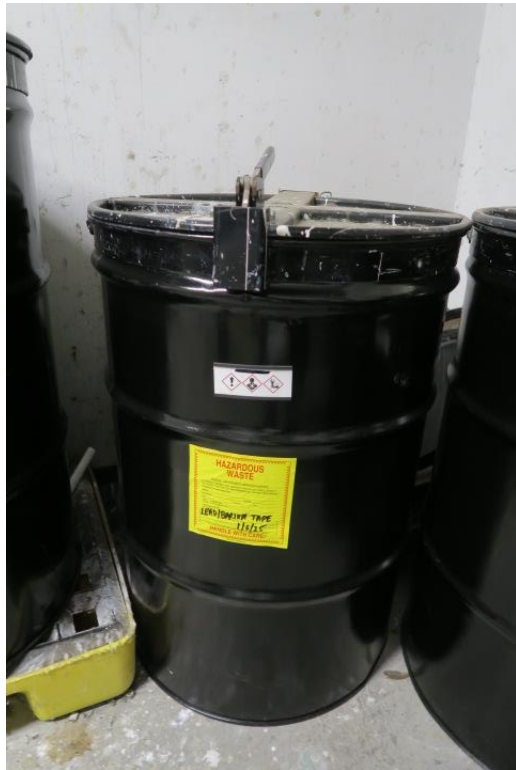
Photo 33: a 55-gallon closed container of lead (D008) and barium (D005) contaminated ceramic tape; the container was labeled with the words “Hazardous Waste,” an accumulation start date of January 6, 2025, and three hazard indicator pictograms, located in the MLC 90-day CAA.

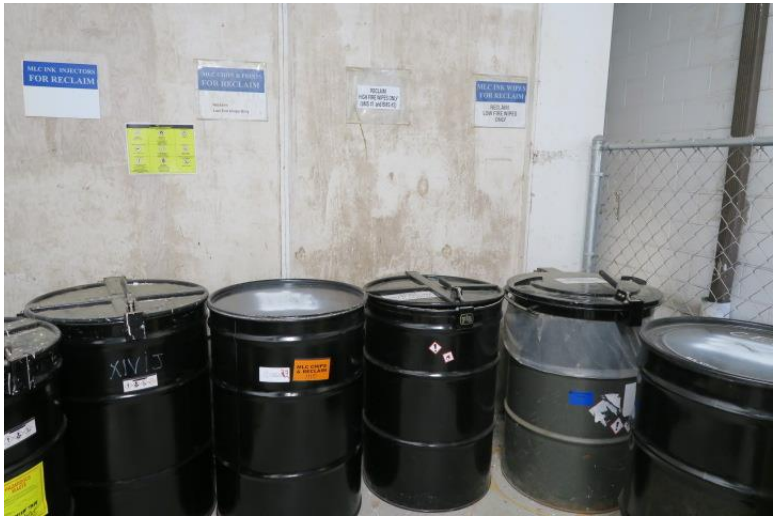
| | <p>Photo 35: five 55-gallon containers for solid reclaim material sent for precious metal recovery, located in the MLC 90-day CAA.</p> |

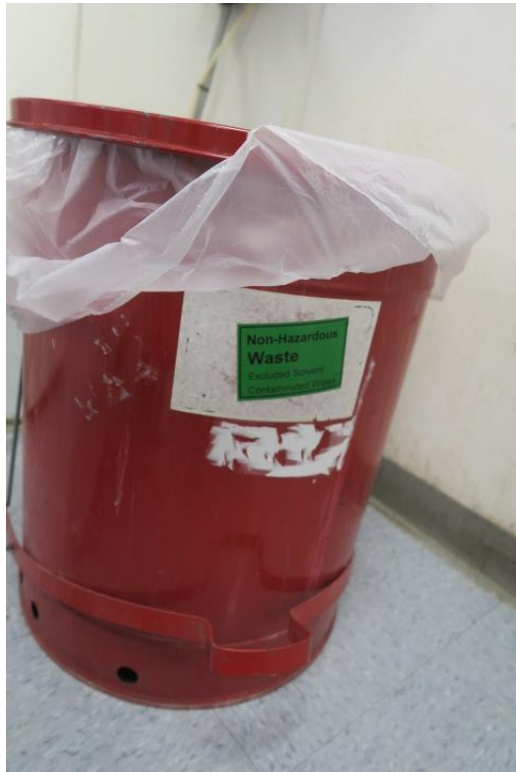
No hazardous waste is generated in the Termination Area, but solvent (IPA) contaminated wipes are generated from cleaning machines. Inspectors observed one closed, ~15-gallon container for solvent contaminated wipes; it was labeled “non-hazardous waste excluded solvent contaminated wipes” but was not labeled with an accumulation start date (Photo 39).

Photo 39: one closed, ~15-gallon container for solvent contaminated wipes; it was labeled “non-hazardous waste excluded solvent contaminated wipes” but was not labeled with an accumulation start date, located in the Termination Area.

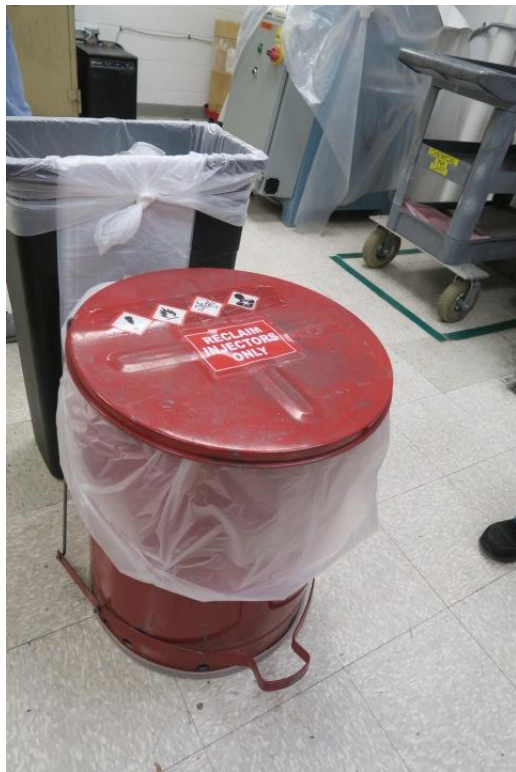
No hazardous waste is generated in the Oven Room. The area contained one, closed ~5-gallon reclaim bin for materials sent for precious metal recovery (Photo 40).

Photo 40: one, closed ~5-gallon reclaim bin for materials sent for precious metal recovery, located in the Oven Room.

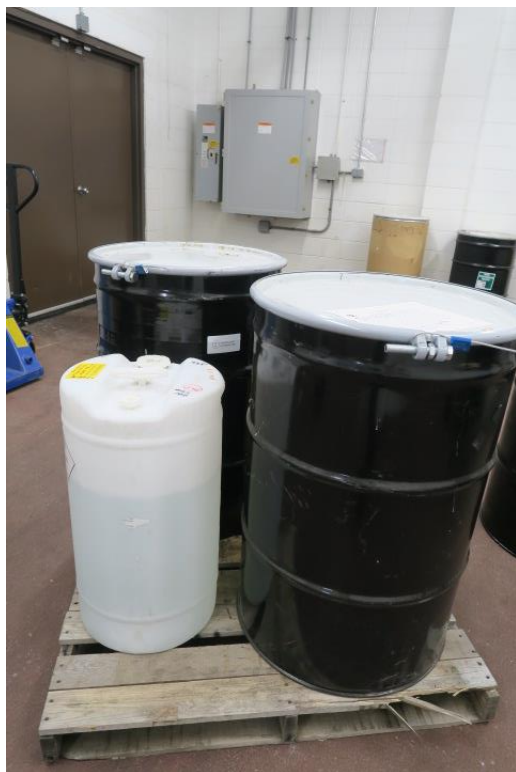
No hazardous waste is generated in this area. Inspectors observed two, closed ~ 15-gallon containers for reclaim material sent for precious metal recovery (Photo 41).

Photo 41: one of the two reclaim bins located in the Ink Lab, ~15-gallons.

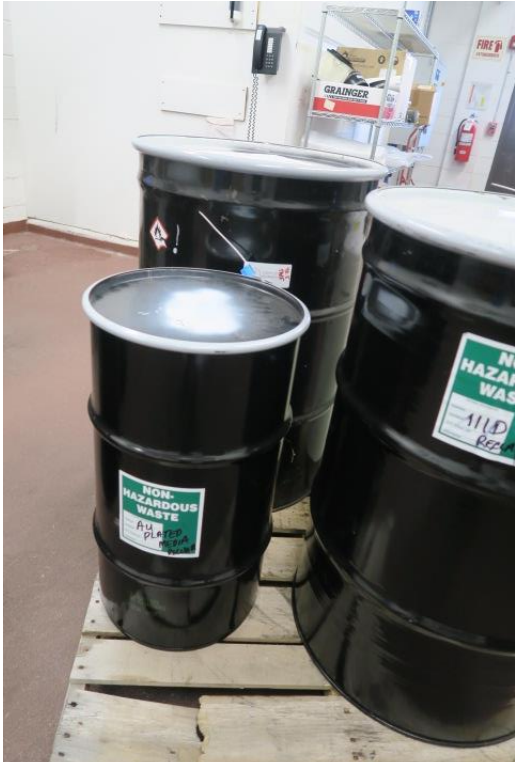
| | <p>Photo 43: two 55-gallon containers (same as pictured above in photo 42) and one 15-gallon container of material to be shipped off-site for precious metal recovery, located in the Reclaim Room.</p> |

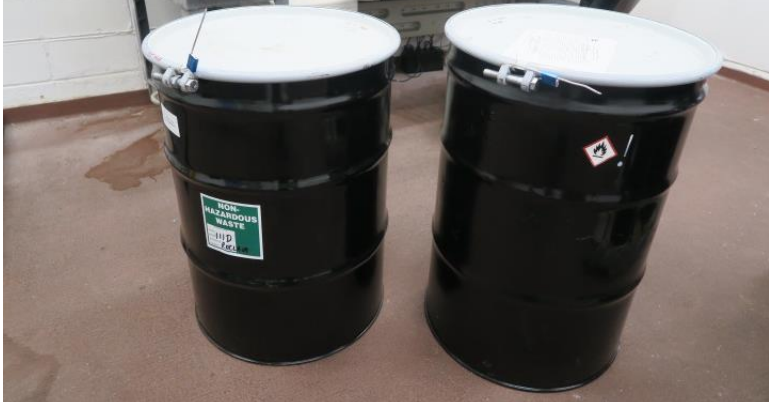
| | <p>Photo 44: two 55-gallon containers of material to be shipped off-site for precious metal recovery, located in the Reclaim Room.</p> |

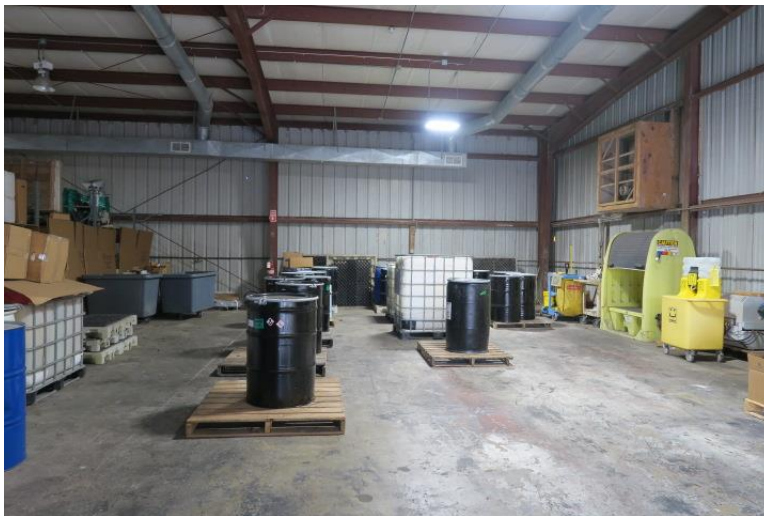
Photo 45: overview shot of the CAA located inside building 8 which contains hazardous waste, excluded solvent contaminated wipes, e-waste, and non-hazardous waste such as expired product and ceramic slurry (row 1-3 from left to right)

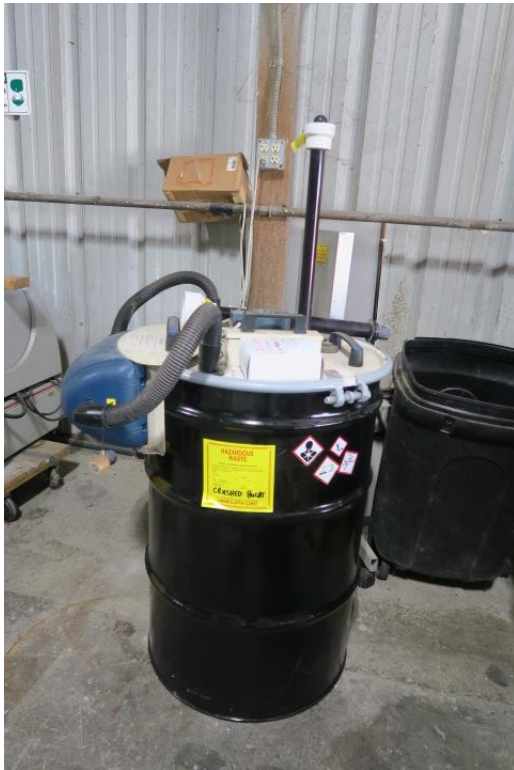
Inspectors observed a pile of e-waste including televisions and computer components which facility personnel stated is ultimately recycled (Photo 50). Near the e-waste was a 55-gallon container labeled as "Hazardous Waste" and "crushed bulbs", it has a bulb crusher connected to the top and four hazard indicator pictograms indicating a health hazard, toxicity, corrosivity, and aquatic toxicity (Photos 51 and 52). Facility personnel stated the crushed mercury lamps are managed as hazardous waste not as universal waste, and the material is sent for recycling once the container is full. The process of crushing the bulbs appears to meet the definition of treatment. Crushing equipment may be used without a permit *if* the lamps are managed as universal waste. Universal waste crushed lamps must be labeled as "Crushed Mercury Lamps" (pursuant to Fla. Admin. Code Ann. r. 62-737.400(5)(b)).

Photo 51: a 55-gallon container labeled as “Hazardous Waste” and “crushed bulbs”, it has a bulb crusher connected to the top and four hazard indicator pictograms, located in the CAA in Building 8.

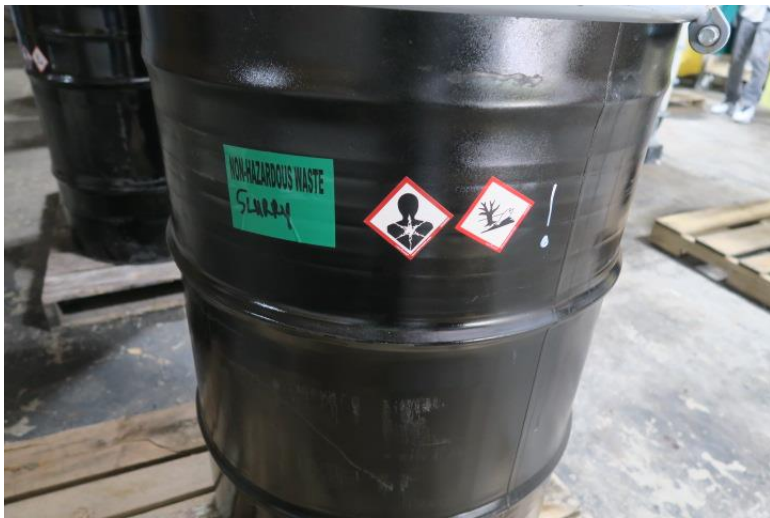
Photo 53: an example of one of the six 55-gallon containers of non-hazardous ceramic slurry, located in the CAA in Building 8 (row 1).

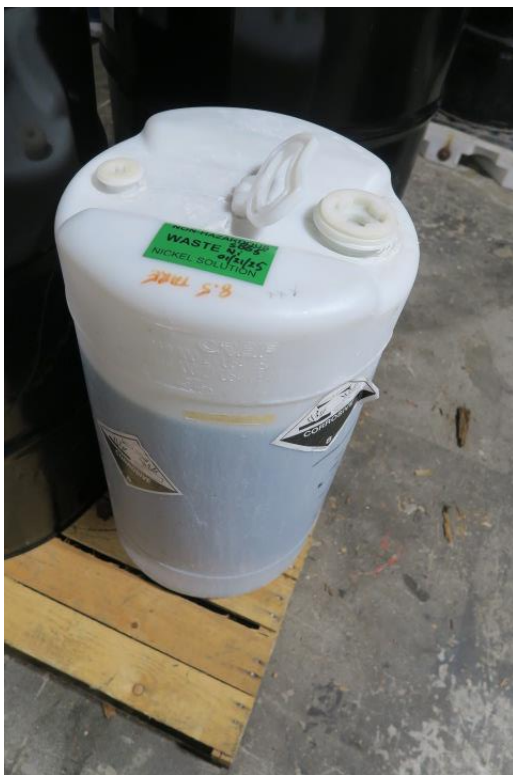
Photo 54: one 15-gallon container of non-hazardous nickel-plating solution, located in the CAA in Building 8 (row 1).

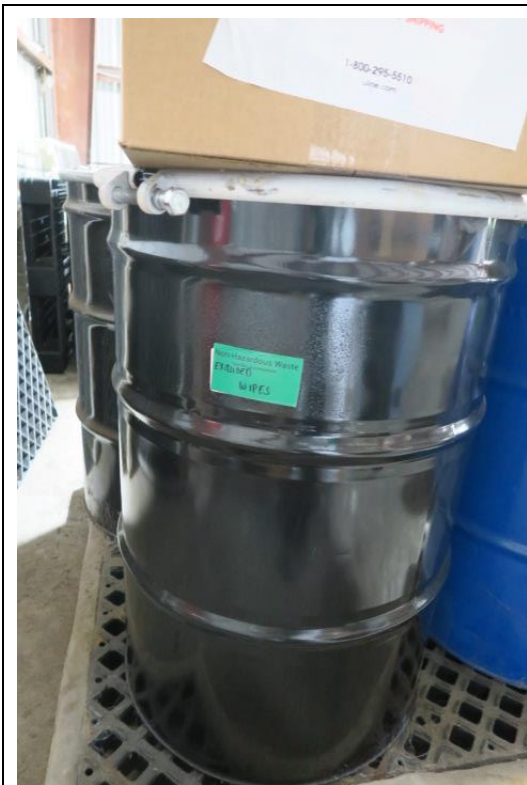
The non-hazardous and hazardous waste was organized into three rows of waste containers positioned on top of pallets. The first row had 11 containers: six 55-gallon containers of non-hazardous ceramic slurry (Photo 53), one 15-gallon container of non-hazardous nickel-plating solution (Photo 54), one 55-gallon non-hazardous K10 (ceramic slurry) debris, one 55-gallon container of non-hazardous expired product (binder) (Photo 55), one 55-gallon container of non-hazardous silicone waste, and one 55-gallon container of excluded solvent contaminated wipes. The container was closed, labeled only as "non-hazardous waste excluded wipes" and was not labeled with an accumulation start date (Photos 56 and 57).

Photo 56: one 55-gallon container of excluded solvent contaminated wipes. The container was closed, labeled only as “non-hazardous waste excluded wipes” and was not labeled with an accumulation start date, located in the CAA in Building 8 (row 1).

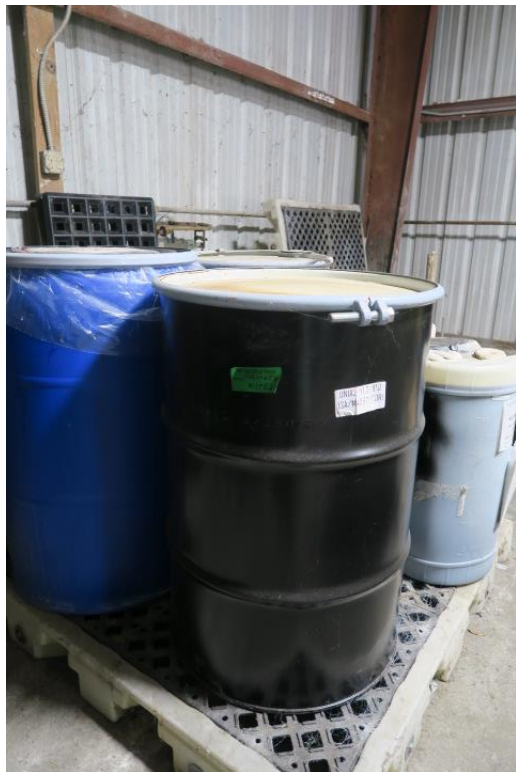
The second row had eight containers: three 55-gallon containers of non-hazardous expired product (binder), two 12-gallon containers of non-hazardous product (ultra coolant) (Photo 58), two large containers (350 kg capacity and 1650 kg capacity) of non-hazardous ceramic slurry (Photo 59), and one 55-gallon container of excluded solvent contaminated wipes. The container was closed, labeled only as “non-hazardous waste excluded wipes” and was not labeled with an accumulation start date (Photos 60 and 61).

Photo 60: one 55-gallon container of excluded solvent contaminated wipes. The container was closed, labeled only as “non-hazardous waste excluded wipes” and was not labeled with an accumulation start date, located in the CAA in Building 8 (row 2).

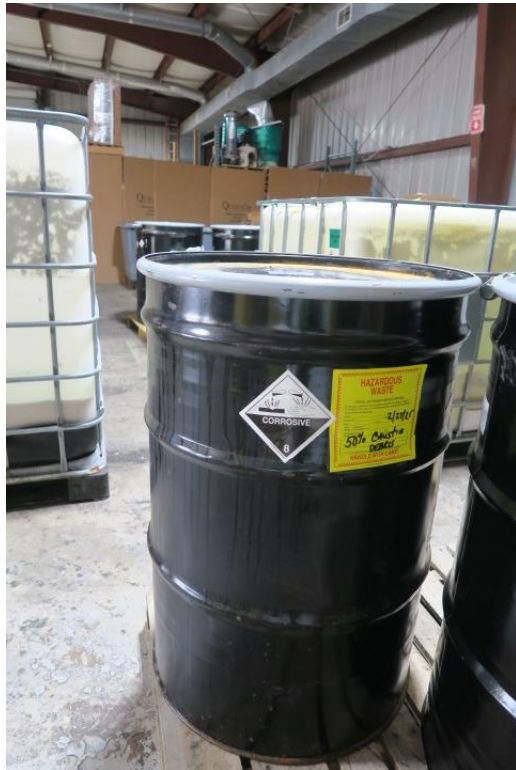
The third row had four hazardous waste containers. Inspectors observed one 55-gallon hazardous waste container of caustic debris; it was closed, labeled with the words “Hazardous Waste,” an accumulation start date of February 27, 2025, and affixed with a corrosive hazard indicator (Photos 62 and 63). Inspectors observed three 55-gallon hazardous waste containers of floor stripper; all containers were closed, labeled with the words “Hazardous Waste,” corrosive hazard indicators, and accumulation start dates of January 23, 2025, January 25, 2025, and February 3, 2025 (Photos 64-69). Wade Musgrave stated that the floor stripper may also contain barium (D005) and lead (D008) from cleaning certain areas of the facility. At the time of the inspection the three containers of floor stripper did not contain a toxic hazard indicator.

Photo 62: observed one 55-gallon hazardous waste container of caustic debris; it was closed, labeled with the words “Hazardous Waste,” an accumulation start date of February 27, 2025, and affixed with a corrosive hazard indicator, located in the CAA in Building 8 (row 3).

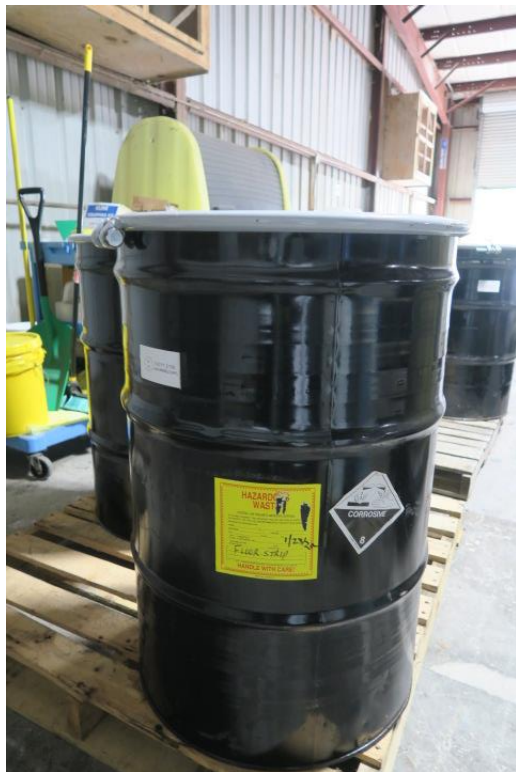
Photo 64: a 55-gallon hazardous waste container of floor stripper; closed, labeled with the words “Hazardous Waste,” corrosive hazard indicators, and accumulation start date of January 23, 2025, located in the CAA in Building 8 (row 3).

In documentation provided via email by Wade Musgrave on March 12, 2025, the waste profile for “Floor stripper and mop water” was updated to include EPA waste codes D005 and D008 for barium and lead. A photo was also provided which shows a toxic hazard indicator was added to a hazardous waste container of floor stripper (Photo 2B).

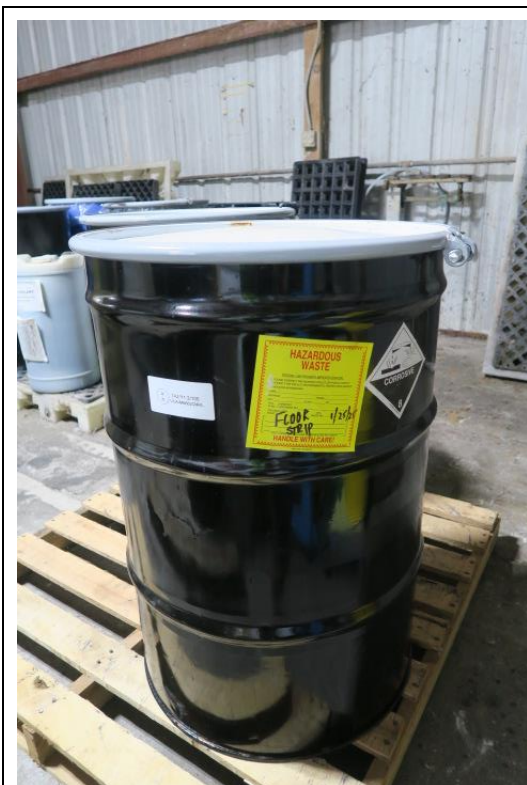
Photo 66: a 55-gallon hazardous waste container of floor stripper; closed, labeled with the words “Hazardous Waste,” corrosive hazard indicators, and accumulation start date of January 25, 2025, located in the CAA in Building 8 (row 3).

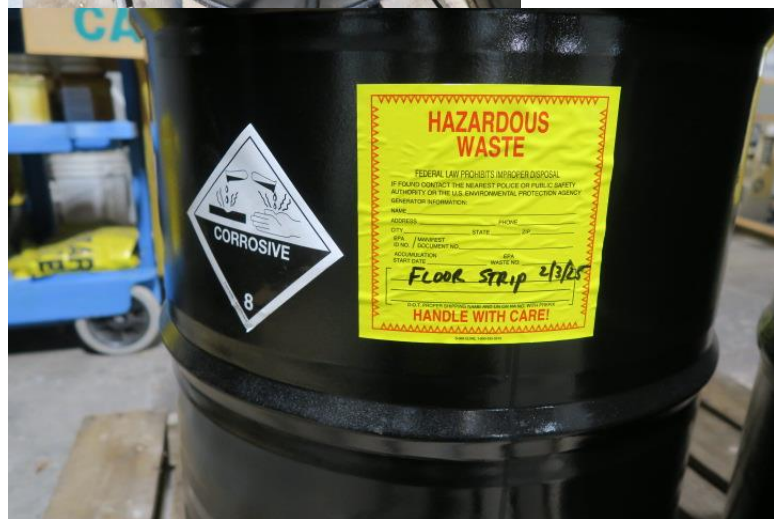
Photo 68: a 55-gallon hazardous waste container of floor stripper; closed, labeled with the words “Hazardous Waste,” corrosive hazard indicators, and accumulation start date of February 3, 2025, located in the CAA in Building 8 (row 3).

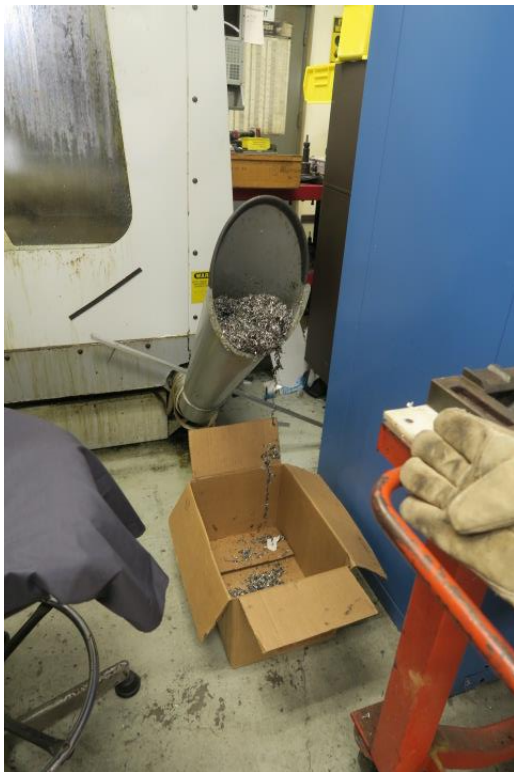
No hazardous or universal waste is generated in the machine shop. Inspectors observed a pile of aluminum shavings/scrap from a computer numeric control machine that are eventually sent for recycling as scrap metal (Photo 70).

Photo 70: a pile of aluminum shavings/scraps from a computer numeric control machine that are eventually sent for recycling, located in the Machine Shop.

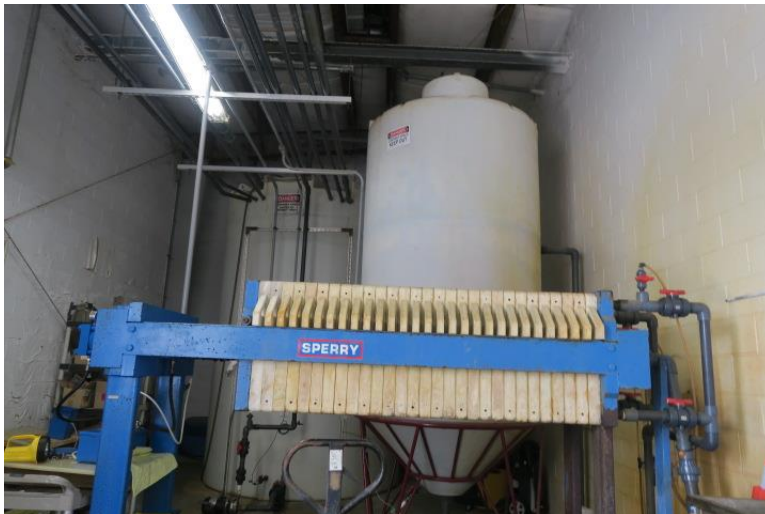
Through the wastewater treatment process, solids are pressed into a filter cake using a filter press and the liquid is removed to continue treatment. The filter cake produced here is a hazardous waste with EPA waste code F006. At the time of the inspection, there was no F006 filter cake hazardous waste accumulating. Typically, the operator will place a 55-gallon container under the filter press (Photo 71) and use a tool to scrape the waste into a funnel placed on top of the container (photo 72). The waste container stays in the FWWTP until it is full and then it is moved to a CAA.

Photo 71: filter press in the final wastewater treatment plant.

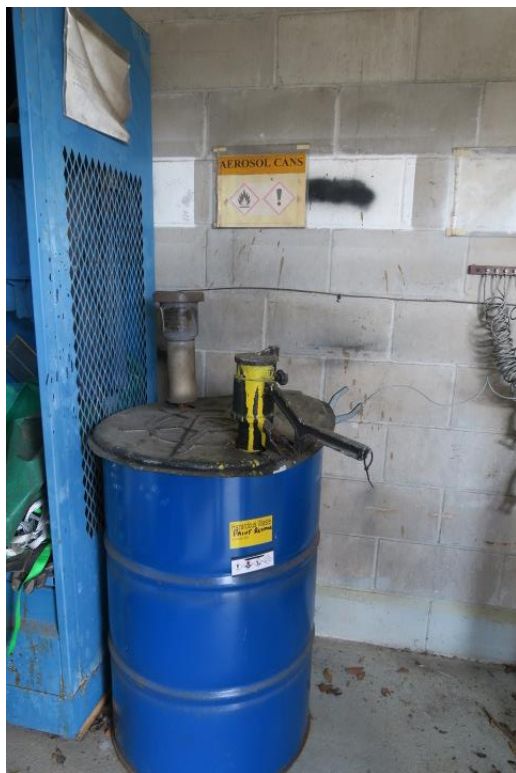
Photo 72: the funnel that is placed on top of a waste container that goes under the filter press pictured in photo 71 to collect hazardous filter cake waste.

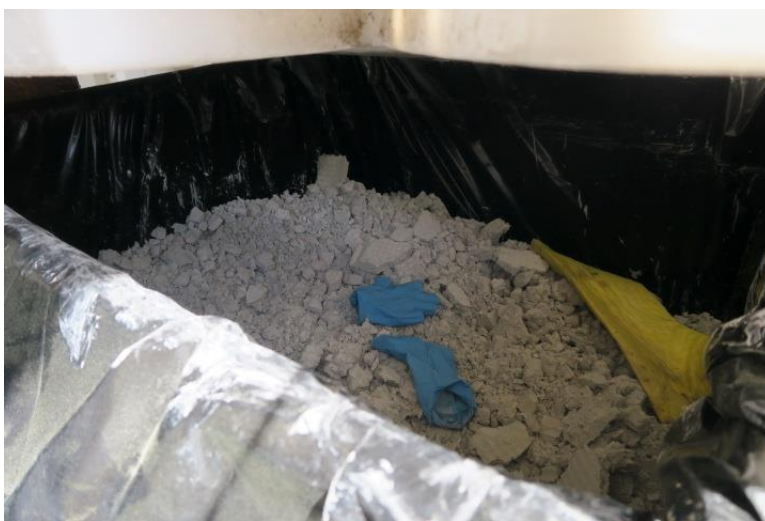
Photo74: one ~1 cubic yard sized container located under the filter press which contained hazardous filter cake and contaminated debris (i.e. gloves), located in the BWWTP.

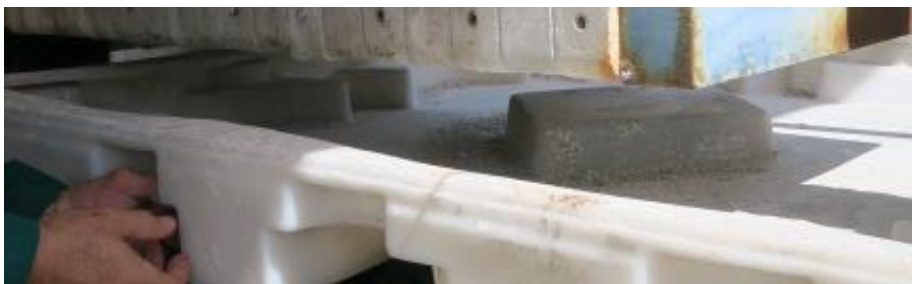
Inspectors observed filter cake waste accumulating on top of the "lid", this waste was open to the environment (Photo 77).

Photo 76: item on top of the container acting as a lid, it was shaped in a way that left parts of the container open to the environment and did not fully close the container.

Photo 77: Inspectors observed filter cake waste accumulating on top of the “lid”, this waste was open to the environment.
