## **RCRA Inspection Report**

HAECO Airframe Services, LLC  
623 Radar Road  
Greensboro, North Carolina 27410

EPA ID#: NCD986186351  
NAICS#: 488119 – Other Airport Operations

March 27, 2024

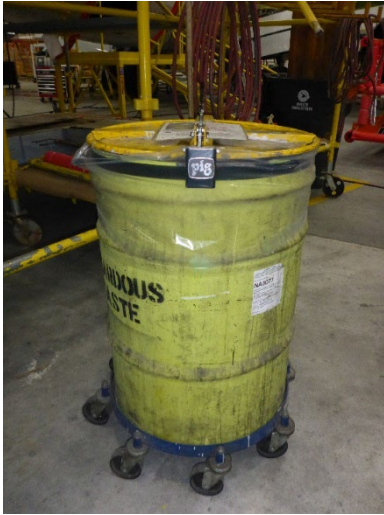
- In the first SAA, the inspectors observed one 55-gallon container (Photos 1), which was labeled D005, D006, D007, D008, D035, F002, F003, F005 hazardous waste debris, gloves, rags and PPE, and marked with an indication that the contents are ignitable and toxic. The inspectors also observed a notice on the top of the container instructing personnel on what materials may and may not be placed inside the container (Photo 2); and

**Photo 1:** One 55-gallon container in a mobile SAA at Hanger #1. The container was labeled D005, D006, D007, D008, D035, F002, F003, F005 hazardous waste debris, gloves, rags and PPE, and marked with an indication that the contents are ignitable and toxic.

**Pursuant to 15A NCAC 13A .0107(a) [40 C.F.R. § 262.15(a)(5)], which is a condition of the SAA Permit Exemption, a generator is required to mark or label its containers (i) with the words "Hazardous Waste" and (ii) with an indication of the hazardous of the contents.**

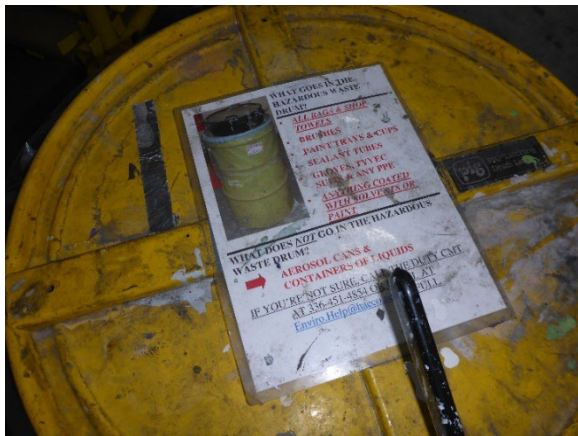
**Photo 2:** Notice on top of the container shown in Photo 1 which instructs personnel on what materials may and may not be placed inside the container.

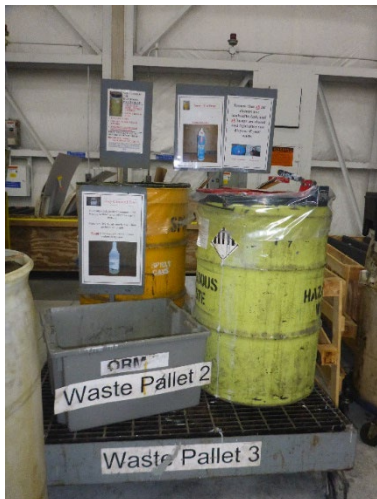
- In the second SAA, the inspectors observed two 55-gallon containers and a 10-gallon plastic bin (Photo 3). One 55-gallon container was labeled D005, D006, D007, D008, D035, F002, F003, F005 hazardous waste debris, gloves, rags, and PPE, and identified with an indication that the contents are ignitable and toxic. The other 55-gallon container was labeled spray cans. Although HAECO personnel indicated that they are in the process of re-profiling used aerosol cans as universal waste, they stated that the cans are currently being managed as hazardous waste. The 55-gallon container of used aerosol cans was not labeled with the words "hazardous waste", and it was not marked with an indication of the hazards of its contents. If HAECO intends to manage used aerosol cans as universal waste, the container should be labeled with the words "universal waste - aerosol can(s)," "waste aerosol can(s)," or "used aerosol can(s)". The 10-gallon plastic bin was labeled "waste pallet 2" and it contained one empty container.

**Photo 3:** Two 55-gallon containers and a 10-gallon plastic bin in a mobile SAA at Hanger #1.

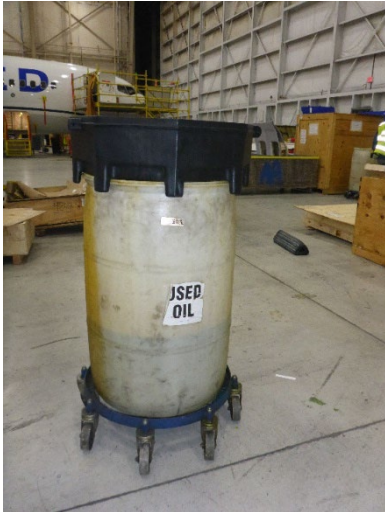
In addition to accumulating hazardous waste in designated mobile SAAs, the Facility also accumulates used oil in designated mobile containers inside Hangar #1. The inspectors observed three 55-gallon containers for accumulating used oil in various locations within the hangar. Each used oil container observed in this hangar was labeled with the words "used oil" and positioned on a rolling base. At least one of the three containers was equipped with a large funnel for draining used oil into the container (Photo 4).

**Photo 4:** A mobile 55-gallon container for accumulating used oil in Hanger #1. The container was labeled used oil and equipped with a funnel.

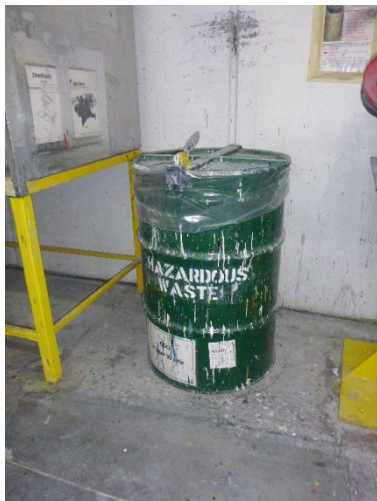
HAECO generates hazardous waste rags, PPE, and used paint booth filters in the Paint Booth area. Personnel stated that paint booth filters are changed about two-to-four times each year, and that cubic yard boxes are brought here to accumulate hazardous waste used paint booth filters when they are removed. HAECO manages a dedicated SAA at the Paint Booth for accumulating hazardous waste used rags and PPE, which are routinely generated in this area. The inspectors observed one 55-gallon container in this SAA (Photo 5). The container was labeled as D005, D006, D007, D008, D035, F002, F003, F005 hazardous waste, and marked to indicate that the contents are ignitable and toxic.

**Photo 5:** One 55-gallon container in a SAA for accumulating hazardous waste solids at the Hanger #1 Paint Shop. The container was labeled D005, D006, D007, D008, D035, F002, F003, F005 hazardous waste debris, gloves, rags and PPE, and marked with an indication that the contents are ignitable and toxic.

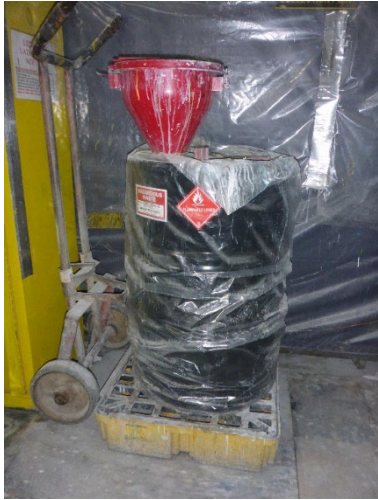
HAECO manages another SAA at the Paint Booth for accumulating unused paints that either remain in the paint booth spray gun after use or that are prepared but not used in the paint booth spray gun. The inspectors observed one 55-gallon container in this SAA (Photo 6). The container was labeled as hazardous waste used liquid paints, and it was equipped with a latched funnel lid. Although the container was identified with a flammable liquid DOT hazard sticker, it was not marked to indicate that the contents are also toxic.

**Photo 6:** One 55-gallon container in a SAA for accumulating waste paint liquids at the Hanger #1 Paint Shop. The container was labeled hazardous waste used liquid paints, and marked with an indication that the contents are ignitable. It was not marked with an indication that the contents are also toxic.

**Pursuant to 15A NCAC 13A .0107(a) [40 C.F.R. § 262.15(a)(5)(ii)], which is a condition of the SAA Permit Exemption, a generator is required to mark or label its containers with an indication of the hazardous of the contents.**

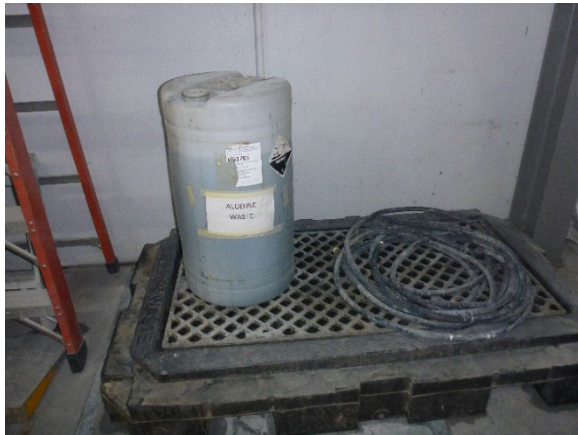
**Photo 7:** One 20-gallon container in a SAA for accumulating chromate plating waste at the Hanger #1 Paint Shop. The container was labeled D002, D007 hazardous waste Alodine waste, and it was identified with a DOT corrosive hazard sticker. It was not marked with an indication that the contents are also toxic.

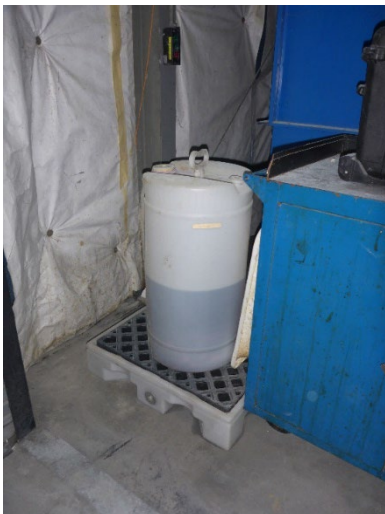
In addition to Painting, HAECO personnel perform spot chromate and cadmium plating in the Paint Shop. The spot plating is performed inside a hooded unit where small trays can be filled with plating liquids. Plating chemicals are applied using a brush and the prepared part is then placed into the tray of plating liquid. After use, the used plating liquids are poured into one of two hazardous waste containers. The Plating Shop manages one SAA for accumulating hazardous waste liquids generated during chromate plating activities and another for accumulating hazardous waste liquids generated during cadmium plating activities. The inspectors observed one 20-gallon container in the Alodine (chromate plating) waste SAA (Photo 7), which was in the corner of the Paint Shop. The container was identified as D002, D007 hazardous waste on a torn hazardous waste label. It was also identified with a corrosive DOT hazard sticker, but it was not marked to indicate that the contents are also toxic. The inspectors observed another 20-gallon container in the cadmium plating waste SAA (Photo 8). The container was not labeled with the words hazardous waste or marked with an indication of the hazards of its contents.

**Photo 8:** One 20-gallon container in a SAA for accumulating cadmium plating waste at the Hanger #1 Paint Shop. The container was not labeled or marked with an indication of the hazards of its contents.

**Pursuant to 15A NCAC 13A .0107(a) [40 C.F.R. § 262.15(a)(5)], which is a condition of the SAA Permit Exemption, a generator is required to mark or label its containers (i) with the words “Hazardous Waste” and (ii) with an indication of the hazardous of the contents.**

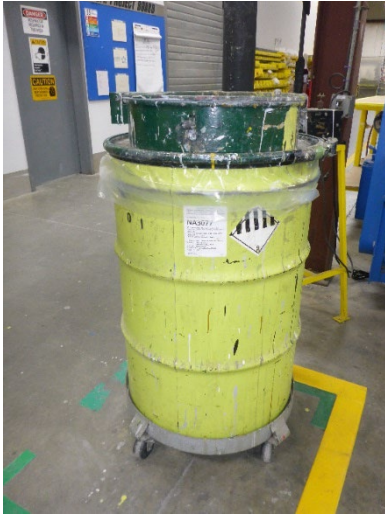
The inspectors observed one 55-gallon container in the first SAA (Photo 9), which is used to accumulate hazardous waste debris, PPE, brushes, and rags. The container was closed; it was labeled with the words "hazardous waste", and it was marked with an indication that the contents are ignitable and toxic.

**Photo 9:** One 55-gallon container in a SAA for accumulating hazardous waste debris, PPE, brushes, and rags generated at the Composite Shop. The container was labeled hazardous waste, and marked with an indication that the contents are ignitable and toxic.

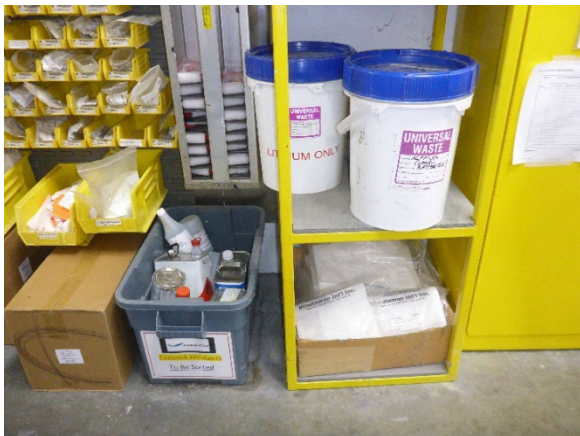
HAECO accumulates universal waste next to the second SAA. The inspectors observed two 5-gallon containers for accumulating universal waste batteries in this area (Photo 10). One 5-gallon container was labeled "universal waste alkaline (used) batteries", and the other was labeled "universal waste non-alkaline batteries, lithium only". Although neither universal waste container was marked with an accumulation start date, HAECO personnel stated that the 5-gallon containers are emptied into larger 55-gallon containers approximately once per month, and that the 55-gallon containers are marked with an accumulation start date. The Facility also had records of two shipments of universal waste sent off-site during calendar year 2022 and two more during calendar year 2023.

The inspectors observed one 10-gallon bin for accumulating small empty containers and small containers of unused or expired products in the second SAA (Photo 10). The bin was labeled "expired products to be sorted" and it contained a number of smaller empty and non-empty containers. The 10-gallon bin has the potential to be holding hazardous waste that is generated in the Composite Shop, but it was not closed or labeled with the words "hazardous waste" or with an indication of the hazards of its contents. Although HAECO's standard operating procedures call for environmental personnel to make the final hazardous waste determination on the contents of these small containers at the CAA, hazardous waste management requirements begin at the point of generation.

**Photo 10:** Two 5-gallon containers for accumulating universal waste batteries and one 10-gallon bin for accumulating empty containers and small containers of unused or expired products generated in the Composite Shop.

**Pursuant to 15A NCAC 13A .0107(a) [40 C.F.R. § 262.11], a person who generates a solid waste, as defined in 15A NCAC 13A .0106(a) [40 C.F.R. § 261.2], must make an accurate determination as to whether that waste is a hazardous waste in order to ensure wastes are properly managed according to applicable RCRA regulations articulated in 15A NCAC 13A .0107(a) [40 C.F.R. § 262.11]. A small or large quantity generator must maintain records supporting its hazardous waste determinations, including records that identify whether a solid waste is a hazardous waste.**

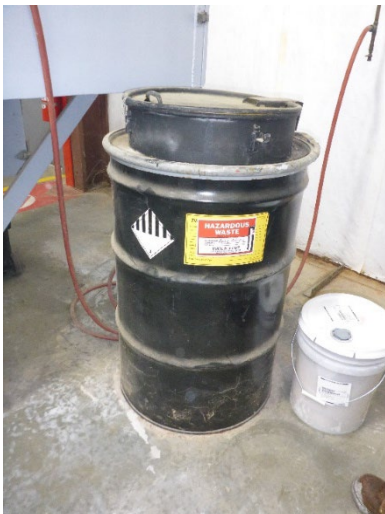
Composite Shop employees may use the available Bead Blast Unit to clean parts, if necessary. Spent bead blast media is accumulated in the fourth SAA. The inspectors observed one 55-gallon drum in the bead blast SAA (Photo 11). The drum was labeled as hazardous waste and marked with an indication that the contents are toxic.

**Photo 11:** One 55-gallon container in a SAA for accumulating used bead blast material generated at the Composite Shop. The container was labeled hazardous waste, and marked with an indication that the contents are toxic.

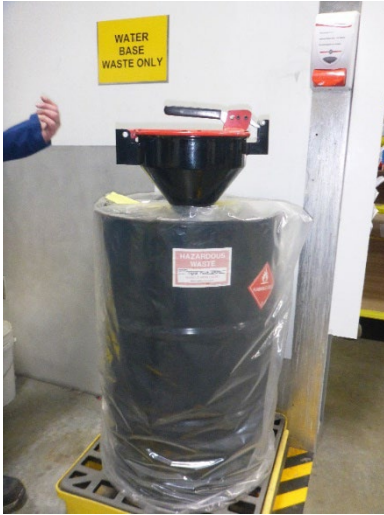
**Photo 12:** One 55-gallon container in a SAA for accumulating liquid paint waste generated at the Composite Shop. The container was labeled hazardous waste, and marked with an indication that the contents are ignitable and toxic.

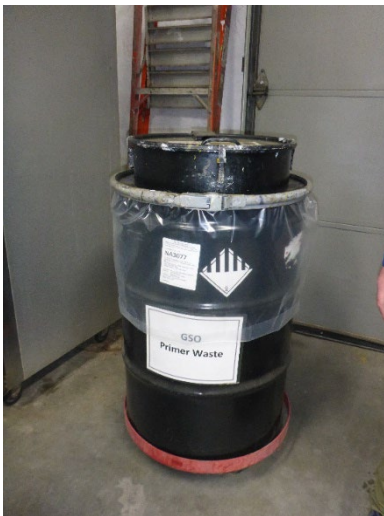
HAECO generates D005, D006, D007, D008, D035, F002, F003, F005 hazardous waste paint debris and accumulates it as GSO Primer waste in a SAA at the Heat Treat Shop. The inspectors observed one 55-gallon container in this SAA (Photo 13). The container was labeled with the words “hazardous waste”, and it was marked with an indication that the contents are ignitable and toxic.

**Photo 13:** One 55-gallon container in a SAA for accumulating hazardous waste generated at the Heat Treat Shop. The container was labeled D005, D006, D007, D008, D035, F002, F003, F005 hazardous waste paint debris, and marked with an indication that the contents are ignitable and toxic.

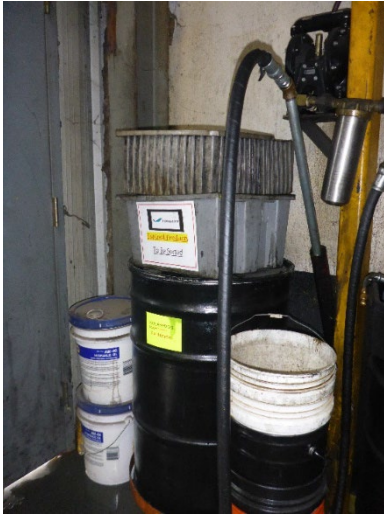
HAECO performs general vehicle maintenance activities at the GSE Shop, and the inspectors observed two SAAs in this area. One 55-gallon container was observed in the first SAA, which is used to accumulate used wipes or gloves as hazardous waste debris. The container was labeled with the words “hazardous waste”, and it was marked with an indication that the contents are ignitable and toxic. Another 55-gallon container and a 10-gallon bin were observed in the second SAA (Photo 14). This 55-gallon container was labeled “non-hazardous aerosol cans for recycle” and the bin was labeled “expired products to be sorted”. Although HAECO personnel indicated that they are in the process of re-profiling used aerosol cans as universal waste, they stated that the cans are currently being managed as hazardous waste. The 55-gallon container of used aerosol cans was not labeled with the words “hazardous waste”, and it was not marked with an indication of the hazards of its contents. HAECO personnel added the word “used” to the label, so that it read “non-hazardous used aerosol cans for recycle”.

The bin was labeled “expired products to be sorted” and contained two containers of expired products. The 10-gallon bin has the potential to be holding hazardous waste that is generated in the GSE Shop, but it was not closed or labeled with the words “hazardous waste” or with an indication of the hazards of its contents. Although HAECO’s standard operating procedures call for environmental personnel to make the final hazardous waste determination on the contents of these small containers at the CAA, hazardous waste management requirements begin at the point of generation.

**Photo 14:** One 55-gallon container and a 10-gallon bin in the GSE Shop's second SAA. The 55-gallon container was labeled "non-hazardous aerosol cans for recycle" and the bin was labeled "expired products to be sorted".

**Pursuant to 15A NCAC 13A .0107(a) [40 C.F.R. § 262.15(a)(5)], which is a condition of the SAA Permit Exemption, a generator is required to mark or label its containers (i) with the words “Hazardous Waste” and (ii) with an indication of the hazardous of the contents.**

**Pursuant to 15A NCAC 13A .0107(a) [40 C.F.R. § 262.11], a person who generates a solid waste, as defined in 15A NCAC 13A .0106(a) [40 C.F.R. § 261.2], must make an accurate determination as to whether that waste is a hazardous waste in order to ensure wastes are properly managed according to applicable RCRA regulations articulated in 15A NCAC 13A .0107(a) [40 C.F.R. § 262.11]. A small or large quantity generator must maintain records supporting its hazardous waste determinations, including records that identify whether a solid waste is a hazardous waste.**

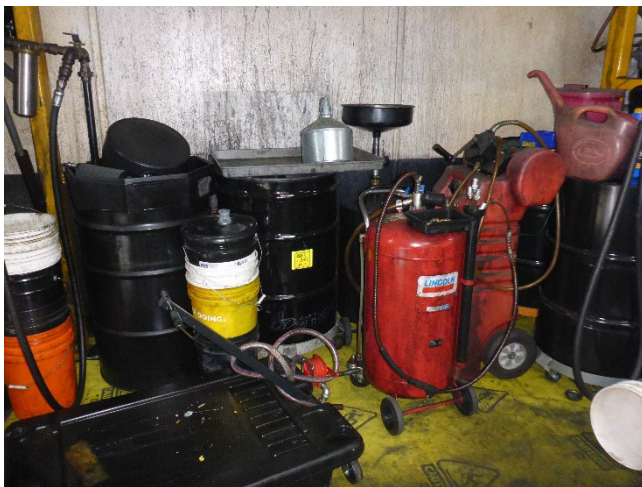
The GSE Shop also generates used oil and used antifreeze. Among the equipment and containers staged under the shelving unit near the door, the inspectors observed one 55-gallon container of used oil, one 55-gallon container of used oil filters, and one 55-gallon container of

used antifreeze (Photo 15). Housekeeping may need attention in this area, as evidenced by stains observed on the wall, containers, and equipment. One the shelf above the containers, the inspectors observed one red tank of used oil (Photo 16). The inspectors observed a used oil filter draining through a funnel and into the 55-gallon container of used oil. The red tank was labeled with the words “used oil”, but the container of used oil was not labeled.

**Photo 15:** One 55-gallon container of used oil, one 55-gallon container of used oil filters and one 55-gallon container of used antifreeze among other equipment in the GSE Shop. Stains on the wall, containers and equipment show evidence of poor housekeeping.

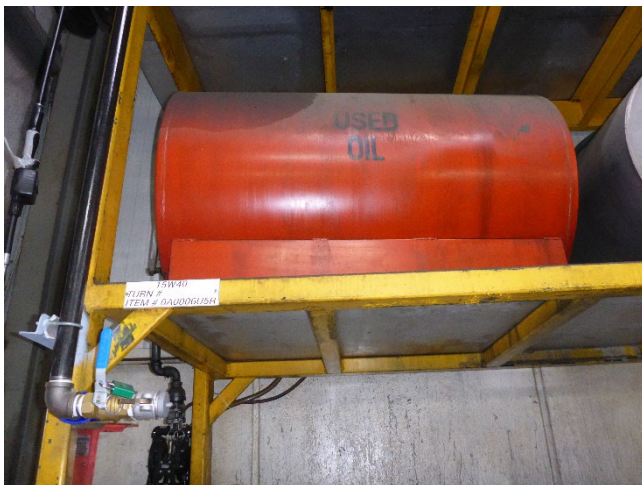
**Photo 16:** Red used oil tank on elevated shelf in the GSE Shop.

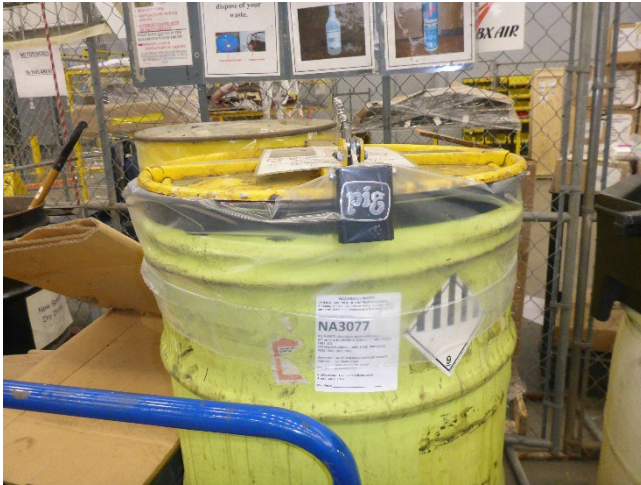
**Photo 17:** One 55-gallon container in a Hanger #4 mobile SAA. The container was labeled D005, D006, D007, D008, D035, F002, F003, F005 hazardous waste debris, gloves, rags, and PPE, but it was not marked with an indication of the hazards of its contents.

**Pursuant to 15A NCAC 13A .0107(a) [40 C.F.R. § 262.15(a)(5)], which is a condition of the SAA Permit Exemption, a generator is required to mark or label its containers (i) with the words “Hazardous Waste” and (ii) with an indication of the hazardous of the contents.**

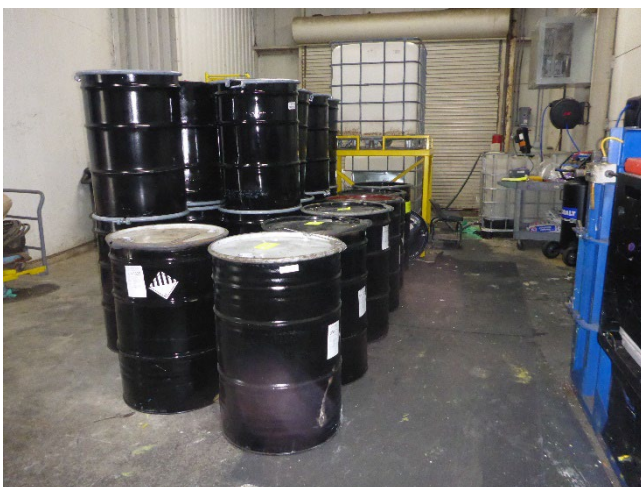
**Photo 19:** Six 55-gallon containers for consolidated hazardous waste debris located next to several empty 55-gallon containers, which are stacked two high, in the Fire Pump House CAA. Each hazardous waste container was closed, labeled with the words "hazardous waste", marked with an accumulation start date and identified with a two-letter customer identification code. Each container was labeled with a DOT class 9 hazard sticker, but none were marked with an indication of the hazards of its contents.

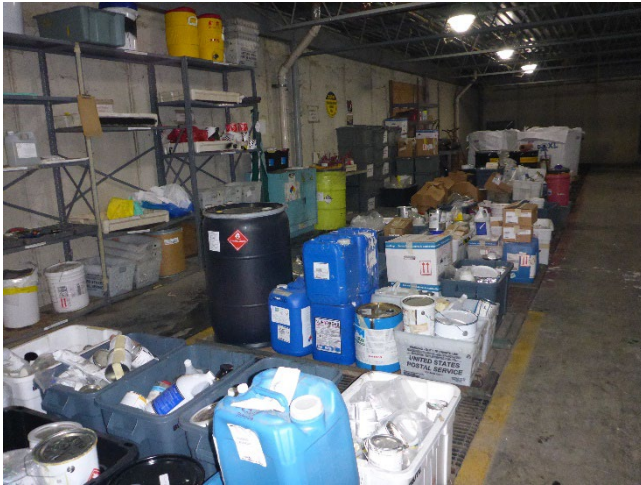
**Photo 20:** The first of three storage sections in the Main CAA. Each section is equipped with conveyance rollers for ease of container movement across the section from side to side.

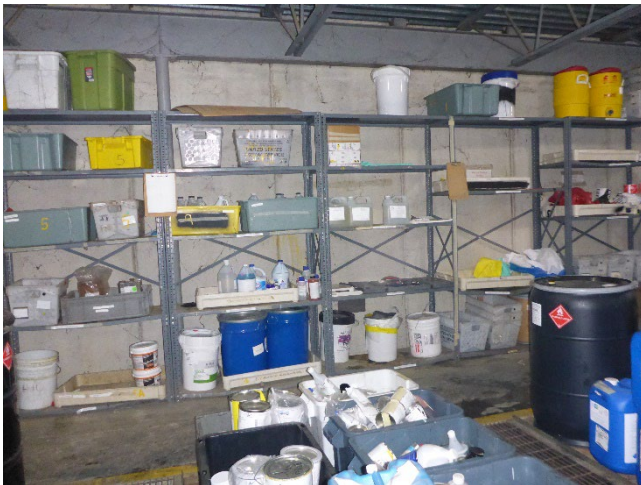
**Photo 21:** Storage shelving for staging lab-pack materials along the outer wall inside the main CAA.

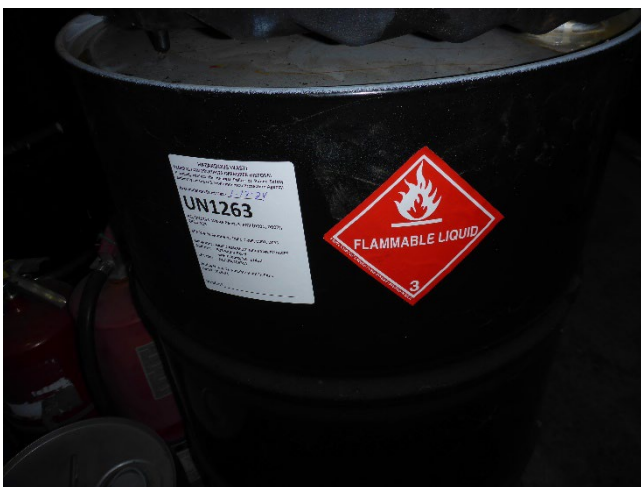
**Photo 22:** Label on active 55-gallon container at the start of the first of three storage sections that run length-wise through the main CAA building. Container used to consolidate waste paint thinner solvent as hazardous waste.

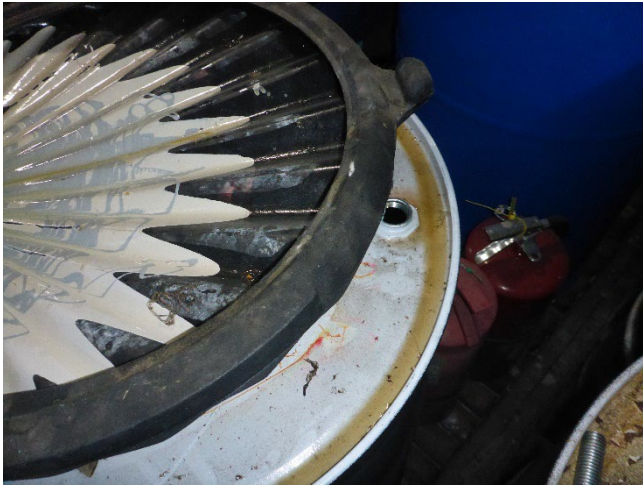
**Photo 23:** An open bung and hazardous waste liquid on the top of a hazardous waste storage container in the main CAA.

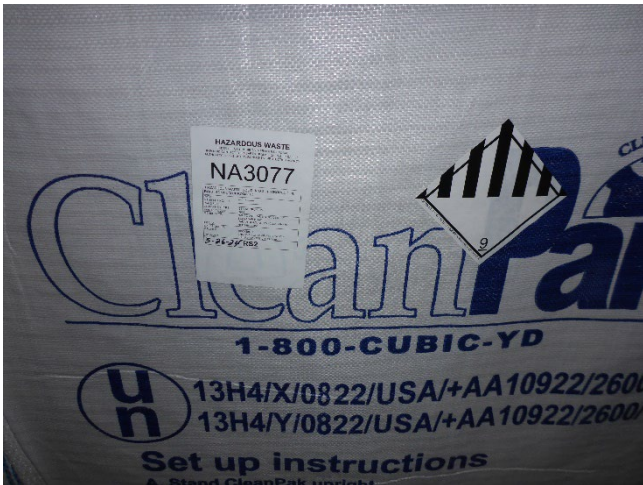
**Photo 24:** Supersack of hazardous waste observed in the second storage section of the main CAA. The supersack was labeled as hazardous waste solid contaminated paint filters, marked with an accumulation start date of March 26, 2024, and identified with a DOT class 9 hazard sticker. It was not marked with an indication that the contents of the container are toxic.

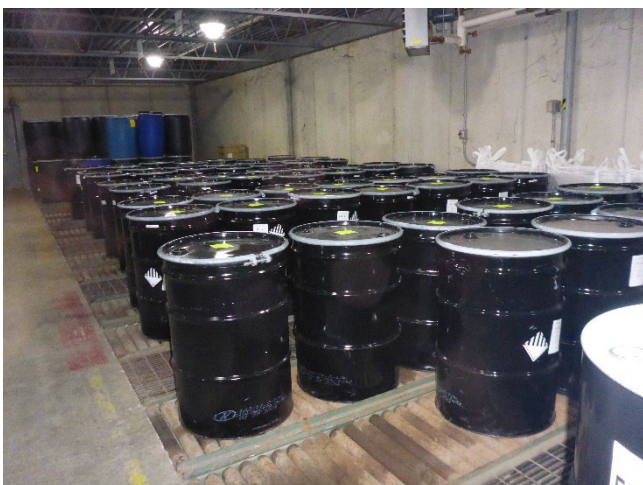
**Photo 25:** Approximately sixty 55-gallon containers of hazardous waste in the third storage section in the main CAA. Each container was labeled D001, D006, D007, D035, F003, F005 hazardous waste flammable solids (acetone, xylene), and marked with an accumulation start date. The oldest container was dated February 26, 2024. Although the containers were each identified with a DOT class 9 hazard sticker, none were marked with an indication that the contents are toxic.
