**Report Title:** Clean Air Act Inspection of Spirit Energy Services – Beech Bottom  
**Inspection Date(s):** 03/27/2024  
**Regulatory Program(s):** To be determined

**Company Name:** Spirit Energy Services  
**Facility Name:** Spirit Energy Services – Beech Bottom  
**Facility Location:** 173 Industrial Park Lane  
Beech Bottom, WV 26030

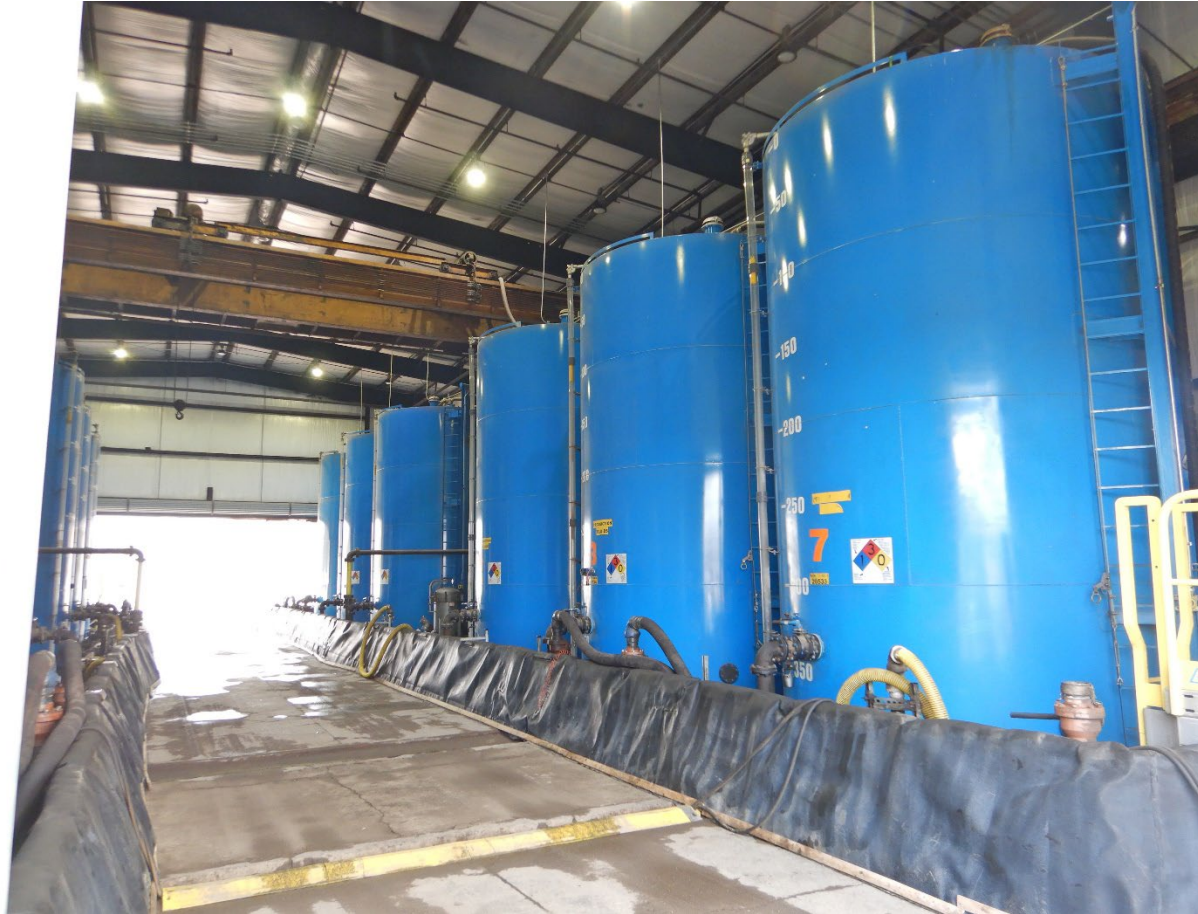
Photo 2 – Right Bank of Tanks

During EPA's walkthrough, no trucks were observed either loading, or unloading. The twelve settling tanks (Photos 2 & 3) were observed inside a covered structure next the maintenance/office building. Six of the tanks are located on one side of the building while the other six tanks are located on the other side with a drive thru in the middle for trucks. The tanks are connected six and six using a common header to collect vapors. EPA observed the tanks from the ground with a FLIR GF320 infrared camera and no emissions were observed from the tanks at that time. There was not a manway for the tank battery so EPA could not observe the top of the tanks. EPA observed the common vapor collection header from the tanks piped into two (2) carbon filters (Photo 5) that were located outside of the tanks building. When observed with the FLIR Camera, EPA observed emissions from a bypass valve on CV11639195 (FLIR Video 1). EPA also observed emissions from the exhaust on CV44103 (FLIR Video 2). EPA showed the emissions to SESBB, and they closed the bypass valve on CV11639195. EPA observed this valve again and no further emissions were observed using the FLIR camera. Emissions were still present at CV44103. SESBB indicated they would contact United Rentals to perform maintenance on the units and remove the bypass valve.

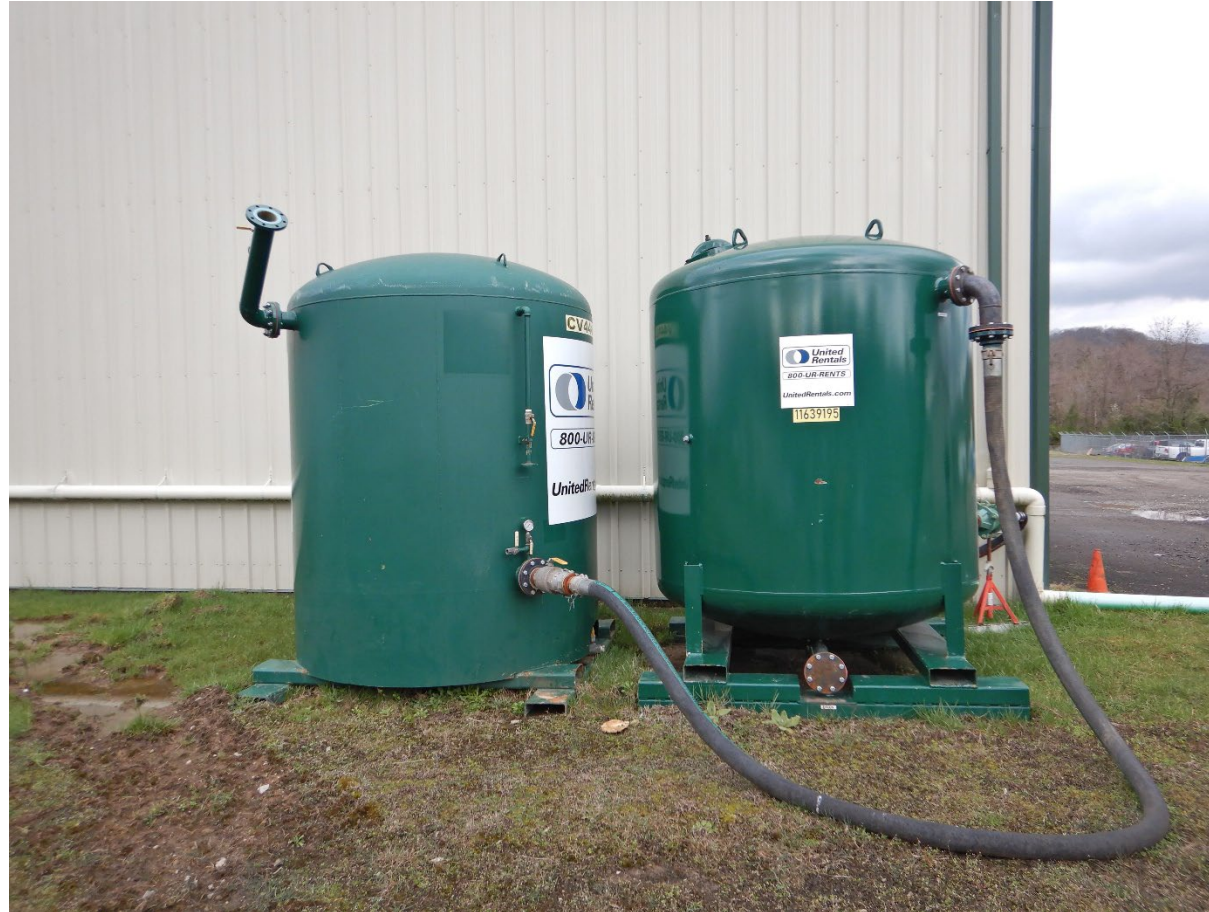
Photo 5 – Two Carbon Filters

- Both carbon canister filters were observed, via the FLIR Camera. One of the carbon canisters was leaking from a valve that was left open and was completely bypassing the control device. Another leak was observed from the exhaust on the second carbon canister. While the carbon system is not expected to be 100% effective when controlling emissions, it is anticipated that no emissions would be observed when trucks are not loading. The only emissions from the tanks, at that time, would be breathing losses. In addition, SESBB indicated that their FLIR camera was not operating so they could not conduct observations of the carbon canisters. SESBB may need to institute additional measures to ensure the system is working properly to control tank emissions and change the carbon beds more frequently.
