## **RCRA Inspection Report**

American Tank Wash Solutions, LLC      EPA ID# ALD155638570  
9561 Old Highway 43  
Creola, Alabama 36525

March 30, 2023

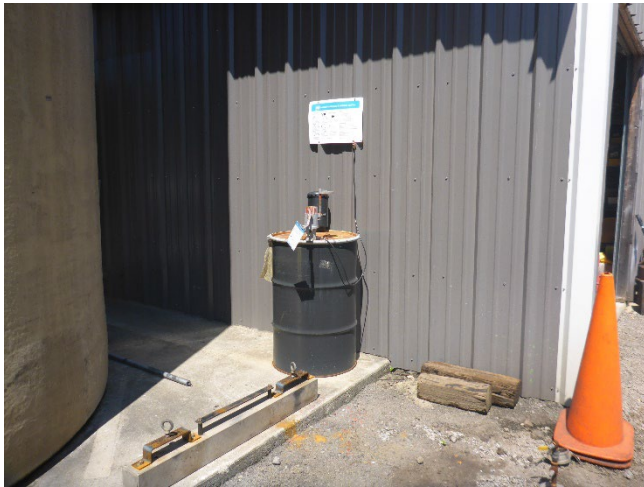
ATW manages one SAA near the truck repair area for managing hazardous waste that is generated by puncturing aerosol cans (Photo 1). The inspectors observed one 55-gallon drum in this SAA. The drum was equipped with a can puncturing device, which was open. The drum was not labeled with the words hazardous waste, and it was not identified with an indication of the hazards of its contents.

**Photo 1:** SAA for managing the contents from punctured aerosol cans. The drum was not labeled with the words hazardous waste or marked with an indication of the hazards of its contents. The bung on the drum was equipped with a can puncture device, which was open.

**Pursuant to ADEM Admin. Code r.335-14-3-.01(5)(a)5. [40 C.F.R. § 262.15(a)(5)], which is a condition of the SAA Permit Exemption, a generator is required to mark or label its containers with the words “Hazardous Waste” and with an indication of the hazards of the contents.**

**Pursuant to ADEM Admin. Code r.335-14-3-.01(5)(a)4. [40 C.F.R. § 262.15(a)(5)], which is a condition of the SAA Permit Exemption, a container holding hazardous waste must be closed at all times during accumulation, except: when adding, removing or consolidating waste; or when temporary venting of a container is necessary for the proper operation of equipment, or to prevent dangerous situations, such as build-up of extreme pressure.**

Personnel immediately closed the 55-gallon drum by rotating the lid on the can puncturing device into the closed position. In an email to Lanny Sasser on April 18, 2023, Dana Hester provided a photograph documenting that a hazardous waste label had been placed onto the 55-gallon drum in the SAA.

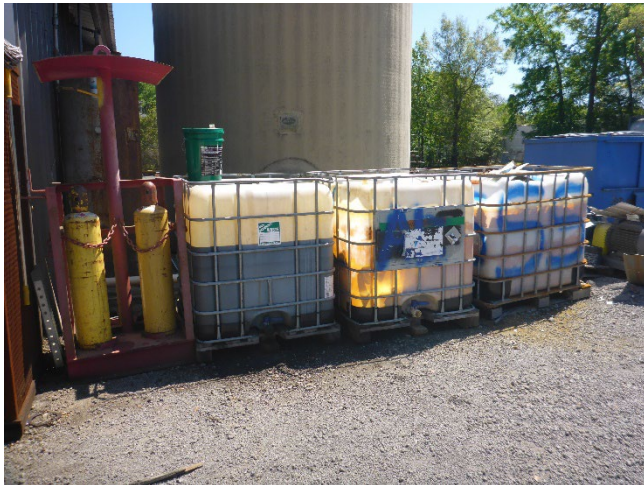
The inspectors also observed one 275-gallon tote of used oil near the truck repair area (Photo 2). The tote was not labeled with the words used oil. It was labeled nonhazardous waste.

**Photo 2:** 275-gallon used oil tote (on the left) labeled nonhazardous waste, but not labeled with the words used oil.

**Pursuant to ADEM Admin. Code r.335-14-17-.03(4)(c) containers and used oil tanks, except underground tanks, used to store used oil at used oil generator locations must be labeled or marked clearly with the words “Used Oil”.**

In an email to Lanny Sasser on April 18, 2023, Dana Hester provided a photograph documenting that the used oil tote had been labeled with the words used oil.

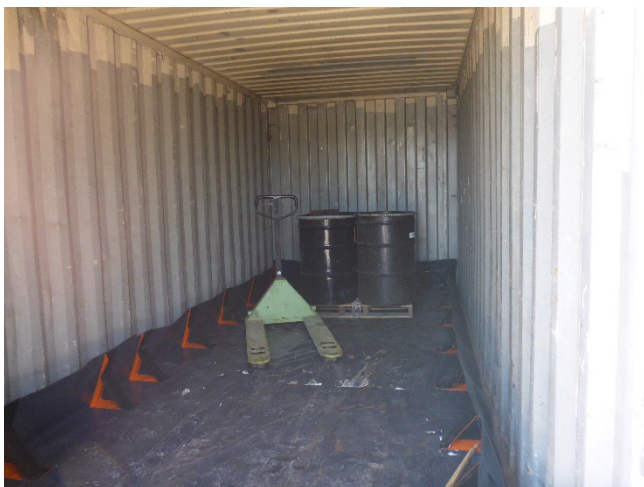
ATW manages a hazardous waste CAA in a trailer box car (Photo 3) near the truck wash bays (Photo 4). The area was secured by a padlock and identified with sign which read “Notice: Restricted Area, Authorized Personnel Only,” and “No Smoking. The inspectors observed a fire extinguisher near the box car, and an emergency shower and eyewash station near the truck wash bays.

The inspectors observed four 55-gallon drums of hazardous waste on a wooden pallet inside the box car CAA. Each of the four drums was labeled as hazardous waste and marked with an accumulation start date. Two drums were labeled as D003 hazardous waste sodium hydrosulfide and dated January 18, 2023, although one of those drums had to be turned to reveal the hazardous waste label. One drum was labeled hazardous waste and dated January 6, 2023, and the last was labeled hazardous waste and dated March 25, 2023. Neither of these two drums were labeled with the EPA Waste Code, and none of the four drums were marked with an indication of the hazards of their contents.

**Photo 3:** Four 55-gallon drums inside a trailer box car, which is the designated hazardous waste central accumulation area (CAA).

**Pursuant to ADEM Admin. Code r. 335-14-3-.01(6)(b)6.(i)(b) and (d) [40 C.F.R. § 262.16(b)(6)(i)], which is a condition of the SQG Permit Exemption, a generator is required to mark or label containers with an indication of the hazards of the contents, and all appropriate EPA hazardous waste numbers associated with the hazardous waste as specified in 335-14-2-.03 and 335-14-2-.04.**

In an email to Lanny Sasser on April 18, 2023, Dana Hester provided photographs documenting that each drum had been labeled with the EPA Waste Code and marked with an indication of the hazards of its contents.

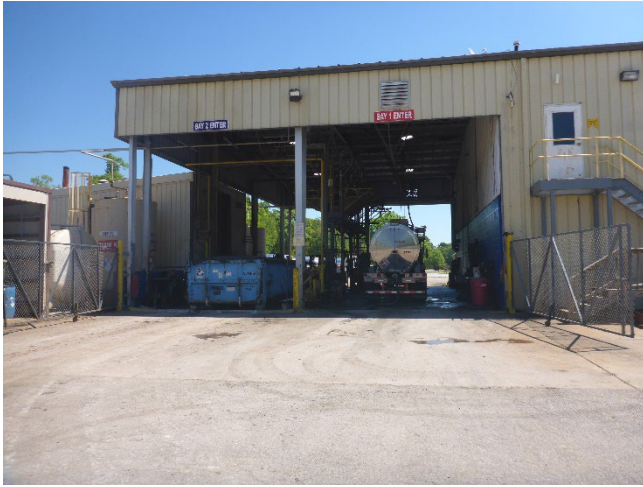
**Photo 4:** Two truck wash bays.
