## **RCRA Inspection Report**

Ameresco Palmetto, LLC  
251 New Hope Road  
Wellford, South Carolina 29385-9467

May 31, 2023

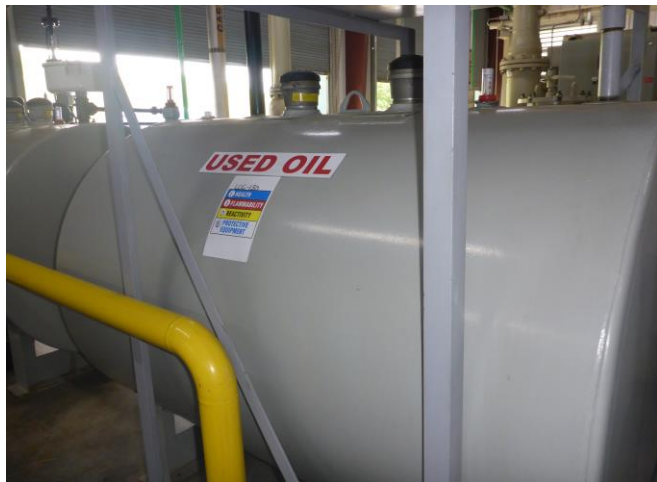
The Facility tour began in the Compressor Room, where the inspectors observed one 600-gallon double walled tank for accumulating used oil generated from general maintenance activities (Photo 1). The tank was labeled with the words "used oil."

**Photo 1 – Compressor Room:** 600-gallon double walled tank for accumulating used oil from general maintenance activities.

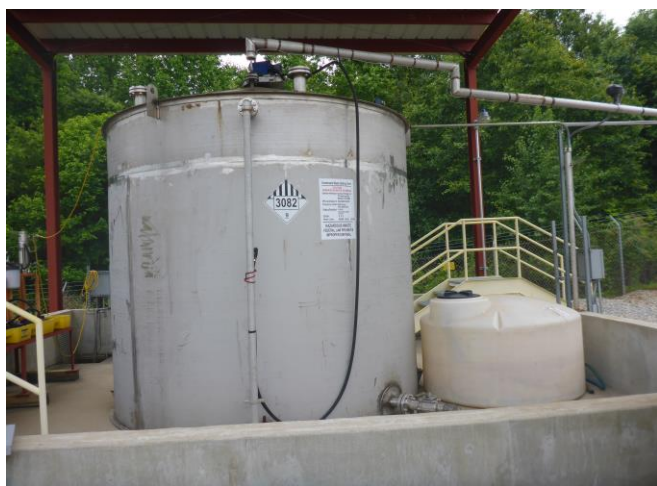
The inspectors observed the 6,000-gallon hazardous waste storage tank (Photo 2) in a covered concrete containment area outside of the facility building. The containment area is equipped with 30-inch high concrete dike walls and the floor is sloped towards a small sump. Bill Rossi stated that the roof cover, which was added in 2022, has reduced the amount of rainwater that accumulates in the secondary containment area. The inspectors observed a garden hose attached to the pump and leading outside of the secondary containment sump (Photo 3) to a nearby ditch (Photo 4). Although, the secondary containment sump is equipped with a float switch designed to trigger an automatic pump (Photo 5), Bill Rossi explained that the pump and switch are not operated as they were designed. Instead, the float switch is connected to an indicator alarm, which alerts personnel that liquid has accumulated in the sump. According to Bill Rossi, personnel must evaluate liquids in the sump to determine how they should be managed. If

**Photo 2 – Hazardous Waste Tank:** 6000-gallon tank used to accumulate landfill gas condensate (D004, D027) and oily liquid waste (D001, D009, D027).

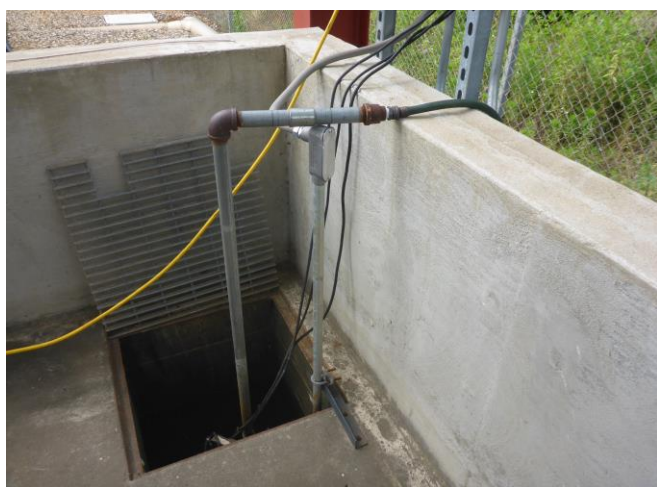
**Photo 3 – Hazardous Waste Tank:** Small sump in the secondary containment area of the hazardous waste tank.

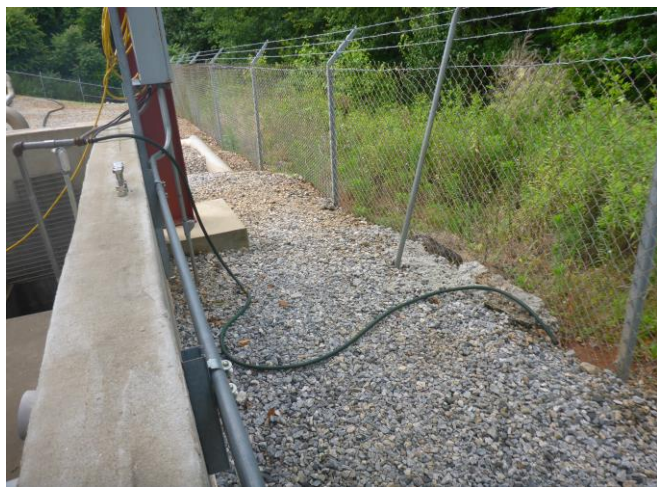
**Photo 4 – Hazardous Waste Tank:** Garden hose leading from the small sump in the secondary containment area of the hazardous waste tank to a nearby ditch.

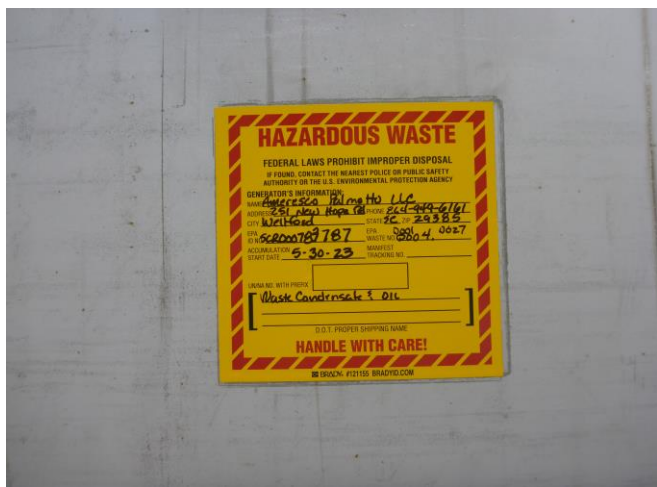
The inspectors observed that the 6,000-gallon hazardous waste storage tank was labeled with the words “hazardous waste” and marked with an accumulation start date of May 30, 2023 (Photo 6). Marks have been placed on the side of the tank next to the level indicator line to identify when the contents of the tank reach a level that is approximately six days away from “full”, a level that is approximately three days away from “full”, and a level that is “full.” The tank was labeled as D001, D004, D009, D027 hazardous waste condensate and oil, and it was identified with a Class 9 DOT hazard placard (Photo 2). However, the tank was not clearly marked with an indication of the hazards of its contents.

**Photo 6 – Hazardous Waste Tank:** Label on 6,000-gallon tank identifying the contents as D001, D004, D009, D027, and marked with an accumulation start date of March 13, 2023. The tank was also labeled with a Class 9 DOT hazard placard, but it was not clearly marked with an indication of the hazards of its contents.

**Pursuant to S.C. Code Ann. Regs. 61-79.262.17(a)(5)(ii) [40 C.F.R. § 262.17(a)(5)(ii)], which is a condition of the LQG Permit Exemption, a generator must mark or label its tank with an indication of the hazards of the contents.**

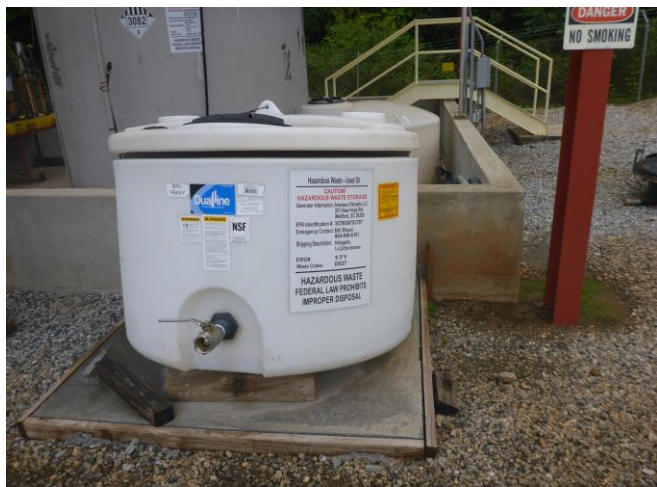
The inspectors observed the 300-gallon oily liquid waste accumulation tote outside of the tank’s secondary containment area (Photo 7). Based on the waste accumulation description provided by Bill Rossi and the hazardous waste manifest records, it appears that the Facility is accumulating over 55-gallons of oily liquid waste in the tote of the period of at least one week. Therefore, it appears that the tote should be managed in a hazardous waste central accumulation area (CAA). The inspectors observed a sign which read, “Danger, No Smoking” on the post next to the 300-gallon tote.

The inspectors observed that the 300-gallon tote contained a small volume of oily liquid waste, and it was being stored at an angle (Photo 7). Bill Rossi explained that the O-ring on the container was broken, and the tote had not been repaired and was being stored at an angle to prevent liquid from leaking out of the container.

**Photo 7 – Hazardous Waste Tote:** 300-gallon tote used to accumulate oily liquid waste (D001, D009, D027).

**Pursuant to S.C. Code Ann. Regs. 61-79.262.17(a)(1)(i) [40 C.F.R. § 262.17(a)(1)(i)], which incorporates S.C. Code Ann. Regs. 61-79.265.1087(c)(4)(iii) [40 C.F.R. § 265.1087(c)(4)(iii)] and is a condition of the LQG Permit Exemption, a generator accumulating hazardous waste in containers must comply with the RCRA Subpart CC organic air emission standards for containers, including, but not limited to the requirement to make first efforts at repair of the defect no later than 24 hours after a defect is detected for the container, cover, or closure devices, and repair shall be completed as soon as possible but no later than 5 calendar days after detection. If a repair cannot be completed within 5 calendar**

**days, the hazardous waste shall be removed from the container and the container shall not be used to manage hazardous waste until the defect is repaired.**

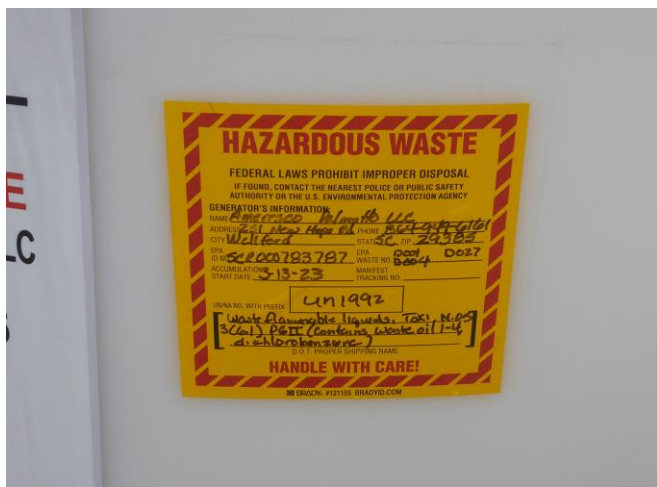
The 300-gallon tote was labeled D001, D004, D027 hazardous waste, identified with an indication that its contents are flammable and toxic, and marked with an accumulation start date of March 13, 2023 (Photo 8). The inspectors observed that this tote contained a small volume of

oily liquid waste, and it was being stored at an angle. Bill Rossi explained that the O-ring on the container was broken, and the tote was being stored at an angle to prevent liquid from leaking out of the container.

**Photo 8 – Hazardous Waste Tote:** Label on 300-gallon tote identifying the contents as D001, D004, D027 flammable and toxic hazardous waste, and marked with an accumulation start date of March 13, 2023.

**Pursuant to S.C. Code Ann. Regs. 61-79.262.17(a)(1)(ii) [40 C.F.R. § 262.17(a)(1)(ii)], which is a condition of the LQG Permit Exemption, if a container holding hazardous waste is not in good condition, or if it begins to leak, the generator must immediately transfer the hazardous waste from this container to a container that is in good condition, or immediately manage the waste in some other way that complies with the LQG Permit Exemption.**

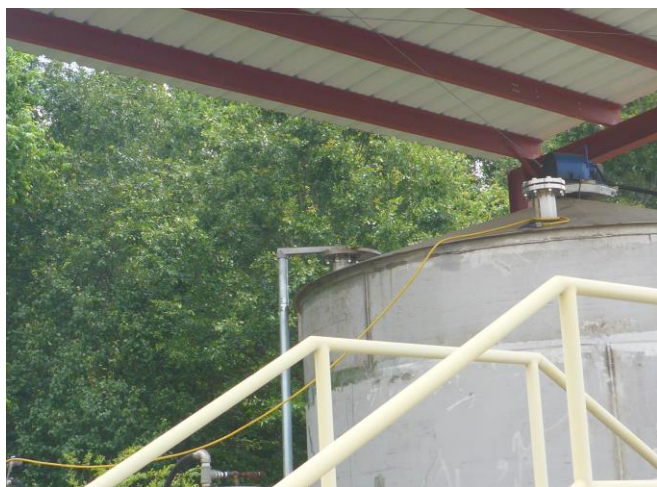
The inspectors observed several potential sources of volatile air emissions from the tank and its ancillary equipment. First, the tank is equipped with a liquid level indication system which consists of a level marker attached with a line to a floating level indicator inside the tank. The inspectors observed that this level indicator line passes through a port in the top of the tank that is open to the atmosphere (Photo 9). Second, the inspectors observed an open port on the top of the tank (Photo 10). Bill Rossi explained that this port was used to physically measure the thickness of the oil layer on top of the landfill gas condensate before the oil skimmer was installed. Third, the inspectors observed an overflow pipe along the side of the tank (Photos 10 and 11). Bill Rossi explained that this is an open pipe, which is designed to direct excess liquid from the tank down through the pipe to the secondary containment system if the tank were to overflow. The inspection participants observed vapors in the atmosphere in the area where the level indicator enters the top of the tank, where the oil measurement port was open on top of the tank, and where the oil skimmer system is installed on top of the tank. The inspectors also observed visual staining and liquid dripping at the input line on the top of the tank. Bill Rossi explained that the landfill gas condensate is chilled to a temperature of 40° F before it flows through the transfer line, and that the observed liquid and staining was likely condensate that had formed on the waste transfer line.

**Photo 9 – Hazardous Waste Tank:** Pipe on top of the tank is ancillary equipment used to transfer landfill gas condensate to the 6,000-gallon hazardous waste tank. The tank is open to the atmosphere through the port on the top of the tank through which the floating level indicator line passes.

**Pursuant to S.C. Code Ann. Regs. 61-79.262.17(a)(2) [40 C.F.R. § 262.17(a)(2)], which incorporates S.C. Code Ann. Regs. 61-79.265.1085(c)(2) [40 C.F.R. § 265.1085(c)(2)] and is a condition of the LQG Permit Exemption, a generator accumulating hazardous waste in tanks must comply with the RCRA Subpart CC organic air emission standards for tanks, including, but not limited to, the requirement for a tank to be equipped with (i) a fixed roof and closure devices designed to form a continuous barrier over the entire surface area of the hazardous waste in the tank; and (iii) each opening in the fixed roof, and any manifold system associated with the fixed roof, shall be (A) equipped with a closure device designed to operate such that when the closure devices is secured in the closed position there are no visible cracks, holes, gaps, or other open spaces in the closure device or between the perimeter of the opening and the closure device.**

**Pursuant to S.C. Code Ann. Regs. 61-79.262.17(a)(2) [40 C.F.R. §262.17(a)(2)], which incorporates S.C. Code Ann. Regs. 61-79.265.1085(c)(3) [40 C.F.R. § 265.1085(c)(3)] and is a condition of the LQG Permit Exemption, a generator accumulating hazardous waste in tanks must comply with the RCRA Subpart CC organic air emission standards for tanks, including, but not limited to, the requirement to install a fixed roof with each closure device secured in the closed position whenever a hazardous waste is in the tank.**

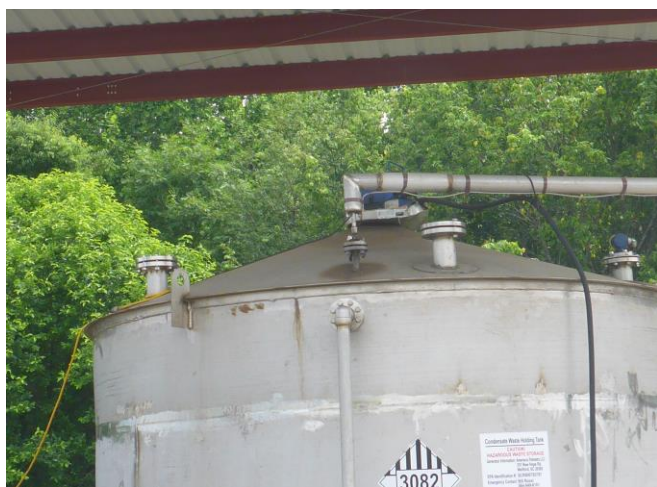
**Photo 10 – Hazardous Waste Tank:** Pipe on top of the tank is ancillary equipment used to transfer landfill gas condensate to the 6,000-gallon hazardous waste tank. The tank is open to the atmosphere through the overflow pipe down the front of the tank, through a port on the top of the tank used to measure the thickness of the oily liquid waste, and through a port on the top of the tank through which the floating level indicator line passes.

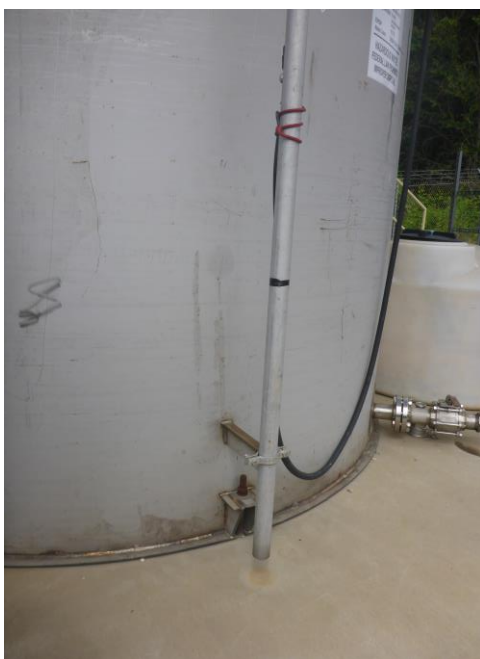
**Photo 11 – Hazardous Waste Tank:** Bottom of the tank overflow pipe.
