## Clean Water Act Section 404: Site Visit/Case Development

| Site Name | Finca Mucarabones - Toa Alta (hereinafter as "the Site") | | | | |

| Inspection Purpose | Follow-up site visit | | |

## Attachment B: Photolog

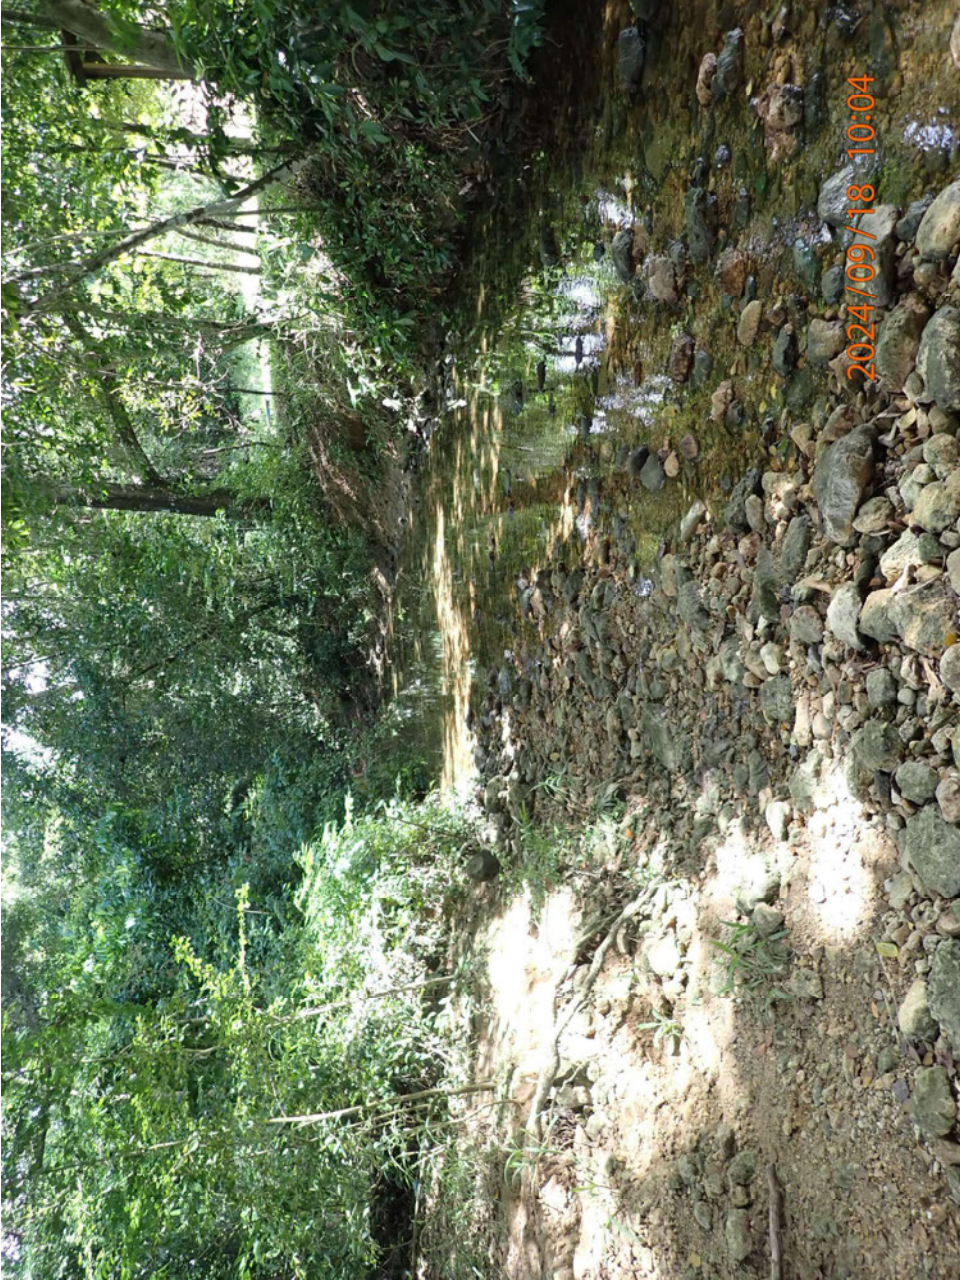
**Photo ID:** P9181116

**Description:** Upstream view of fill material on Quebrada Quilés.

| PRLA indicated to EPA that fill removal activities would be taking place in less than two weeks. | | | |

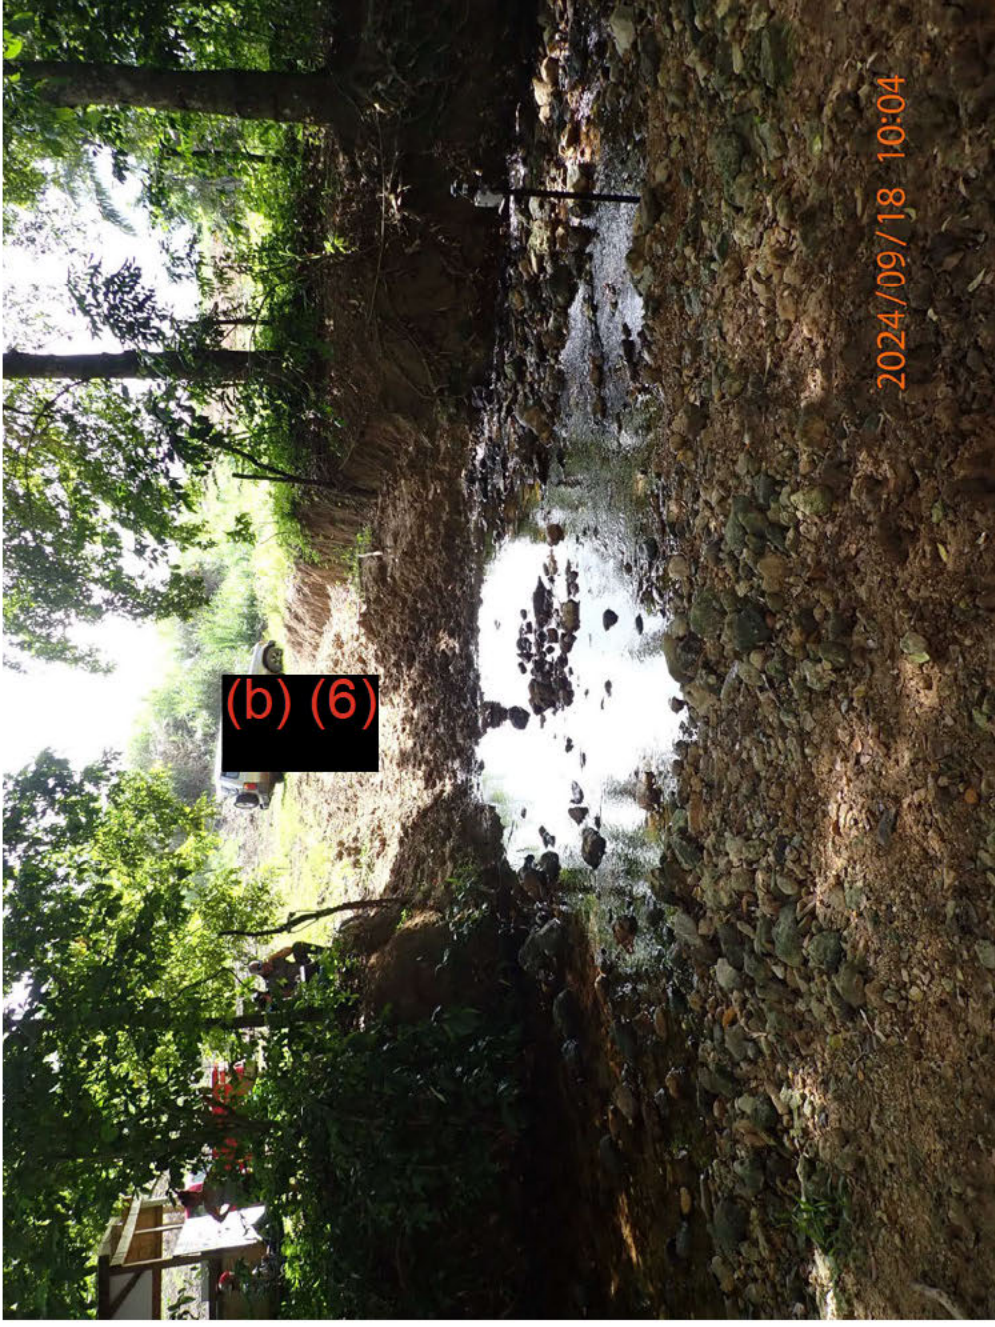
**Photo ID:** P9181120

**Description:** Dirt road crossing and observed disturbance of perennial stream banks, Quebrada Quilés.

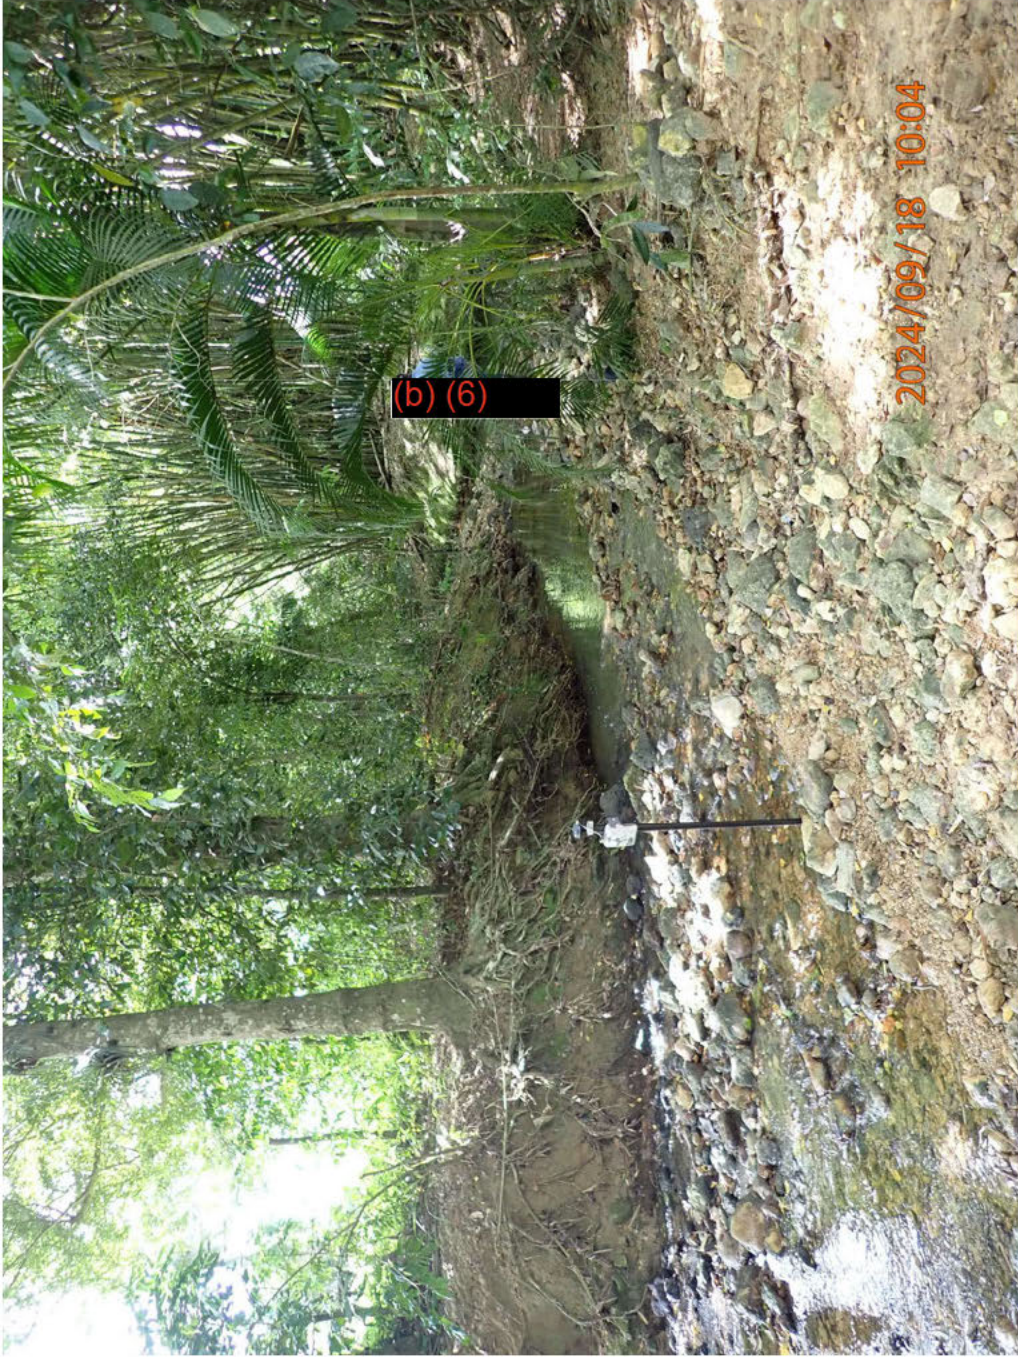
**Photo ID:** P9181122

**Description:** Fill material can be observed spreading downstream of Quebrada Quilés.

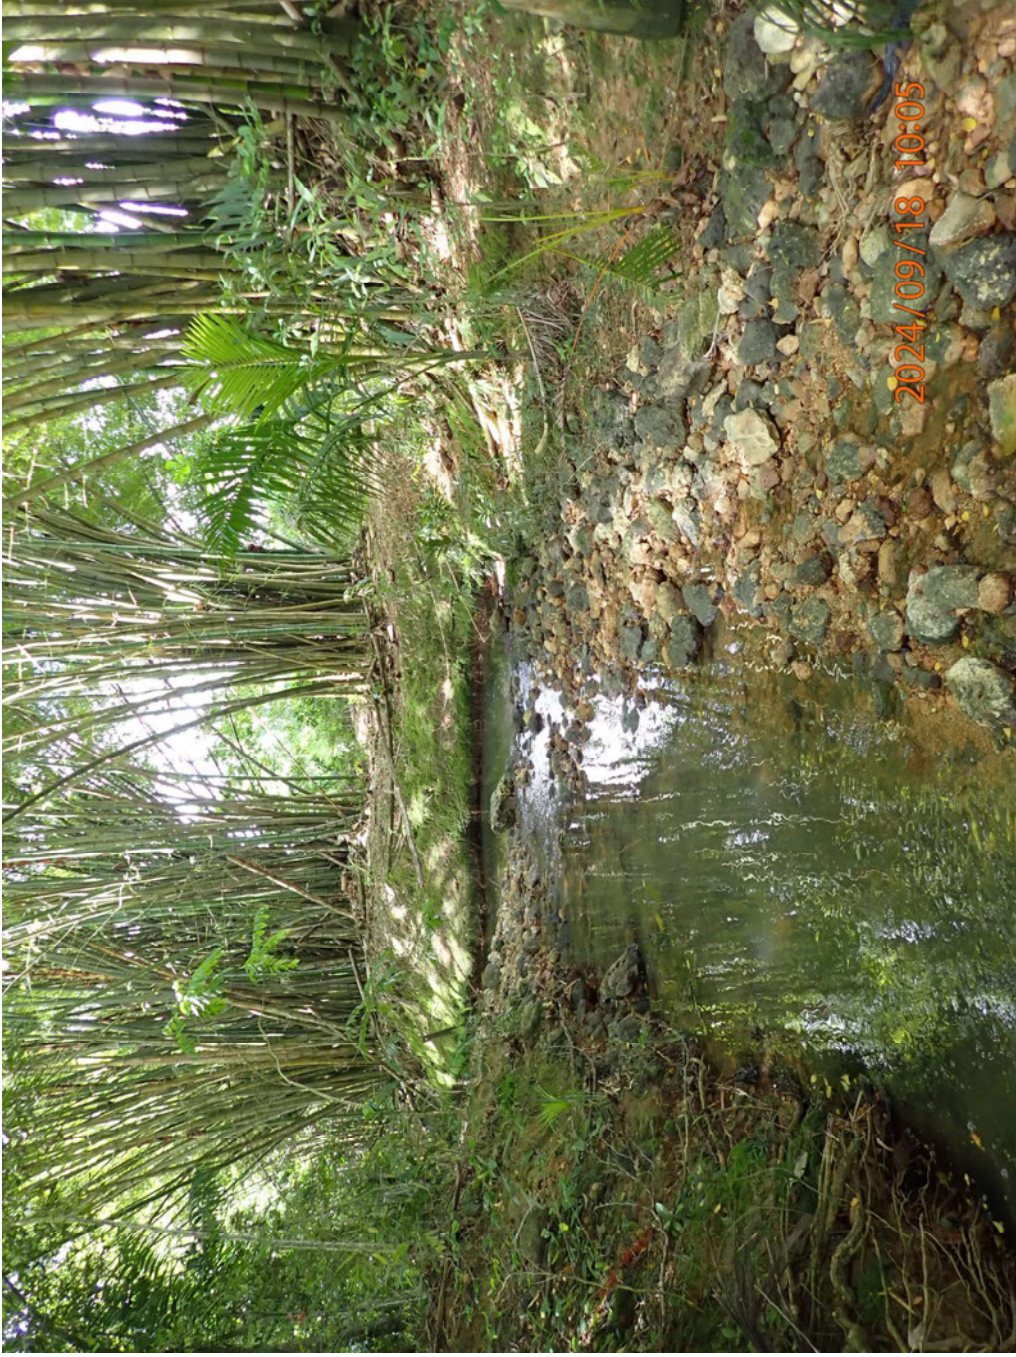
**Photo ID:** P9181128

| Potential areas of jurisdictional streams may be present on the site that were potentially filled with approx. a foot of fill material. Material had dispersed after the first site inspection. | | | |

**Description:** North to south view of dispersed fill material in stream bed of Quebrada Quilés.

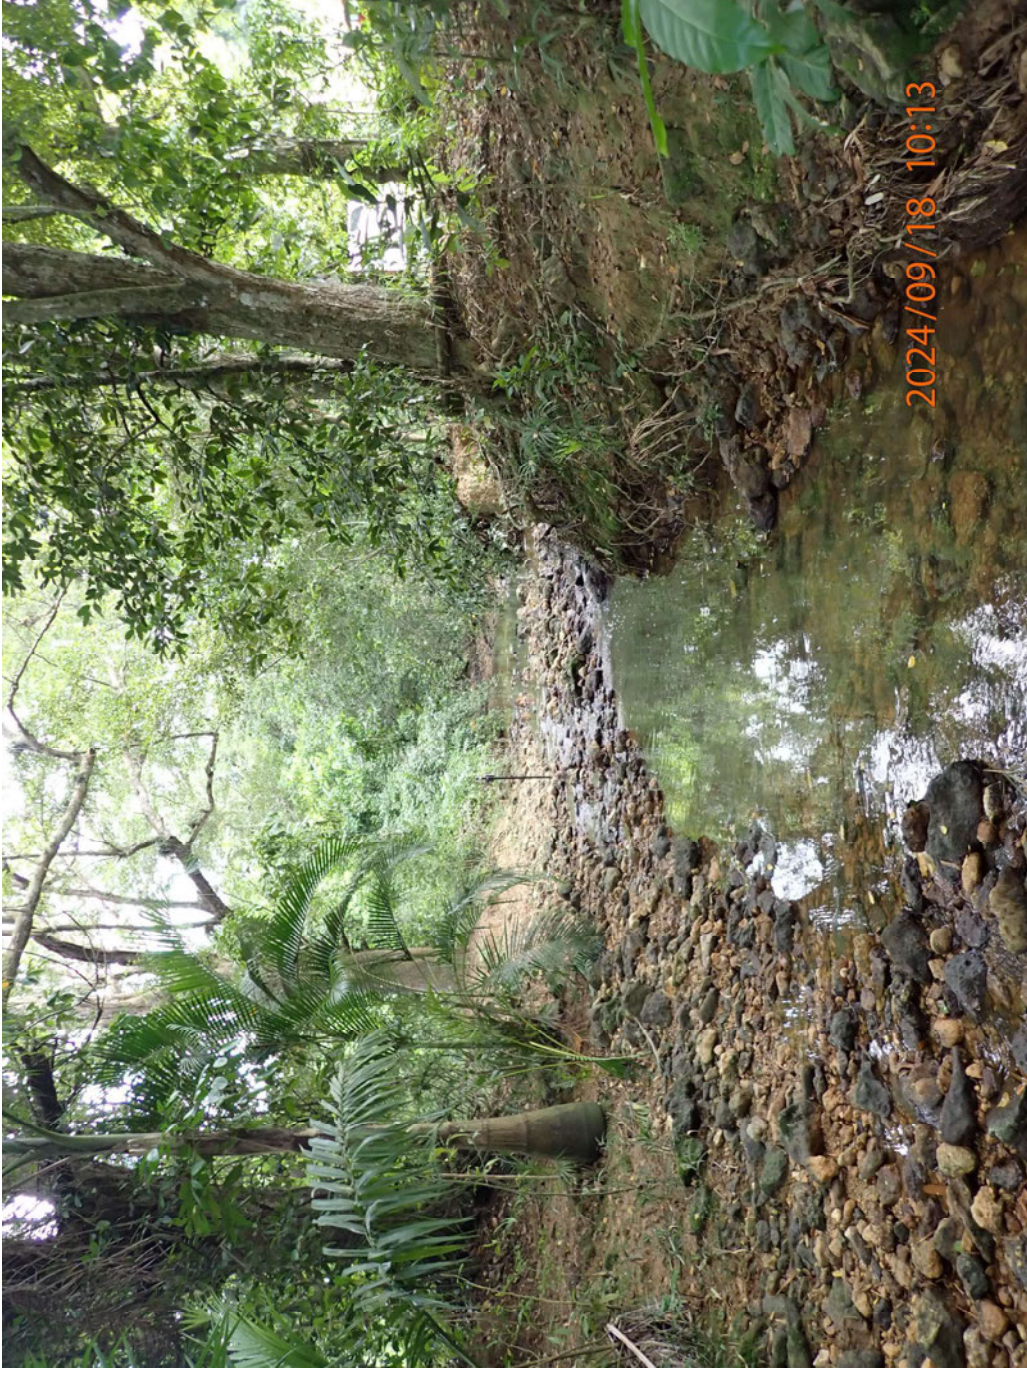
**Photo ID:** P9181140

**Description:** South to north view of fill material in stream bed of Quebrada Quilés.
