## Clean Water Act Section 404: Site Visit/Case Development

| Site Name | Greenwood 950, LLC-Walden Ferry Road | | | | |

## Appendix 1

### Photograph Log

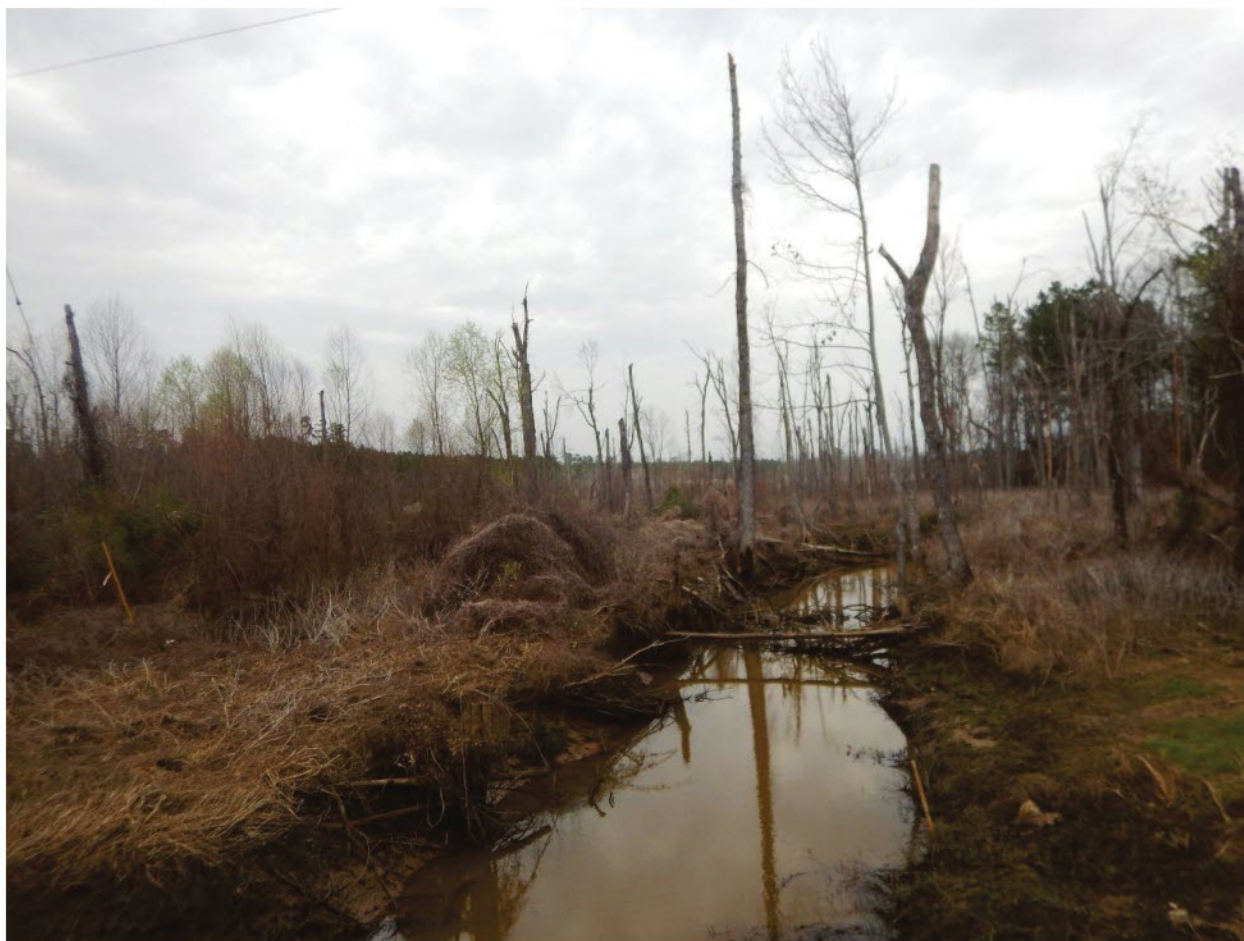
Photo No. 1

| Photo File Name | Date and Time of Photo | Photographer | Description |
|---|---|---|---|
| DSCN6300.JPG | 02/28/2024, 8:36 AM | Chelsey Sherwood | Showing stream channel and wetland area. Note the standing dead timber. Picture taken from road facing downstream, north. |

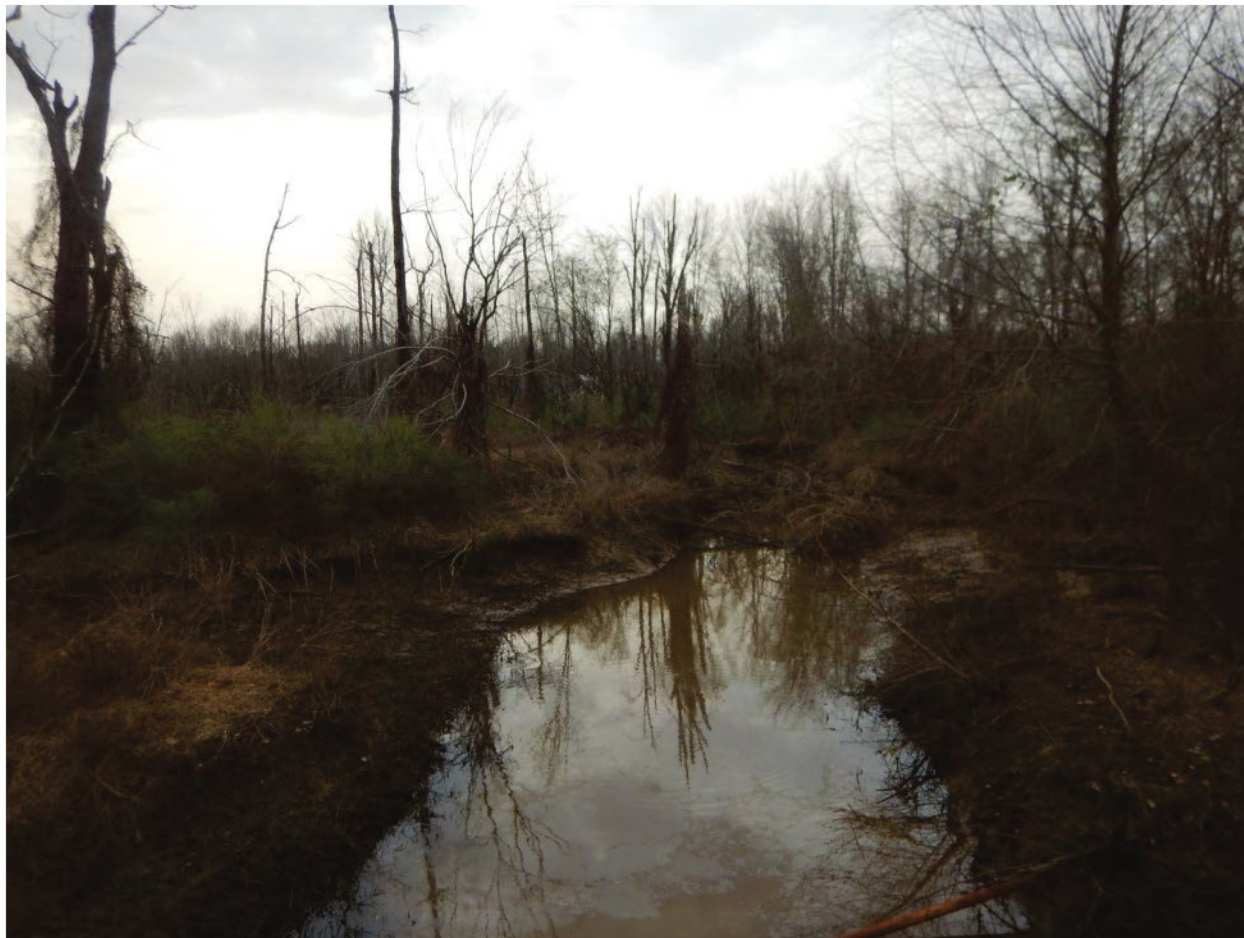
Photo No. 2

| Photo File Name | Date and Time of Photo | Photographer | Description |
|---|---|---|---|
| DSCN6301.JPG | 02/28/2024, 8:36 AM | Chelsey Sherwood | Showing stream channel and wetland area. Picture taken from road facing upstream, south. |

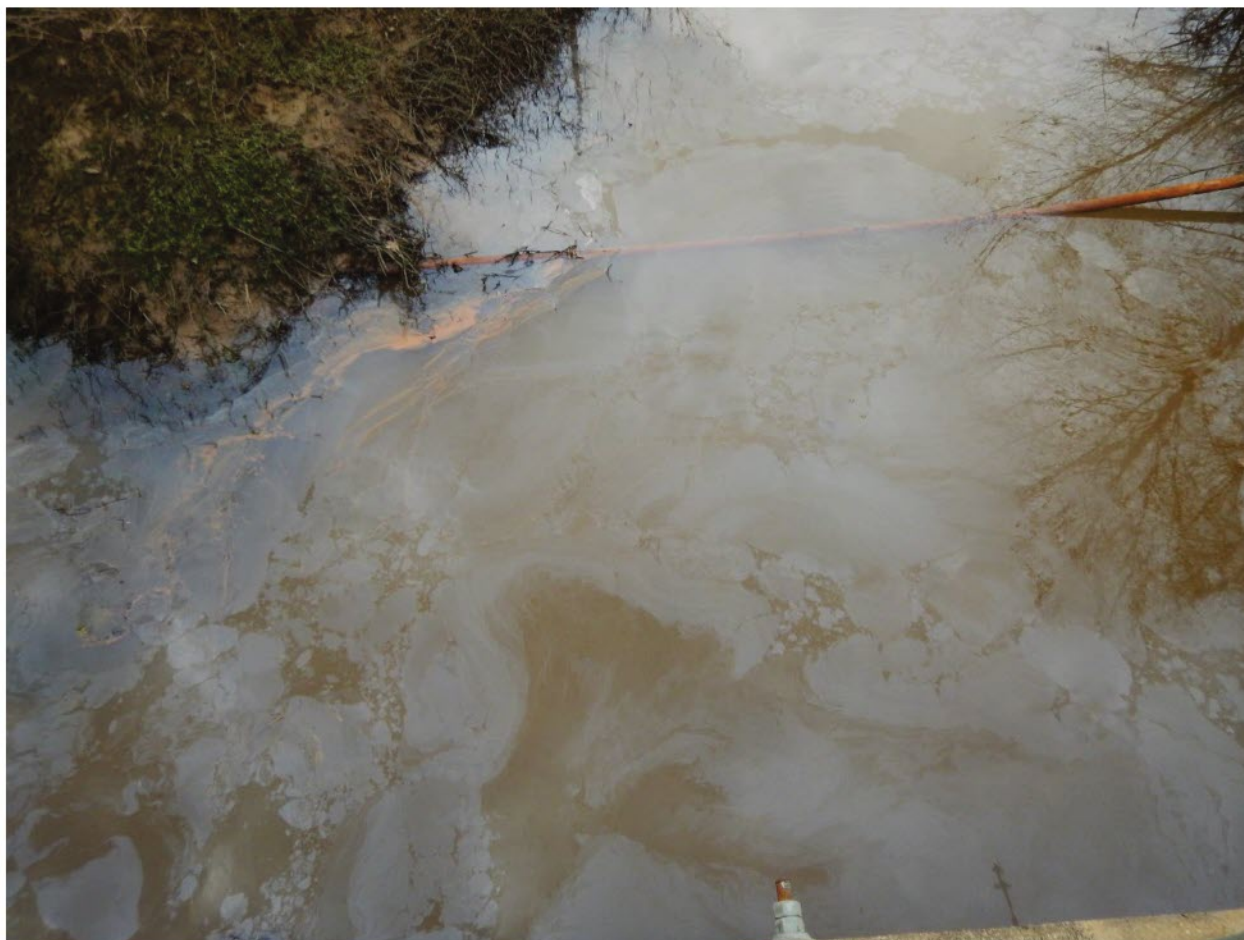
Photo No. 3

| Photo File Name | Date and Time of Photo | Photographer | Description |
|---|---|---|---|
| DSCN6302.JPG | 02/28/2024, 8:37 AM | Chelsey Sherwood | Showing the oil sheen in the stream. Picture taken from road facing upstream, south. |

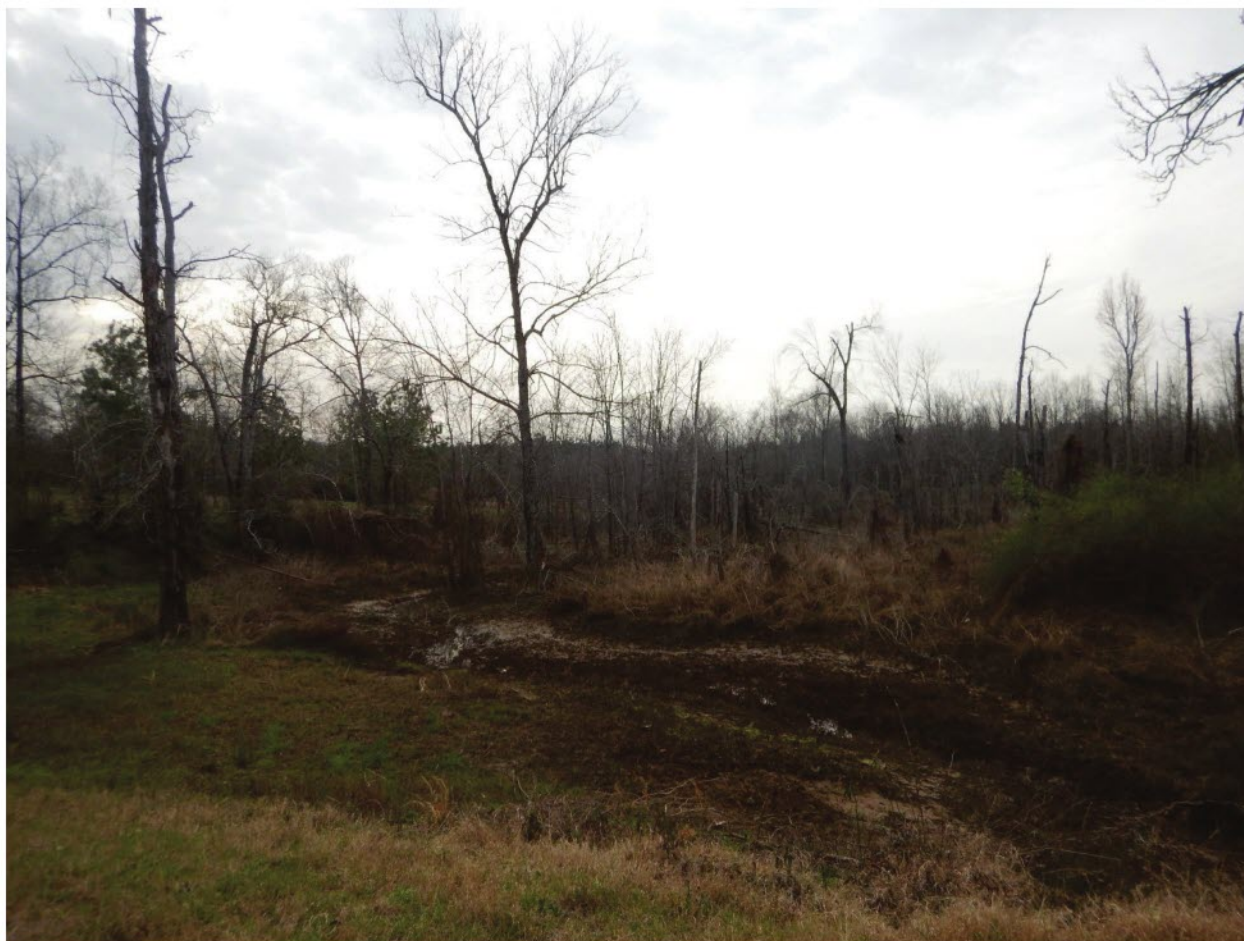
Photo No. 4

| Photo File Name | Date and Time of Photo | Photographer | Description |
|---|---|---|---|
| DSCN6303.JPG | 02/28/2024, 8:39 AM | Chelsey Sherwood | Showing stressed vegetation in wetland area. Picture taken facing southeast. |

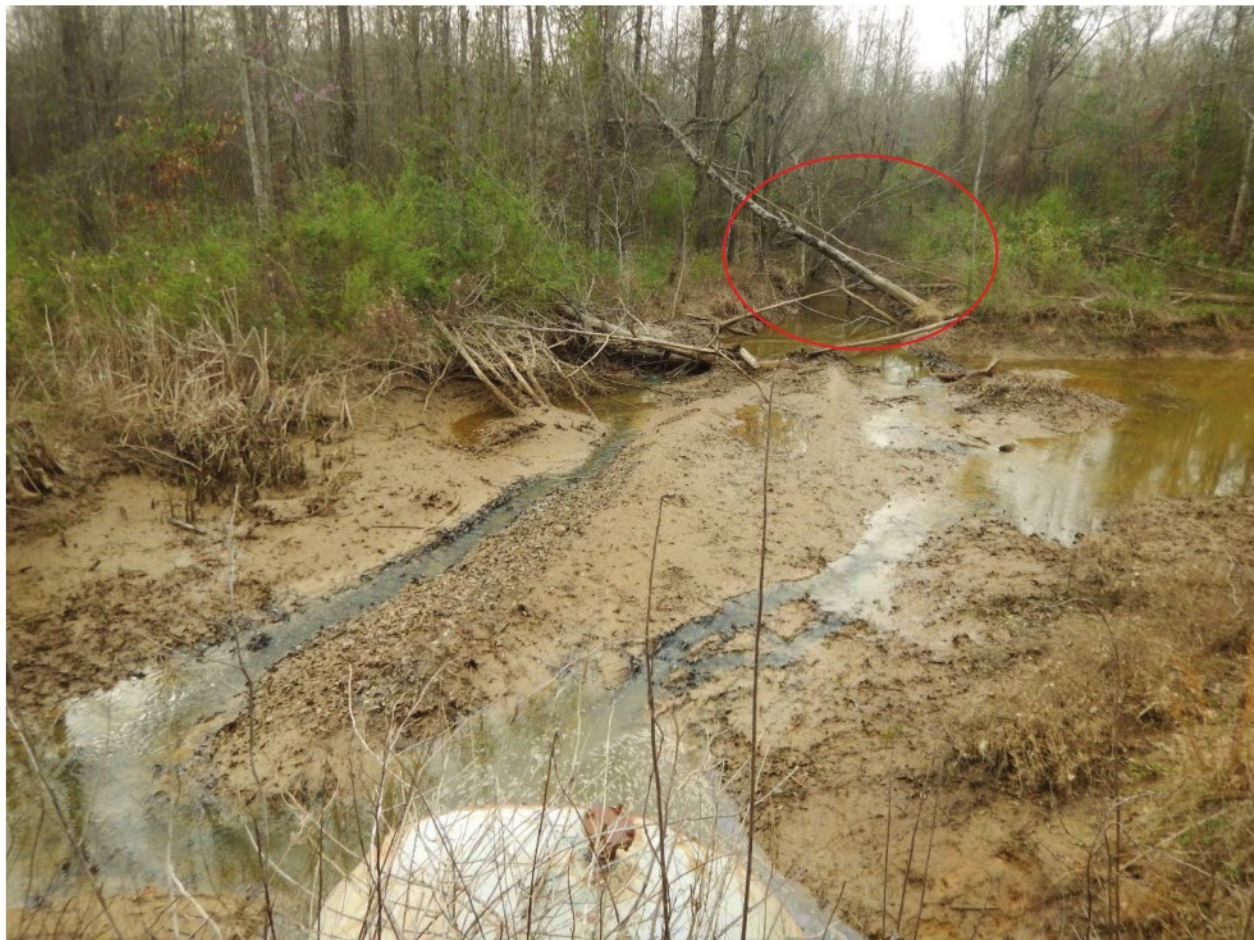
Photo No. 5

| Photo File Name | Date and Time of Photo | Photographer | Description |
|---|---|---|---|
| DSCN6304.JPG | 02/28/2024, 9:03 AM | Chelsey Sherwood | Showing excavated stream channel. Original channel is circled in red. Note the excessive sediment deposition. Picture taken from the berm that was built facing south, upstream. |

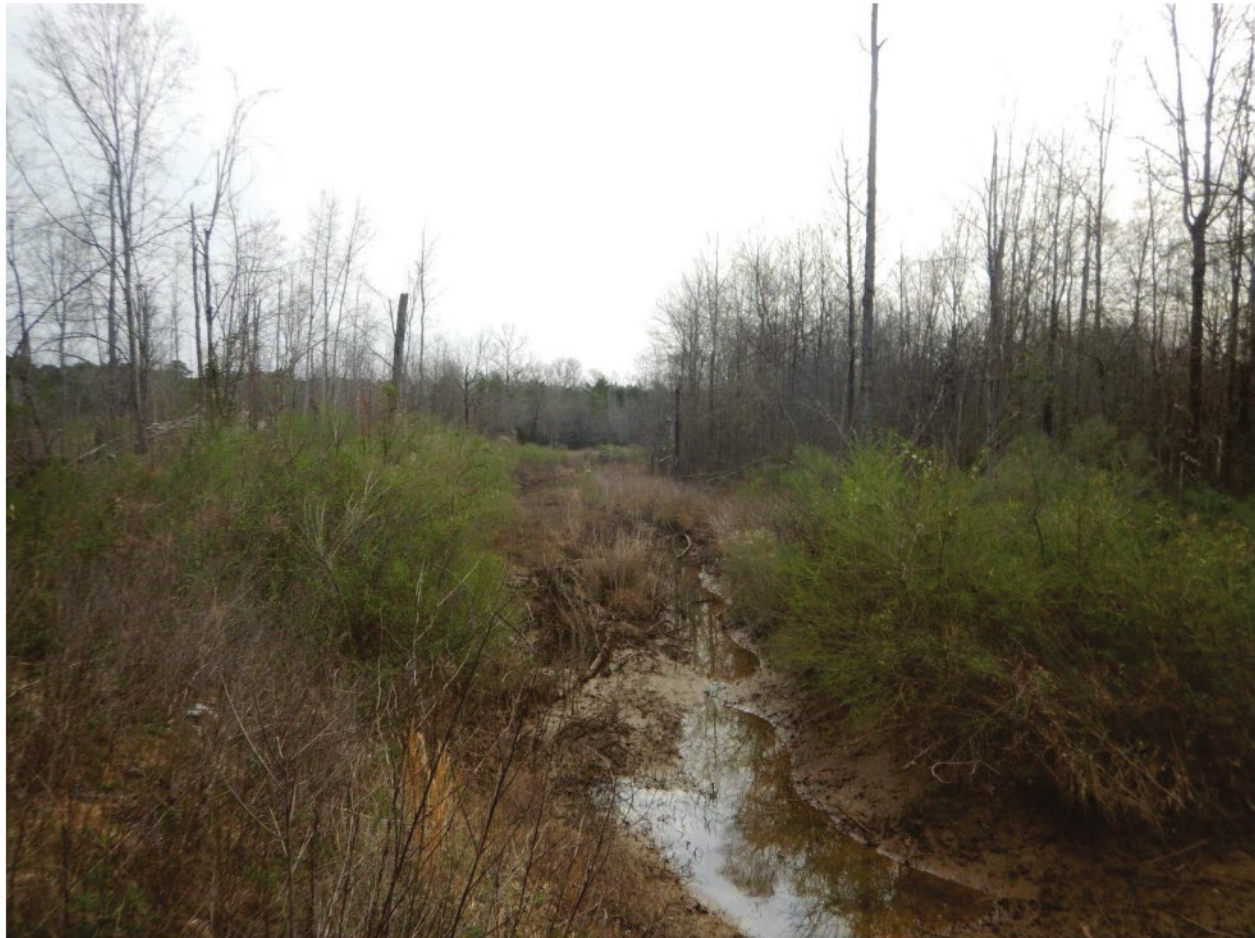
Photo No. 6

| Photo File Name | Date and Time of Photo | Photographer | Description |
|---|---|---|---|
| DSCN6305.JPG | 02/28/2024, 9:04 AM | Chelsey Sherwood | Showing excavated channel through stream and wetland area. Note the excessive sediment deposition. Picture taken facing east. |

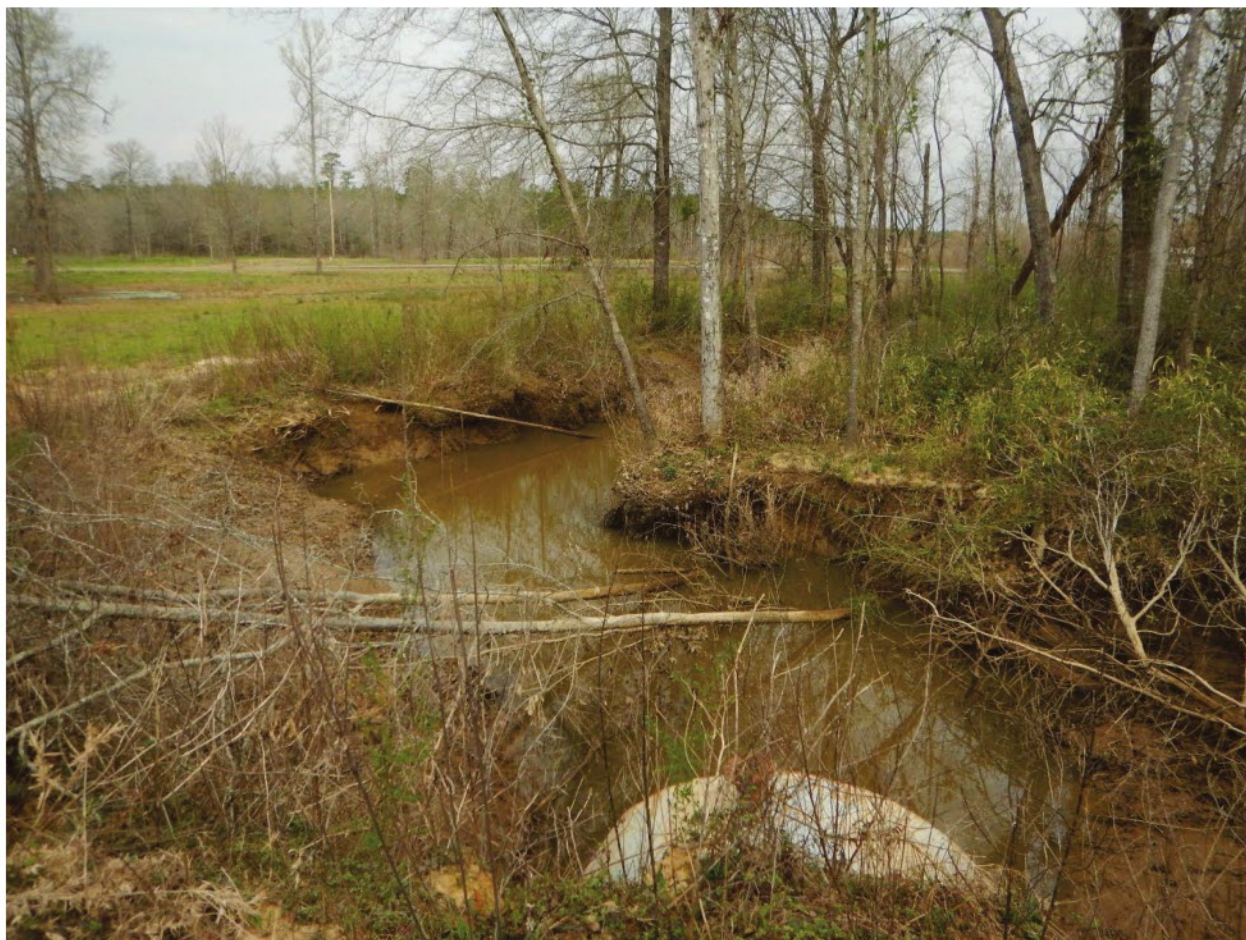
Photo No. 7

| Photo File Name | Date and Time of Photo | Photographer | Description |
|---|---|---|---|
| DSCN6306.JPG | 02/28/2024, 9:04 AM | Chelsey Sherwood | Showing stream channel that has been excavated and culverted. Picture taken facing north, downstream. |

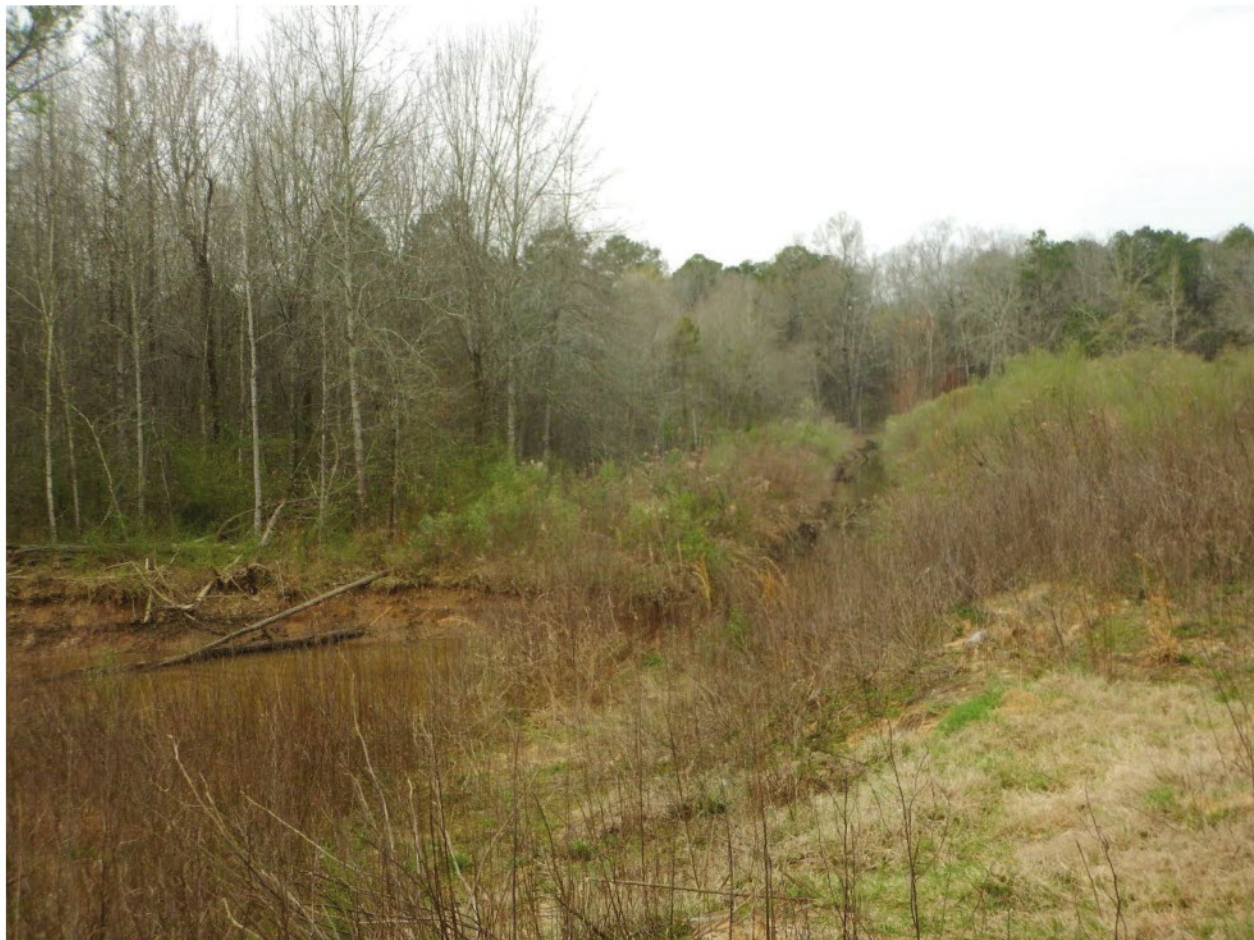
Photo No. 8

| Photo File Name | Date and Time of Photo | Photographer | Description |
|---|---|---|---|
| DSCN6307.JPG | 02/28/2024, 9:05 AM | Chelsey Sherwood | Showing excavated channel through stream and wetland area from on top of the berm built. Picture taken facing west. |

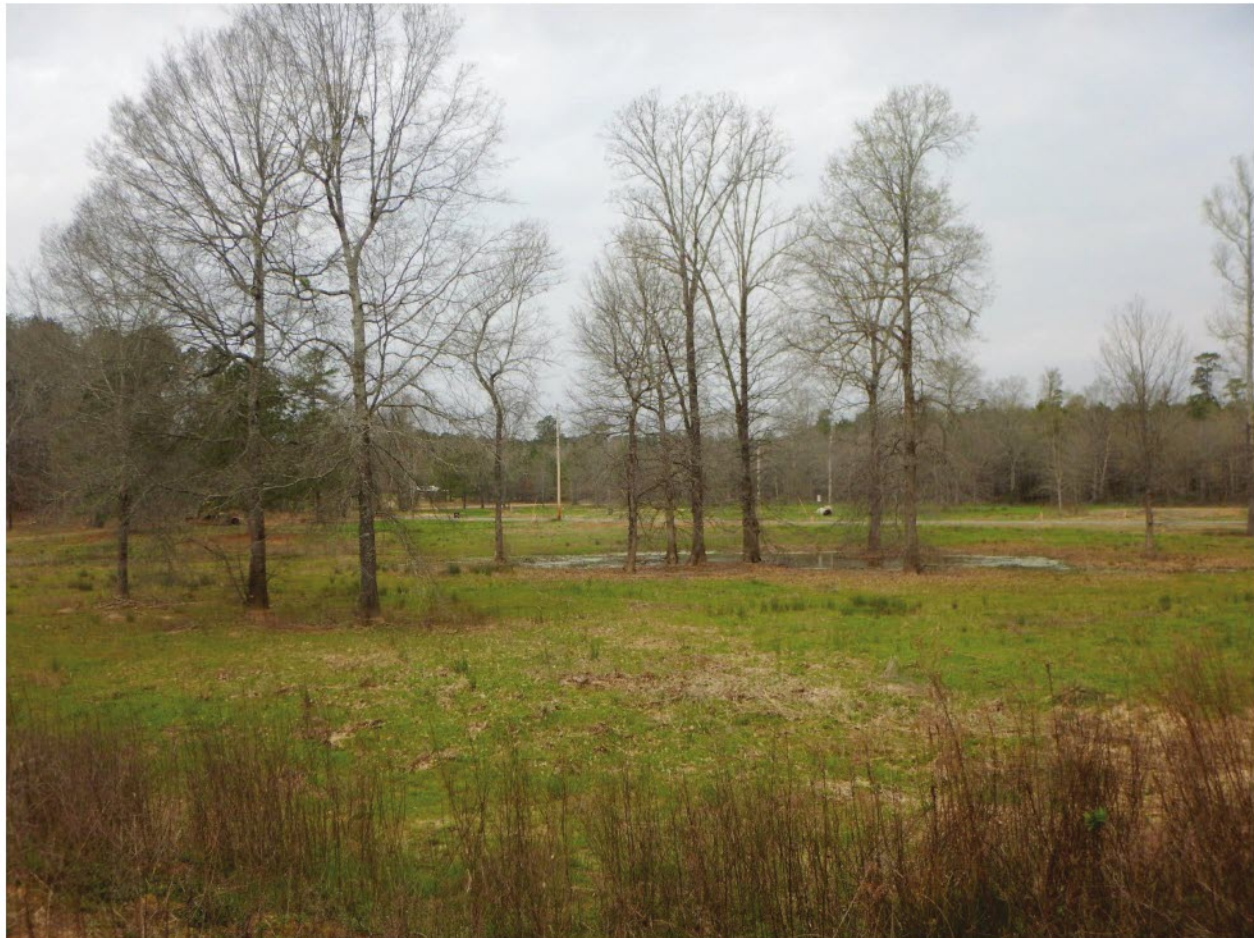
Photo No. 9

| Photo File Name | Date and Time of Photo | Photographer | Description |
|---|---|---|---|
| DSCN6308.JPG | 02/28/2024, 9:08 AM | Chelsey Sherwood | Showing wetland area. Note the water marks and sediment on trees and <i>Juncus</i> . Picture taken facing northwest from on top of berm. |

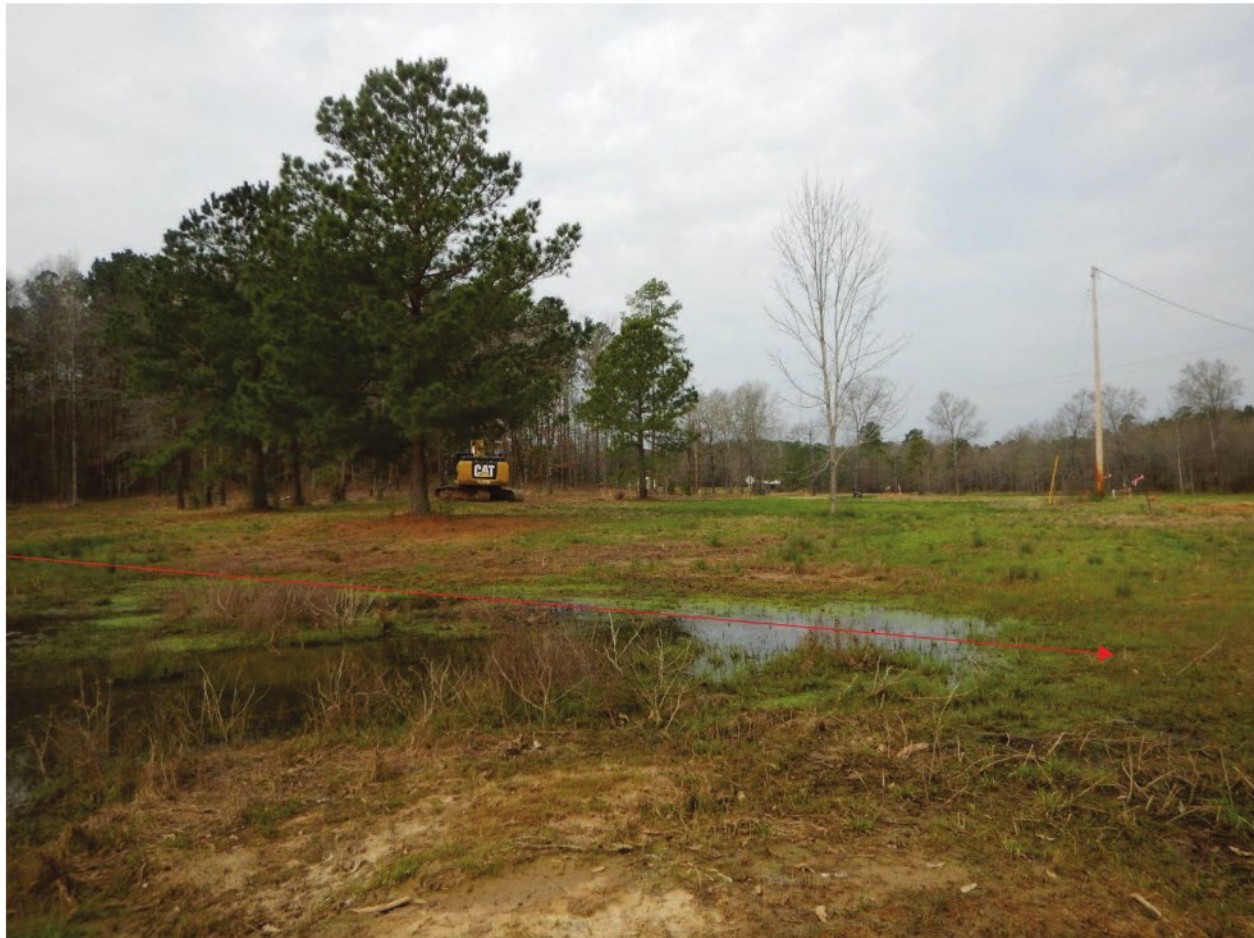
Photo No. 10

| Photo File Name | Date and Time of Photo | Photographer | Description |
|---|---|---|---|
| DSCN6309.JPG | 02/28/2024, 9:11 AM | Chelsey Sherwood | Showing wetland area. Note there originally was a stream channel in this area indicated by red arrow. Picture taken facing west. |

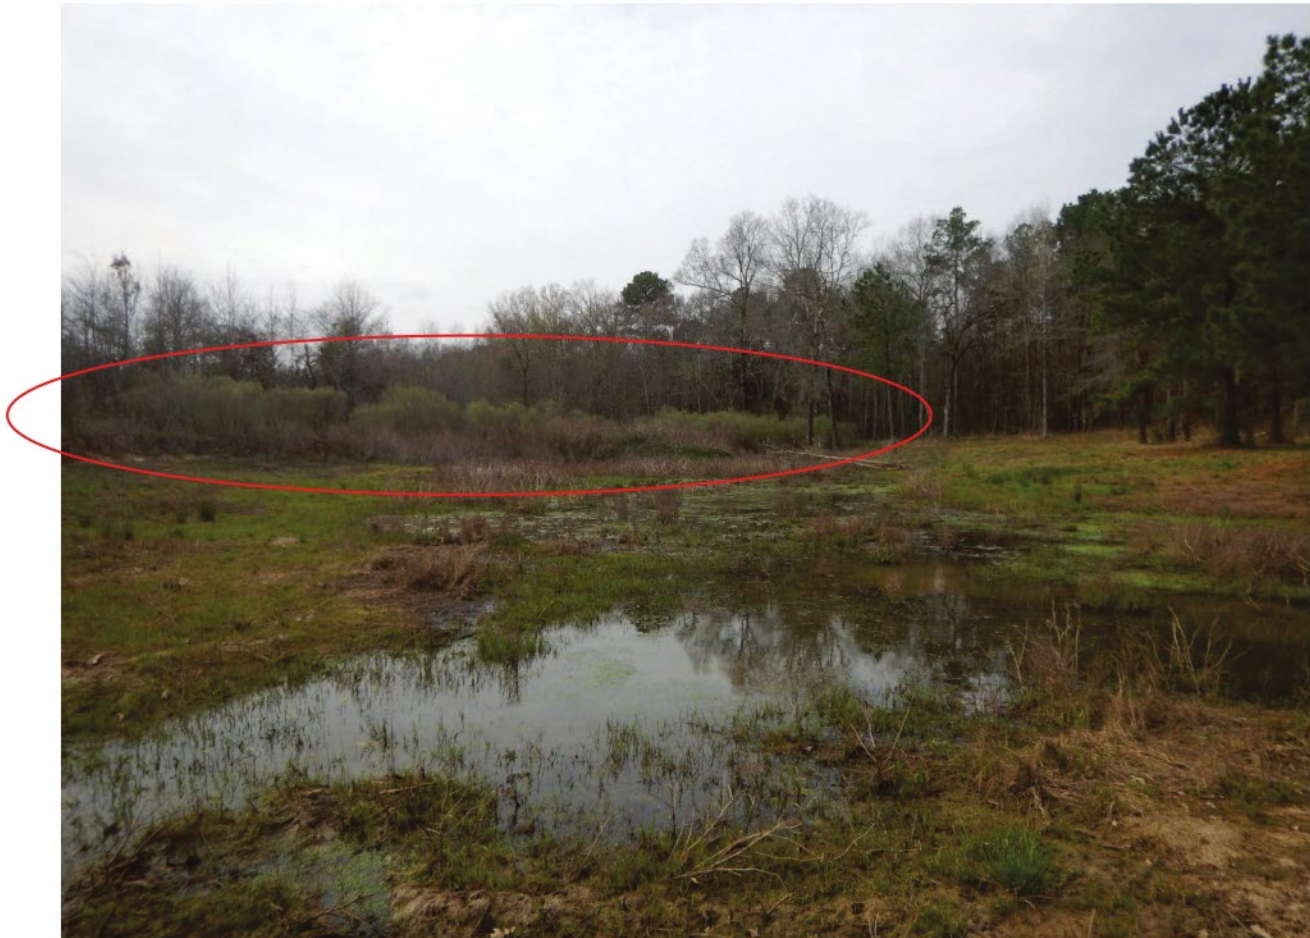
Photo No. 11

| Photo File Name | Date and Time of Photo | Photographer | Description |
|---|---|---|---|
| DSCN6310.JPG | 02/28/2024, 9:12 AM | Chelsey Sherwood | Showing wetland area and berm that was built (circled in red) through the wetland and stream severing connection. Picture taken facing southwest. |

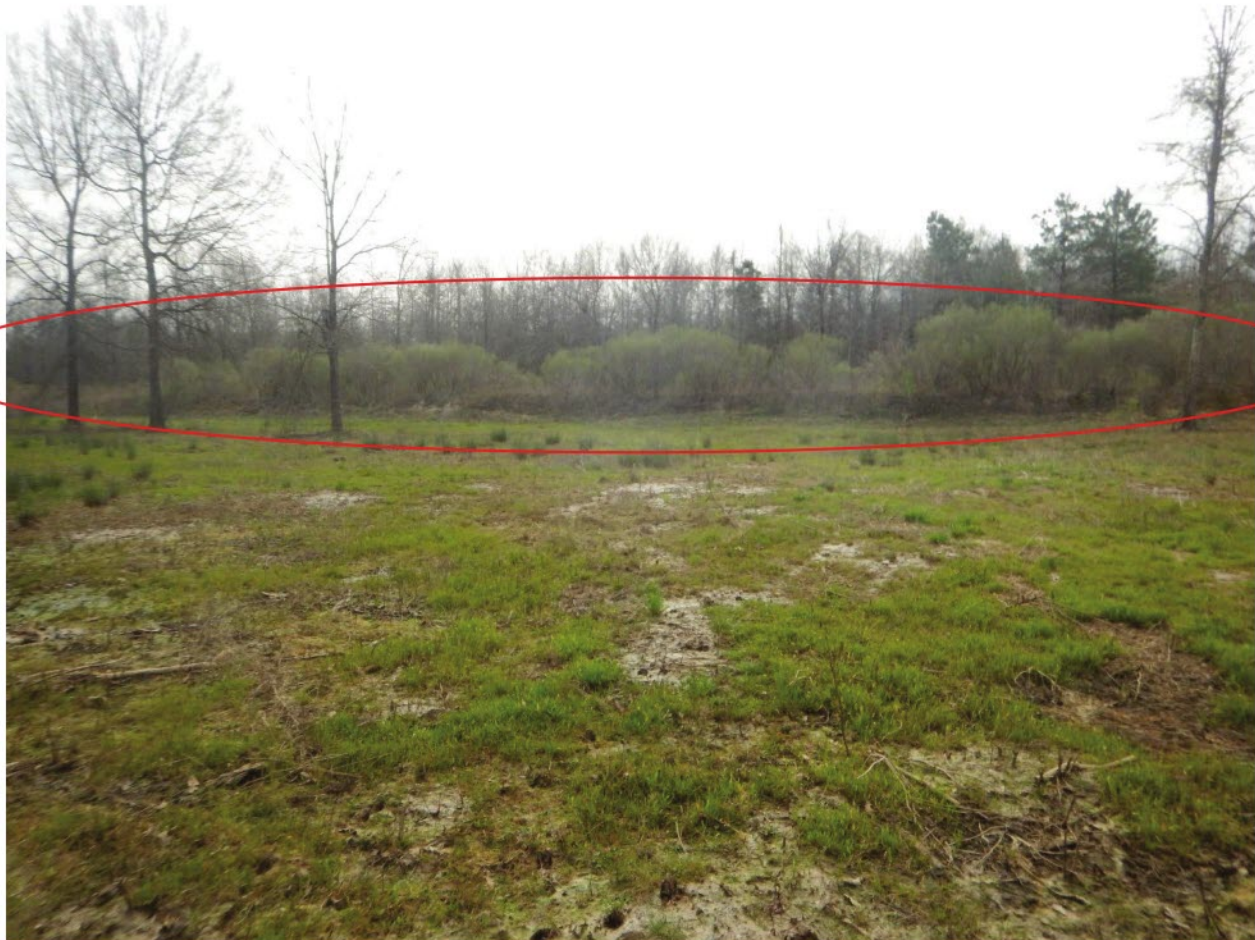
Photo No. 12

| Photo File Name | Date and Time of Photo | Photographer | Description |
|---|---|---|---|
| DSCN6311.JPG | 02/28/2024, 9:12 AM | Chelsey Sherwood | Showing wetland area and berm that was built (circled in red) through the wetland and stream severing connection. Picture taken facing south. |

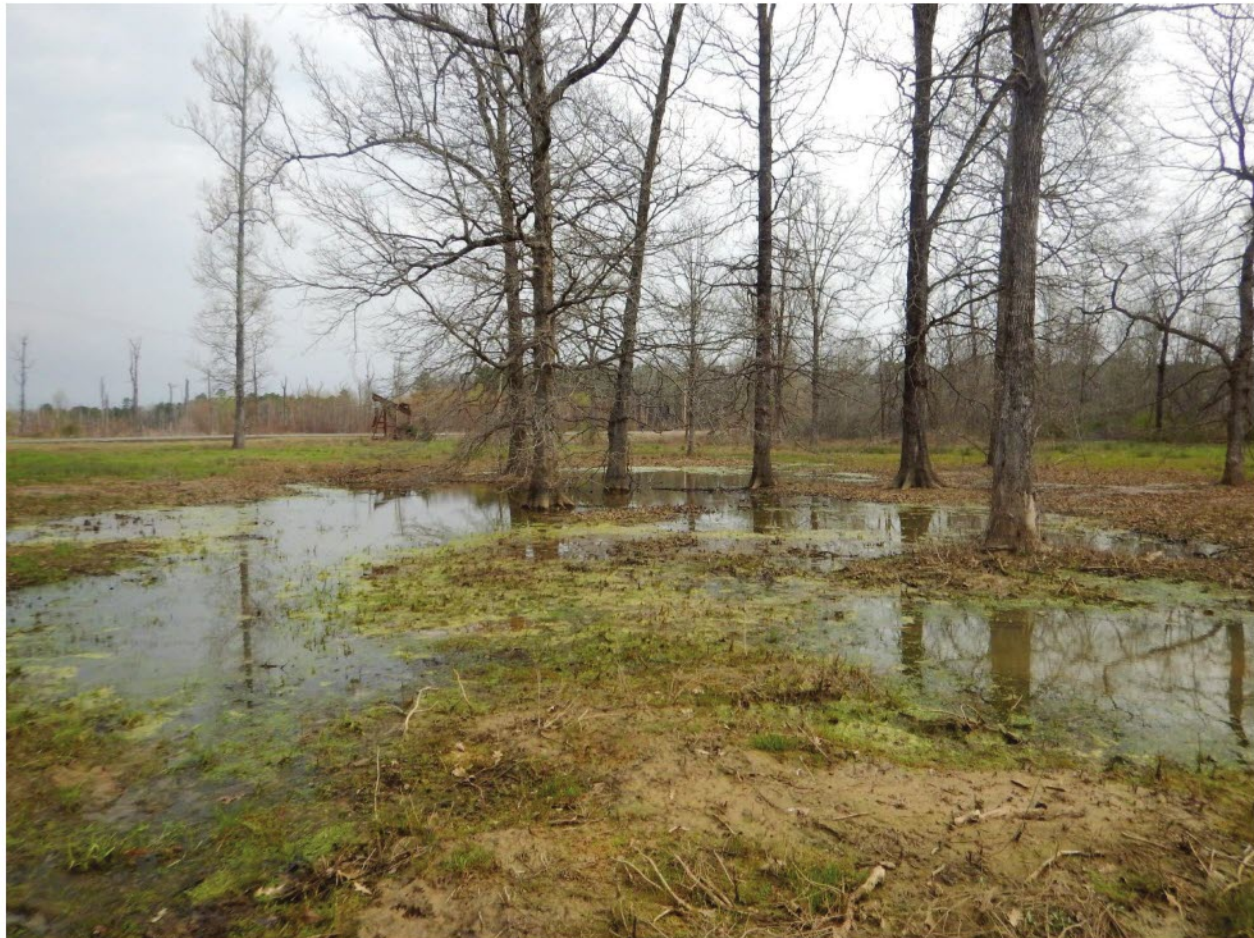
Photo No. 13

| Photo File Name | Date and Time of Photo | Photographer | Description |
|---|---|---|---|
| DSCN6312.JPG | 02/28/2024, 9:12 AM | Chelsey Sherwood | Showing wetland area. Note water lines on trees and sediment deposition. Picture taken facing northeast. |

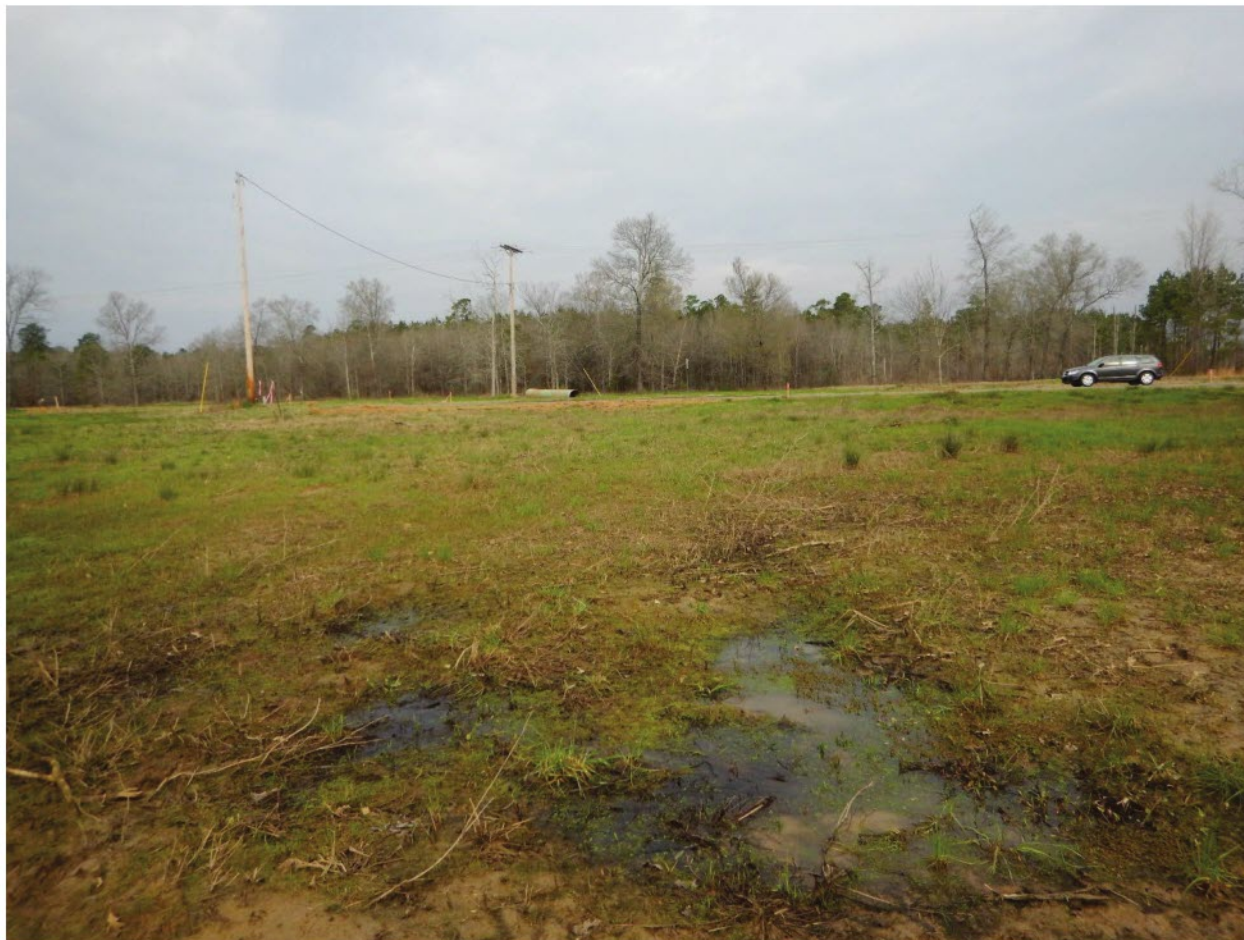
Photo No. 14

| Photo File Name | Date and Time of Photo | Photographer | Description |
|---|---|---|---|
| DSCN6313.JPG | 02/28/2024, 9:13 AM | Chelsey Sherwood | Showing wetland area and where originally there was a stream. Picture taken facing north. |

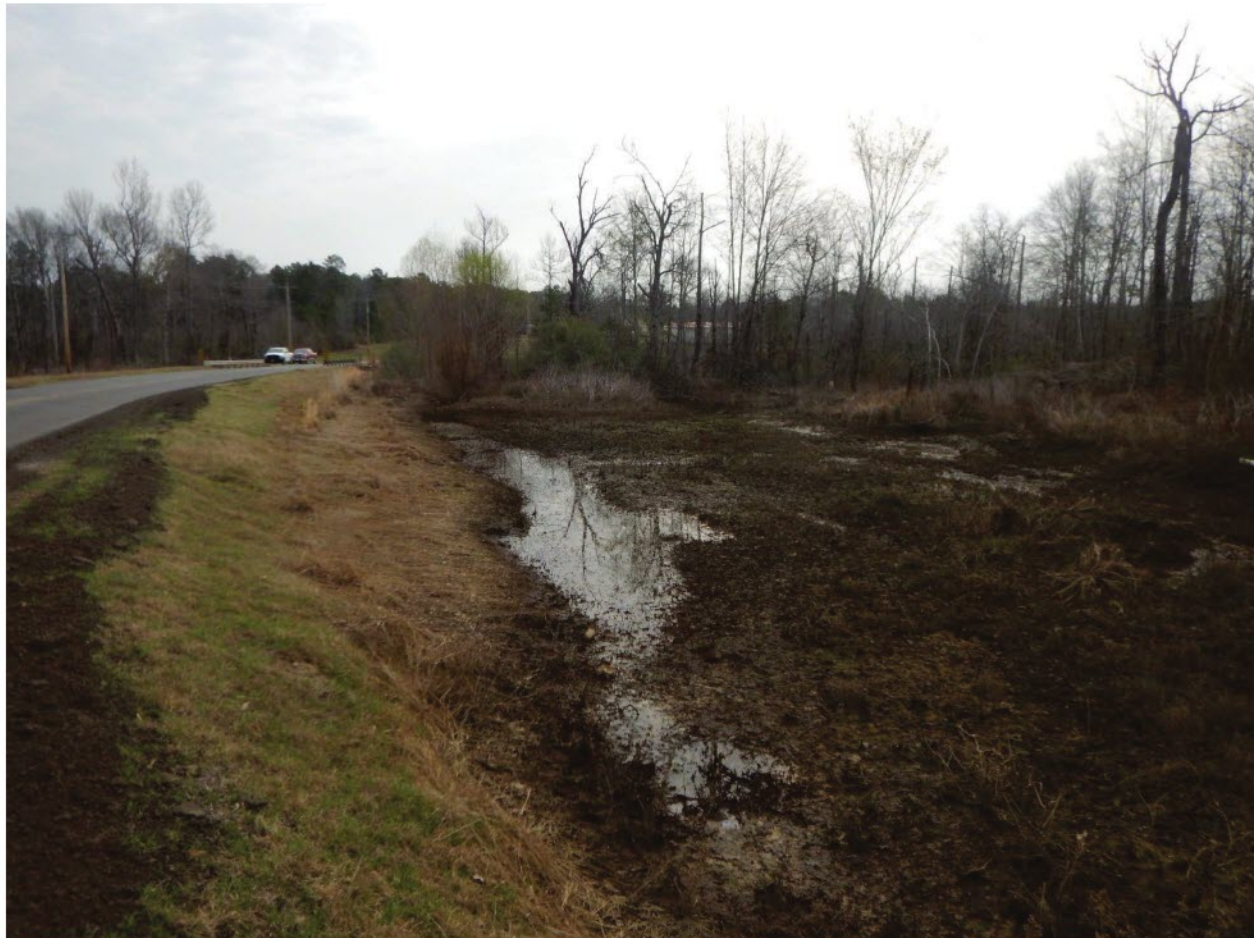
Photo No. 15

| Photo File Name | Date and Time of Photo | Photographer | Description |
|---|---|---|---|
| DSCN6314.JPG | 02/28/2024, 9:17 AM | Chelsey Sherwood | Showing stream and wetland area. Picture taken facing east, downstream. |

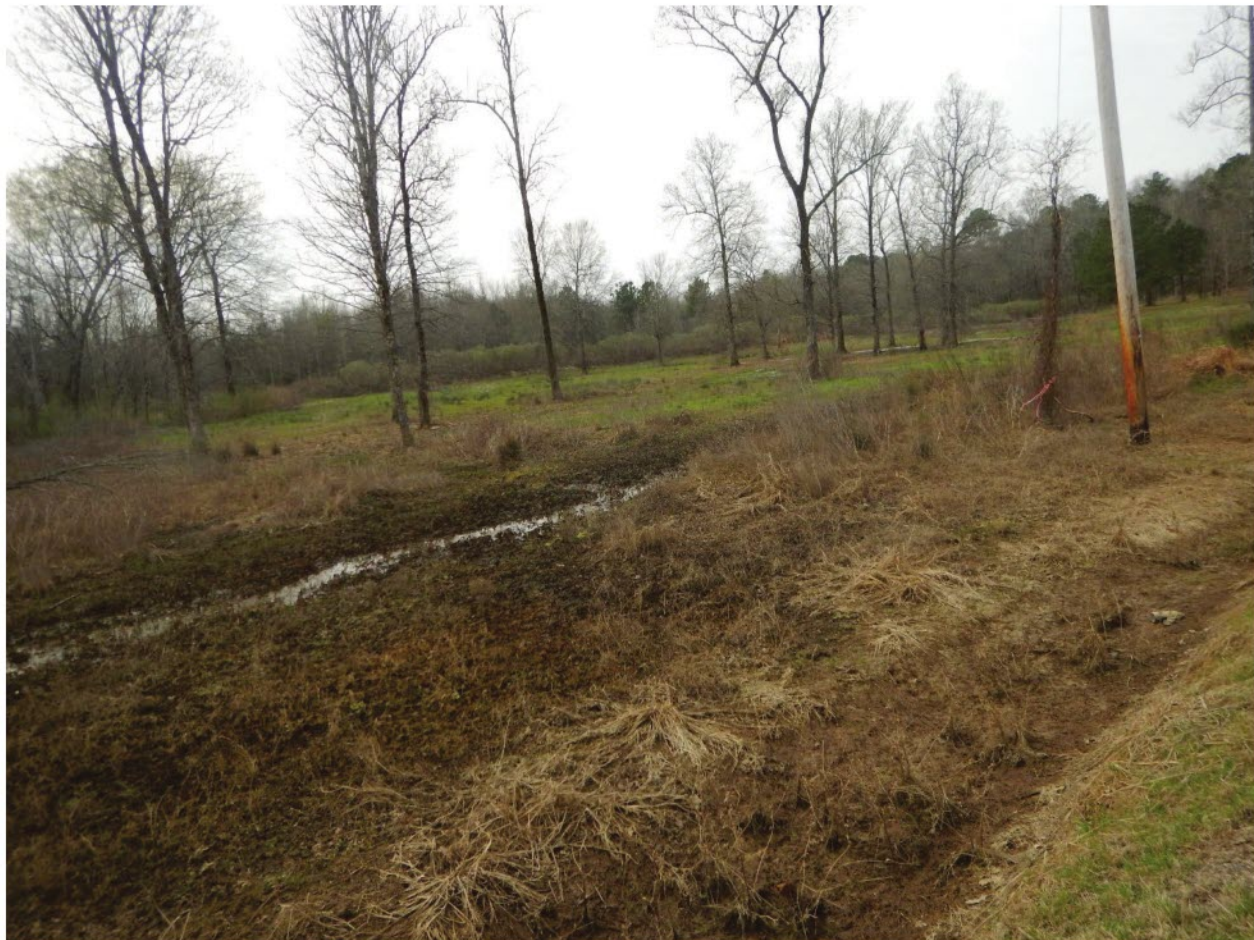
Photo No. 16

| Photo File Name | Date and Time of Photo | Photographer | Description |
|---|---|---|---|
| DSCN6315.JPG | 02/28/2024, 9:18 AM | Chelsey Sherwood | Showing wetland area and where there appeared to have been a stream channel south of the road. Picture taken facing southwest. |

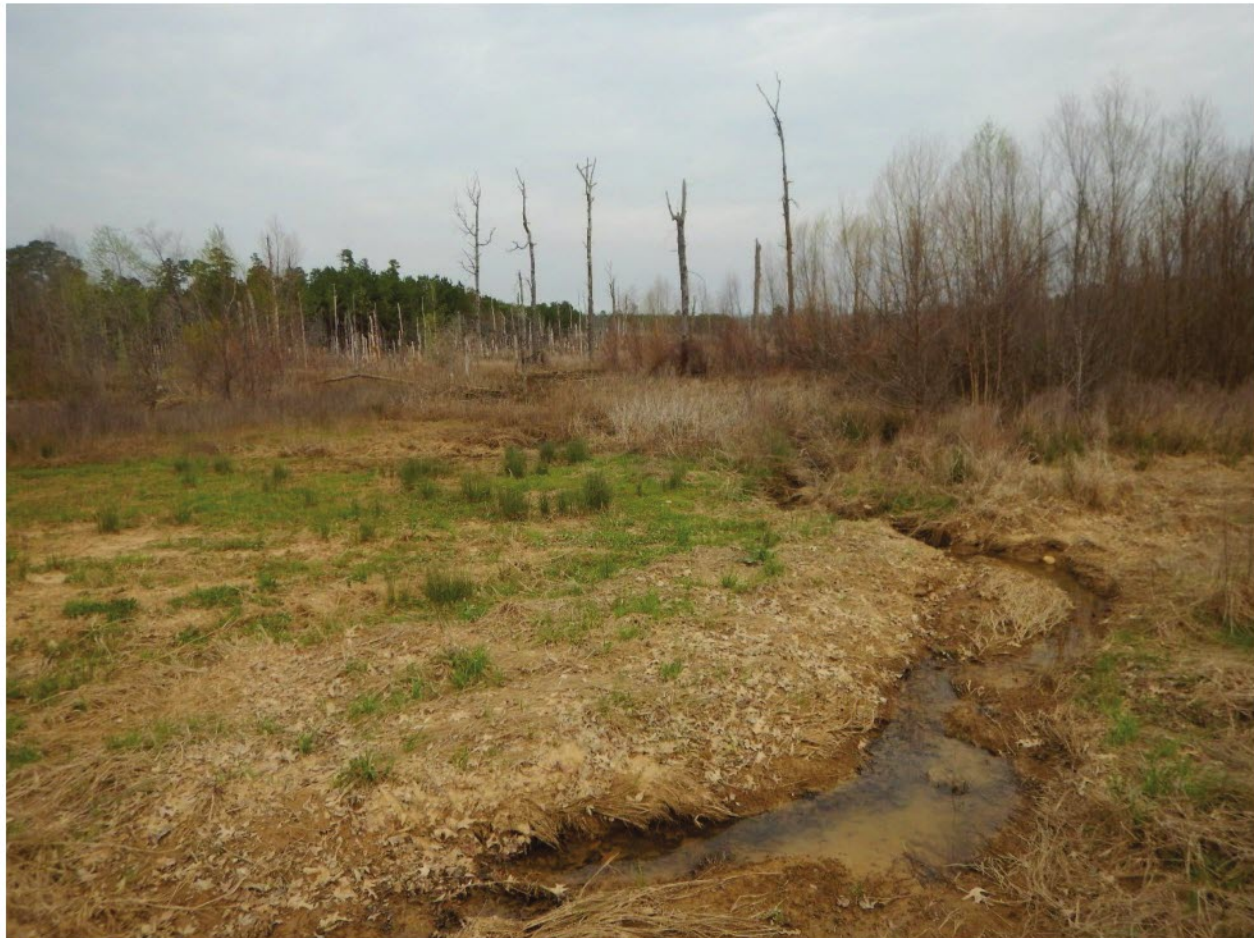
Photo No. 17

| Photo File Name | Date and Time of Photo | Photographer | Description |
|---|---|---|---|
| DSCN6316.JPG | 02/28/2024, 9:19 AM | Chelsey Sherwood | Showing wetland area and stream channel north of the road. Picture taken facing north, downstream. |

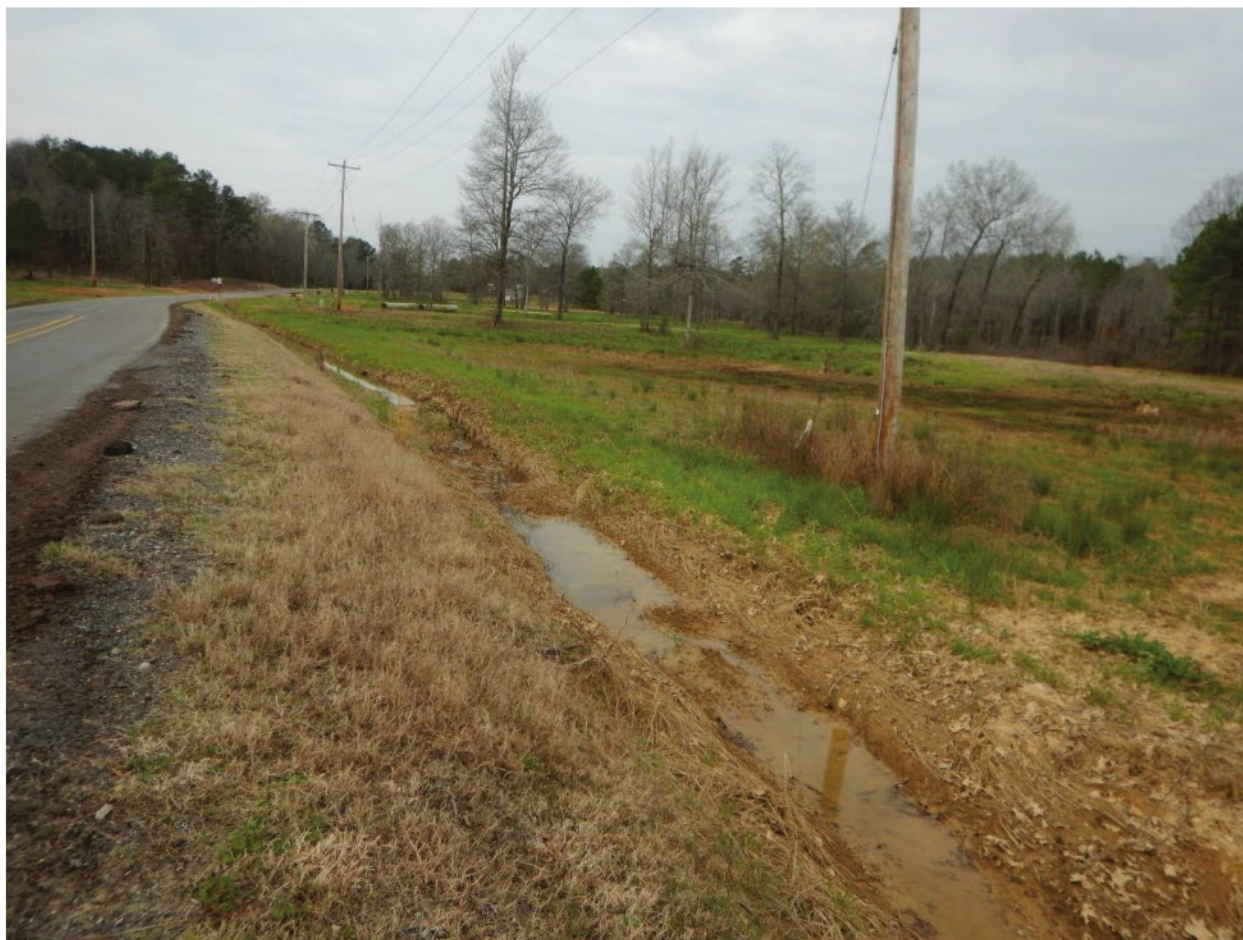
Photo No. 18

| Photo File Name | Date and Time of Photo | Photographer | Description |
|---|---|---|---|
| DSCN6317.JPG | 02/28/2024, 9:19 AM | Chelsey Sherwood | Showing wetland area and channel that parallels road. Note the sediment deposition. Picture taken facing west, upstream. |
