## Clean Water Act Section 404: Site Visit/Case Development

| Site Name | Greenwood 950, LLC-Walden Ferry Road | | | | |

## Appendix 1

### Photograph Log

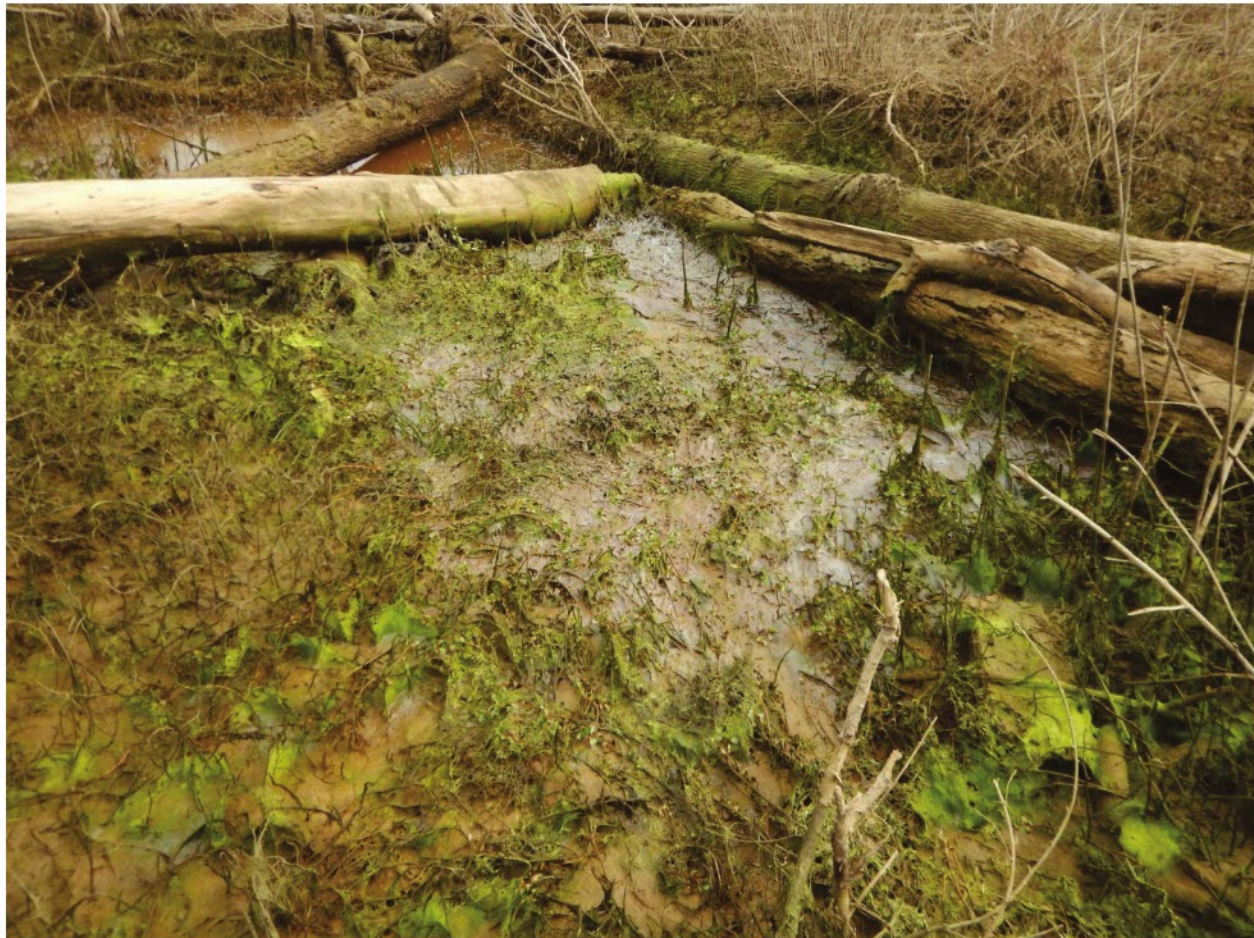
Photo No. 19

| Photo File Name | Date and Time of Photo | Photographer | Description |
|---|---|---|---|
| DSCN6318.JPG | 02/28/2024, 9:22 AM | Chelsey Sherwood | Showing filamentous algae, orange-colored sediments, and sheen in wetland. |

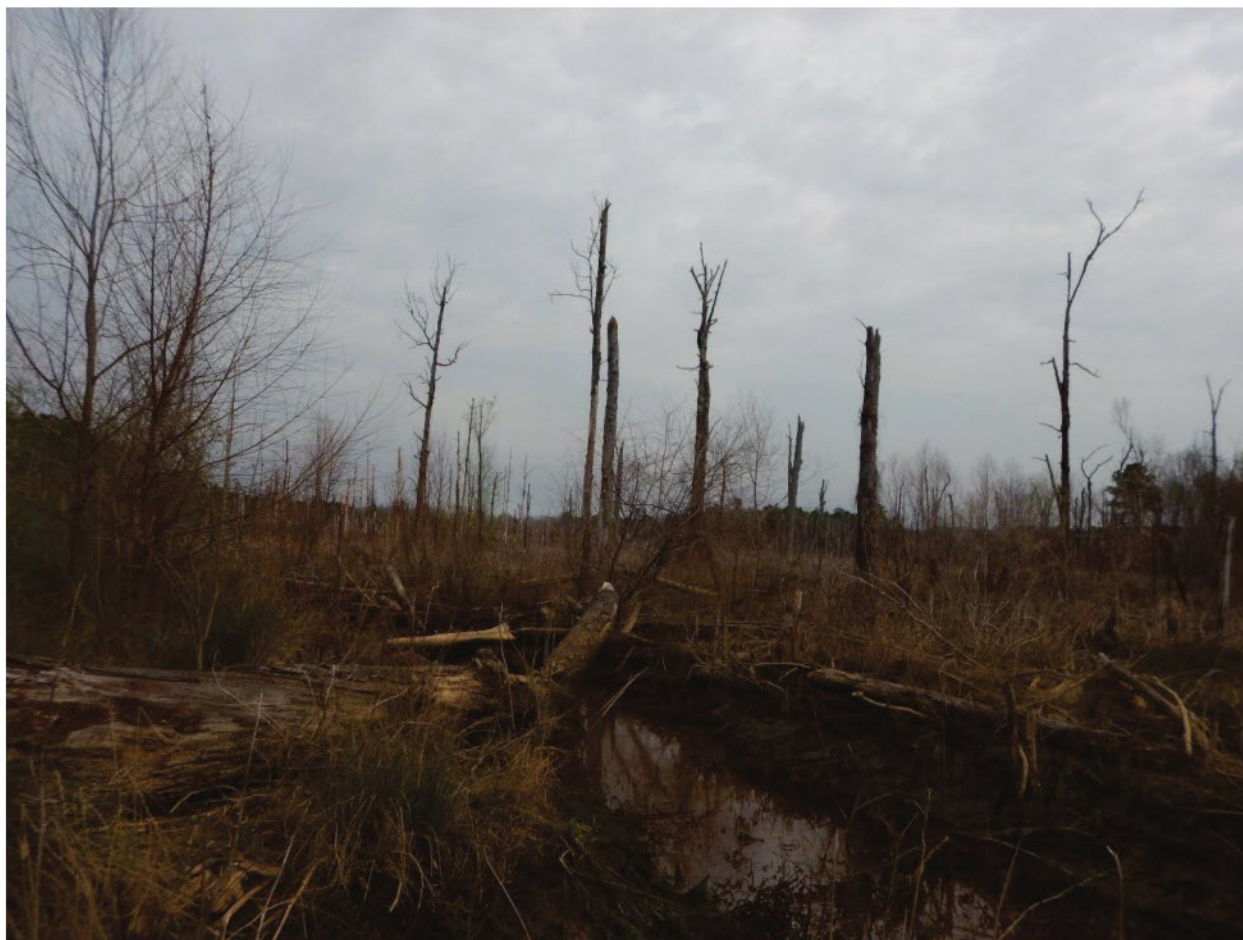
Photo No. 20

| Photo File Name | Date and Time of Photo | Photographer | Description |
|---|---|---|---|
| DSCN6319.JPG | 02/28/2024, 9:24 AM | Chelsey Sherwood | Showing stressed vegetation in wetland area. Picture taken facing north. |

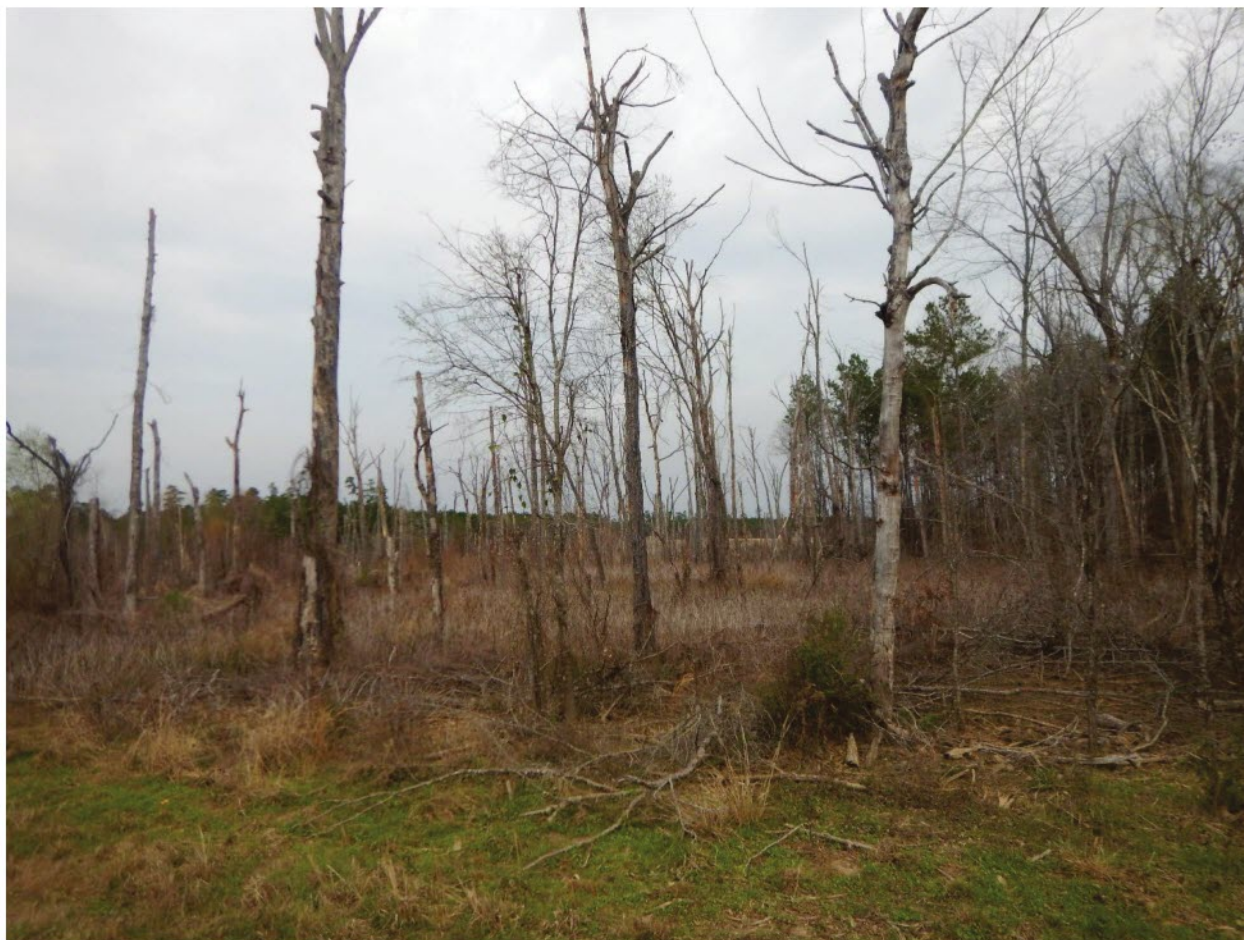
Photo No. 21

| Photo File Name | Date and Time of Photo | Photographer | Description |
|---|---|---|---|
| DSCN6320.JPG | 02/28/2024, 9:31 AM | Chelsey Sherwood | Showing wetland area and stressed vegetation. Picture taken facing northeast. |

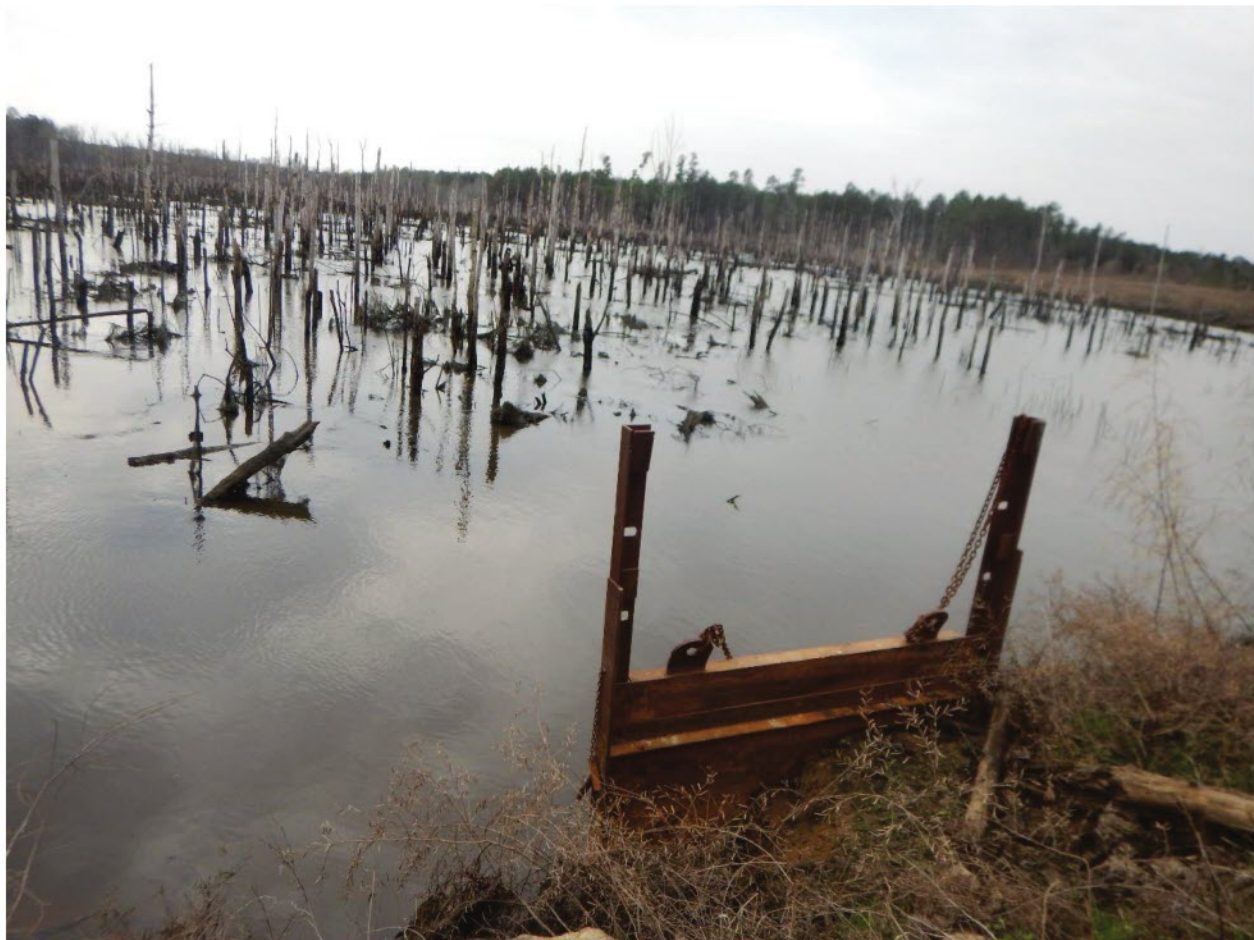
Photo No. 22

| Photo File Name | Date and Time of Photo | Photographer | Description |
|---|---|---|---|
| DSCN6321.JPG | 02/28/2024, 9:57 AM | Chelsey Sherwood | Showing flood control structure gate and the stream and wetland complex. Note the dead trees. Picture taken facing south. |

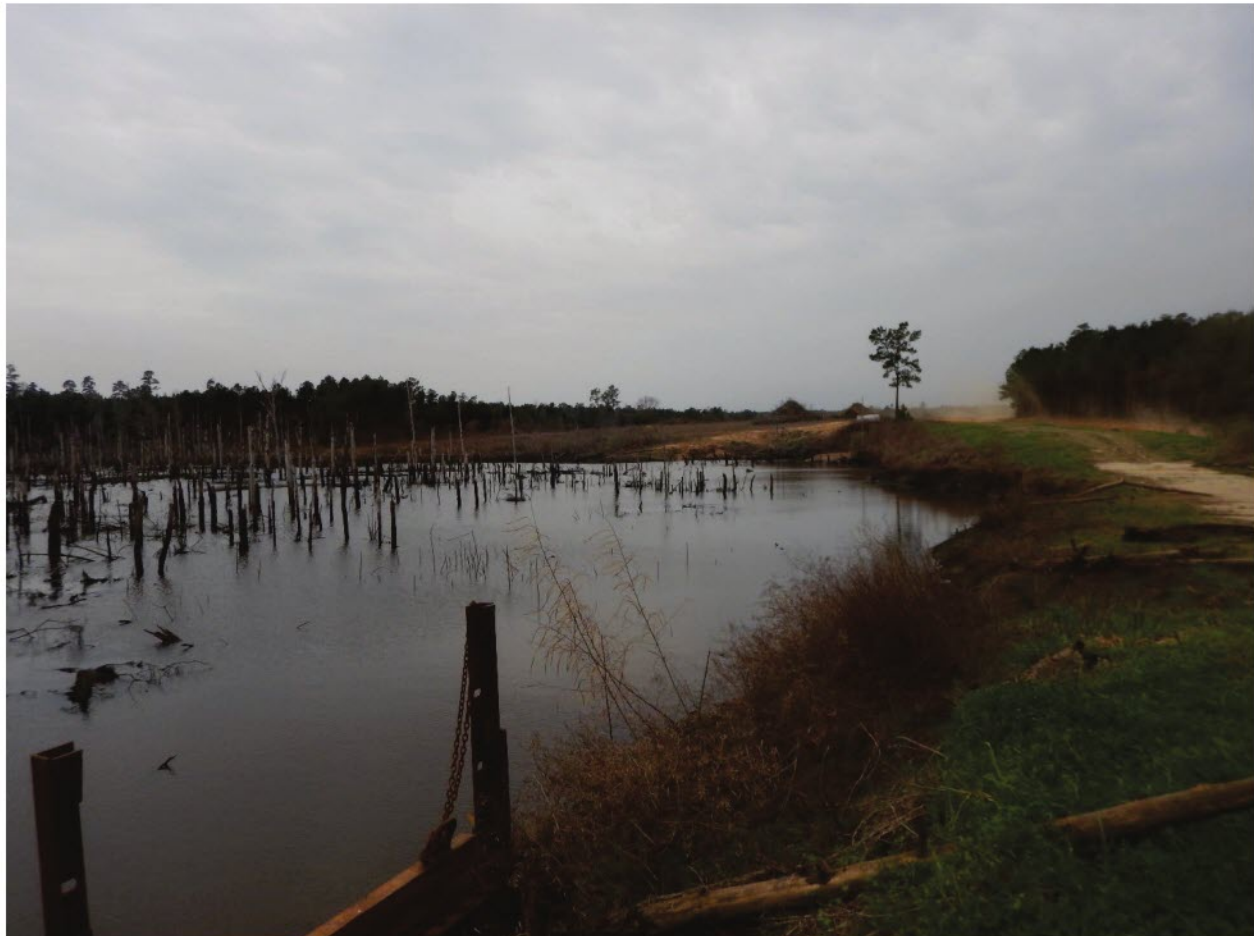
Photo No. 23

| Photo File Name | Date and Time of Photo | Photographer | Description |
|---|---|---|---|
| DSCN6322.JPG | 02/28/2024, 9:57 AM | Chelsey Sherwood | Showing flood control structure gate and the stream and wetland complex. Note the dead trees. Picture taken facing west. |

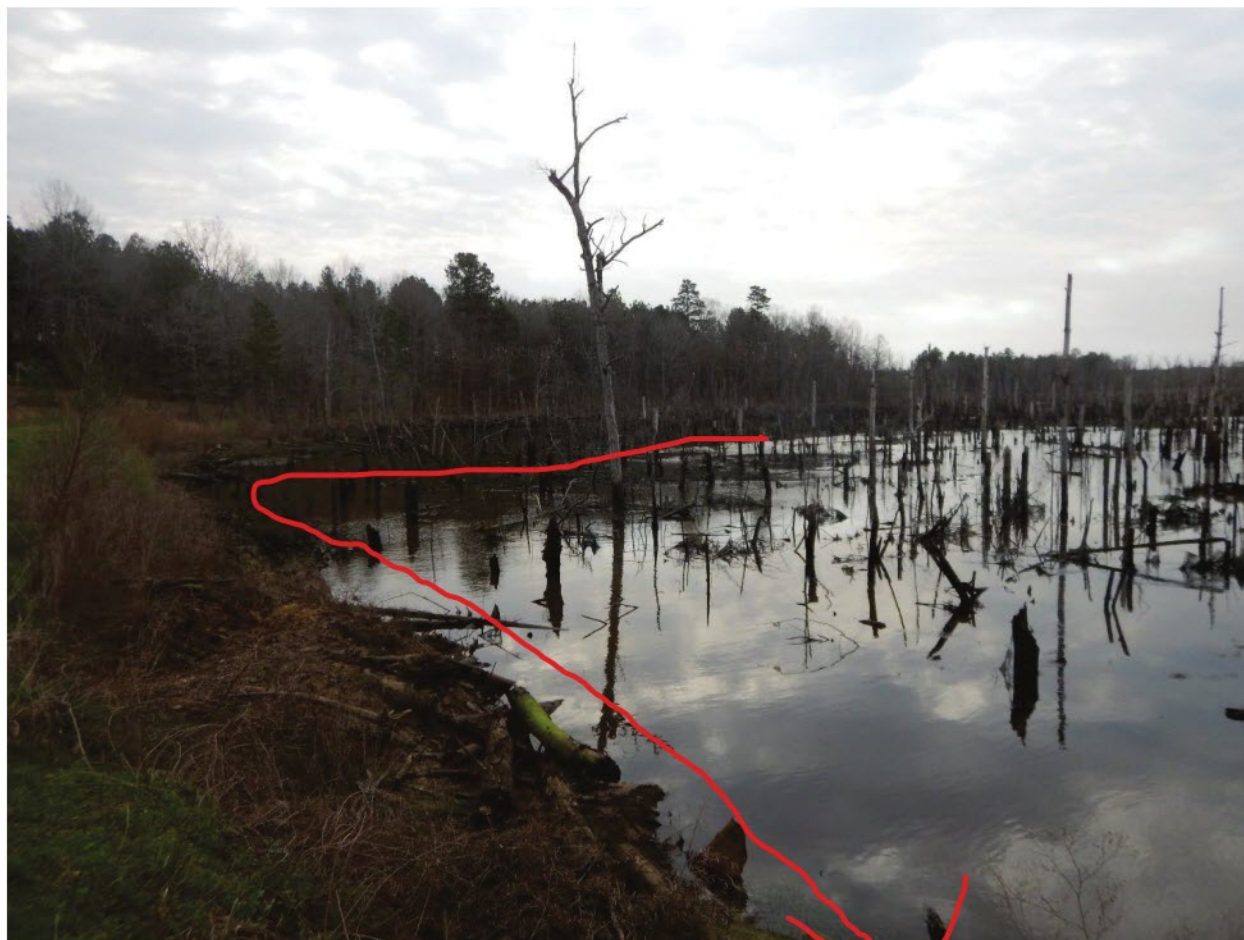
Photo No. 24

| Photo File Name | Date and Time of Photo | Photographer | Description |
|---|---|---|---|
| DSCN6323.JPG | 02/28/2024, 9:57 AM | Chelsey Sherwood | Showing stream and wetland complex. The red arrow shows approximate location of where stream channel flows. Note the dead trees. Picture taken facing east. |

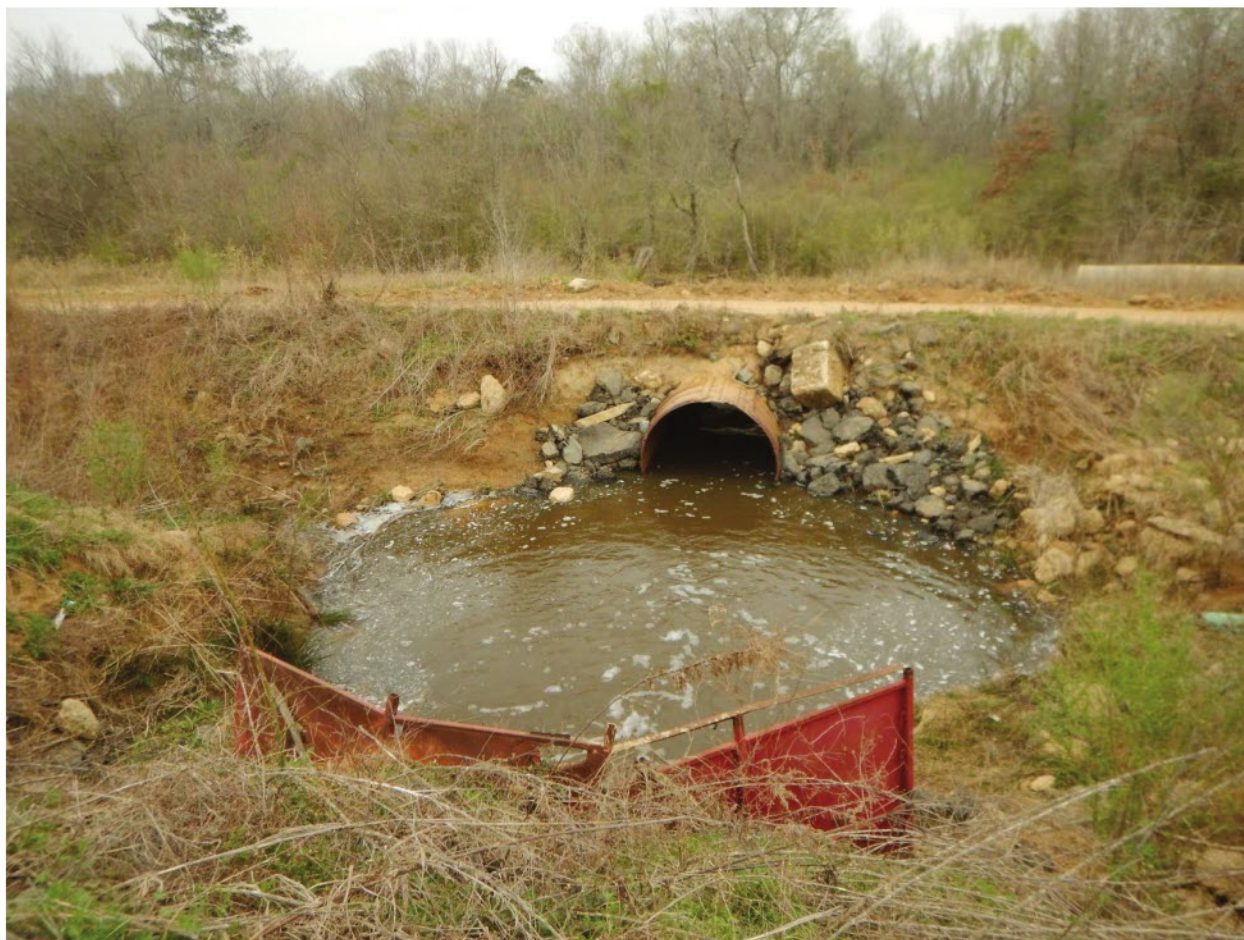
Photo No. 25

| Photo File Name | Date and Time of Photo | Photographer | Description |
|---|---|---|---|
| DSCN6324.JPG | 02/28/2024, 10:00 AM | Chelsey Sherwood | Showing flood control structure gate. Picture taken facing north, downstream. |

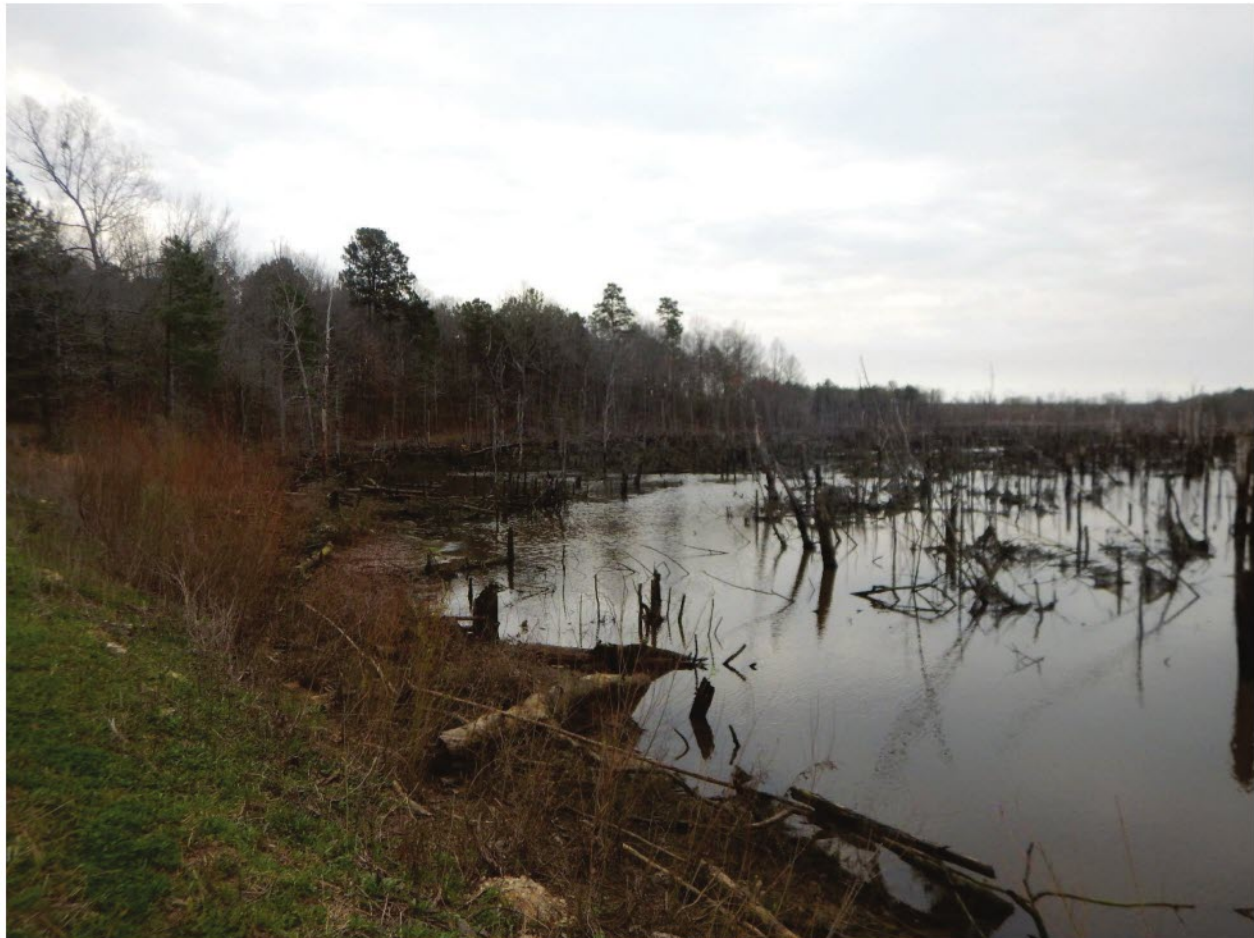
Photo No. 26

| Photo File Name | Date and Time of Photo | Photographer | Description |
|---|---|---|---|
| DSCN6325.JPG | 02/28/2024, 10:04 AM | Chelsey Sherwood | Showing stream channel and wetland complex. Picture taken facing southeast. |

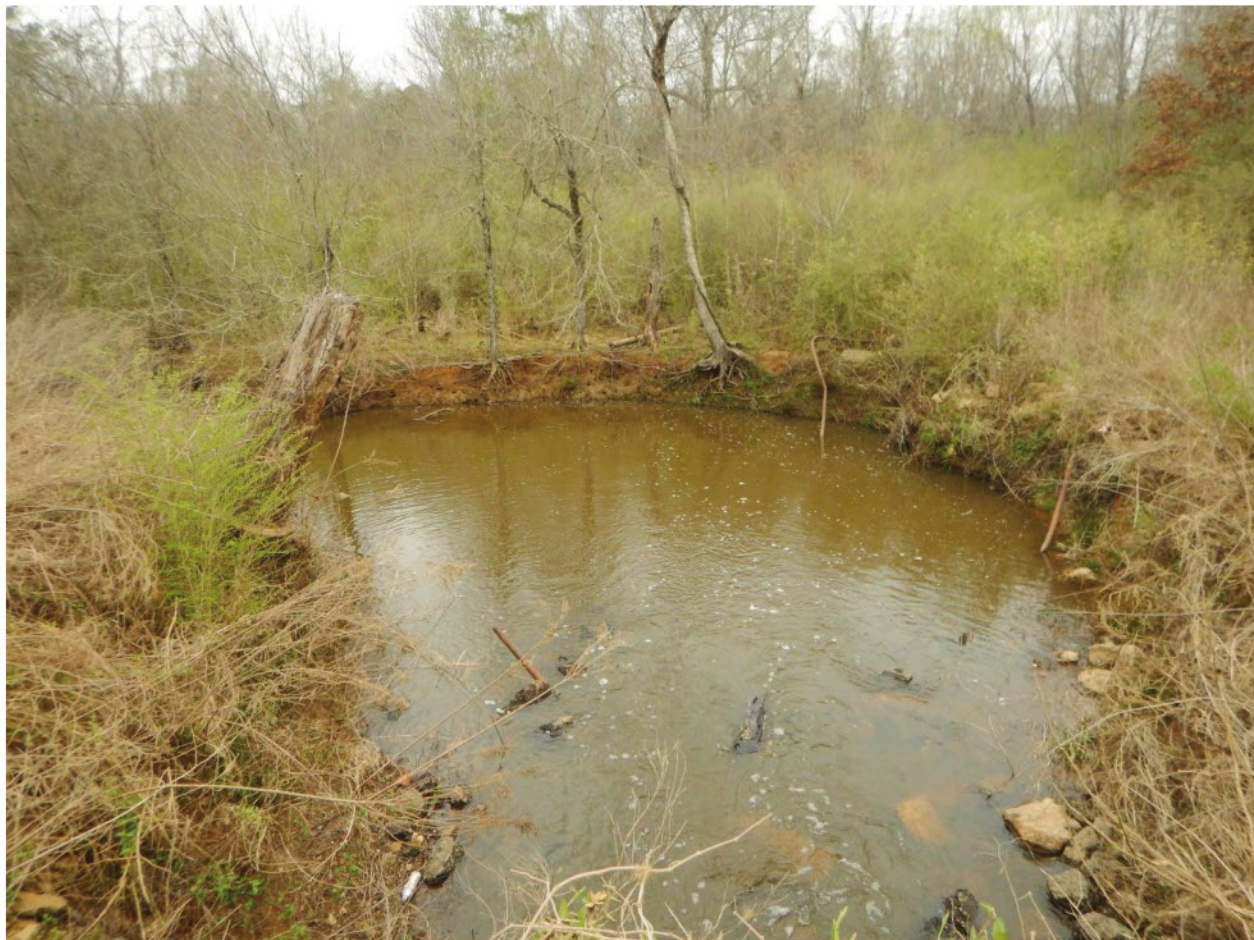
Photo No. 27

| Photo File Name | Date and Time of Photo | Photographer | Description |
|---|---|---|---|
| DSCN6326.JPG | 02/28/2024, 10:07 AM | Chelsey Sherwood | Showing stream channel outflow from culvert. Picture taken facing north, downstream. |

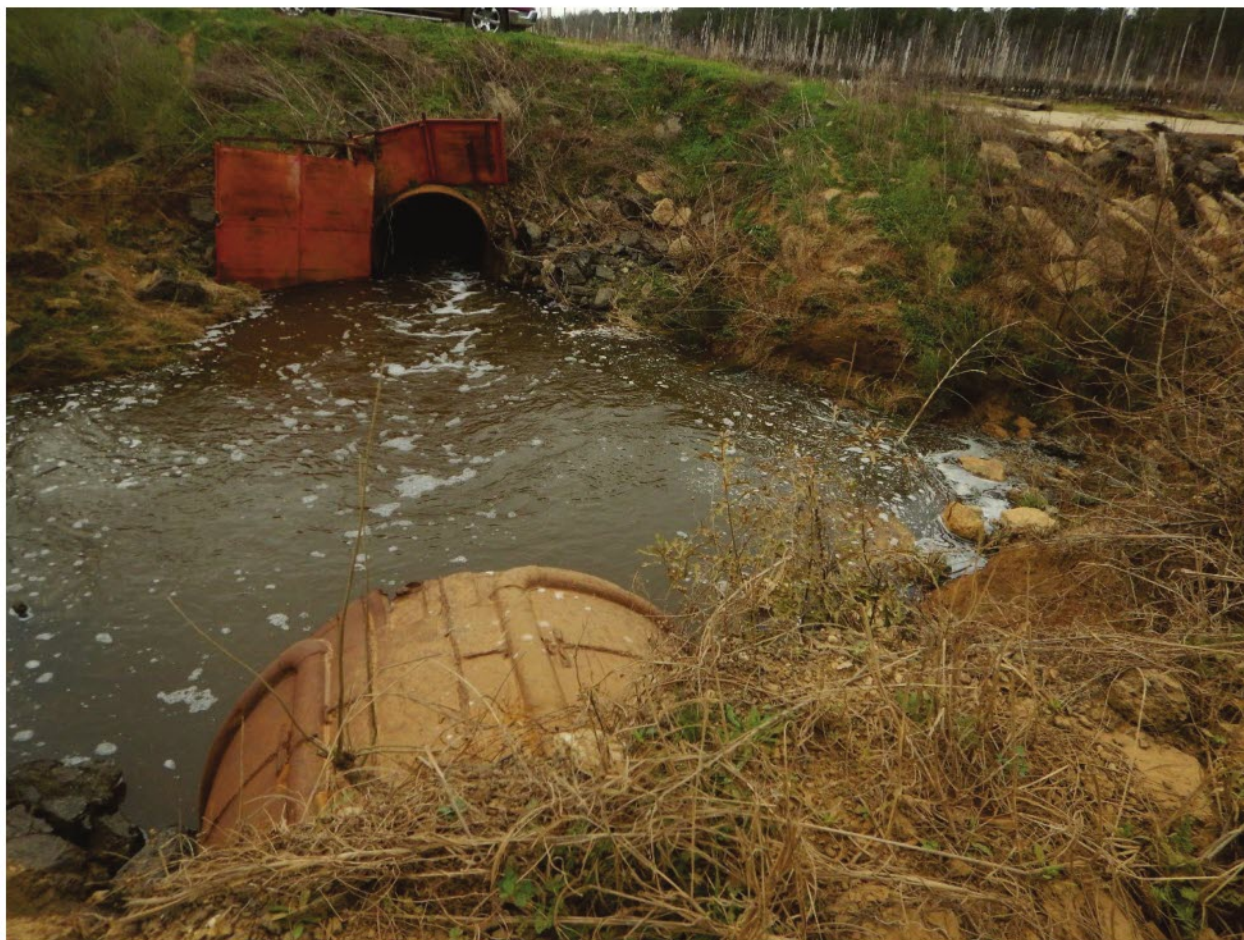
Photo No. 28

| Photo File Name | Date and Time of Photo | Photographer | Description |
|---|---|---|---|
| DSCN6327.JPG | 02/28/2024, 10:07 AM | Chelsey Sherwood | Showing stream channel outflow from culvert. Picture taken facing south, upstream. |

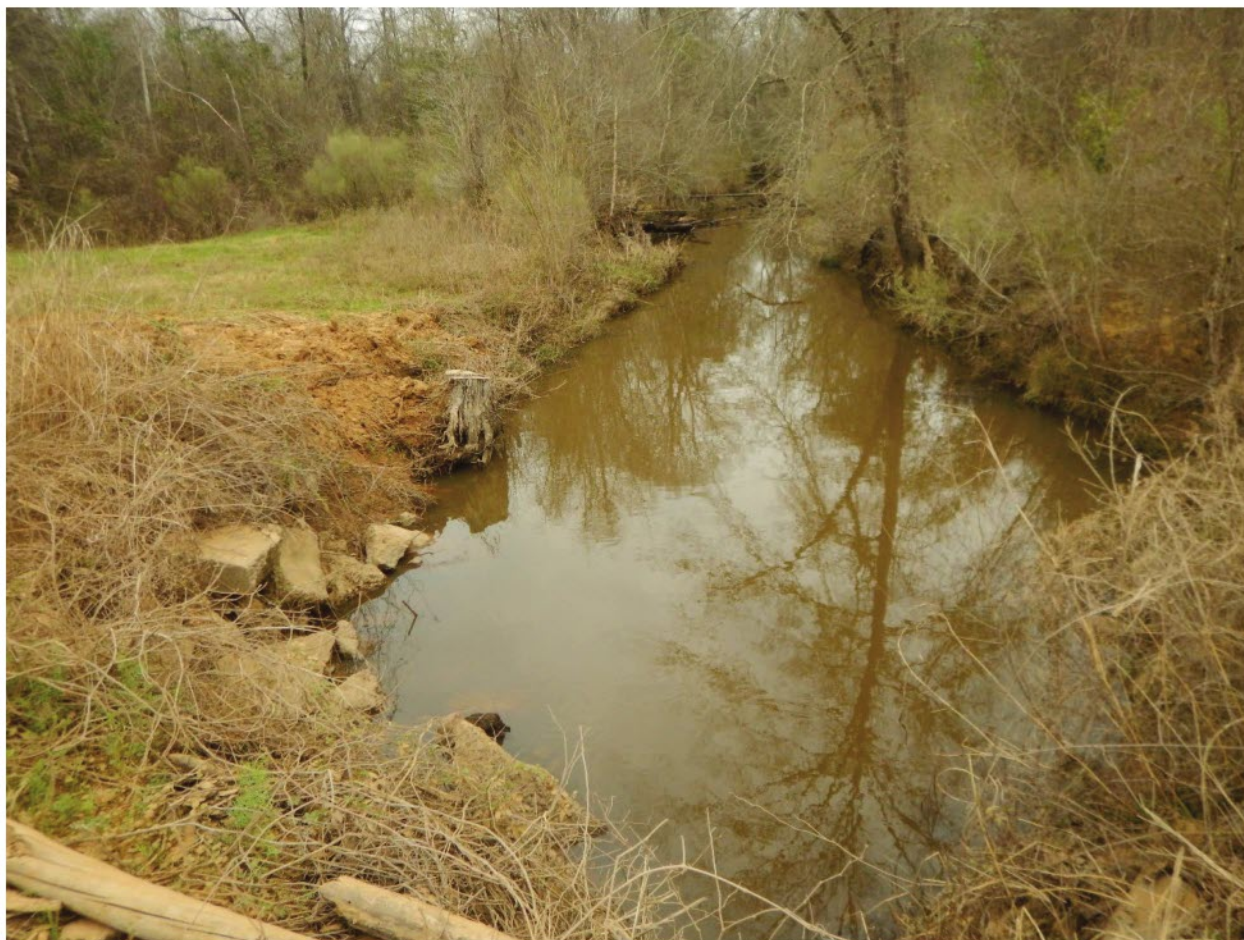
Photo No. 29

| Photo File Name | Date and Time of Photo | Photographer | Description |
|---|---|---|---|
| DSCN6328.JPG | 02/28/2024, 10:09 AM | Chelsey Sherwood | Showing stream channel outflow from culvert. Note fill on river left and in stream channel. Picture taken facing north, upstream. |

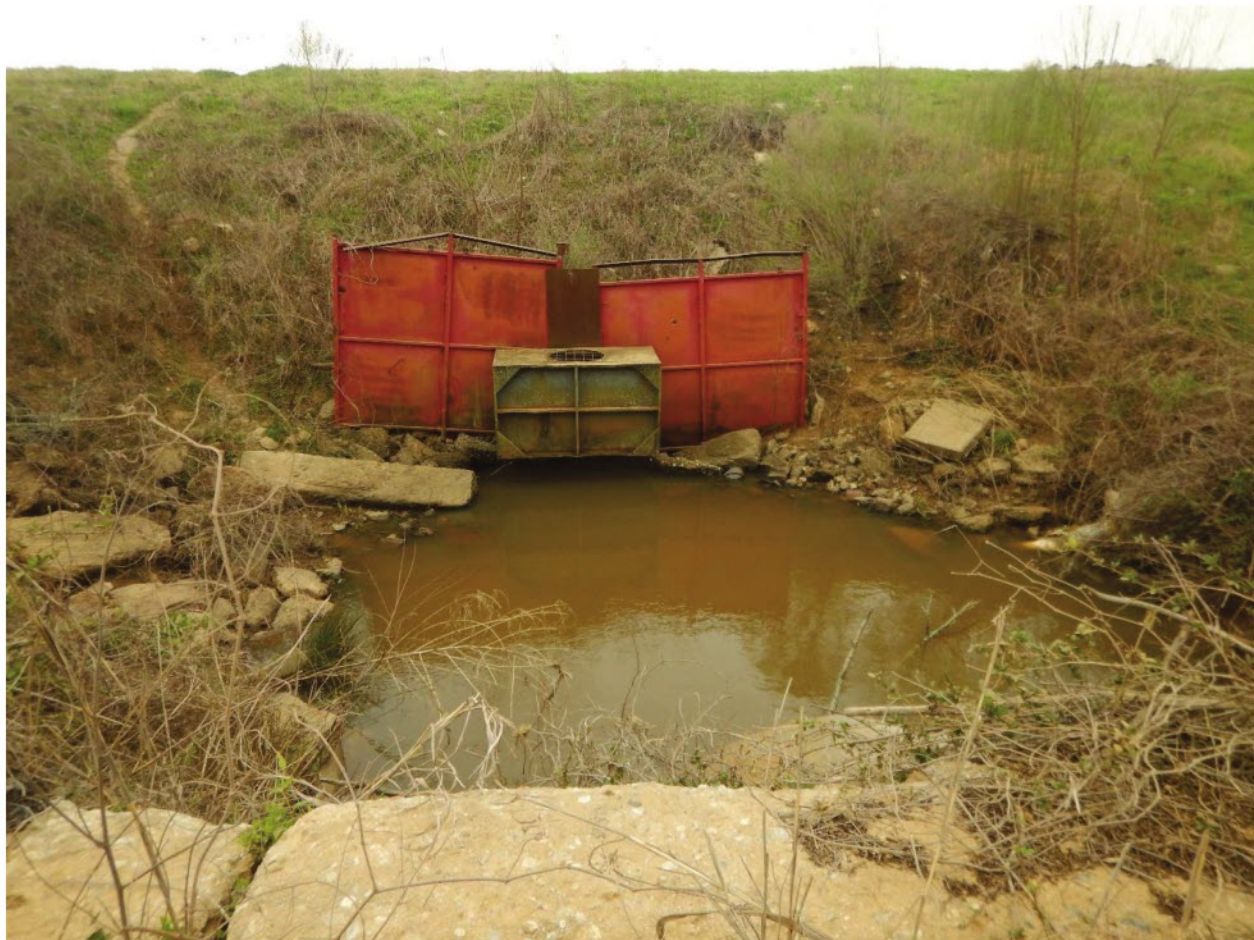
Photo No. 30

| Photo File Name | Date and Time of Photo | Photographer | Description |
|---|---|---|---|
| DSCN6329.JPG | 02/28/2024, 10:10 AM | Chelsey Sherwood | Showing flood control gate. Picture taken facing south, upstream. |

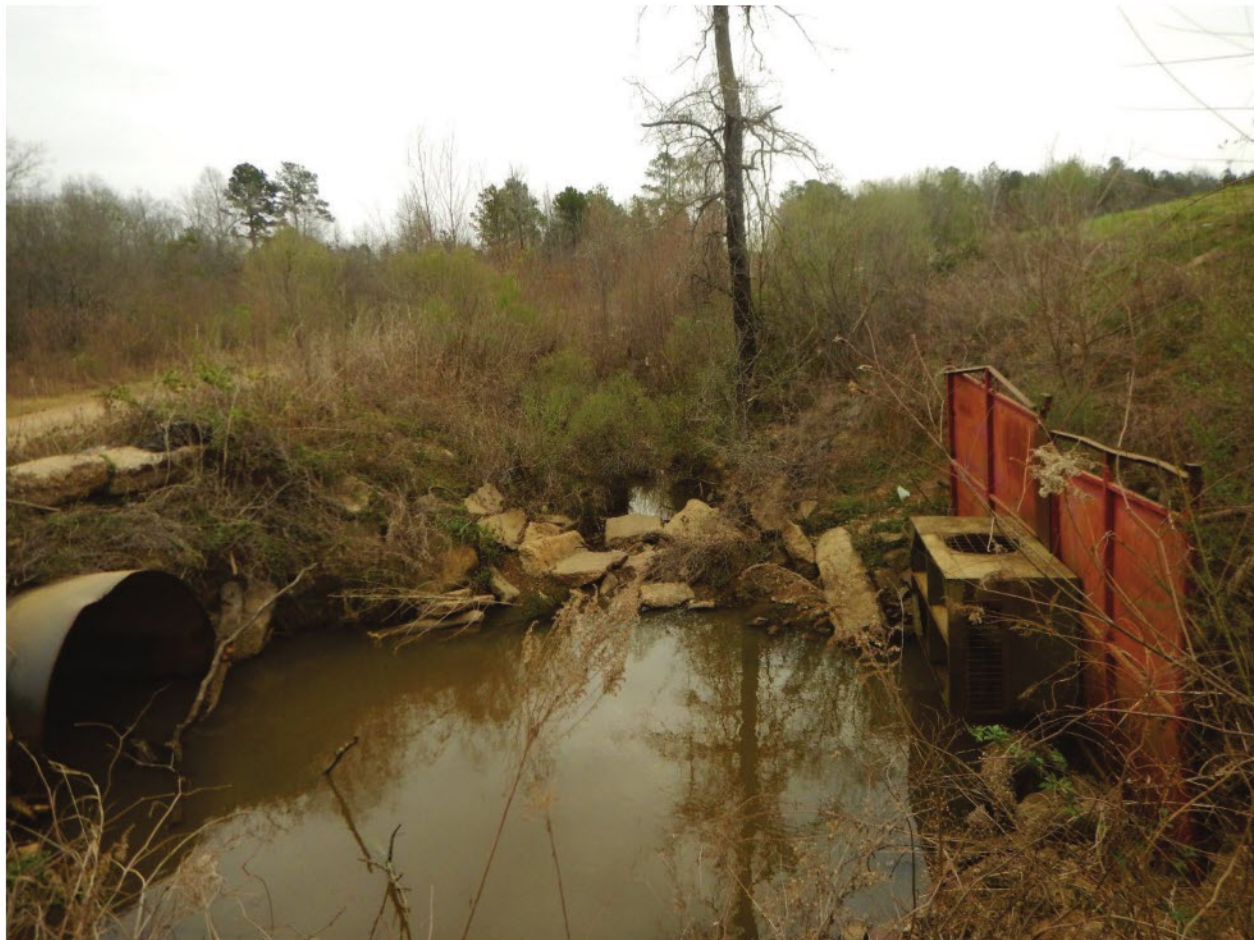
Photo No. 31

| Photo File Name | Date and Time of Photo | Photographer | Description |
|---|---|---|---|
| DSCN6330.JPG | 02/28/2024, 10:11 AM | Chelsey Sherwood | Showing flood control gate and culvert. Note fill material in channel. Picture taken facing east. |

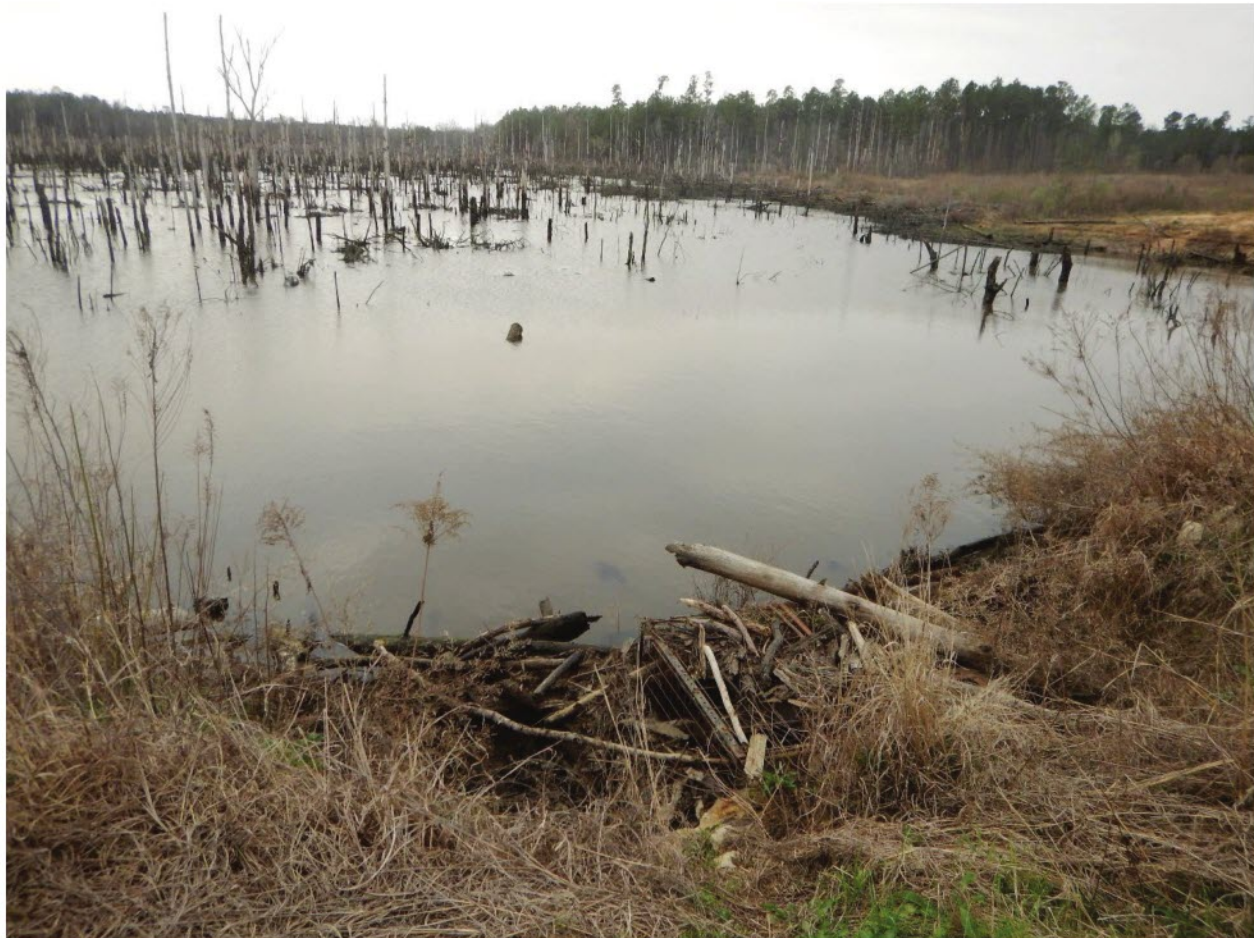
Photo No. 32

| Photo File Name | Date and Time of Photo | Photographer | Description |
|---|---|---|---|
| DSCN6331.JPG | 02/28/2024, 10:12 AM | Chelsey Sherwood | Showing flood control gate. Note debris piled around and on top of gate. Picture taken south, downstream. |

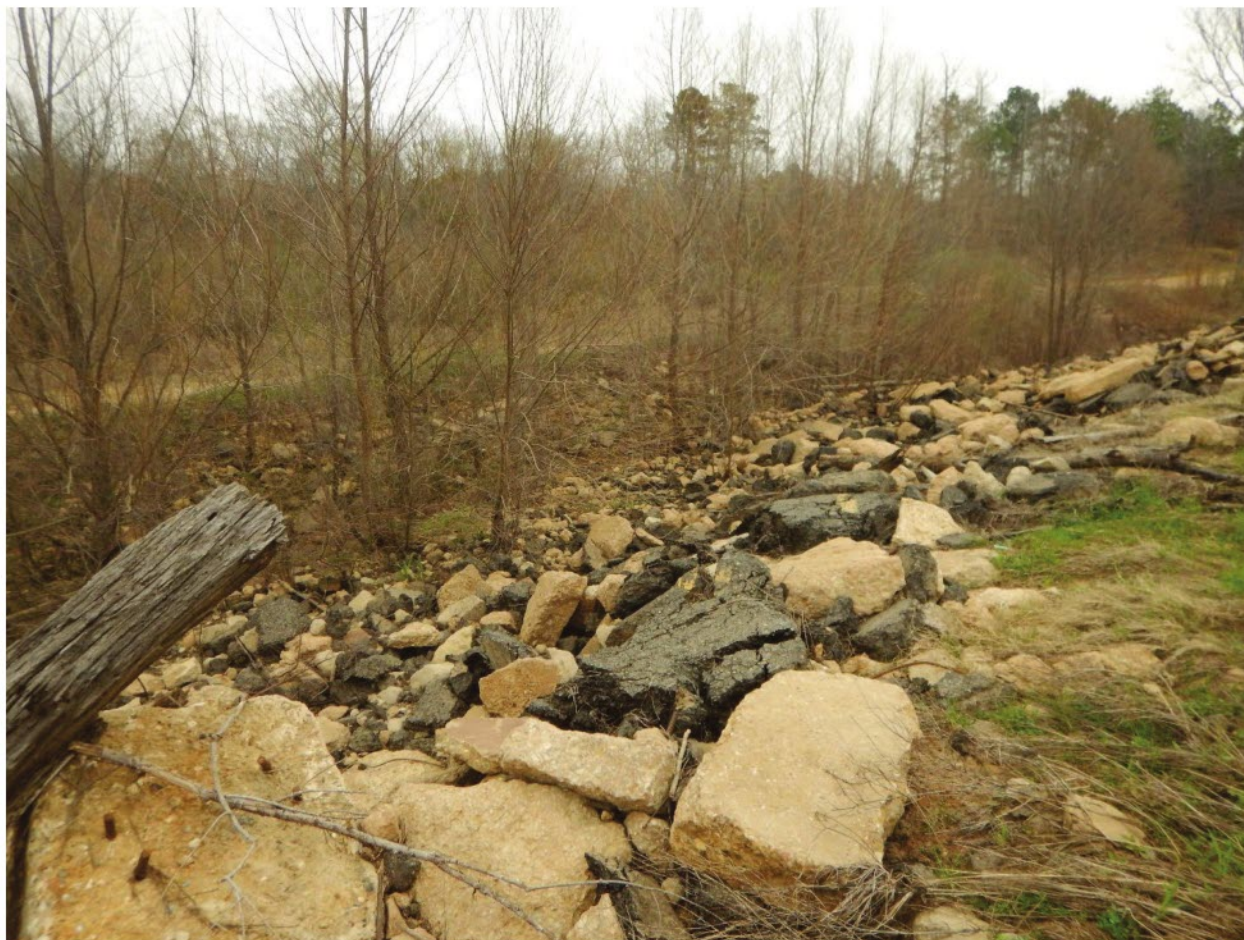
Photo No. 33

| Photo File Name | Date and Time of Photo | Photographer | Description |
|---|---|---|---|
| DSCN6332.JPG | 02/28/2024, 10:13 AM | Chelsey Sherwood | Showing broken concrete and asphalt placed along and in the channel between the two flood control gates. Picture taken east. |

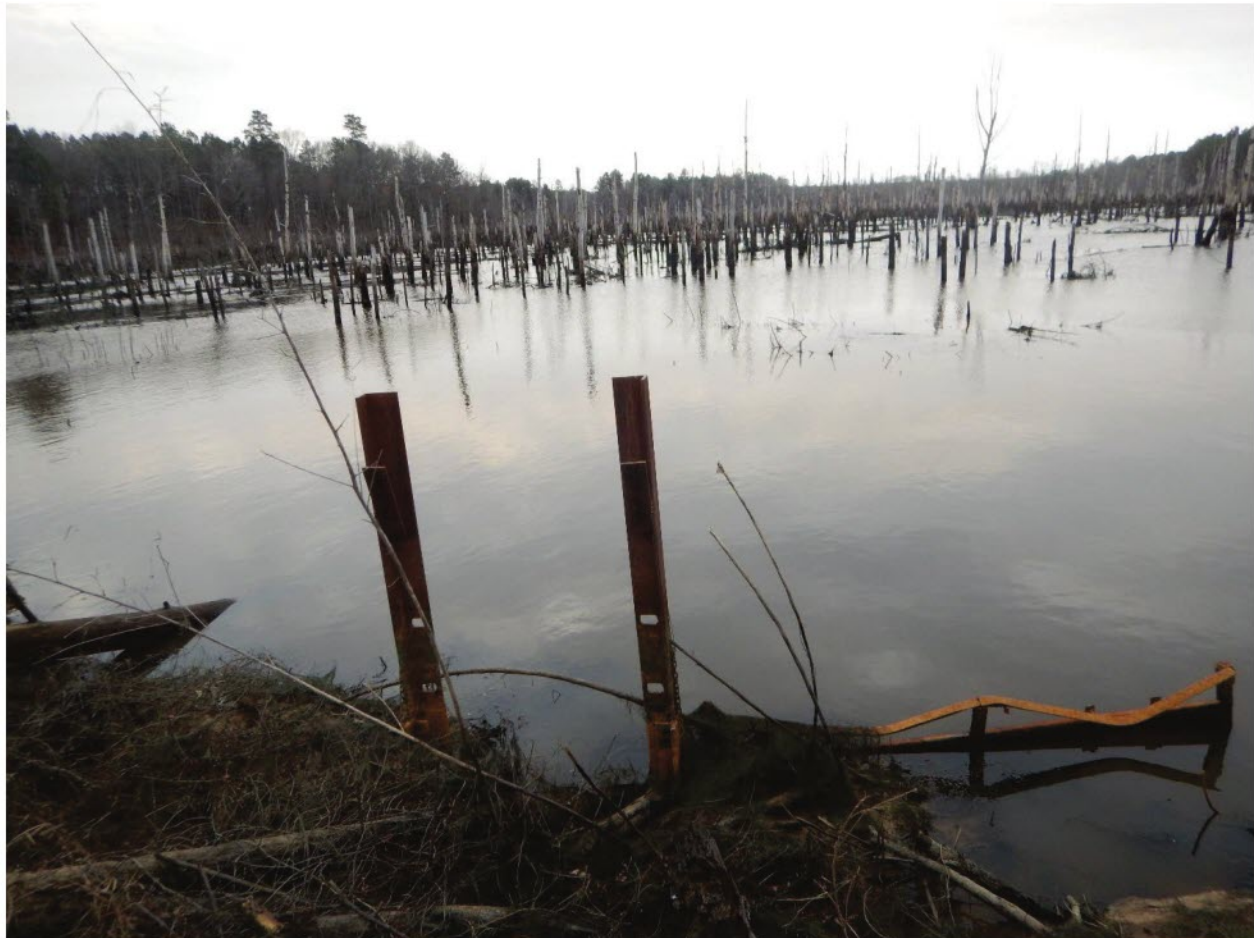
Photo No. 34

| Photo File Name | Date and Time of Photo | Photographer | Description |
|---|---|---|---|
| DSCN6333.JPG | 02/28/2024, 10:14 AM | Chelsey Sherwood | Showing flood control gate. Picture taken facing south. |
