## **RCRA Inspection Report**

Eglin Air Force Base  
501 DeLeon St, Suite 100 (Bldg. 696)  
Eglin Air Force Base, Florida 32542

EPA ID Number: FL8570024366

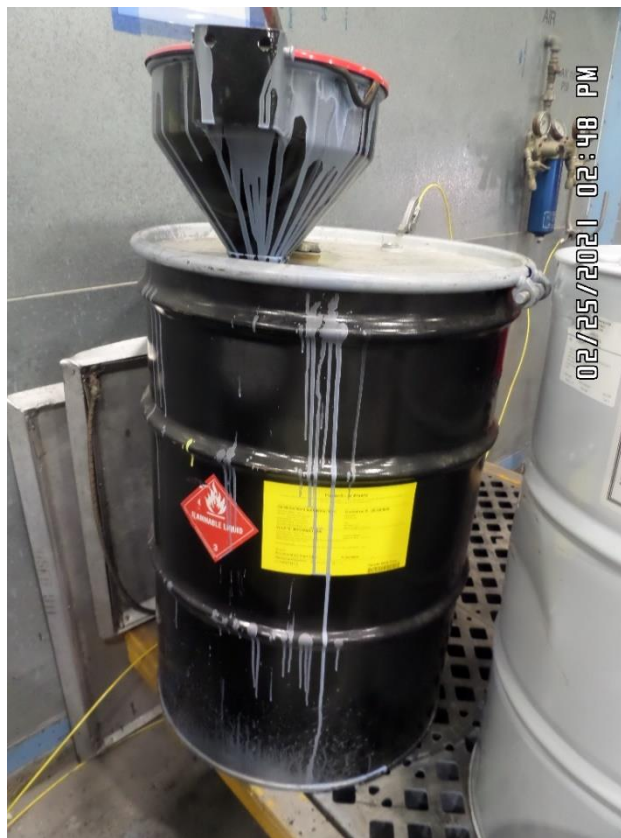
In one end of the hangar, operators from Tyndall Air Force Base (temporarily working at EAB) conduct maintenance in their aircraft. At the time of the inspection, the area was storing a 55-gallon SAA container of paint debris, a 55-gallon SAA container of waste adhesive, a 55-gallon SAA container of waste debris, a 55-gallon SAA container of paint-related material, and a 55-gallon SAA container of paint waste. The inspection team noticed paint drips and residue on the open-top funnel and container storing paint waste (See Figure 1). The container was changed at the end of the inspection. All containers were closed and labeled.

**Figure 1 - 55-gallon SAA container storing paint waste**

**Pursuant to Fla. Admin. Code Ann. r. 62-730.160(1) [40 C.F.R. § 262.34(a)(4)], which incorporates Fla. Admin. Code Ann. r. 62-730.180(2) [40 C.F.R. § 265.31], and is a condition of the LQG Permit Exemption, a generator is required to maintain and operate its facility to minimize the possibility of a fire, explosion, or any unplanned sudden or non-sudden release of hazardous waste or hazardous waste constituents to air, soil, or surface water which could threaten human health or the environment.**
