## **RCRA Inspection Report**

Safety Kleen Systems, Inc.  
161 Industrial Loop S  
Orange Park, FL 32073-6259

EPA ID#: FLD980847214  
NAICS #: 562112 – Hazardous Waste  
Collection

March 7, 2025 8:00 AM

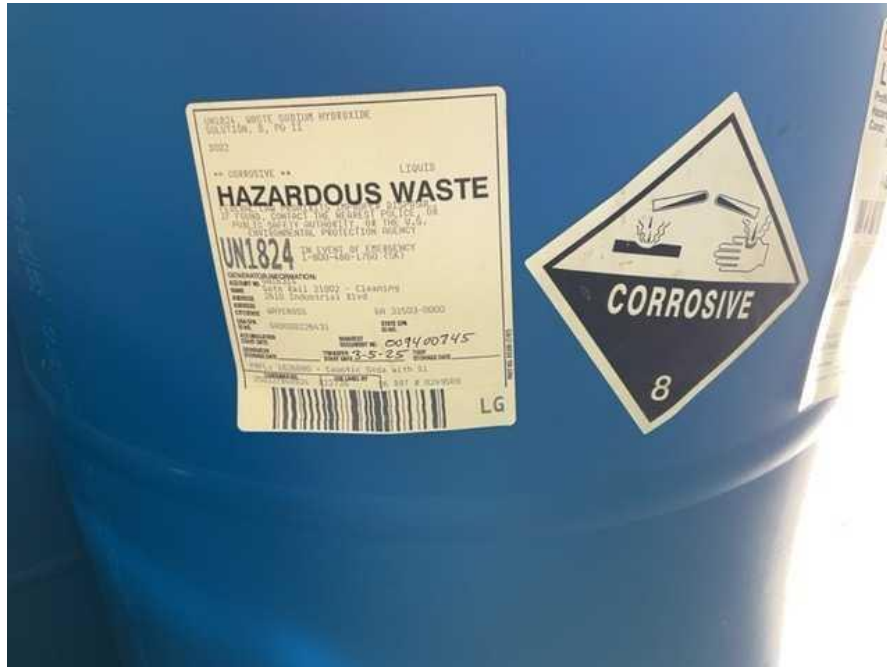
| [Photo 1] | | | IMG-20250307085231523154045.jpg |

| Label on container in HW Transfer Facility Storage Area | | | |

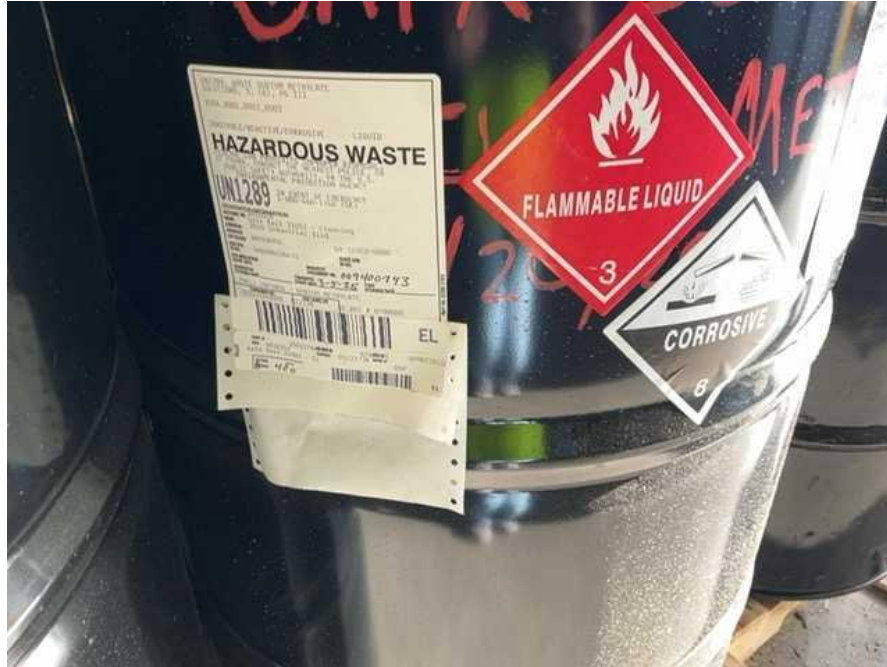
| [Photo 2] | | | IMG-20250307085315531591802.jpg |

| Label on container in HW Transfer Facility Storage Area | | | |

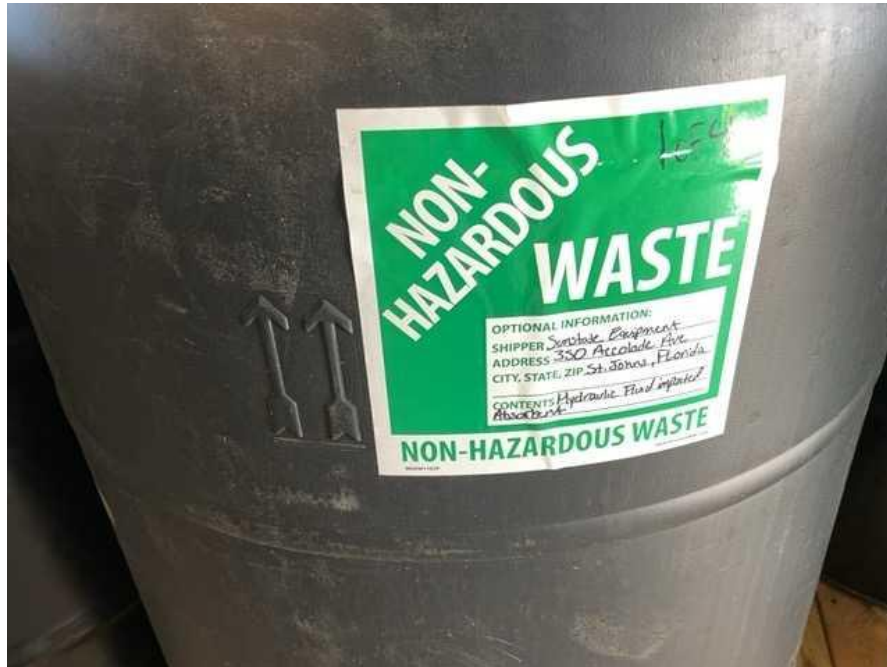
| [Photo 3] | | | IMG-20250307085340534081054.jpg |

| Label on container in HW Transfer Facility Storage Area | | | |

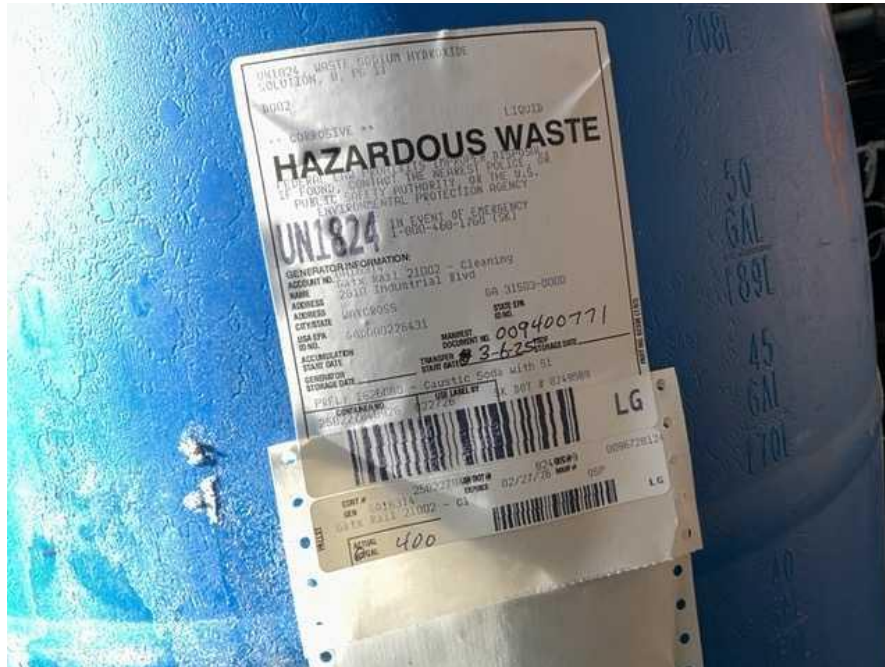
| [Photo 4] | | | IMG-202503070854575457114070.jpg |

| Label on container in HW Transfer Facility Storage Area | | | |

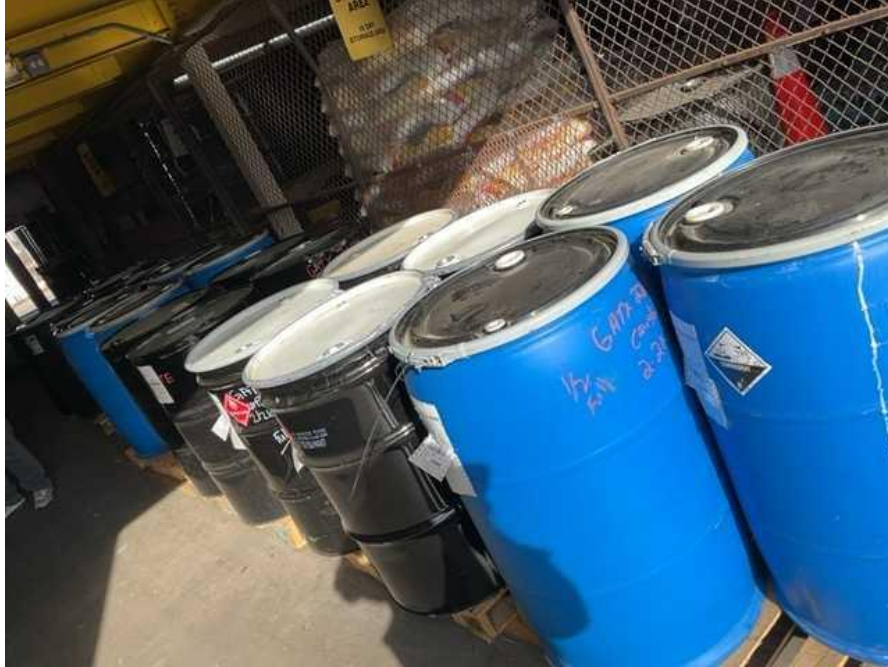
| [Photo 5] | | | IMG-202503070857245724103677.jpg |

| Label on container in HW Transfer Facility Storage Area | | | |

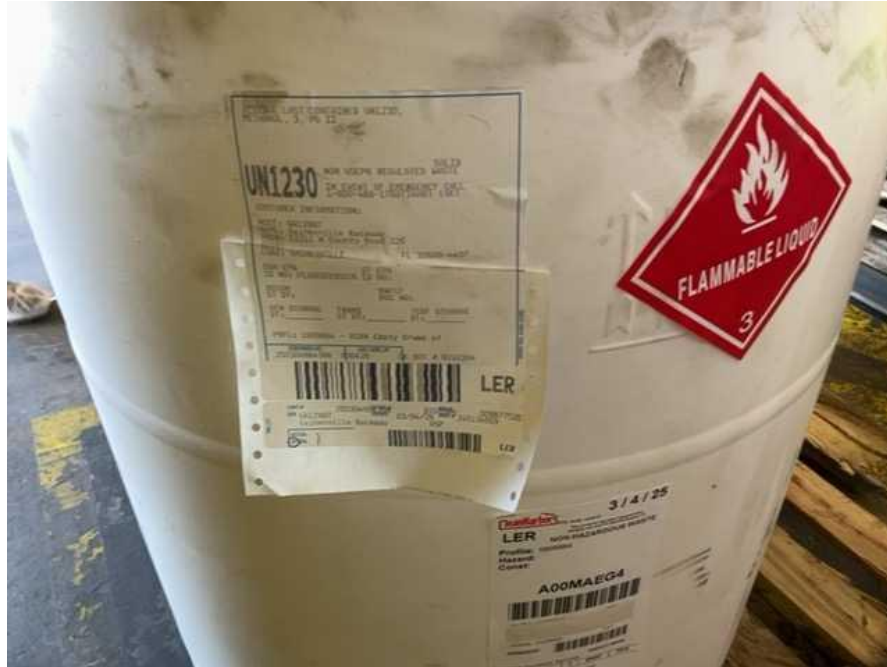
| [Photo 6] | | | IMG-2025030709071471467833.jpg |

| Label on container in HW Transfer Facility Storage Area. This container was RCRA empty at the time of the CEI. | | | |

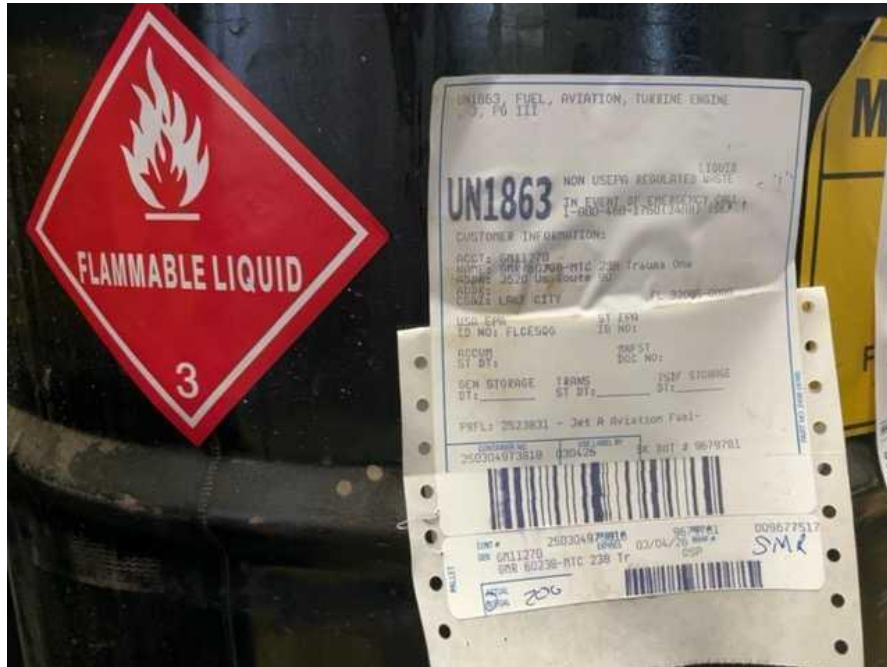
| [Photo 7] | | | IMG-2025030709093193182419.jpg |

| Label on container in HW Transfer Facility Storage Area | | | |

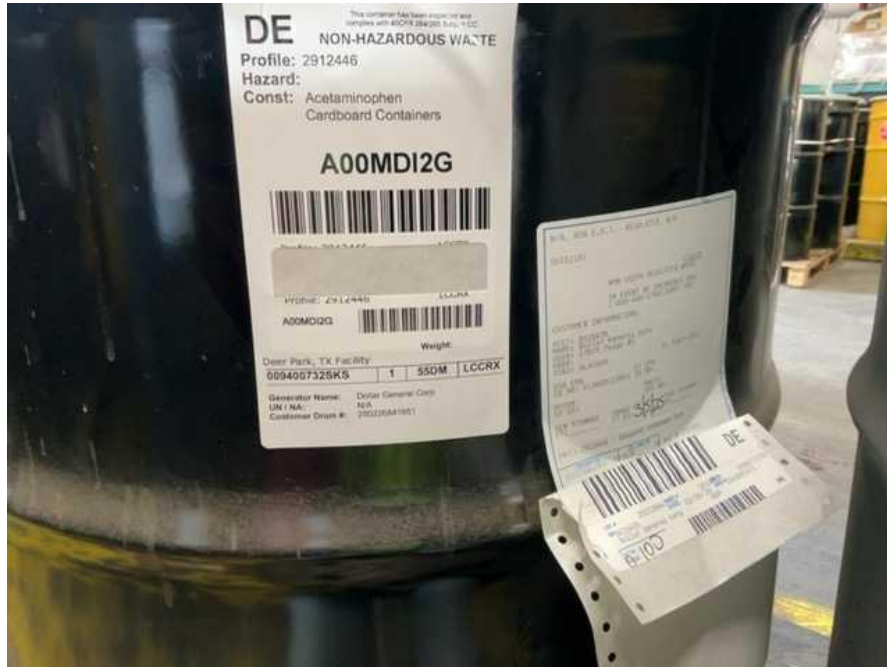
| [Photo 8] | | | IMG-20250307091113111371436.jpg |

| Label on container in HW Transfer Facility Storage Area | | | |

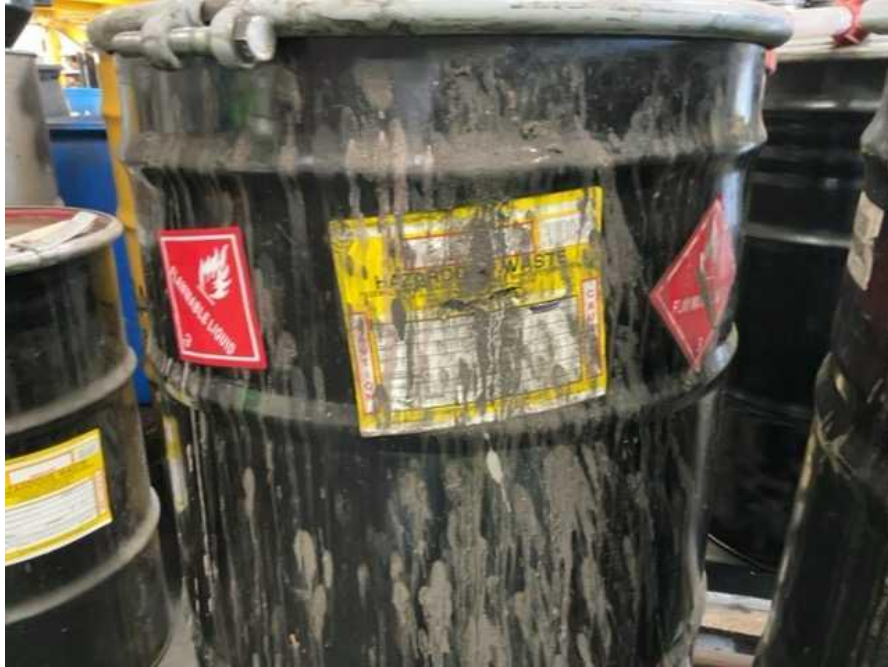
| [Photo 9] | | | IMG-20250307091752175290046.jpg |

| Label on container in Branch Generated Waste Storage Area | | | |

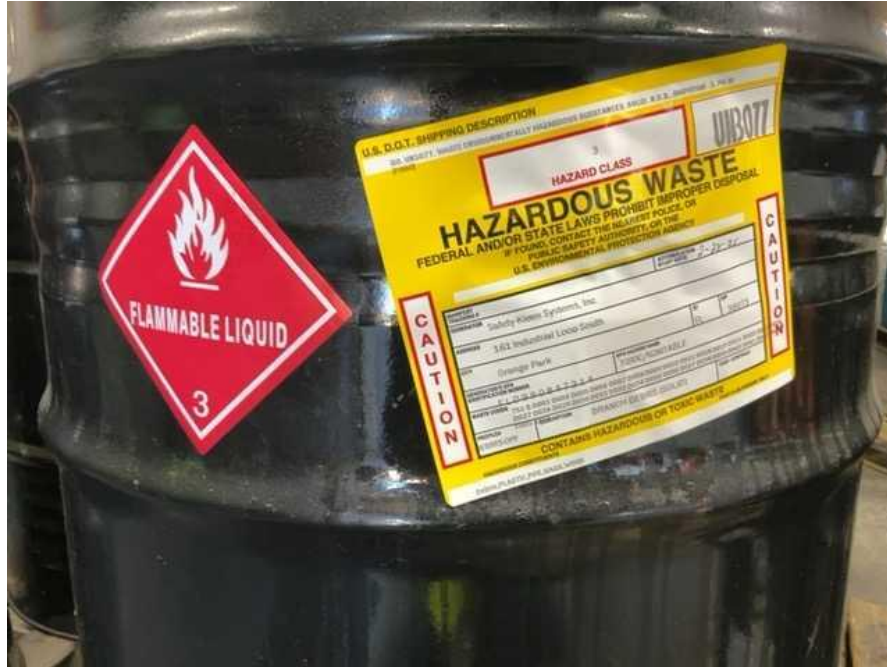
| [Photo 10] | | | IMG-20250307092122212293457.jpg |

| Label on container in Branch Generated Waste Storage Area | | | |

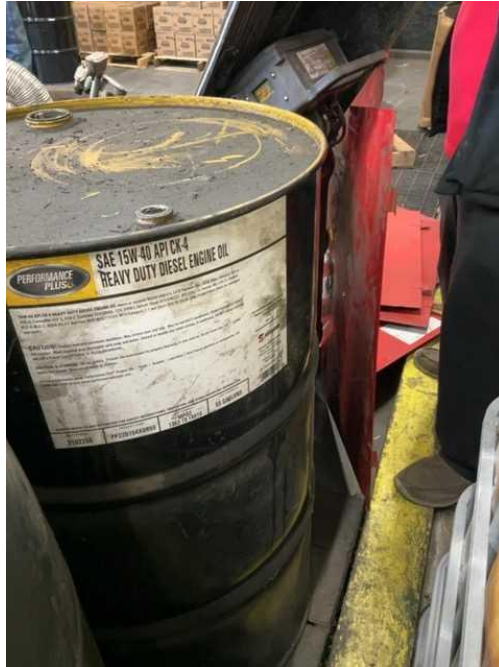
| [Photo 11] | | | IMG-20250307092530253090704.jpg |

- Three 55-gallon containers labeled with the words “hazardous waste, toxic,” and marked with a DOT flammable diamond. The containers were dated 2/16/25, 2/28/25, and 3/4/25.
- One 65-gallon overpack drum labeled with the words “hazardous waste, toxic,” and marked with a DOT flammable diamond. This container was dated 2/10/25.
- Two 55-gallon containers labeled “used oil.”
- One 55-gallon container marked with a product diesel oil label (Photo 11). Facility representatives were not able to identify if this container held product or if the drum had been recycled to store used oil. This deficiency was corrected following the inspection on April 15, 2025 when the facility informed inspectors via email that the container was determined to hold product for truck oil.

| Container marked with a product label in branch generated waste storage area. At the time of the CEI, facility representatives could not verify if this container held product or waste. | | | |

**Pursuant to Fla. Admin. Code Ann. r. 62-730.160(1) [40 C.F.R. § 262.11], a person who generates a solid waste, as defined in Fla. Admin. Code Ann. r. 62-730.030(1) [40 C.F.R. § 261.2], must make an accurate determination as to whether that waste is a hazardous waste in order to ensure wastes are properly managed according to applicable RCRA regulations articulated in Fla. Admin. Code Ann. r. 62-730.160(1) [40 C.F.R. § 262.11].**

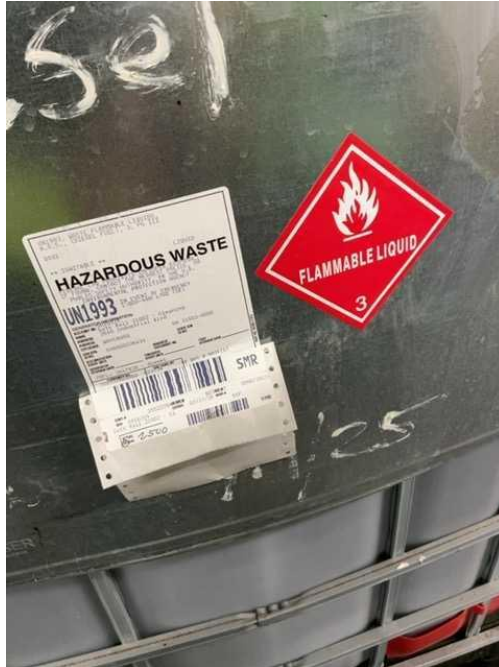
| [Photo 12\ | | | IMG-20250307092751275190287.jpg |

Inspectors observed eight 275-gallon totes along the wall of the transfer storage area. Six of these totes held flammable hazardous waste diesel and two held nonhazardous waste. Five of the hazardous waste containers were dated 3/4/25 and one was missing a date (Photo 12). The information for the hazardous waste totes was reviewed in the operating log during the records review. Per the operating log, four totes arrived at the facility on March 4, one on March 5 and one on March 6, 2025. This was corrected on site. The nonhazardous waste containers were dated 3/6/25.

| 275-gallon tote label in the transfer facility storage area | | | |

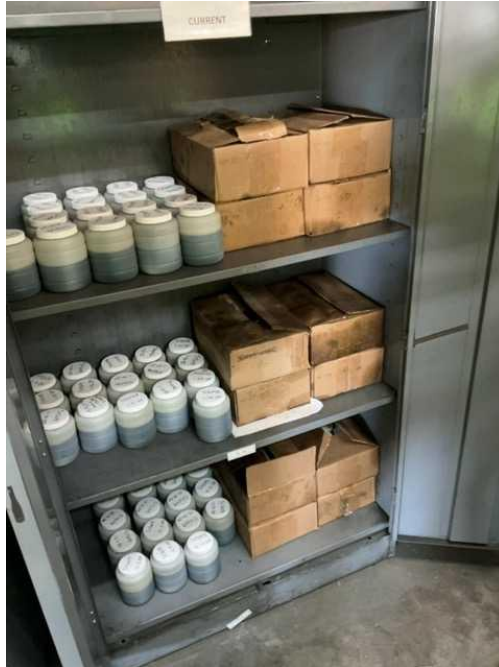
| [Photo 13] | | | IMG-2025030709320632676711.jpg |

| Shelf storing used oil/ oily water samples. The shelf was separated by date sample was collected. | | | |

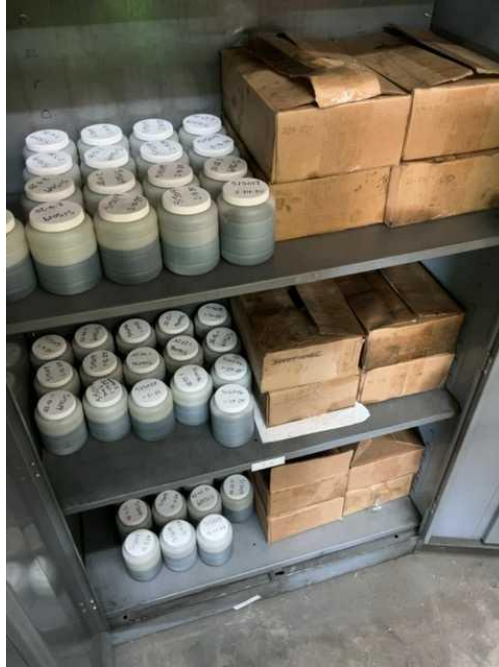
| [Photo 14] | | | IMG-20250307093337333781147.jpg |

| Shelf storing used oil/ oily water samples. The shelf was separated by date sample was collected. | | | |

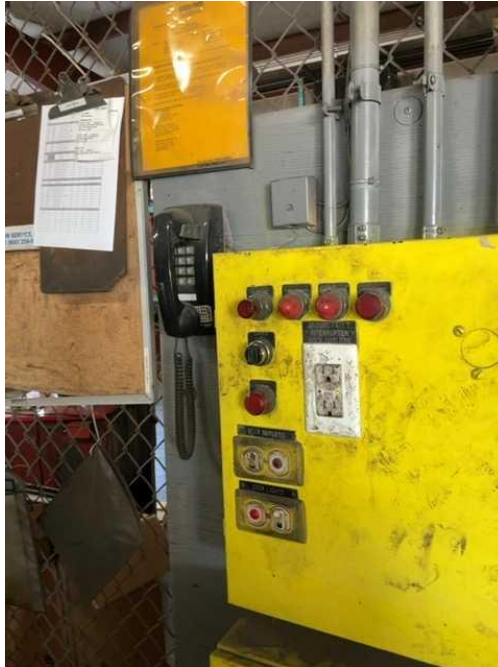
| [Photo 15] | | | IMG-20250307094240424086122.jpg |

Inspectors observed fire extinguishers, alarms, spill kits, and a telephone in the warehouse with the transfer facility storage area and CAA (Photo 15). A 4 ft box of universal waste lamps generated onsite was observed in the corner of the warehouse. This container was closed, marked with the words “universal waste, waste lamps” and dated 4/22/2024 (Photos 35-36).

| A functional telephone observed in the transfer storage area. | | | |

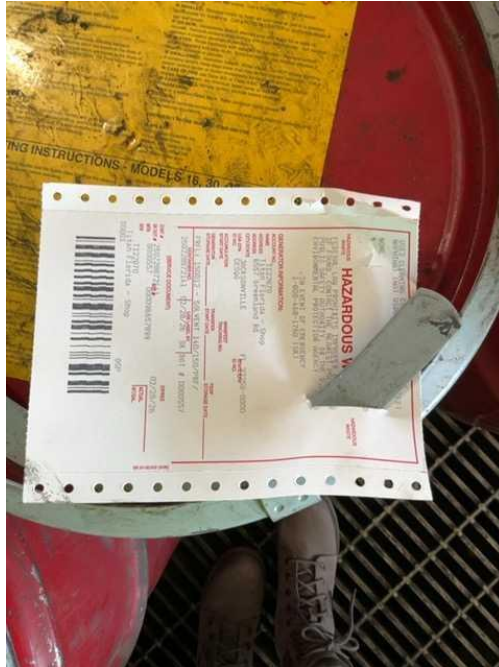
| [Photo 16] | | | IMG-20250307094655465595369.jpg |

At the time of the inspection, rows of 15-gallon containers of used solvent were staged by the return and fill station waiting disposal into the unit (Photo 25). These containers were labeled with the words "hazardous waste" and marked with the date they were picked up from the customer. Facility representatives informed inspectors that waste solvent containers are labeled with a DOT flammable or toxic placard depending on the customer facility it was generated. Inspectors observed four containers that were missing the accumulation date (Photos 16-17). This was corrected on site.

| A label on a 15-gallon used solvent container observed in the Return and Fill Station. | | | |

**Pursuant to Fla. Admin. Code Ann. r. 62-730.160(1) [40 C.F.R. § 262.17(a)(5)(i)], which is a condition of the LQG Permit Exemption, a generator must mark or label its containers with the following: the words "Hazardous Waste"; an indication of the hazards of the contents; and the date upon which each period of accumulation begins clearly visible for inspection on each container.**

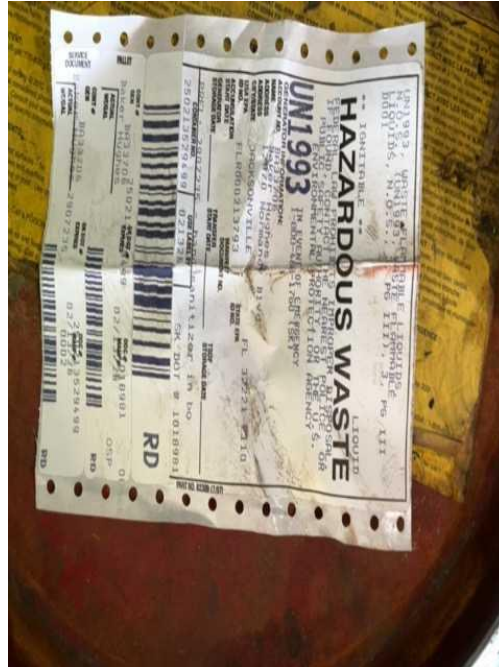
| [Photo 17] | | | IMG-20250307094713471396025.jpg |

| A label on a 15-gallon used solvent container observed in the Return and Fill Station. | | | |

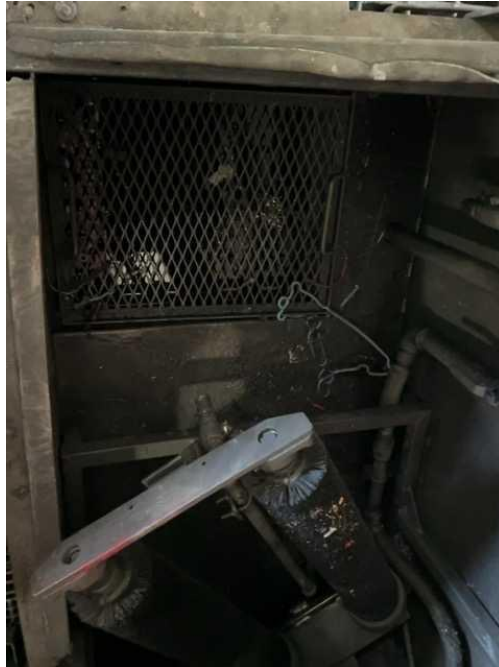
| [Photo 18] | | | IMG-20250307094914491465699.jpg |

| Drum dryer observed inside Return and Fill wet dumpster | | | |

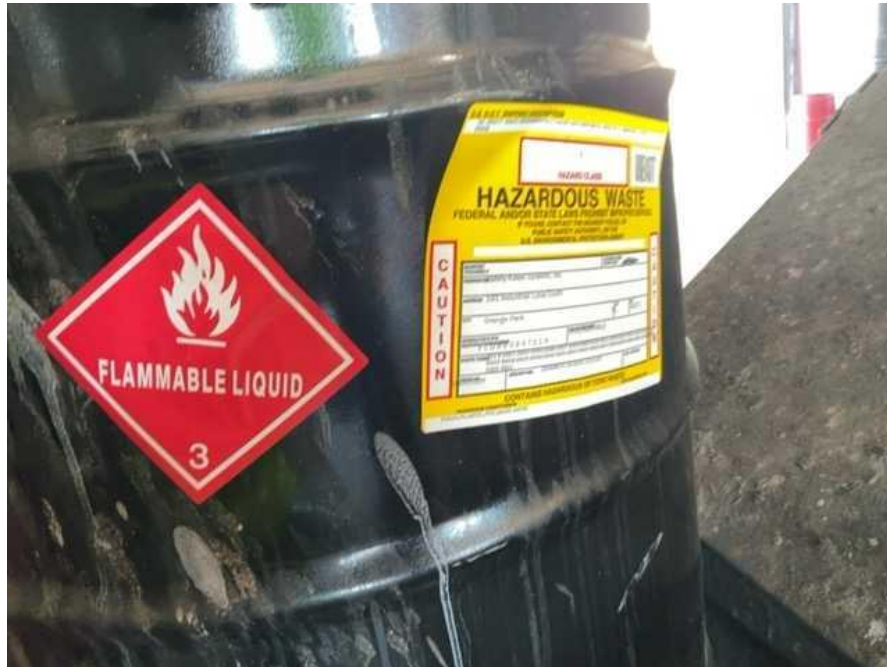
| [Photo 19] | | | IMG-2025030709510251283083.jpg |

| Transfer waste observed near the Return and Fill Station | | | |

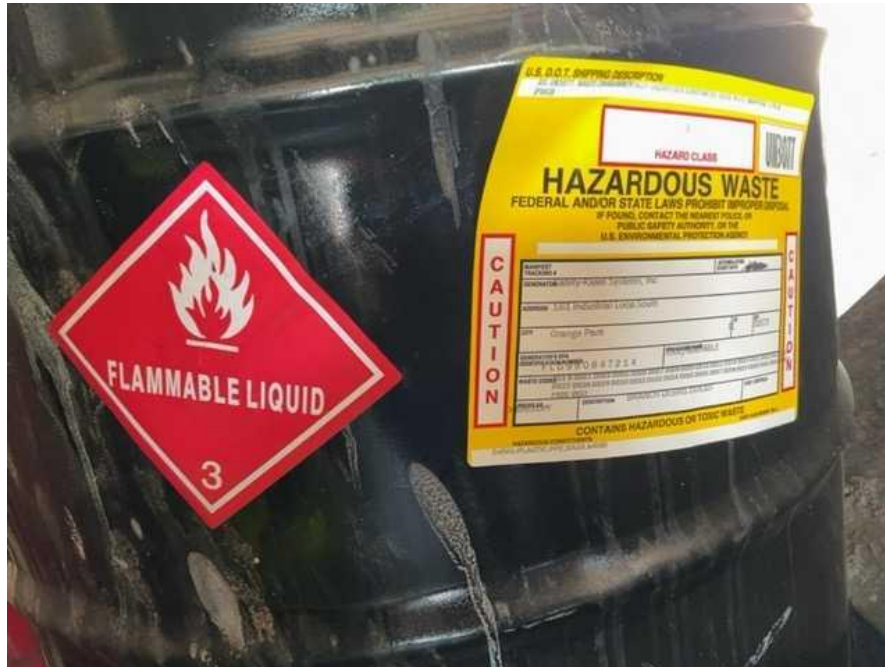
| [Photo 20] | | | IMG-20250307095146514689943.jpg |

| Transfer waste observed near the Return and Fill Station. | | | |

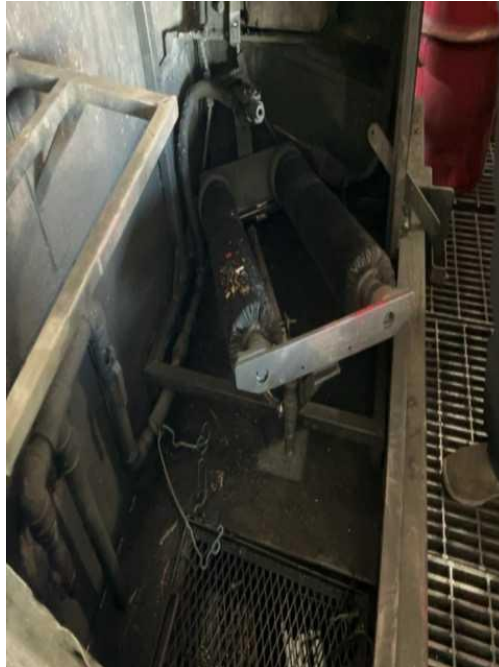
| [Photo 21] | | | IMG-20250307095155515567772.jpg |

| Drum Dryer in Return and Fill Station wet dumpster. | | | |

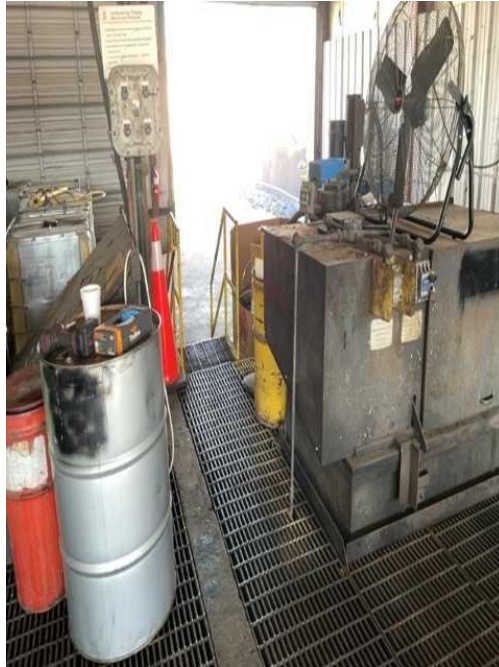
| [Photo 22] | | | IMG-20250307095208528101297.jpg |

| Outside view of Return and Fill wet dumpster. | | | |

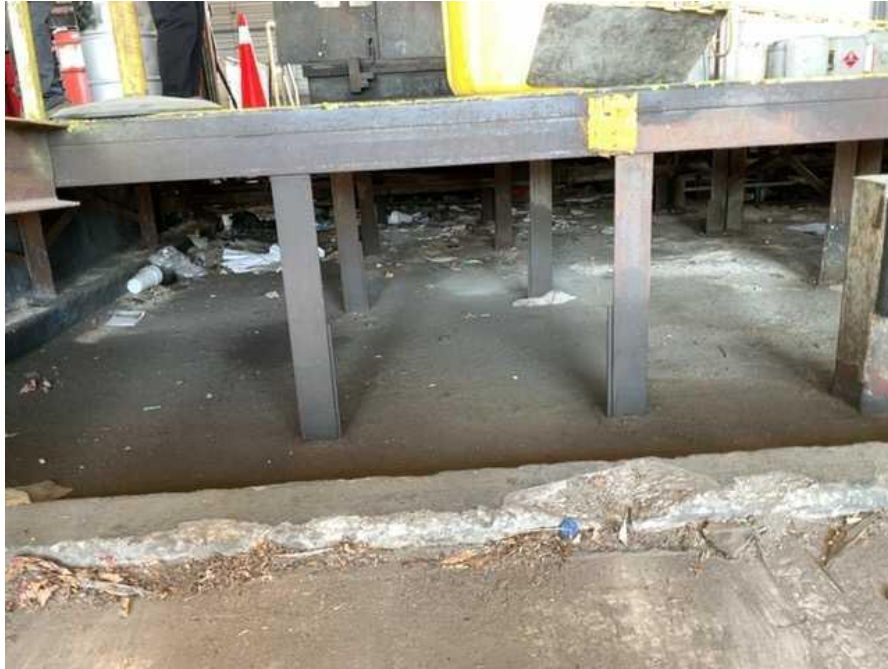
| [Photo 23] | | | IMG-202503070953205320105427.jpg |

| Secondary containment under Return and Fill Station. | | | |

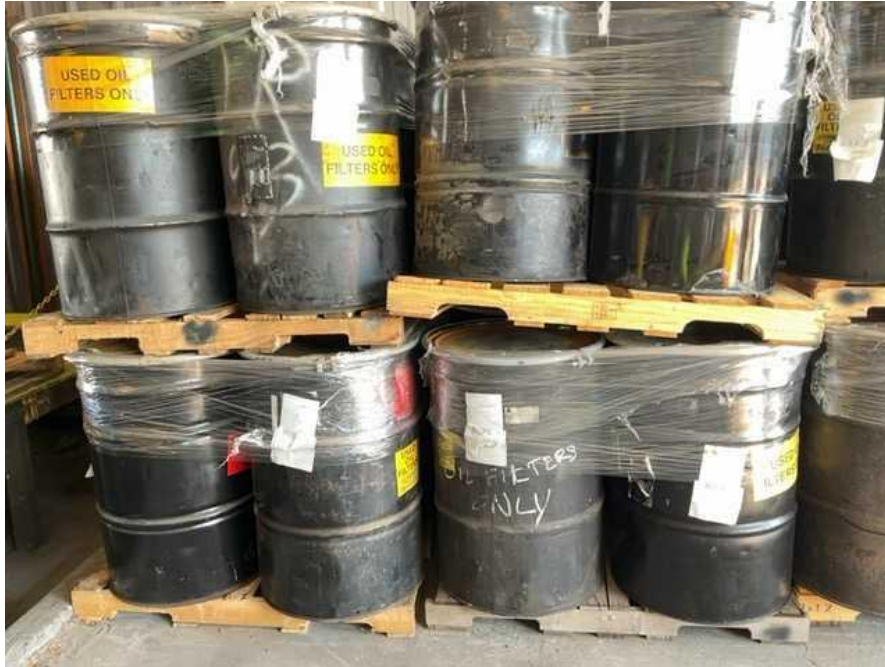
| [Photo 24] | | | IMG-202503070953305330108120.jpg |

Inspectors observed a 55-gallon satellite container of contaminated gloves and rags in this area. This container was labeled with the words, "hazardous waste" and an indication of the contents' hazards. Forty 55-gallon containers labeled "used oil filters" were staged by the dock for shipment off site. SK's HW permit designates a portion of the return and fill area for transfer facility storage as well. Inspectors observed two pallets of waste in this area holding three 55-gallon containers of used oil, four 5-gallon container of hazardous waste, and two 25-gallon containers of hazardous waste (Photos 19-20). Double stacked pallets of product recently unloaded in the receiving area were observed (Photo 24)

| Product storage near Return and Fill Station, | | | |

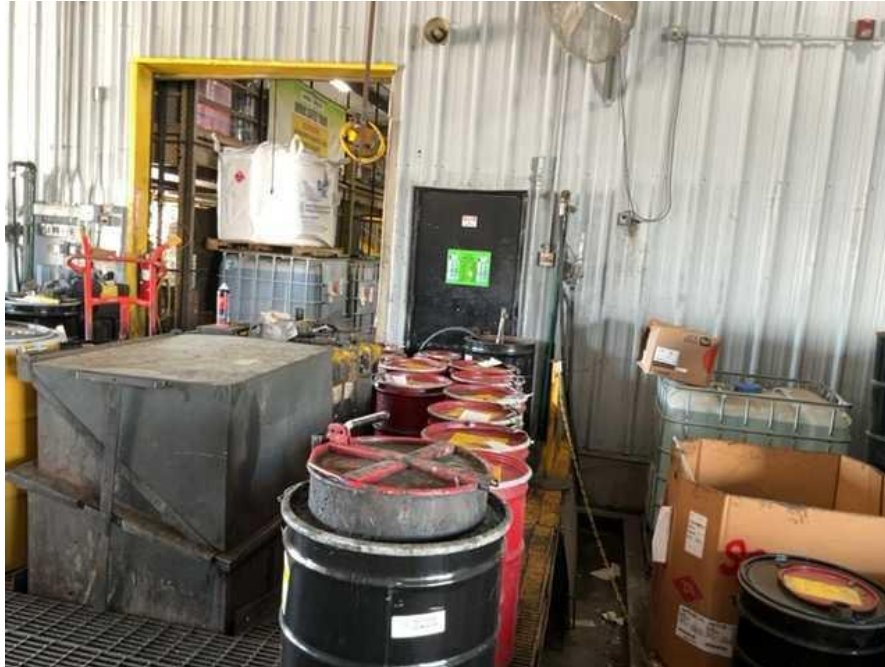
| [Photo 25] | | | IMG-20250307100226226103230.jpg |

| 15-gallon used solvent containers staged near Return and Fill Station. | | | |

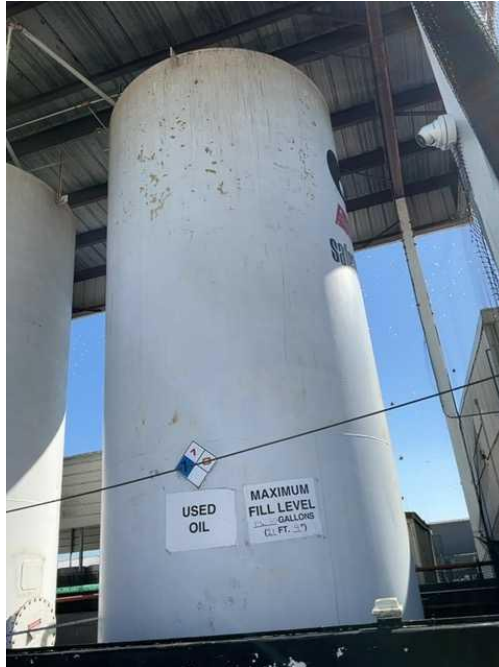
| [Photo 26] | | | IMG-2025030710062162173317.jpg |

| Used Oil tank in Tank Farm | | | |

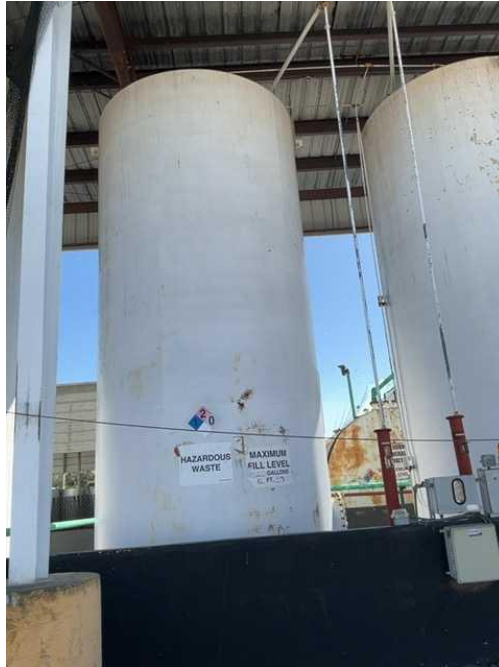
| [Photo 27] | | | IMG-2025030710063463468191.jpg |

SK manages three vertical 15,000-gallon above ground storage tanks at the facility; one tank is designated for hazardous waste accumulation and two store used oil (Photos 27-28). The hazardous waste tank accumulates the parts washer solvent piped from the return and fill station, and the used oil tank accumulates off site used oil generated by customers.

| Hazardous waste tank in Tank Farm. | | | |

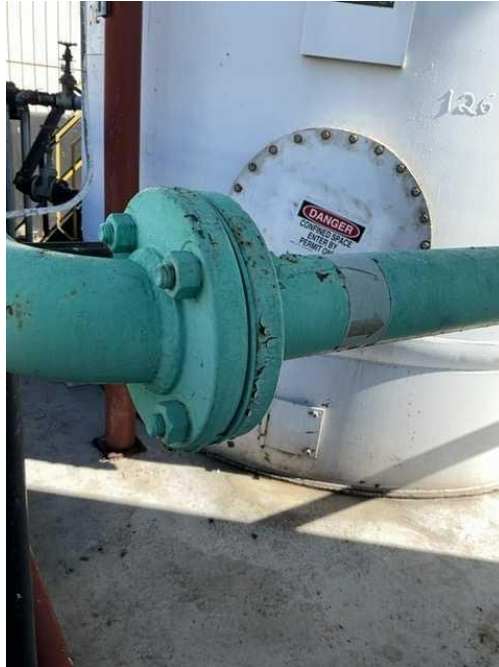
| [Photo 29] | | | IMG-20250307101216121679529.jpg |

| connection on pipe – this was marked green for product. | | | |

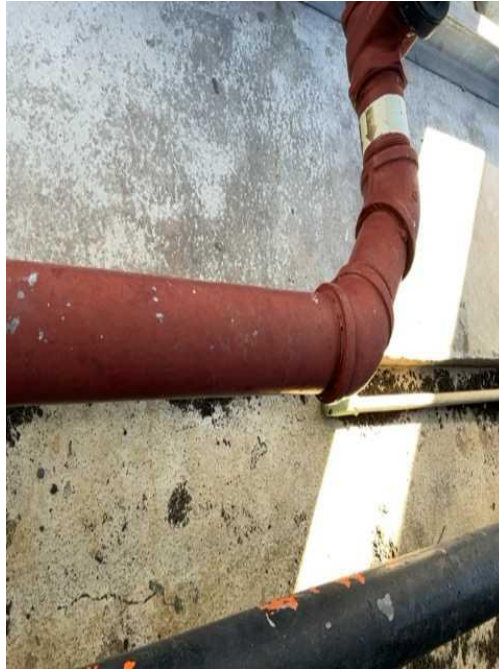
| [Photo 30] | | | IMG-202503071012321232100958.jpg |

| BB connection on tank piping. This connection appeared to be sealed at the time of the inspection. | | | |

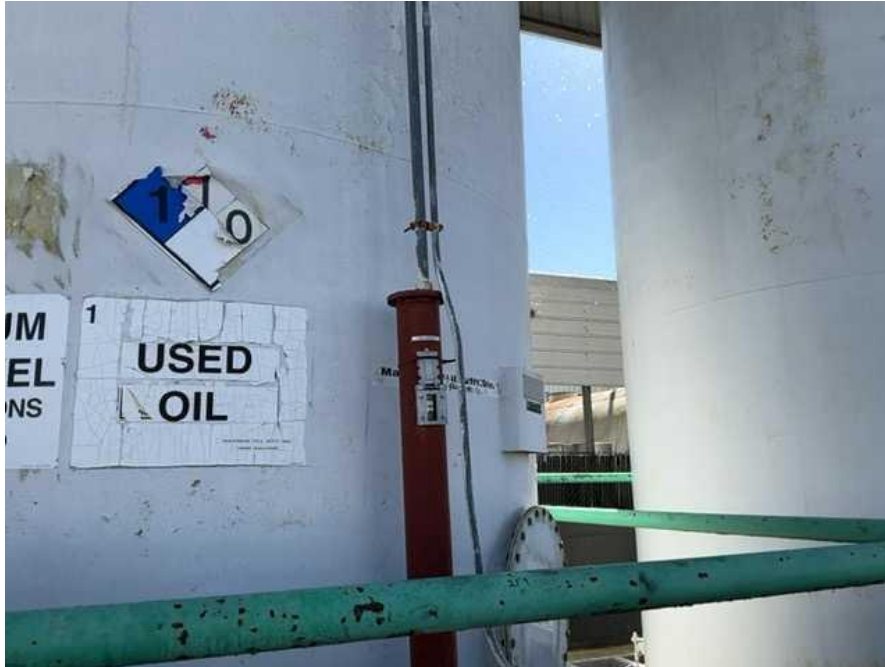
| [Photo 31] | | | IMG-20250307101548154869524.jpg |

| Visual gauge in front of used oil tank. | | | |

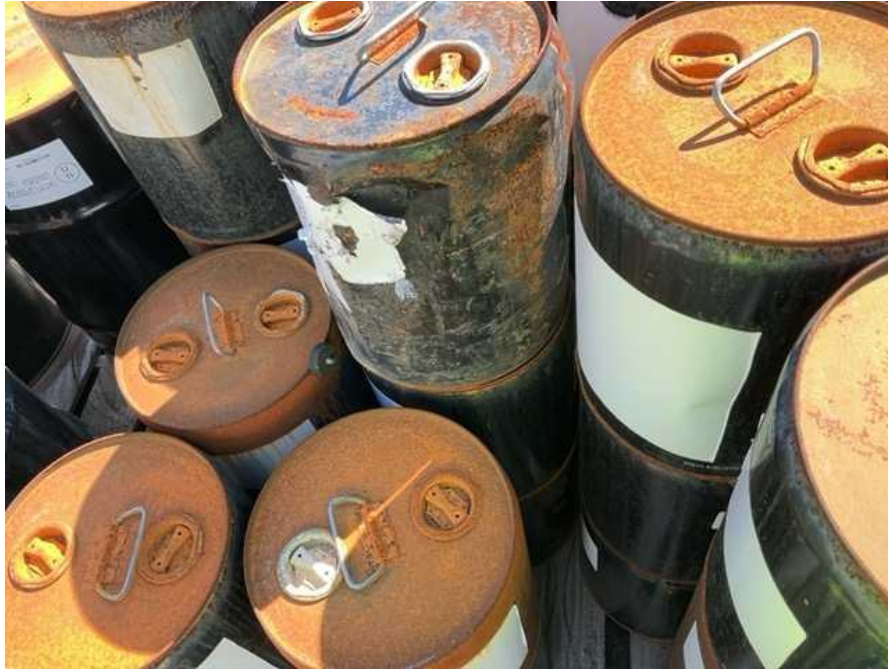
| [Photo 32] | | | IMG-202503071019501950114225.jpg |

| Rusty cans of paint product outside product storage trailer. | | | |

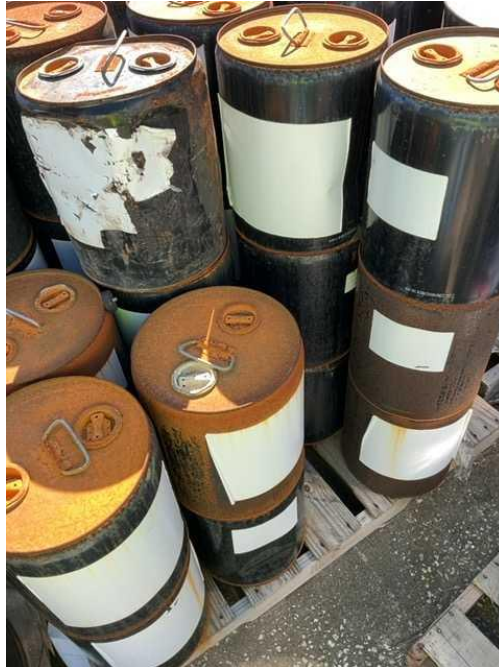
| [Photo 33] | | | IMG-202503071019551955115520.jpg |

| Rusty paint cans observed outside product storage. | | | |

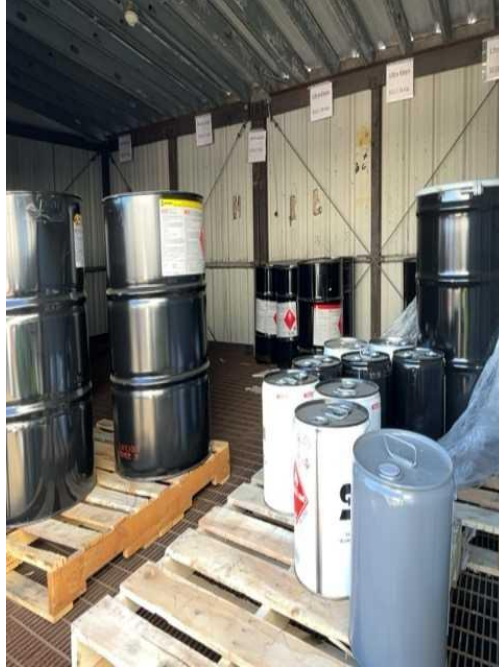
| [Photo 34] | | | IMG-20250307102152215290282.jpg |

SK manages a trailer in the facility parking lot for product storage (Photo 34). No waste was observed in this area.

| Paint storage area | | | |

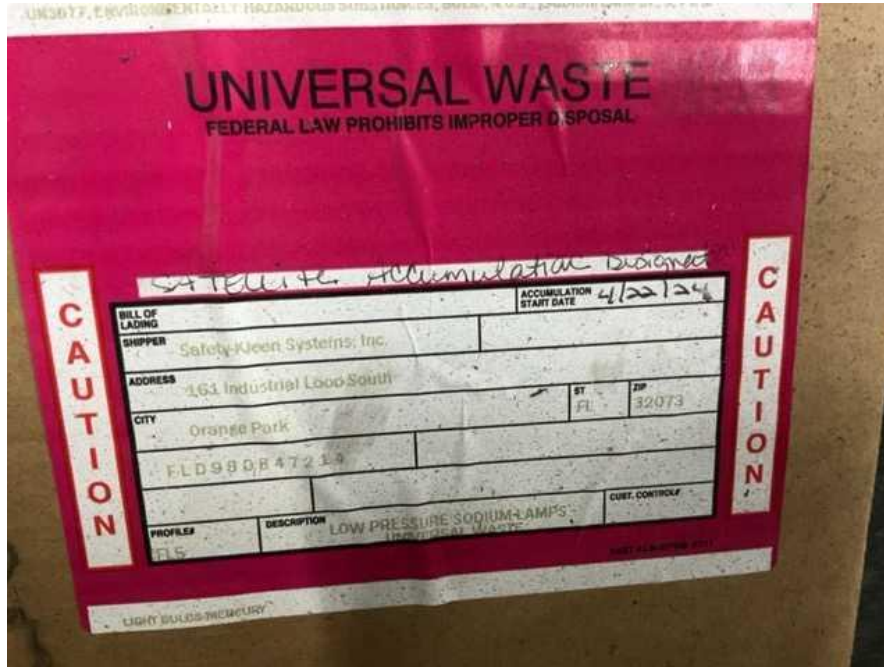
| [Photo 35] | | | IMG-20250307102722272296600.jpg |

| Label on Universal Waste Lamps | | | |
