## **RCRA Inspection Report**

Rohm & Haas Chemicals LLC (RHC)  
730 Dale Avenue  
Knoxville, Tennessee 37921  
Knox County

September 12, 2023; 8:35 am – 4:30 pm.

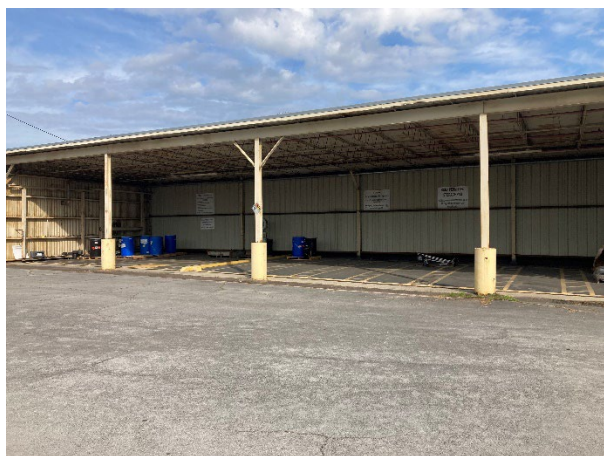
Photograph 1: Permitted Container Storage Area and CAA for containers.

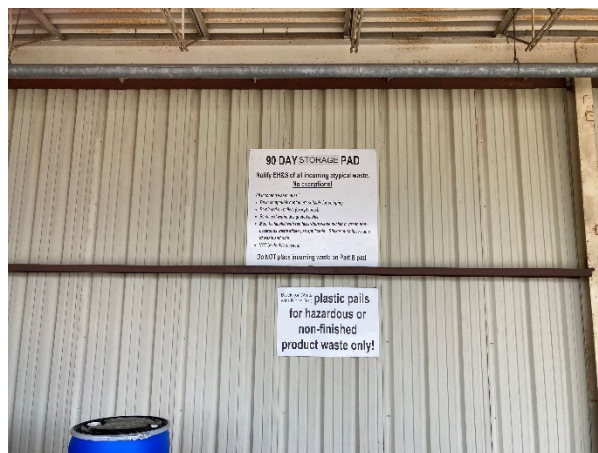
RHC manages a CAA adjacent to with their permitted hazardous waste storage area (Photos 4-8). The area was identified with appropriate signage. The CAA is equipped with an internal communications or alarm system capable of providing immediate emergency instruction to facility personnel; it is equipped with a device capable of summoning emergency assistance from local police departments, fire departments, or state or local emergency response teams; it is equipped with portable fire extinguishers, fire control equipment, spill control equipment, and decontamination equipment; and it is equipped with water to supply water hose streams, or foam producing equipment, or automatic sprinklers, or water spray system.

Photograph 4: Signage for CAA for containers.

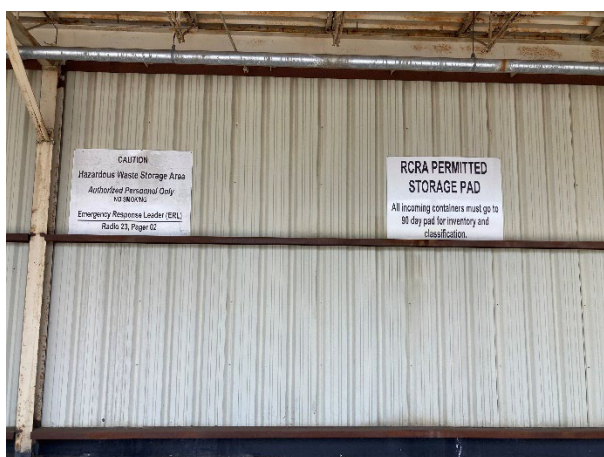
Photograph 2: Signage for Permitted Container Storage Area.

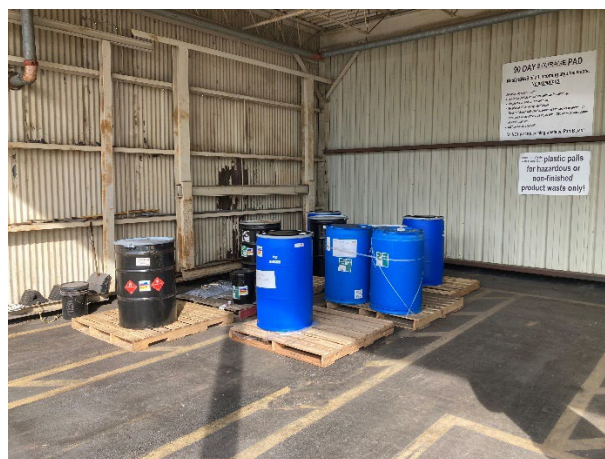
At the time of the inspection, there was one 5-gallon plastic pail labeled as non-hazardous waste, three 55-gallon metal containers labeled as WS94, WS75 and WS50 hazardous waste, respectively, six 55-gallon containers labeled as non-hazardous waste, one 50-pound bag labeled as non-hazardous waste, two 55-gallon containers of WS92, and two 55-gallon containers of used oil were stored in the 90-day area of the shed. Each container was in good condition, closed, and labeled as to the indication of hazards of its contents. The oldest ASD for these containers was August 25, 2023. One 55-gallon container of building steel debris was not labeled with an indication of the hazard (Photo 7). The inspection team noted one area where the floor of the CAA had been repaired. This area did not appear to have been resealed after the repair. RHC documented that the floor was re-sealed in this area and added newly painted lines to re-establish aisles.

Photograph 5: CAA for containers.

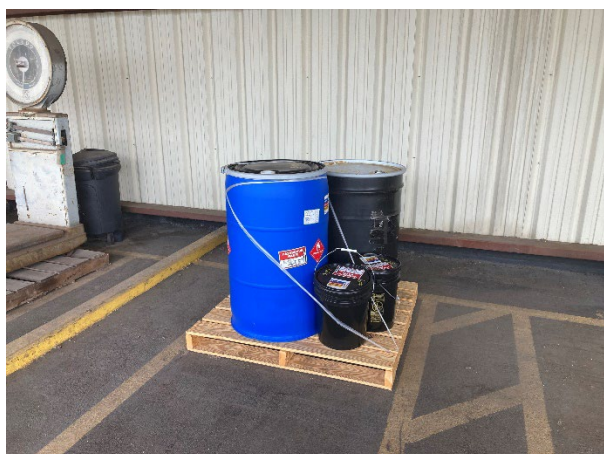
| Container Size | Waste (WS#) | Accumulation Start Date and Photo Number |
|---|---|---|
| One 55-gallon black metal container | Spent aerosol cans (WS94) | 8/4/2023 – Photo 3 |
| One 55-gallon blue poly container | Diesel and Sand | 7/19/2023 – Photo 3 |
| Two 5-gallon plastic containers | One for Sharps and one for Lab Pack Code B | 8/24/2023 – Photo 3<br>9/1/2023– Photo 3 |

Each container was in good condition, closed, and labeled with the words "Hazardous Waste" and with the indication of the hazard. The oldest ASD was July 19, 2023. The inspection team noted pre-cursors to cracks developing in the floor of the area (Photo 8). The inspection team also noted that the sump underneath the grates were partially full of dirt and debris. The inspection team recommends that this sump area be cleaned out when buildup of debris is noted. These are areas of concern for the inspection team.

Photograph 3: Permitted Container Storage Area .

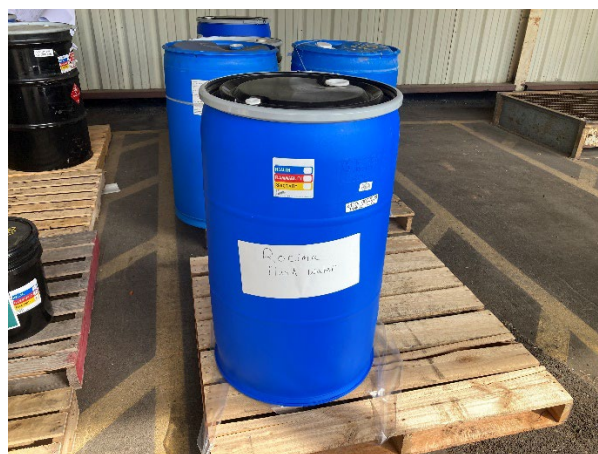
Photograph 6: CAA for containers.

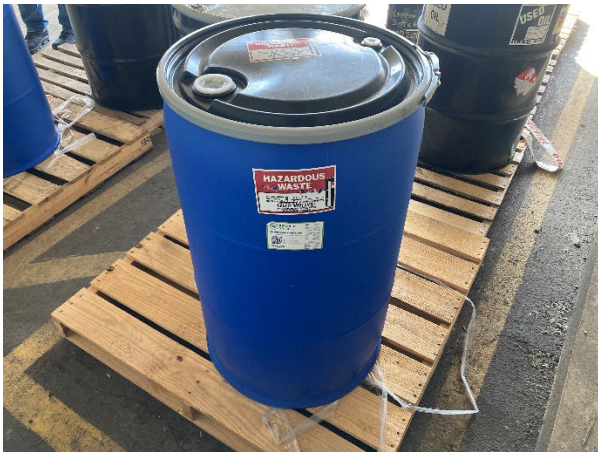
Photograph 7: CAA for containers.

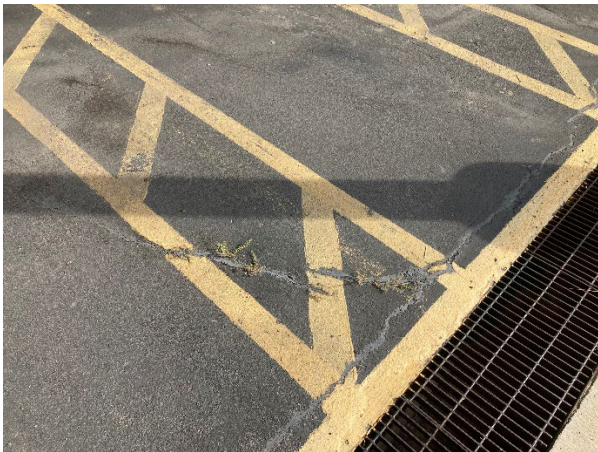
Photograph 8: Floor of Hazardous waste container CAA.

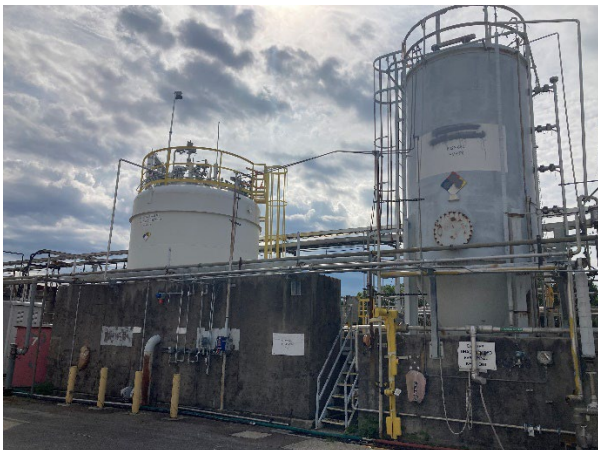
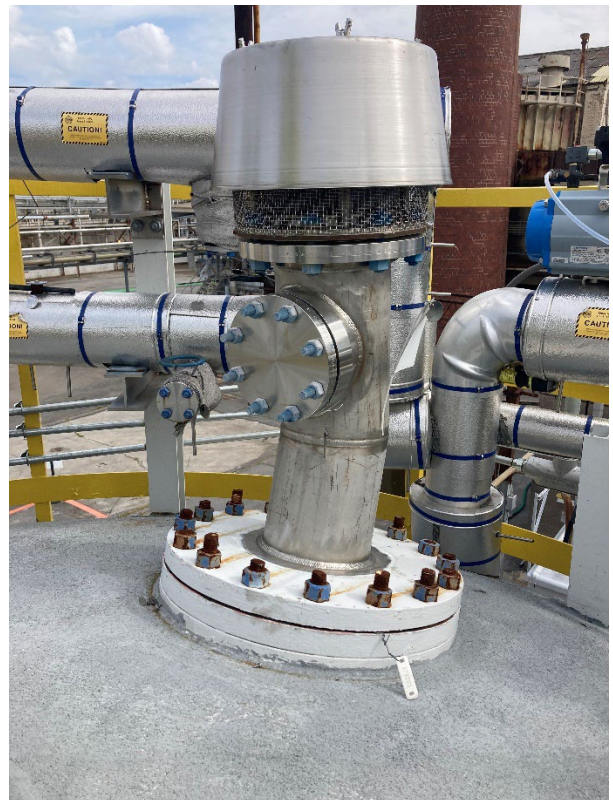
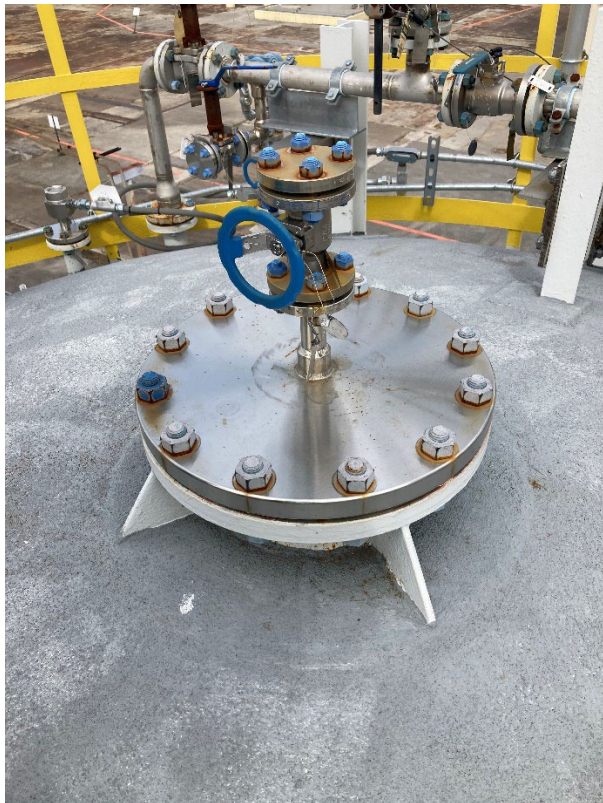
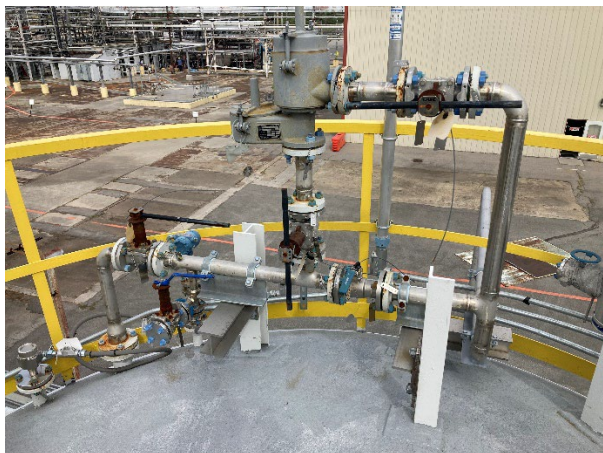
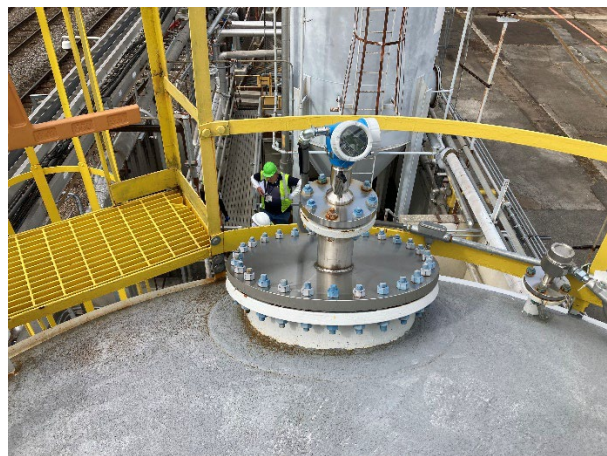
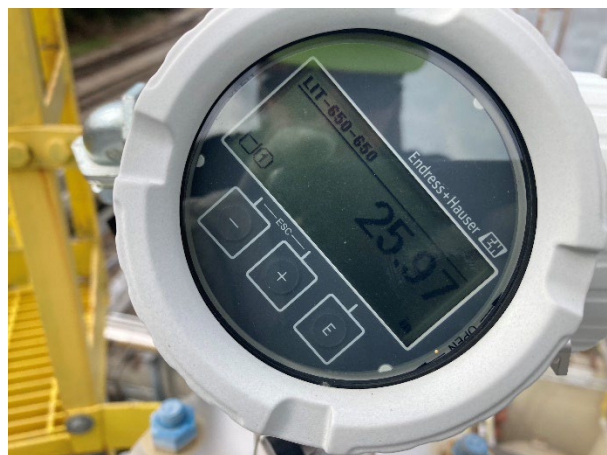
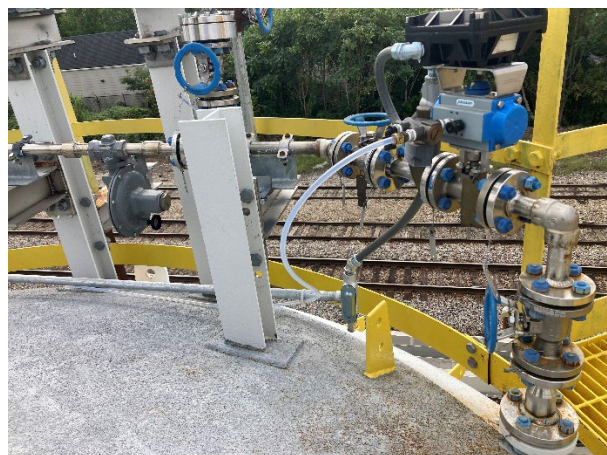
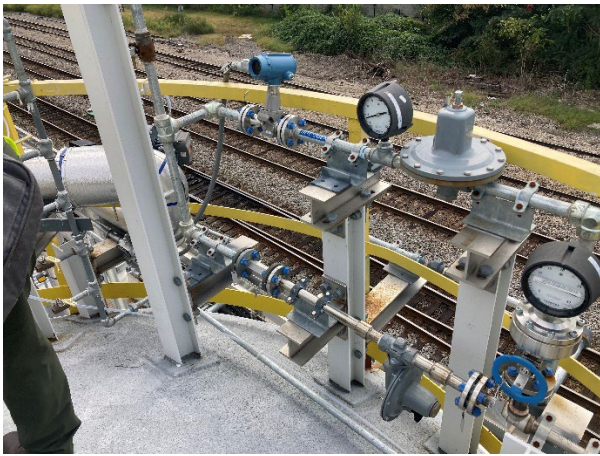
RHC operates one CAA 6,500-gallon hazardous waste tank for storage of process waste which is shipped out as waste flammable liquids (Xylene) D001 (Photos 9-17). The first waste managed in this tank was in November 2021. Hazardous waste is generated during the process and transferred to this tank via pipeline or container. This tank is housed in a secondary containment dike. This tank is subject to RCRA Subpart BB and CC regulations. Tank 650 has a vacuum/pressure relief valve (VPRV) which is the primary means of emission control. The tank is also connected to the site closed-vent system and thermal vapor incinerator. Ancillary equipment for Tank 650, which consist of 51 valves, 1 pump (inspected monthly), 1 spill stop, and 1 relief valve, are subject to subpart BB and inspected on a quarterly basis and recorded in a log.

The CAA tank was labeled with the words “Hazardous Waste” and the indication of the hazard. The indication of the hazard label was damaged. Although still legible, the inspection team recommends that the label be replaced. Records show that the tank was last emptied on August 29, 2023, well within the last 90 days. The inspection team noted that the piping to the process was labeled with an incorrect tank number. Formerly these lines were used to transfer waste from the process to the permitted hazardous waste tank (Tank 660) that was closed in

2021. There was also a section of the transfer line that had been replaced but was not painted to match the remaining transfer line. The inspection team noted some debris inside the secondary containment of Tank 650. This is an area of concern for the inspection team, and it is recommended that the debris be removed on a regular basis or as accumulated.

Photograph 9: Hazardous waste tank CAA.

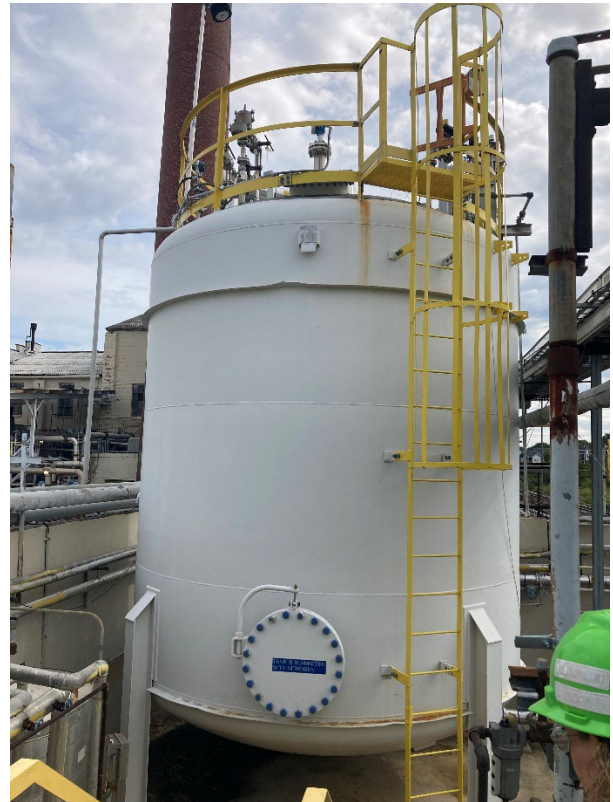
Photograph 10: Former Hazardous waste permitted tank.

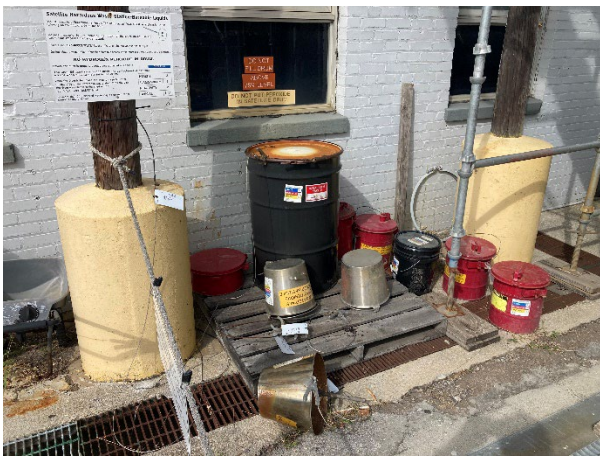
| Area | Container size and waste accumulated | Comments (Photo #) |
|---|---|---|
| Pumphouse Nine | One 55-gallon metal container of mixed monomers (WS 29) | (Photo 18) |

Photograph 18: SAA Pumphouse 9.

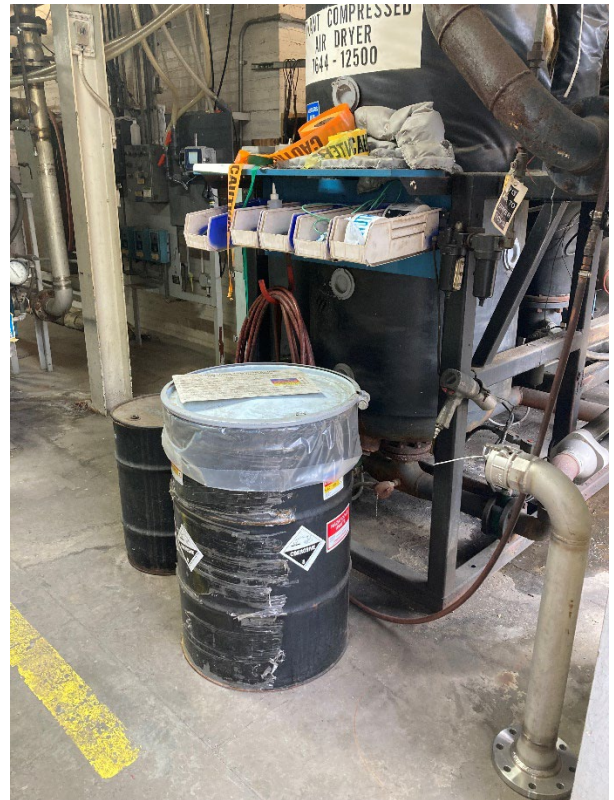
| Area | Container size and waste accumulated | Comments (Photo #) |
|---|---|---|
| Scrubber area | One 55-gallon metal container for spent caustic Filters (WS112) | There was no waste in this container on the day of the inspection (Photo 19) |

Photograph 19: SAA Scrubber Area.

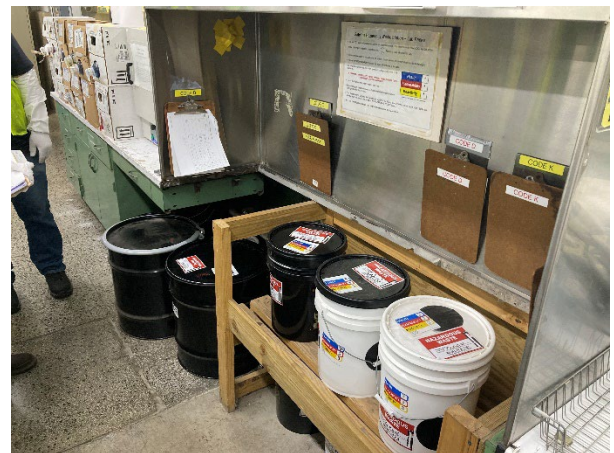
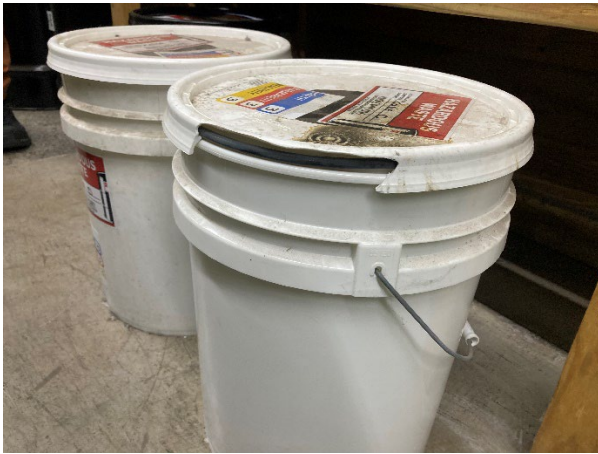
| Area | Container size and waste accumulated | Comments (Photo #) |
|---|---|---|
| QC Laboratory | Five 5-gallon containers for Code B, Code C, Code D, Code K, Code O, and Sharpes hazardous waste (WS15)<br>One 20-gallon container for contaminated glass (WS50) | The Code O container had a broken lid and was open (Photos 20-21) |

**Pursuant to Tenn. Comp. R. & Regs. 0400-12-01-.03(1)(f)1.(iv) [40 C.F.R. § 262.15(a)(4)], which is a condition of the SAA Permit Exemption, a generator is required to keep containers of hazardous waste closed at all times during accumulation, except when adding, removing, or consolidating waste; or when temporary venting of a container is necessary for the proper**

Photograph 20: SAA laboratory.

Photograph 21: SAA laboratory.

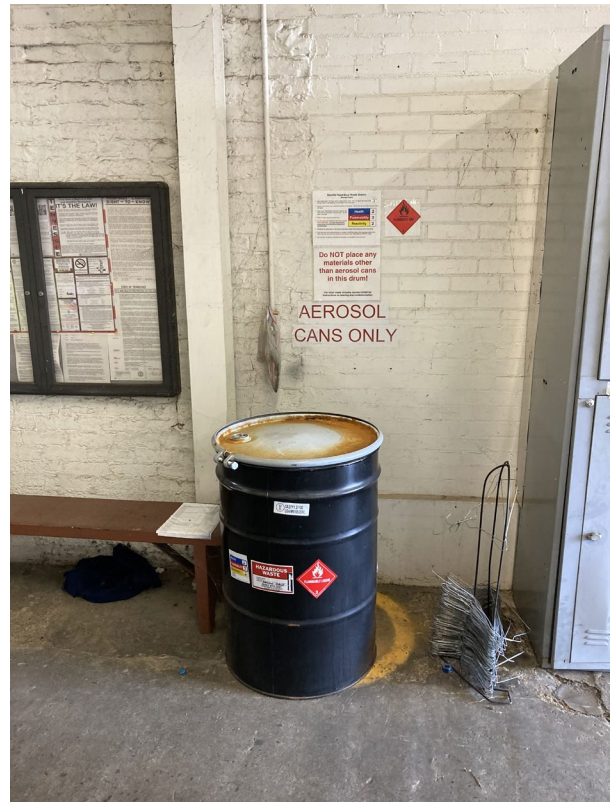
| Area | Container size and waste accumulated | Comments (Photo #) |
|---|---|---|
| Maintenance shop | 55-gallon metal container of Aerosol Cans (WS94) | (Photo 23) |

Photograph 23: SAA Maintenance Shop.

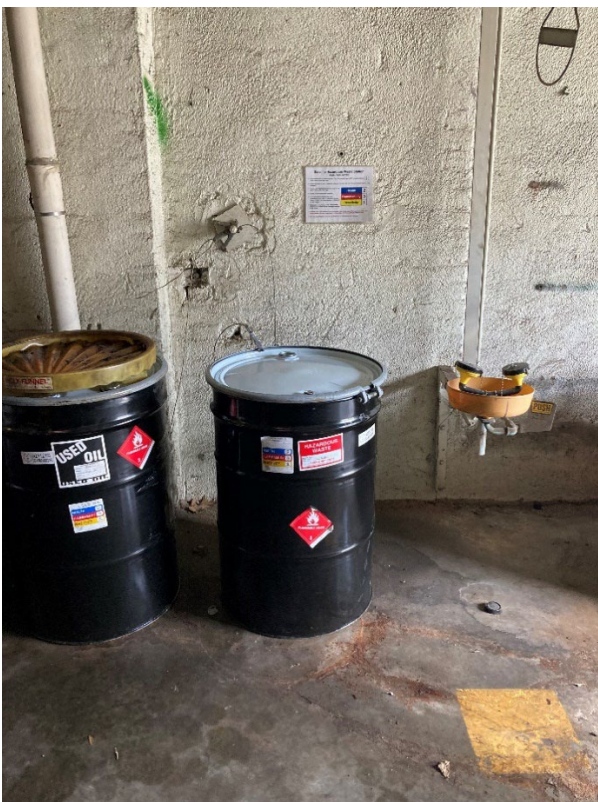
| Area | Container size and waste accumulated | Comments (Photo #) |
|---|---|---|
| Used Oil Room<br>Lower Paint Shop | Two 55-gallon containers of Used oil<br>One 55-gallon container of SAA paint related material (WS75) | (Photo 22) |

Photograph 22: SAA Used Oil Room.

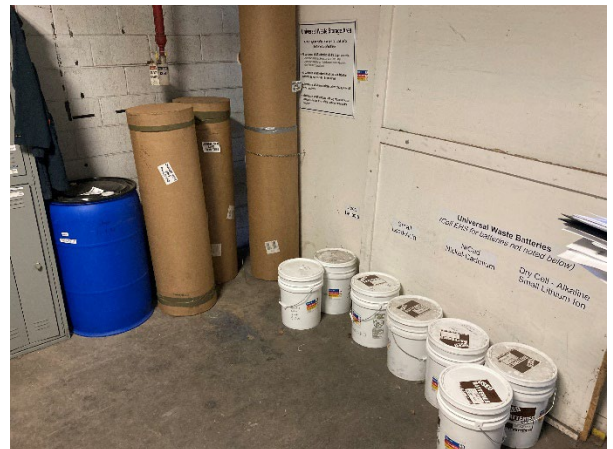
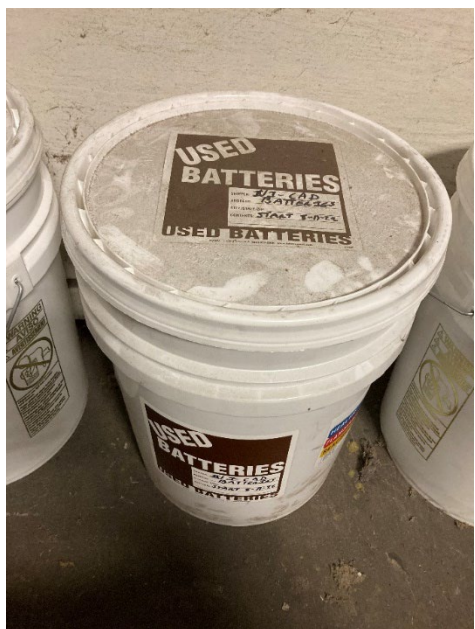
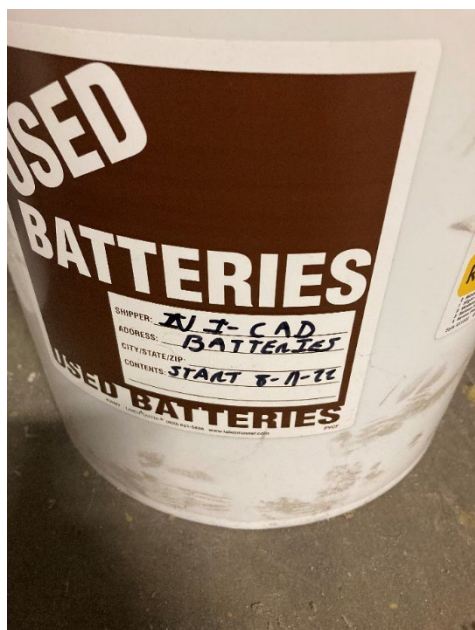
RHC manages universal waste (UW) lamps and batteries in the electrical shop (Photos 24-26).

Each of the containers of lamps and batteries was in good condition, closed, labeled as universal waste, and marked with an ASD. The ASD for the NiCad batteries was listed as August 11, 2022; however, shipping records indicated that this date had not been changed on the container when the most recent shipment was sent off site. The oldest date observed on any container of UW batteries was May 5, 2023, and on any container of UW lamps was December 1, 2022.

Photograph 24: Universal Waste Storage in Electrical Shop.

Photograph 25: UW Li-Ion battery storage bucket.

Photograph 26: UW Li-Ion battery storage bucket.
