**Report Title:** Clean Water Act Compliance Inspection Report  
**Inspection Date(s):** August 8, 2023  
**Regulatory Program(s):** National Pollutant Discharge Elimination System (NPDES)  
**Type of Activity:** CAFO Inspection  
**Facility Name:** J&D Farms  
**Facility Address:** 16833 Wilson Hill Road, Georgetown, DE 19947  
**Facility Latitude:** 38.712852  
**Facility Longitude:** -75.416489  
**County/Parish:** Sussex County  
**CAFO Permit No:** DE5000N11  
**Site Specific Permit No:** DEA117089  
**NAICS Code:** 112310  
**SIC:** 0251  
**Unique Project #:** 3E23WN109A

## DELAWARE CAFO INSPECTION REPORT

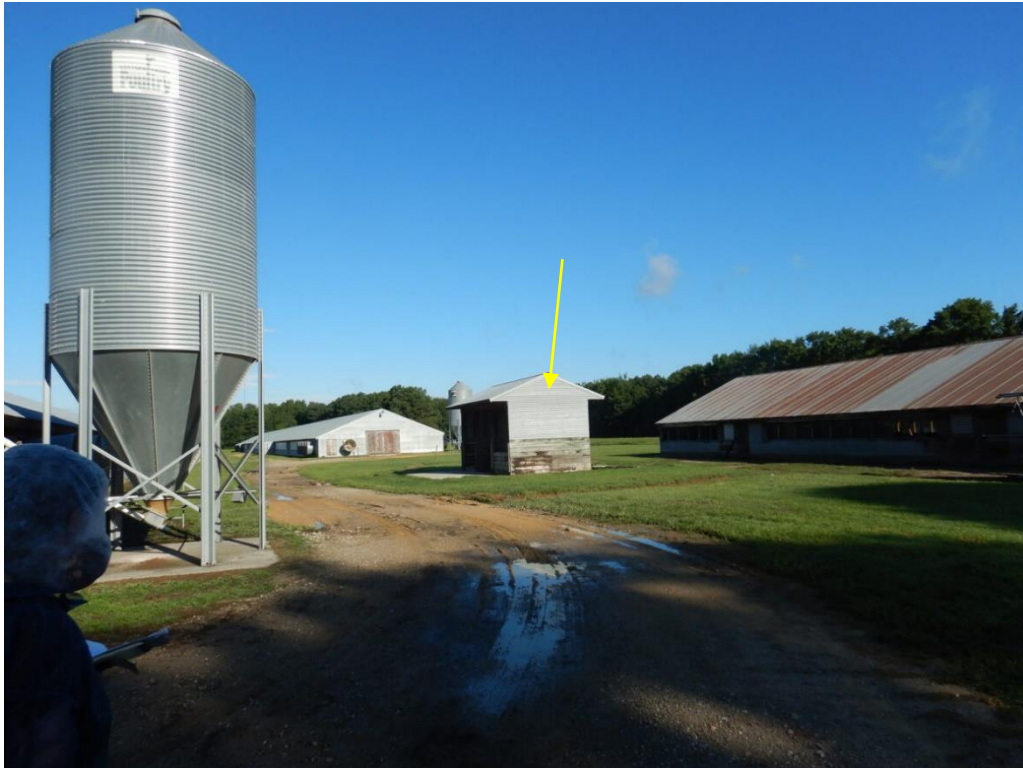
Photograph 1. View looking northwest from the eastern edge of the facility. The Poultry Barn 1 feed storage is shown on the left side of the photo and the mortality composting shed (indicated by the arrow) and Poultry Barn 2 are shown in the center of the photo. The barn at the right side of the photo is not in use.

Manure is windrowed inside the barns, and the piles are turned every 3-4 days. Manure is removed once per year by the manure recipient directly from the west ends of the poultry barns. The facility has a manure storage shed onsite, but it is currently used for equipment storage. Mortalities are composted in a compost shed located east of the Poultry Barn 2 (Photographs 1 and 2).

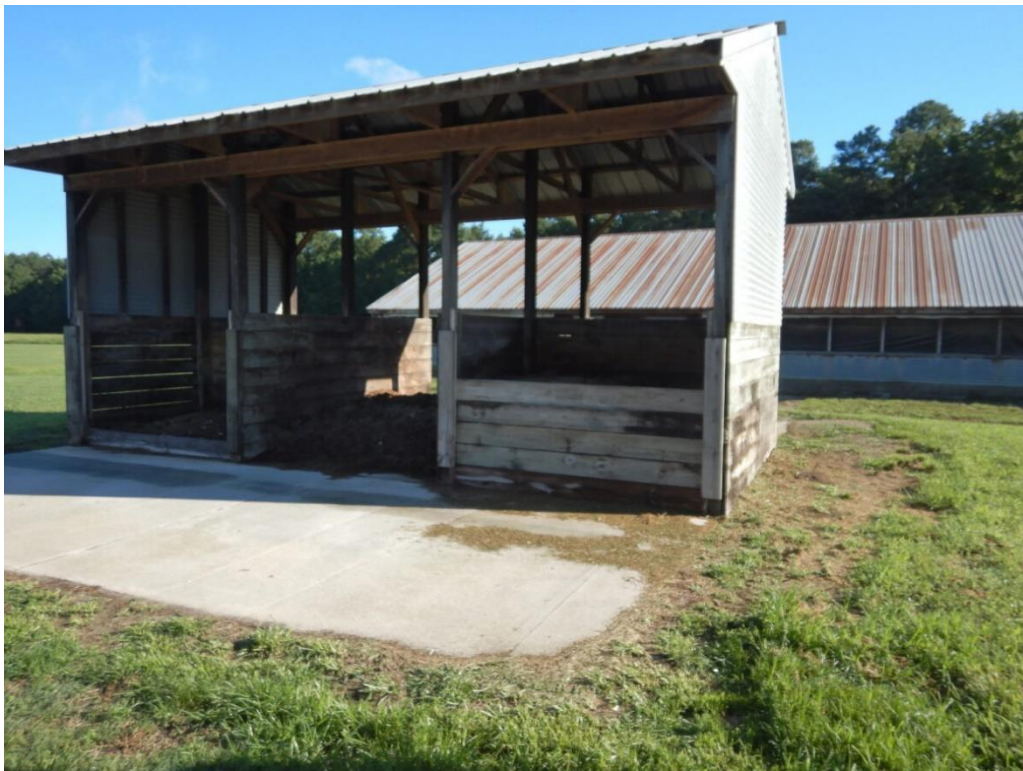
Photograph 2. View looking north at the mortality composting shed. The EPA inspection team did not identify the nature of the material on the concrete.

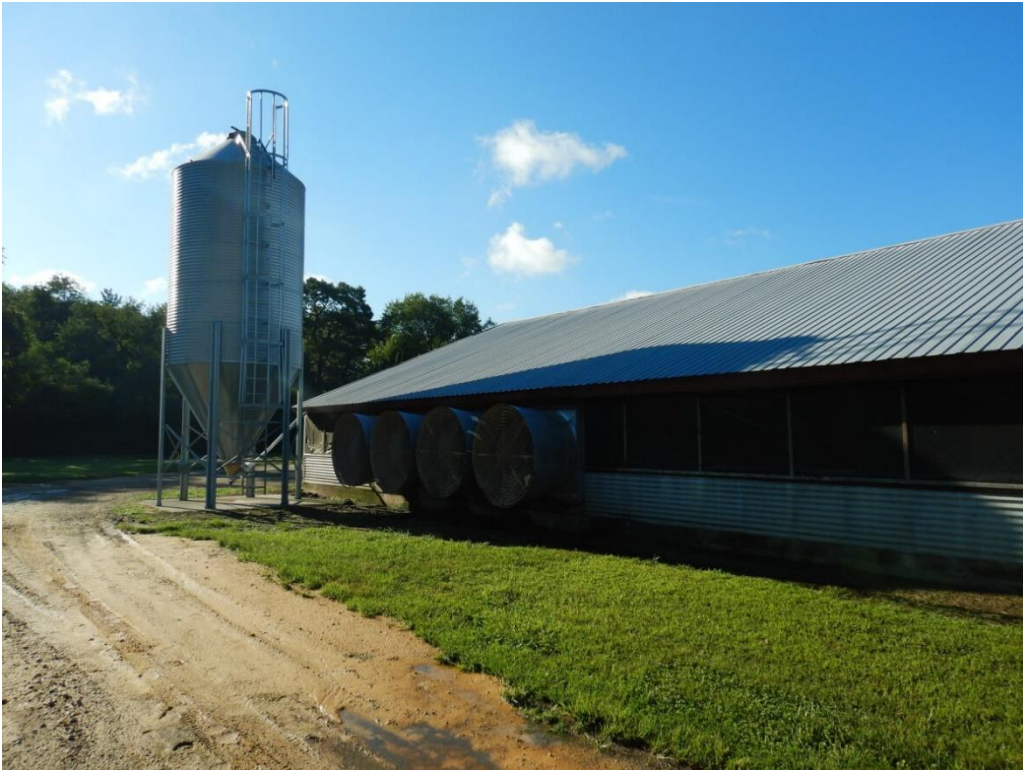
Photograph 3. View, looking southeast, of the exhaust fans and feed storage bin located on the northeast corner of Poultry Barn 1.

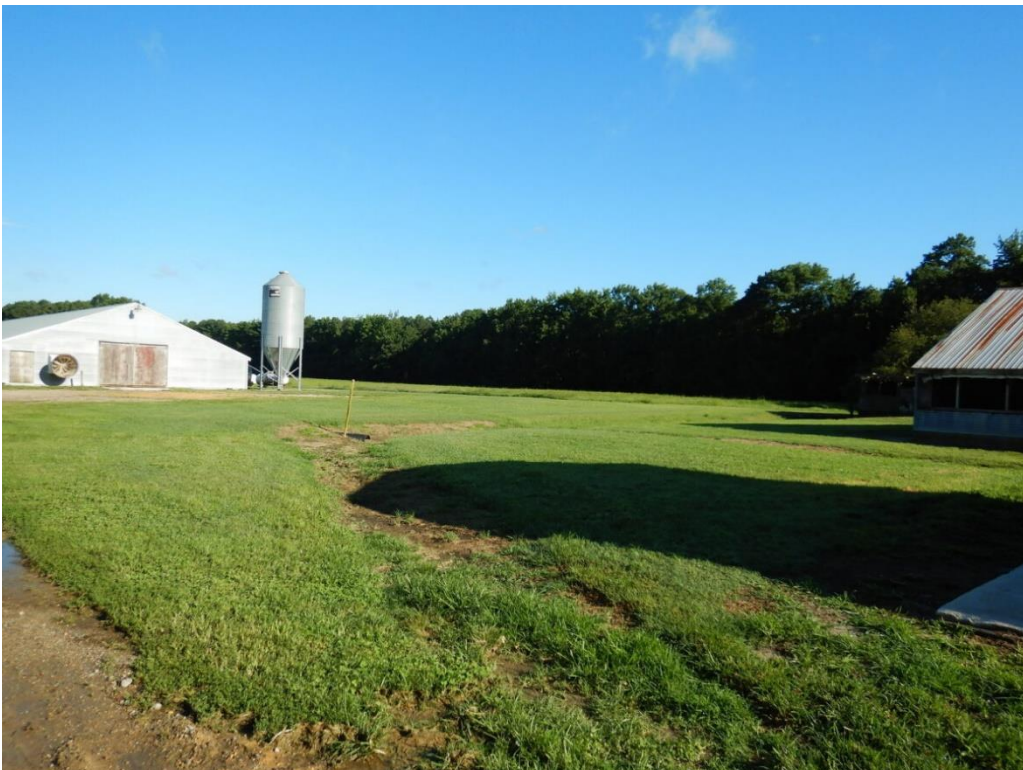
Photograph 4. View looking northwest along the swale running west of the mortality compost shed. Poultry Barn 2 is visible at the left side of the photo.

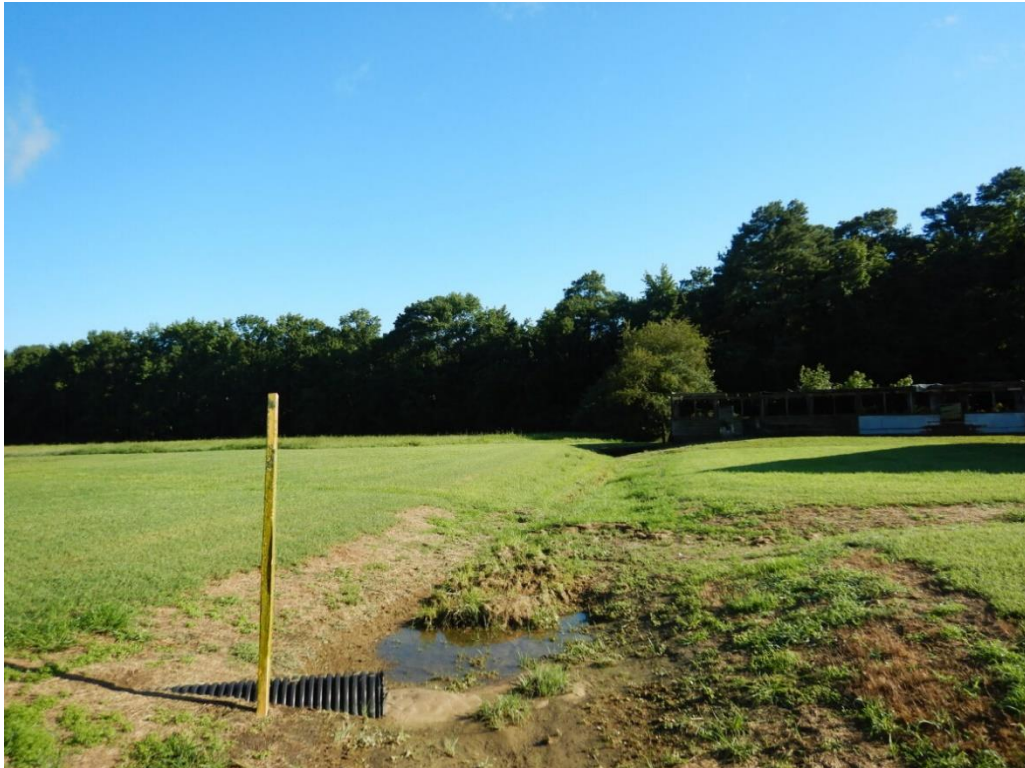
Photograph 5. View of a culvert that outlets into the swale shown in Photograph 4. The swale directs flow towards the northern boundary of the facility.

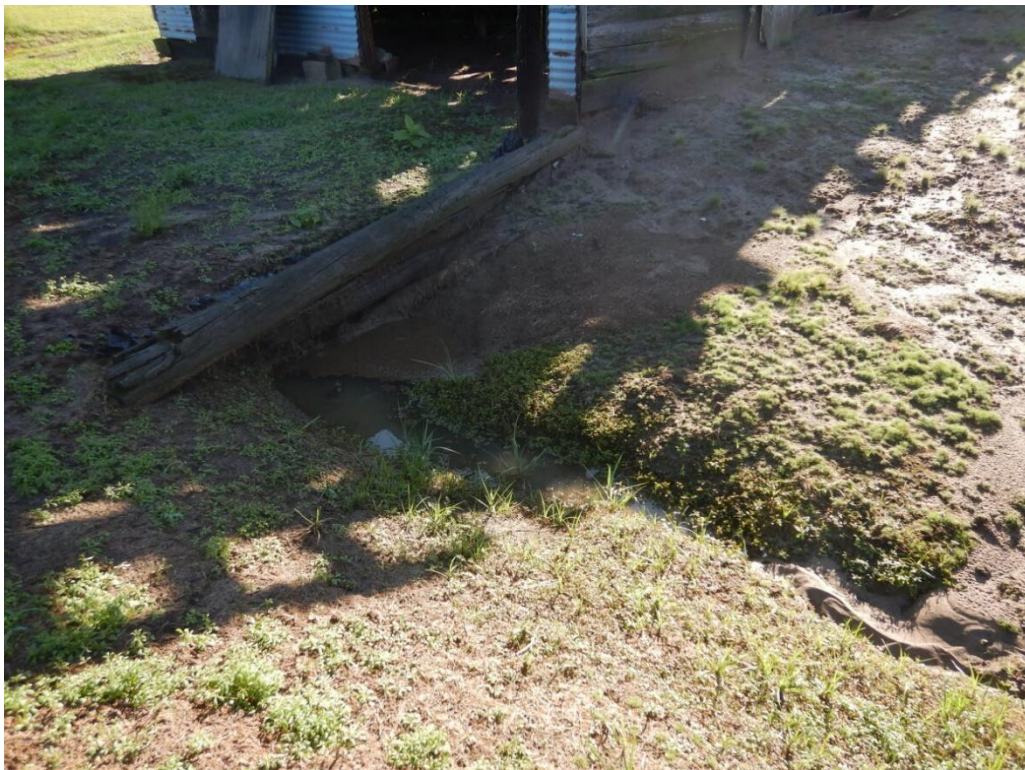
Photograph 6. View of the swale shown in Photographs 4 and 5, near the northern edge of the production area. The swale appeared to continue under the wood framework supporting the sloped building entrance, visible in the upper left part of the photo. The photographer is standing on the west side of the swale.

During periods of heavy rain, the swale located northeast and east of Poultry Barn 2 would appear to capture runoff from the areas around the mortality composting shed and poultry barn exhaust fans as well as some roof runoff from the poultry barns. Runoff captured in the area around the exhaust fans located on the southeast corner of Poultry Barn 2 would appear to flow into a culvert located immediately south of the exhaust fans along the north side of Poultry Barn 1. During the site tour, the inspectors noted accumulated feathers near these exhaust fans (Photographs 12-14, and 21). From this culvert inlet, runoff would appear to flow northeast under the facility road through the culvert and into the swale (Photograph 5). From this point, runoff would appear to flow north. The inspection team observed accumulated water in this swale near one of the facility's abandoned buildings (Photograph 6); however, it appeared that runoff would continue under the wood

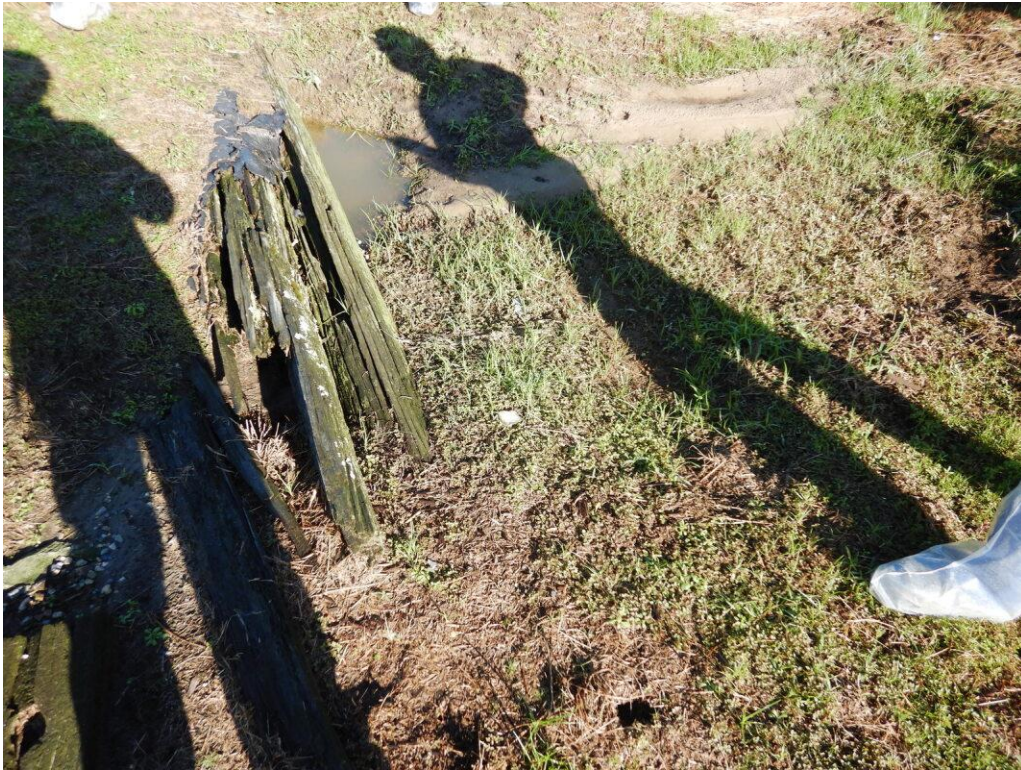
Photograph 7. View of the north side of the sloped building entrance. Note the standing water in the swale and the sediment deposition in the top right portion of the photograph which would appear to indicate flows continue away from the location of standing water, north towards the tree line at the north side of the production area. The photographer is standing on the east side of the swale.

framework supporting the sloped entrance to the building and enter the swale on the far side, continuing on towards the northern boundary of the production area (Photograph 7). There appeared to be sufficient gradient to support the flow of water during a heavy rainstorm to continue offsite into the wooded area located along the northern boundary of the production area.

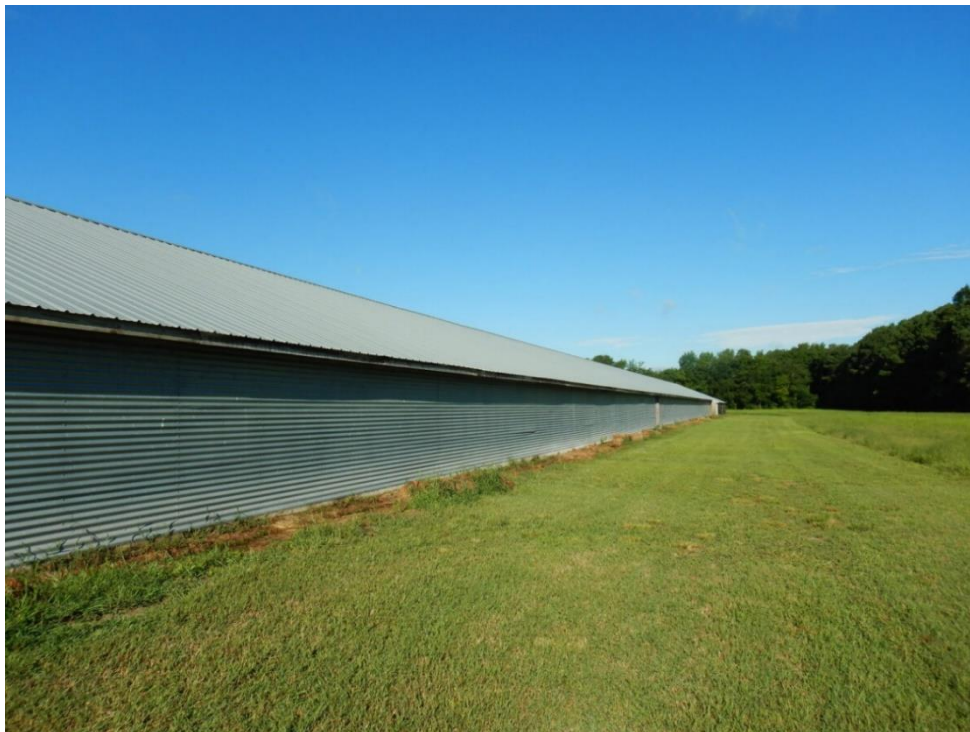
Photograph 8. View facing west along the north wall of Poultry Barn 2.

During periods of heavy rain, it would appear that runoff from the north side of Poultry Barn 2 would flow into the adjacent facility field (Photograph 8). Runoff from the manure pads located on the west side of each poultry barn would flow west into the adjacent grassy areas and facility field (Photographs 9, 11, and 19). Runoff from the area near the southwest portion of Poultry Barn 2 would flow into the adjacent grassy area (Photographs 10 and 11) and remain onsite.

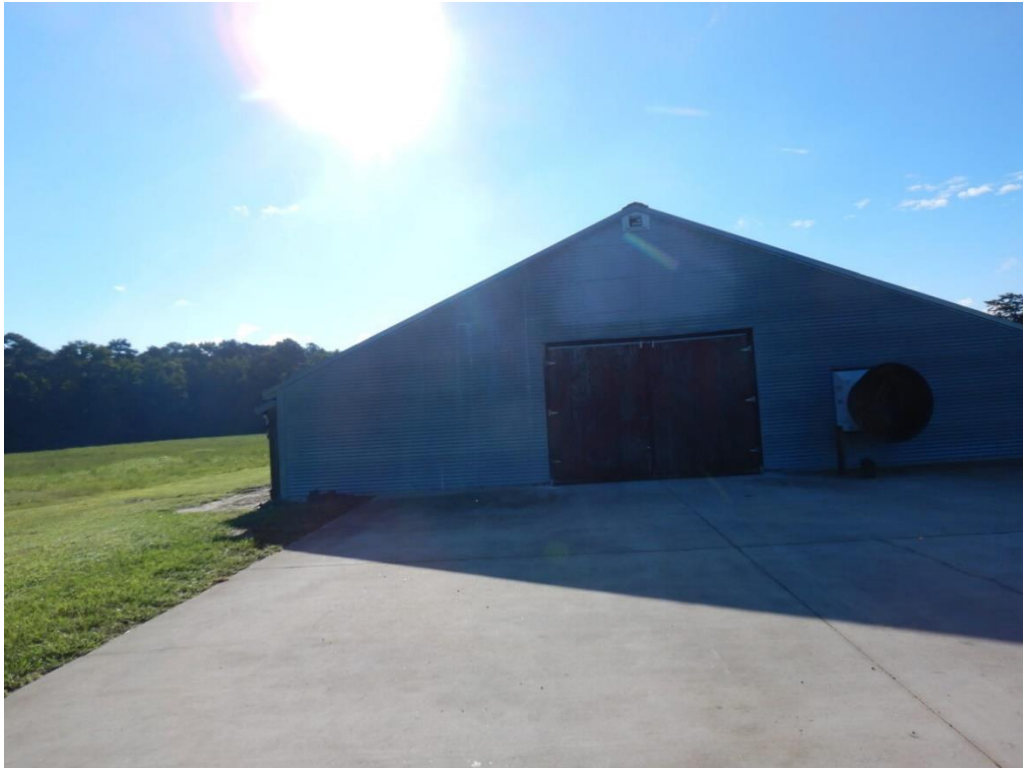
Photograph 9. View of the west side of Poultry Barn 2 and the barn's concrete pad.

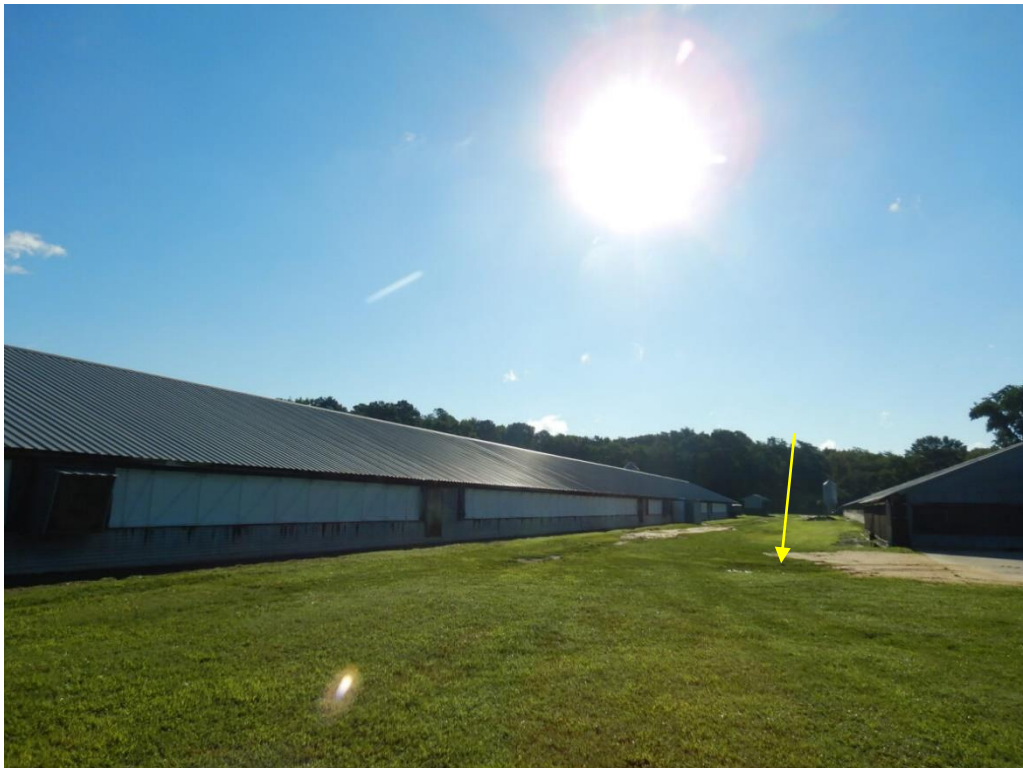
Photograph 10. View of both poultry barns taken from the western side of the facility. Poultry Barn 2 is on the left side of the photo and Poultry Barn 1 is on the right side of the photo. The arrow indicates the location of the standing water shown in Photograph 10.

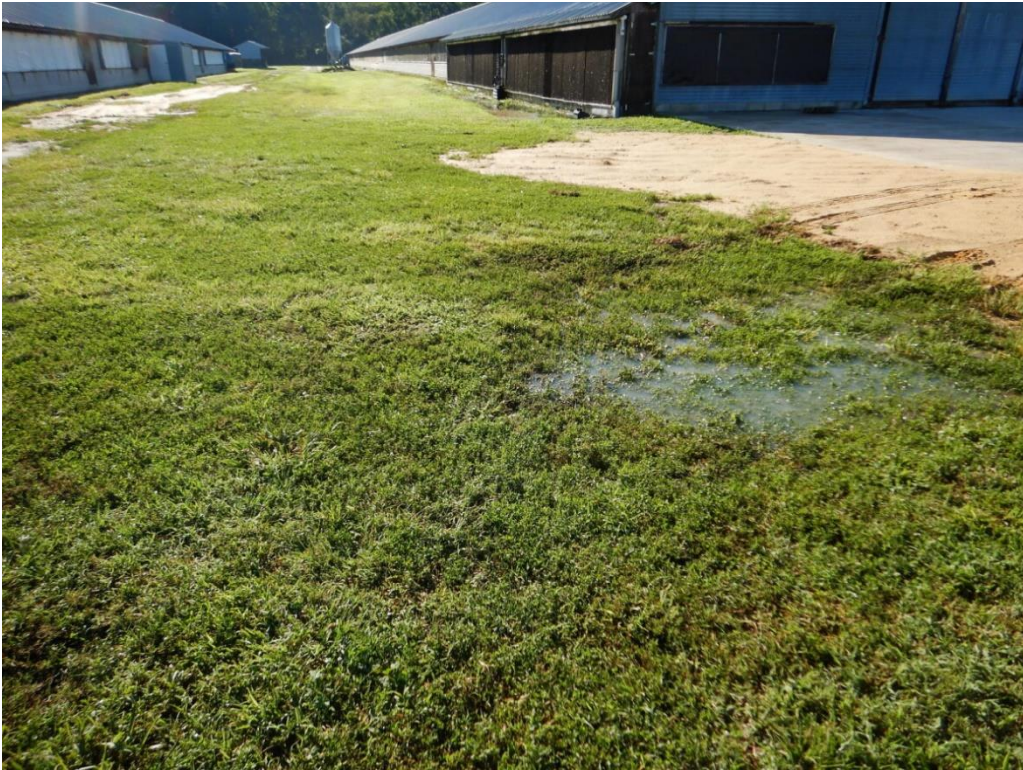
Photograph 11. View of standing water located 30-40 ft northwest of Poultry Barn 1.

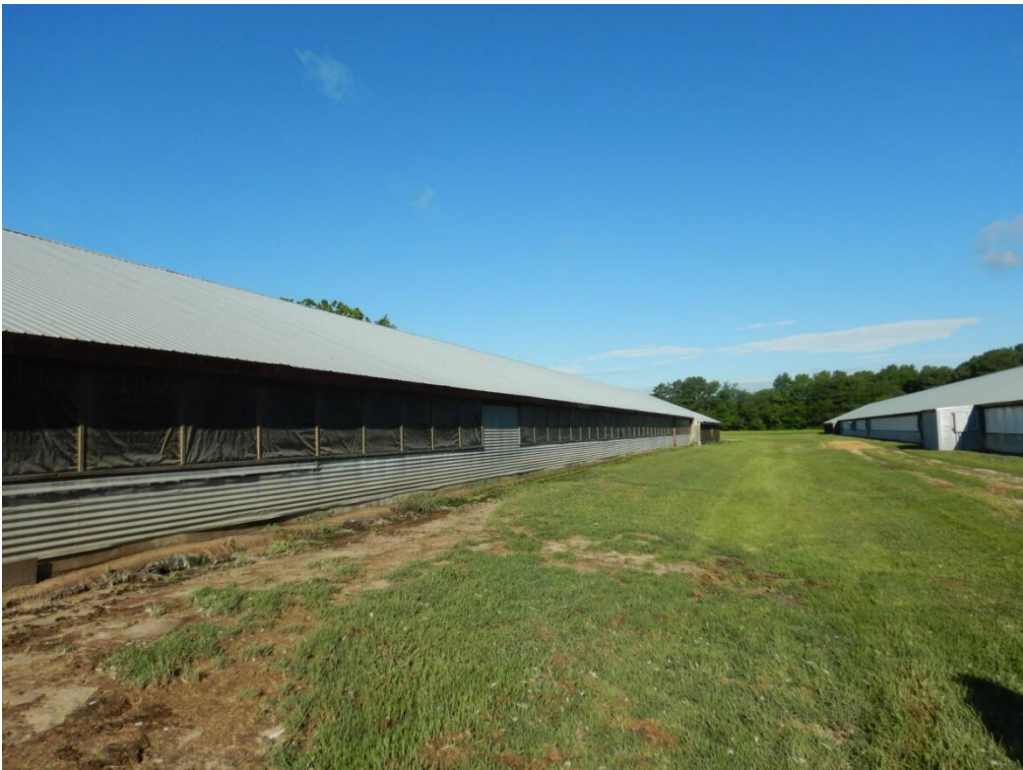
Photograph 12. View looking west at both poultry barns. Poultry Barn 1 is on the left side of the photo and Poultry Barn 2 is on the right side of the photo. Note the feathers on the ground at the bottom of the photo.

All of the animal confinement, manure storage, and mortality composting is done under roofed structures. In the areas surrounding these buildings, the inspectors saw accumulated feathers and standing water in places (Photographs 12-14, and 21). The inspectors noted that the topography of the site is generally flat. As noted on page 1 of the report, Georgetown, DE received 1.47 inches of rain the night prior to the inspection. The areas of standing water observed during the site walk appear to indicate that some stormwater is retained in low areas on the site (Photographs 10, 11, 15, and 16); however, there were other areas that appear to be swales that may carry flow, although no flow was observed exiting the site at the time of the inspection.

- While the concrete pads on the west side of the poultry barns appeared clean during the site tour, the inspection team observed standing water across from the exhaust fans on the northeast corner of Poultry Barn 1. The standing water was green and feathers were observed nearby (Photograph 14). The inspection team also observed a few other areas with accumulated feathers across from exhaust fans (Photographs 12-14, and 21). See question 40 of the Inspection Checklist below.

The inspection team also observed a few other areas with accumulated feathers across from poultry barn exhaust fans (Photographs 12-14, and 21). Runoff from these areas would flow into either the depression on the south side of Poultry Barn 1 or into the swale directing runoff toward the northern facility boundary.

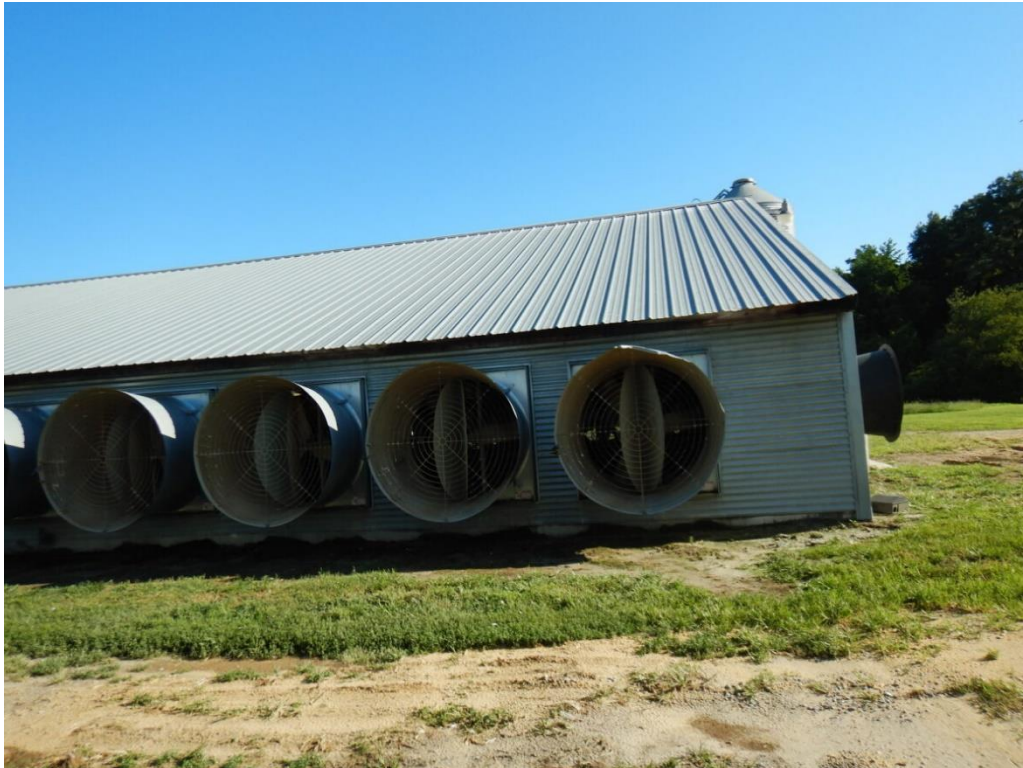
Photograph 13. Exhaust fans on the southeast corner of Poultry Barn 2. Note the feathers on the ground beneath the fans.

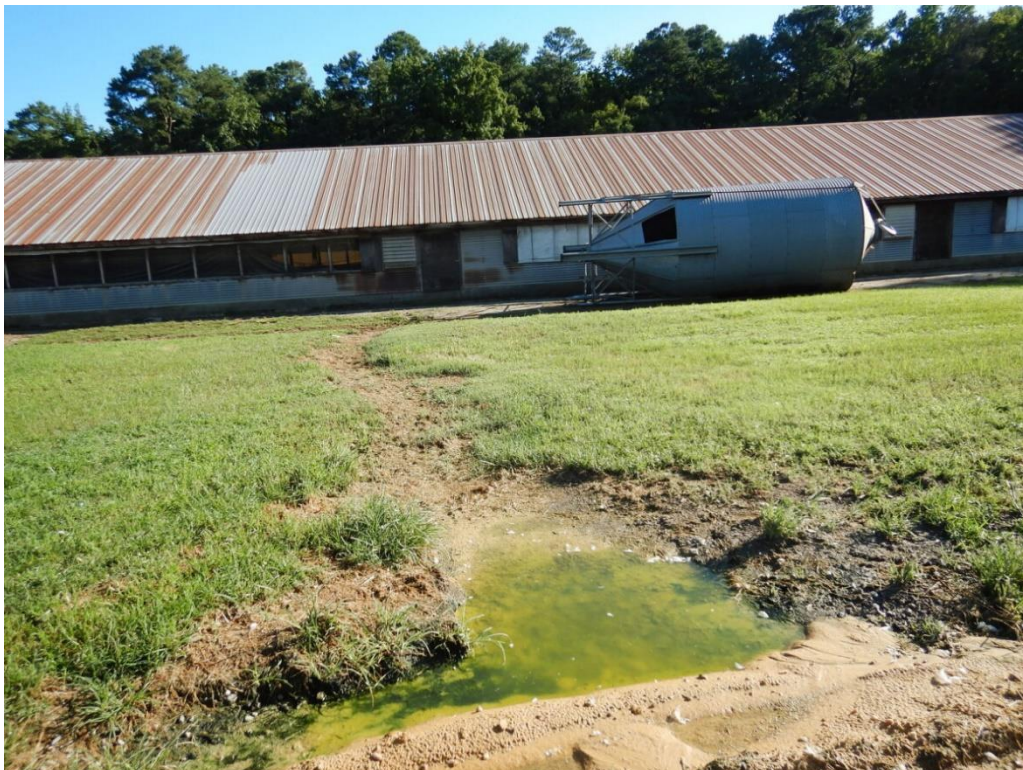
Photograph 14. View, looking north, of standing water located east of the mortality composting shed. Note the green discoloration and feathers present at the bottom of the photo.

During the site tour, the inspection team observed green standing water adjacent to the mortality composting shed and across from the exhaust fans on the northeast corner of Poultry Barn 1 and also observed accumulated feathers nearby (Photograph 14). It appears that during periods of heavy rain, runoff from this area of green standing water would be within the flow path directing runoff west and north into the swale running towards the northern facility boundary.

The inspection team observed green standing water and accumulated feathers adjacent to the mortality composting area and across from the exhaust fans on the northeast corner of Poultry Barn 1 (Photograph 14). It appears that during periods of heavy rain, runoff from this area of green standing water would be within the flow path directing runoff west and north into the swale running towards the northern facility boundary. As discussed in the *Inspection Overview and Facility Description* Section of this report, there appeared to be sufficient gradient to support the flow

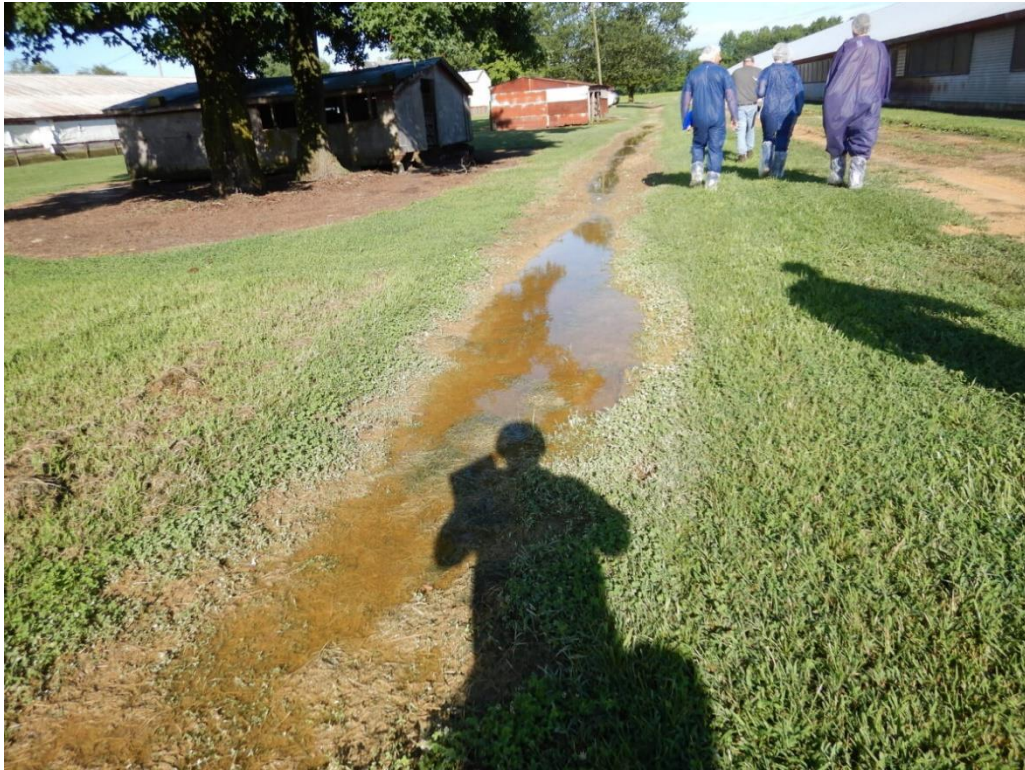
Photograph 15. View looking west along the depression located along the south side of the production area (photo taken from the southeast corner of Poultry Barn 1).

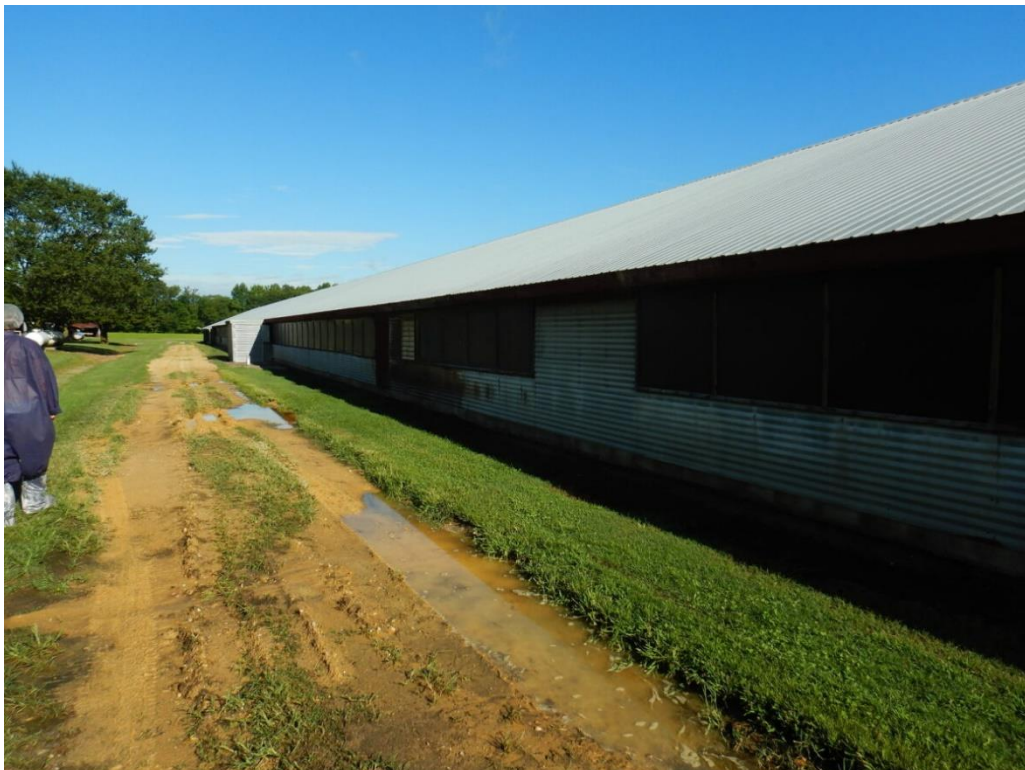
Photograph 16. View along the south side of Poultry Barn 1.

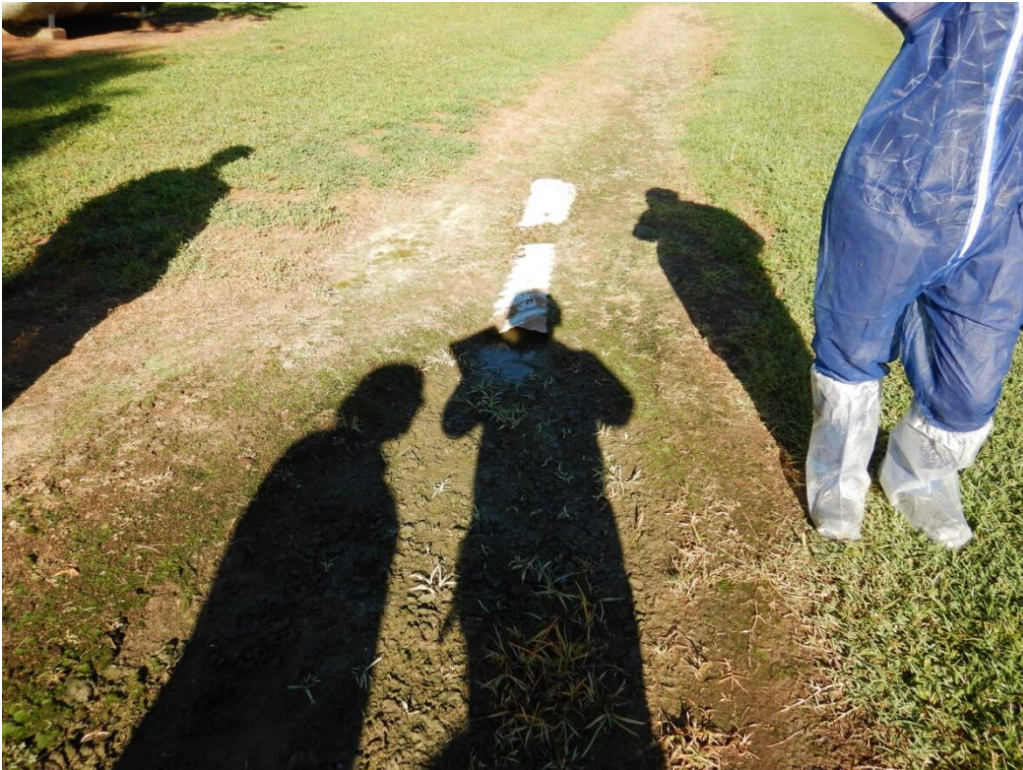
Photograph 17. View of a partially buried culvert located near the southwest corner of Poultry Barn 1. The inspectors did not determine the purpose of the culvert.

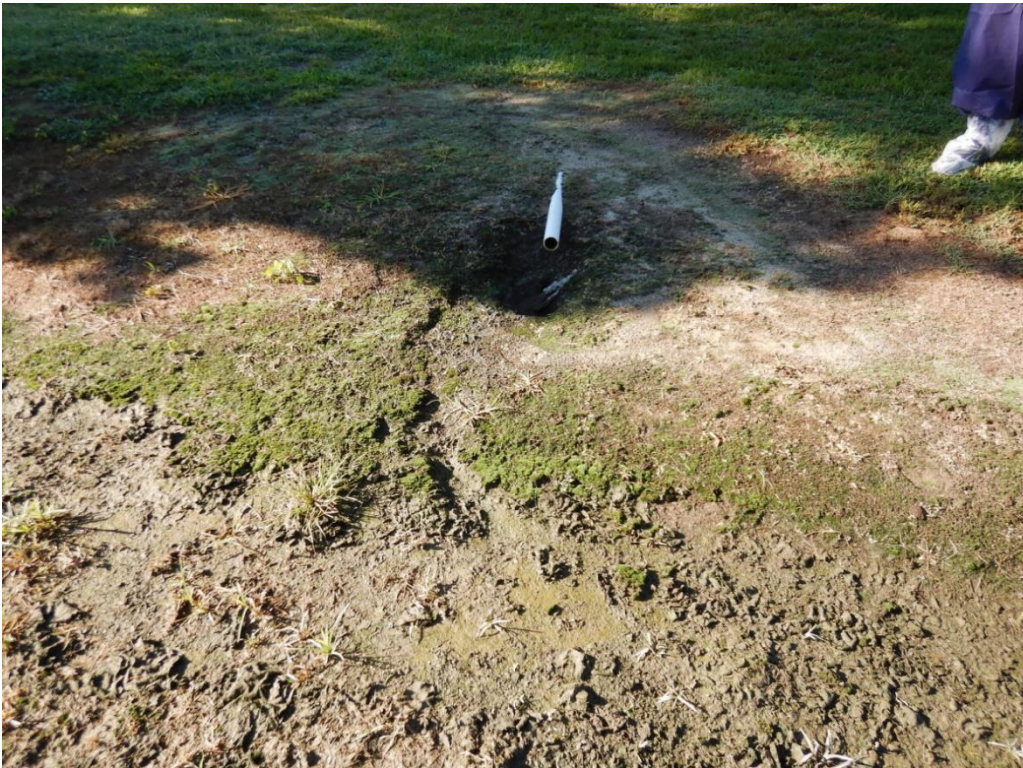
Photograph 18. View, facing south, of a PVC pipe outlet located near the southwest corner of Poultry Barn 1. The facility operator was not certain of the purpose of the pipe.

During periods of heavy rain, the depression which runs along the southern side of Poultry Barn 1 would appear to capture runoff from the areas on the south side of the building, roof runoff, and runoff from the area around the exhaust fans (Photographs 15, 16, and 20). During the site tour, the inspectors noted accumulated feathers across from the exhaust fans on the southeast corner of Poultry Barn 1 (Photograph 21). In addition, the inspection team observed a white PVC pipe near the southwest corner of Poultry Barn 1 (Photograph 18). The facility operator stated he believed that the PVC pipe was connected to a sump pump in an adjacent residence, but was not certain. This PVC pipe would drain to a production area if it were to convey flow.

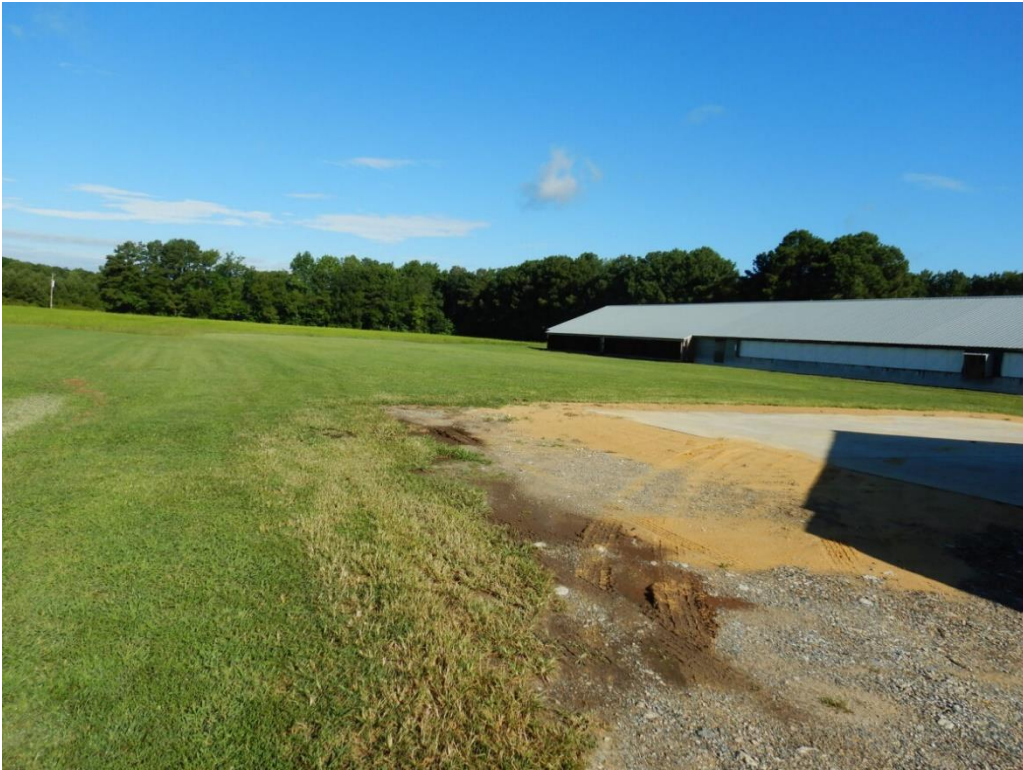
Photograph 19. View of the concrete pad on the west end of Poultry Barn 1 with Poultry Barn 2 visible in the background.

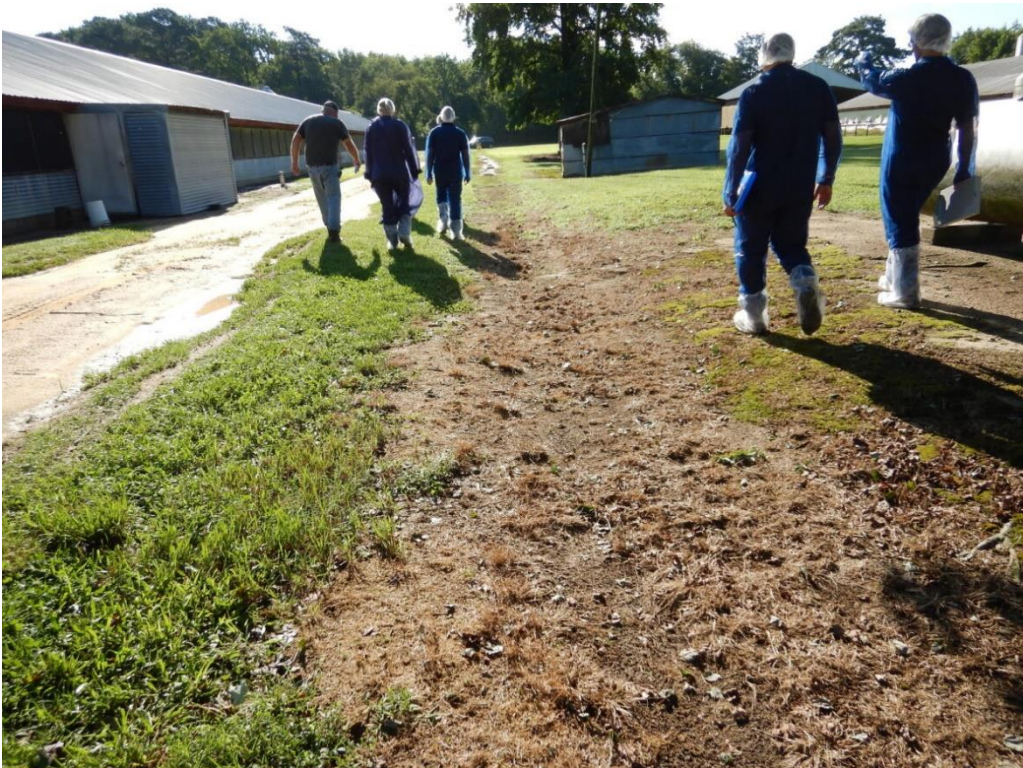
Photograph 20. View, looking east, of the depression located south of Poultry Barn 1 (taken from the southwest corner of the barn).

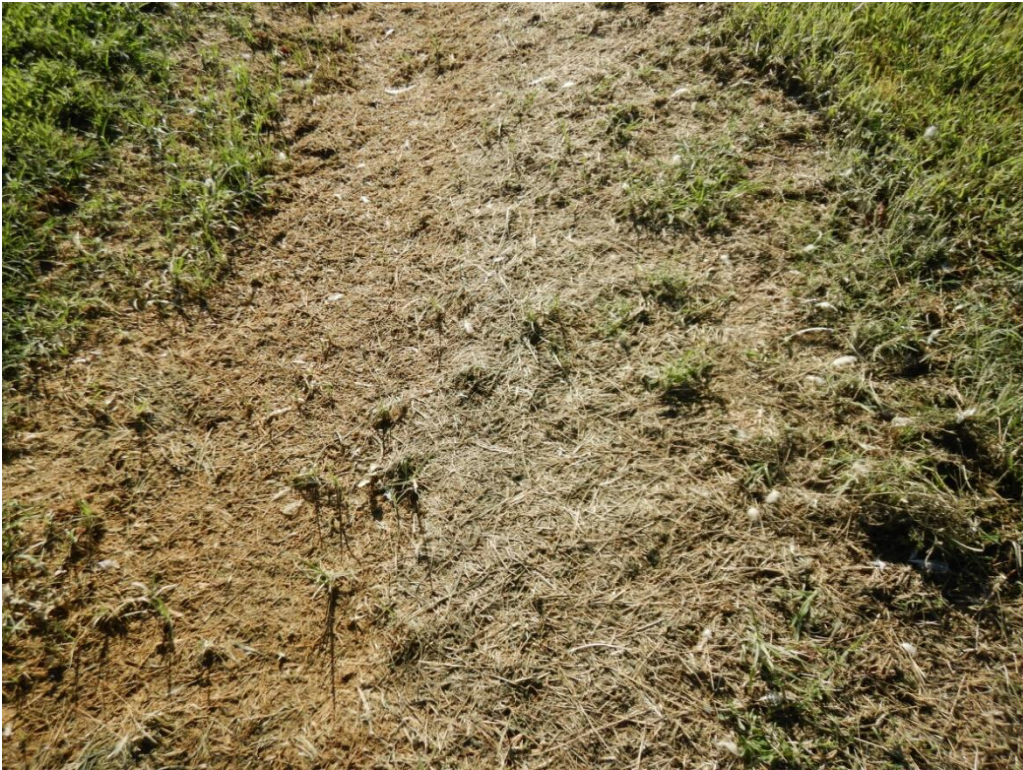
Photograph 21. View of feathers on the ground in the depression located south of Poultry Barn 1.

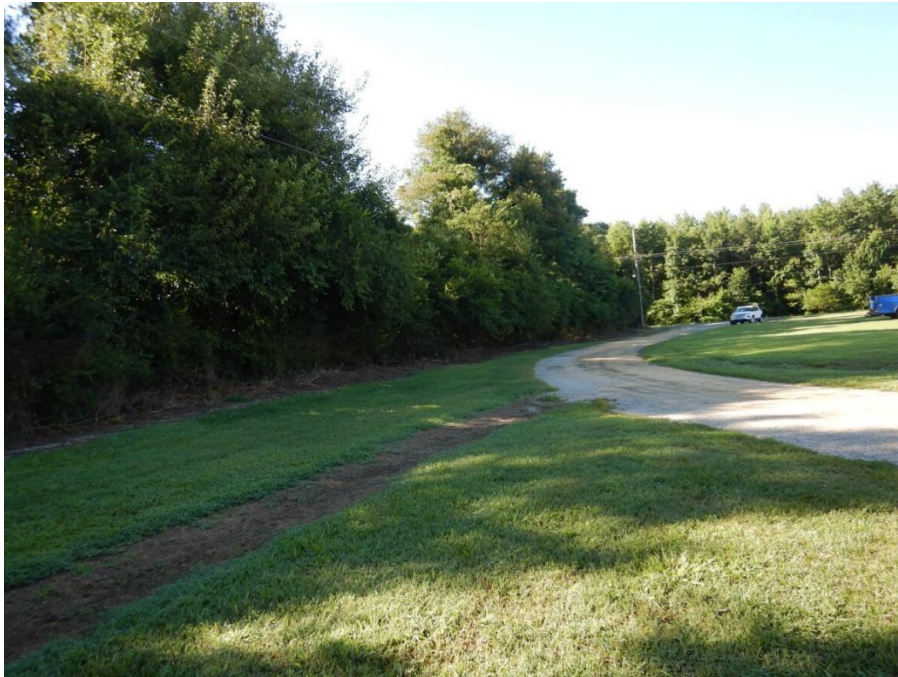
Photograph 22. View looking south towards the facility entrance and swale that runs along the east side of the production area.

During periods of heavy rain, it would appear that the swale located along the east side of the production area would capture stormwater off the adjacent facility road and east side of Poultry Barn 1, and eventually convey flow into the swale that directs runoff towards the north facility boundary (Photographs 22 and 23).

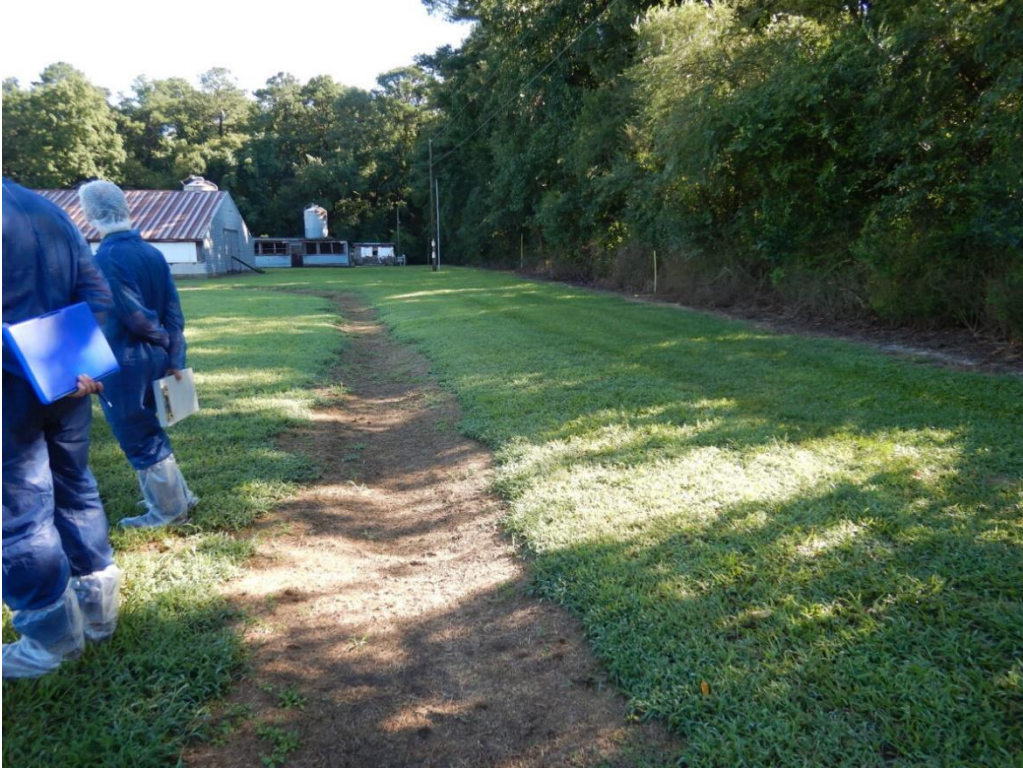
Photograph 23. View looking north along the swale on the east side of the production area.
