**Purpose:** NPDES SSO Inspection Trip Report

**Facility:** City of Cahokia Heights, Illinois

**Dates of Inspection:** July 25-26, 2022

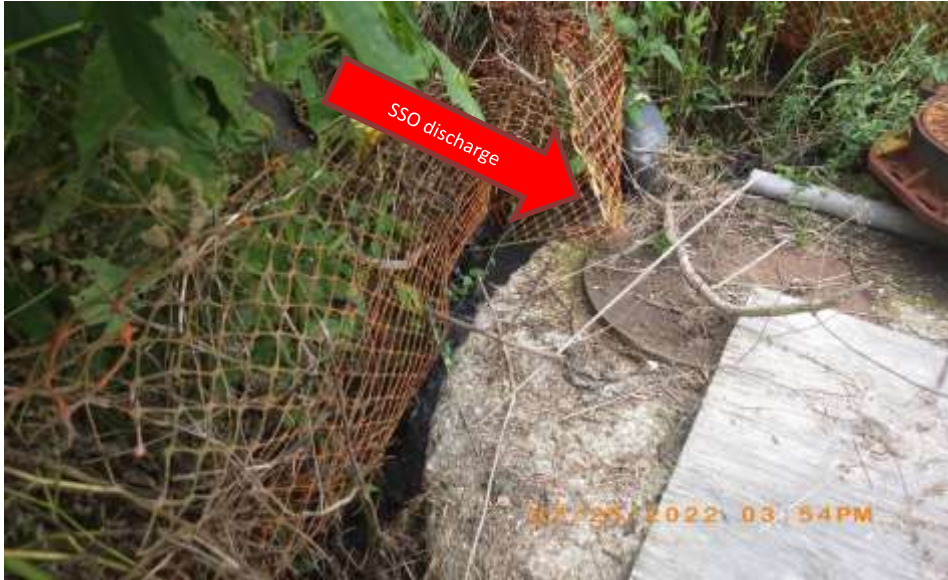
1: CCHM012

| <u>Location</u> | <u>Time</u> | <u>Observations</u> |
|---|---|---|
| Lauralee Drive, Lift Station 51, Cahokia Heights | 3:54 P.M. | The lift station was overflowing into the adjacent wetland when the pumps cycled on, approximately every 5 minutes. (see Photo Log image CHHM0012). Video was also captured at this location. I informed the City sewer department of the situation. |

Description: The lift station was overflowing into the adjacent wetland when the pumps cycled on, approximately every 5 minutes. Red arrow denotes SSO discharge location.

| <u>Location</u> | <u>Time</u> | <u>Observations</u> |
|---|---|---|
| Lauralee Drive, Lift Station 51, Cahokia Heights | 2:00 P.M. | City sewer crews were repairing the lift station when we arrived. The crew leader said a rag clogged the lift station pump, causing the dry-weather SSO on July 25, prior to the storm. I did not observe an SSO at this location on July 26. |

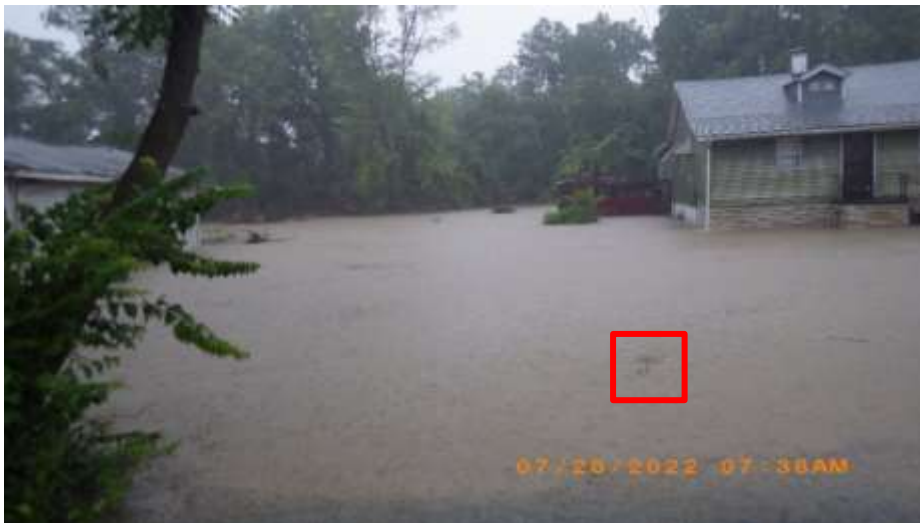
2: CHWW0027

| <u>Location</u> | <u>Time</u> | <u>Observations</u> |
|---|---|---|
| SSO from cleanout on North 82 <sup>nd</sup> Street, Cahokia Heights | 7:38 A.M. | The cleanout was overflowing. The ditch leading from the cleanout was inundated and yards in the area were flooded. (see Photo Log image CHWW0027). Video was also captured at this location. |

Description: The cleanout (outlined in red) was overflowing. The ditch leading from the cleanout was inundated and yards in the area were flooded.

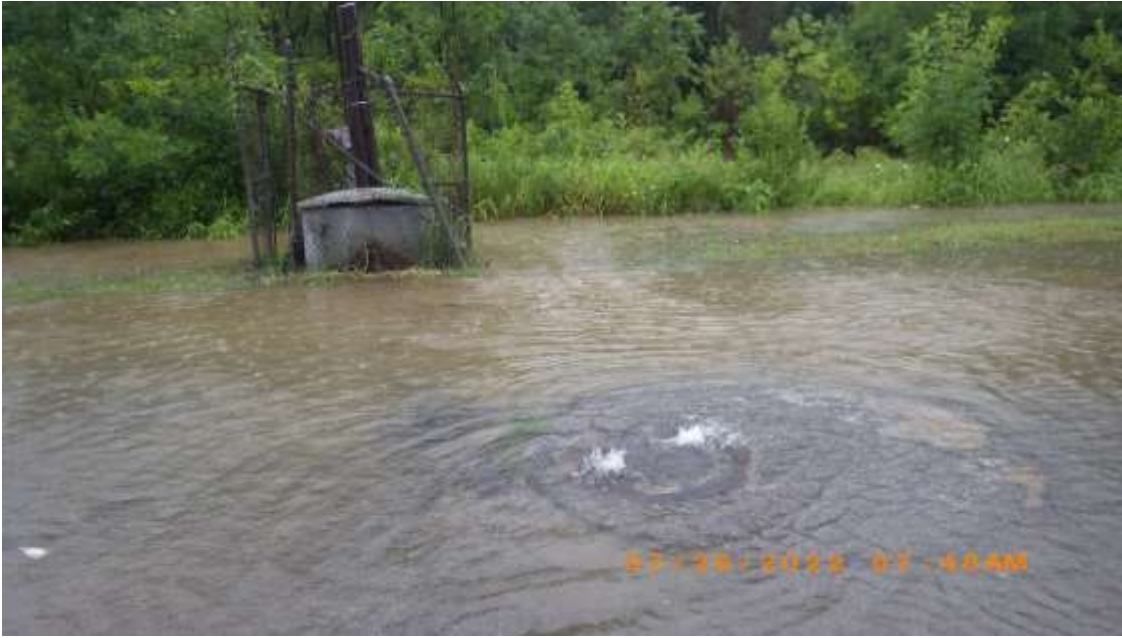
3: CHWW0030

| <u>Location</u> | <u>Time</u> | <u>Observations</u> |
|---|---|---|
| North 73rd Street, Cahokia Heights. | 7:48 A.M. | The roadside ditches along the street were completely inundated with floodwater. Sanitary sewage was discharging from the manhole. (see Photo Log image CHWW0030). Video was also captured at this location. |

Description: The roadside ditches along the street were inundated with floodwater, along with sanitary sewage discharging from the manhole.

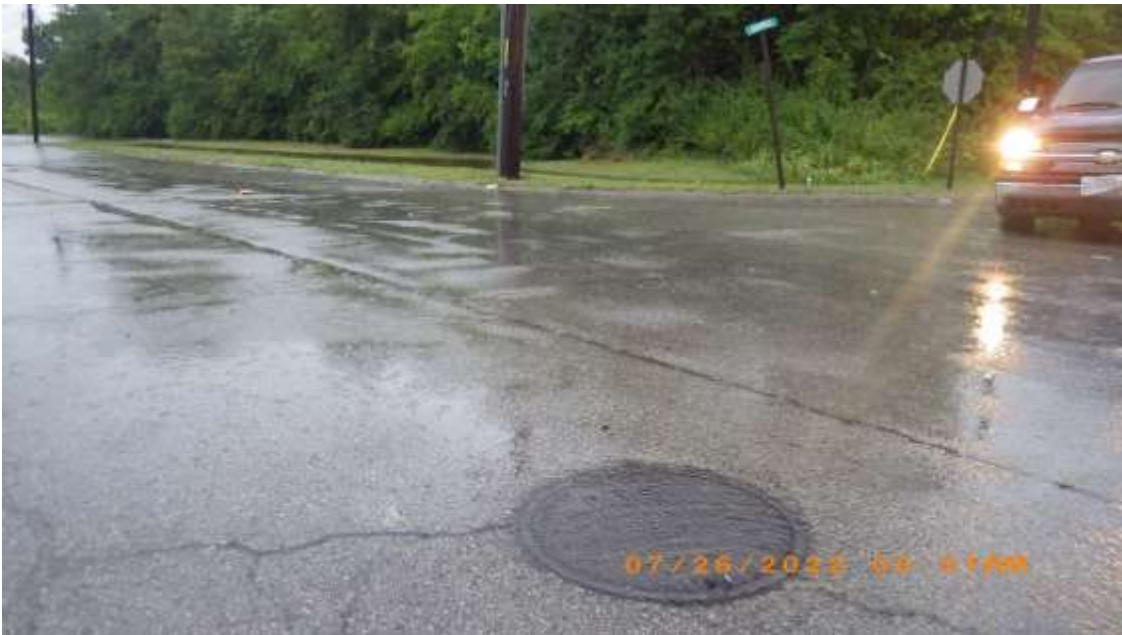
4: CHWW0034

| <u>Location</u> | <u>Time</u> | <u>Observations</u> |
|---|---|---|
| North 73rd Street and Dorris Street, Cahokia Heights. | 8:01 A.M. | Sanitary sewage was discharging from the manhole. (see Photo Log images CHWW0034 and CHWW0037). Video was also captured at this location. |

Description: Sanitary sewage discharging from the manhole.

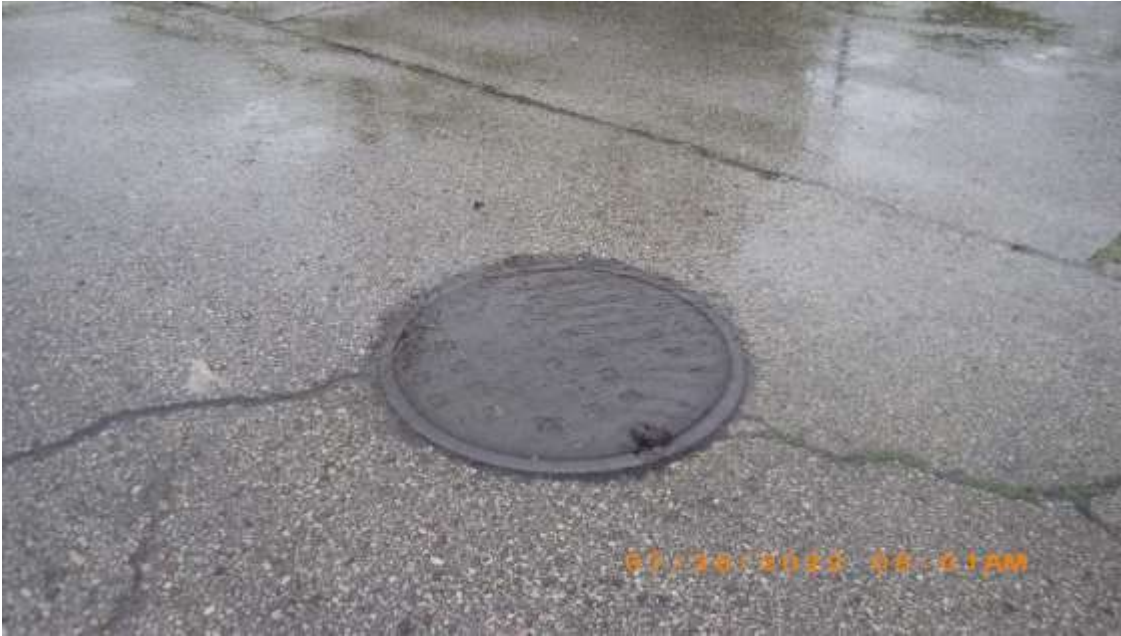
5: CHWW0037

Description: Sanitary sewage discharging from the manhole.

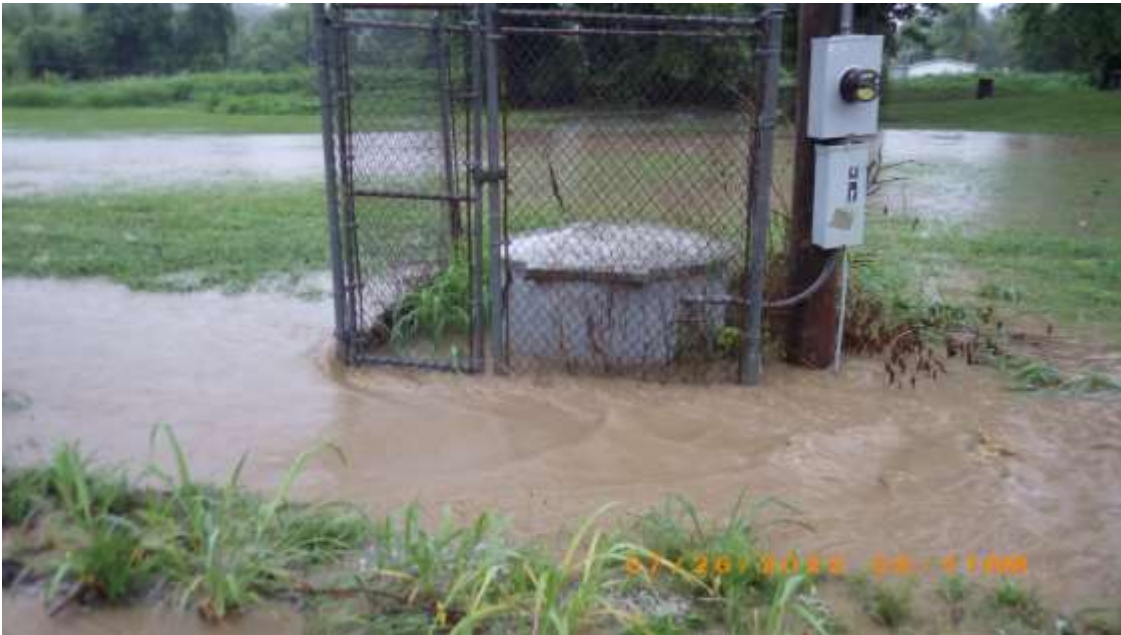
6: CHWW0038

| <u>Location</u> | <u>Time</u> | <u>Observations</u> |
|---|---|---|
| North 82nd Street & Bellevue Avenue Lift Station, Cahokia Heights. | 8:11 A.M. | Roadside ditches were inundated and a lift station structure on Bellevue Avenue was partially submerged. (see Photo Log image CHWW0038). Video was also captured at this location. |

Description: Inundated roadside ditches and a partially submerged lift station structure on Bellevue Ave.

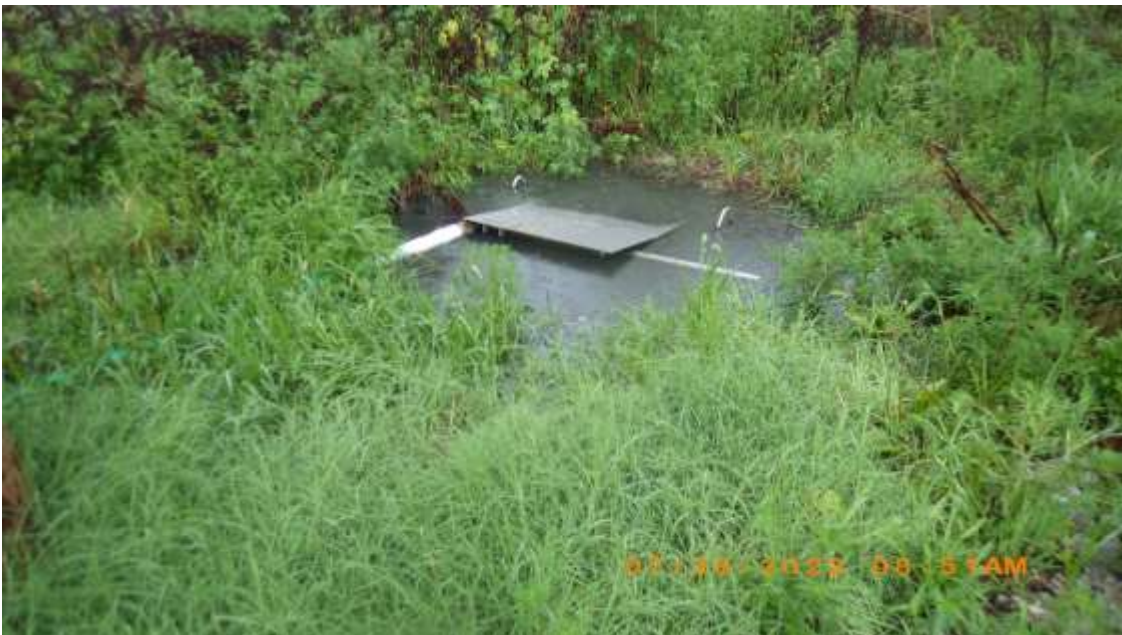
8: CHWW0041

| <u>Location</u> | <u>Time</u> | <u>Observations</u> |
|---|---|---|
| Old Missouri Ave, Lady of Snows Lift Station, Cahokia Heights | 8:51 A.M. | Lift station was submerged. (see Photo Log image CHWW0041). Also captured video of street runoff flowing into a sanitary sewer manhole. |

Description: Lift station submerged.
