**COMPLIANCE EVALUATION INSPECTION REPORT  
U.S. ENVIRONMENTAL PROTECTION AGENCY, REGION 5**

**Purpose:** NPDES Compliance Evaluation Inspection

Rock Island Arsenal (RIA)  
1 Rock Island Arsenal  
Rock Island, Illinois, 61299

**Date of Inspection:** August 1 - 2, 2023

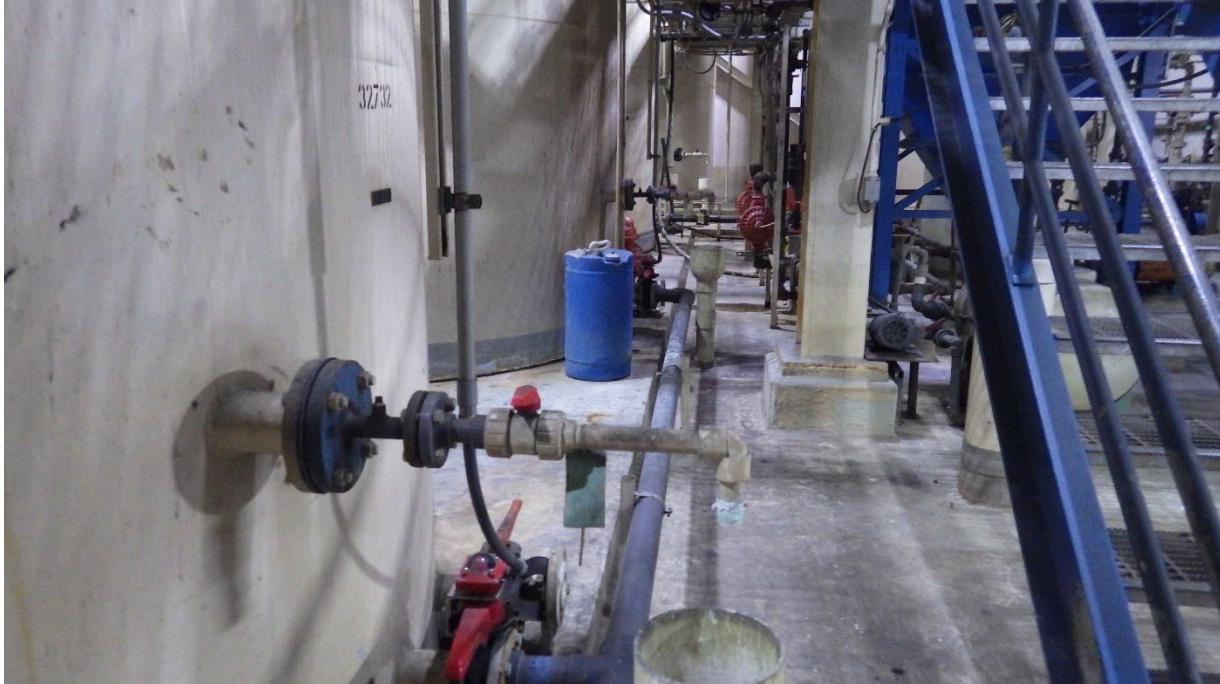
2: RIMG0037

Description: Mixing and storage tanks within the pretreatment system. On the left foreground are three batch tanks and sludge tanks are in the center back. Samples can be collected via the spigot on each tank once the tank is 30% full. There is a drain under the spigot that drains back to the start of the pretreatment system.

Location: JMTTC Pretreatment Unit

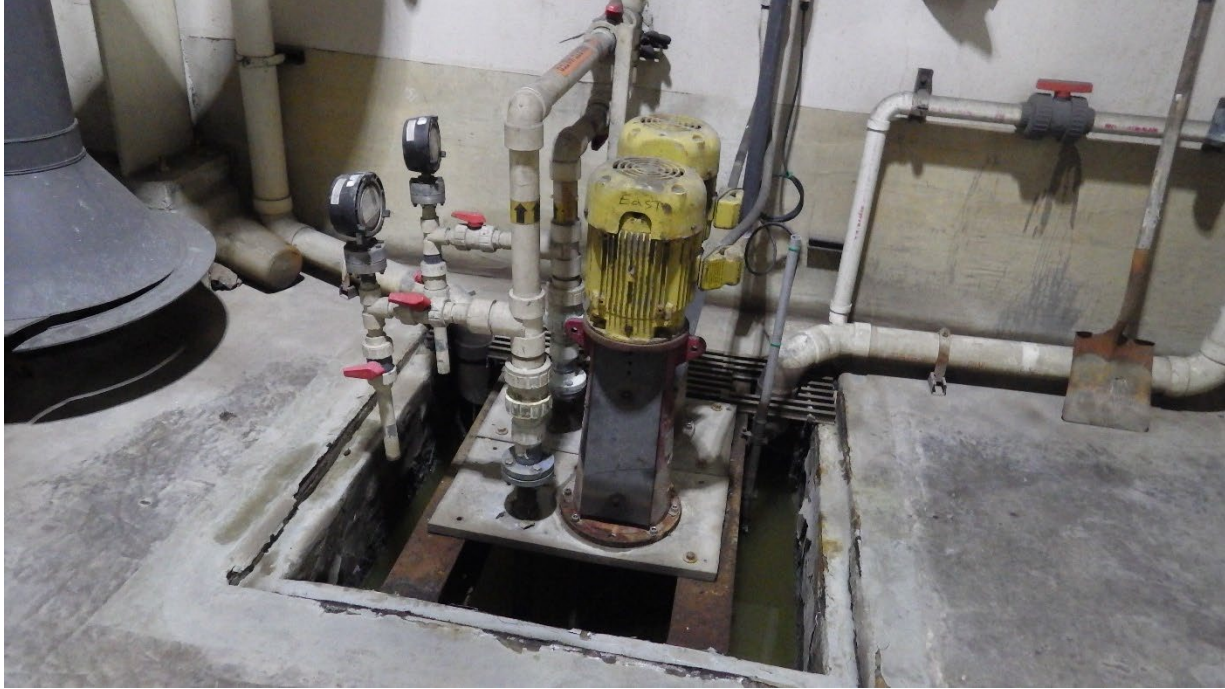
3: RIMG0038

Description: Sump in the pretreatment area that receives wastewater from a secondary containment area via gravity. Previously, there was an event when the secondary containment sump received too much water and the entire pretreatment area was under 1-2 feet of water which caused some pumps to need to be replaced.

Location: JMTC Pretreatment Unit

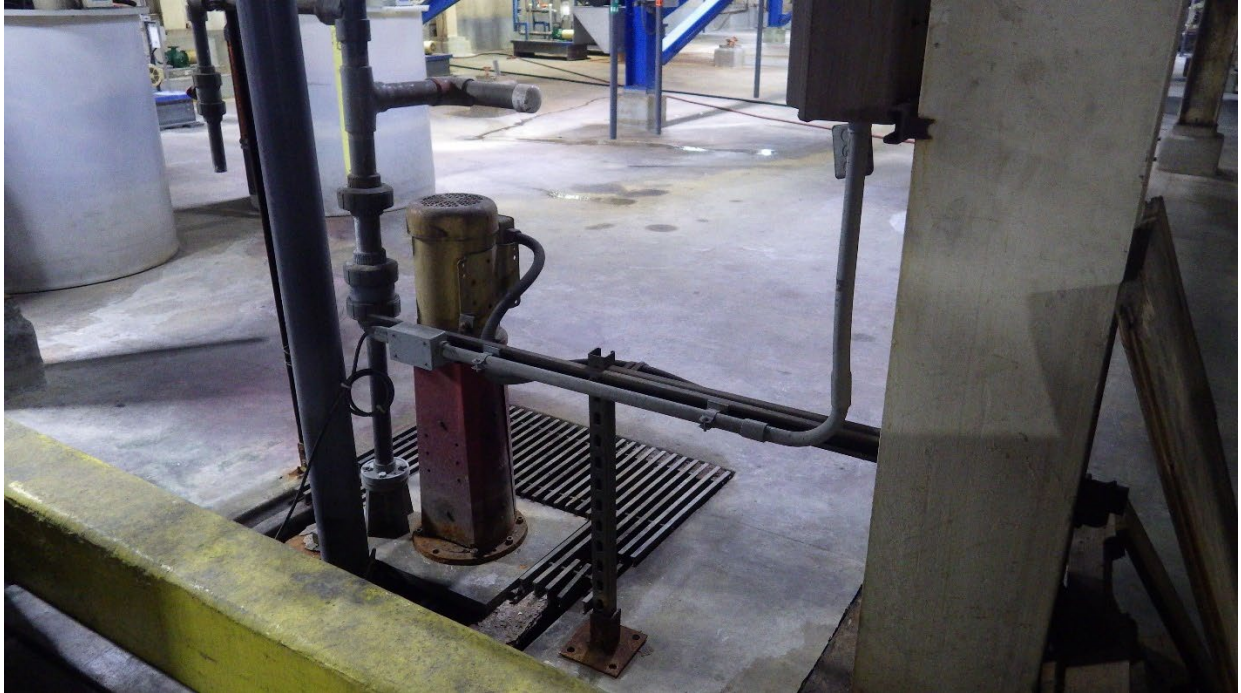
5: RIMG0040

Description: Primary pump that receives wastewater from the plating units above and pumps it to the JMTC Plating Unit

Location: JMTC plating area located upstream of the pretreatment unit

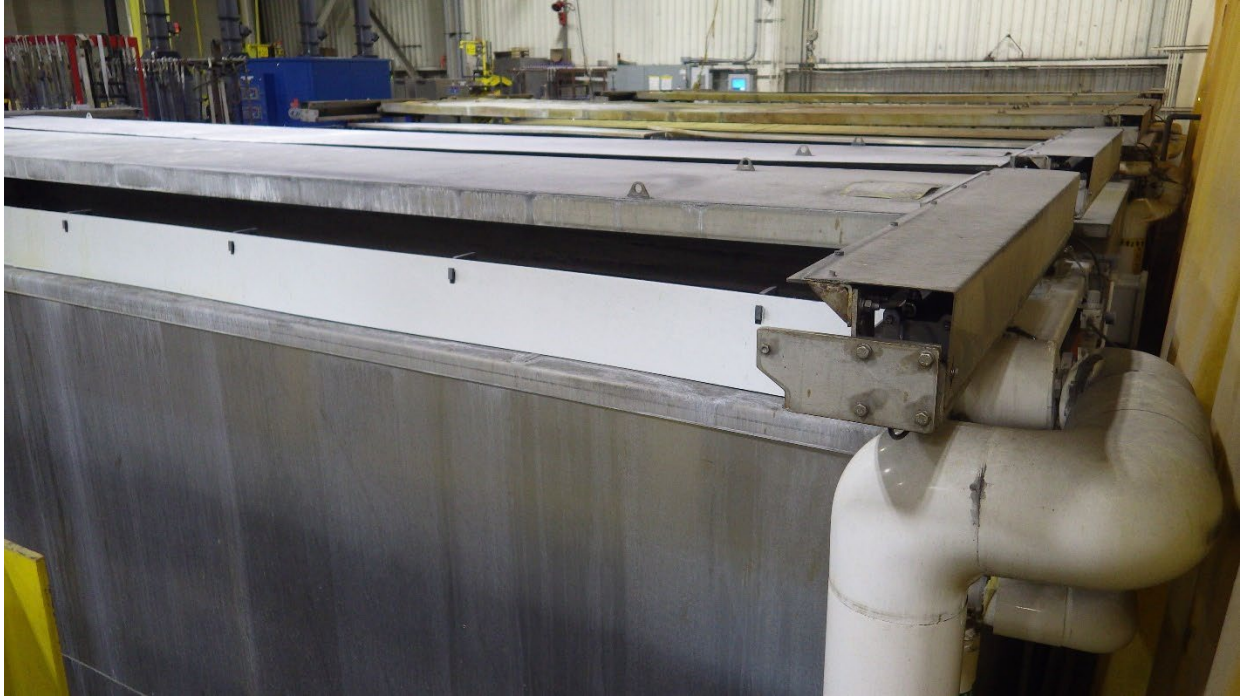
6: RIMG0041

Description: One of the plating lines that discharge to the JMTC Pretreatment Unit. Wastewater is designed to overflow the units and fall into the primary confinement area below.

Location: JMTC plating area located upstream of the pretreatment unit

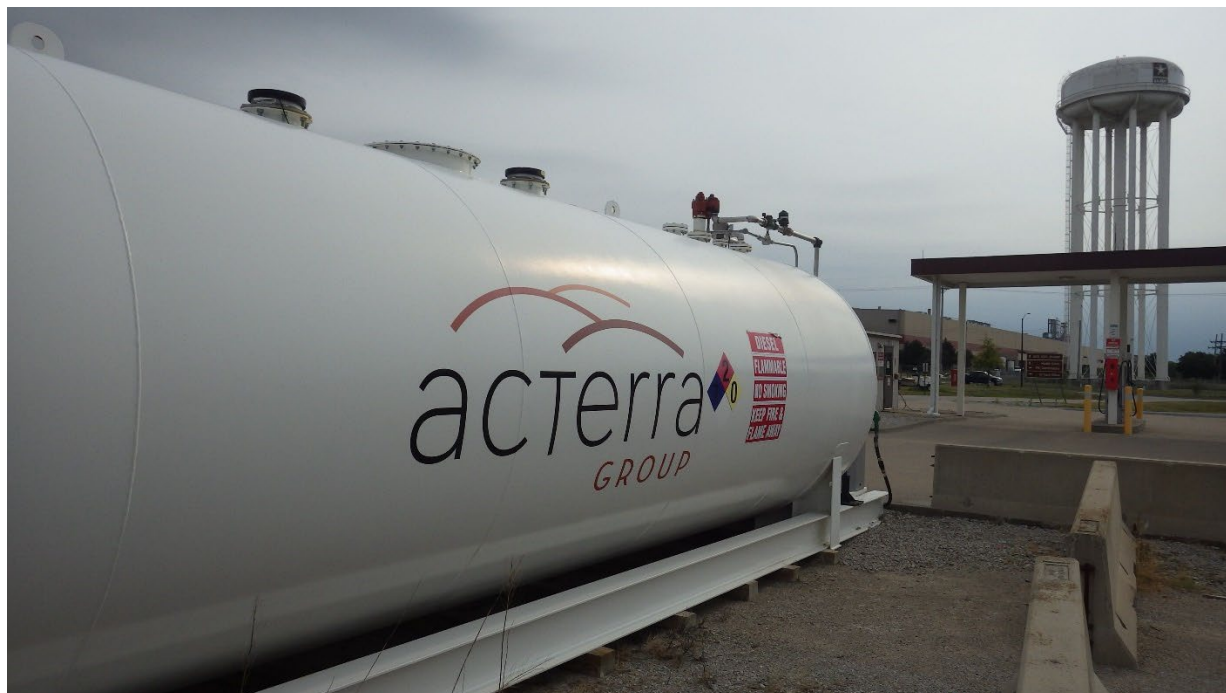
8: RIMG0045

Description: Double walled above ground fuel storage tank located in the fueling station.

Location: Fueling station

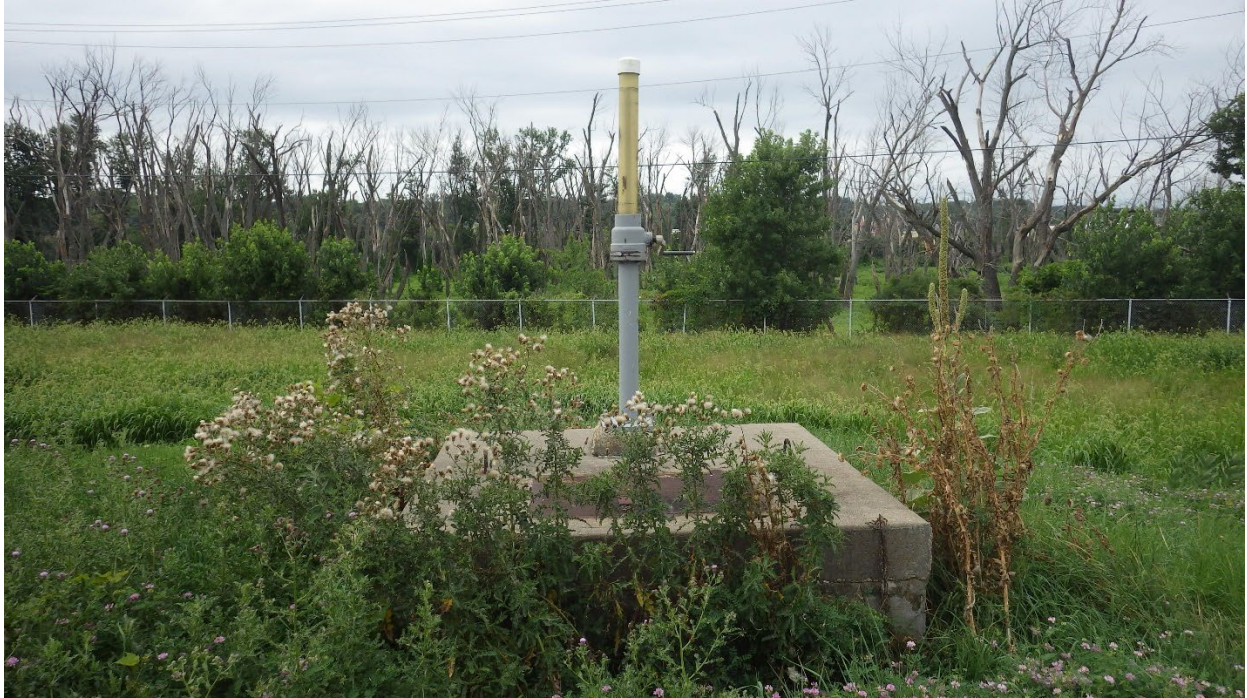
9: RIMG0046

Description: Southern view of the valve upstream of Outfall 5 where compliance samples are collected. The actual outfall is located in the marshy area beyond the fenceline and was not accessible during the inspection.

Location: Compliance sampling collection point for Outfall 5

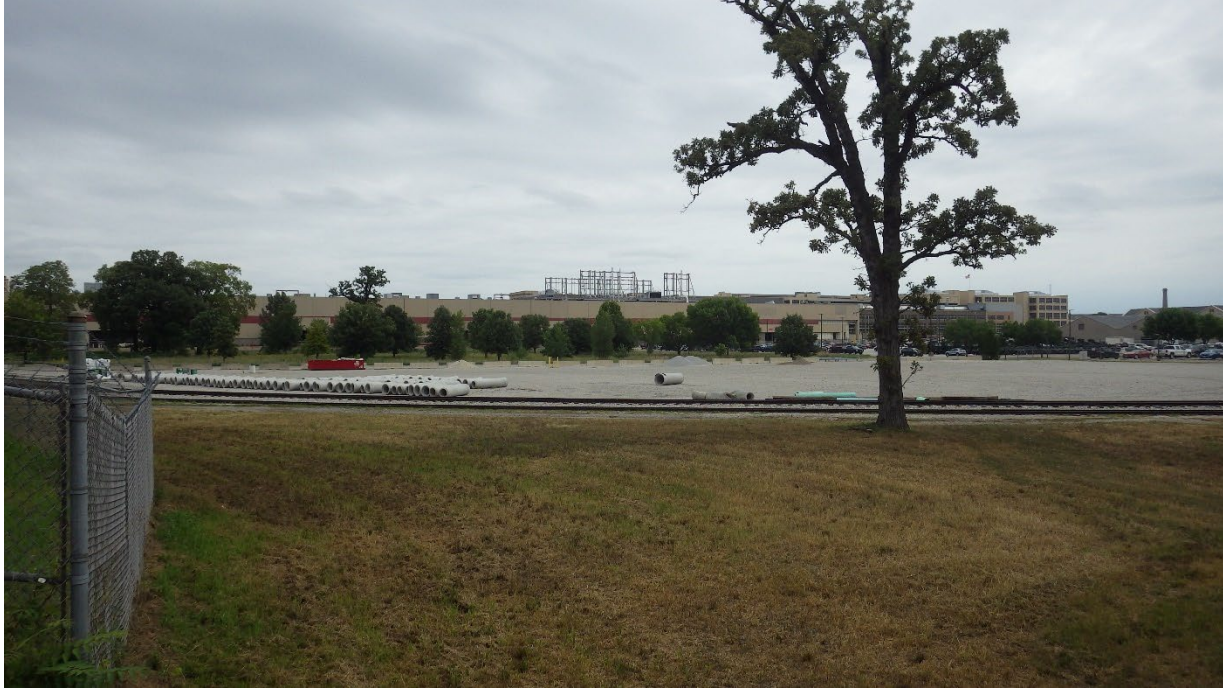
10: RIMG0047

Description: Non-vegetated area beyond the railroad tracks is the location of the former coal pile which is now a CERCLA groundwater monitoring site. Ms. Gilbert stated that the plan for this area is to install solar and RICE generators.

Location: Former coal pile

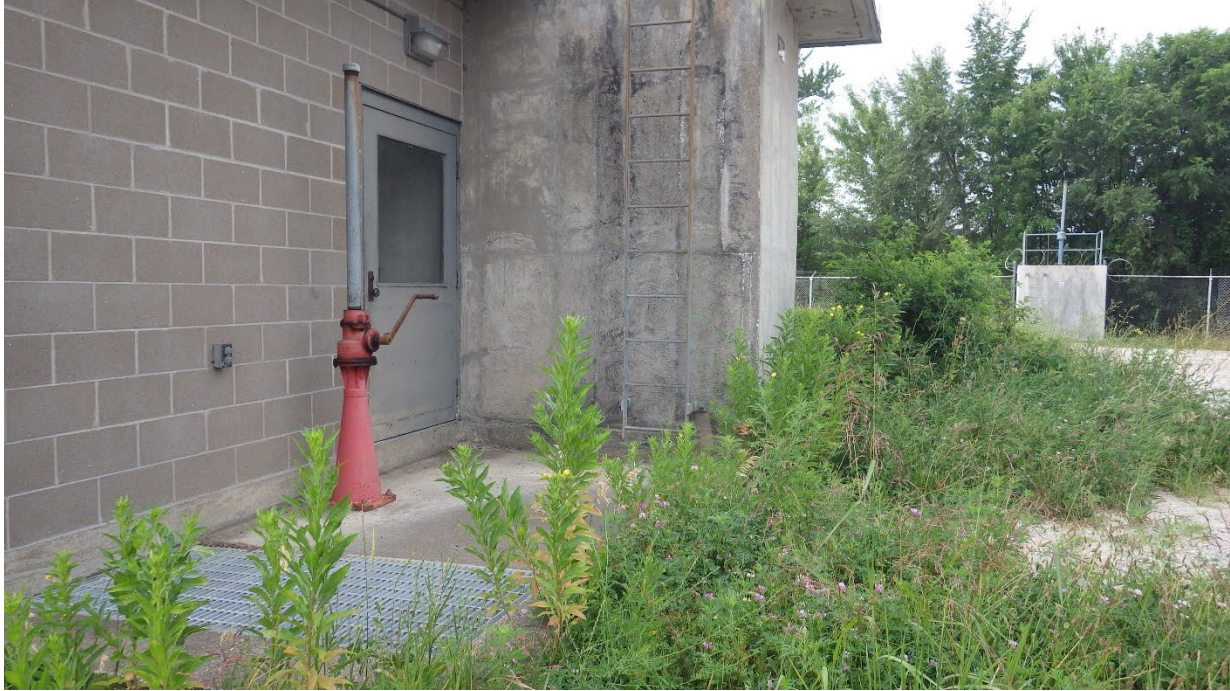
11: RIMG0048

Description: Pumphouse and valves upstream of Outfalls 6 and 7. The compliance samples for Outfalls 6 and 7 are collected at the grate next to the pumphouse. In the right rearground is the fenceline and the actual outfalls are located in the marshy area beyond the fenceline and were not accessible at the time of the inspection.

Location: Compliance sample point for Outfalls 6 and 7

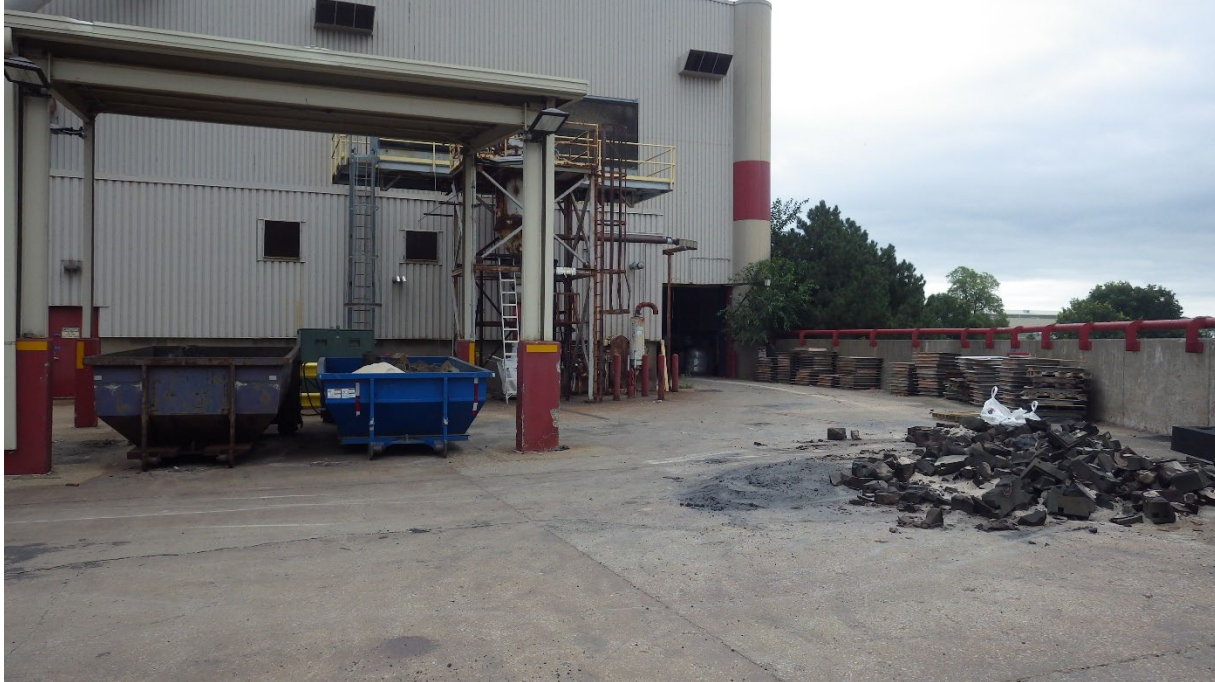
12: RIMG0049

We drove to the foundry yard on the west of the foundry building. At this location a dumpster for sand mold waste is located under a canopy roof. We observed some sand molds that were on the ground, outside of the roof. Ms. Gilbert spoke with foundry staff who stated that the procedure is to let the sand cool on the ground first then transfer it under roof to the dumpster. They assured us that all the sand that was observed had only been placed there that morning and would be removed by the end of the day. I asked Ms. Gilbert if the protocols change when wet weather is expected, and she stated that the foundry staff do not put the hot waste sand molds outside on the ground during wet weather. There was a nearby inlet with a drain filter to keep sand from entering the stormwater system. I observed there was sand and some debris on the filter. Ms.

Description: In the foundry yard hot sand molds are left to cool (right) and by the end of the day will be placed into the dumpsters that are covered by a canopy (left).

Location: Foundry yard

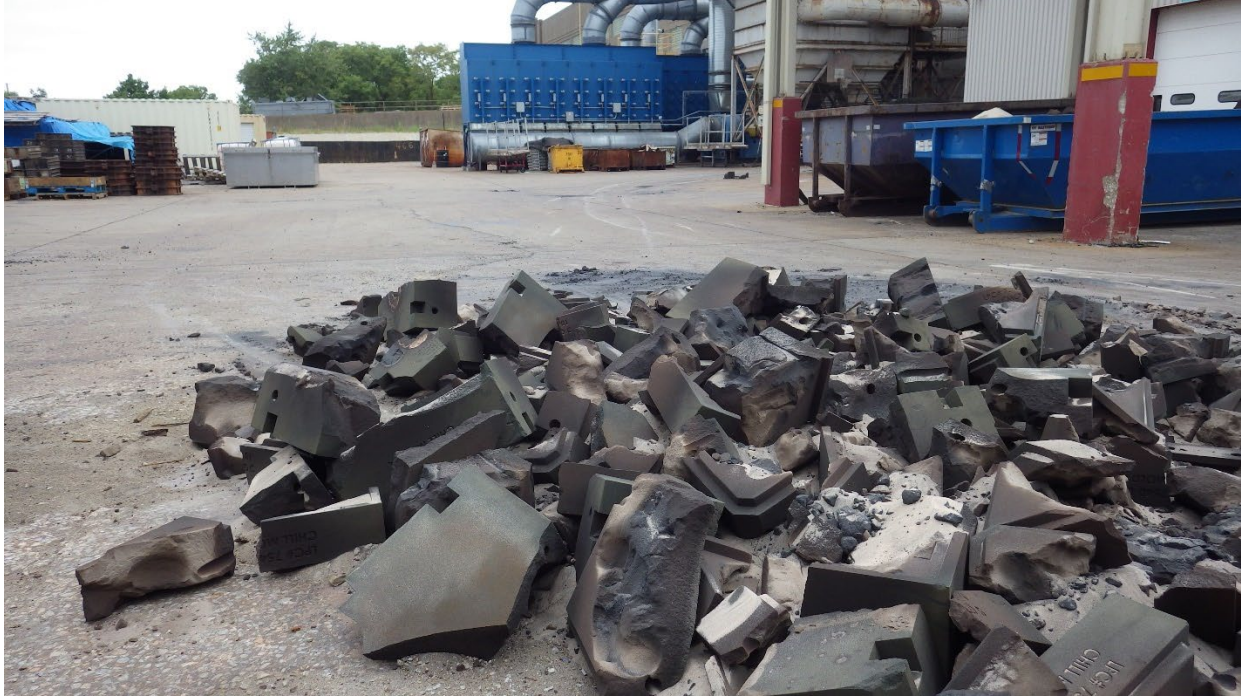
13: RIMG0051

Description: Waste sand molds that are left in the foundry yard to cool prior to moving them to the dumpsters underroof. The stormwater inlet is located in the center rear ground.

Location: Foundry yard

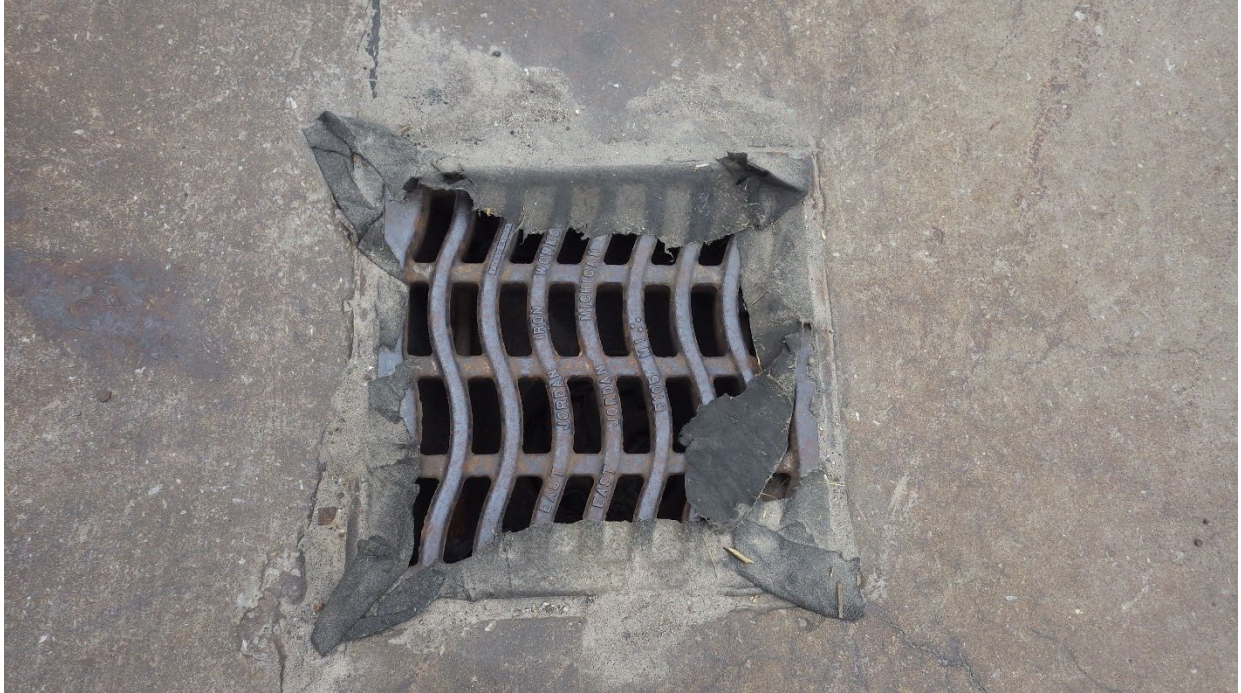
14: RIMG0052

2. There was vegetative or industrial debris on the Zone 5 and foundry stormwater inlets.
3. Barrels labeled hazardous waste were located in the foundry yard and near the stormwater inlet and no secondary containment was present.

Description: Stormwater inlet located in the foundry yard, near the sand molds. The inlet has a drain filter that is assigned to JMTC for periodic inspection and replacement. At the time of the inspection, sand and debris were present on the filter and inlet.

Location: Foundry yard

Gilbert stated that JMTC is assigned to replace the inlet filter as needed. Also, in the foundry yard, I observed a sign for "Emission Control Dust" hazardous waste accumulation area. I saw some barrels labeled hazardous waste and I did not observe secondary containment for the hazardous waste in this area. Ms. Gilbert stated that the dry scrubbers for the foundry building and for Building 299 are indoors.

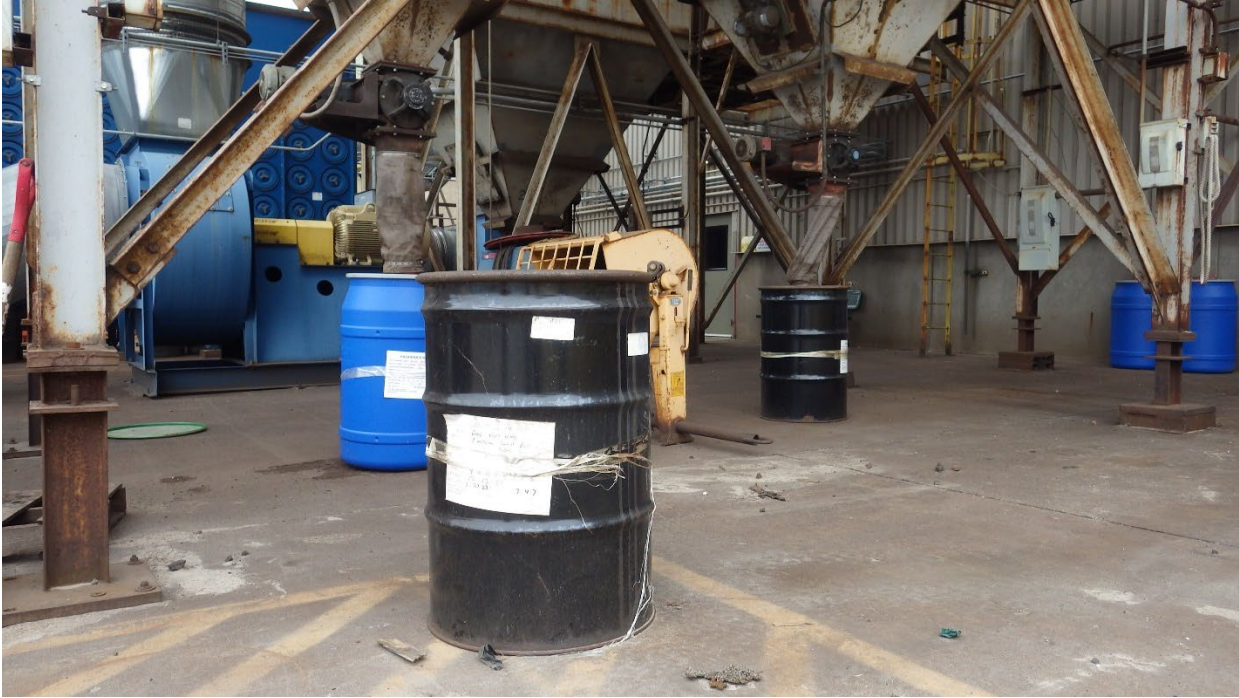
15: RIMG0053

Description: Barrels labeled hazardous waste that were located in the foundry yard and near the stormwater inlet from photo 14. No secondary containment was present.

Location: Foundry yard

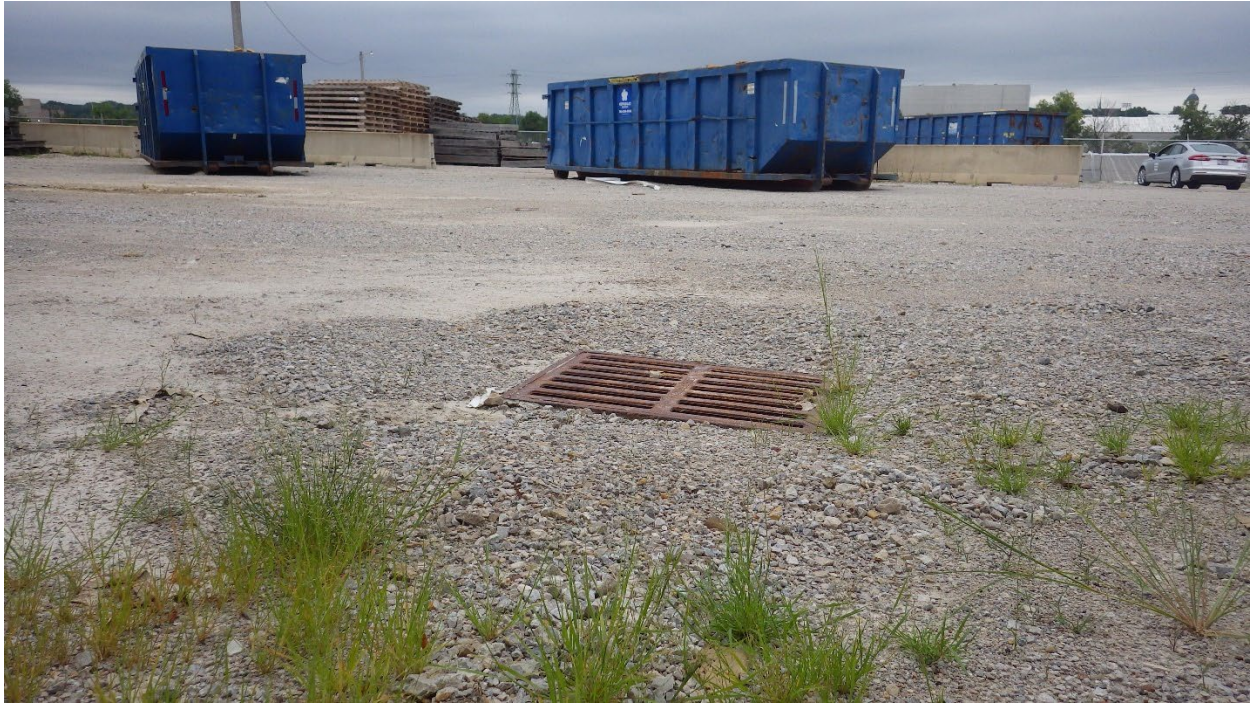
16: RIMG0054

We viewed dumpster storage areas south of multiuse Building 299. I observed that many of these dumpsters were open or did not have lids. At this site only wood pallets had been discarded into the dumpsters. We also viewed the storage area that is identified as outdoor Jeep storage. I saw vehicles, trailers and other miscellaneous dry storage located there. Ms. Gilbert stated that in 2029 this will be phased out as a storage area and a structure is expected to be built.

Description: Dumpsters and waste storage located in Industrial Zone 2. Dumpsters were not covered at the time of the inspection. The dumpsters were full of wood pallets.

Location: Dumpster storage

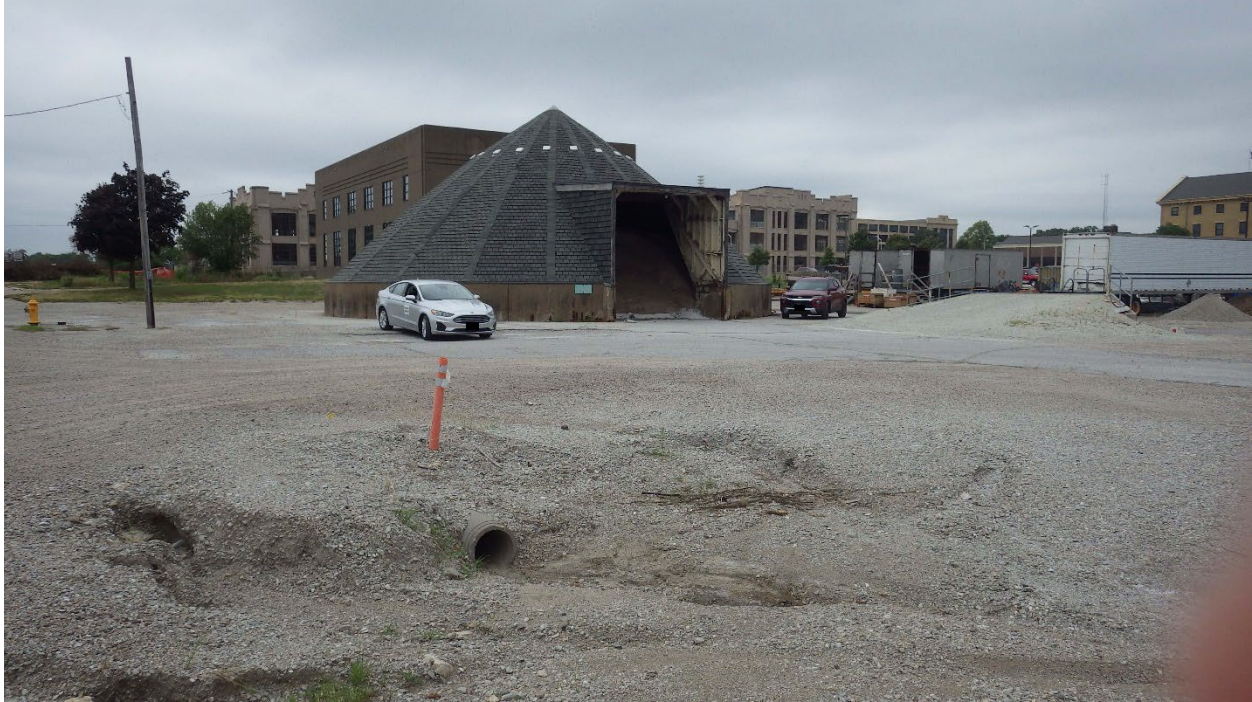
17: RIMG0055

We drove to the salt storage dome that is north of the outdoor Jeep storage. At this location I viewed some erosion, white staining on the ground and salt spillage in the loading area. Ms. Gilbert stated there is already an approved regrading project for later this year to repair the erosion.

Description: Erosion area present near the salt storage dome. Some salt staining was present near the erosional area. Salt spillage was present near the salt loading area.

Location: Salt storage dome

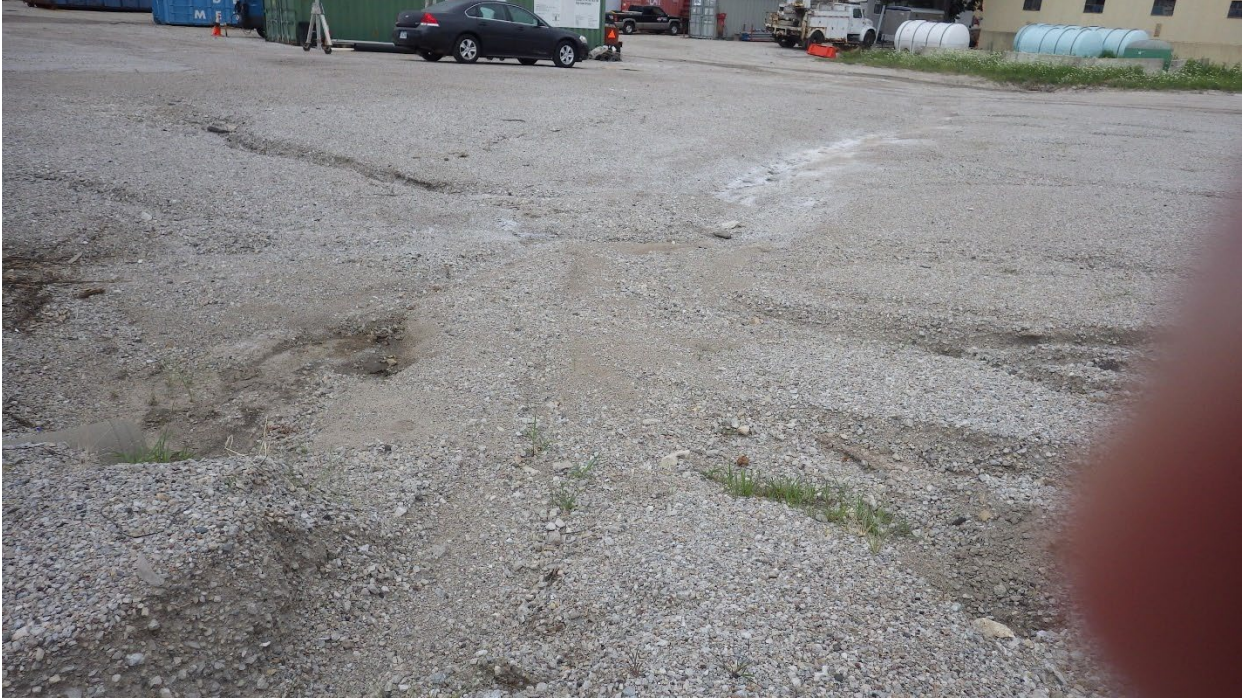
18: RIMG0056

Description: Erosion and white salt staining on a stormwater pathway leading to the stormwater inlet. This photo is the flow pathway downstream of Photo 17.

Location: Salt storage dome

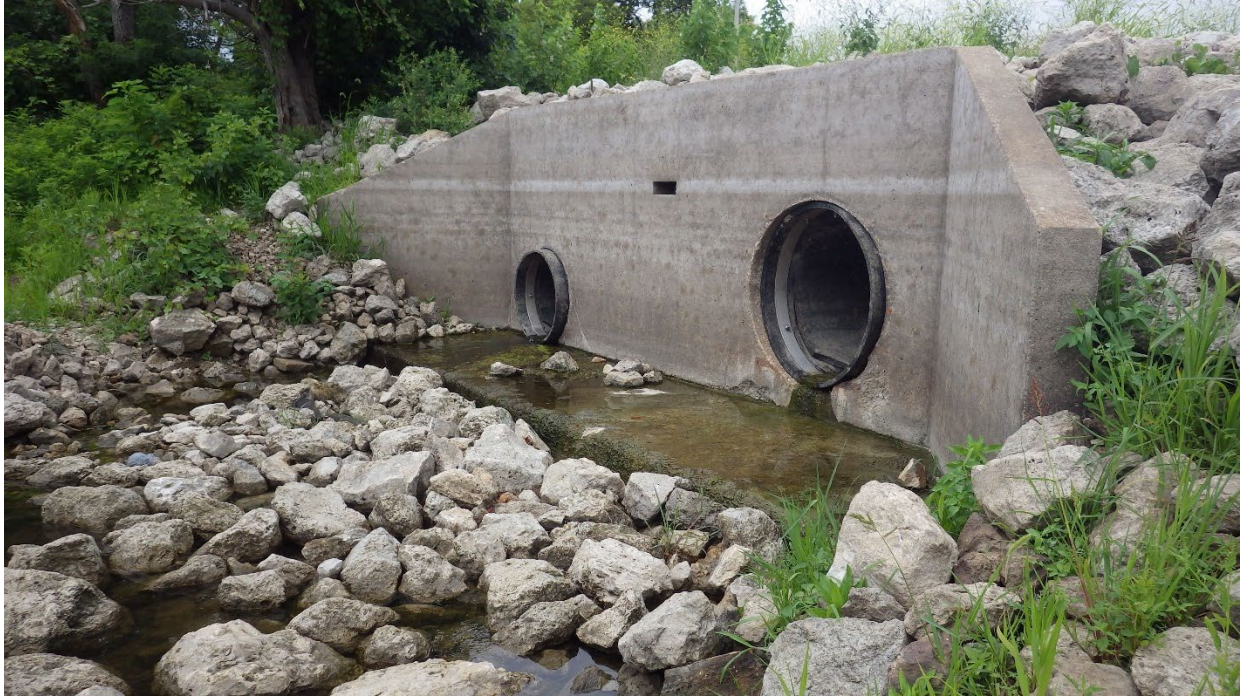
19: RIMG0057

Description: Outfalls 10 and 11. Construction had recently finished on these two outfalls to separate them and make them more accessible. At the time of the inspection, both outfalls had some flow.

Location: Outfalls 10 and 11

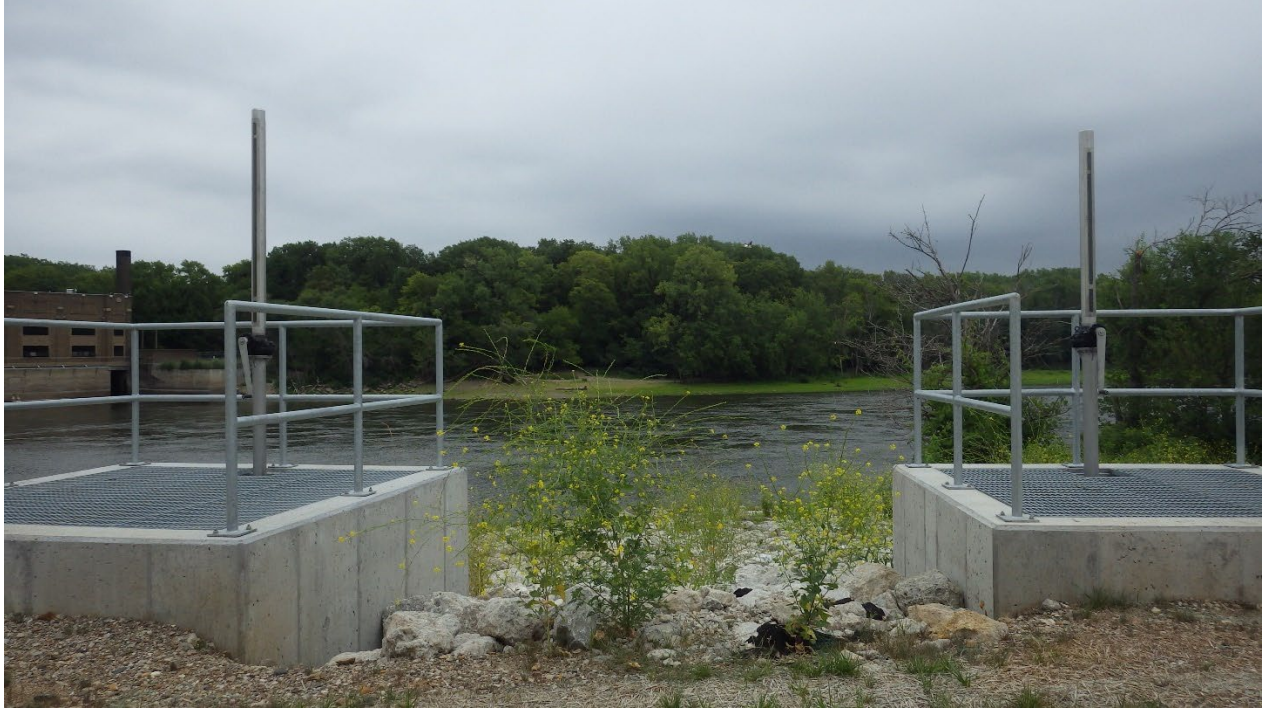
20: RIMG0058

Description: Valves upstream of Outfalls 10 and 11. This photograph is taken above the outfalls shown in Photo 19 and shows the receiving waters of the Mississippi River. The construction permit was still active since the vegetative cover had not taken.

Location: Outfalls 10 and 11

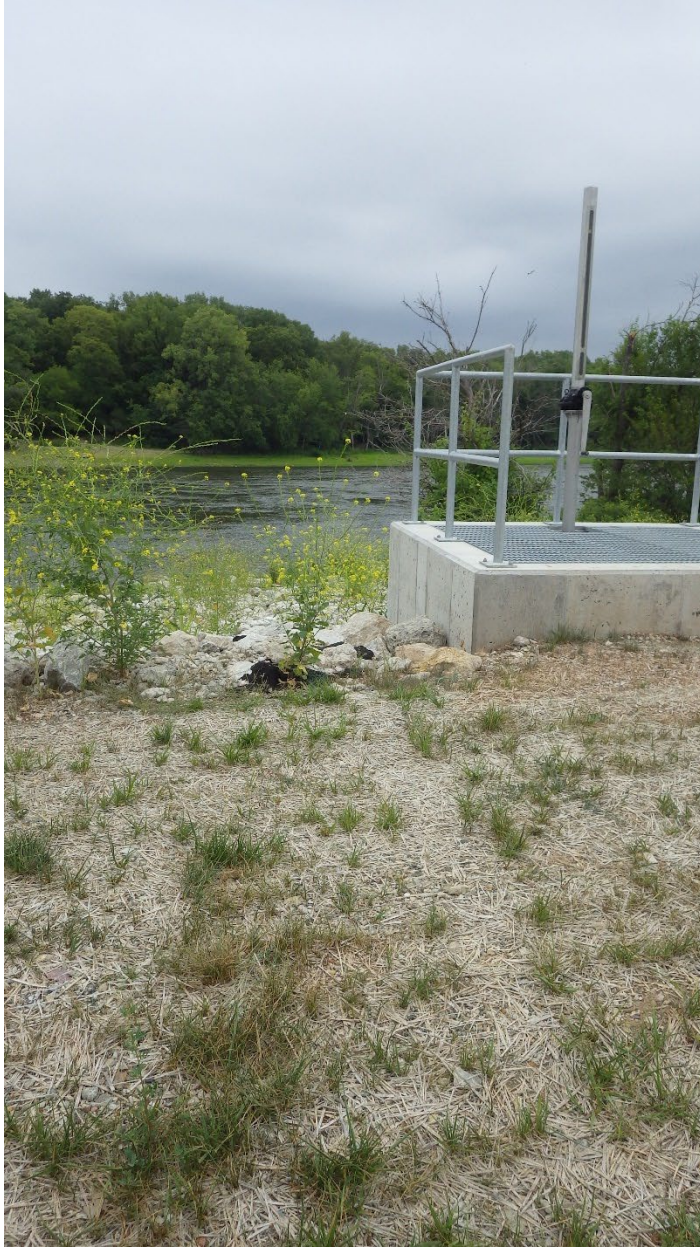
21: RIMG0059

Description: Vegetative cover near the valves for Outfalls 10 and 11 shows in Photo 20.

Location: Outfall 10 and 11

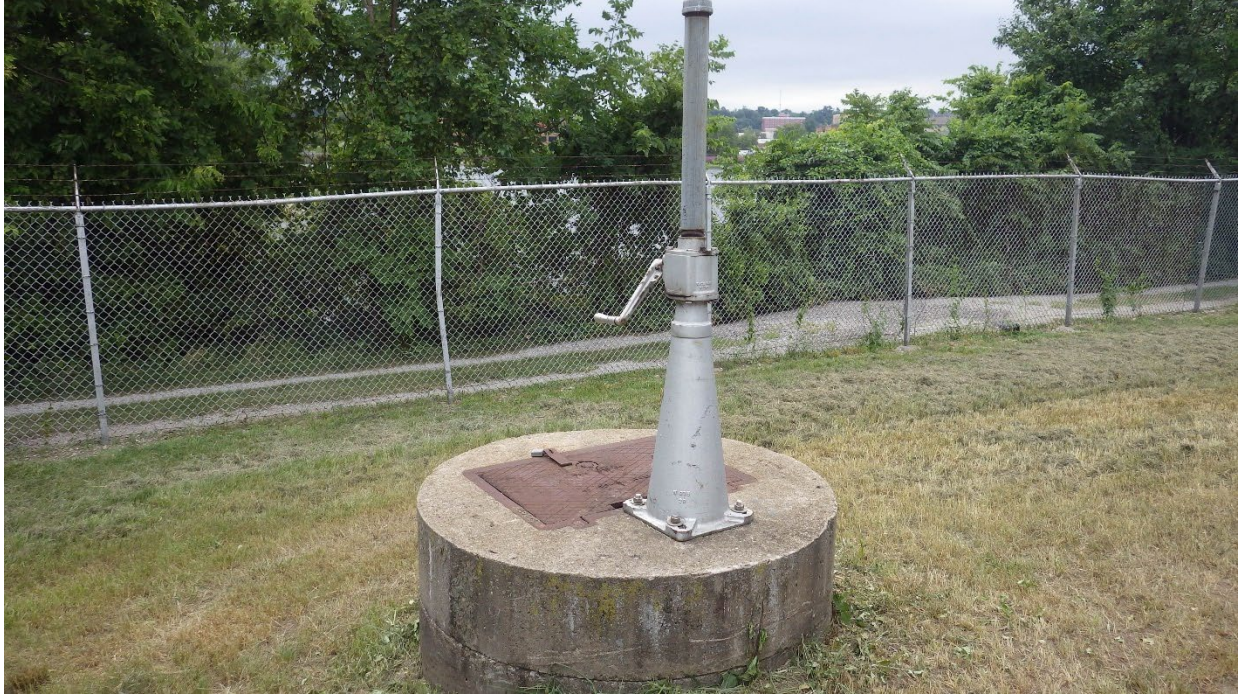
22: RIMG0060

Description: Valve upstream of Outfall 13 in and the compliance sample point. The outfall is located beyond the fenceline and was not accessible.

Location: Outfall 13

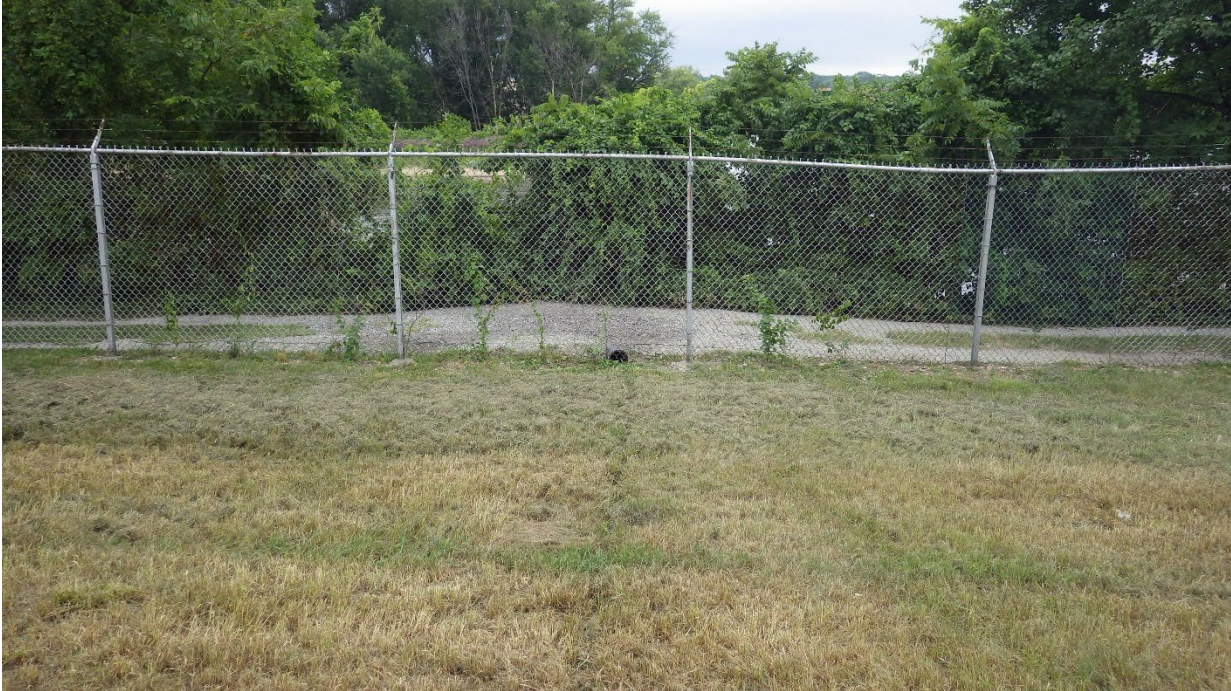
23: RIMG0061

Description: Discharge pipe that was installed under the fenceline near Outfall 13 and a hose line in the grass leading to the discharge pipe. Ms. Gilbert stated that this point had been used to pump out stormwater during the last flood event when the outfalls valves were closed to prevent flooding entering the stormwater system.

Location: Outfall 13

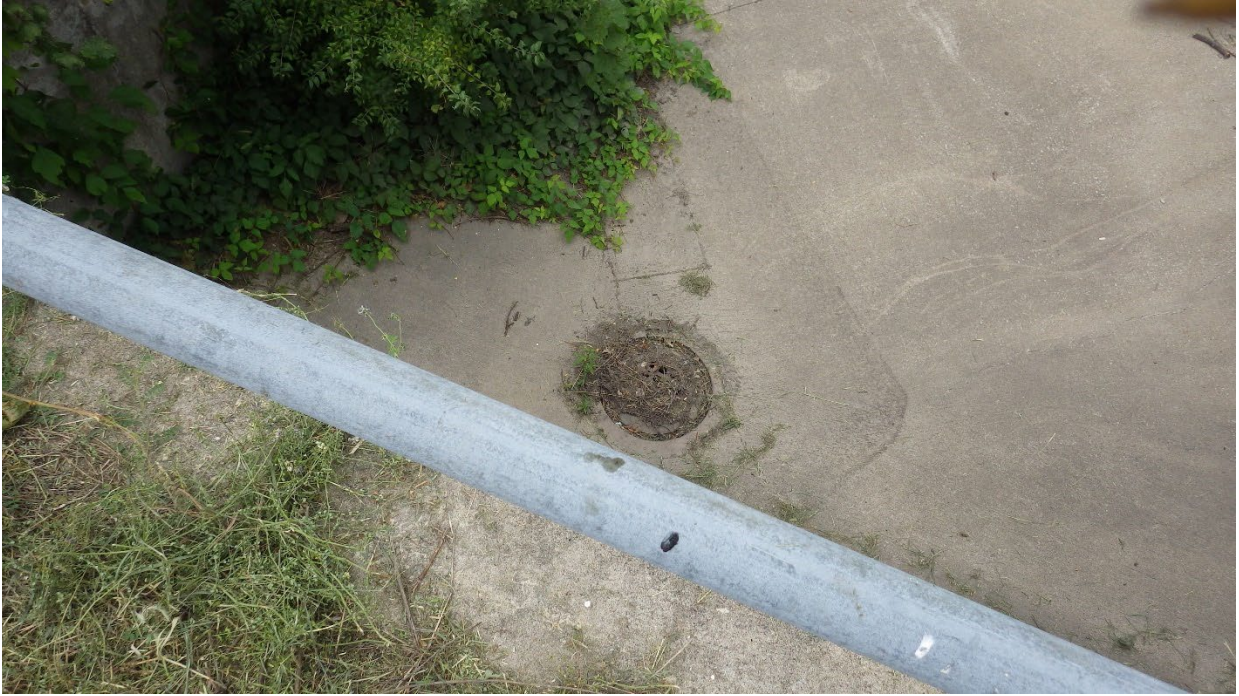
24: RIMG0062

Description: Stormwater inlet in a low lying area of Industrial Zone 5. Ms. Gilbert stated that a sump pump was place in this area during the last flood event and pumped to the discharge point on Photo 23. At the time of the inspection, there was grass and debris on the inlet and an inlet filter was not in use.

Location: Industrial Zone 5 near Outfall 13

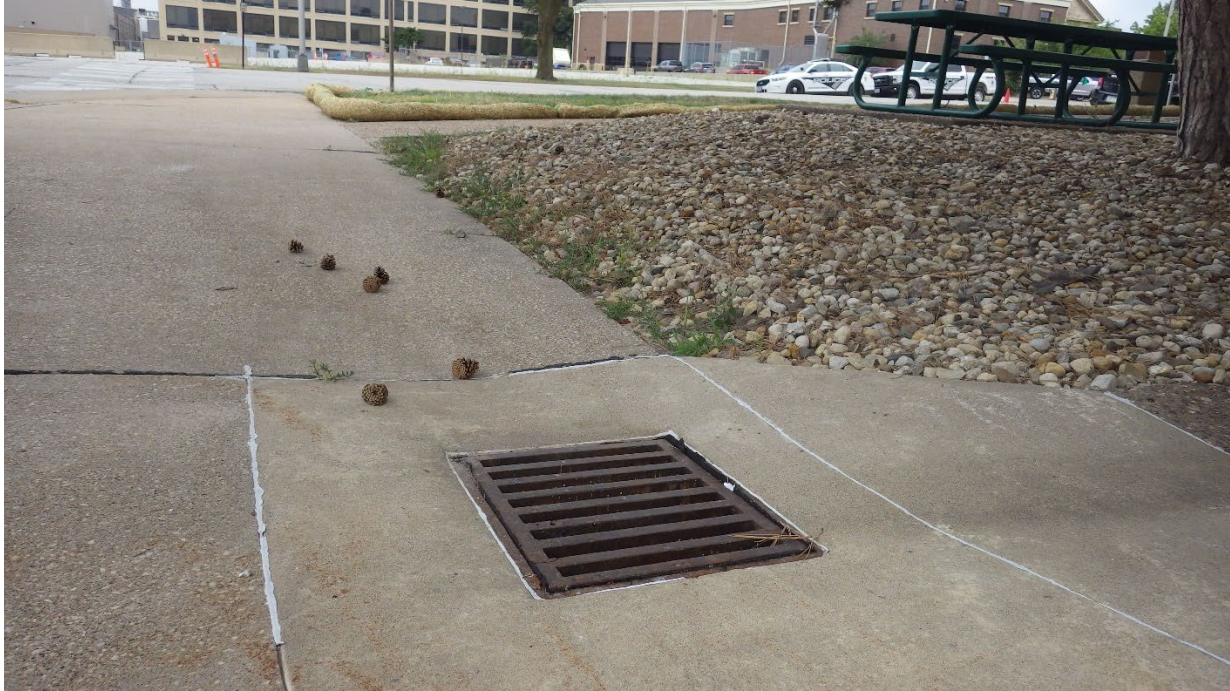
25: RIMG0063

Description: Stormwater inlet near the Garrison offices. Ms. Gilbert stated that the snowplows tear up the grass which contributes to sediment entering the stormwater system. In places like this inlet, a straw waddle is used to prevent erosion from leaving the grass, and a drain filter is used in the inlet.

Location: Garrison offices

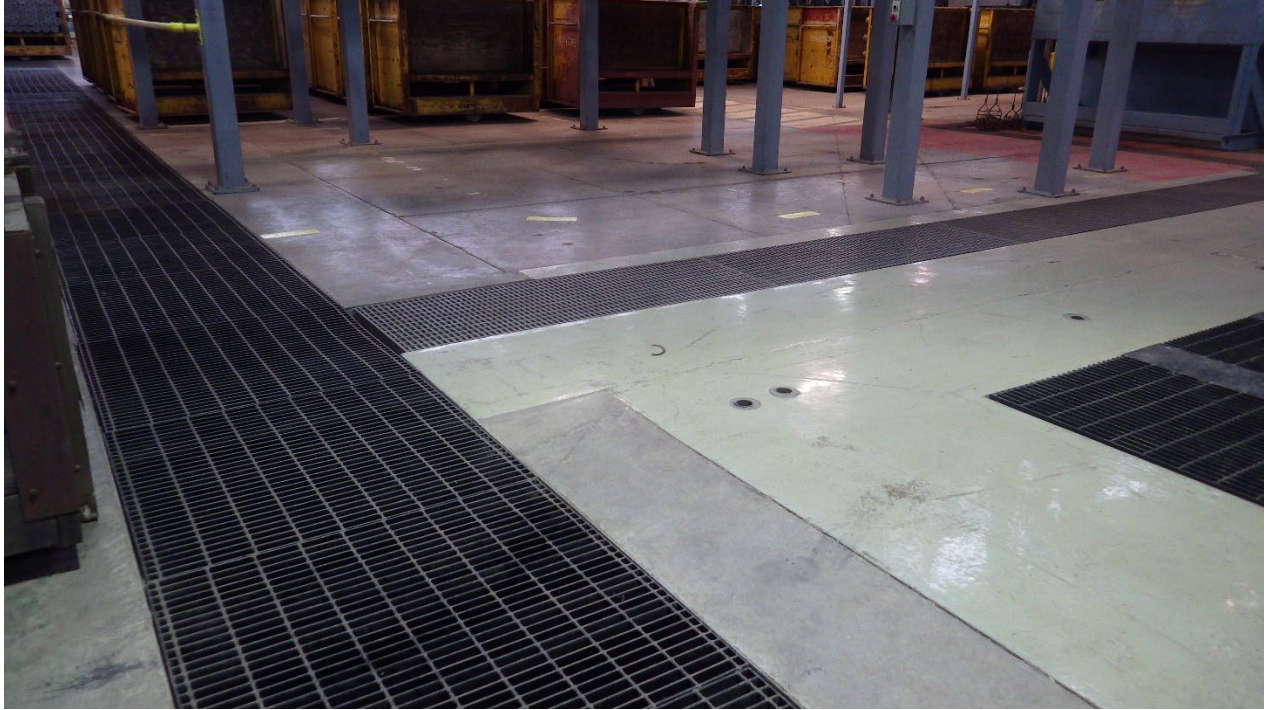
8: RIMG0064

Description: Processing area where drains in the floor are designed as secondary containment and to route wastewater to the pretreatment unit.

Location: Quad City Cartridge Case Facility

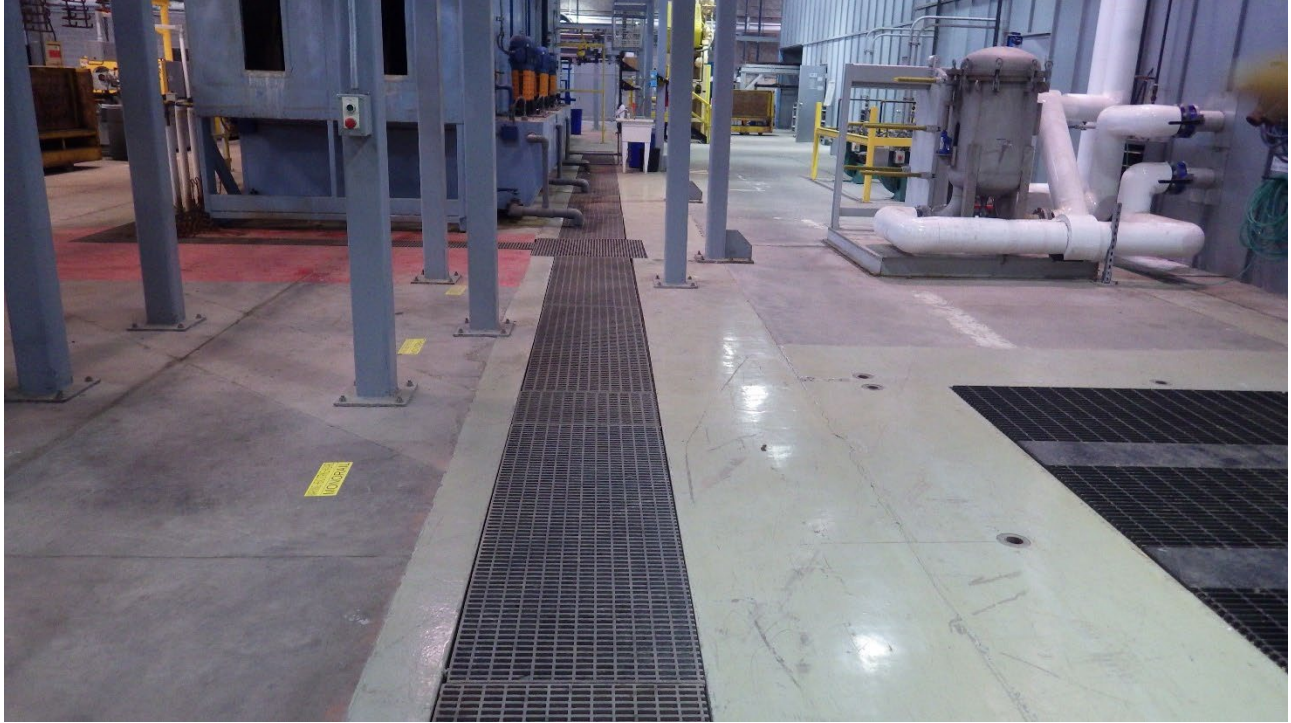
26: RIMG0065

Description: Wash tunnel that is designed to discharge to the floor drains and then to the pretreatment units.
