**COMPLIANCE EVALUATION INSPECTION REPORT  
U.S. ENVIRONMENTAL PROTECTION AGENCY, REGION 5**

**Purpose:** NPDES Compliance Evaluation Inspection

Rock Island Arsenal (RIA)  
1 Rock Island Arsenal  
Rock Island, Illinois, 61299

**Date of Inspection:** August 1 - 2, 2023

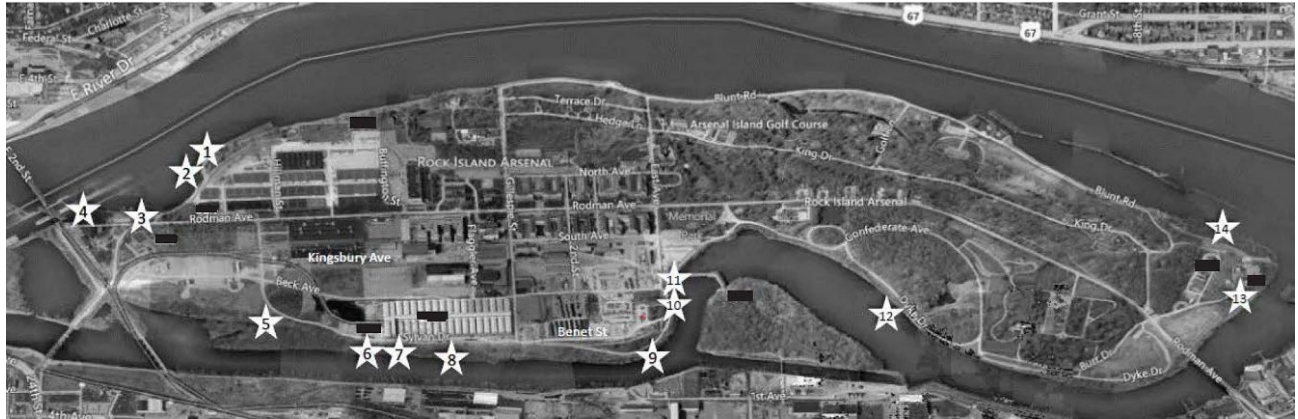
## Appendix B: Aerial image of Rock Island Arsenal with stormwater outfalls

Note: Aerial image with stormwater outfalls taken from Rock Island Arsenal's Stormwater Pollution Prevention Plan. Images do not represent conditions observed and are only to be used as reference.

- 1 Outfall D93 (Manhole D93)
- 2 Outfall D92 (Manhole D92)
- 3 Outfall D98 (Manhole D98)
- 4 Outfall D105
- 5 Outfall F14 (Catch Basin)
- 6 Outfall 295 (Sluice Gate) (SWO 201)
- 7 Pump Station 295

- 8 Outfall E56
- 9 Outfall 127 (Manhole 127) (SWO 102)
- 10 Outfall C39 (Manhole C39)
- 11 Outfall C45 (Manhole C45)
- 12 Sluice Gate #3 at Test Track (SWO 101)
- 13 Sluice Gate and Catch Basin SE (SWO 001)
- 14 Sluice Gate And Outfall (SWO 002)
