Clean Water Act (CWA) Inspection Report

| <b>Type of Inspection</b> | CEI - Compliance Evaluation Inspection | | | |
| <b>Facility or Site Name</b> | North Haven PUD | | | |

### Photograph Log- North Haven PUD

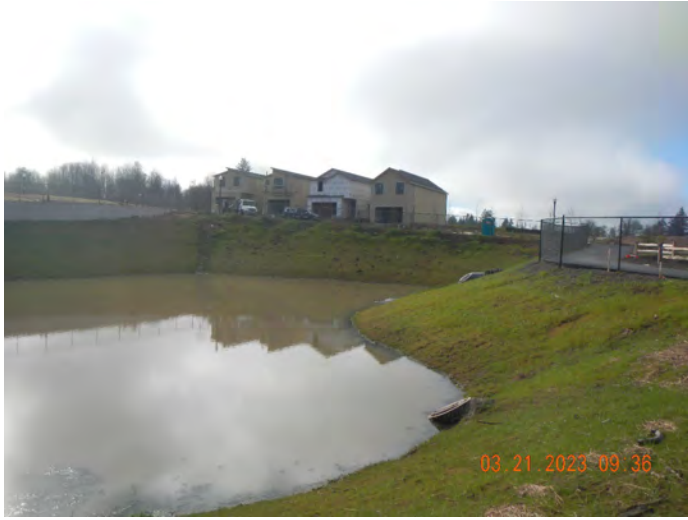
Photo #:01 (DSCN3161)

| Observed primary stormwater collection pond for Phase 1a and majority of Phase 2a ( <b>Photo 1</b> ). The pond is located/referenced by the permittee as "Tract R Stormwater Pond." Observed water entering the pond at numerous designated areas of the collection system. Pond overflow was discharging at the time of the inspection to the central wetland via dispersion structure ( <b>Photo 2</b> ). |

Description: Facing southeast, photo of the primary stormwater pond (Tract R) located within the eastern portion of the development.

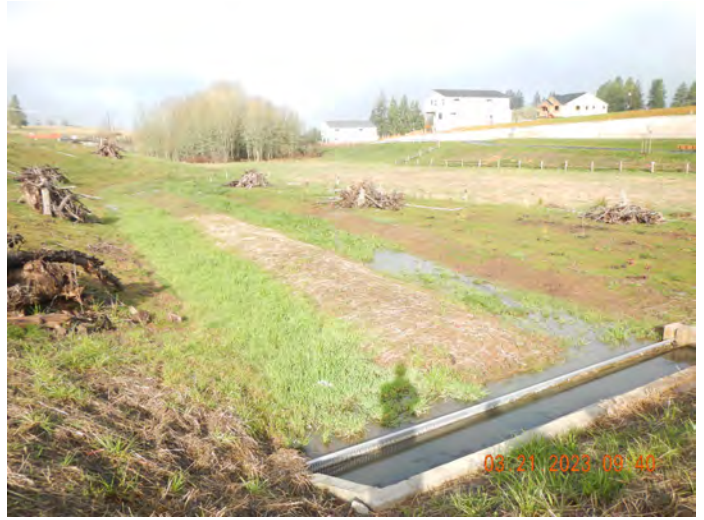
Photo #:02 (DSCN3162)

Description: Facing west, photo of the primary stormwater pond's (Tract R) discharge to the vegetative wetland area located in the central area of the development.

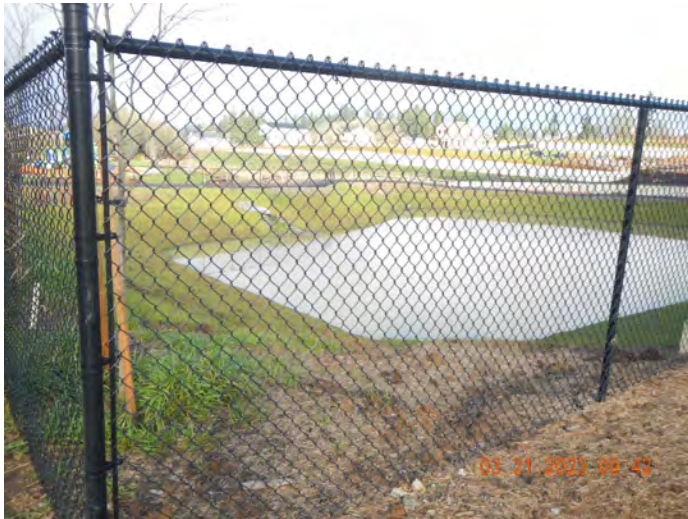
Photo #:03 (DSCN3163)

| Observed southeastern slope of the Tract R Stormwater Pond, including straw mulch and hydroseeded areas ( <b>Photo 3</b> ). |

Description: Facing northwest, photo of the primary stormwater pond (Tract R).

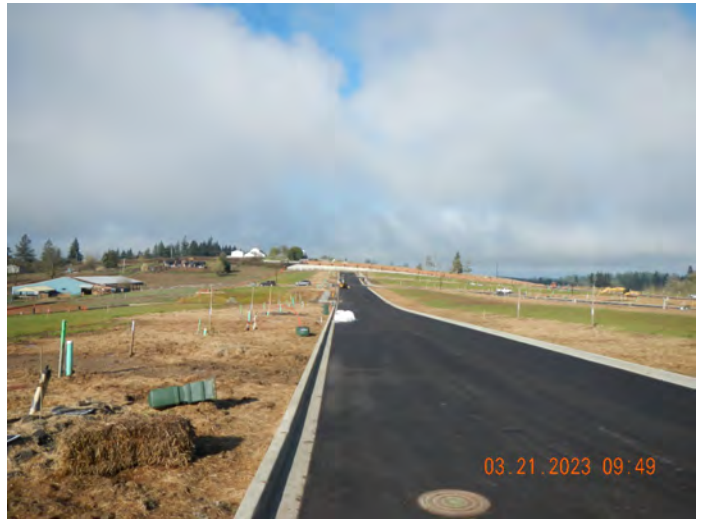
Photo #:04 (DSCN3164)

| Observed roadside catch basins, residential lots, and roadways within Phase 2a ( <b>Photo 4</b> ). Area was referenced by the permittee as "Tract G." Mr. Christenson discussed that roadside catch basins were recently cleaned and "jetted" approximately two weeks prior to the inspection. Current inspection activity includes backfilling sidewalks. Roadways are swept every other day. Observed straw mulching within disturbed lots and roadways were generally free of sediment and debris. |

Description: Facing west, photo of the southern lots within the current phase of the development.

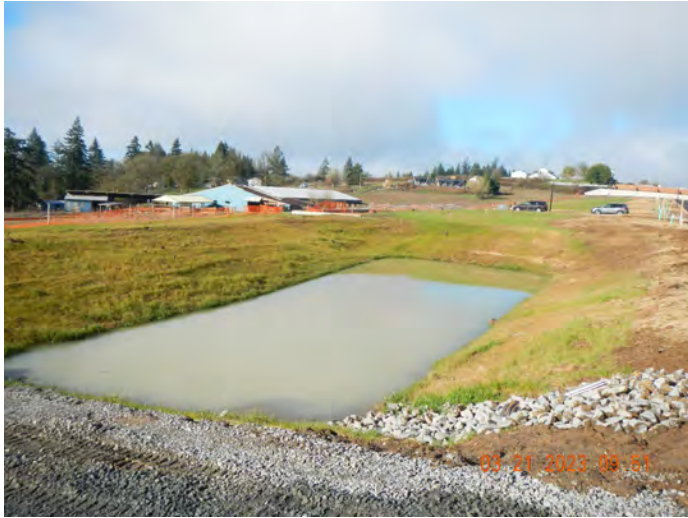
Observed secondary stormwater collection pond within Phase 2a (**Photo 5**). The pond is referenced by the permittee as “Tract G Stormwater Pond.” Observed the future overflow control structure and current discharge piping (**Photo 6**). Discharge piping routes stormwater from the pond to a dispersion trench located south of the pond (**Photo 7 & Photo 8**). The dispersion trench discharges to neighboring field to the south. Unstabilized areas observed at the outlet of the dispersion trench.

Photo #:05 (DSCN3165)  
Description: Facing west, photo of southern stormwater pond (Tract G).

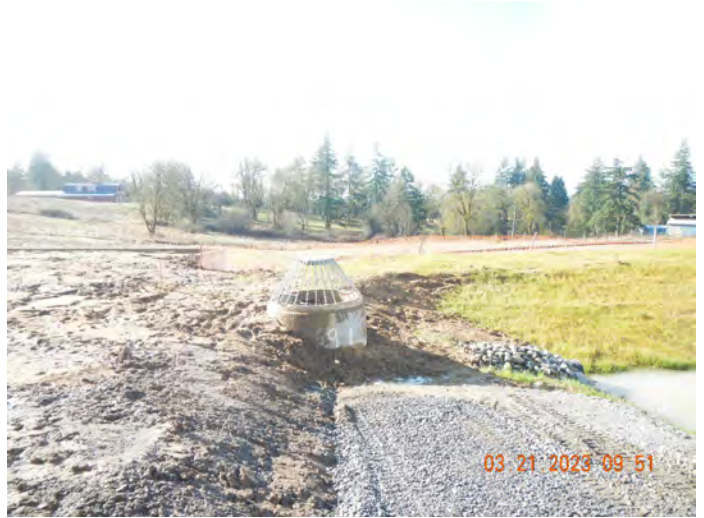
| AOC Reference #: JK6-OB-003 | Phase 2a/Tract G/Tract G Stormwater Pond |
|---|---|
| <p>At the time of inspection during the walk-through within Phase 2a, we observed/discussed unstabilized areas along the southeastern slope of the Tract G stormwater pond near the overflow structure (<b>Photo 6</b>). It was discussed that nearby areas had been previously mulched, and the mulch had since deteriorated. The concern is the exposed soils could contribute to additional sediment entering the Tract G stormwater pond.</p> | |

Photo #:06 (DSCN3166)  
Description: Facing south, photo of the overflow structures to the southern stormwater pond (Tract G).

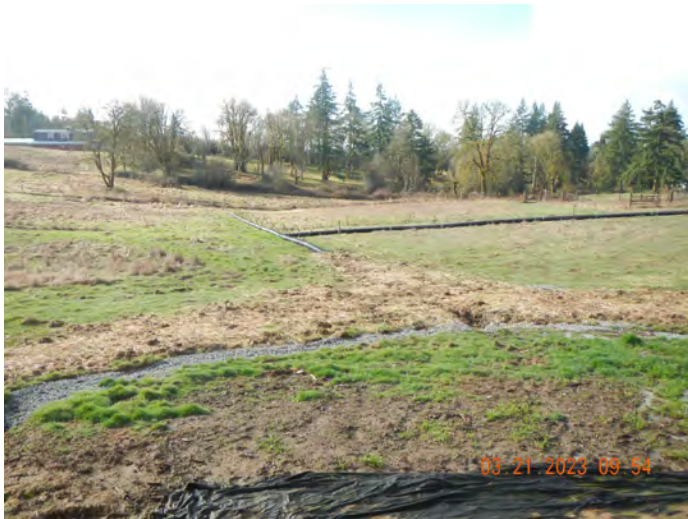
Photo #:07 (DSCN3167)  
Description: Facing south, photo of the discharge area from the southern stormwater pond (Tract G). Stormwater discharges from the pond to a dispersion trench to the neighboring property/vegetative area.

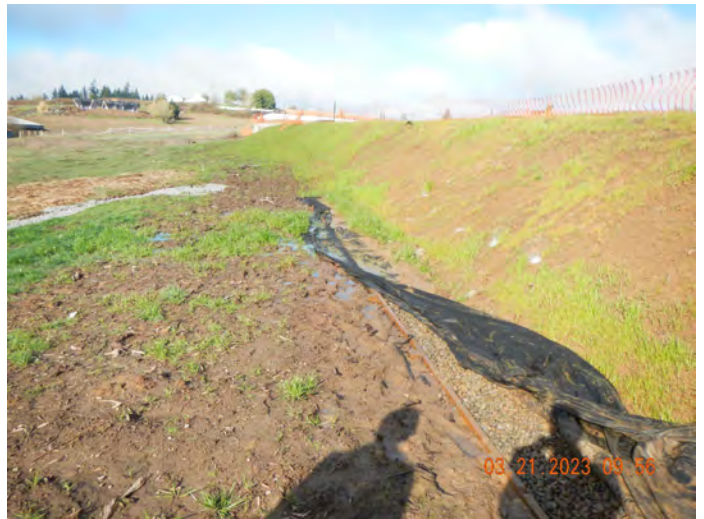
| AOC Reference #: JK6-OB-003 | Phase 2a/Tract G/Tract G Stormwater Pond |
|---|---|
| <p>We also observed/discussed exposed areas downslope of the pond’s discharge/dispersion trench to the southern neighboring property (<b>Photo 8</b>).</p> | |

Photo #:08 (DSCN3168)  
Description: Facing west, photo of the discharge area from the southern stormwater pond (Tract G). Stormwater discharges from the pond to a dispersion trench, to the neighboring property/vegetative area.

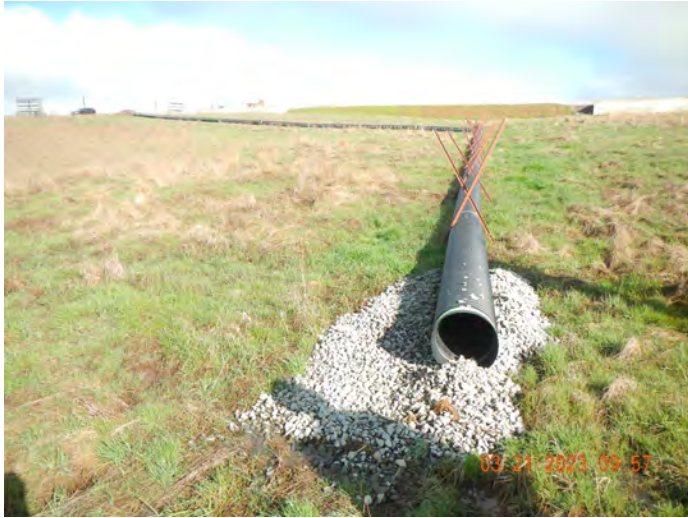
Photo #:09 (DSCN3169)

Observed above ground conveyance piping installed by neighboring property to convey stormwater discharging from the dispersion trench over a portion of the vegetative field (**Photo 9 and Photo 10**). Returned to Tract G Stormwater Pond to view discharge piping (**Photo 11**).

Description: Facing north, photo of the discharge conveyance installed by the property owner to the south.

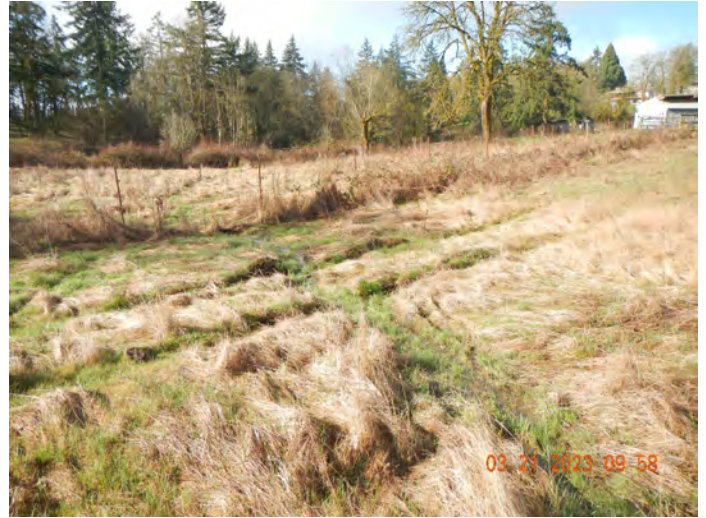
Photo #:10 (DSCN3170)

Description: Facing south, photo of the receiving vegetative area from the southern discharge conveyance installed by the property owner to the south.

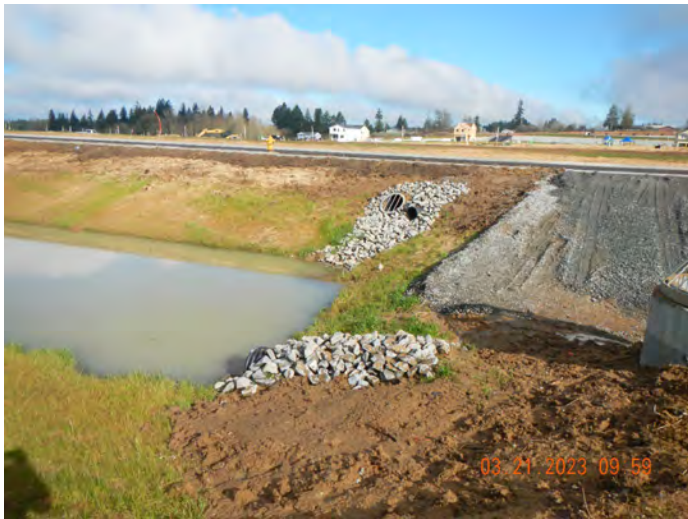
Photo #:11 (DSCN3171)

Description: Facing north, photo of southern stormwater pond (Tract G).

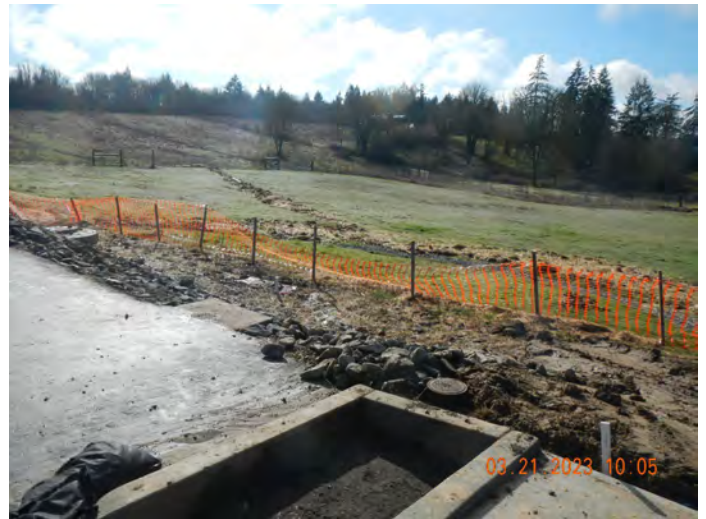
Photo #:12 (DSCN3172)

Continued the walk-through to the west and observed secondary dispersion trench installed within southern area of Phase 2a (**Photo 12**).

Description: Facing southeast, photo of the dispersion trench and stormwater catchment area west of Tract G.

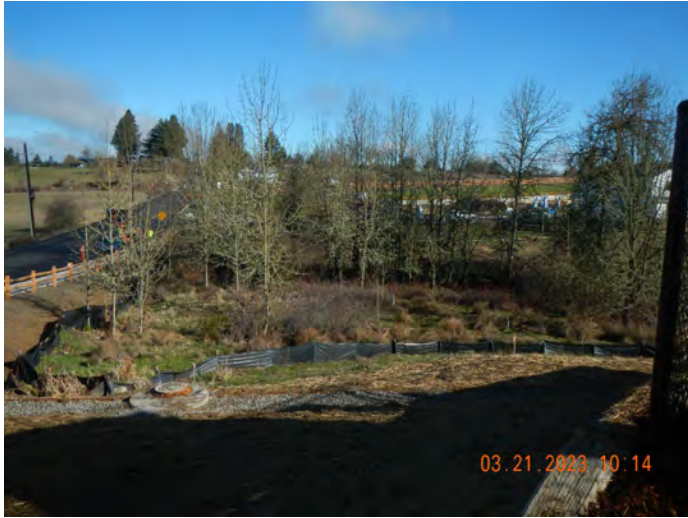
Photo #:13 (DSCN3173)

Observed western areas of Phase 2a along NW 11<sup>th</sup> Avenue. Stormwater from this drainage area is collected via catch basins and is routed to a stormwater vault/structure prior to discharging into the vegetative wetland area (**Photo 13**). Disturbed areas were covered with straw mulch and silt fencing was observed.

Description: Facing north, photo of the western portion of the vegetative wetland area located in the central portion of the development.

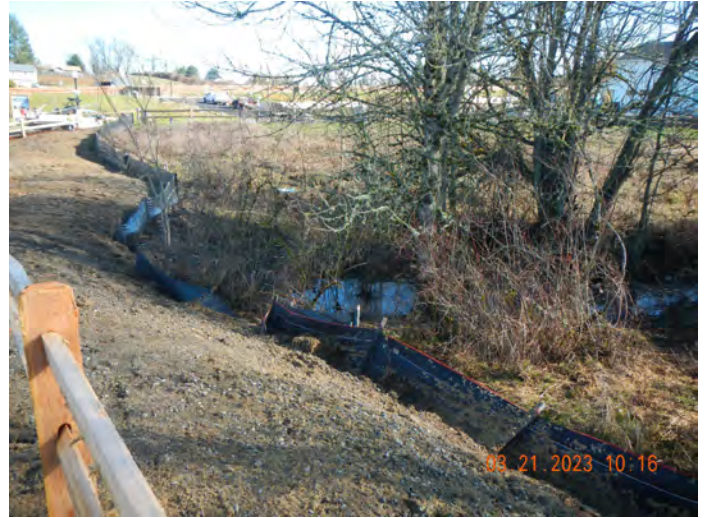
Photo #:14 (DSCN3174)

Observed the discharge of the vegetative wetland area (**Photo 14**) along NW 11<sup>th</sup> Avenue. The wetland discharges to a culvert that extends under NW 11<sup>th</sup> Avenue and then daylight on the west side of NW 11<sup>th</sup> Avenue. This location is considered the monitoring point for Outfall 001 (West Outfall) to Packard Creek (**Photo 15**). Observed area of downed silt-fencing near the wetland area discharge on the east side of NW 11<sup>th</sup> Avenue.

| AOC Reference #: JK6-OB-007 | Location: Phase 2a/Western Area/Wetland Outfall |
|---|---|
| <p>At the time of inspection, during our walk through near the wetland outfall along NW 11<sup>th</sup> Avenue, we observed/discussed downed silt-fencing upslope of the wetland area outfall (<b>Photo 14</b>). This downed silt-fencing was first identified in the January 23, 2023, Site Inspection Report as a corrective action item. The concern is the BMP in need of maintenance based upon the written standard and the length of time since the issue had been identified.</p> | |

Description: Facing north, photo of silt-fencing along the western perimeter of the vegetative wetland area located in the central portion of the development. A section of silt-fence was observed to be down and in need of maintenance.

| AOC Reference #: JK6-OB-007 | Location: Phase 2a/Western Area/Wetland Outfall |
|---|---|
| <p><i>The Stormwater Management Manual for Western Washington (July 2019) lists maintenance standards for BMP C233 (Silt Fence) which includes: “Remove sediment deposits when the deposit reaches approximately one-third the height of the silt-fence, or install a second silt-fence.</i></p> | |
| <p><i>Part S4.B.2.b of permit states: “Based on the results of the inspection (site inspection), the Permittee much correct the problems identified, by: b. Immediately beginning the process of fully implementing and maintaining appropriate source control and/or treatment BMPs, within 10 days of the inspection. If installation of necessary treatment BMPs is not feasible within 10 days, Ecology may approve additional time when an extension is requested by a Permittee within the initial 10-day response period.</i></p> | |

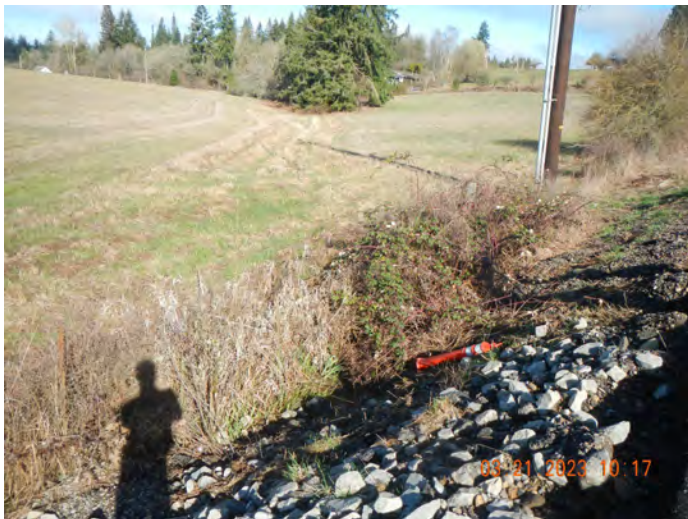
Photo #:15 (DSCN3175)

Description: Facing north, photo of approximate sampling location of Outfall 001, west of NW 11<sup>th</sup> Ave.

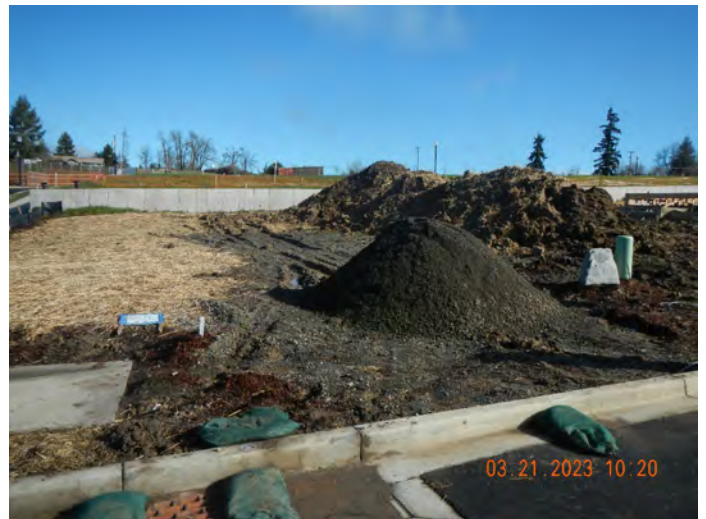
Photo #:16 (DSCN3176)

Continued the walk-through into Phase 1a. Observed multiple homes being constructed. Lots were generally well stabilized with covered straw mulch. observed perimeter silt fencing in areas. Observed unstabilized stockpiles observed within lots 193 and 192. Lot numbers were provided via on-site signage (**Photo 16 – Photo 18**). Roadways were generally free of sediment and debris.

At the time of inspection, during our walk through near the west end of Phase 1a, we observed/discussed unworked/uncovered stockpiles within Lot(s) 192/193 (**Photo 16 – Photo 18**).

Description: Facing north, photo of stockpiles within lot #192/193.

*Section S.9.D.5.f of the permit states: “the Permittee must stabilize stockpiles from erosion, protected with sediment trapping measures, and where possible, be located away from storm drain inlets, waterways, and drainage channels.*

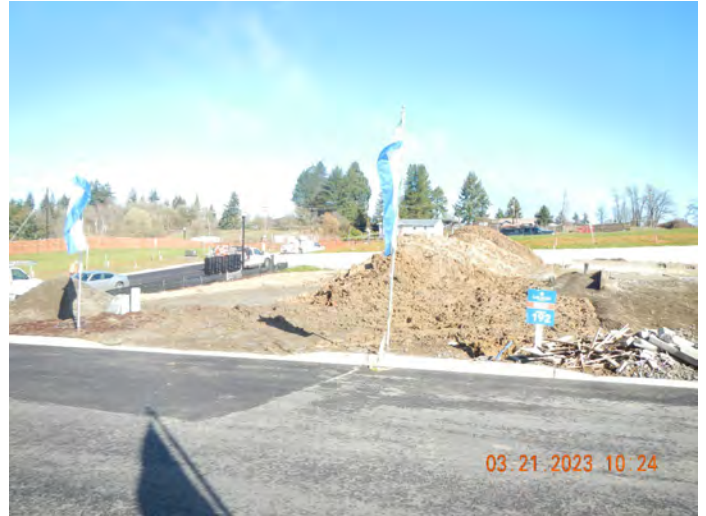
Photo #:18 (DSCN3178)

Description: Facing north, photo of stockpiles within lot #192/193.

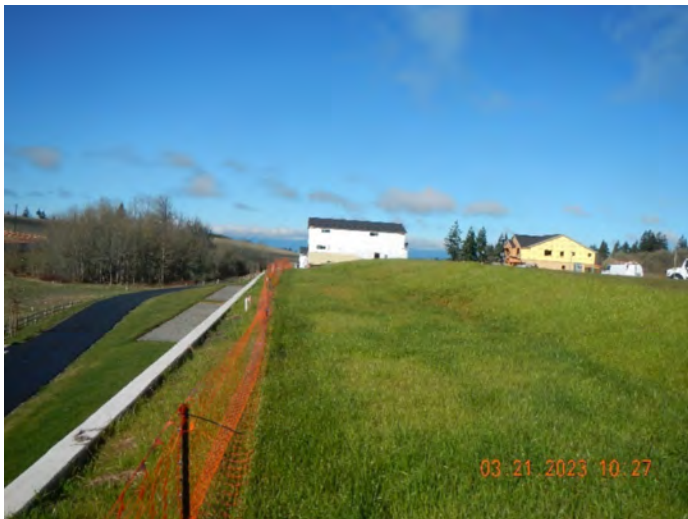
Photo #:19 (DSCN3179)

**Location:** Phase 1a/Eastern Areas**Observation #:** JK6-OB-009Established hydroseeding observed within majority of Phase 1a areas (**Photo 19**).**SECTION III – RECORDS REVIEW****Record: Stormwater Pollution Prevention Plan (SWPPP)****Ref #:** JK6-RR-001

Description: Facing west, photo of hydroseeded area(s) in Phase 1a.
