## RCRA COMPLIANCE EVALUATION INSPECTION REPORT

CryoLife, Inc.  
1655 Roberts Blvd., NW  
Kennesaw, Georgia 30144

September 15, 2021

**EPA RCRA CEI Photographs**

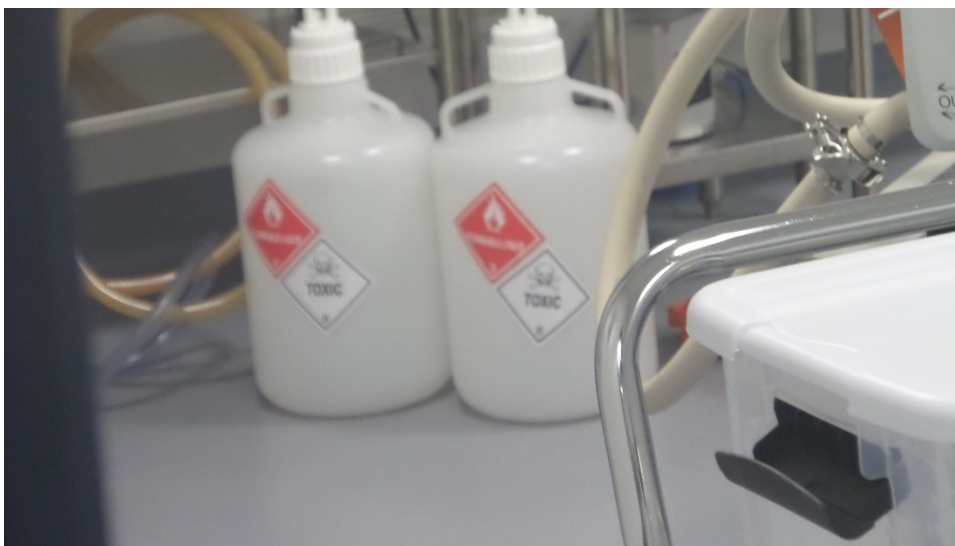
The laboratory operator indicated that to minimize fire risk, the spent solvent from cleaning the reactor and dryer is collected in 10-gallon containers (Photograph 1) and transferred to a 55-gallon container also kept in the laboratory. The inspectors observed that the two 10-gallon containers were neither marked nor labeled with the words "Hazardous Waste." The 55-gallon containers were properly labeled, closed, and appeared to be in good condition (Photographs 2

**Pursuant to Ga. Comp. R. and Regs. 391-3-11-.08(1) [40 C.F.R. § 262.15(a)(5)], which is a condition of the SAA Permit Exemption, a generator is required to do the following: mark or label its containers (i) with the words “Hazardous Waste.”**

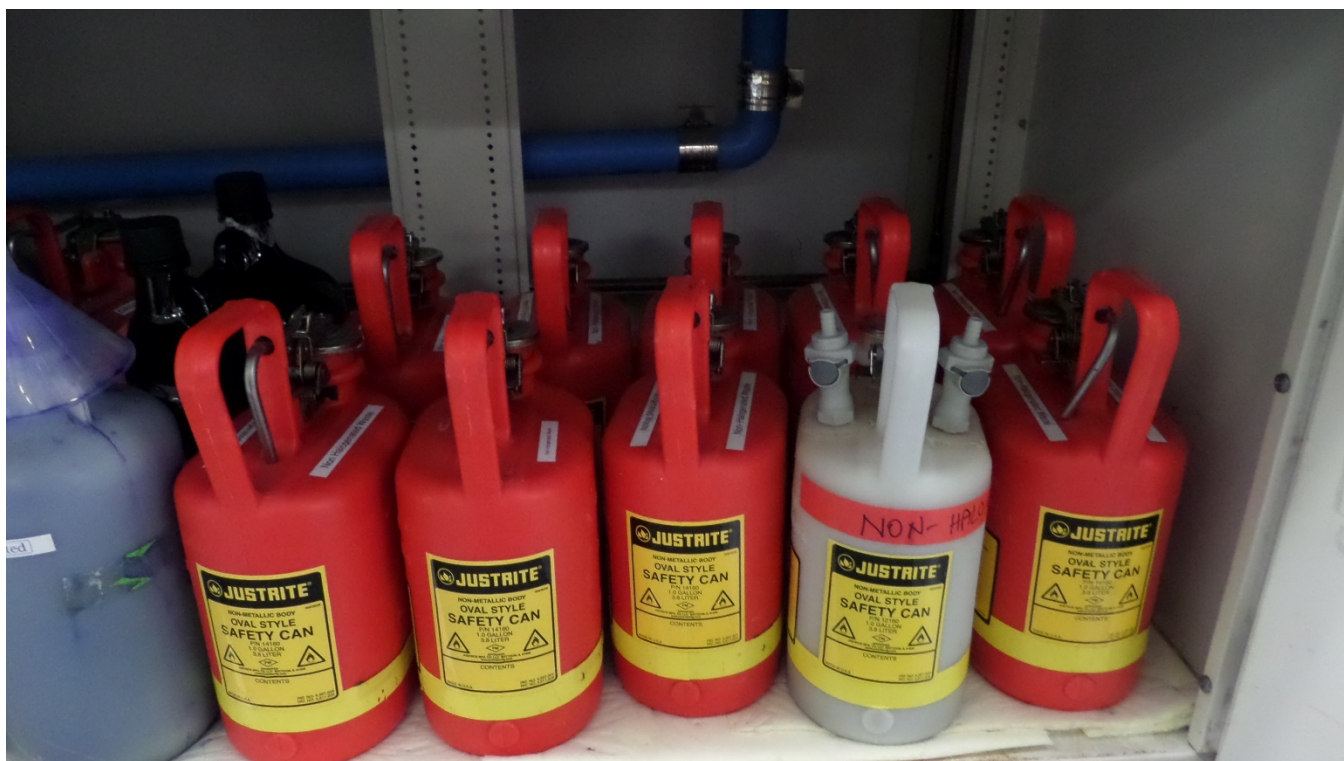
This laboratory generates non-halogenated spent solvents (D001/F003) from testing activities, which are collected in 4-liter containers. The laboratory operators keep a log with the composition of the waste in each container. The containers are kept in cabinets. During the inspection, the inspectors observed 19 4-liter containers (Photograph 4). All containers were properly labeled “Non-halogenated waste,” closed, and appeared to be in good condition.

**Pursuant to Ga. Comp. R. and Regs. 391-3-11-.08(1) [40 C.F.R. § 262.15(a)(5)], which is a condition of the SAA Permit Exemption, a generator is required to do the following: mark or label its containers (i) with the words “Hazardous Waste.”**

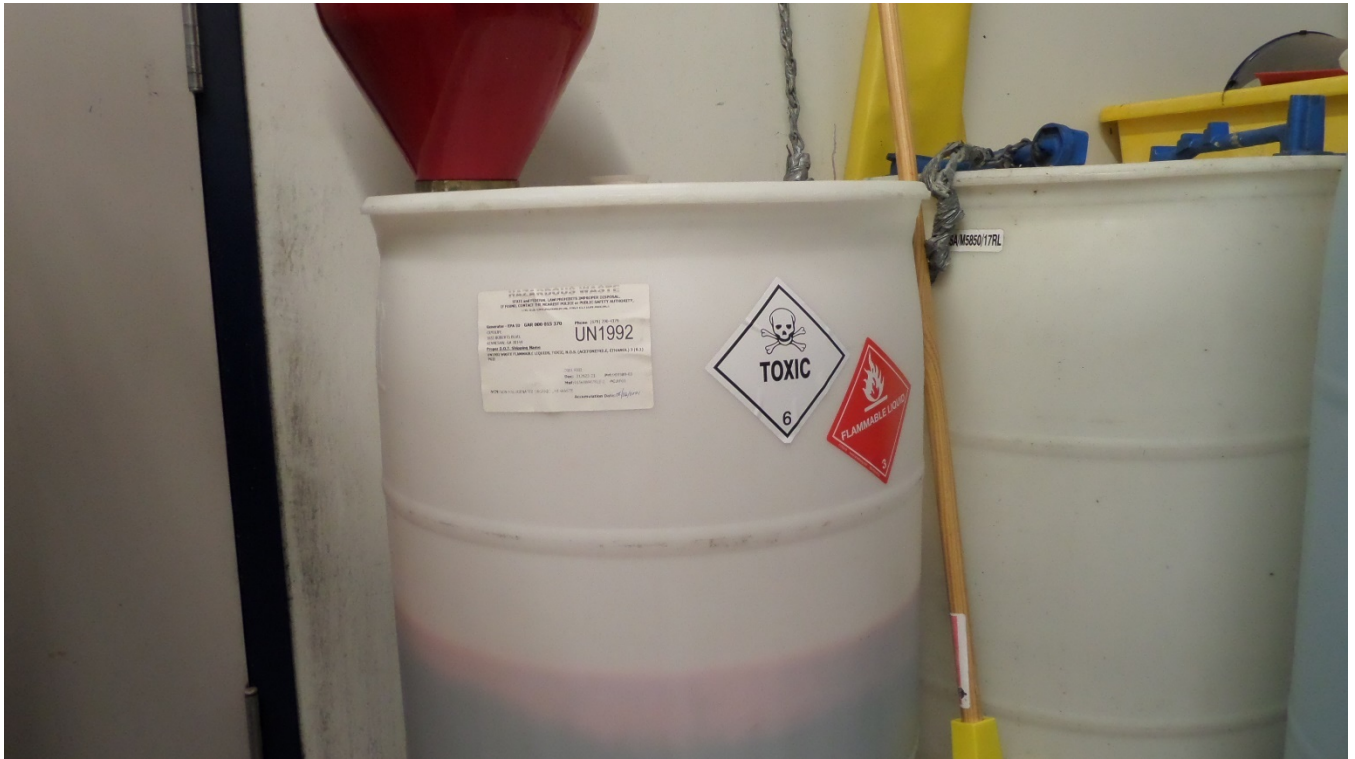
The hazardous waste CAA is in a room off the unloading/loading dock area, in the back of Building #2. Access to the room is controlled with an electronic lock. In the CAA, the inspectors observed one 55-gallon container with spent solvent (D001/F003), dated 9/14/21 (Photograph 5); and one 55-gallon with non-halogenated spent solvent (D001/F003), dated 8/26/21 (Photograph 6).

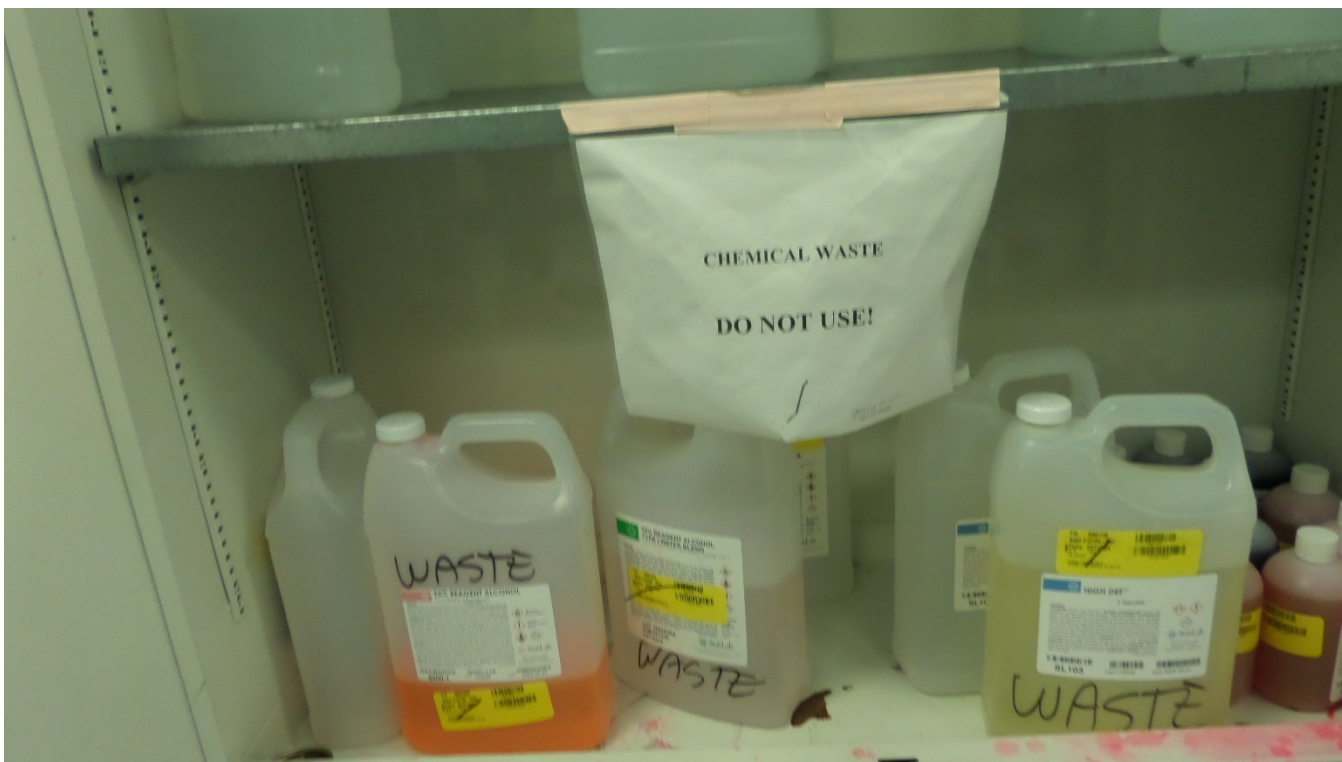
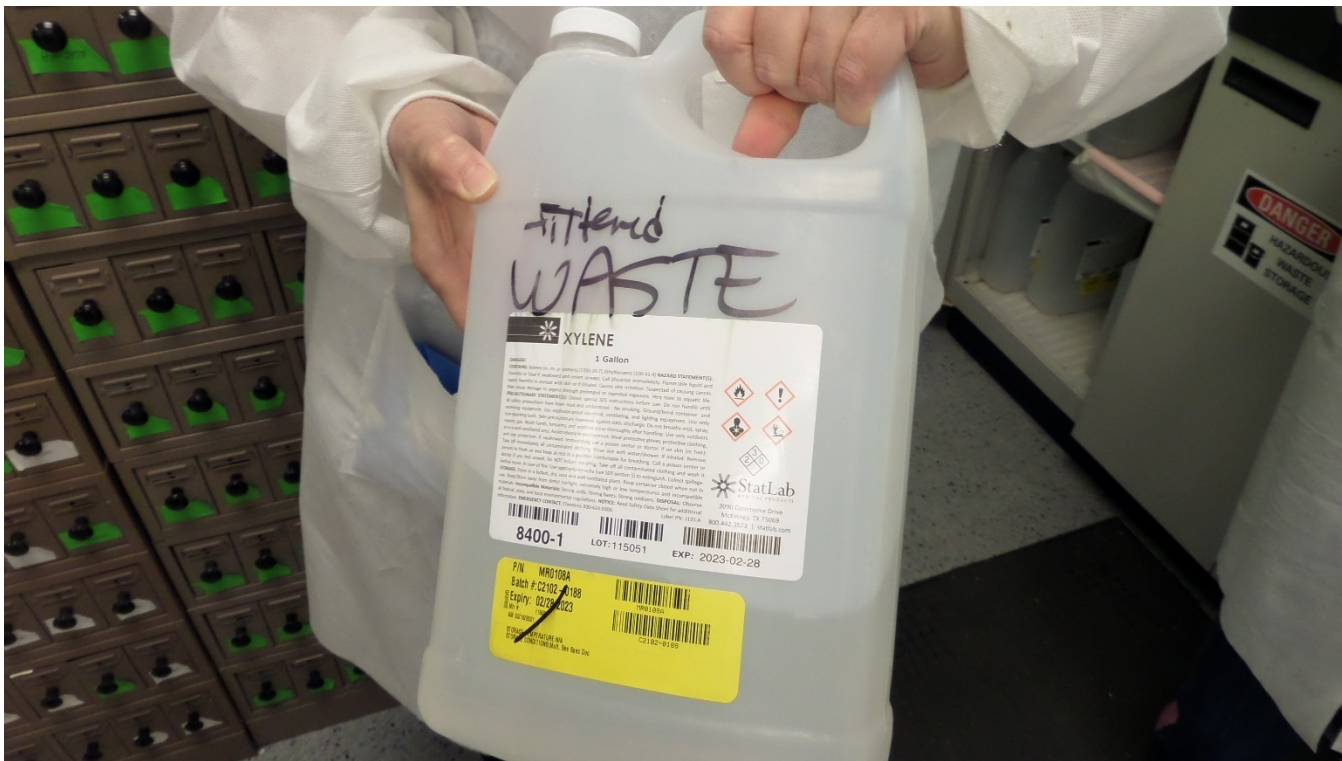
In the laboratory, the inspectors observed ten 1-gallon containers of spent alcohol (D001/F003) and one 1-gallon container of spent xylene (D001/F003). Both solvents are used for tissue samples preparation. The containers were in good condition, closed, labeled with the hazards of their contents, and marked with the word “Waste” (Photographs 7 and 8).

**Pursuant to Ga. Comp. R. and Regs. 391-3-11-.08(1) [40 C.F.R. § 262.15(a)(5)], which is a condition of the SAA Permit Exemption, a generator is required to do the following: mark or label its containers (i) with the words “Hazardous Waste.”**
