## **RCRA Inspection Report**

Goodrich Corporation Landing Systems  
Services  
3201 N.W. 167<sup>th</sup> Street  
Miami Gardens, Florida 33056

EPA ID#: FLD982106080  
NAICS #: 336411 – Aircraft Manufacturing

February 05, 2025, at 10:00 A.M.

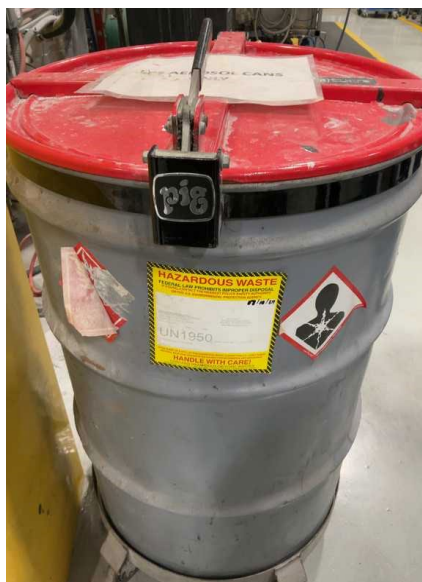
| Photo 01 | | | IMG-202502051109439431985788.jpg |

| 55-gallon SAA container of spent aerosol cans. The container was labeled “Hazardous Waste”, marked with an indication of the hazard of the contents, and closed. | | | |

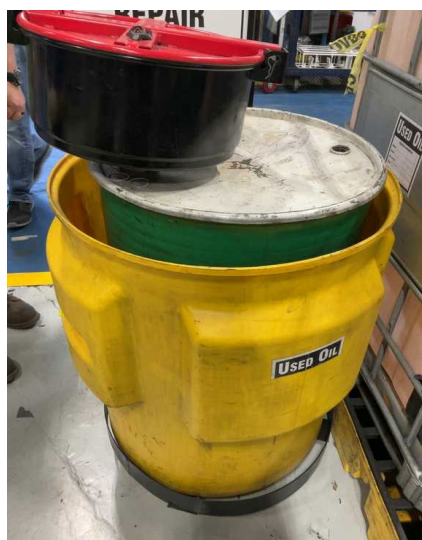
| Photo 02 | | | IMG-202502051112071272045753.jpg |

| 55-gallon container of used oil equipped with a funnel, within an overpack container. The container was labeled used oil. There was some used oil observed in the secondary containment; however, it was less than 10% of the containment. | | | |

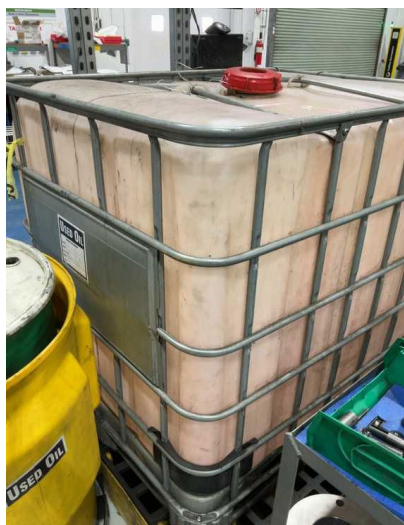
| Photo 03 | | | IMG-2025020511121312132319577.jpg |

| 250-gallon tote of used oil. The container was labeled "Used Oil". There was some used oil observed in the secondary containment; however, it was less than 10% of the containment. | | | |

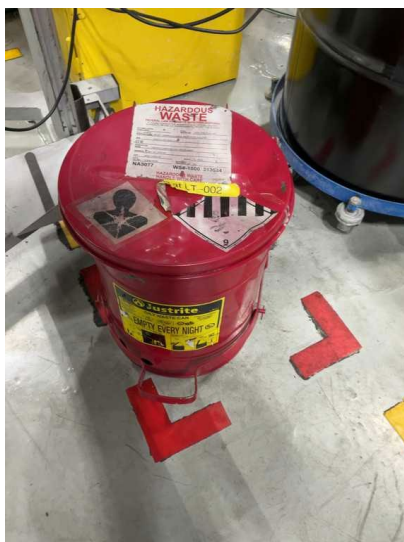
| Photo 04 | | | IMG-202502051117041742026456.jpg |

| 5-gallon SAA containers of solvent-contaminated wipes. The containers were closed, labeled "Hazardous Waste", and marked with an indication of the hazard of the contents. | | | |

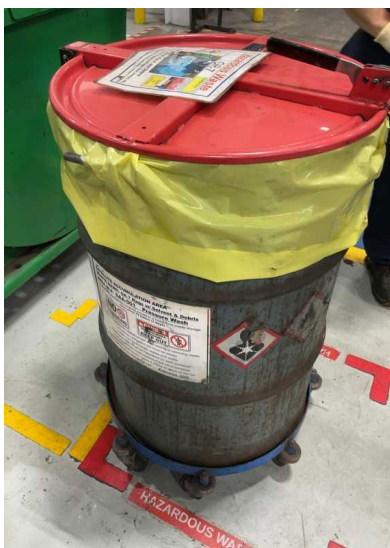
| Photo 05 | | | IMG-2025020511185918592079414.jpg |

| 55-gallon SAA container of solvent-contaminated wipes, paint, and debris. The containers were closed, labeled "Hazardous Waste", and marked with an indication of the hazard of the contents. | | | |

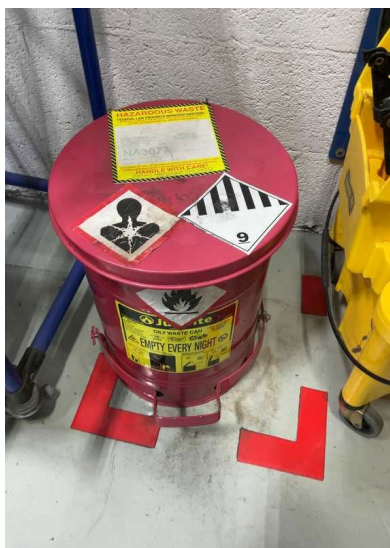
| Photo 06 | | | IMG-202502051121002102706539.jpg |

| One 5-gallon closed container for solvent-contaminated wipes (Photo 06). The container was labeled "Hazardous Waste", marked with an indication of the hazard of the contents, and closed. | | | |

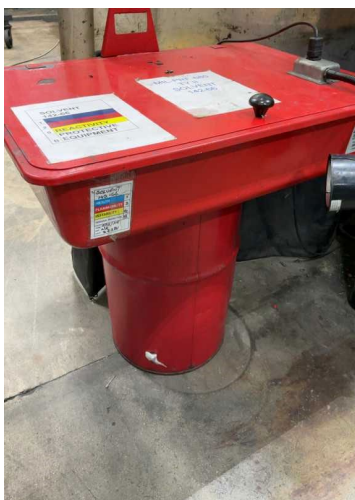
| Photo 07 | | | IMG-2025020511241124112075326.jpg |

| Safety-Kleen parts washer which gets serviced by Safety-Kleen every 6 weeks. | | | |

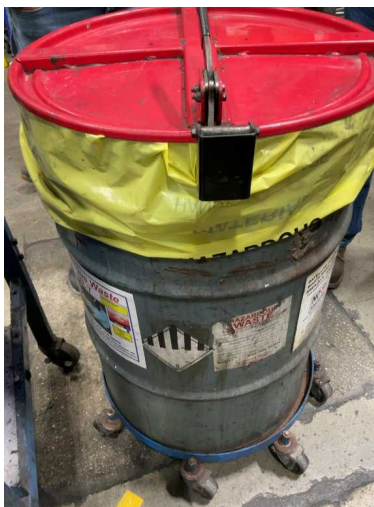
| Photo 08 | | | IMG-2025020511245924592220399.jpg |

| 55-gallon container for solvent-contaminated wipes, paint, and debris. The container was labeled "Hazardous Waste", marked with an indication of the hazard of the contents (opposite side of container), and closed. | | | |

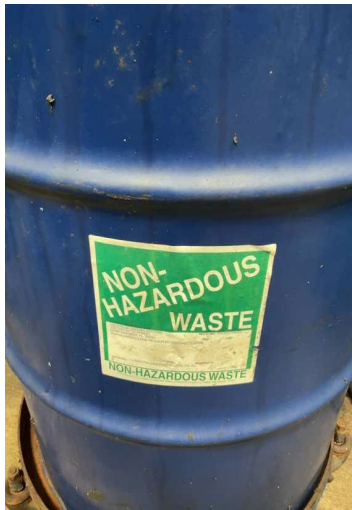
| Photo 09 | | | IMG-2025020511293029302116482.jpg |

| 55-gallon container for grinding sludge. The container was closed and labeled "Non-Hazardous Waste". The inspectors requested a waste profile for this waste stream. | | | |

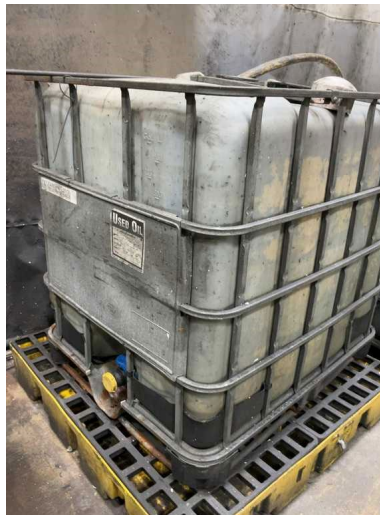
| Photo 10 | | | IMG-2025020511301530152356059.jpg |

| 300-gallon tote of used oil. The container was labeled "Used Oil". | | | |

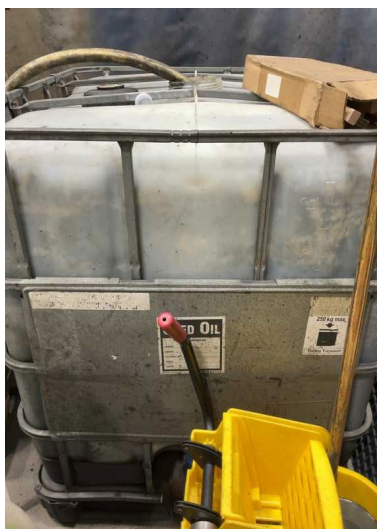
| Photo 11 | | | IMG-2025020511302430242153104.jpg |

| 250-gallon tote of used oil. The container was labeled "Used Oil". | | | |

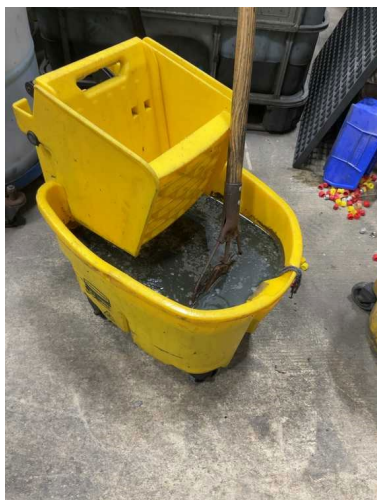
| Photo 12 | | | IMG-2025020511312931292717140.jpg |

| 5-gallon buckets of mop water. Managed as hazardous waste. | | | |

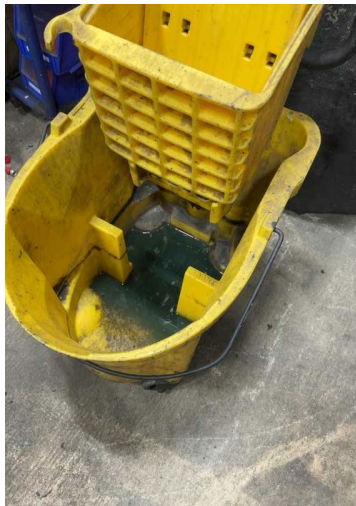
| Photo 13 | | | IMG-2025020511313331332531076.jpg |

| 5-gallon buckets of mop water. Managed as hazardous waste. | | | |

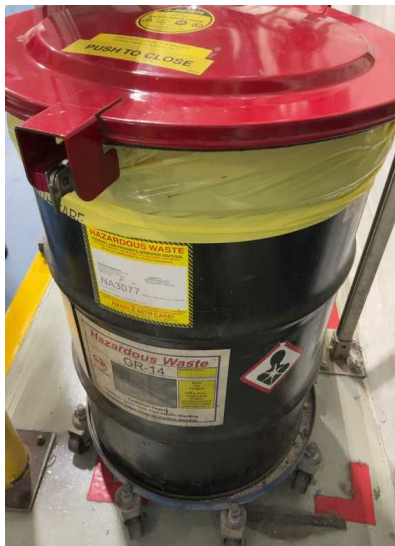
| Photo 14 | | | IMG-2025020511413841381938218.jpg |

| 55-gallon SAA container of contaminated debris. The container was closed, labeled "Hazardous Waste", and marked with an indication of the hazard of the contents. | | | |

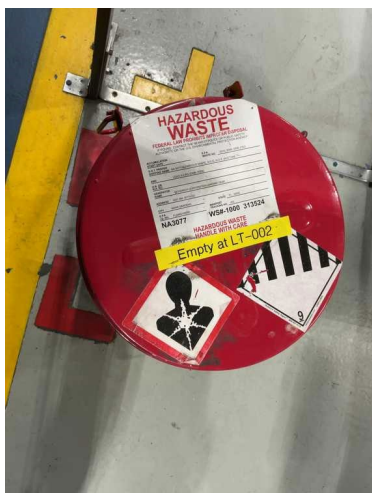
| Photo 15 | | | IMG-2025020511461846181994308.jpg |

| 5-gallon SAA container for solvent-contaminated wipes. The container was closed, labeled "Hazardous Waste", and marked with an indication of the hazard of the contents. | | | |

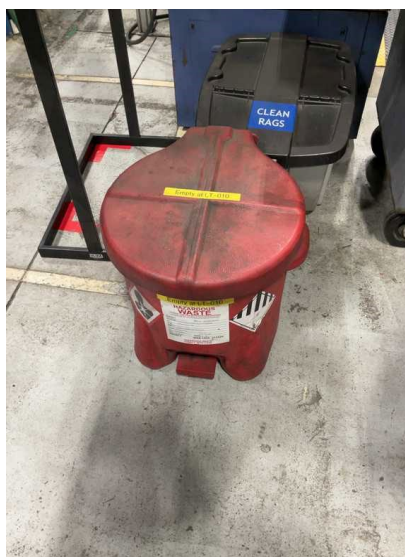
| Photo 16 | | | IMG-2025020511563256322714224.jpg |

| 5-gallon SAA containers of solvent-contaminated wipes. All containers were closed, labeled "Hazardous Waste", and marked with an indication of the hazard of the contents. | | | |

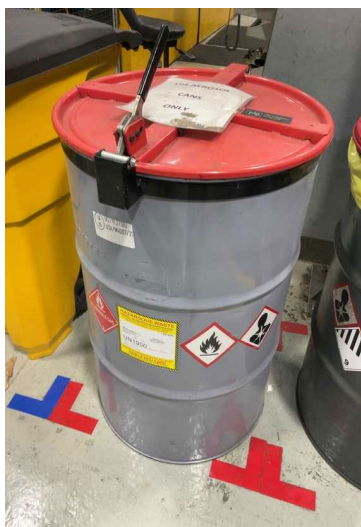
| Photo 17 | | | IMG-2025020511585758571979230.jpg |

| 55-gallon SAA container of spent aerosol cans. The container was closed, labeled "Hazardous Waste", and marked with an indication of the hazard of the contents. | | | |

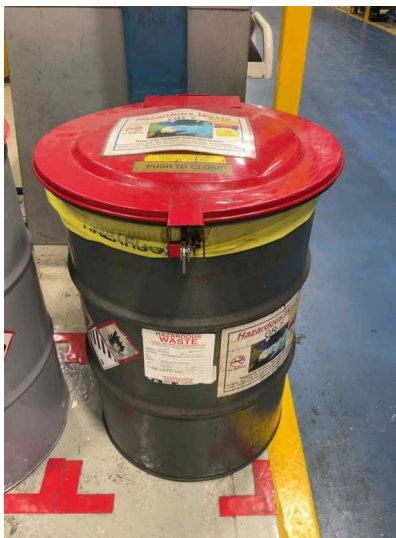
| Photo 18 | | | IMG-202502051159025921982422.jpg |

| 55-gallon container of used rags with solvent, paint, and debris. The container was closed, labeled "Hazardous Waste", and marked with an indication of the hazard of the contents. | | | |

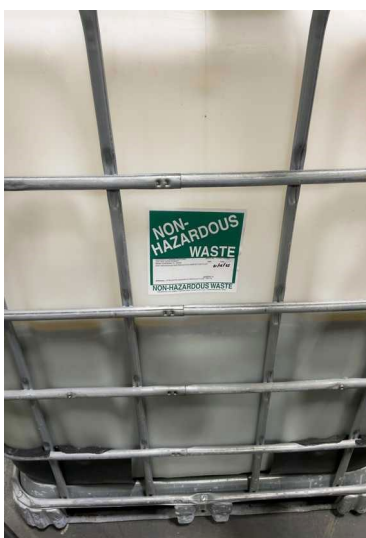
| Photo 20 | | | IMG-2025020512113111311996976.jpg |

| 250-gallon closed tote containing magnetic particle fluid labeled as "Non-Hazardous Waste". | | | |

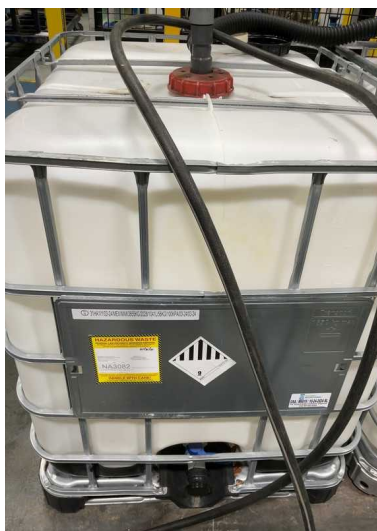
| Photo 21 | | | IMG-2025020512124512452639594.jpg |

| 250-gallon closed tote of mop water contaminated with cadmium and chromium. The container was labeled "Hazardous Waste", dated 01/31/2025, but missing an indication of the hazard of the contents. | | | |

Facility personnel immediately marked the containers with indications of the hazards of the contents for toxicity.

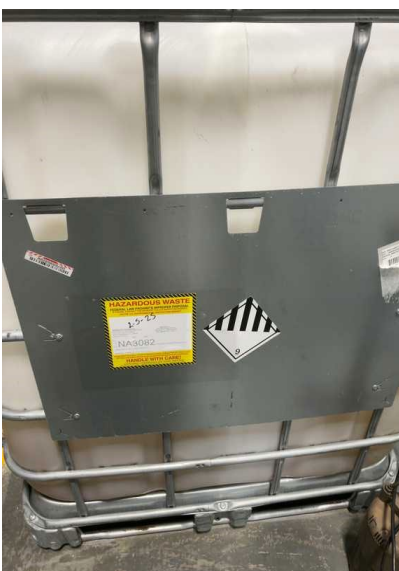
| 250-gallon tote of brine water from the distillation unit. The tote has an opening port at the top which was open for venting purposes. The container was labeled "Hazardous Waste, dated 02/05/2025, and missing an indication of the hazard of the contents. | | | |

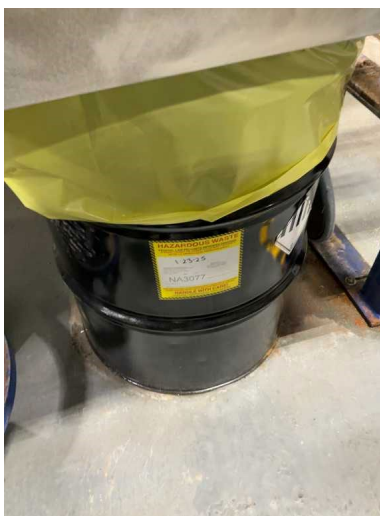
| Photo 23 | | | IMG-2025020512185918591760162.jpg |

| 55-gallon container of filter cake. The container was closed, dated 01/23/2025, but missing an indication of the hazard of the contents. | | | |

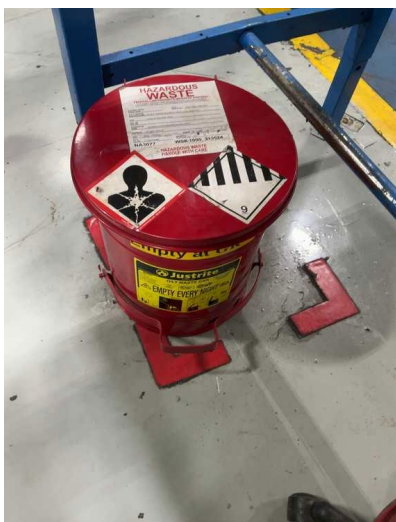
| Photo 24 | | | IMG-2025020512244924491984748.jpg |

| One of 10 5-gallon SAA containers for solvent-contaminated wipes (contaminated with acetone and lead). The containers were closed, labeled "Hazardous Waste", and marked with an indication of the hazard of the contents. | | | |

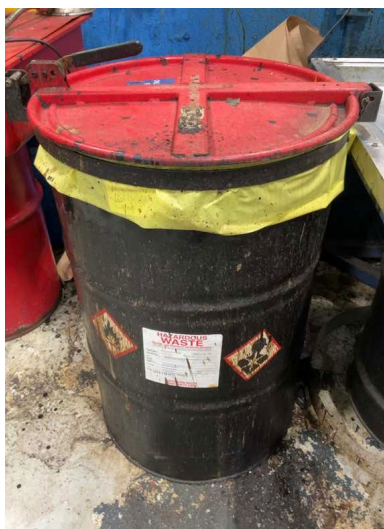
| Photo 25 | | | IMG-2025020512261226122378842.jpg |

| 55-gallon SAA container of solvent-contaminated wipes (acetone and methyl ethyl ketone). The container was closed, labeled "Hazardous Waste", and marked with an indication of the hazard of the contents. | | | |

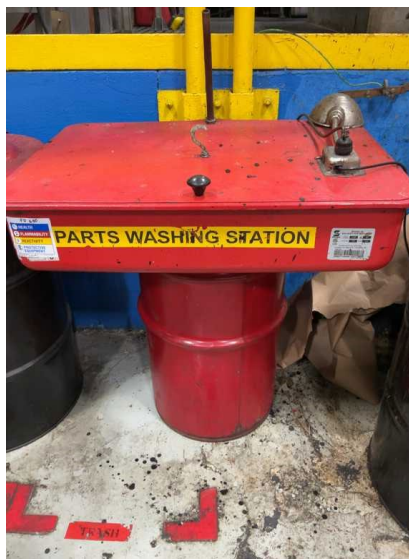
| Photo 26 | | | IMG-2025020512263026302188194.jpg |

| Safety-Kleen parts washer which gets serviced by Safety-Kleen every 6 weeks. | | | |

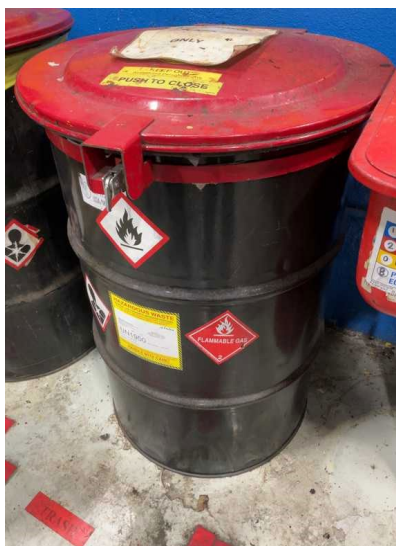
| Photo 27 | | | IMG-2025020512265026502070078.jpg |

| 55-gallon SAA container of spent aerosol cans. The container was closed, labeled "Hazardous Waste", and marked with an indication of the hazard of the contents. | | | |

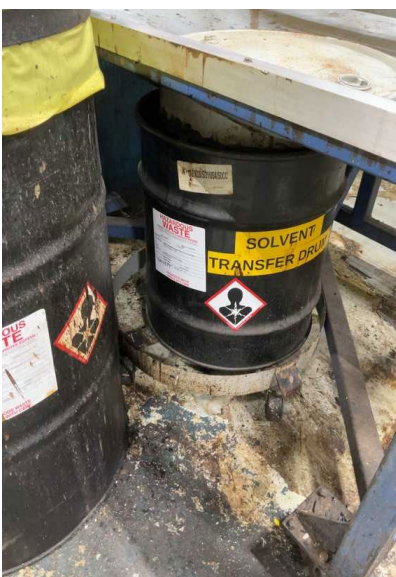
| Photo 28 | | | IMG-202502051241074172614280.jpg |

| 25-gallon container labeled solvent transfer drum underneath a drip pan used in the cleaning process for parts that will undergo electroplating. After each use, the solvent is transferred to a 55-gallon SAA container. | | | |

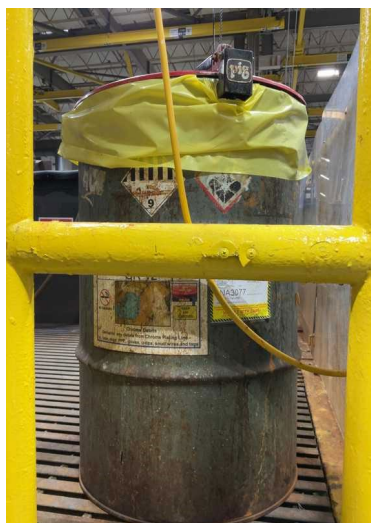
| Photo 29 | | | IMG-202502051243034332180491.jpg |

| 55-gallon SAA container chromium debris, PPE. The container was closed, labeled “Hazardous Waste”, and marked with an indication of the hazard of the contents. | | | |

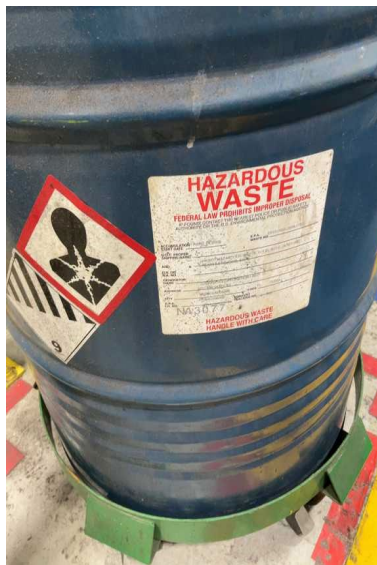
| Photo 30 | | | IMG-202502051252045242298418.jpg |

| 55-gallon SAA container of solvent-contaminated wipes and debris. The container was closed, labeled “Hazardous Waste”, and marked with an indication of the hazard of the contents. | | | |

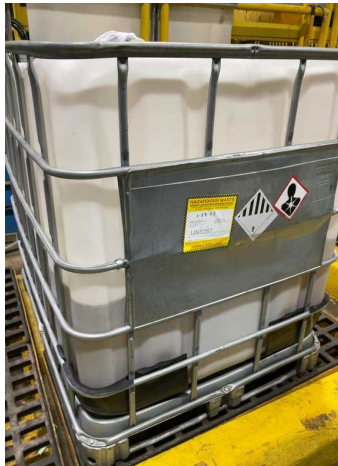
| 250-gallon container that was open and in the process of transferring plating bath solution that has high carbonate. Once the transfer of plating solution is complete, the tote is transferred to CAA 1. The container was labeled "Hazardous Waste", marked with an indication of the hazard of the contents, and dated 01/27/2025. | | | |

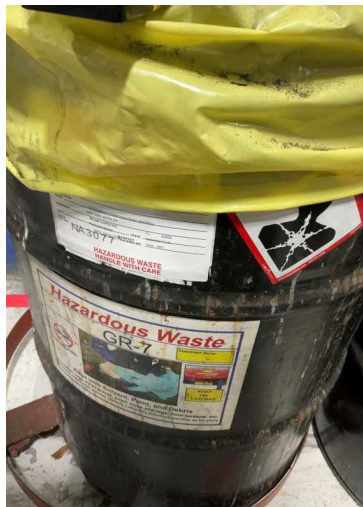
| Photo 32 | | | IMG-202502051305265261988197.jpg |

| 55-gallon SAA container of used solvent-contaminated wipes, paint, and debris. The container was closed, labeled "Hazardous Waste", and marked with an indication of the hazard of the contents. | | | |

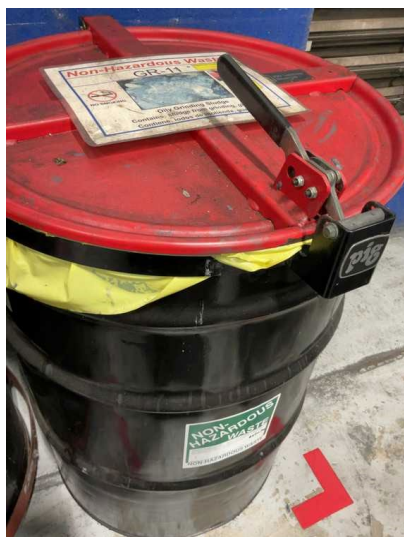
| Photo 33 | | | IMG-202502051305325322015120.jpg |

| 55-gallon closed container of oily grinding sludge, labeled as non-hazardous waste. | | | |

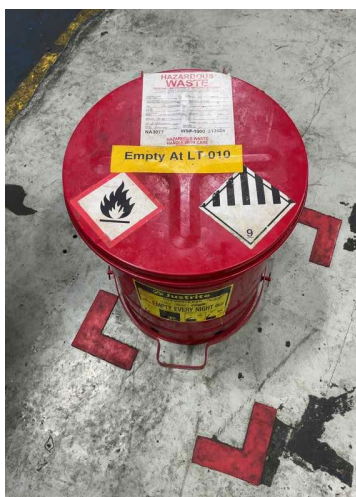
| Photo 34 | | | IMG-2025020513145514553863150.jpg |

| One of two 5-gallon SAA containers of solvent-contaminated wipes. The containers were closed, labeled "Hazardous Waste", and marked with an indication of the hazard of the contents. | | | |

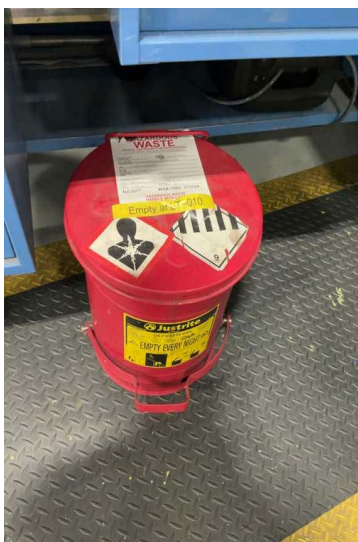
| Photo 35 | | | IMG-2025020513151815182257390.jpg |

| One of six 5-gallon SAA containers of solvent and lead-contaminated wipes. The containers were closed, labeled "Hazardous Waste", and marked with an indication of the hazard of the contents. | | | |

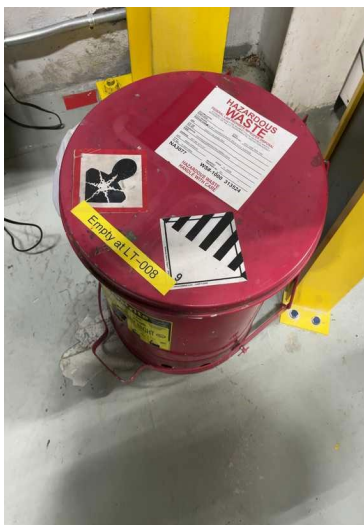
| Photo 36 | | | IMG-2025020513232823282107624.jpg |

| One of 5-gallon SAA container for solvent-contaminated wipes. The container was closed, labeled "Hazardous Waste", and marked with an indication of the hazard of the contents. | | | |

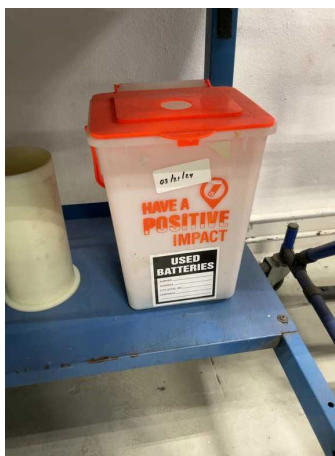
| Photo 37 | | | IMG-2025020513255425541920003.jpg |

| One 3-gallon container of used batteries. The container was closed, labeled "Used Batteries", and dated 03/21/2024. | | | |

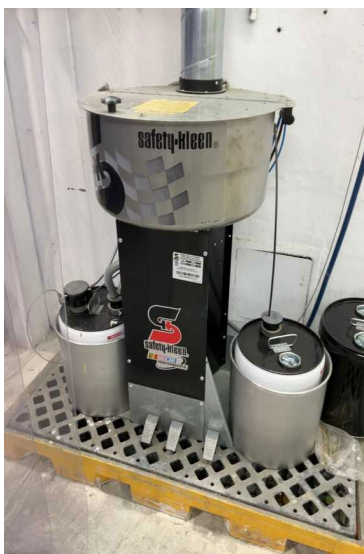
| Photo 38 | | | IMG-2025020513295229522005691.jpg |

| Safety-Kleen parts washer which gets serviced by Safety-Kleen every 6 weeks. | | | |

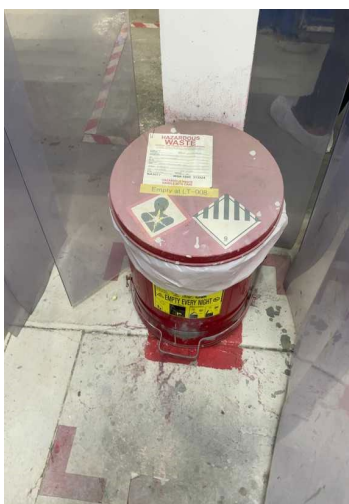
| Photo 39 | | | IMG-202502051330033032177082.jpg |

| 5-gallon SAA containers of solvent-contaminated wipes. The containers were closed, labeled "Hazardous Waste", and marked with an indication of the hazard of the contents. | | | |

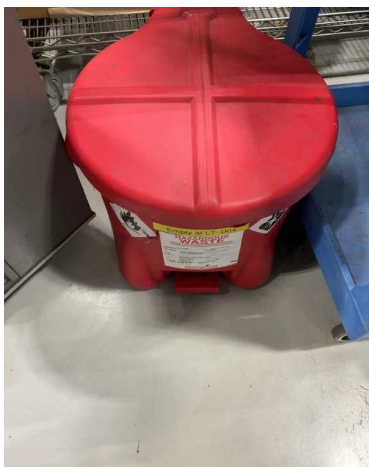
| Photo 40 | | | IMG-2025020513333833381738496.jpg |

| 5-gallon SAA containers of solvent-contaminated wipes. The containers were closed, labeled "Hazardous Waste", and marked with an indication of the hazard of the contents. | | | |

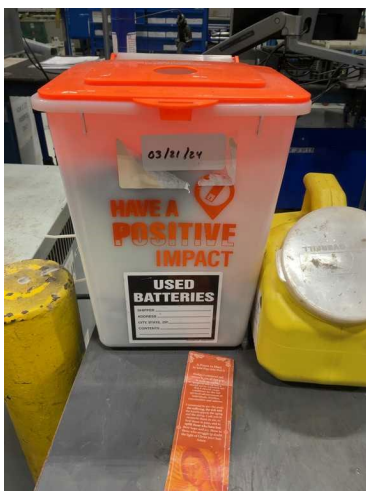
| Photo 41 | | | IMG-2025020513341334132098121.jpg |

| 3-gallon container of universal waste batteries. The container was closed, labeled "Used Batteries", and dated 03/21/2024. | | | |

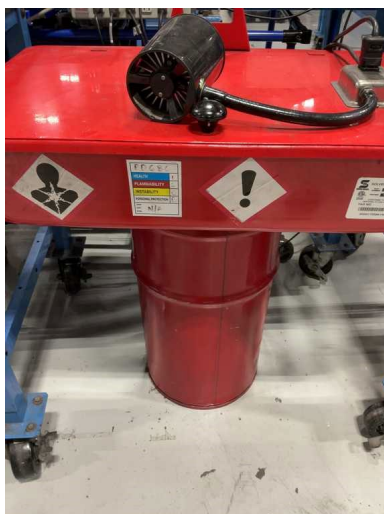
| Photo 42 | | | IMG-2025020513352035201725921.jpg |

| Safety-Kleen closed Safety-Kleen parts washer which gets serviced by Safety-Kleen every 6 weeks. | | | |

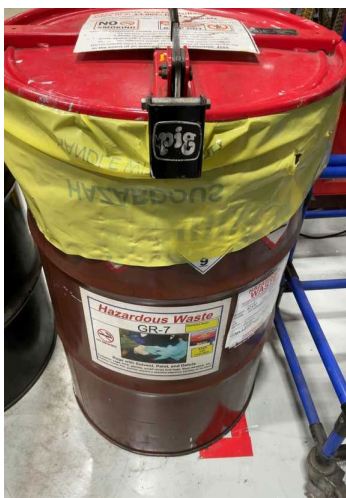
| Photo 43 | | | IMG-20250205133737372189360.jpg |

| One of two 55-gallon SAA containers of solvent-contaminated wipes, paint, and debris. of solvent-contaminated wipes. The containers were closed, labeled “Hazardous Waste”, and marked with an indication of the hazard of the contents. | | | |

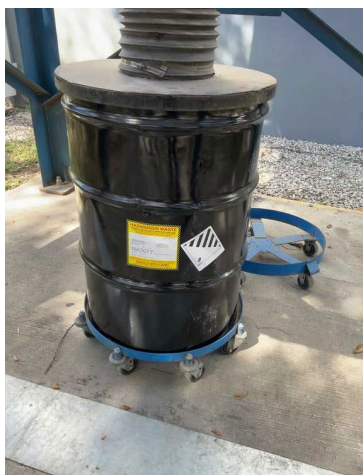
| Photo 44 | | | IMG-2025020513442444243477574.jpg |

| SAA container of hazardous waste solids with cadmium. The container was closed, labeled “Hazardous Waste”, but missing an indication of the hazard of the contents. | | | |

This large and enclosed media blast booth is used for sand blasting parts coming from disassembly. Hazardous waste solids contaminated with cadmium are collected in two bag houses within the enclosed booth. GCLSS manages one SAA at each bag house. The booth was in operation at the time of the inspection and required PPE and a respirator to enter; however, inspectors were provided with a photo of the SAAs inside. One 55-gallon container of hazardous waste solids with cadmium were shown at each SAA inside the media blast booth. Each container was closed, labeled “Hazardous waste”, but missing an indication of the hazard of the contents.

Pursuant to Fla. Admin. Code Ann. r. 62-730.160(1) [40 C.F.R. § 262.15(a)(5)(ii)], a generator must mark or label its container with the following: (ii) An indication of the hazards of the contents (examples include, but are not limited to, the applicable hazardous waste characteristic(s) (i.e., ignitable, corrosive, reactive, toxic); hazard communication consistent with the Department of Transportation requirements at 49 CFR part 172 subpart E (labeling) or subpart F (placarding); a hazard statement or pictogram consistent with the Occupational Safety and Health Administration Hazard Communication Standard at 29 CFR 1910.1200; or a chemical hazard label consistent with the National Fire Protection Association code 704).

Ashley Blondek provided photos of the two containers at the baghouse SAAs marked with indication of the hazards of the contents via email on February 25, 2025.

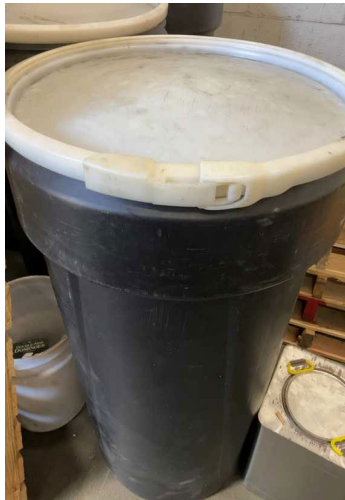
| Photo 46 | | | IMG-2025020514563756371891107.jpg |

| 60-gallon laboratory pack container. The containers (3) were pending TCLP analysis for a hazardous waste determination to be made. The containers were not labeled. | | | |

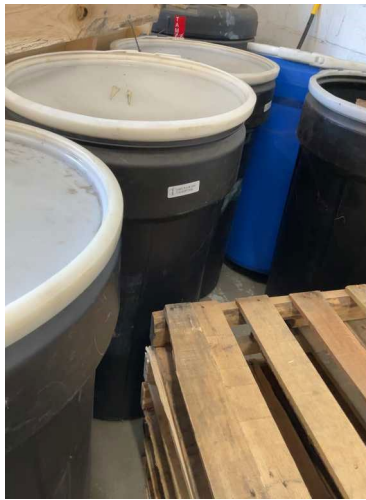
| Photo 47 | | | IMG-2025020514564456441869180.jpg |

| 60-gallon laboratory pack container. The containers (3) were pending TCLP analysis for a hazardous waste determination to be made. The containers were not labeled. | | | |

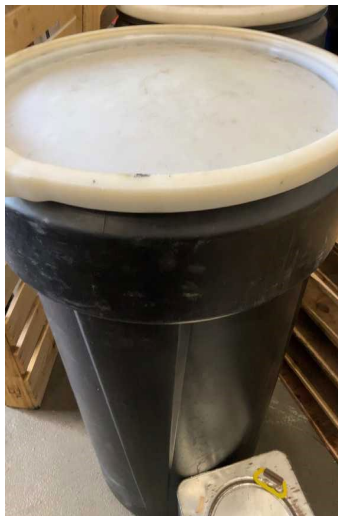
| Photo 48 | | | IMG-2025020514582358232107596.jpg |

| 60-gallon laboratory pack container. The containers (3) were pending TCLP analysis for a hazardous waste determination to be made. The containers were not labeled. | | | |

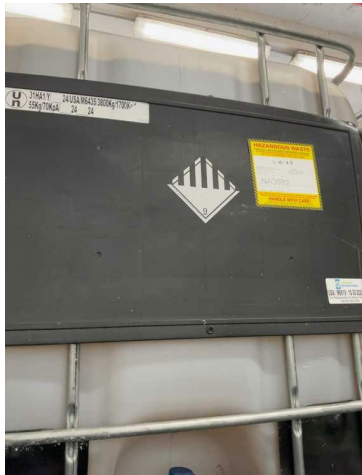
| Photo 49 | | | IMG-202502051506496491798087.jpg |

| 250-gallon tote of hazardous waste. The container was closed, labeled "Hazardous waste", dated, and marked with a D.O.T. Class 9 placard which does not indicate the hazard of the contents. | | | |

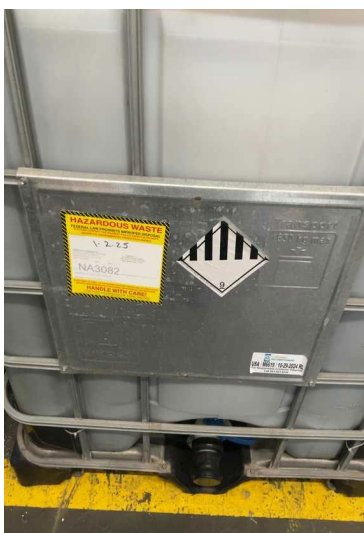
| Photo 51 | | | IMG-202502051507537531971781.jpg |

| 250-gallon totes of hazardous waste. The containers were closed, labeled "Hazardous waste", dated, and marked with a D.O.T. Class 9 placard which does not indicate the hazard of the contents. | | | |

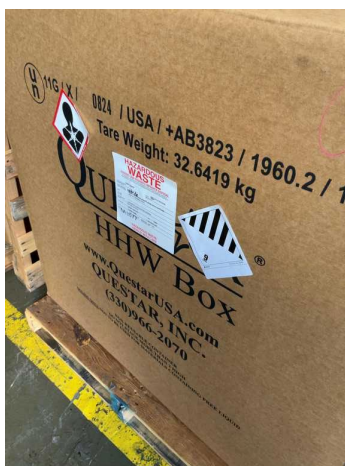
| Photo 53 | | | IMG-2025020515184018402759083.jpg |

| 55-gallon containers of hazardous waste. The containers were closed, labeled "Hazardous Waste", dated and marked with an indication of the hazard of the contents. | | | |

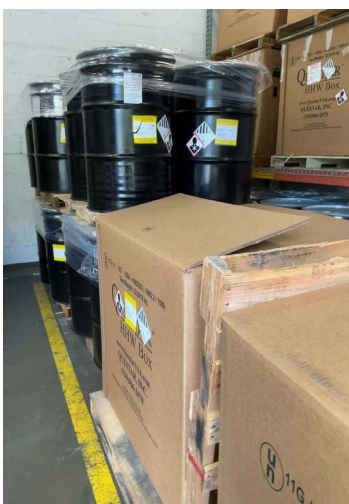
| Photo 54 | | | IMG-2025020515191219122303610.jpg |

| Cubic yard cardboard box of hazardous waste solids. Closed, labeled "Hazardous Waste" date, but was missing an indication of the hazard of the contents. This was corrected onsite during the inspection. | | | |
