## **RCRA Inspection Report**

Arkema Inc. (Arkema)  
4444 Industrial Parkway  
Calvert City, Kentucky 42029  
Marshall County

EPA ID# KYD006370159  
NAICS# 32512 – Industrial Gas  
Manufacturing

**Attachment A**  
**Photographs of Arkema Inc.**  
**EPA ID# KYD-006-370-159**  
**By: Timothy Steward, Arkema Inc.**

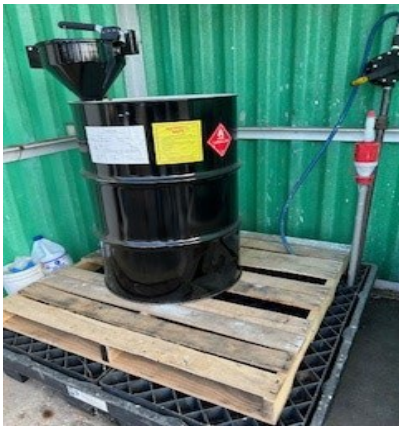
The inspectors observed one 55-gallon satellite container had a funnel with a closed latch on a spill pallet storing paint related waste (Photo-1). The container was observed to be closed, labeled with the words "Hazardous Waste" and with indication of hazards of the contents. There were no leaks or spills observed near the container.

Photo-1 SAA Container (Contractor Area)

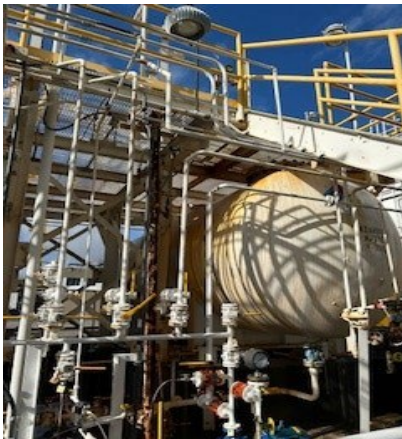
All the tanks had secondary containment systems consisting of concrete walls and floor surrounding the tanks. The secondary containment for the tanks appeared to be free of cracks and gaps. The inspectors observed rust and signs of corrosion on some of the ancillary piping associated with the Tank V-0229 and Tank V-0121 system (Photo-2) and (Photo-3). The saddle support for Tank V-0229 was in disrepair (Photo-4).

Based on the review of the daily tank inspection logs, rust and corrosions and the saddle support in disrepair observed by the inspectors did not appear to be documented and on a schedule for a remedial action to prevent an environmental or human health hazard.

Photo-2 Rust and Signs of Corrosion on Tank's Ancillary Equipment

**Pursuant to the Hazardous Waste Permit KYD-006-370-159, Module III.L – Tank System Management Practices, which incorporates III.L.9.1 Inspections and 401 KAR 39:090, Section 1 and Sections 1(1)-(7) [40 CFR Part 264.195], the permittee shall inspect each tank system, including but not limited to ancillary equipment and secondary containment as well as the area surrounding each tank specified in Attachment D and Attachment F. The inspection shall include above ground portion of the tank system, if any to detect corrosion or release of waste.**

**Pursuant to the Hazardous Waste Permit KYD-006-370-159, Module III.L.9 Inspections which incorporates III.L.9.5, and 401 KAR 39:090, Section 1 and Sections 1(1)-(7) [40 CFR Part 264.195] the Permittee shall remedy any deterioration or malfunction of equipment or structures which the inspection reveals on a schedule which ensures that the problem does not lead to an environmental or human health hazard, where a hazard is imminent or has already occurred, remedial action shall be taken immediately [40 CFR Part 264.15].**

The facility personnel indicated that rust and corrosion on the ancillary piping and the saddle of the tank in disrepair shall be evaluated for appropriate remedial action.

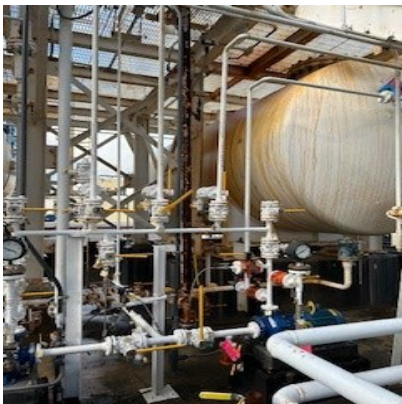
Photo-3 Rust and Signs of Corrosion on the tank's ancillary equipment

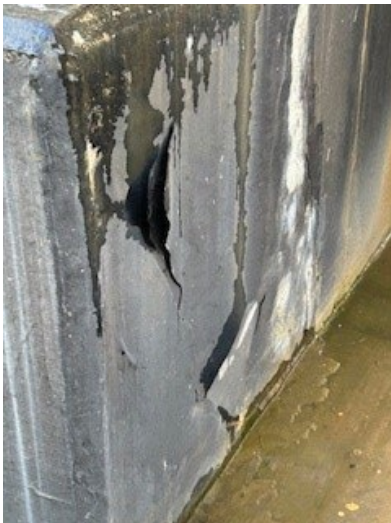
Photo-4 Disrepair saddle on which one of the hazardous waste tank was mounted

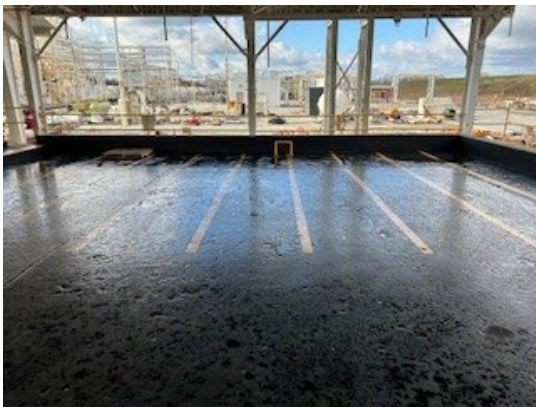
The containers of hazardous wastes are stored in a covered concrete pad and a concrete berm (Photo-5). The inspectors observed a sign indicating the storage area and “No Smoking”. The storage area was equipped with a fire extinguisher and a spill kit. There were no containers of hazardous waste in the storage at the time of inspection (Photo-5).

Photo-5 No Waste Storage in CAA

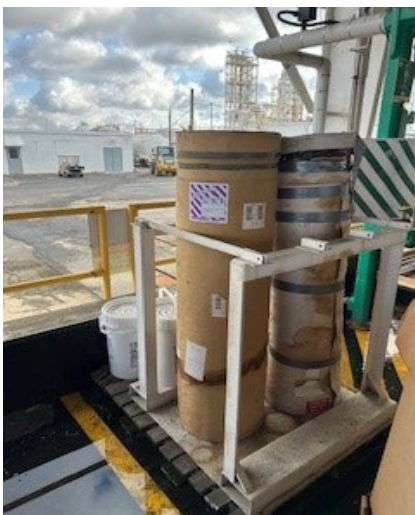
The inspectors observed two cardboard cylindrical containers containing four-foot universal waste lamps stored near the concrete berm exposed to precipitation. One of the universal waste containers was wrapped with duct tape at several places did not appear to be securely closed and had visible stains on the bottom exterior of the container (Photo-6).

The boxes were observed to be labeled and dated. The oldest date observed was 03/25/2024. The inspectors observed five 5-gallon buckets containing waste batteries near the universal lamps. The waste batteries were observed to closed, labelled and dated. The oldest date was observed to be 06/29/2024.

Photo-6 Universal Waste Staging Area

**Pursuant 401 KAR 39:080, Section 3(1) [40 C.F.R. § 273.13(d)], a SQHUW must manage universal waste lamps in a way that prevents releases of any universal waste or component of a universal waste to the environment.**

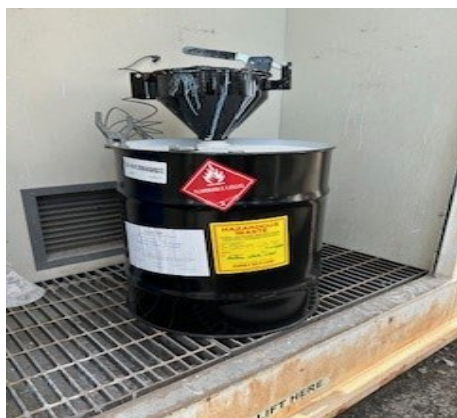
The analytical lab provides quality control testing for inbound samples from the production area and final outbound samples from the finished product. There is one CAA outside the Kynar Lab. There was one 30-gallon container at the time of inspection (Photo-7). The container was observed to be closed and labeled with the words "Hazardous Waste" and with indication of the hazards of the contents. The oldest accumulation date was observed to be 11/05/2024.

Photo-7 Kynar Lab-CAA
