## REPORT OF VISUAL INSPECTION

September 10, 2024

TOEROEK ASSOCIATES, INC. and TETRA TECH INC.

U.S. ENVIRONMENTAL PROTECTION AGENCY

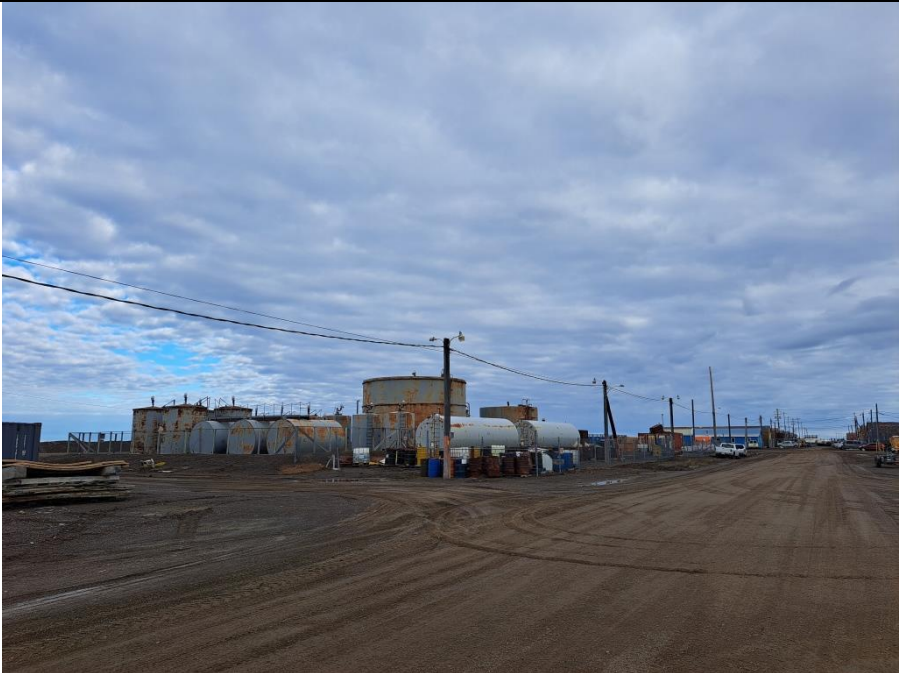
| Description | This photograph shows the UIC Drum Storage area on the UIC property, adjacent to Iḷisaḡvik College. | | | 1 |

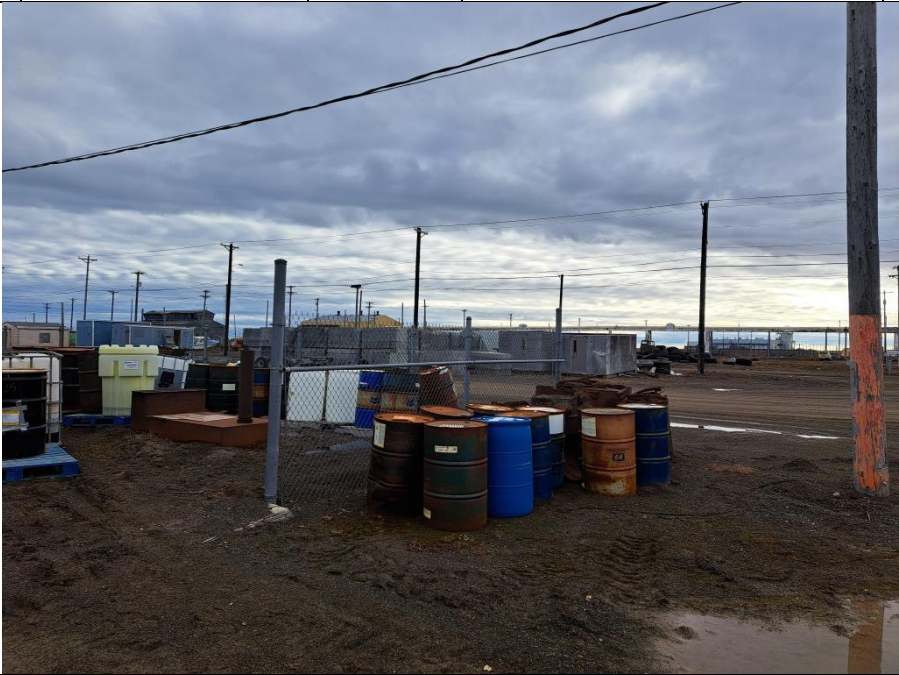
When I arrived, I observed an approximately 15,000-square-foot area surrounded by a 6-foot-high chain link fence (Photograph 2). The entry to the fenced area did not have a gate, and the area did not have any signage. I took photographs primarily from the right-of-way. Because the area appeared to be unsecured and did not have any posted prohibitions or contact information, I briefly entered the fenced area to photograph labels on containers.

| Description | This photograph shows 10 55-gallon containers (drums) and eight open drums filled with sand and concrete just outside the fenced area. The fence was not gated. | | | 2 |

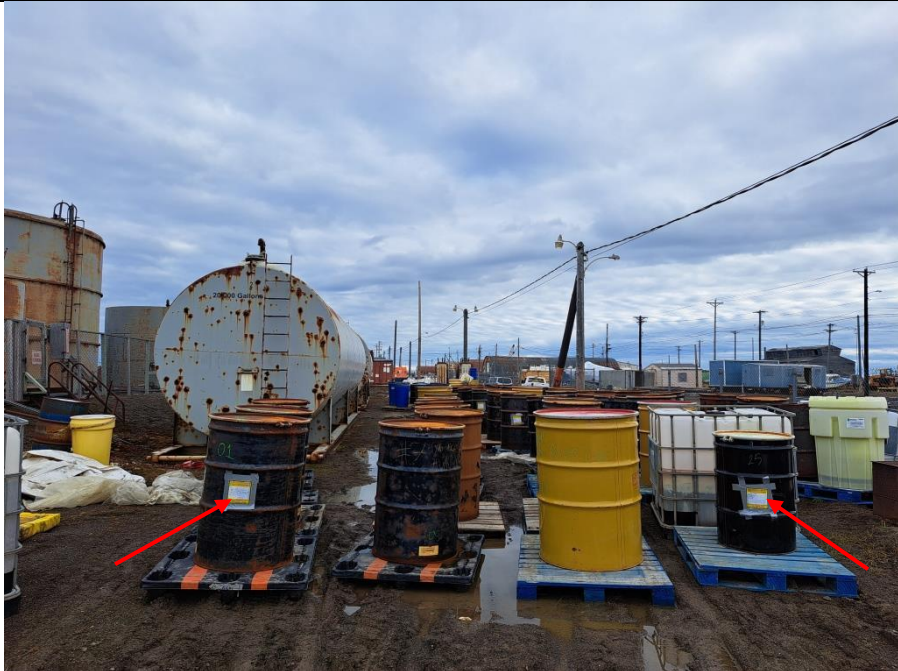
Inside the fenced area, I observed approximately 100 drums, five totes, 20 transformers, 20 1-cubic-yard textile bags (super sacks), and five shipping containers. The horizontal tanks inside the fence were labeled for “LP” (the common abbreviation for “liquid propane”), but their contents or fill level was not determined.

| Description | This photograph shows the area inside the fence, which held approximately 100 drums, 20 transformers, five 300-gallon containers (totes), 20 1-cubic-yard textile bags (super sacks), and five shipping containers. The horizontal tanks inside the fence were labeled for “LP” (liquid propane), but their contents or fill level was not determined. Drums in the foreground were labeled as hazardous waste (arrows). | | | 3 |

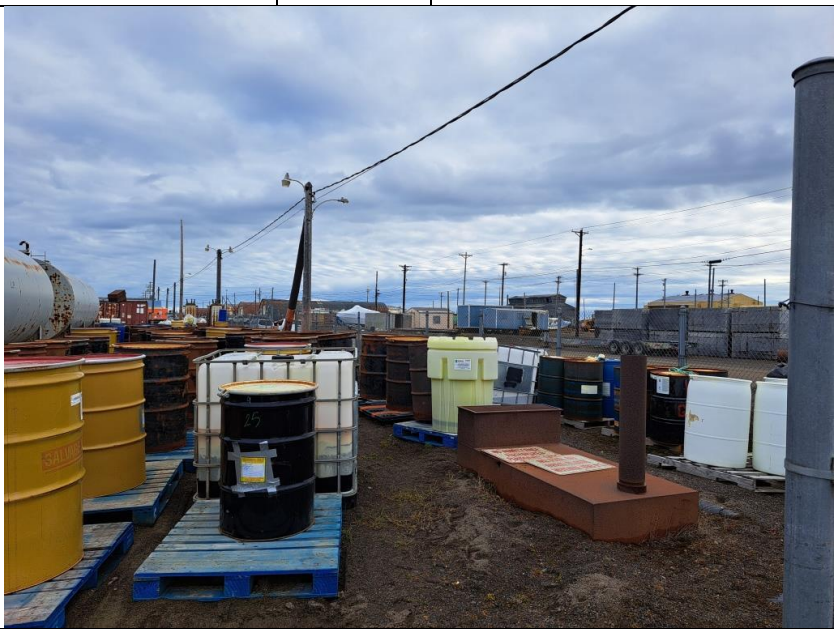
| Description | This photograph shows another view of the containers in the fenced area. | | | 4 |

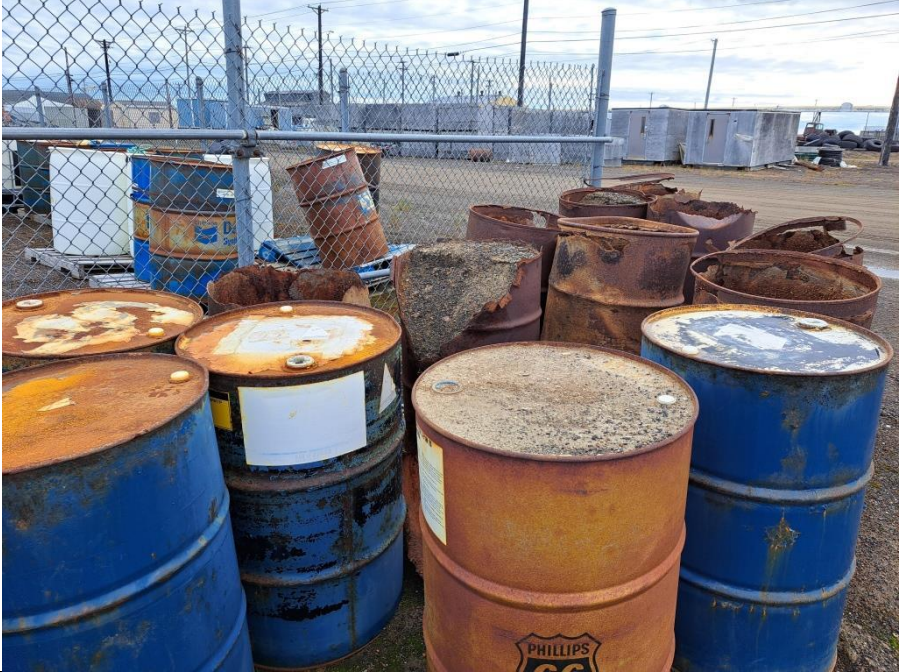
| Description | This photograph shows another view of the containers outside the fenced area, shown in Photograph 2. | | | 5 |

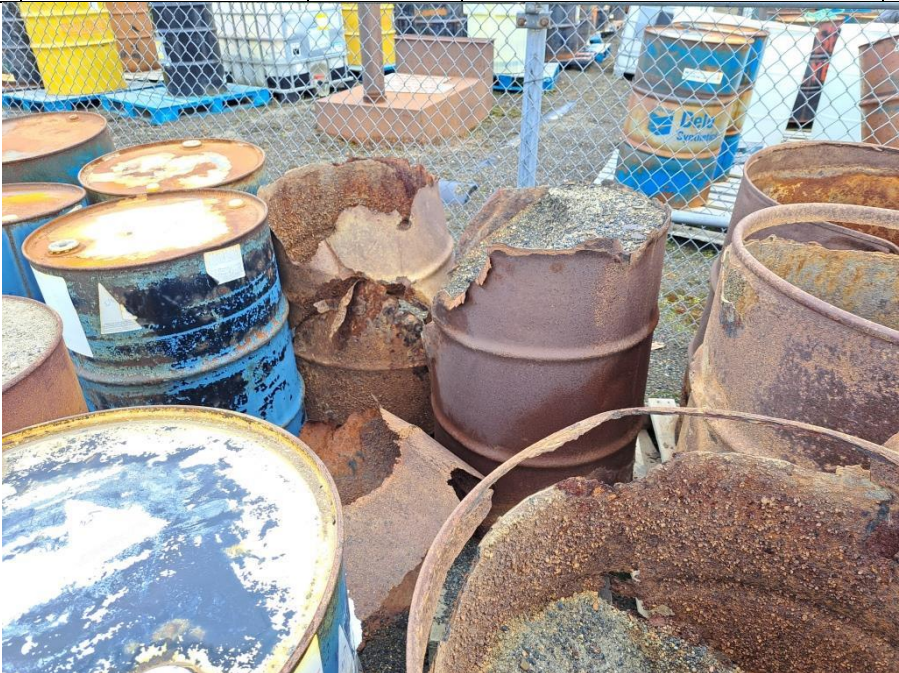
| Description | This photograph shows another view of the containers outside the fenced area, shown in Photograph 2. | | | 6 |

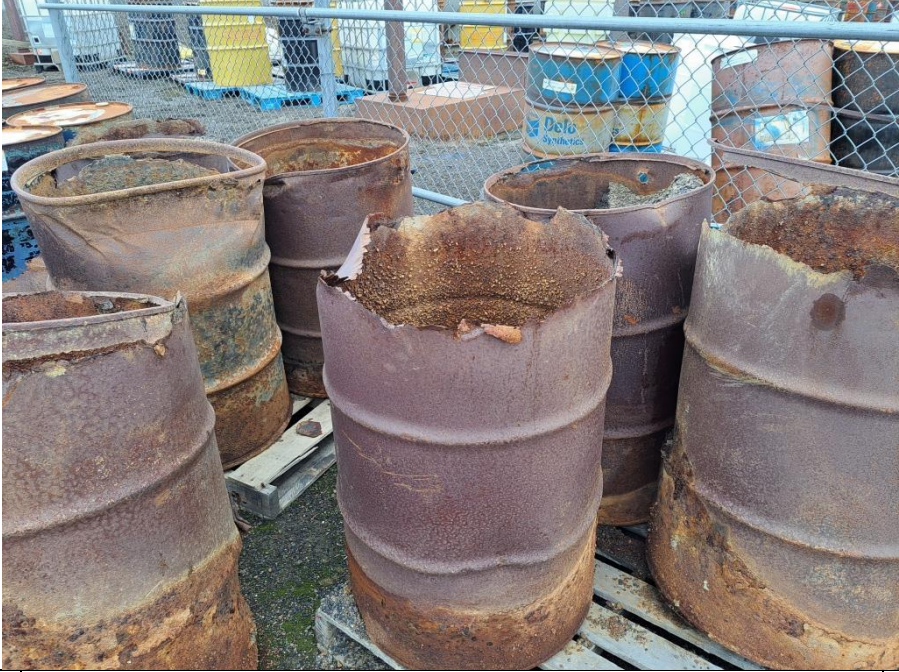
| Description | This photograph shows another view of the containers outside the fenced area, shown in Photograph 2. | | | 7 |

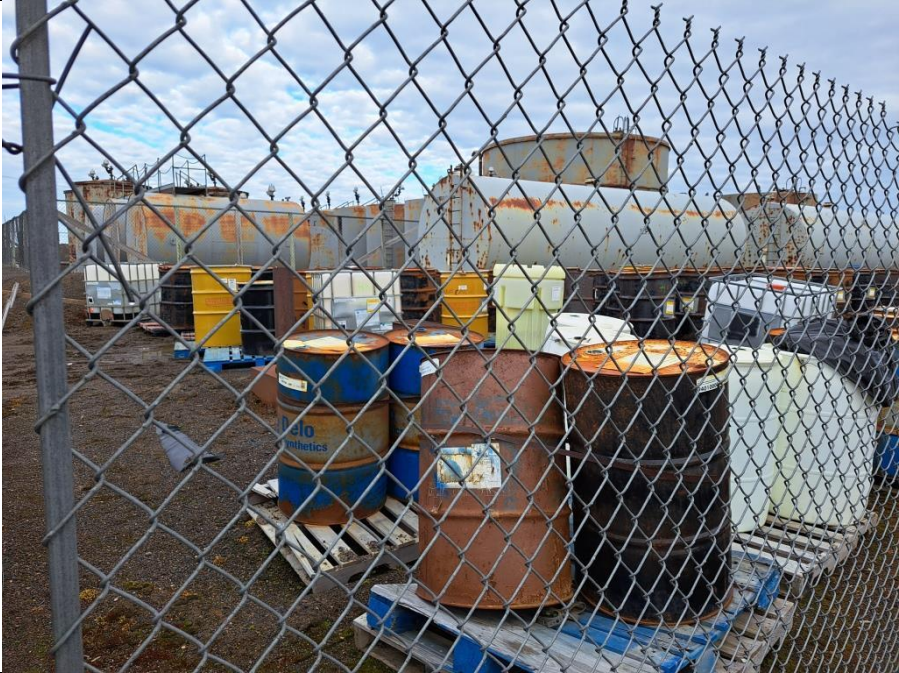
| Description | This photograph shows another view of the containers inside the fenced area, shown in Photograph 3. | | | 8 |

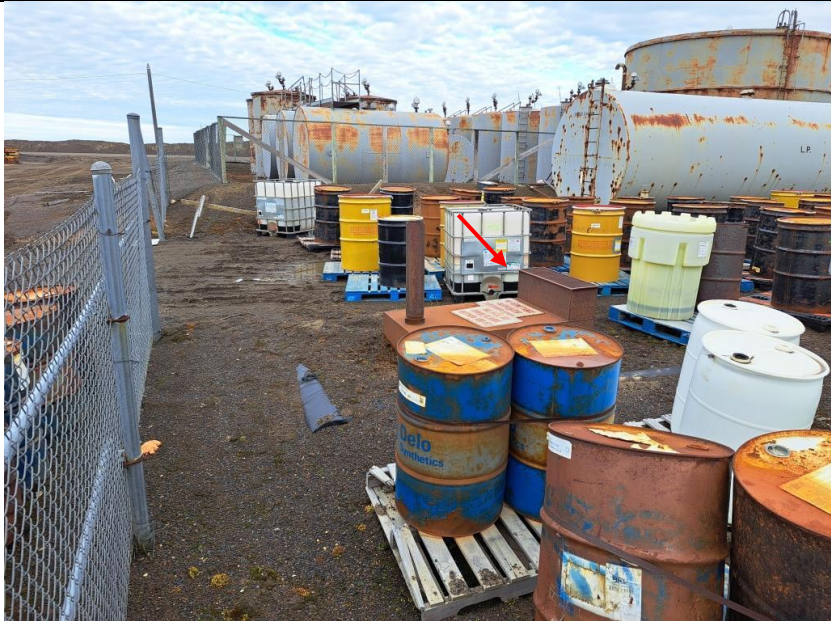
| Description | This photograph shows another view of the containers inside the fenced area, shown in Photograph 3. A “hazardous waste” label is visible on one of the totes (arrow). | | | 9 |

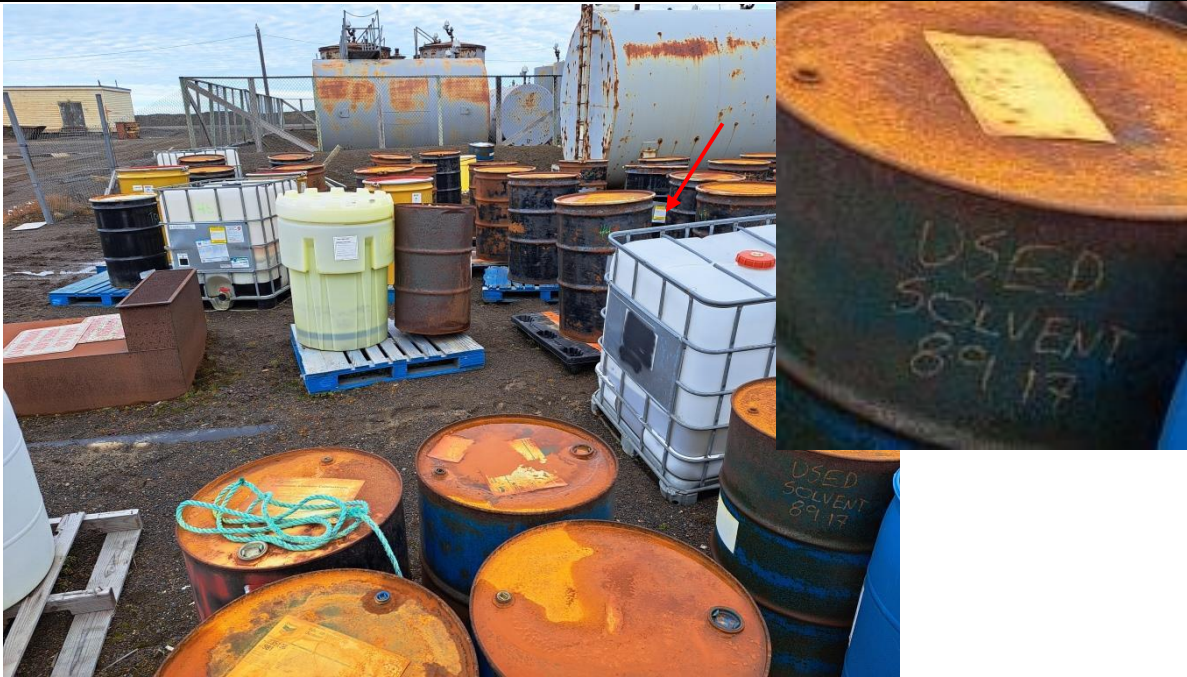
In addition to the containers of waste related to the Avak Creek release, I observed approximately 50 other containers with either no labels or incomplete labels. I observed one container that was labeled as “used solvent” and dated August 9, 2017 (Photograph 10).

| Description | This photograph shows another view of the containers inside the fenced area, shown in Photograph 3. A “hazardous waste” label is visible on one of the drums (arrow). A drum in the foreground is labeled as “used solvent” and dated August 9, 2017 (inset). | | | 10 |

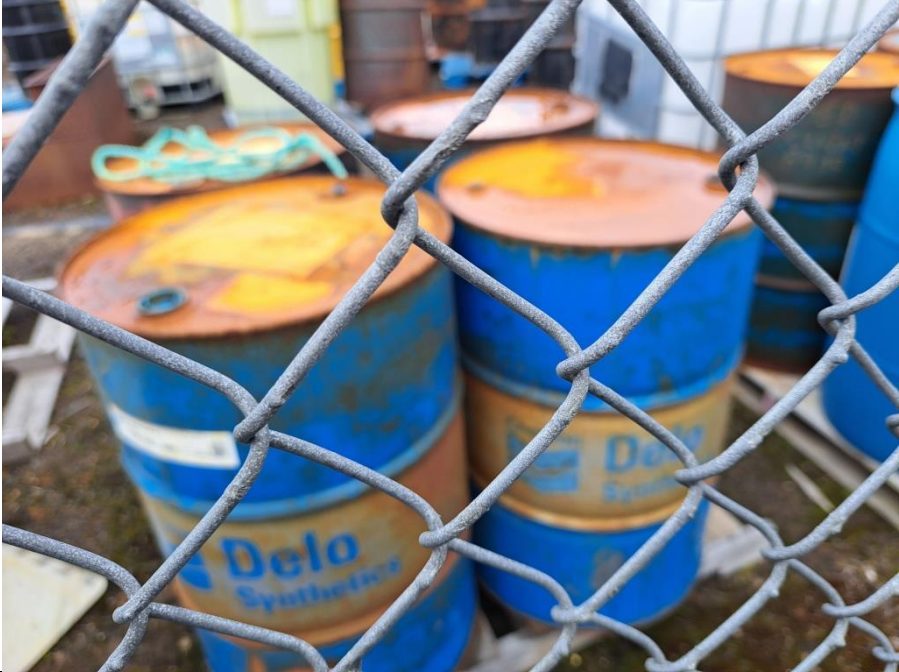
| Description | This photograph shows another view of the containers inside the fenced area, shown in Photograph 3. | | | 11 |

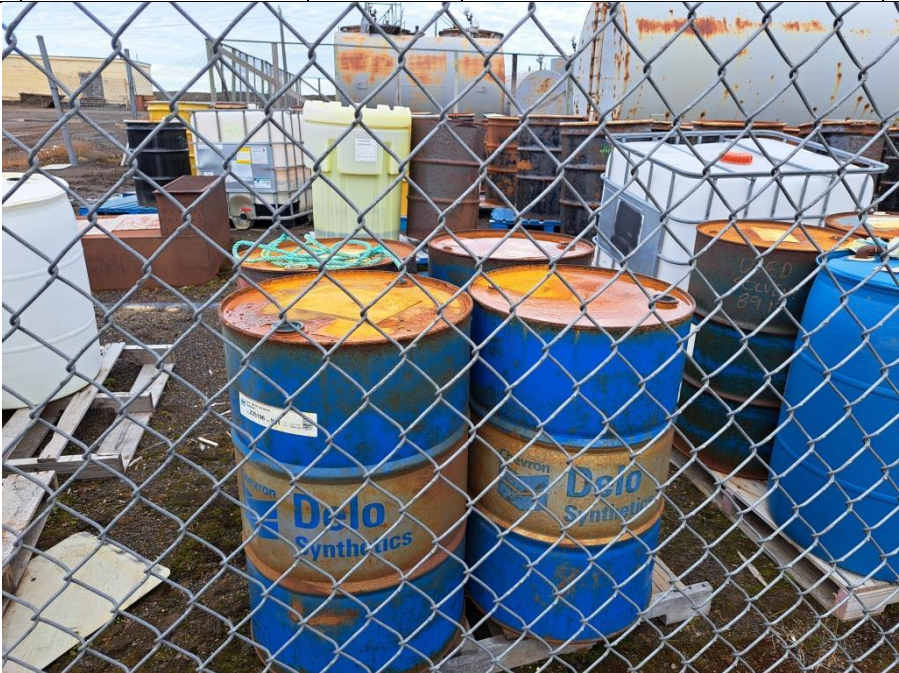
| Description | This photograph shows another view of the containers inside the fenced area, shown in Photograph 3. | | | 12 |

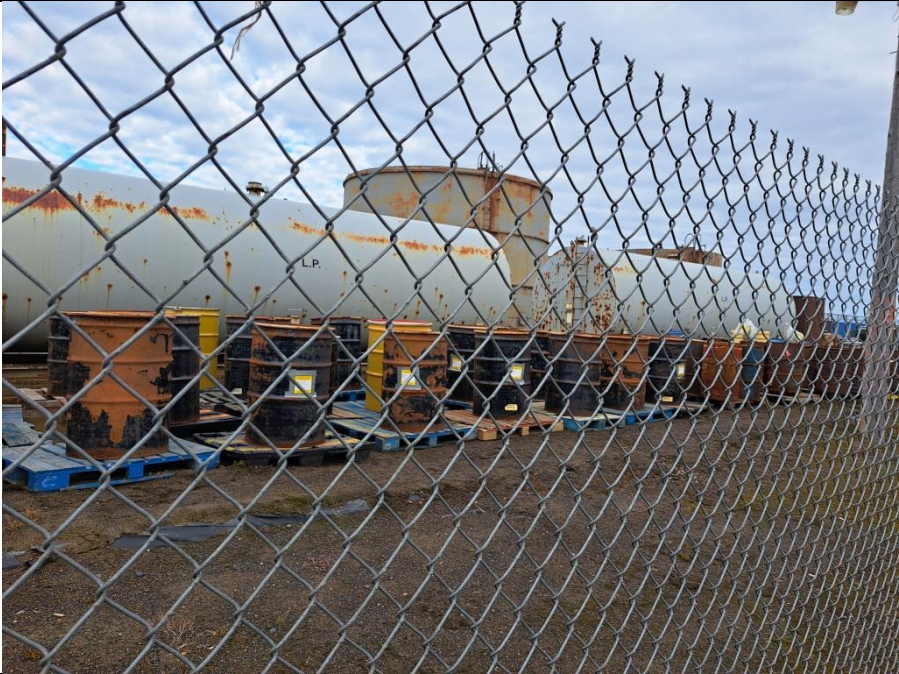
| Description | This photograph shows approximately 30 drums on pallets, with yellow “hazardous waste” labels. | | | 13 |

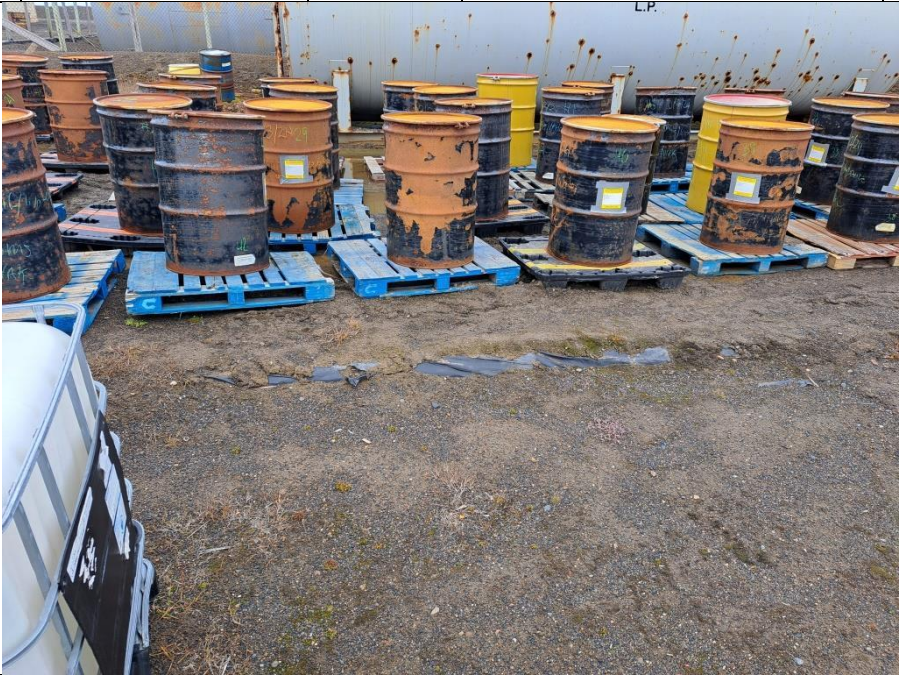
| Description | This photograph shows another view of the containers shown in Photograph 13. | | | 14 |

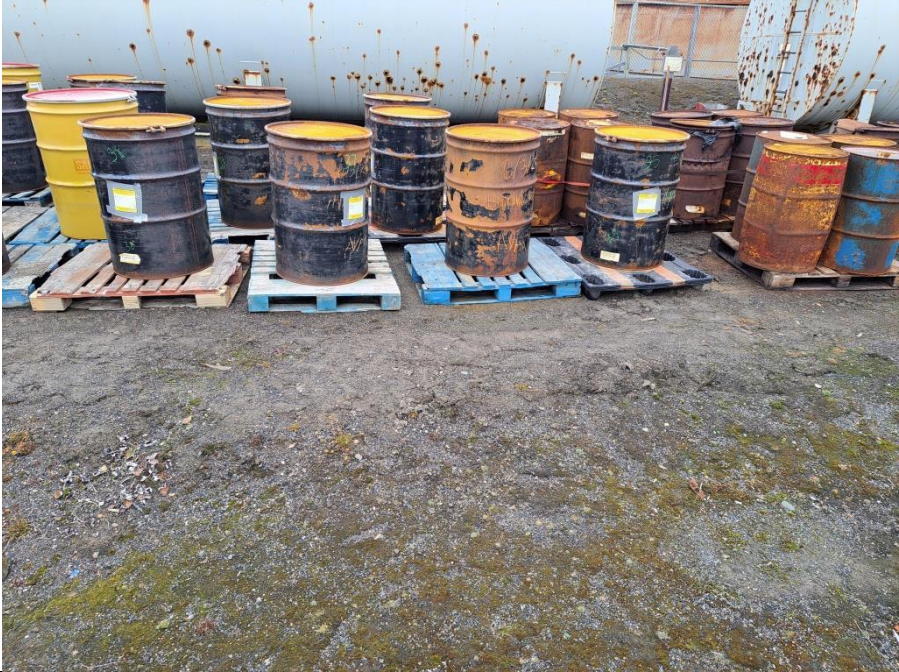
| Description | This photograph shows another view of the containers shown in Photograph 13. | | | 15 |

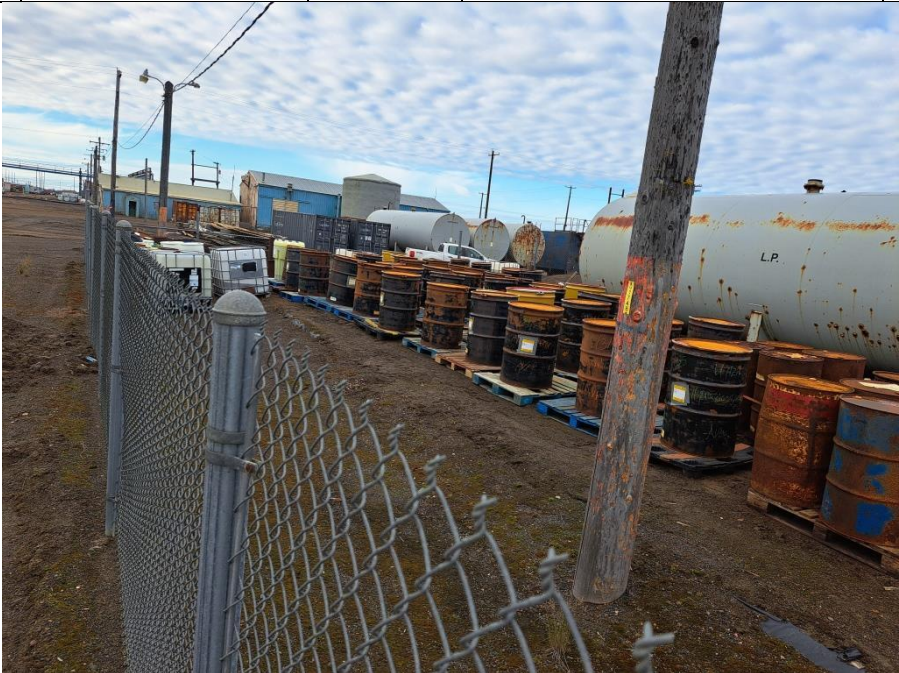
| Description | This photograph shows another view of the containers shown in Photograph 13. | | | 16 |

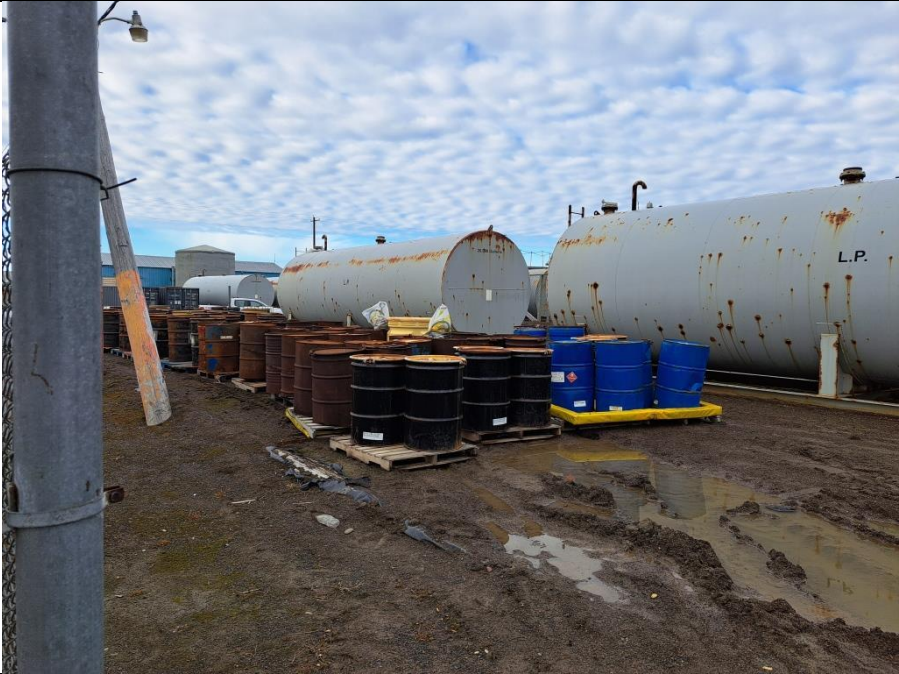
| Description | This photograph shows another view of the containers shown in Photograph 13. | | | 17 |

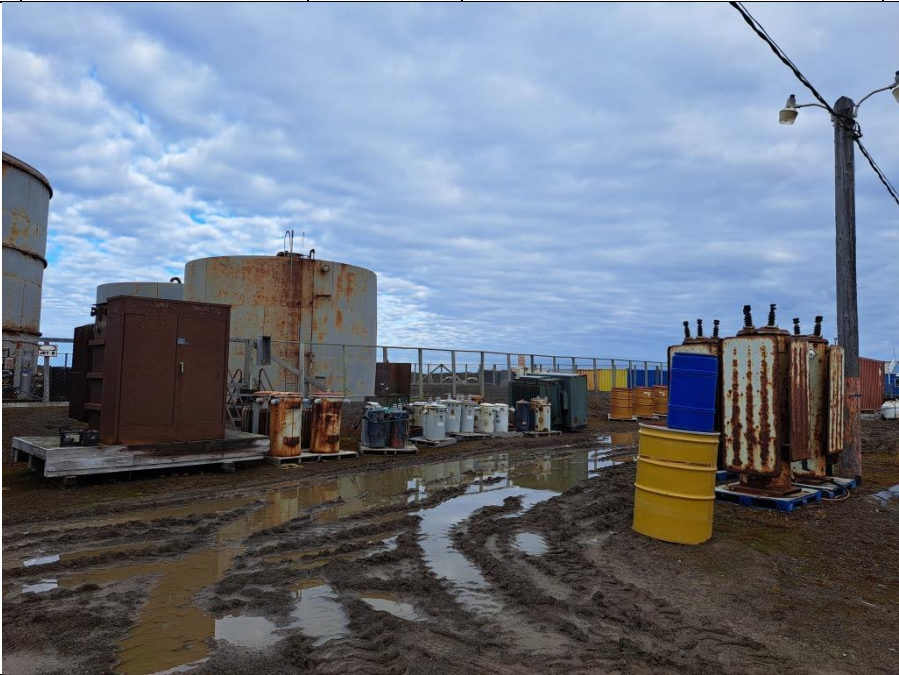
| Description | This photograph shows the approximately 30 transformers inside the fenced area. | | | 18 |

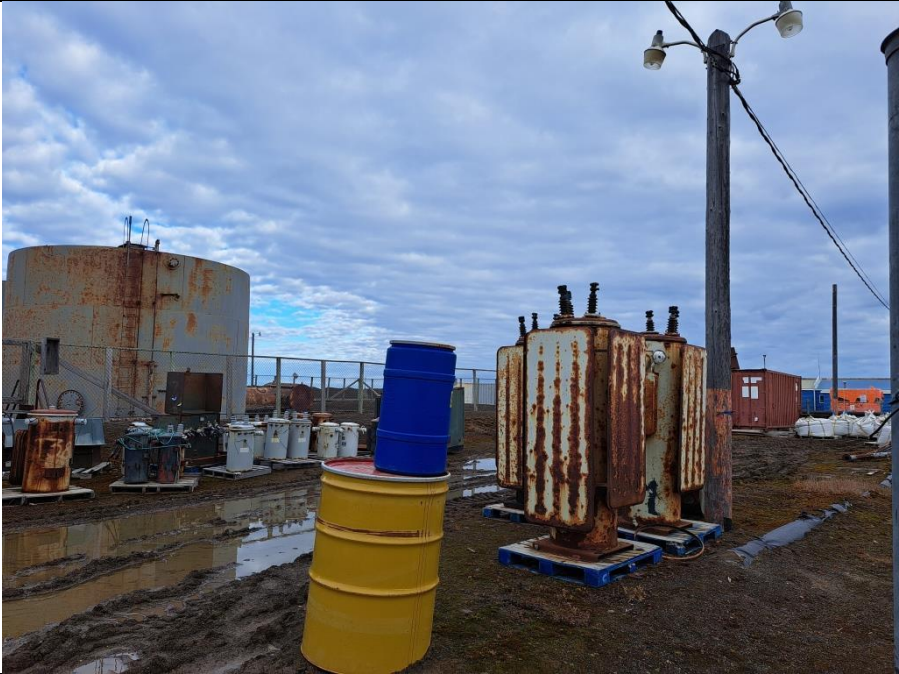
| Description | This photograph shows another view of the transformers shown in Photograph 18. The super sacks are visible in the background, next to the shipping container. | | | 19 |

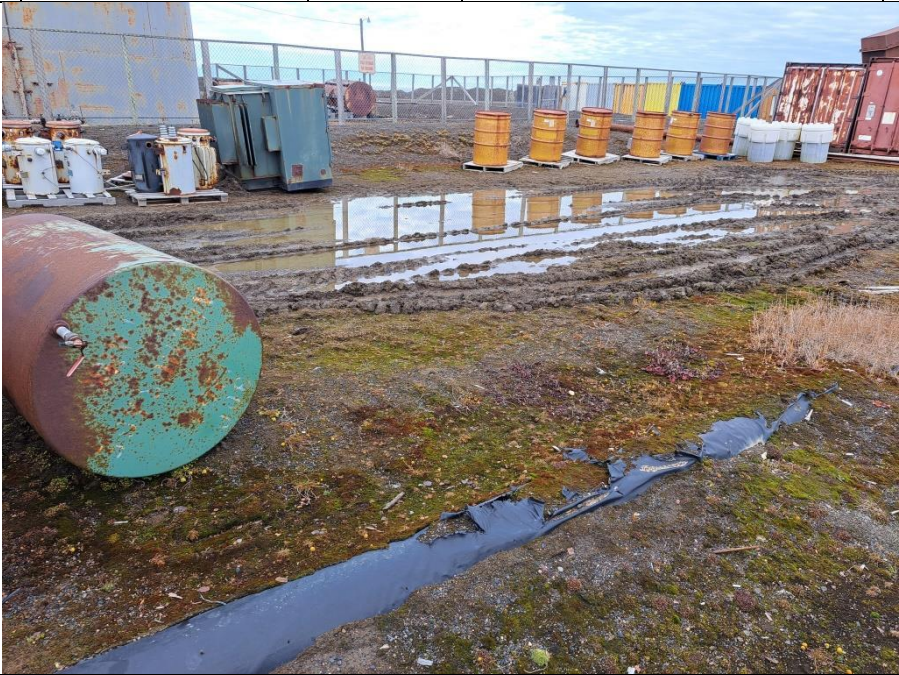
| Description | This photograph shows overpack and salvage drums and some of the transformers visible in Photograph 18. | | | 20 |

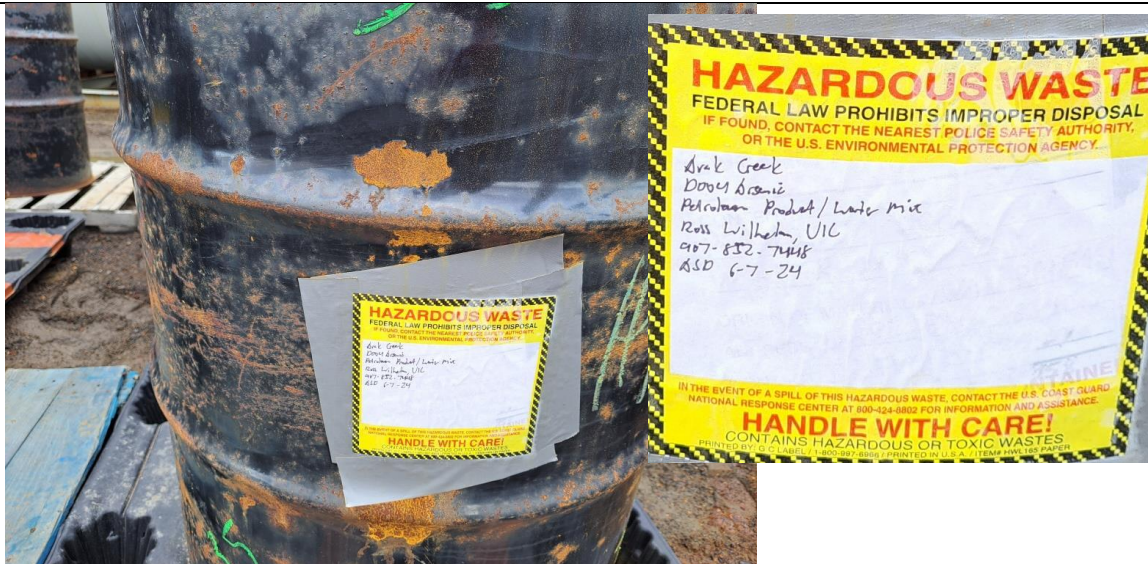
Most of the drums and all of the totes were labeled as “hazardous waste.” They were identified as characteristically toxic arsenic-containing hazardous waste and dated in June 2024 (Photographs 21 through 24). A label on one of the totes suggested that the waste determination was based on analysis (“this container on hold pending analysis”) (Photograph 24). Contact information was also provided on these containers (Ross Wilhelm of UIC, 907-852-7448).

| Description | | This photograph shows the label on one of the drums in Photograph 13, identifying the waste as arsenic-containing (D004) mixed petroleum-water hazardous waste. It is dated June 7, 2024, and is identified as coming from Avak Creek. The inset shows the label. | | | 21 |

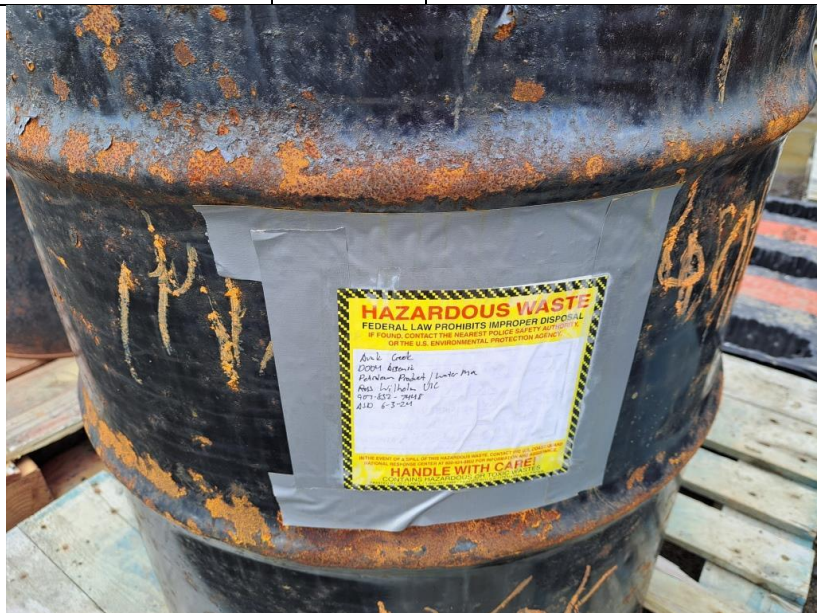
| Description | | This photograph shows the label on one of the drums in Photograph 13, identifying the waste as arsenic-containing (D004) mixed petroleum-water hazardous waste. It is dated June 4, 2024, and is identified as coming from Avak Creek. | | | 22 |

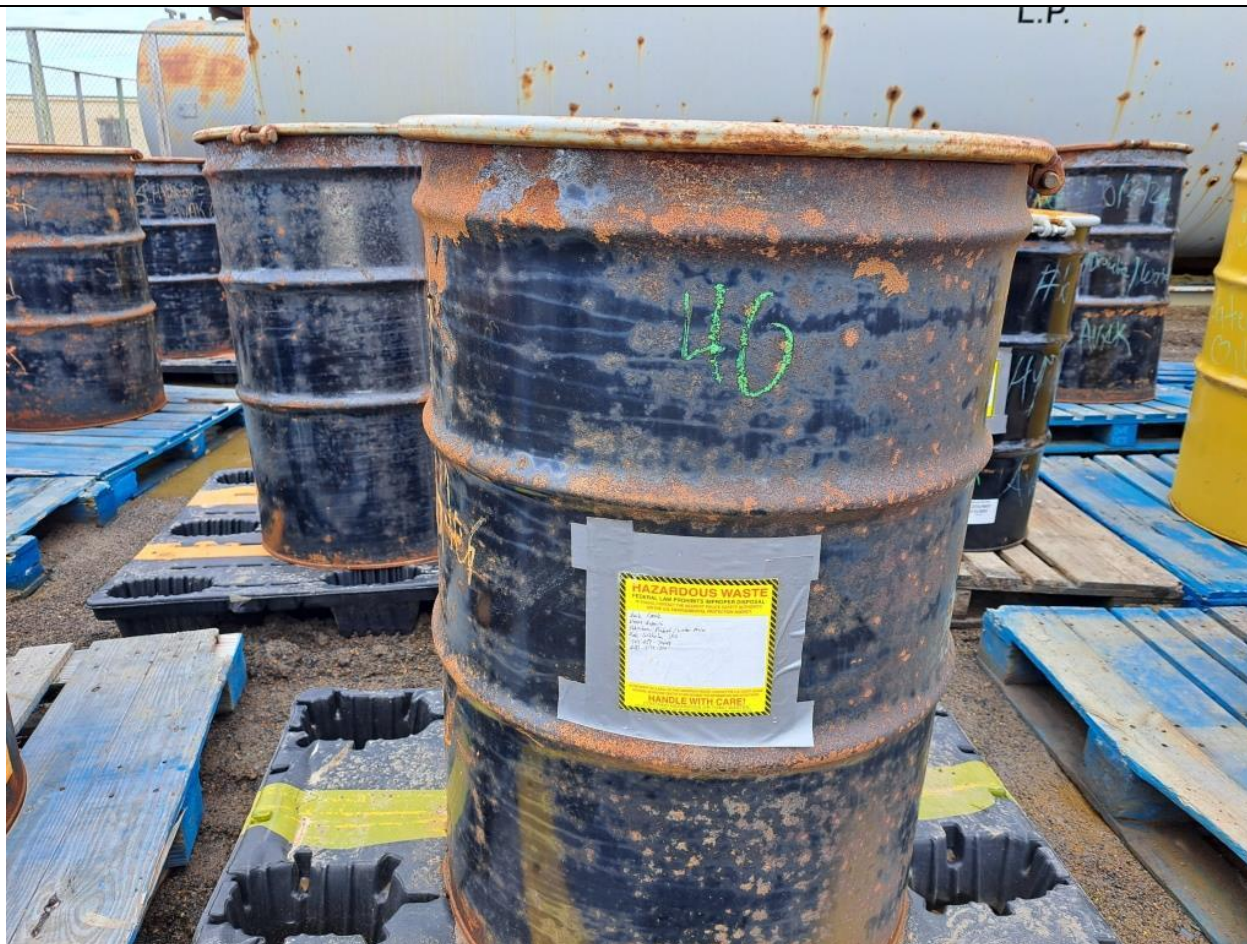
| Description | This photograph shows the label on one of the drums in Photograph 13, identifying the waste as arsenic-containing (D004) mixed petroleum-water hazardous waste. It is dated June 4, 2024, and is identified as coming from Avak Creek. The drum is labeled as container #40 (or 46). Drums in the background are also labeled as related to the Avak release and also dated June 4, 2024. The yellow drum at right is labeled as water and oil, and appears to be dated May 2024. | | | 23 |

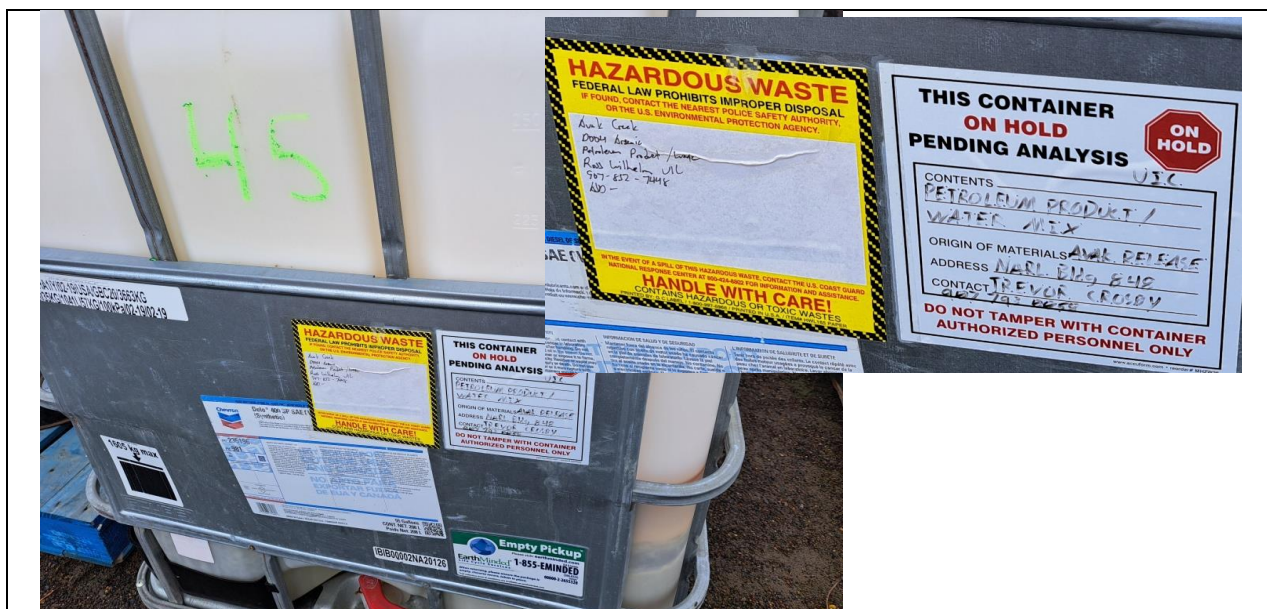
| Description | This photograph shows the label on the tote identified in Photograph 9, identifying the waste as arsenic-containing (D004) mixed petroleum-water hazardous waste. It is undated and is identified as coming from “Avak Release.” The inset shows the labels. The tote is labeled as container #45. | | | 24 |
