## **RCRA Inspection Report**

DaikyoNishikawa USA Inc.  
9000 Greenbrier Parkway, NW, Unit 95  
Madison, AL 35756  
Limestone County  
EPA ID Number: ALR000065730

**COMPLIANCE EVALUATION INSPECTION PHOTOGRAPHS**

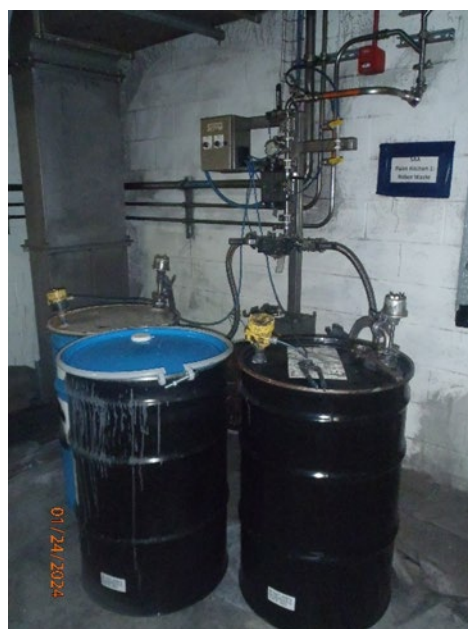
Picture 4 – Paint Kitchen 2 non-hazardous waste drums

Paint Kitchen 2 was an enclosed paint shop with product drums and mixing equipment. The inspectors observed two 55-gallon drums of non-hazardous base coat primer water-based paint waste (Pictures 4-5). The drums were closed and labeled.

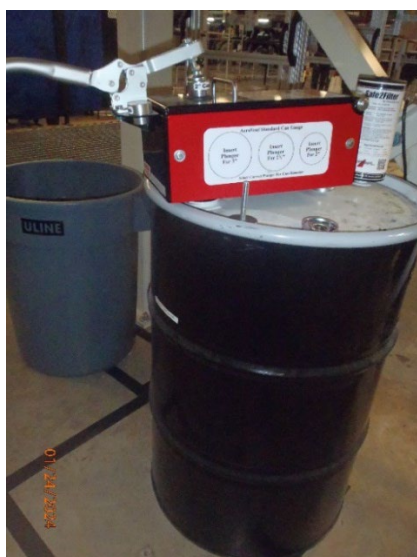
Picture 3 – Aerovent Aerosol Can puncture system drum

The inspectors then walked through the Production Area and observed the moulding press and the base coat paint system. An Aerovent aerosol can puncture system was observed in the Production Area (Picture 3). At the time of the inspection, the 55-gallon drum was empty and not labeled.

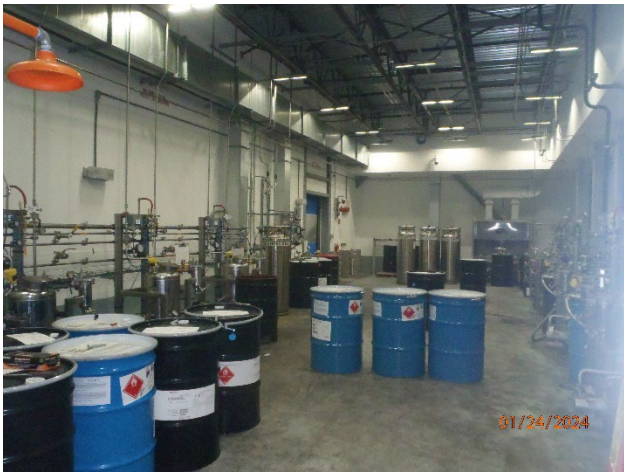
Picture 6 – Paint Kitchen 2 SAA

In the Clear Coat Paint Room, the inspectors observed a SAA with a 55-gallon hazardous waste drum of Robowaste actively being piped into the drum (EPA Waste Codes D001, F003 and F005) (Pictures 6-7). The drum was closed and labeled. Next to the paint waste drum was a 55-gallon drum of used paint waste debris such as absorbent pads with solvent, personal protection equipment, rags, and cups. At the time of the inspection, the drum was not labeled or placarded. Mr. Sweeney had staff to immediately label the drum.

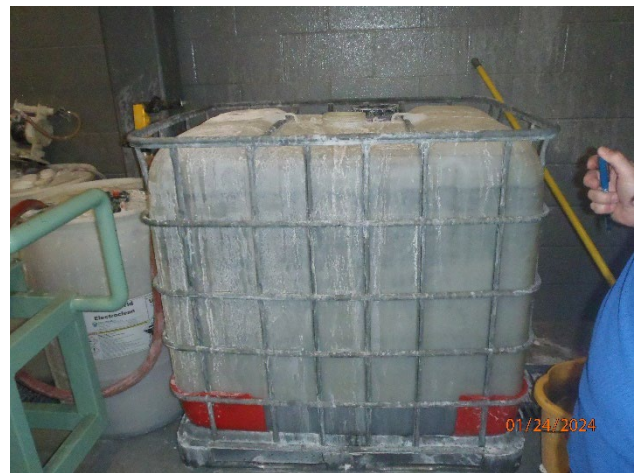
Picture 11 – Electro Clean Storage HW tote

The Electro Clean Storage Area is maintained by Michelle Hood, who explained that sodium hydroxide is used in cleaning the parts. The inspectors observed an empty 55-gallon SAA drum near the door and a 350-gallon tote of waste sodium hydroxide closer to the process and used as a collection container when the process was pumped out (Pictures 11-13). At time of the inspection, the tote only had 40-gallons inside, and the inspectors were told that it takes a week to reach 55-gallon in the tote. Then the contents of the tote would be pumped into the drum for pick up. The inspectors observed the tote was not closed or labeled. Mr. Sweeney had staff to immediately close and label the tote.

The inspectors explained that if the tote exceeded 55-gallons the area became a CAA and would require weekly inspections, signage and to be secured. Also transferring from SAA to SAA is not

allowed and the facility needed to decide how they would collect the waste sodium hydroxide other than using the tote and then transferring the waste into drums. The inspectors also observed the secondary containment in the floor was full and needed clean out.

**Pursuant to ADEM Admin. Code r. 335-14-3-.01(2) [40 C.F.R. § 262.17(a)(5)(i)], which is a condition of the LQG Permit Exemption, a generator must mark or label its containers with the following: the words “Hazardous Waste”; an indication of the hazards of the contents; and the date upon which each period of accumulation begins clearly visible for inspection on each container.**

On February 2, 2024, Mr. Sweeney emailed the inspectors pictures of the slush mould room where the tote was collecting waste. Mr. Sweeney stated that the issues had been corrected by removing the tote and they had started collecting the waste in only 55-gallon drums. In addition, the secondary containment grating had been cleaned out.
